Department of Energy
Office of Legacy Management

Subject: Transmittal of the June 2008 Fernald Site Inspection Forms

FERNALD PRESERVE FIELD WALKDOWN INSPECTION FORM

**Fernald Preserve
 Consolidated Finding Locations
 for June 2008 Site Inspection**

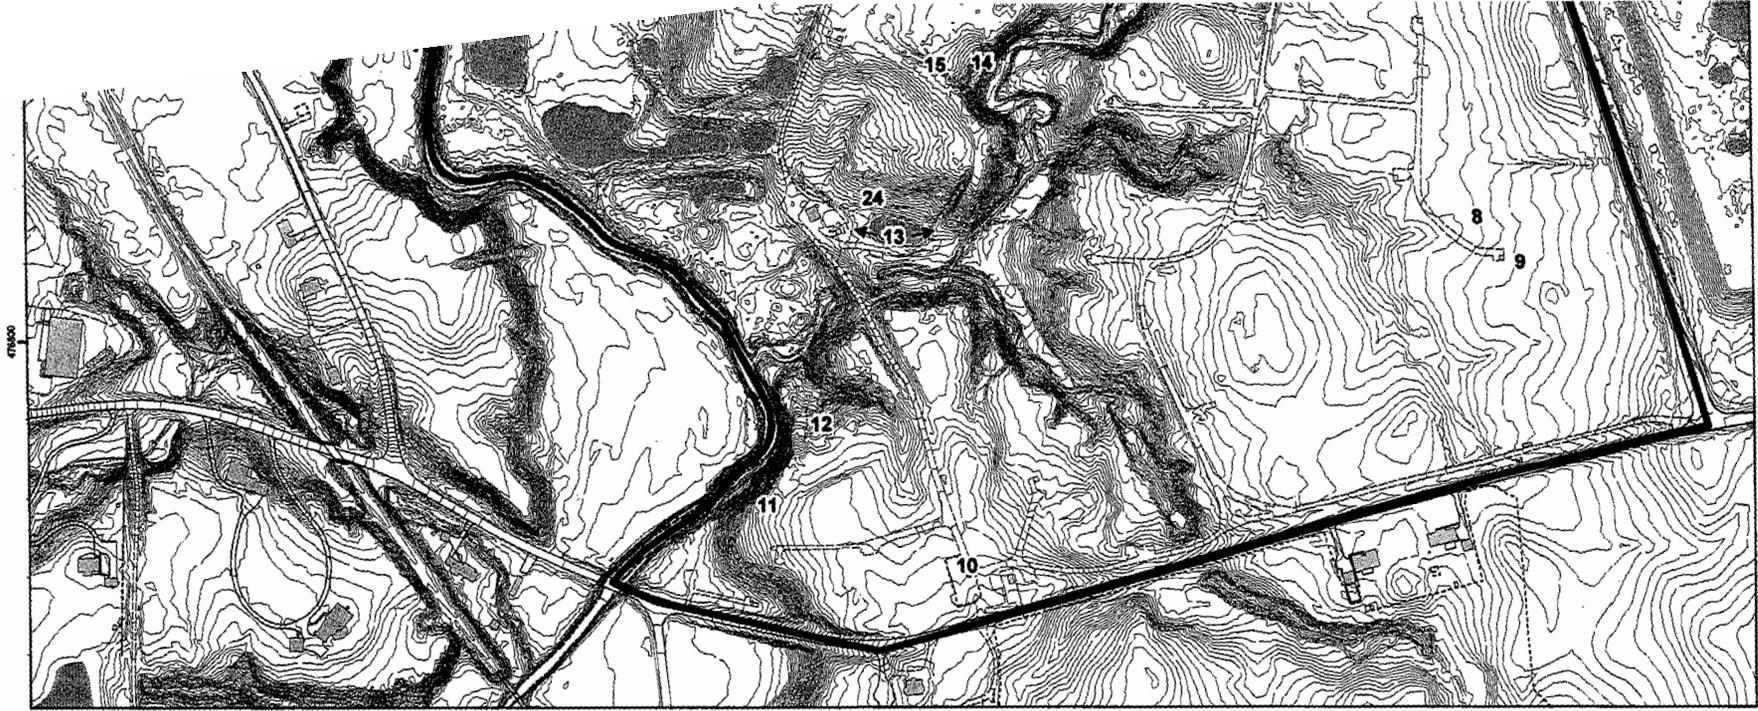
NOTE: Findings are numbered and provided on the June 2008 Field Walkdown Form.
