State of Ohio Environmental Protection Agency

October 8, 2009

**RE: Standing Water in the Drainage Channels of the On-Site Disposal Facility (OSDF)**

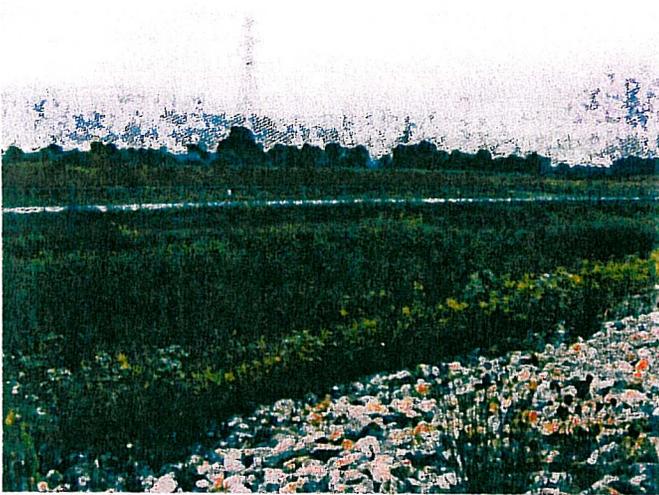
On September 10, 2009 Ohio EPA participated in the quarterly inspection of the OSDF. During this inspection and previous inspections large stands of cattails have been observed in the drainage channels of the OSDF. (See attached photographs). The presence of cattails indicates persistent standing water in the drainage channel.

The drainage channel was designed to convey surface water away from the OSDF. Cattails are evidence of ponding in the drainage channel and it appears that the original grade of the channel has not been maintained or was not sufficient to meet the design criteria.

Figure 1. Cattails present along the east drainage channel of the OSDF.

Ohio EPA requests that a meeting be scheduled in the near future to discuss the inspection findings and their potential impacts to the integrity of the OSDF. The meeting should include a representative from the OSDF designer, Geosyntec; as well as, DOE-LM, Stoller, US EPA, and Ohio EPA.

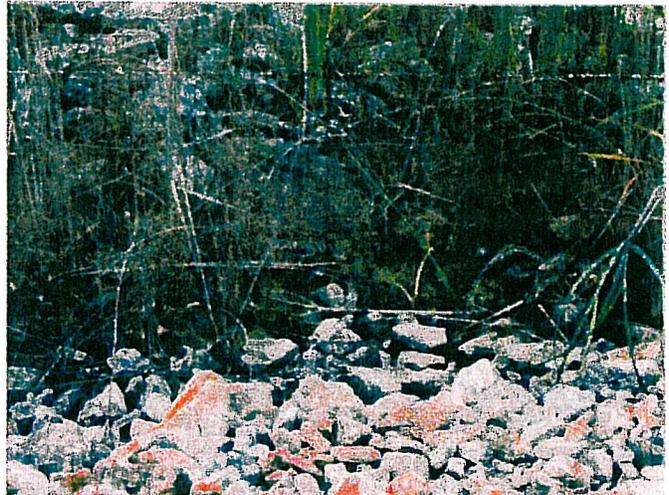
Figure 2. Ponding water along the drainage channel of the OSDF.

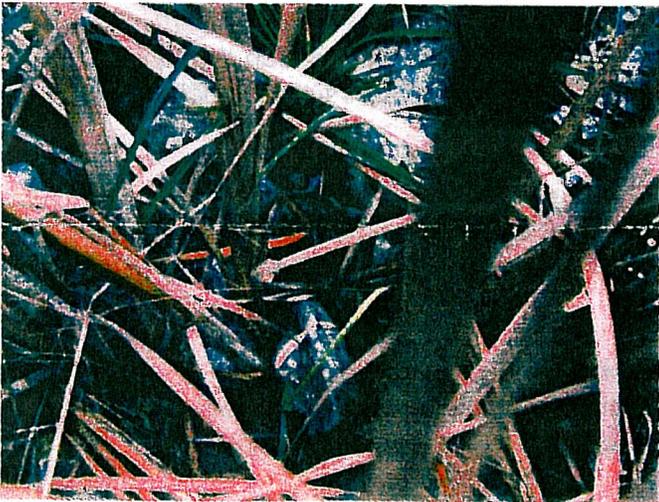
Ohio EPA also observed cattail growth up-gradient from the base of the drainage channel indicating potential seeps to the drainage channel. These areas may be an indication of preferential flow from the cover, or some other source, to the drainage channel.

Figure 3. Water from apparent seeps.

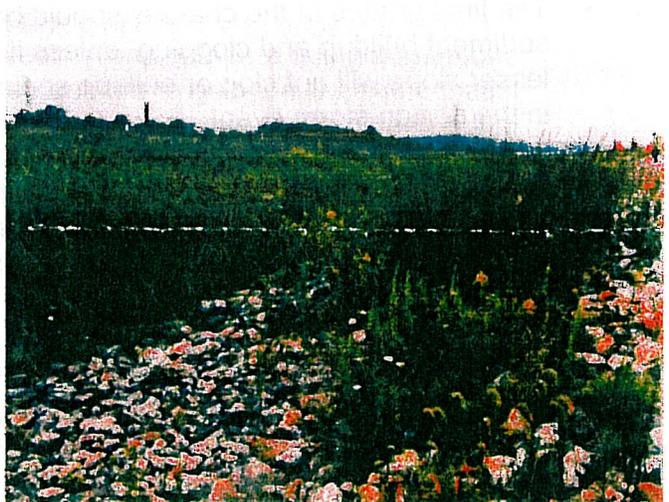
Figure 4. Apparent seep, east side of OSDF.
