Department of Energy
Office of Legacy Management

SUBJECT: Transmittal of the December 2009 Fernald Site Inspection Forms

FERNALD PRESERVE FIELD WALKDOWN INSPECTION FORM

Fernald Preserve
 Consolidated Finding Locations
 for December 2009 Site Inspection

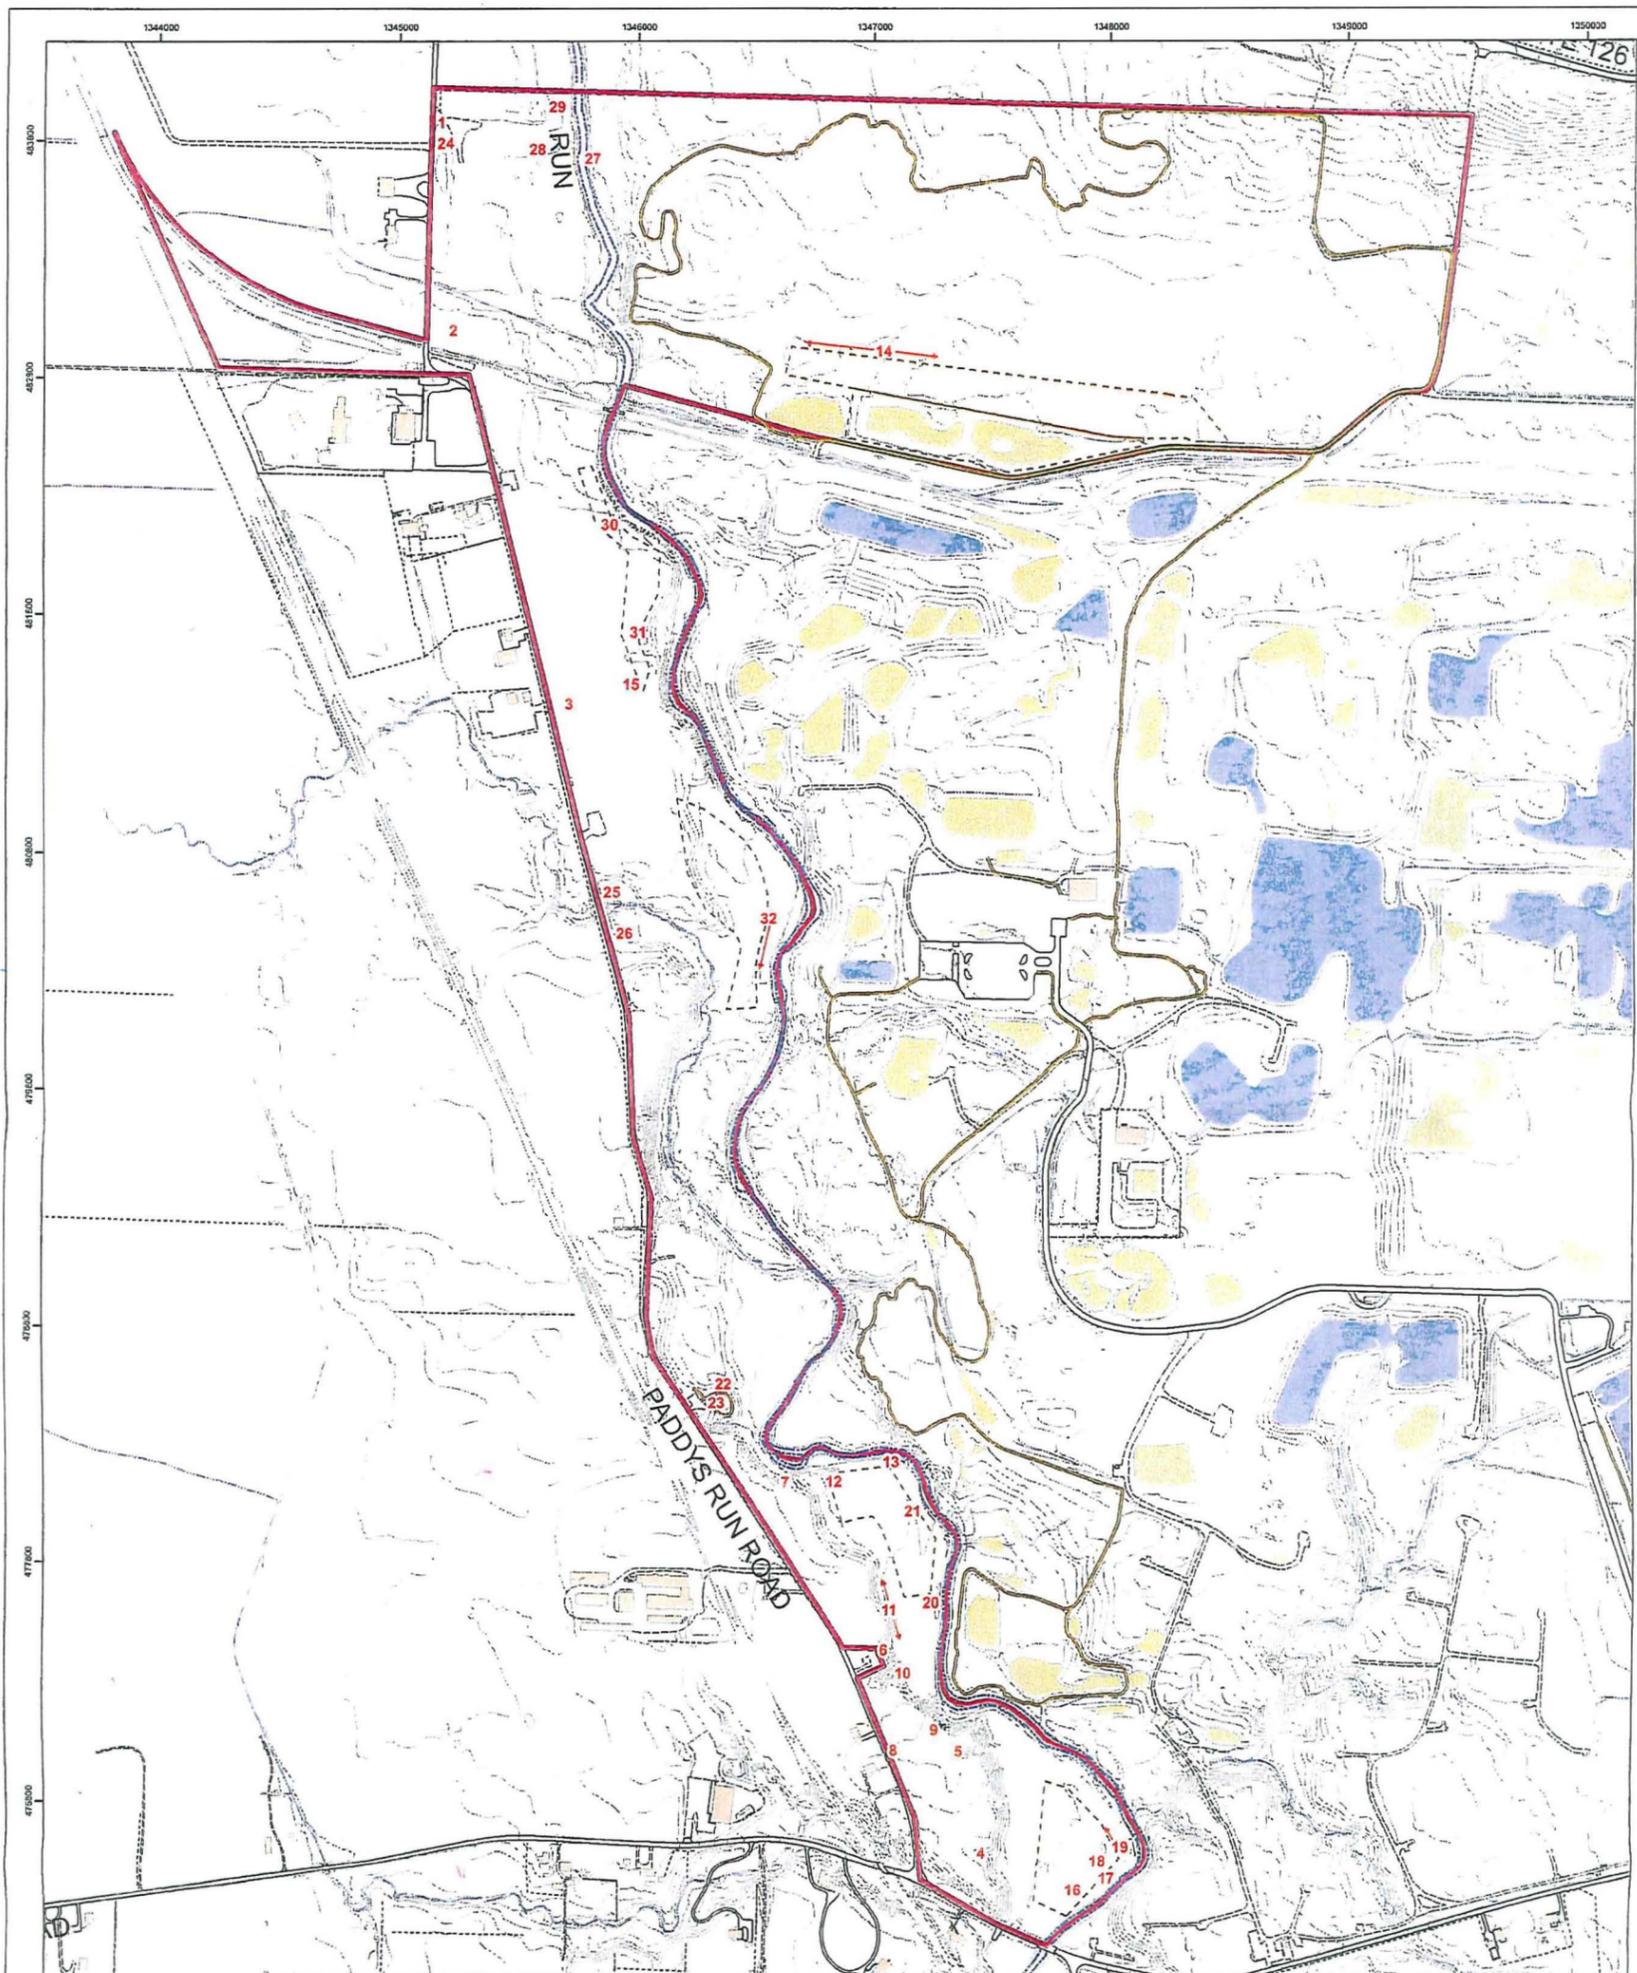
NOTE: Findings are numbered and provided on the December 2009 Field Walkdown Form.
