Department of Energy  
Office of Legacy Management

**SUBJECT: Transmittal of the March 2010 Fernald Preserve On-Site Disposal Facility Inspection Forms**

# On-Site Disposal Facility Inspection Report

## March 2010

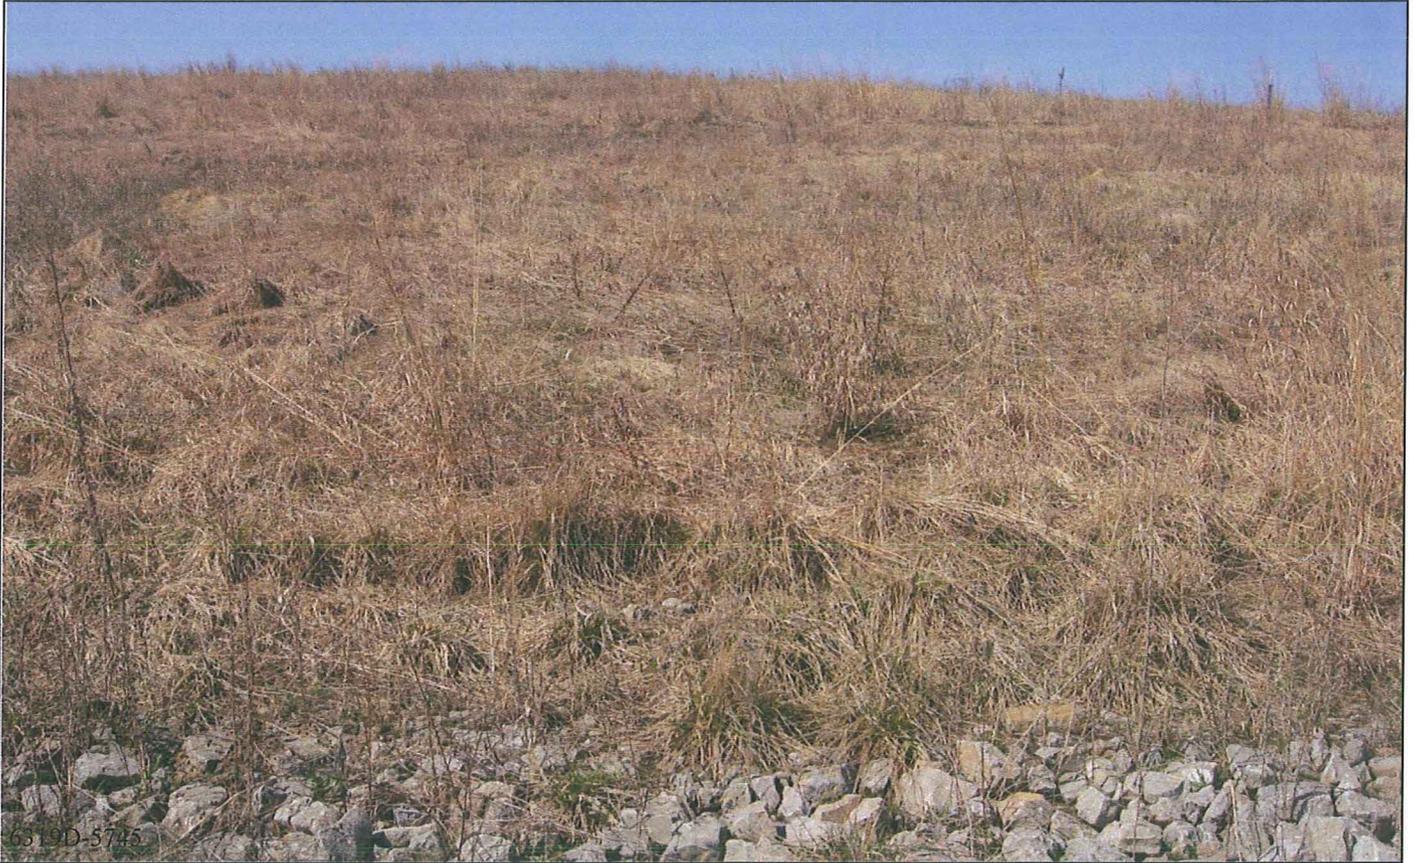
**East Face Cell 1**

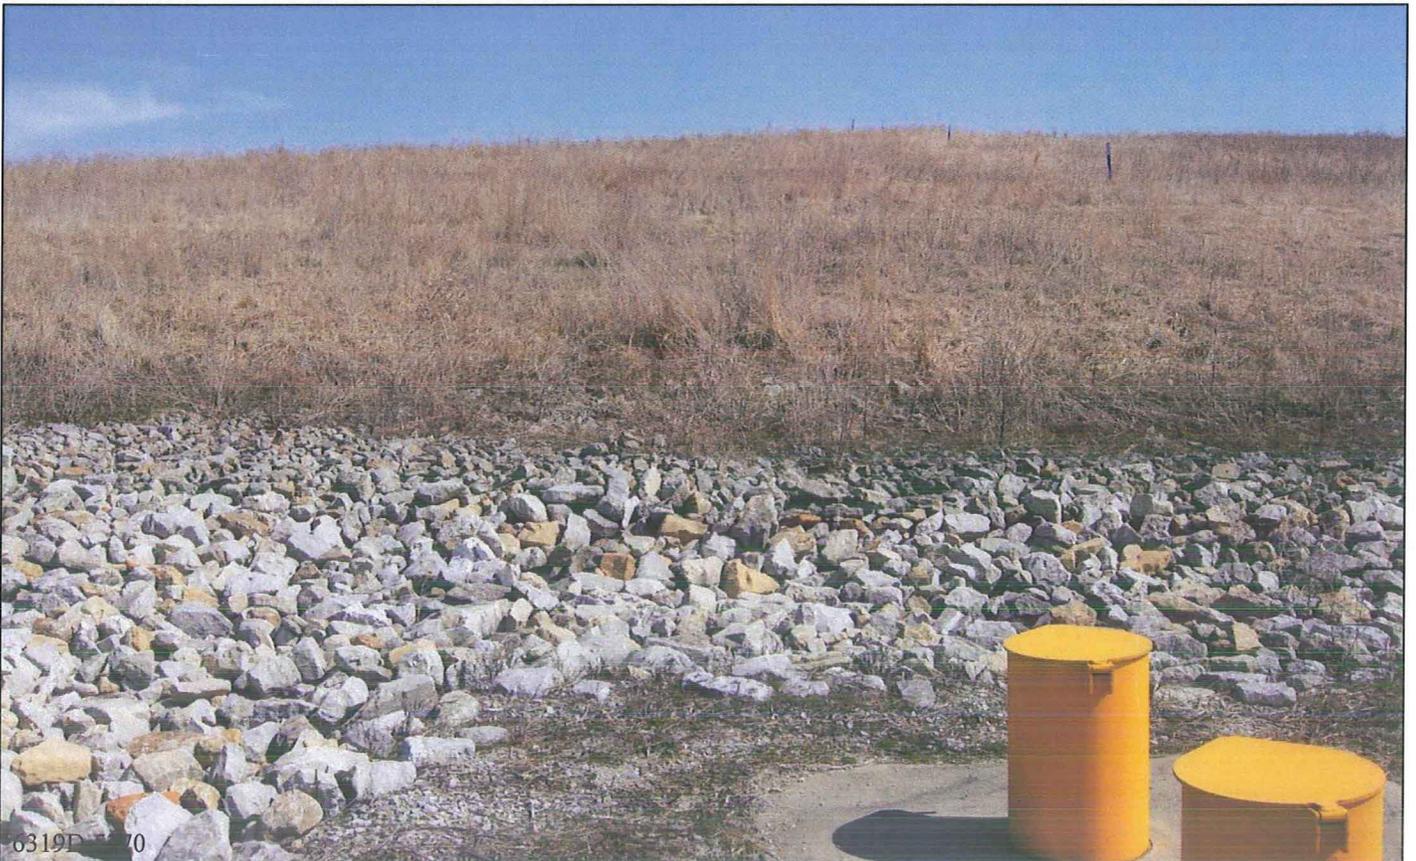
**West Face Cell 1**

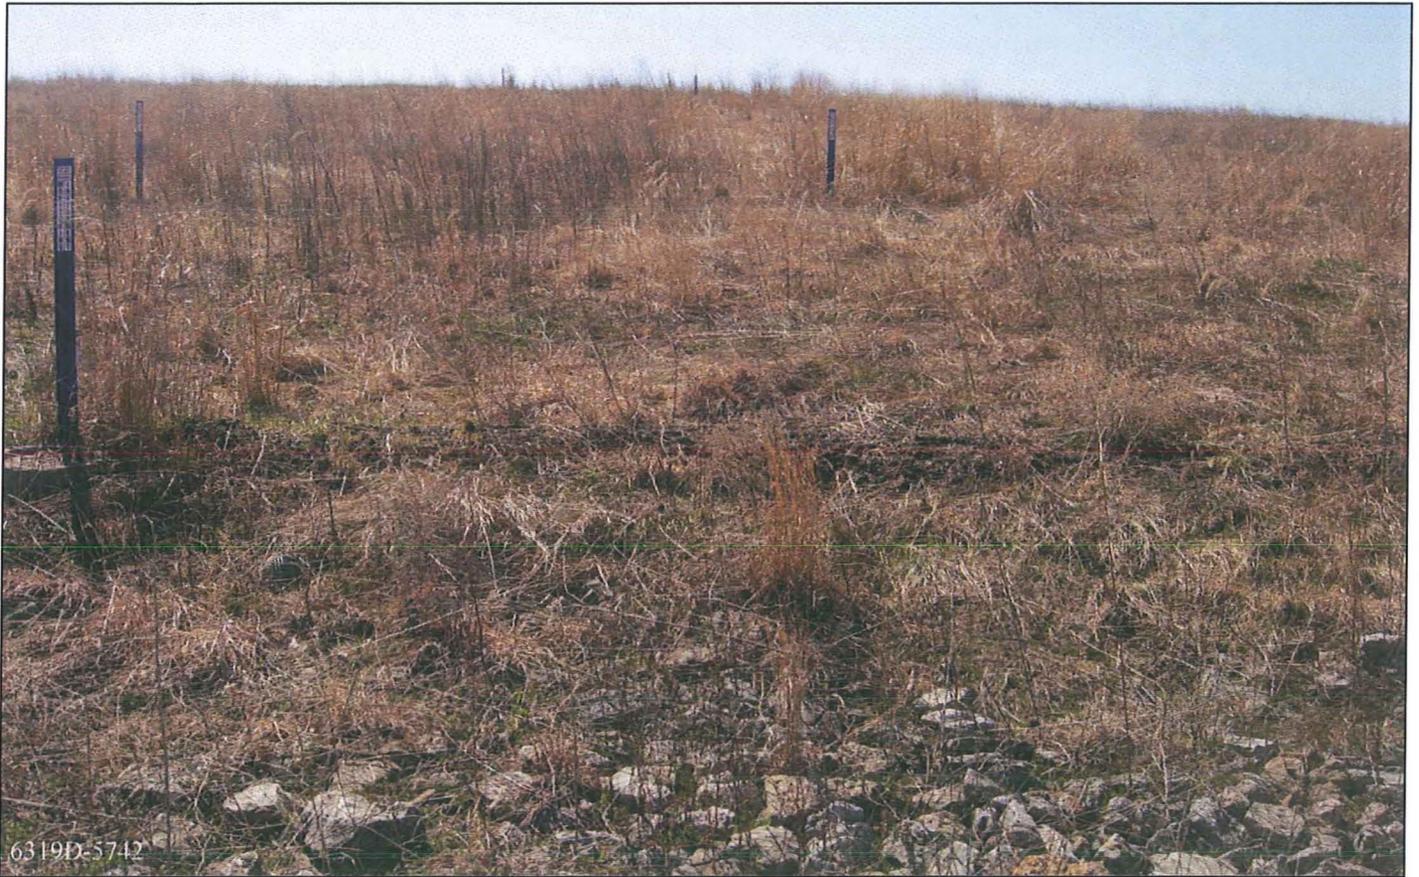
6319D-5742

**North Face Cell 1**

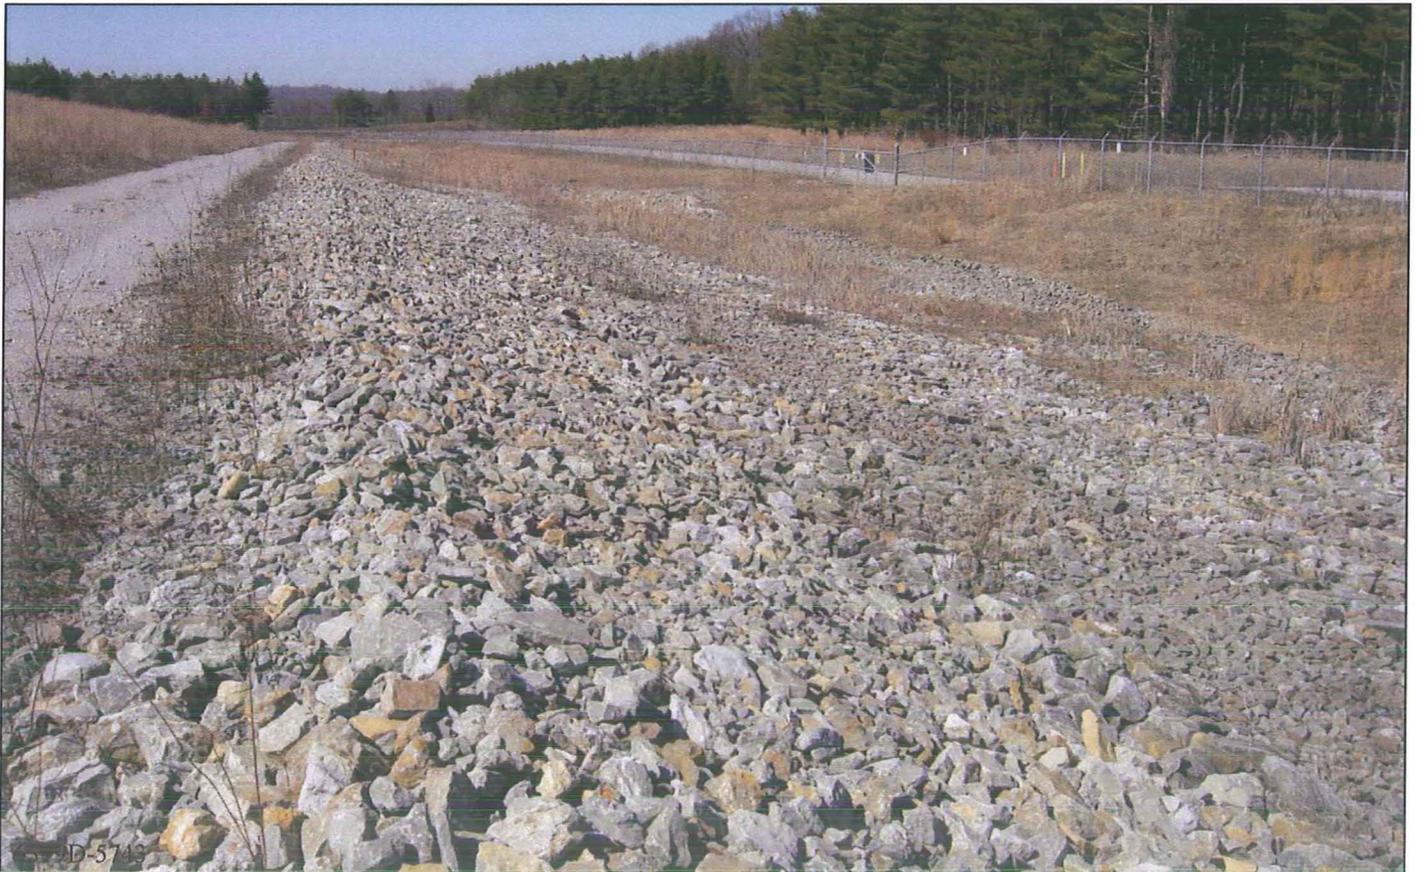
6319D-5743

**North Drainage (looking west)**

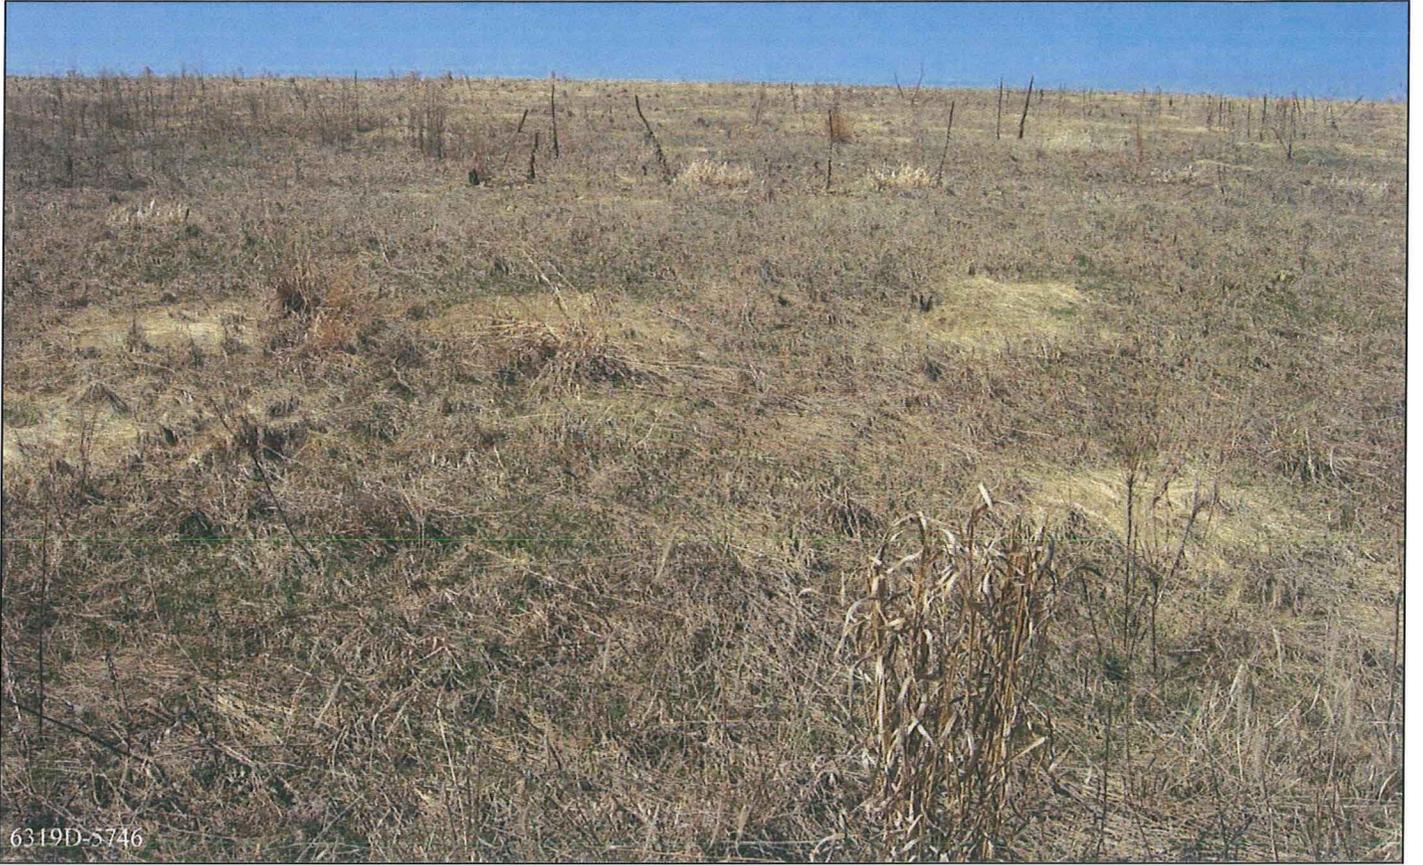
6319D-5746

**East Face Cell 2**

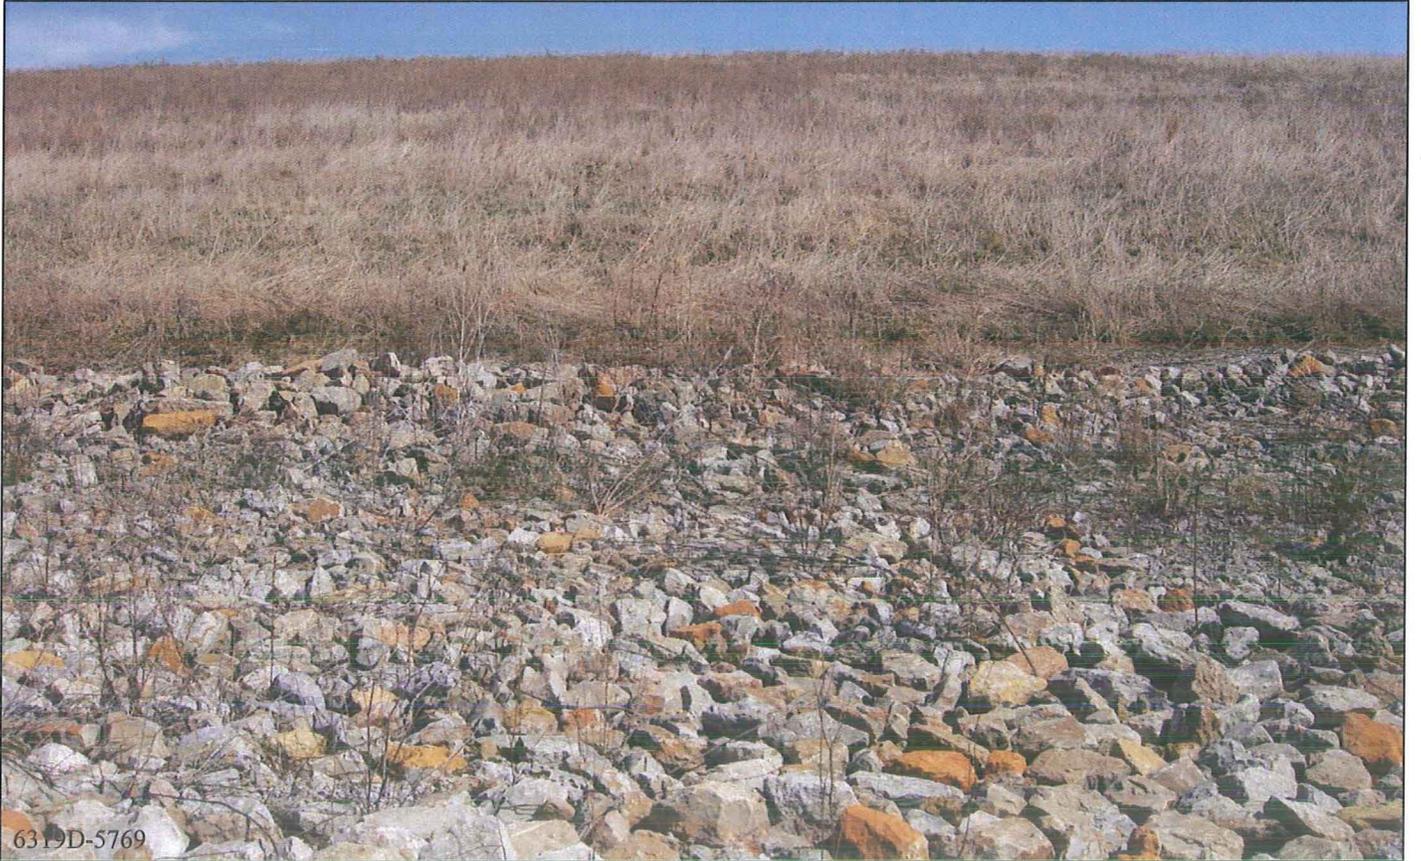
6319D-5769

**West Face Cell 2**

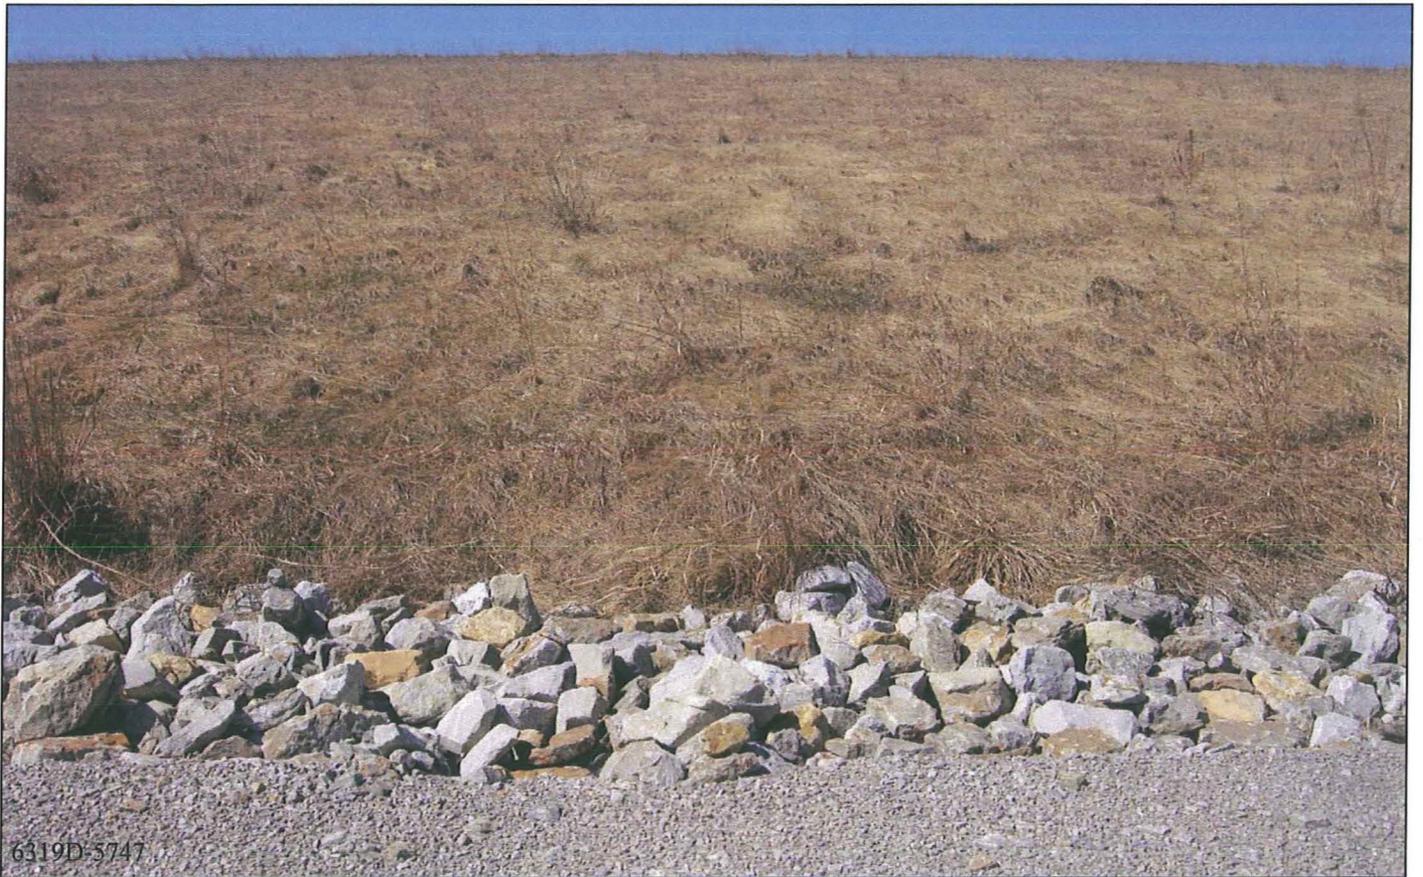
**East Face Cell 3**

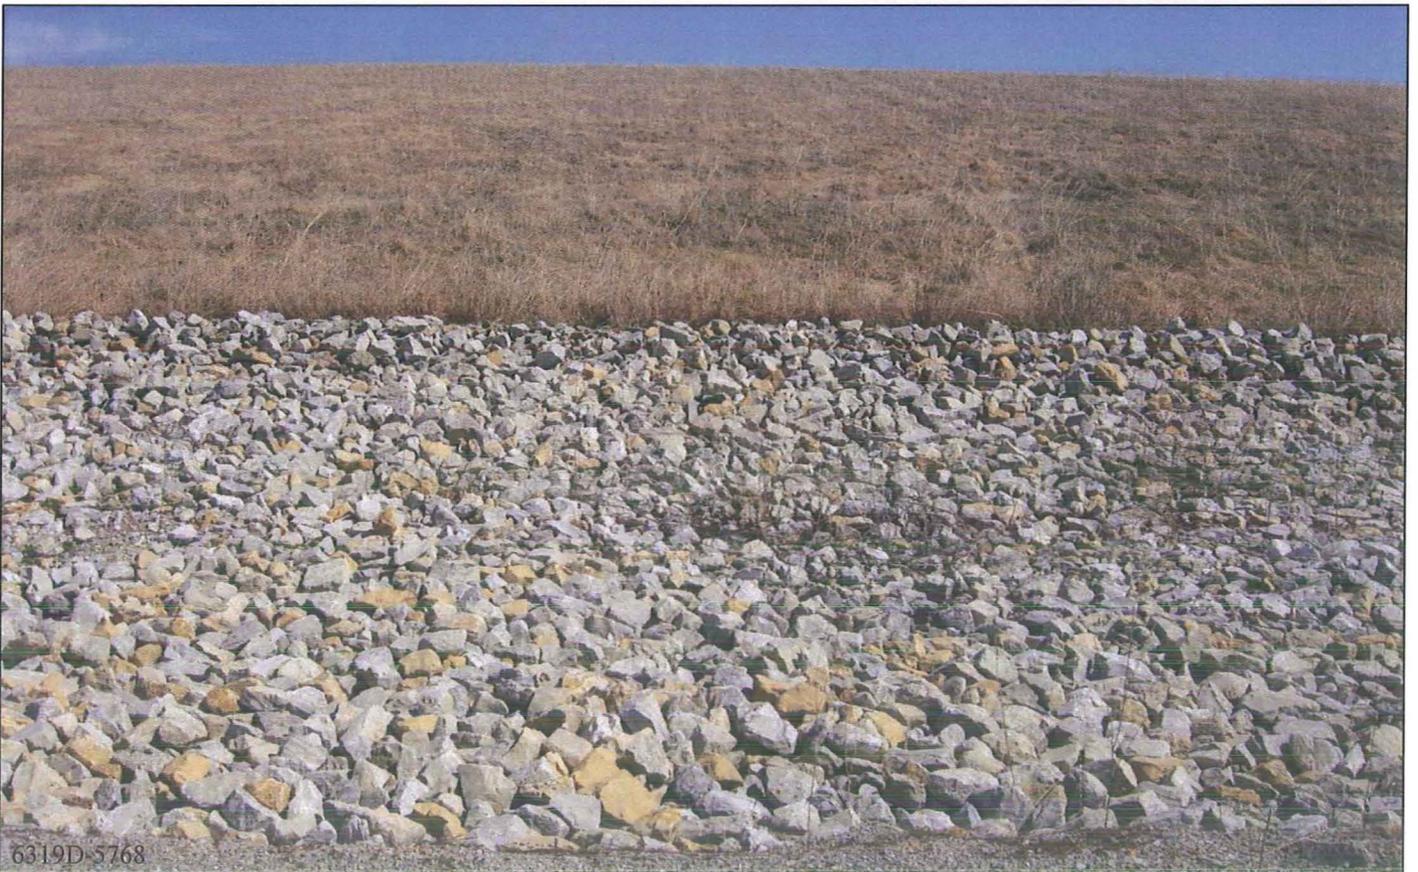
**West Face Cell 3**

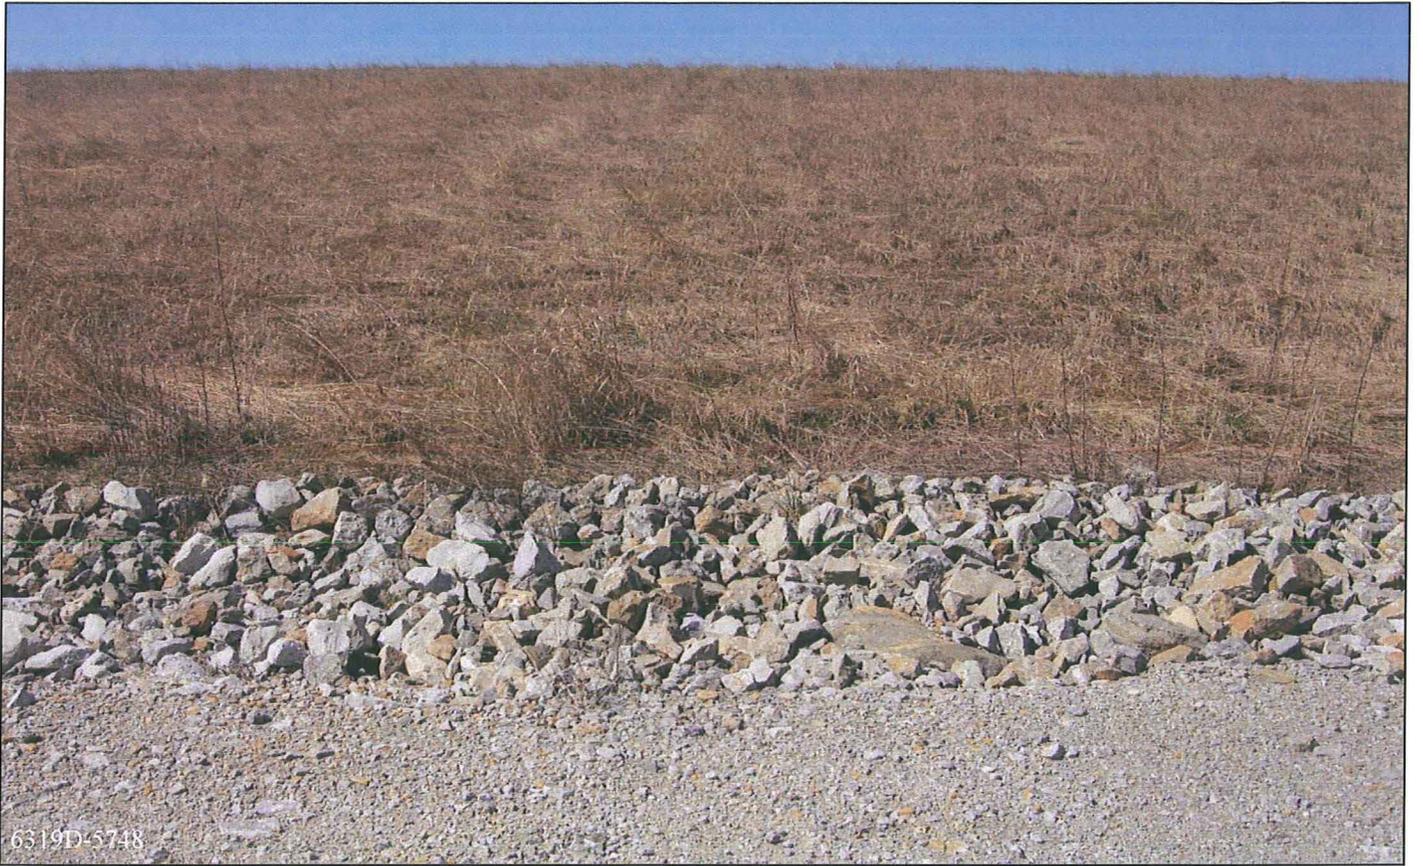
**East Face Cell 4**

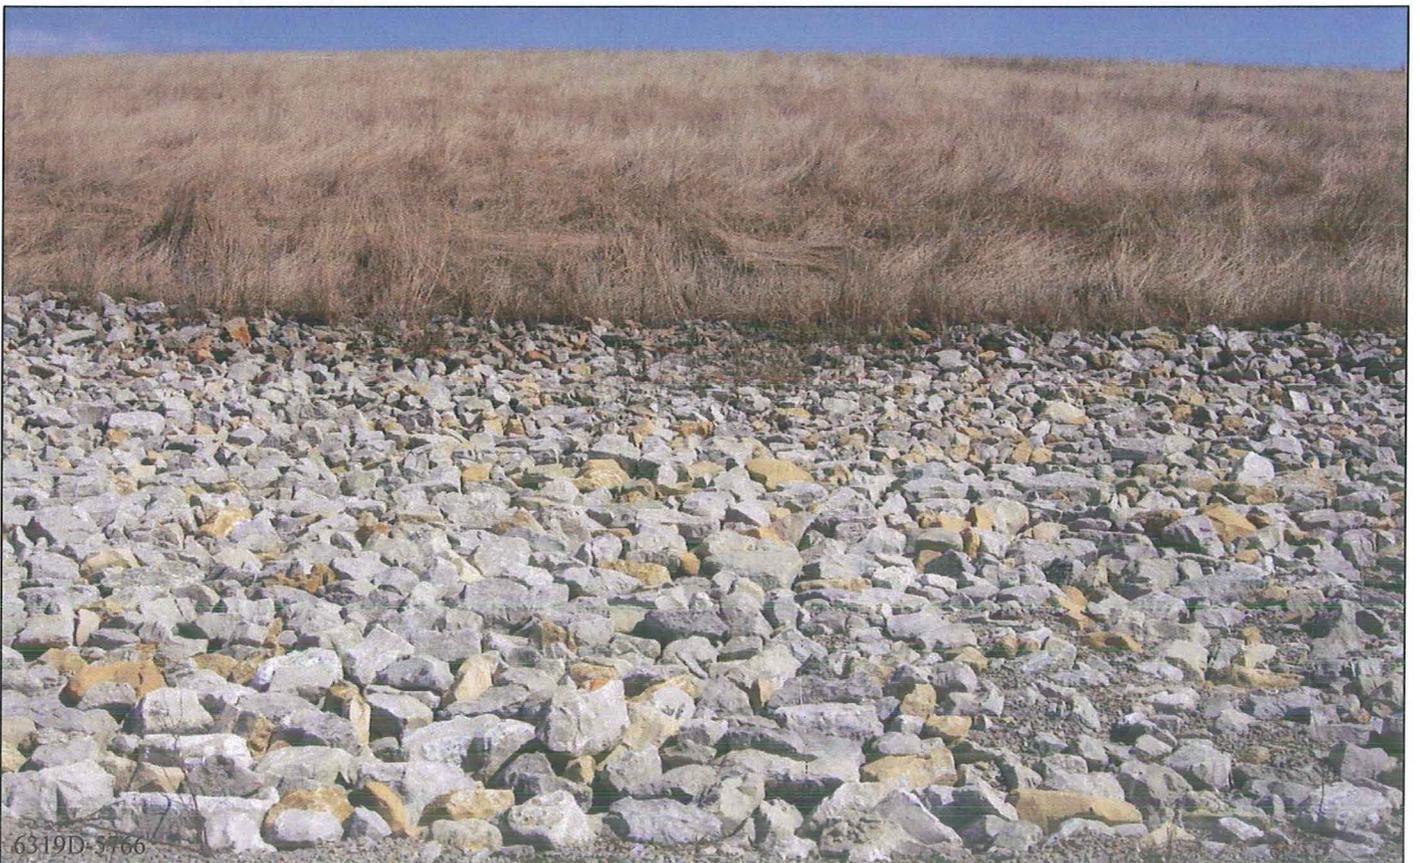
**West Face Cell 4**

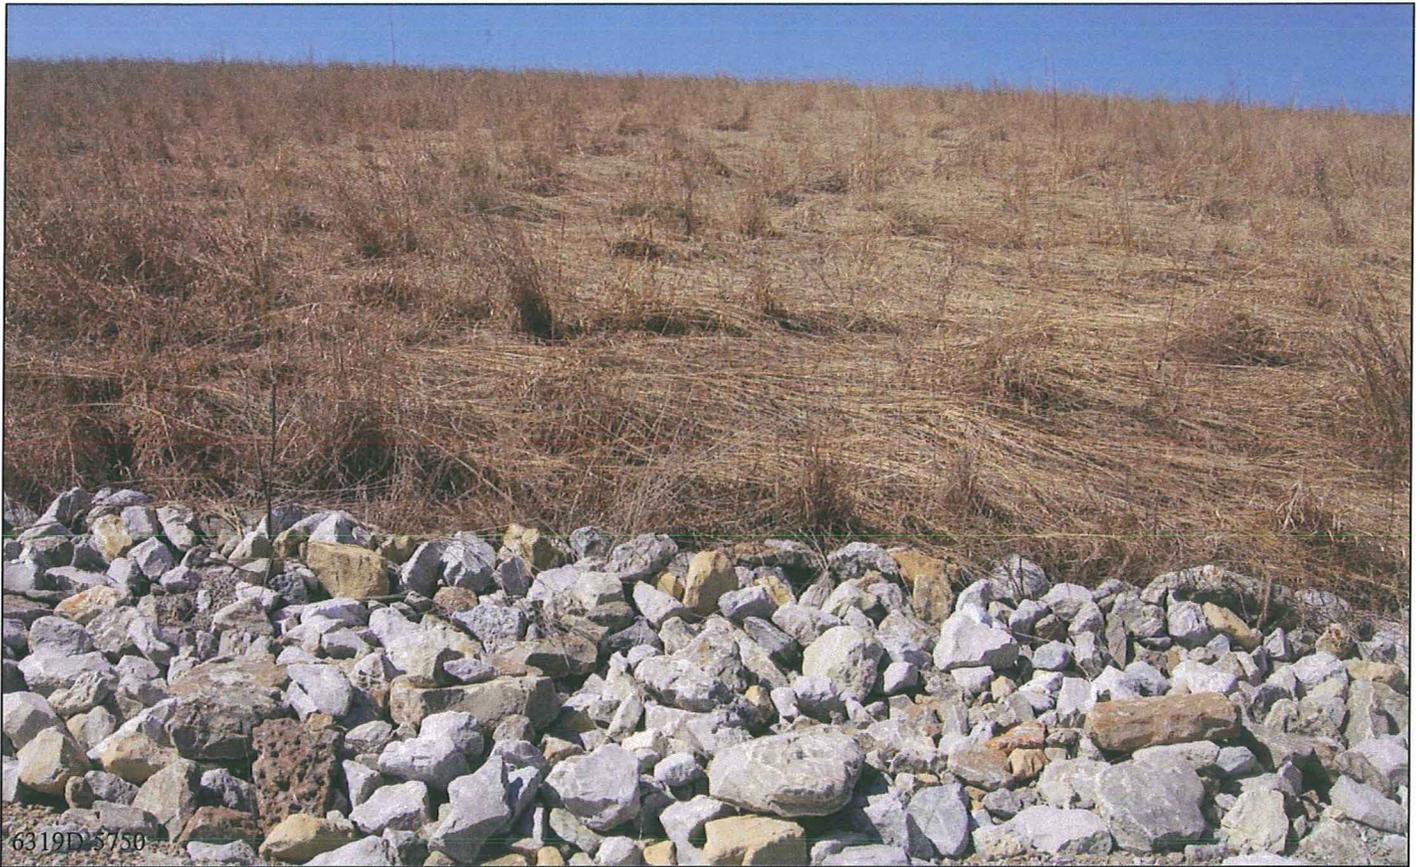
**East Face Cell 5**

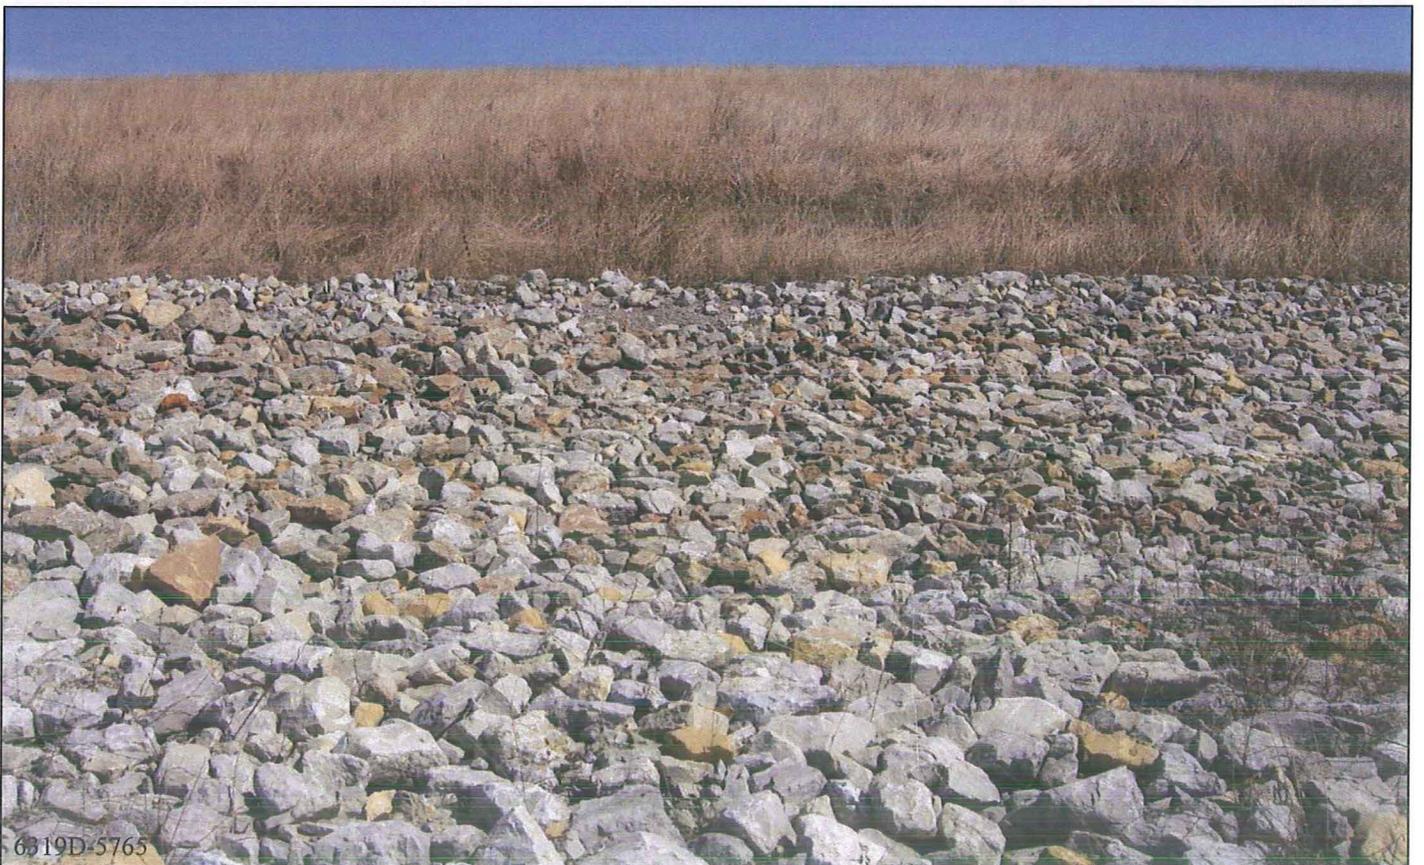
**West Face Cell 5**

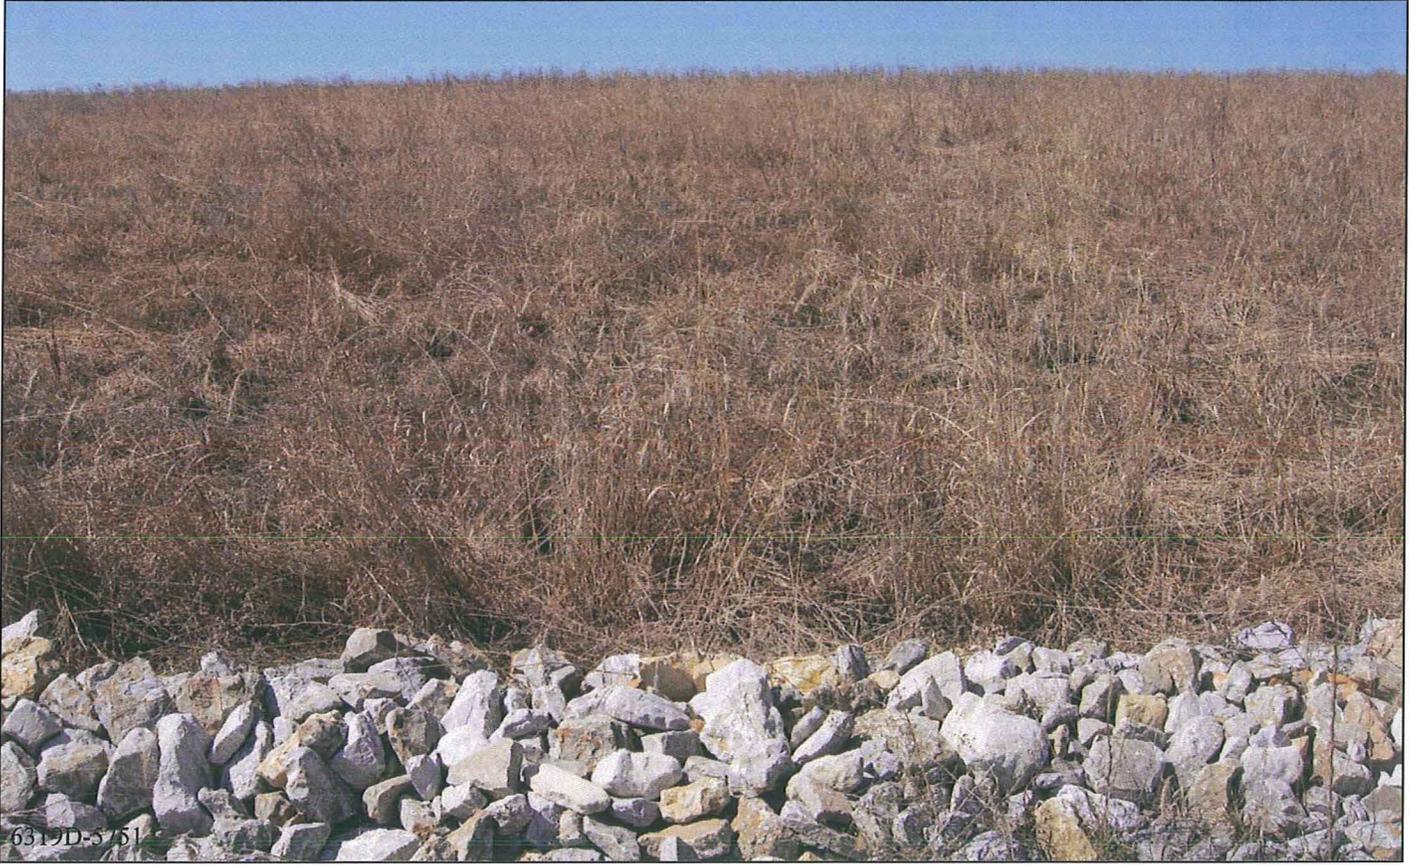
**East Face Cell 6**

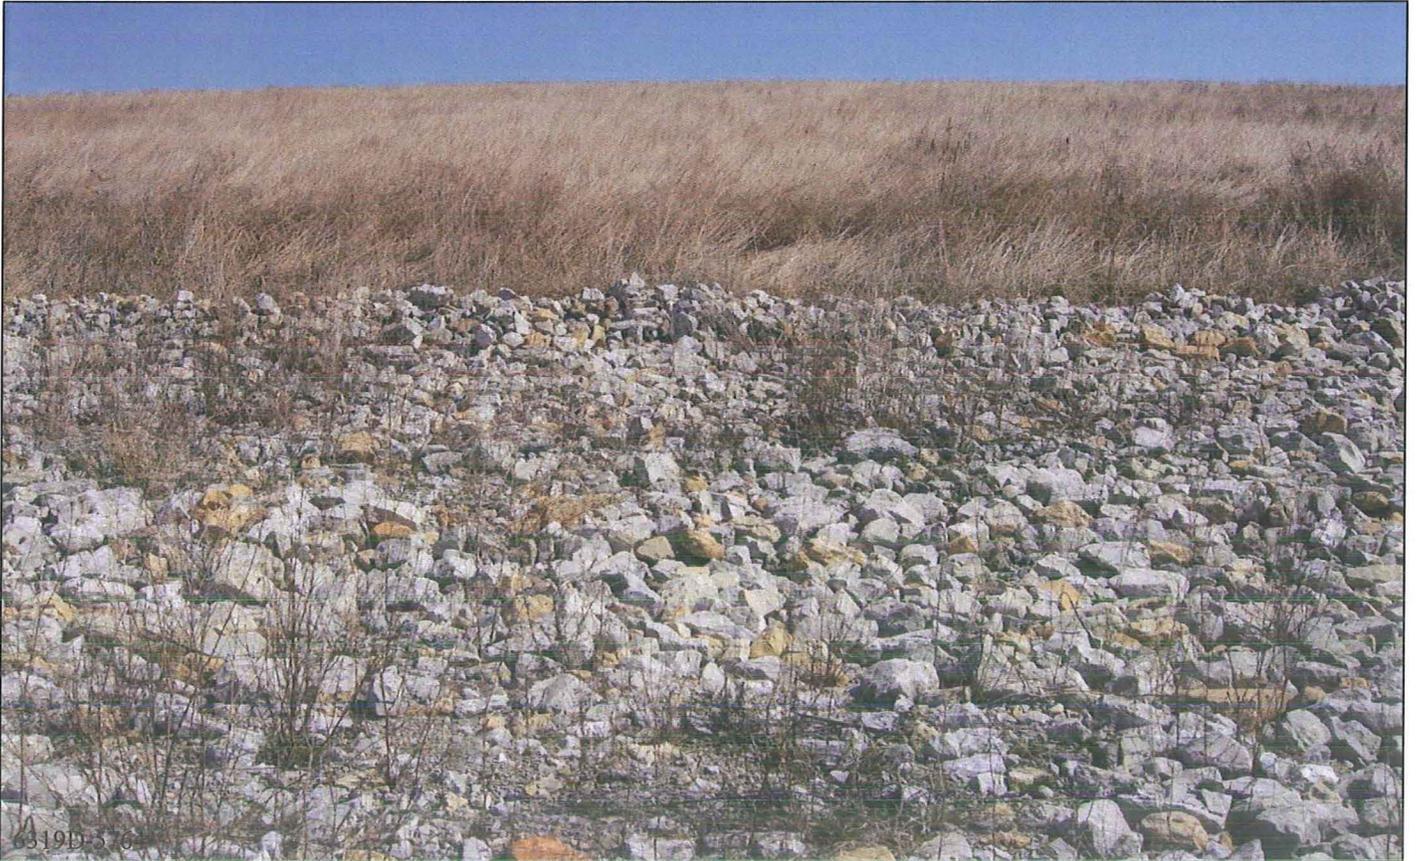
**West Face Cell 6**

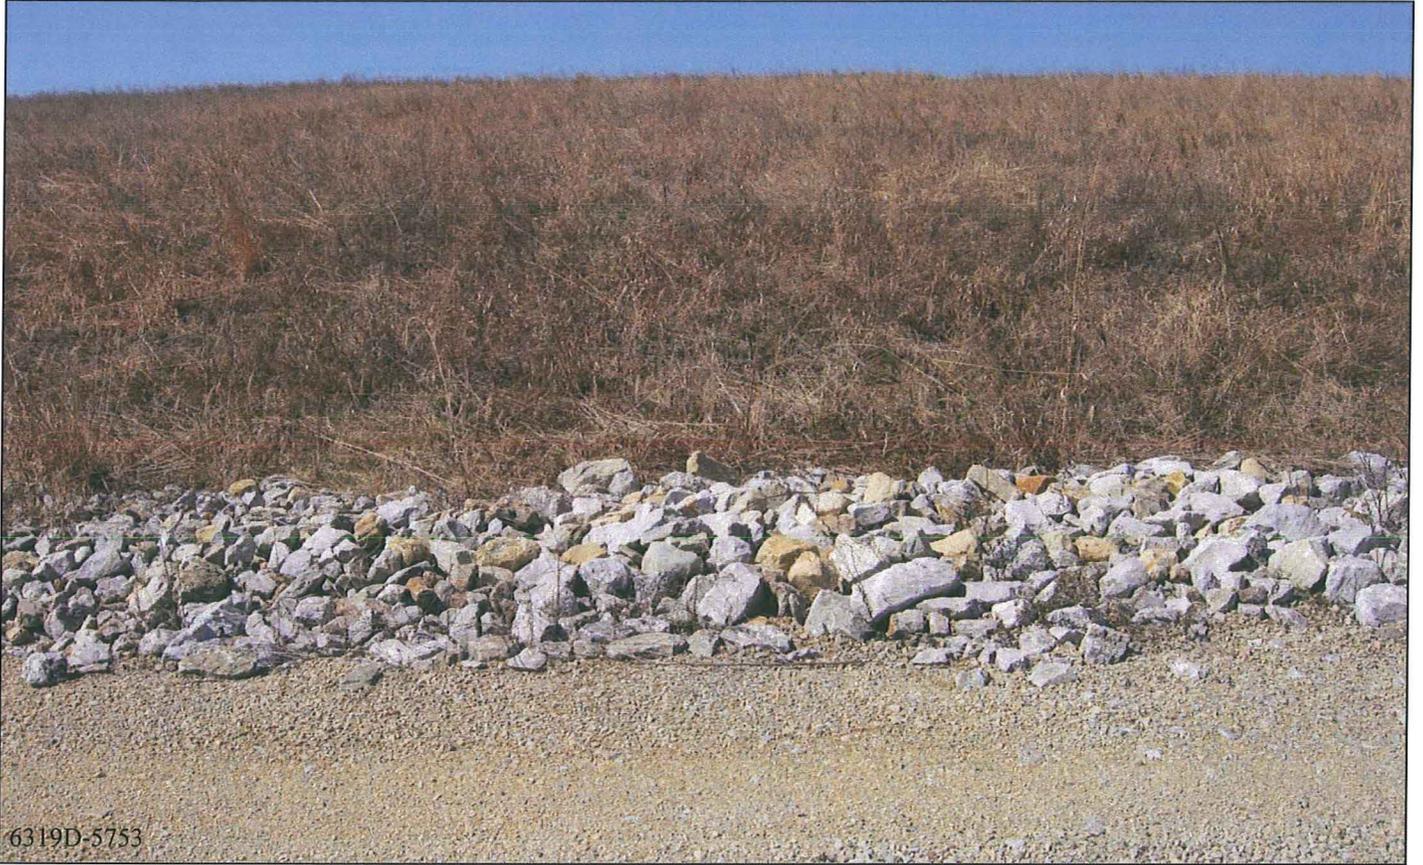
6319D-5753

**East Face Cell 7**

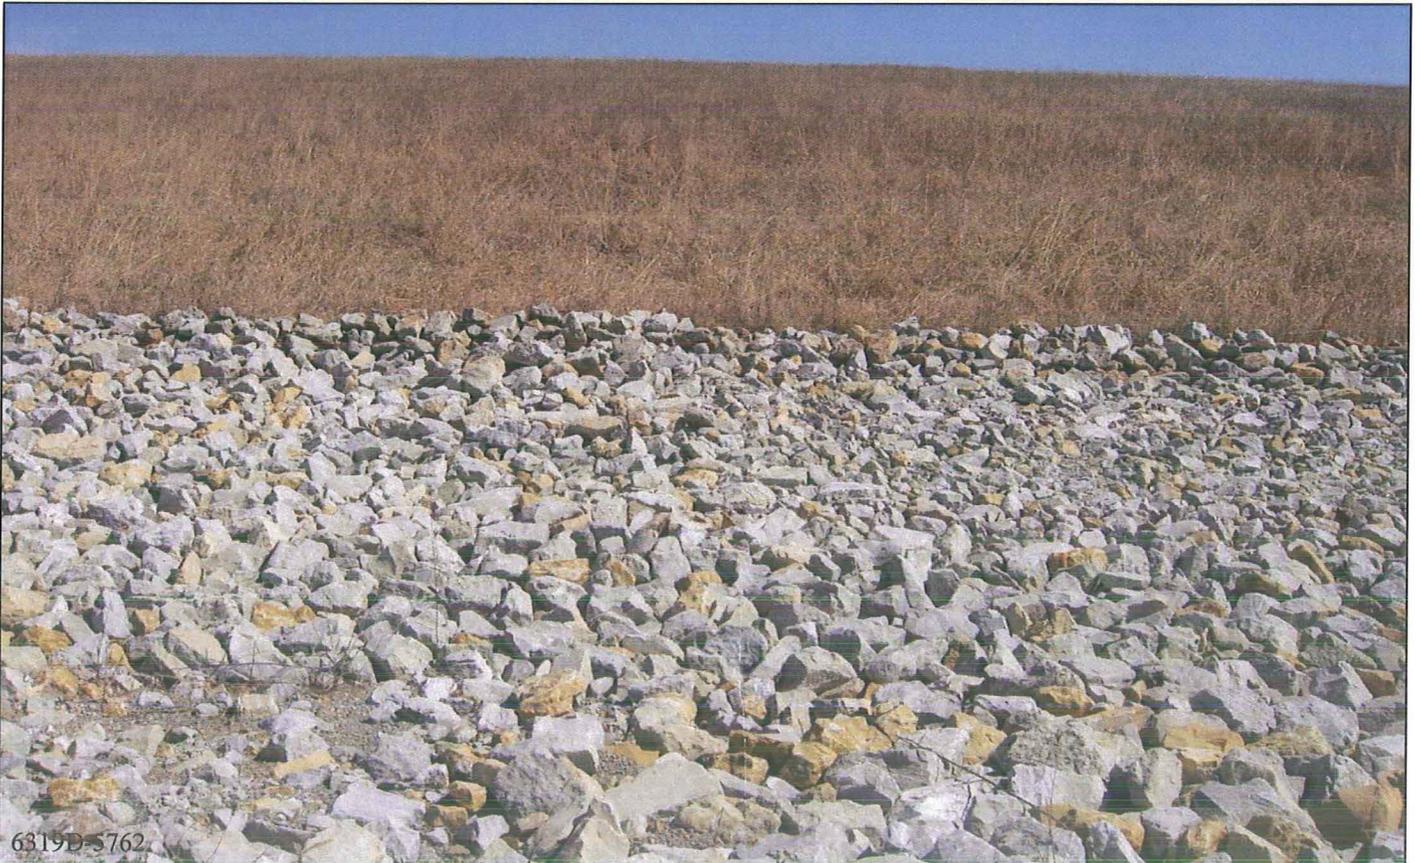
6319D-5762

**West Face Cell 7**

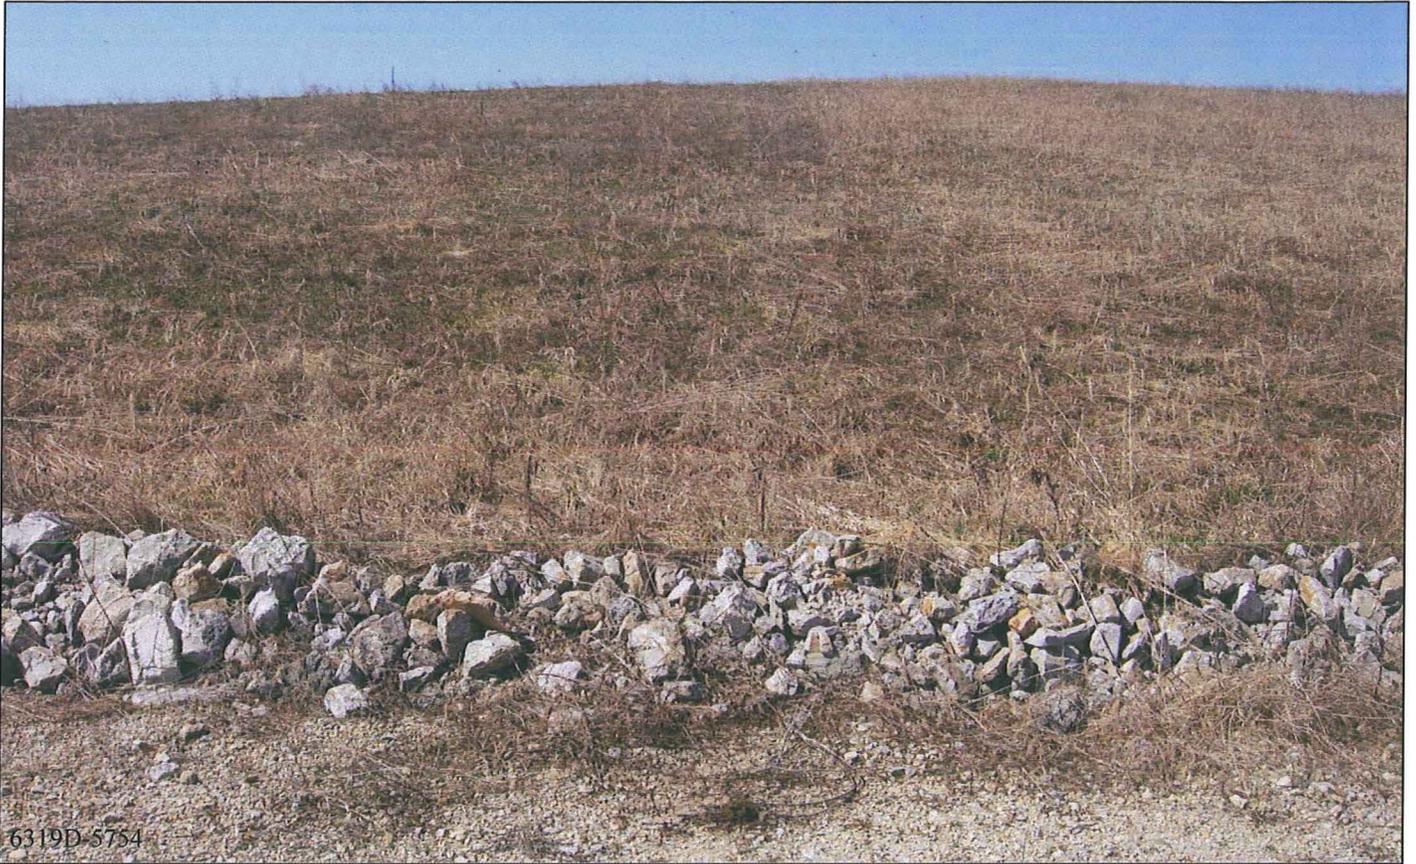
**East Face Cell 8**

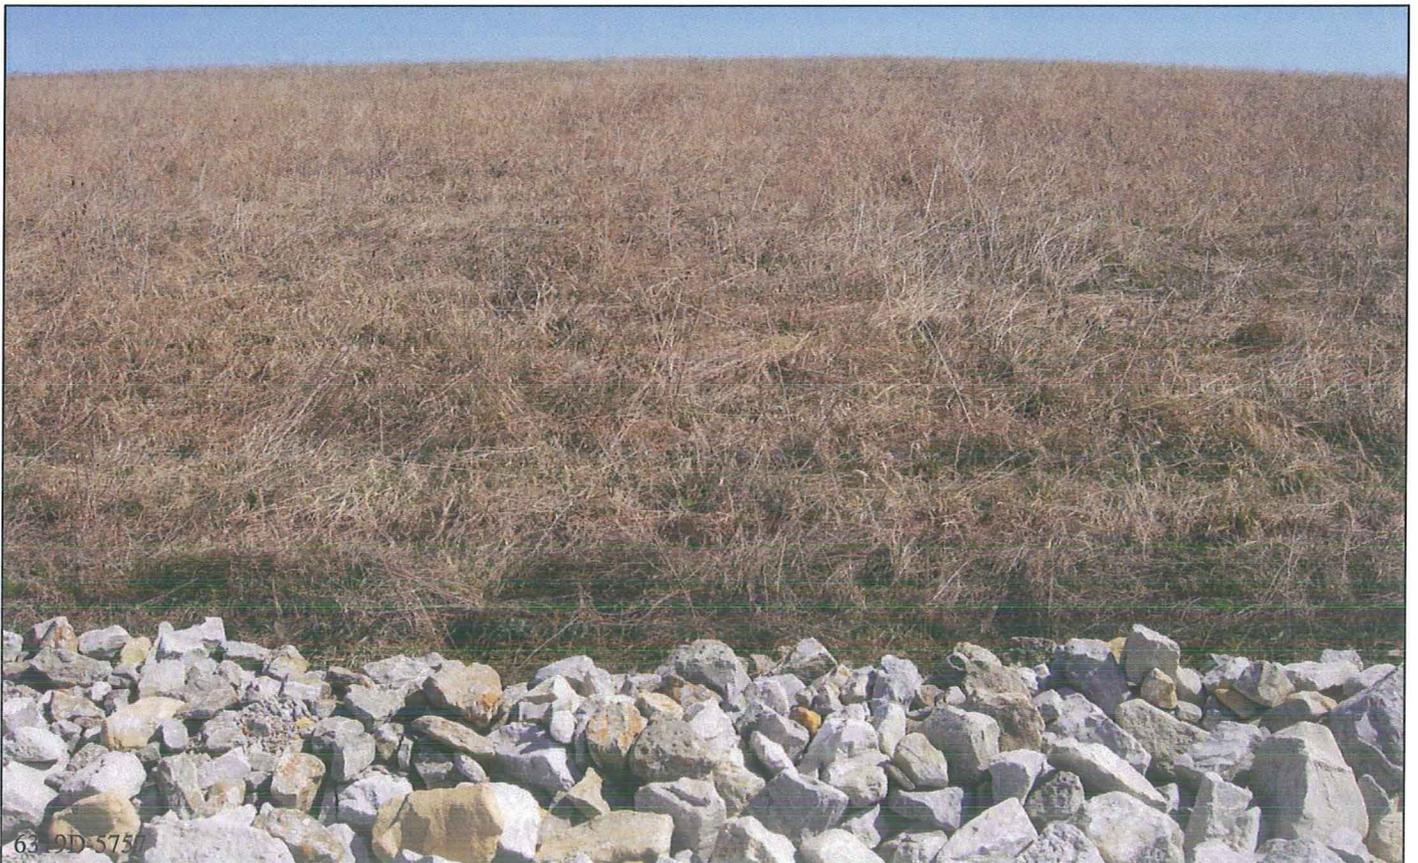
**West Face Cell 8**
