Department of Energy  
Office of Legacy Management

**SUBJECT: Transmittal of the March 2010 Fernald Preserve On-Site Disposal Facility Inspection Forms**

# On-Site Disposal Facility Inspection Report

## March 2010

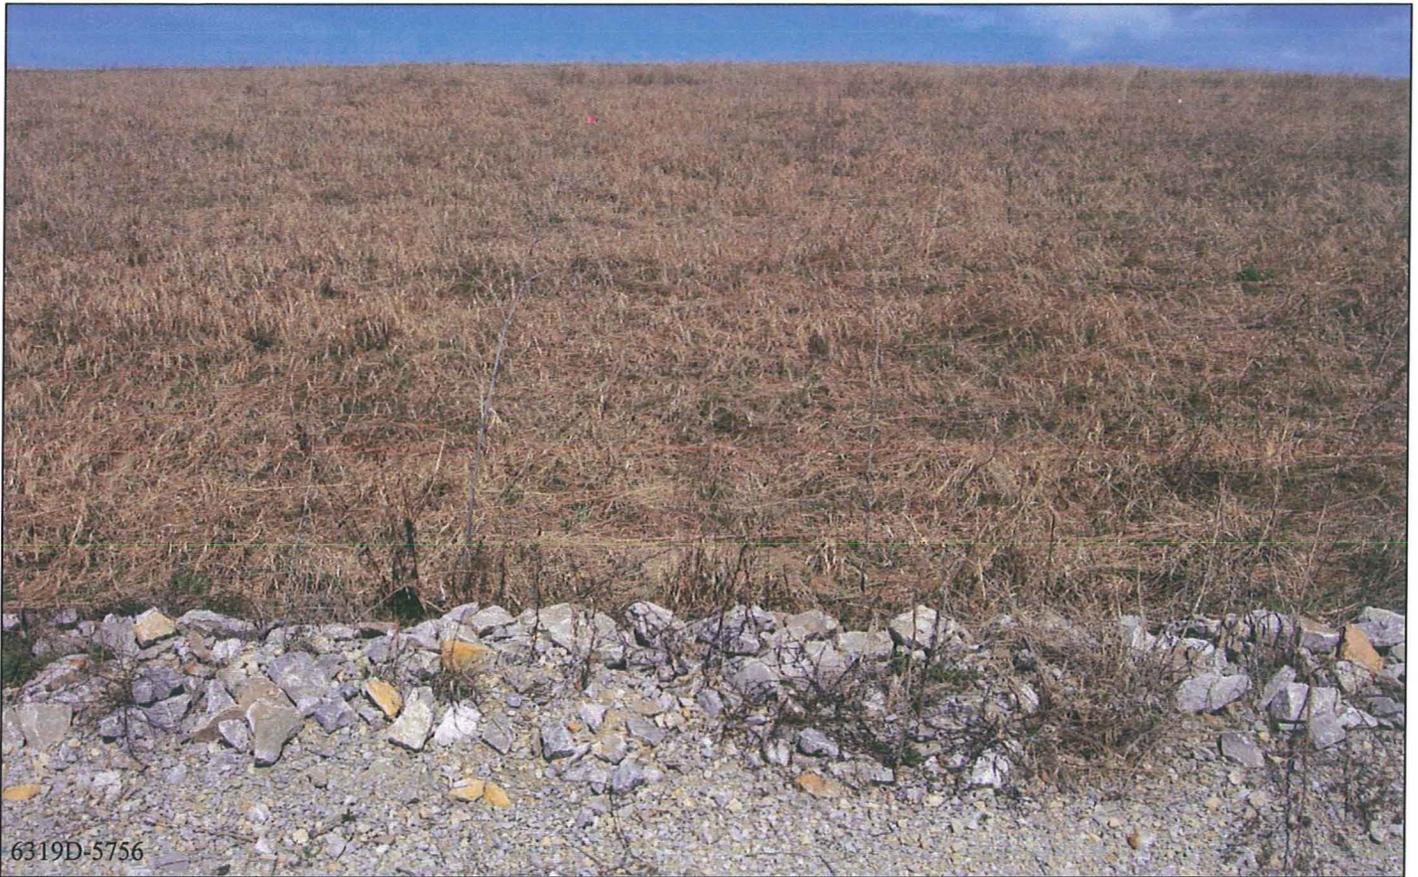
6319D-5756

**South Face Cell 8**

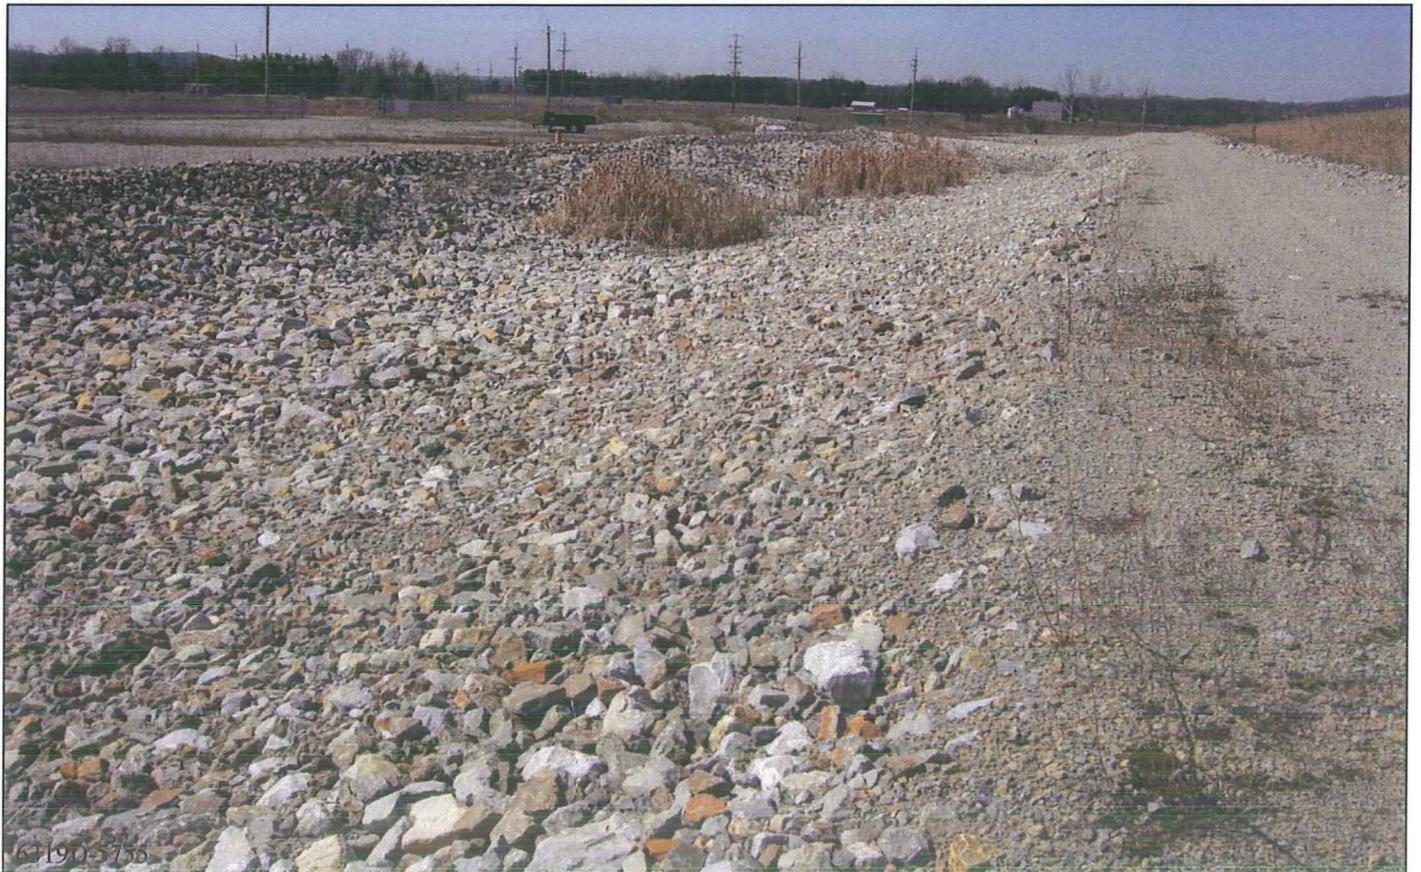
6319D-5756

**South Drainage (looking west)**

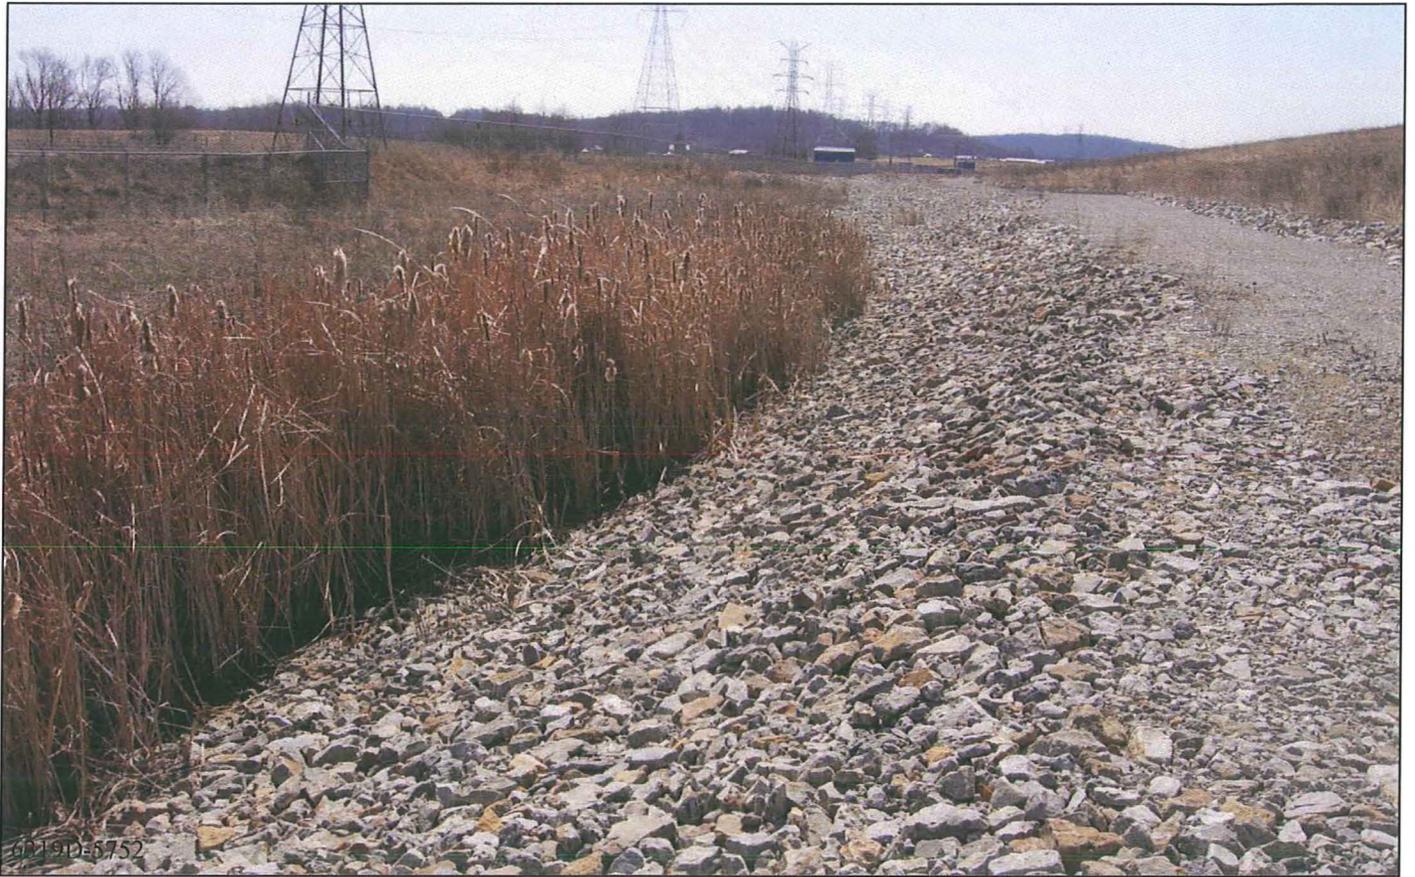
**East Drainage Cell 7 (looking south)**

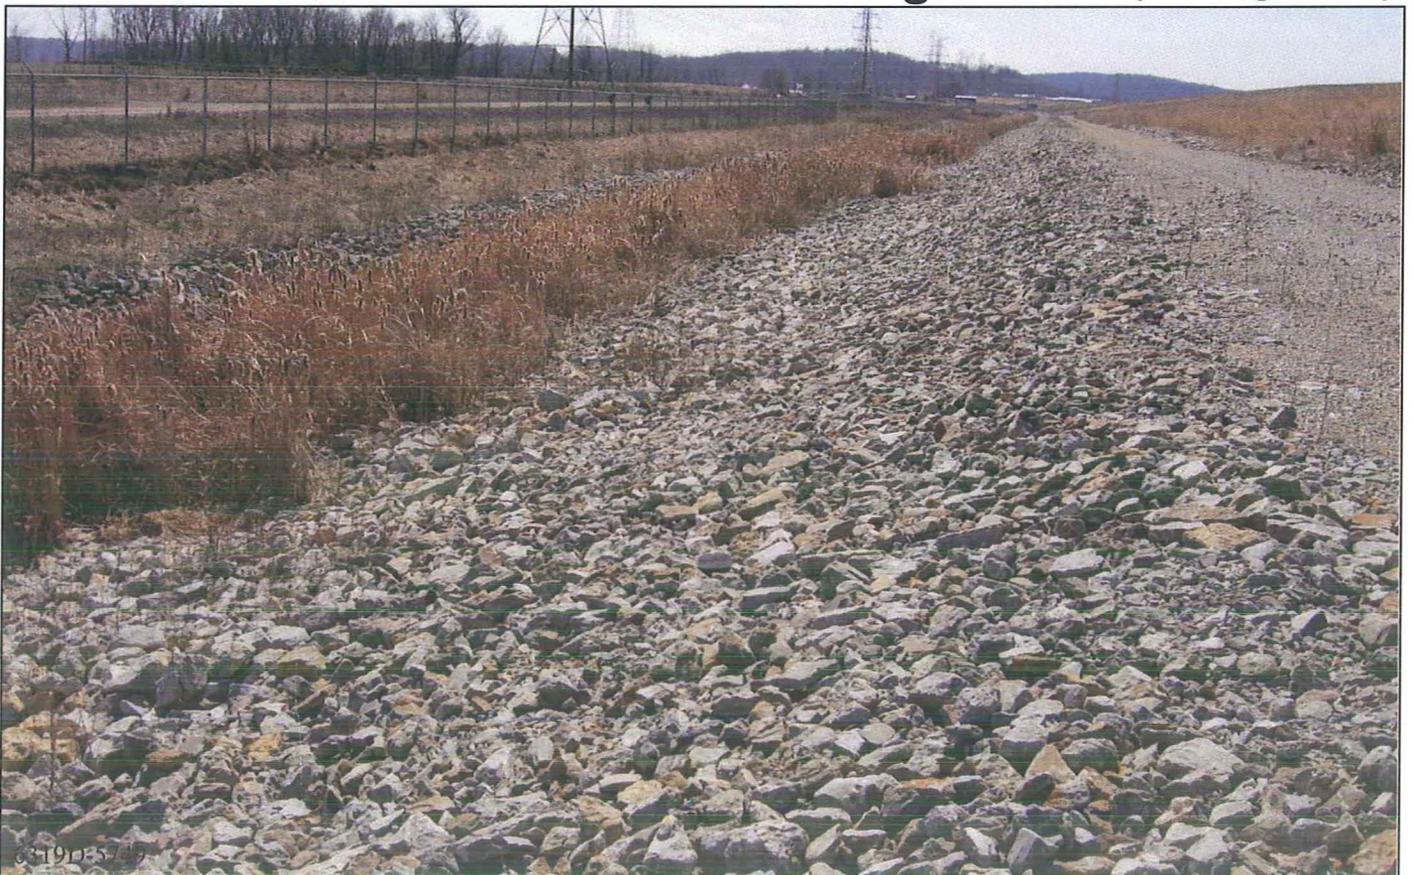
**East Drainage Cell 4 (looking south)**

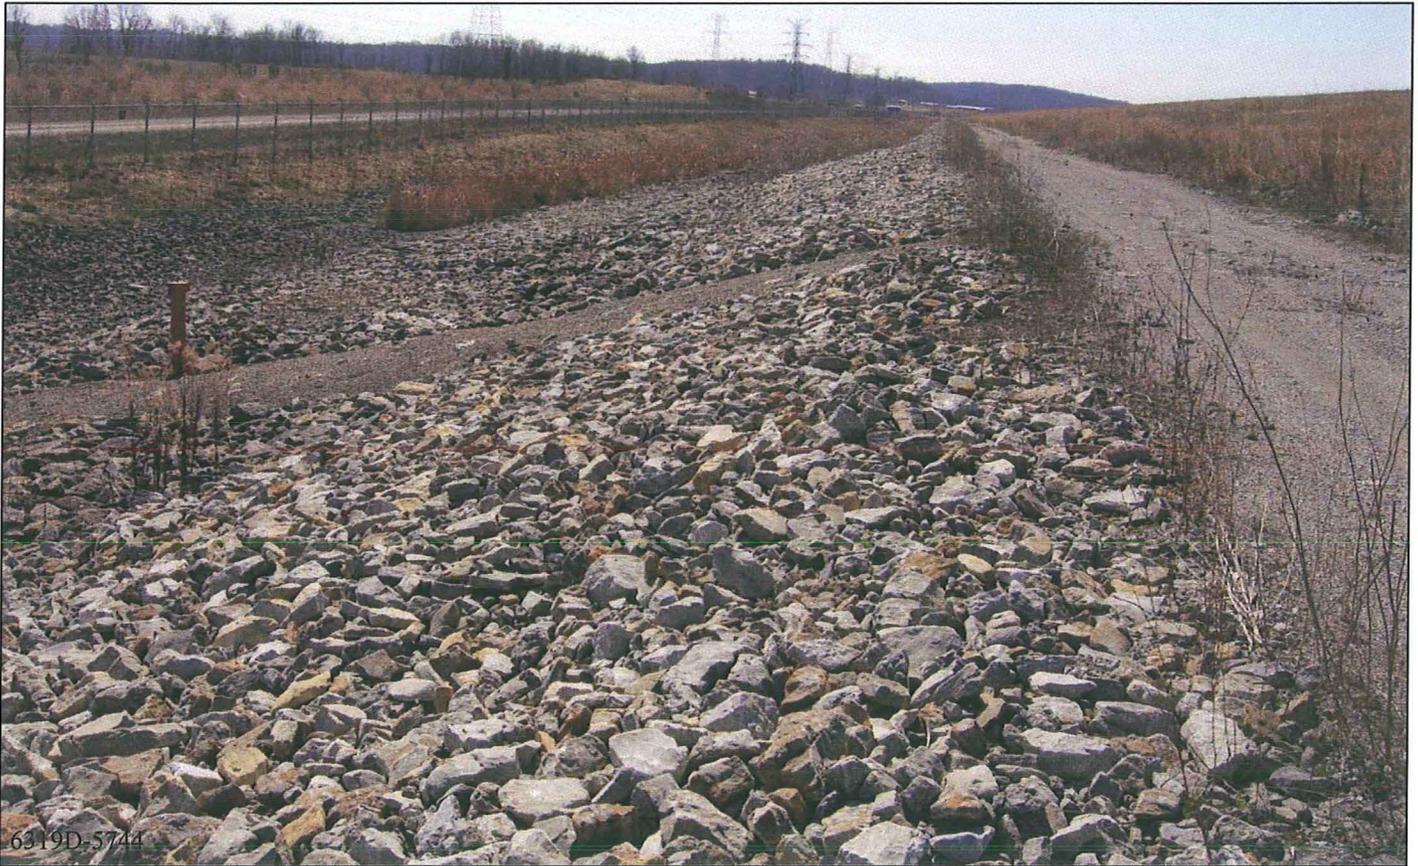
6319D-5744

**East Drainage Cell 1 (looking south)**

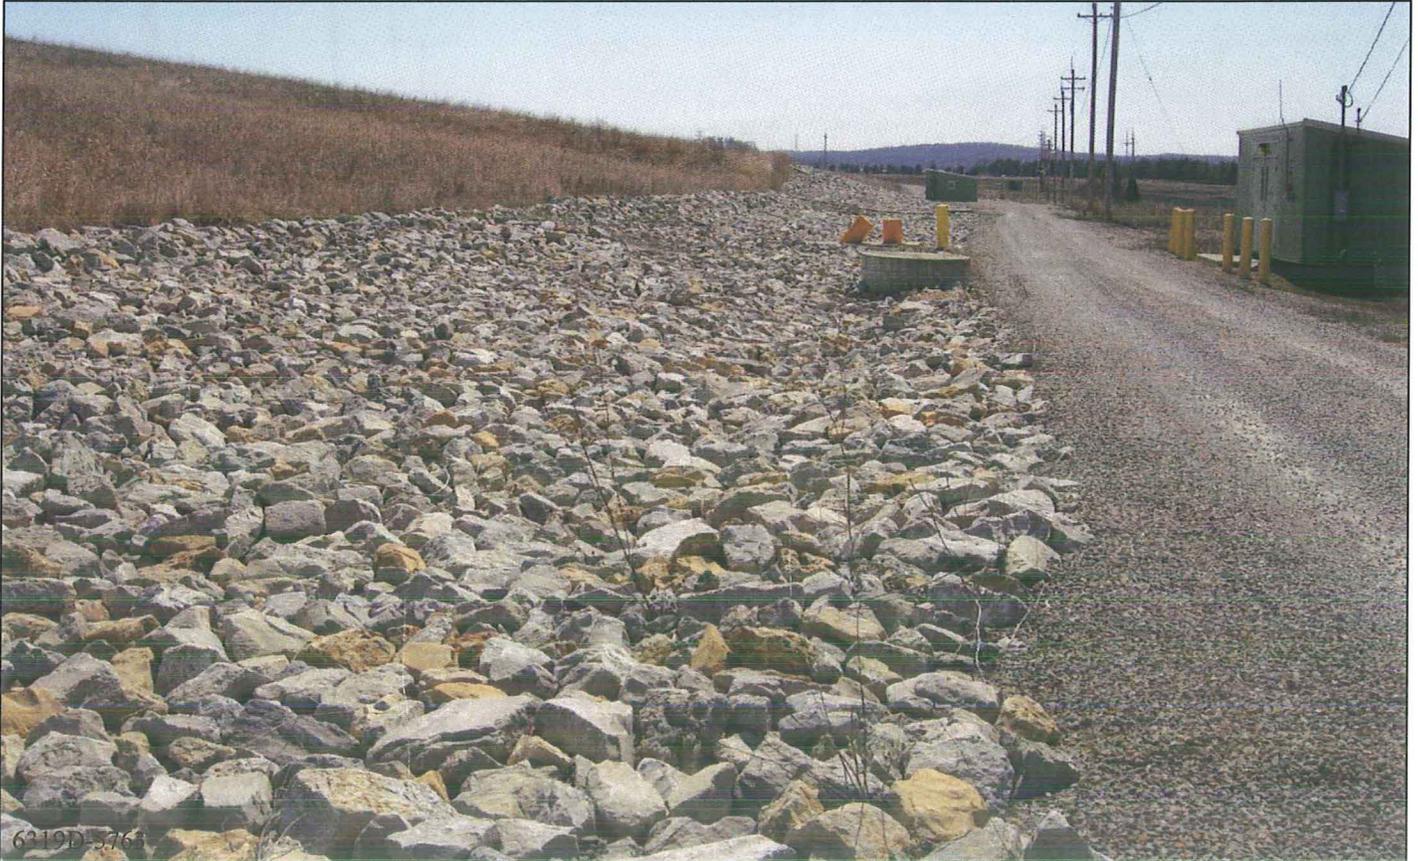
6319D-5764

**West Inner Drainage Cell 7 (looking south)**

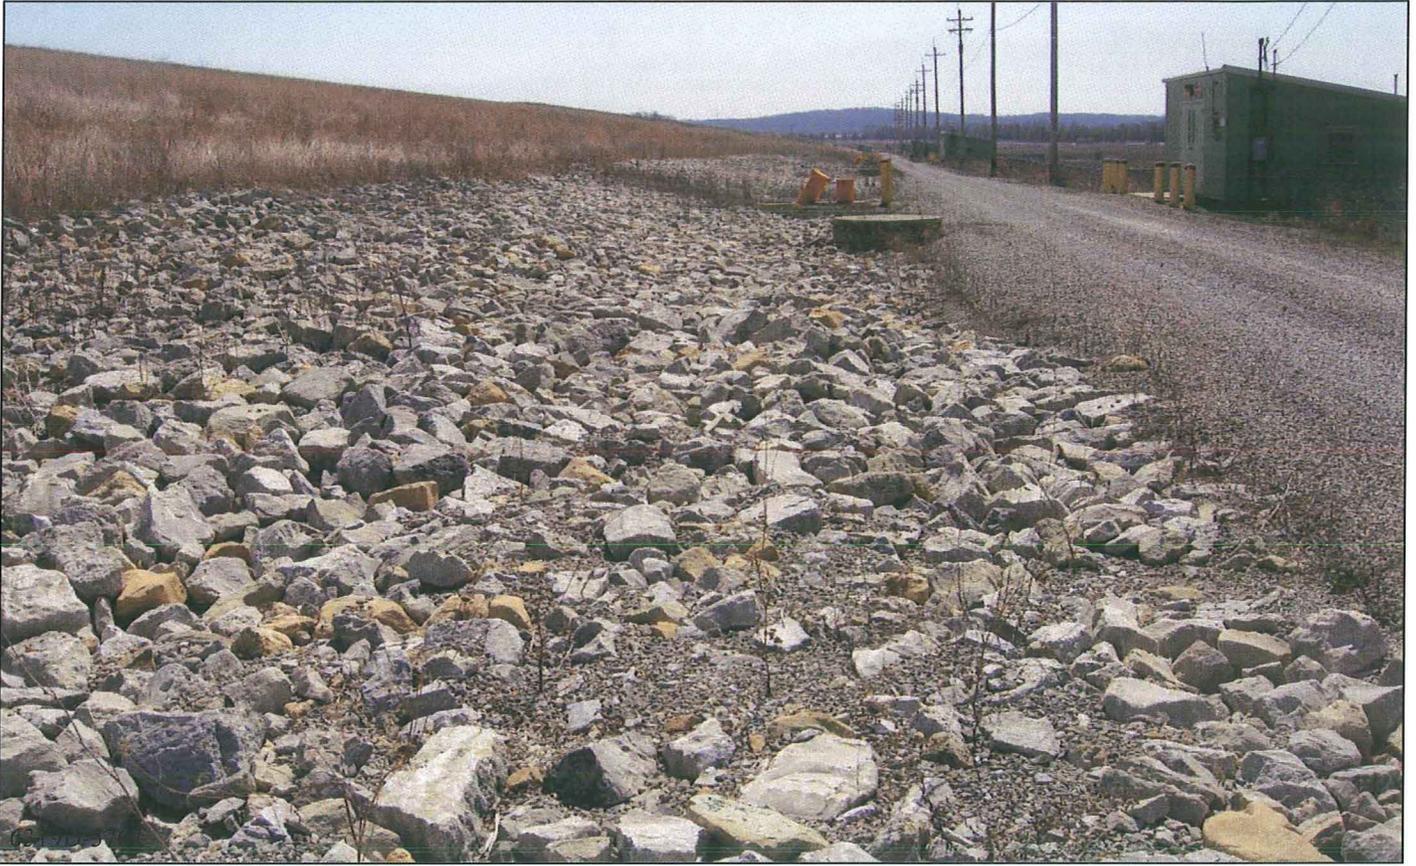
**West Inner Drainage Cell 4 (looking south)**

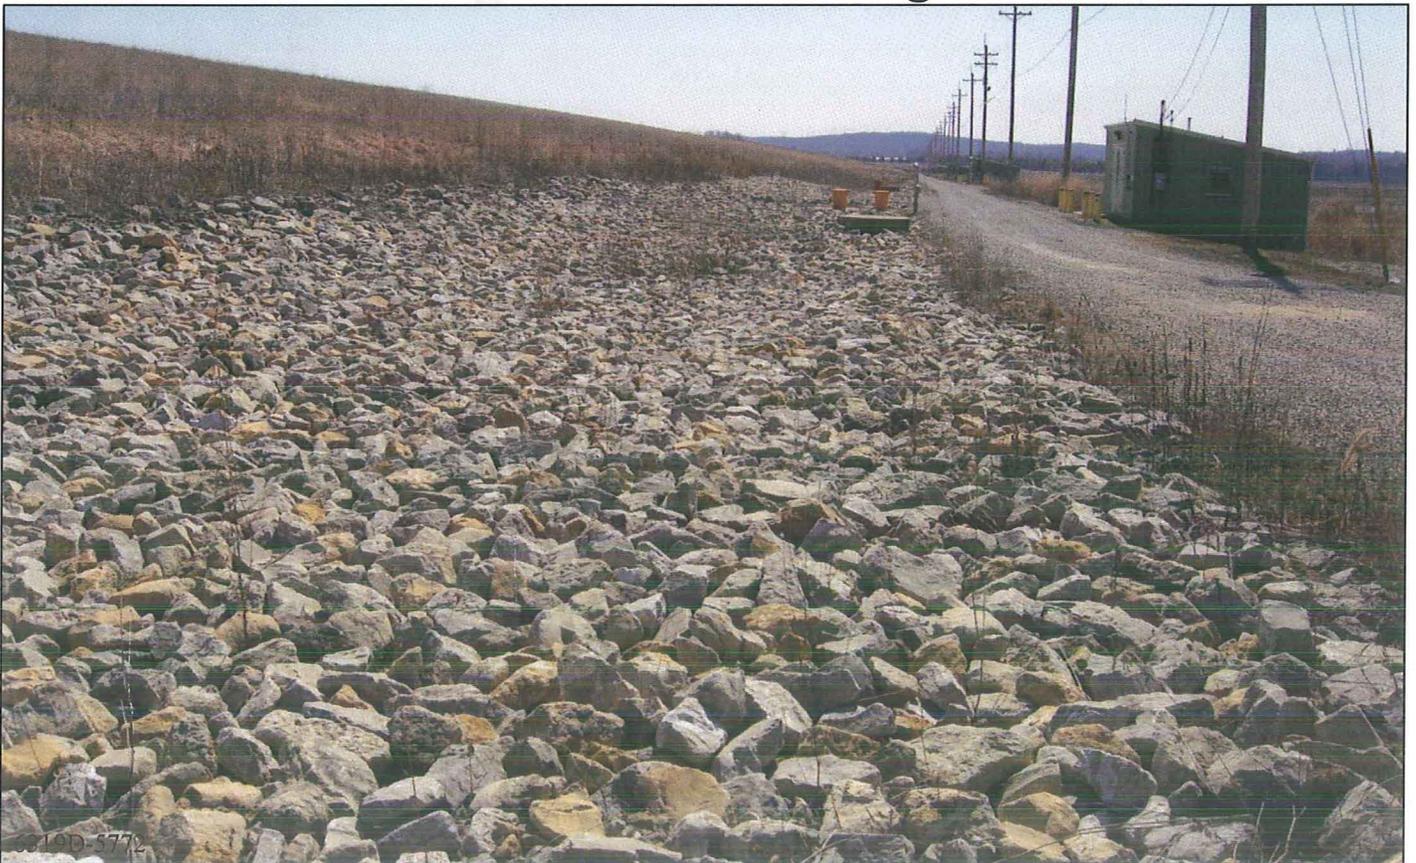
**West Inner Drainage Cell 1 (looking south)**

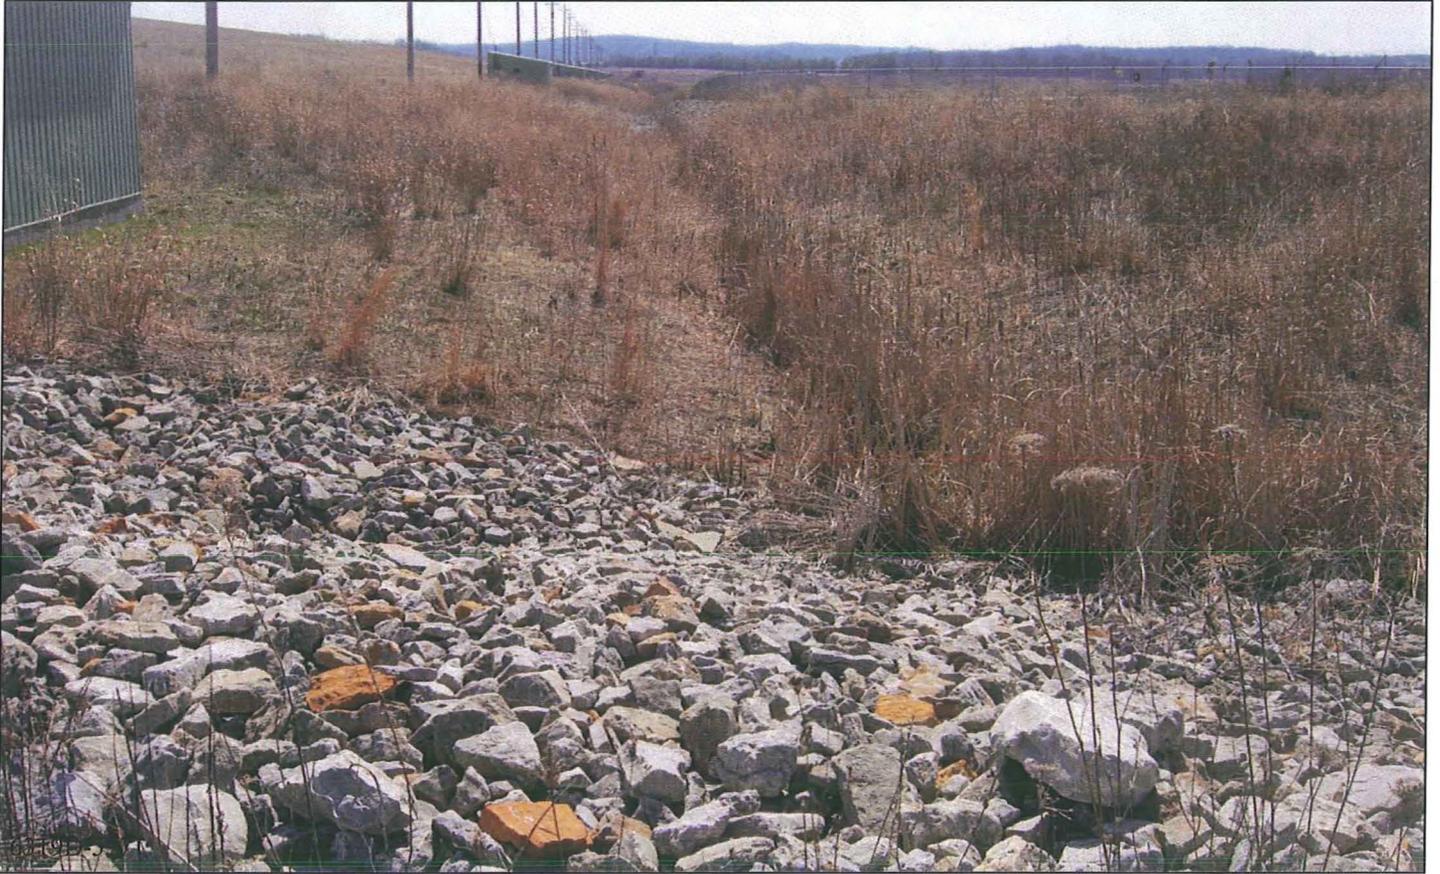
**West Outer Drainage Cell 1 (looking south)**

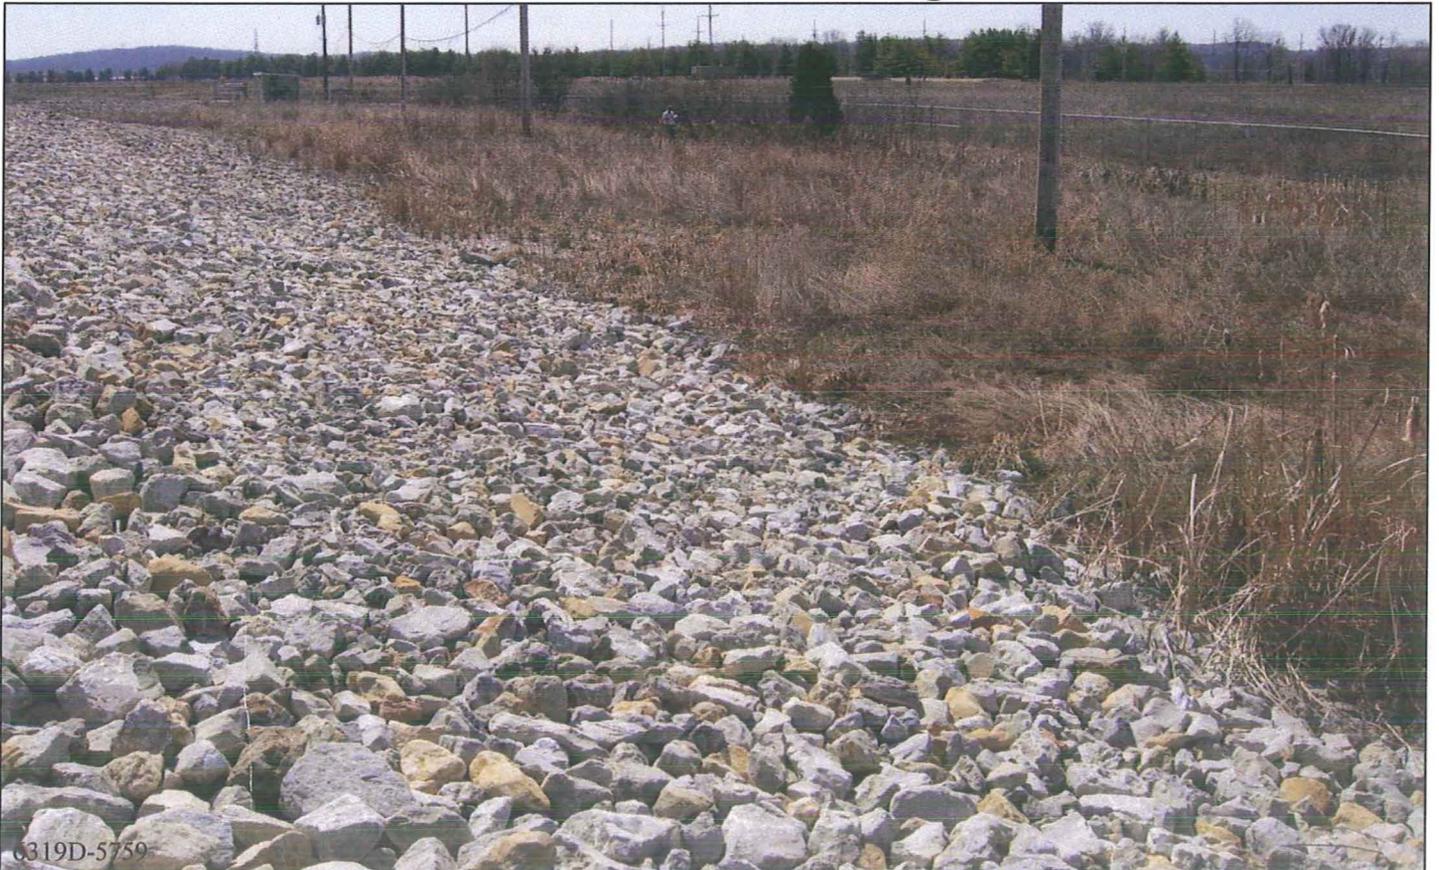
**West Outer Drainage Cell 8 (looking south)**

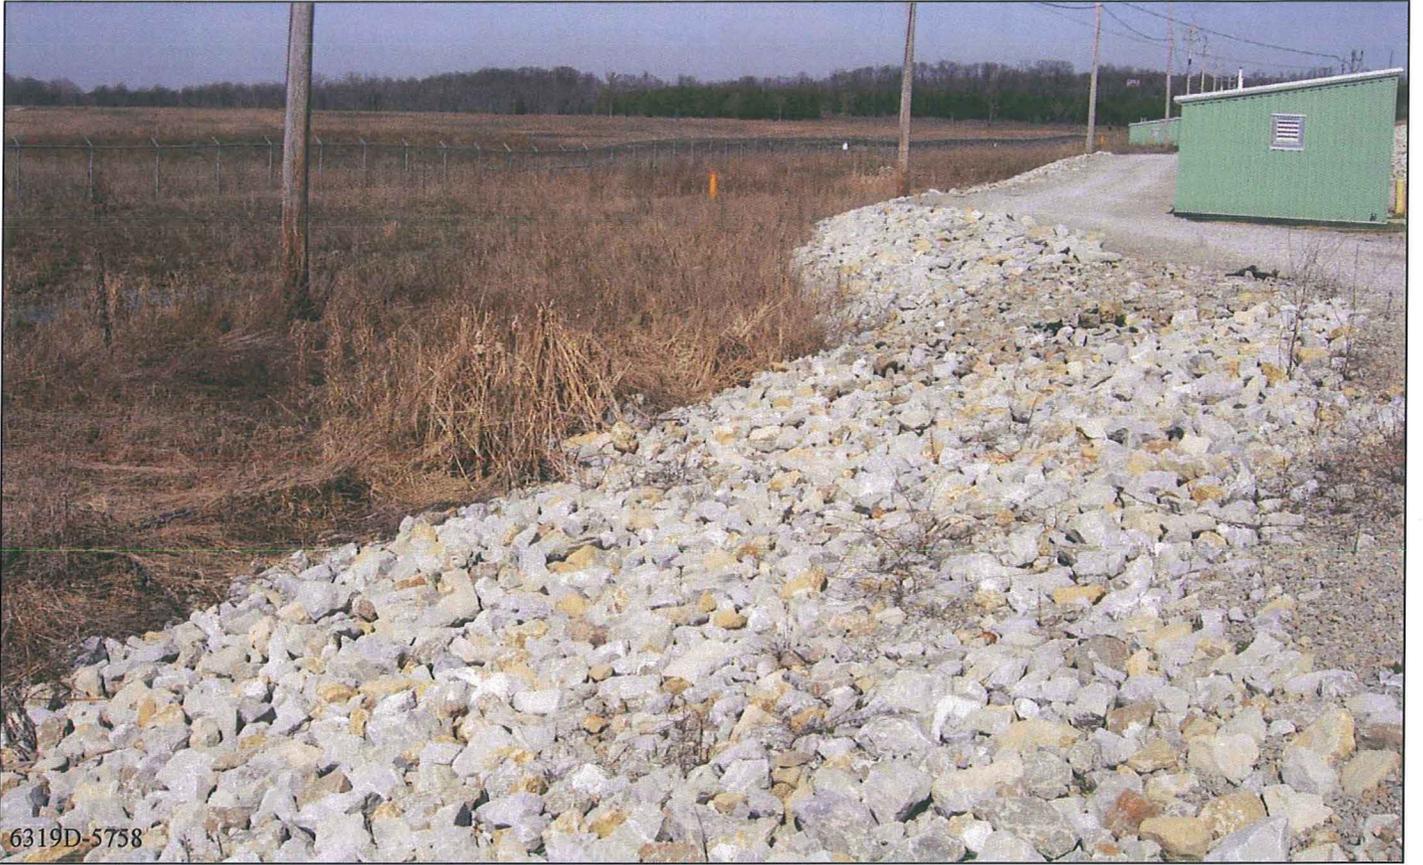
**West Outer Drainage Cell 8 (looking north)**
