Department of Energy  
Office of Legacy Management

**SUBJECT: Transmittal of the June 2010 Fernald Site Inspection Forms**

Fernald Preserve Field Walkdown Inspection

**Fernald Preserve  
 Consolidated Finding Locations  
 for June 2010 Site Inspection**

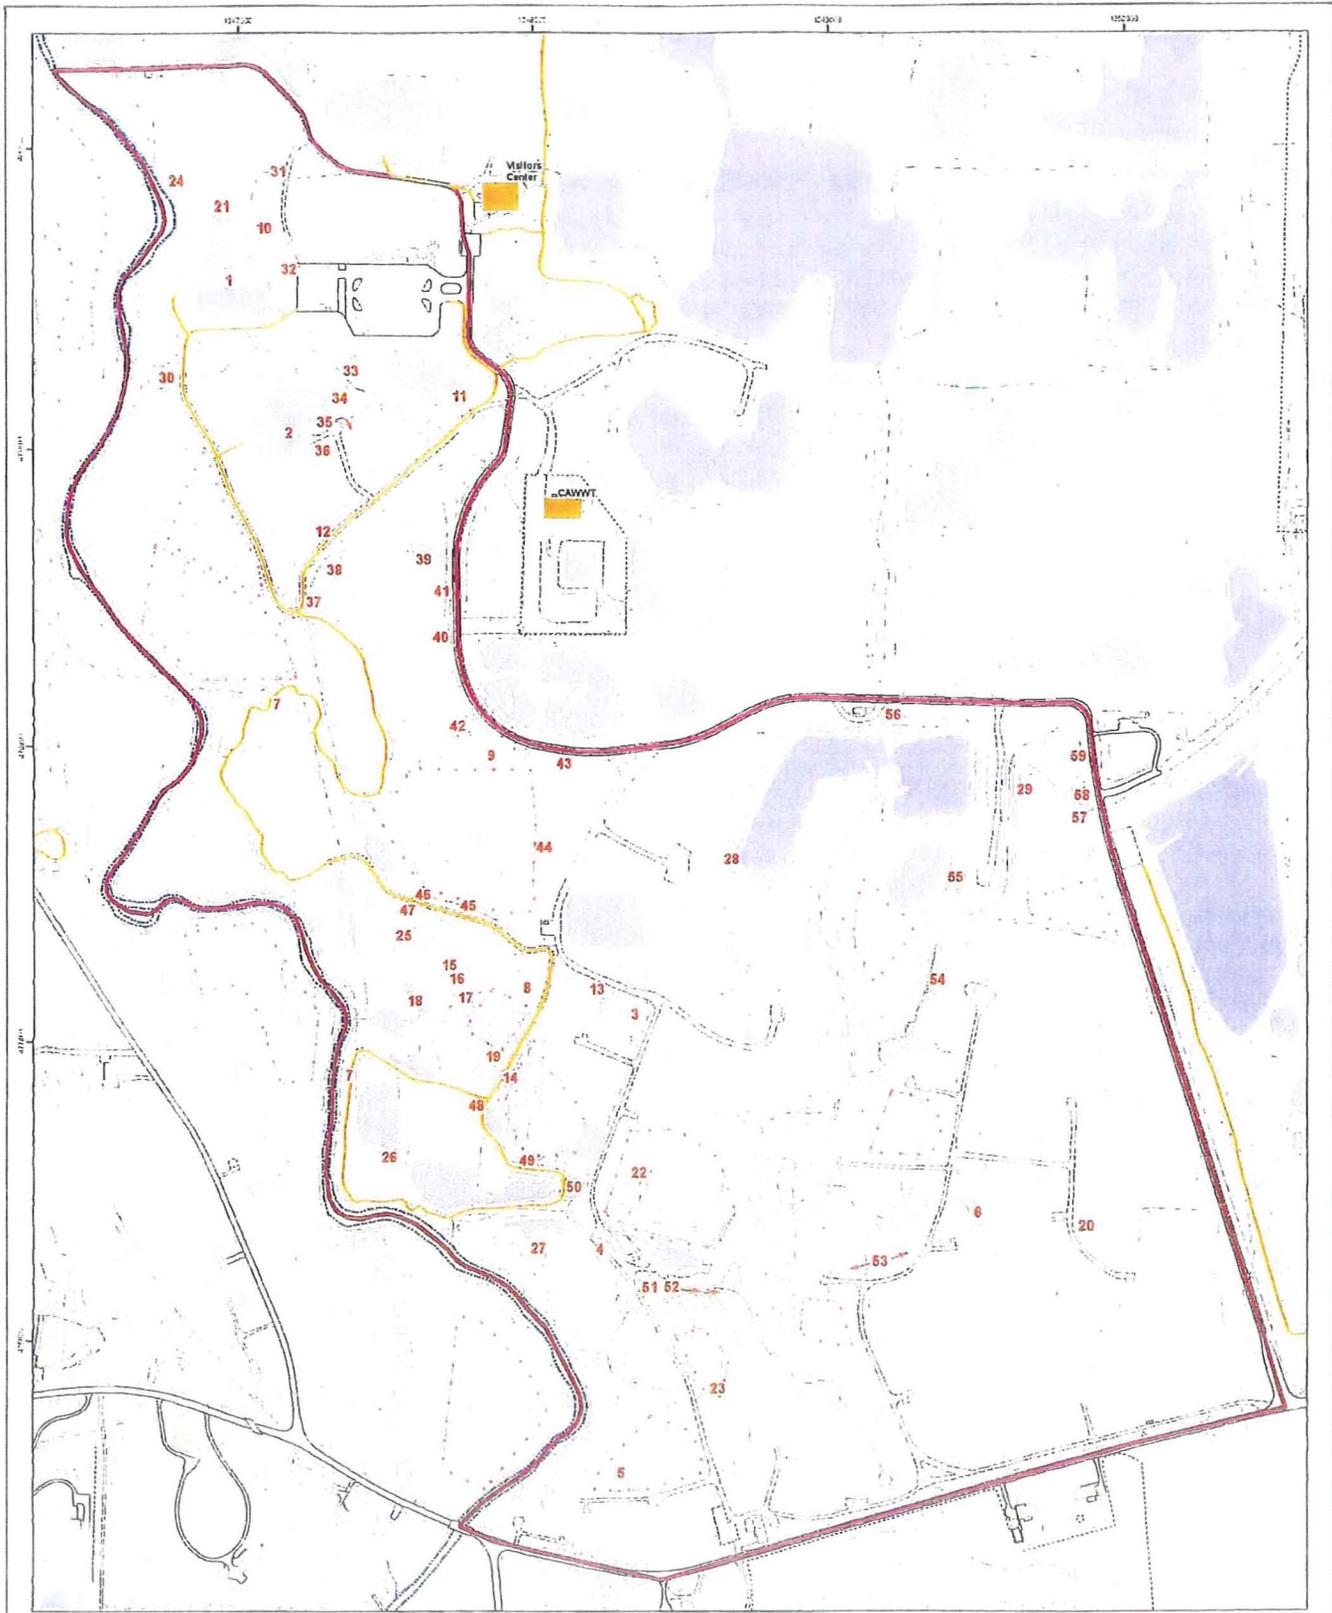
NOTE: Findings are numbered and provided on the June 2010 Field Walkdown Form  
 NOTE: Paddy's Run will be inspected as accessible - Summerfall
