Department of Energy
Office of Legacy Management

SUBJECT: Transmittal of the December 2010 Fernald Site Inspection Forms

Fernald Preserve Field Walkdown Inspection

Fernald Preserve
 Consolidated Finding Locations for North Section
 of December 2010 Site Inspection

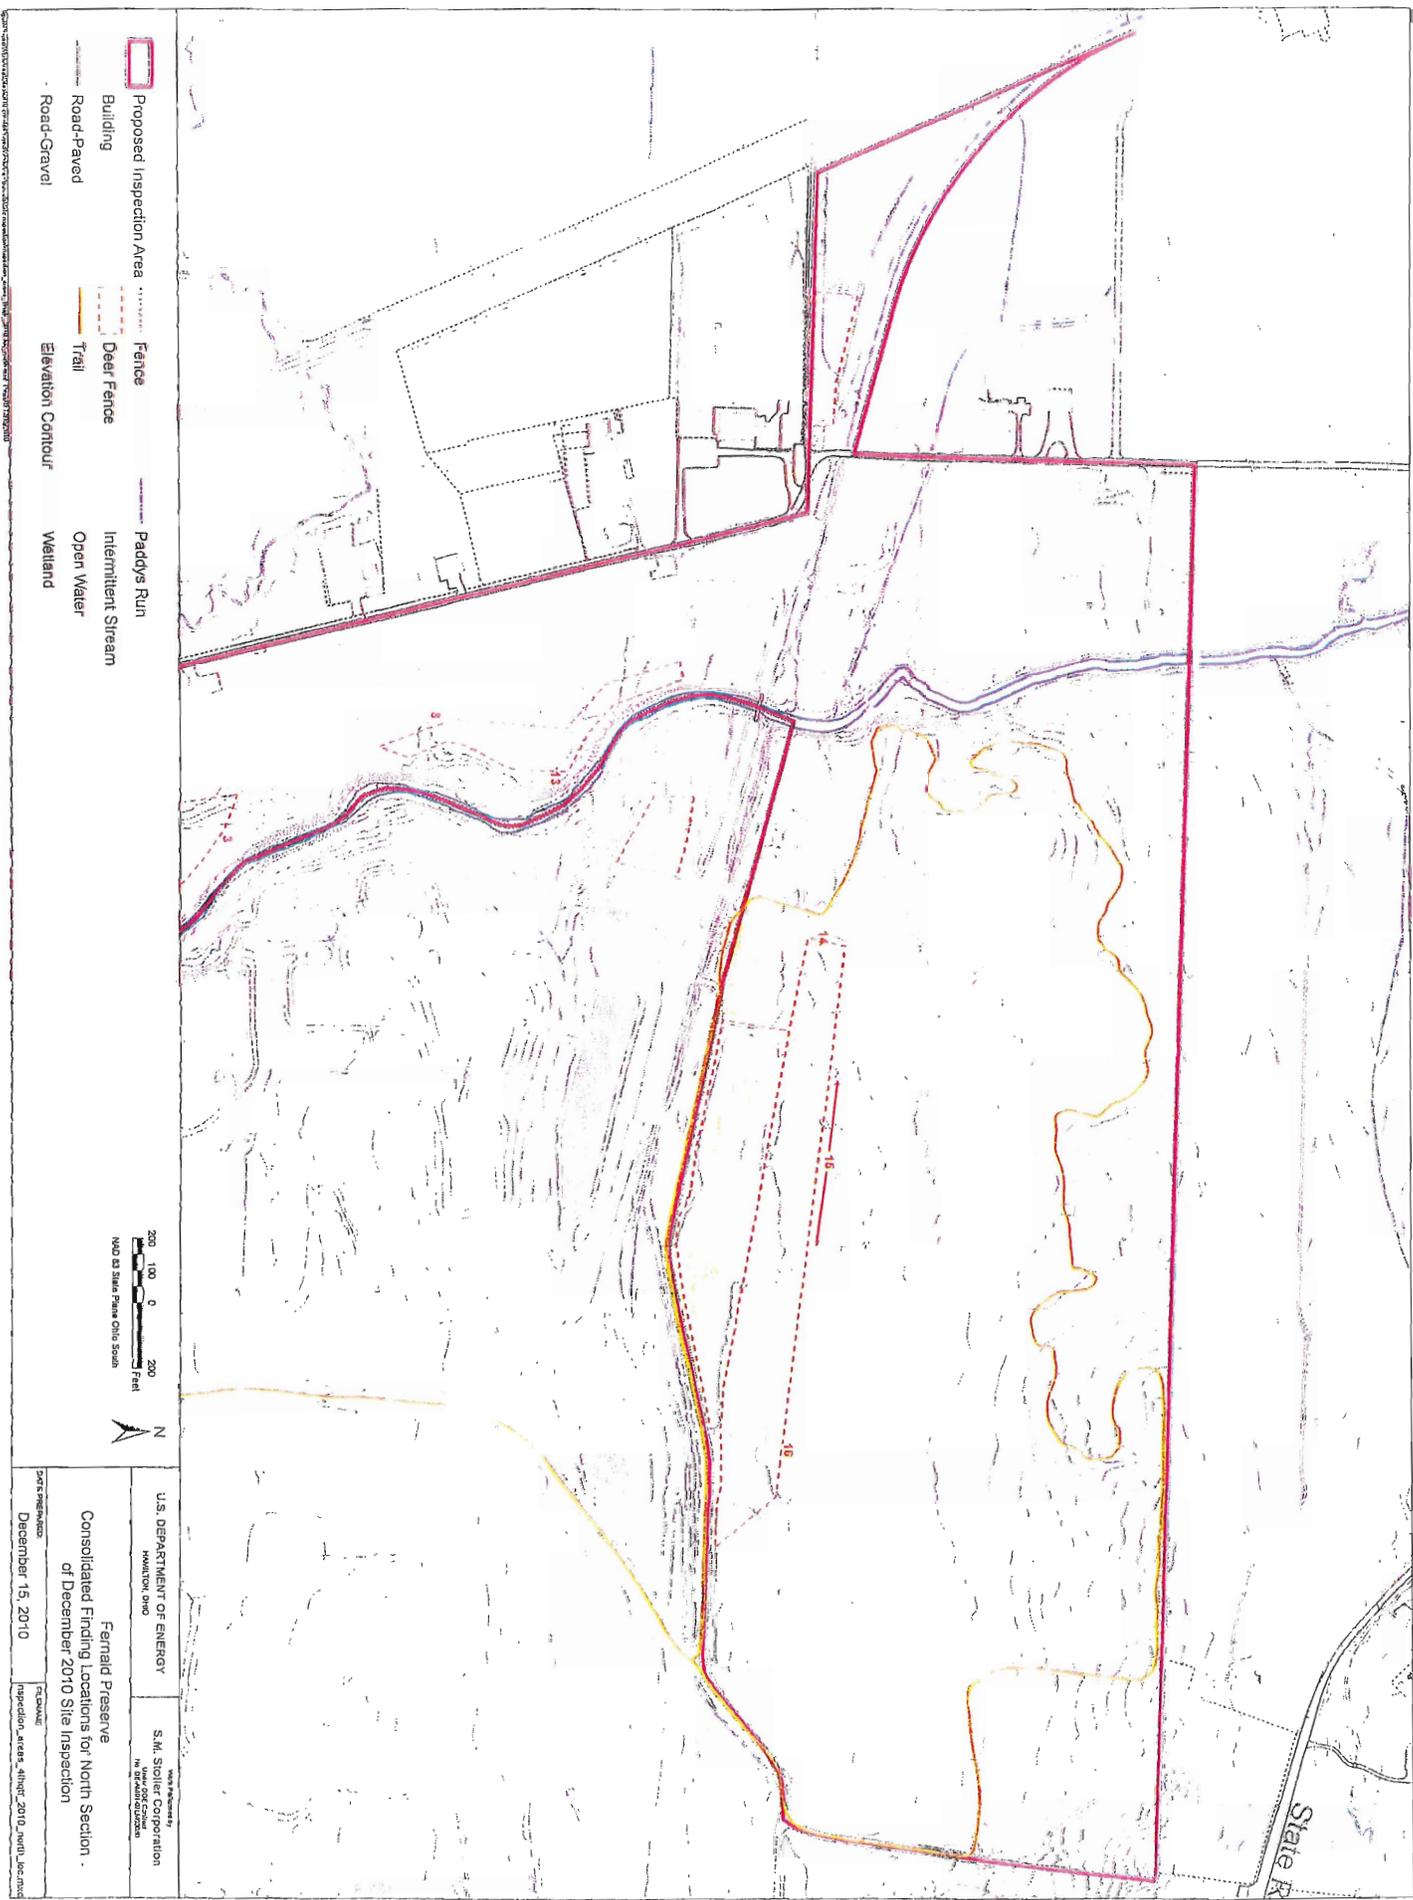
No.	Location (Use Map Whenever Possible)	GPS?	Type of Finding				Description	Photo? (File No.)	Follow Up		
			Unauthorized Use	Disturbance	Vegetation	Other			Corrected	Maintenance Req'd	Cont. Observation
1	Duke substation	NO				X	Debris	NO		X	
2	Duke substation	NO				X	Bluebird box off post	NO		X	
3	A8PIII-N, south deer fence	NO				X	North side of fence down	NO		X	
4	A8PIII-N, south deer fence	NO				X	East gate open	NO		X	
5	A8PIII-N, south deer fence	NO				X	South end of fence down	NO		X	
6	A8PIII-N, south deer fence	NO				X	West side of fence down	NO		X	
7	A8PIII-N, south deer fence	NO				X	West side of fence down	NO		X	
8	A8PIII-N, north deer fence	NO				X	West side of fence down	NO		X	
9	Field north of Duke substation	NO				X	Debris (red clay/brick)	NO		X	
10	A8PIII, south deer fence	NO				X	Southwest corner down	NO		X	
11	Deer fence at rainbow bridge	NO				X	Tree cages need removed. Limbs down on east side of fence.	NO		X

12	Deer fence at rainbow bridge	NO				X	Tree across fence	NO		X	
13	A8PIII-N, north deer fence	NO				X	East side has holes and the fence is slipping down poles	NO		X	
14	A6PI deer fence	NO				X	West end fence is down	NO		X	
15	A6PI deer fence	NO				X	Tree on fence on north side	NO		X	
16	A6PI deer fence	NO				X	Hole in north side	NO		X
