**SUBJECT: Transmittal of the December 2013 Fernald Preserve On-Site Disposal Facility  
Inspection Forms**

Fernald Preserve OSDF Walkdown Inspection Report

# On-Site Disposal Facility Inspection Report December 2013

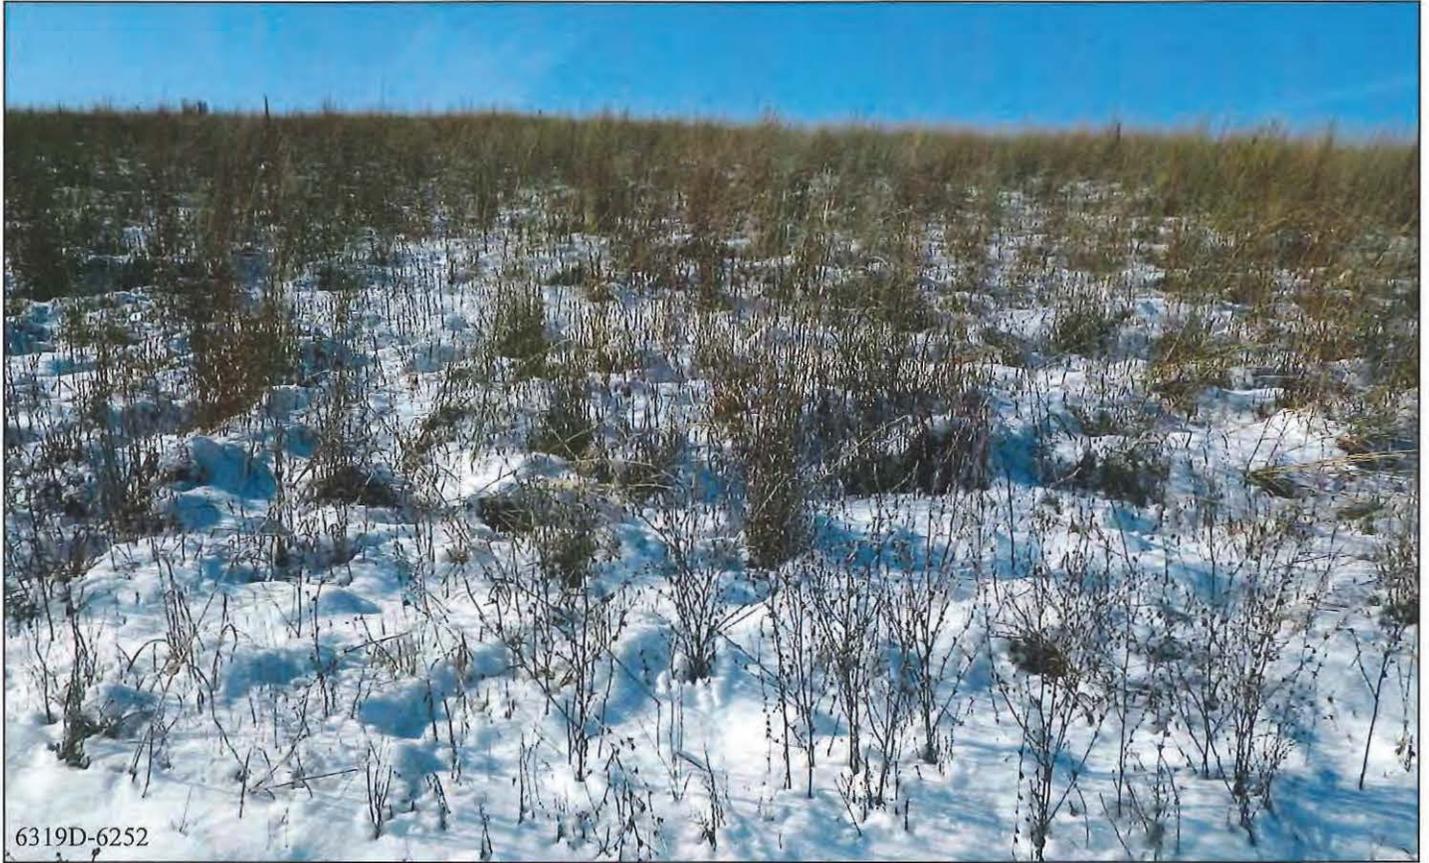
6319D-6252

**East Face Cell 1**

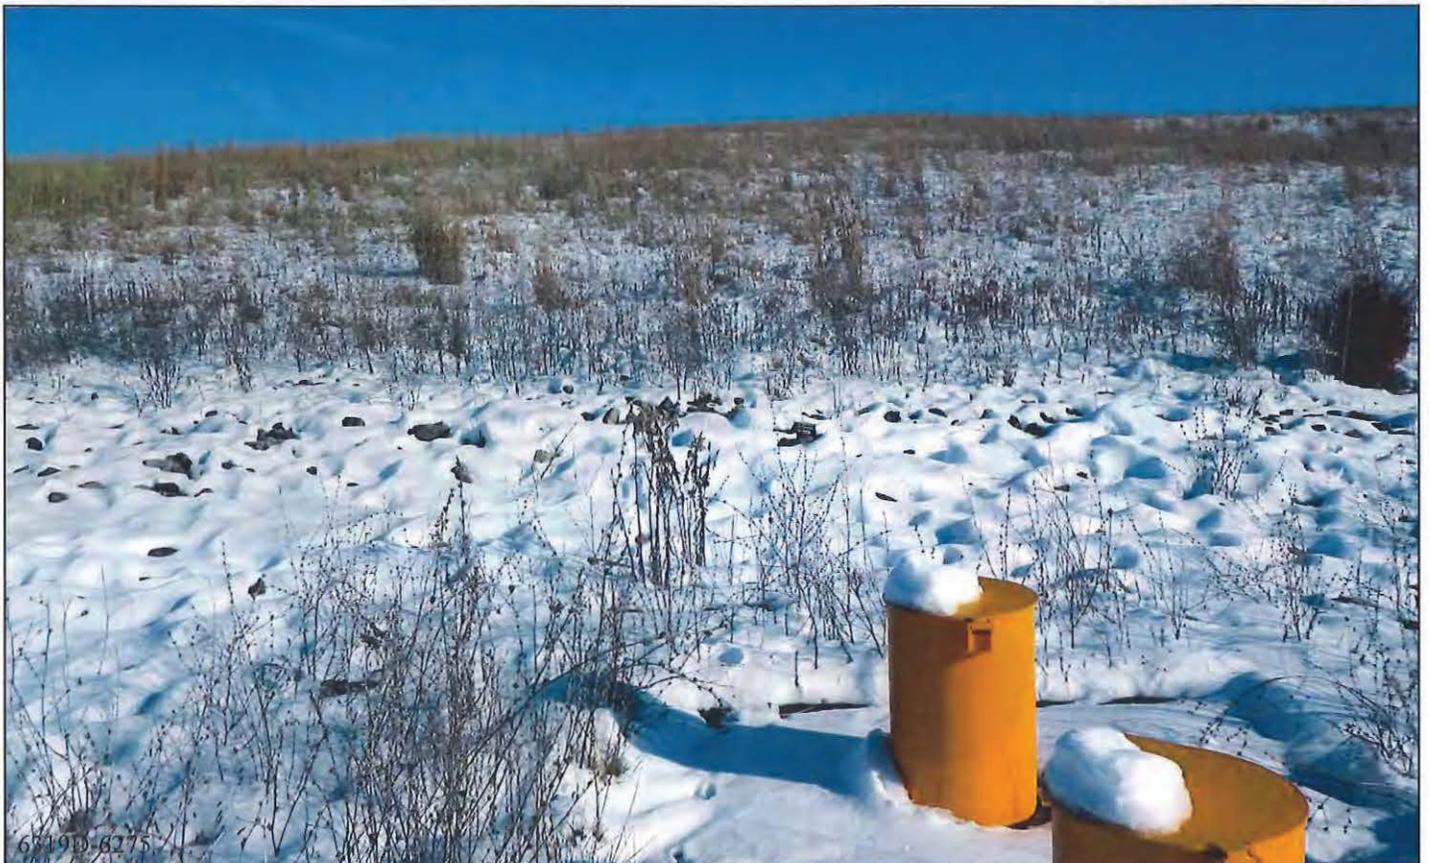
6319D-6275

**West Face Cell 1**

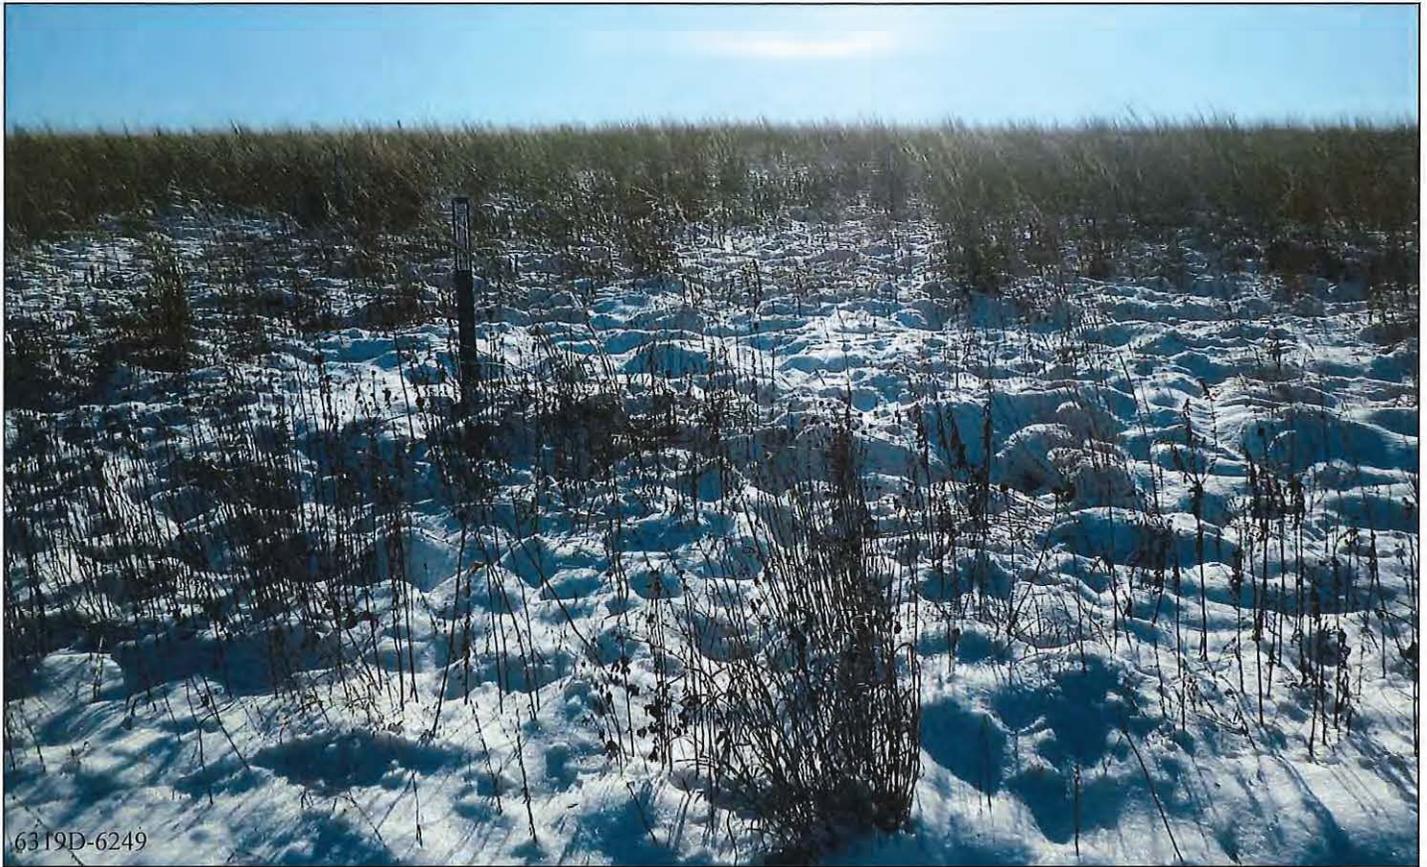
6319D-6249

**North Face Cell 1**

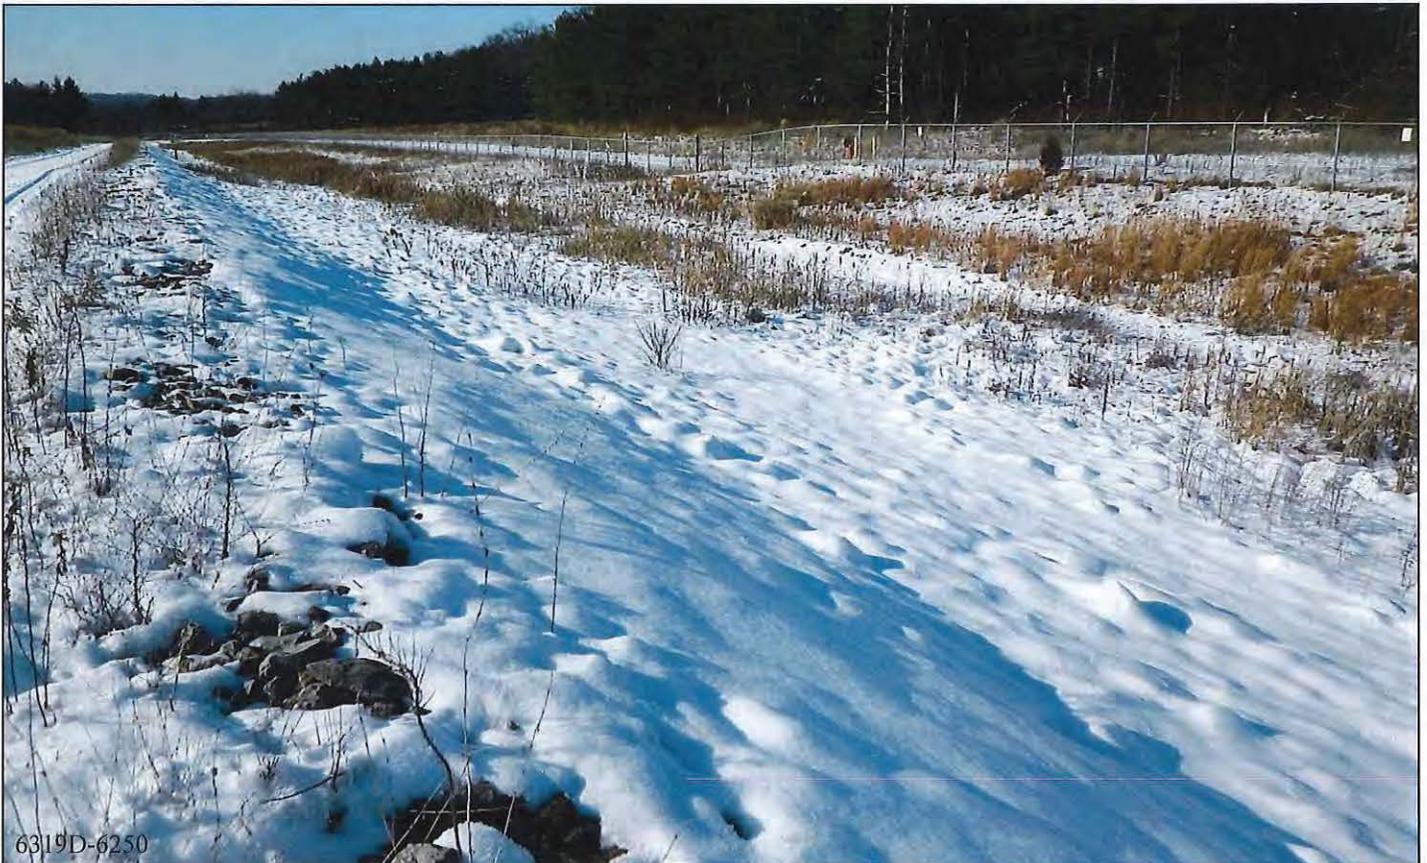
6319D-6250

**North Drainage (looking west)**

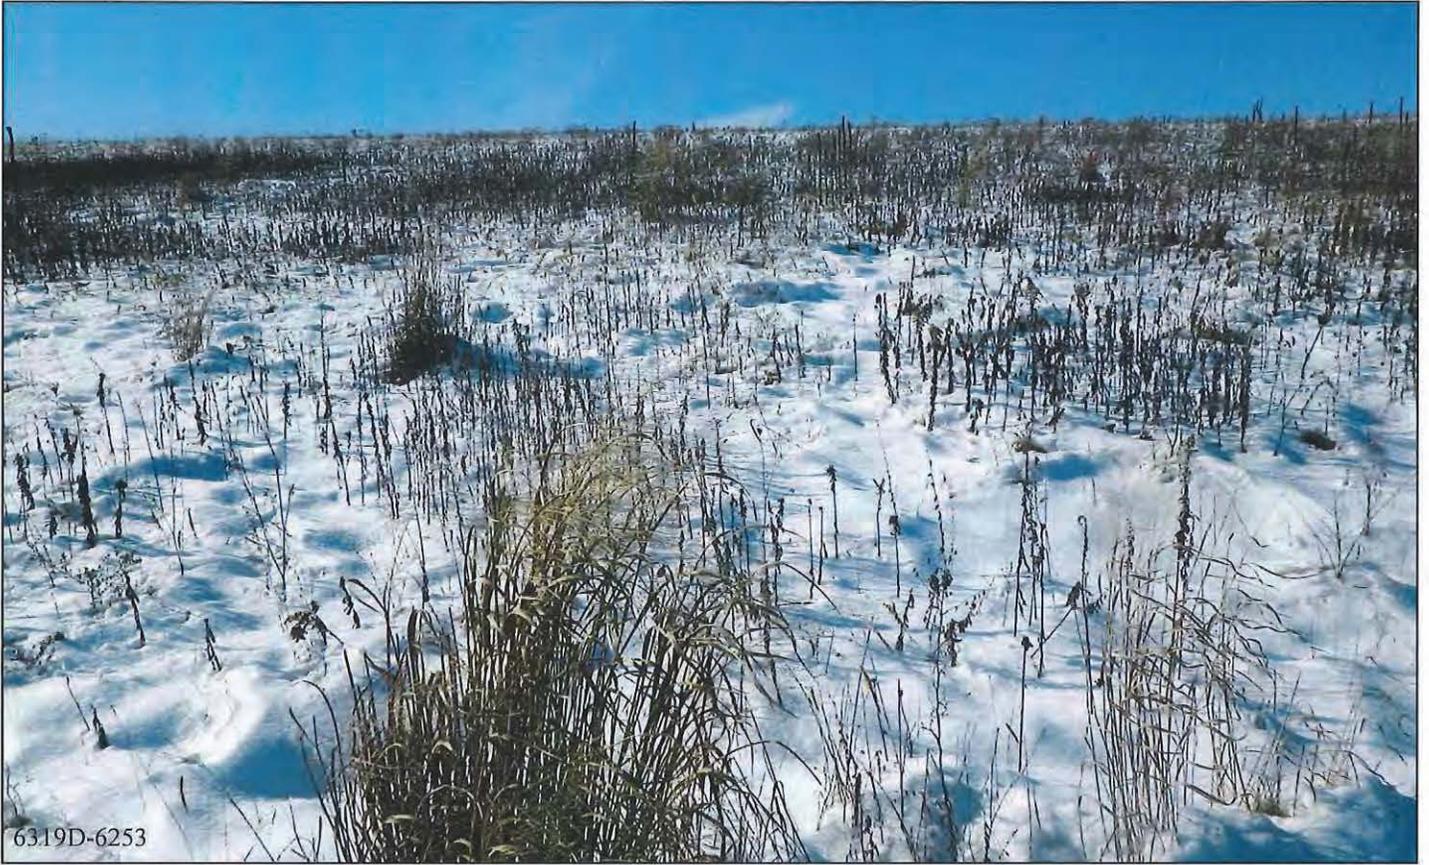
**East Face Cell 2**

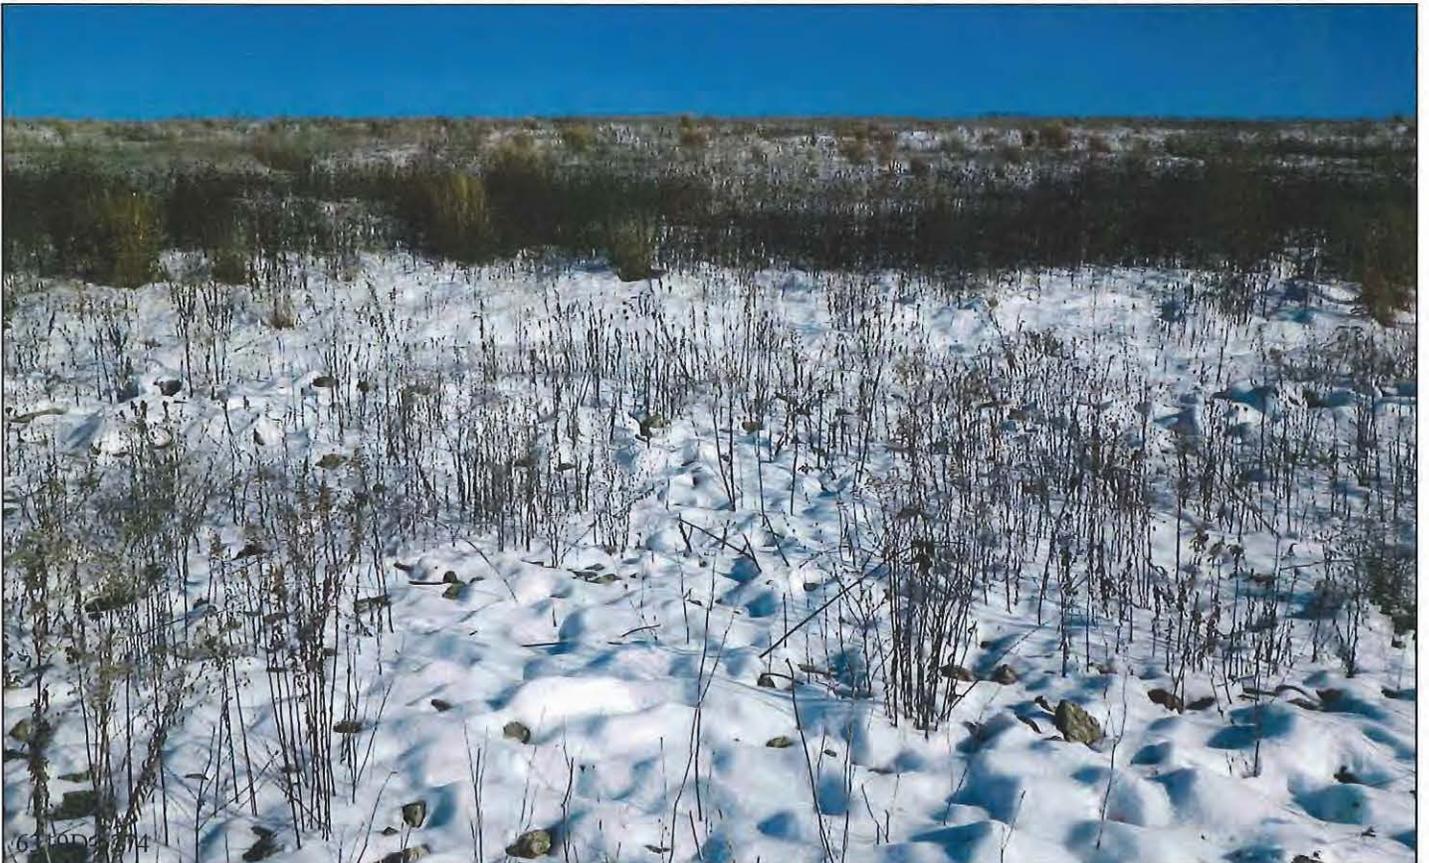
**West Face Cell 2**

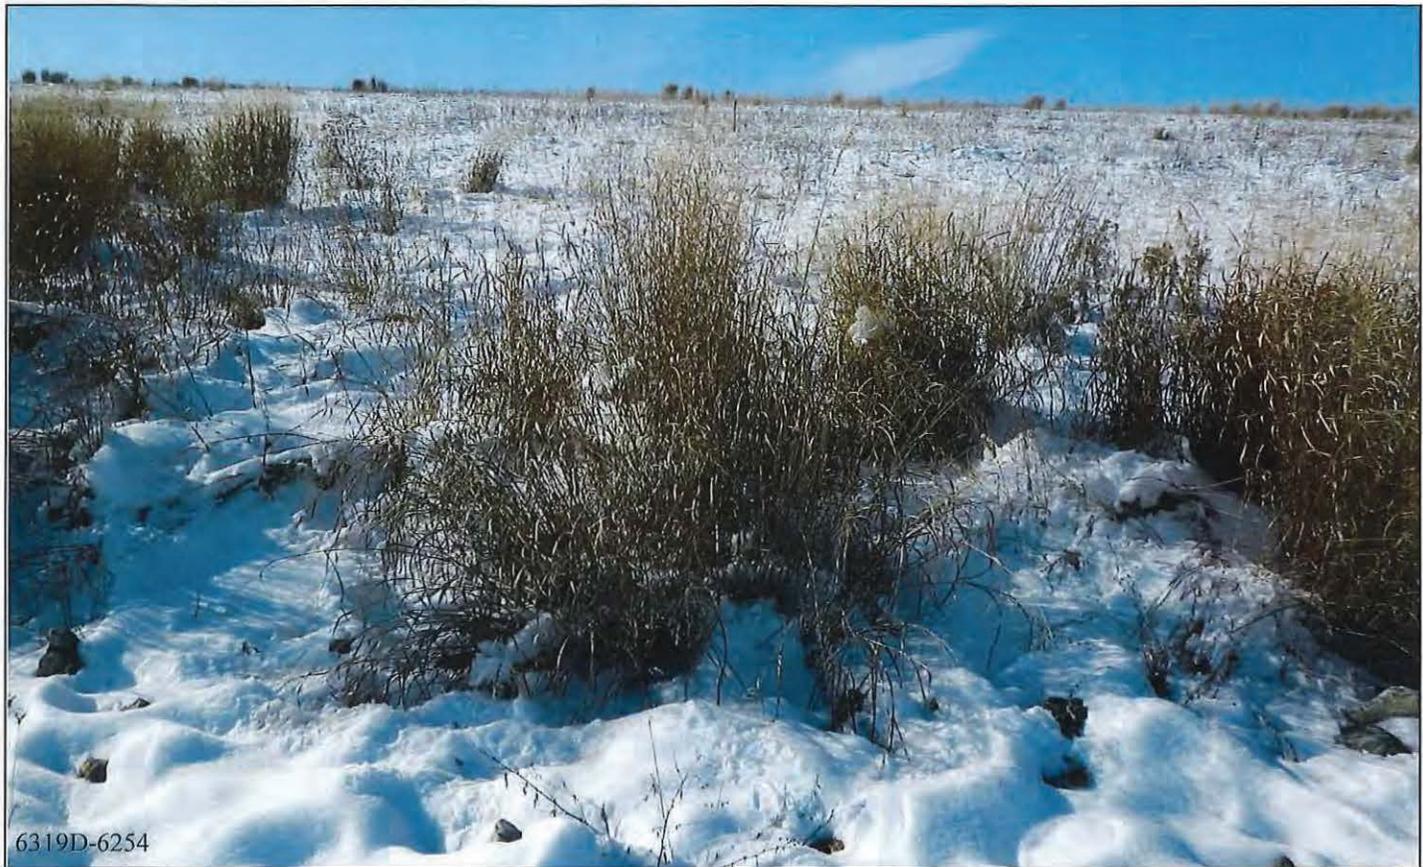
6319D-6254

**East Face Cell 3**

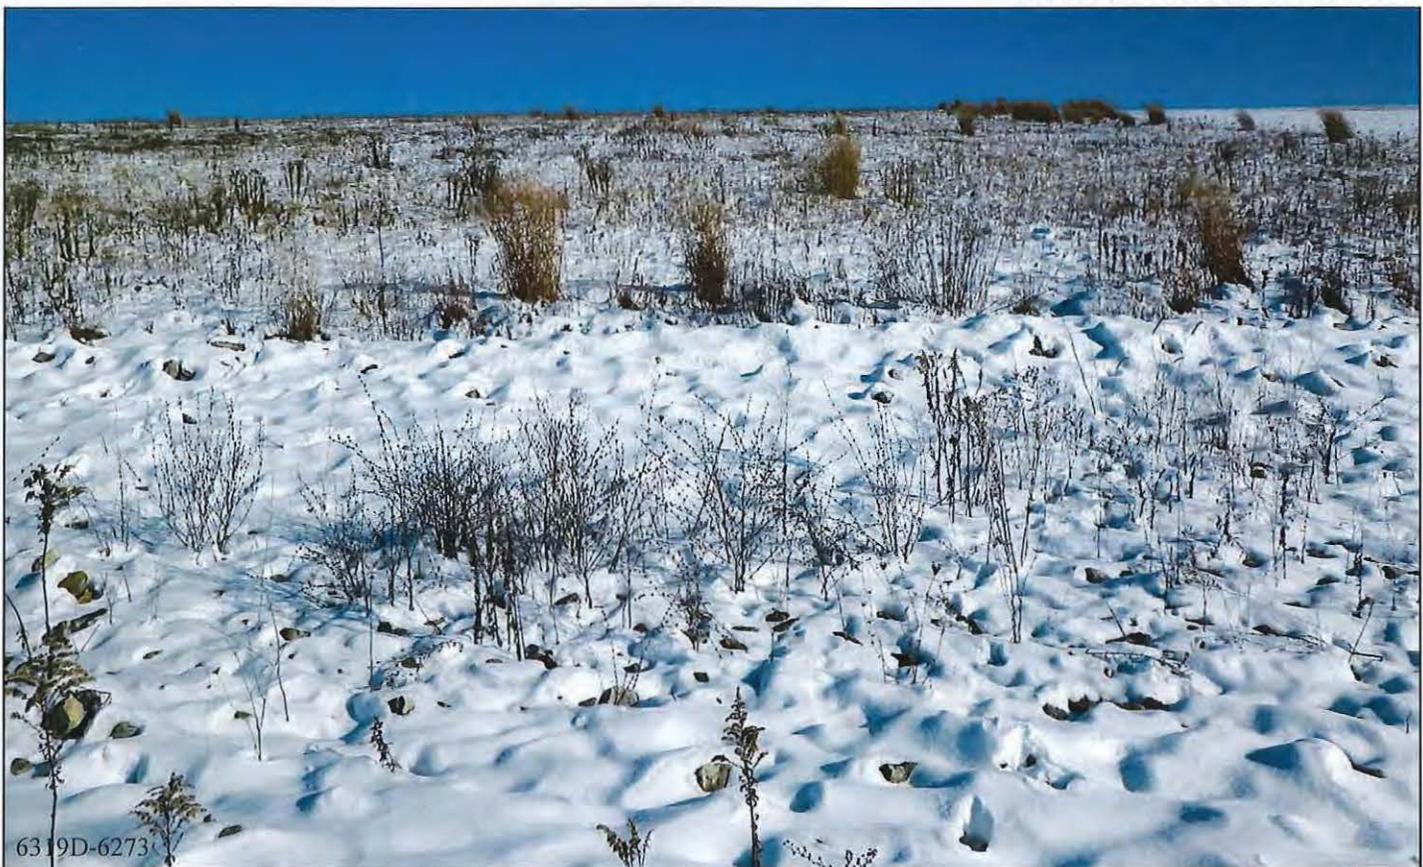
6319D-6273

**West Face Cell 3**

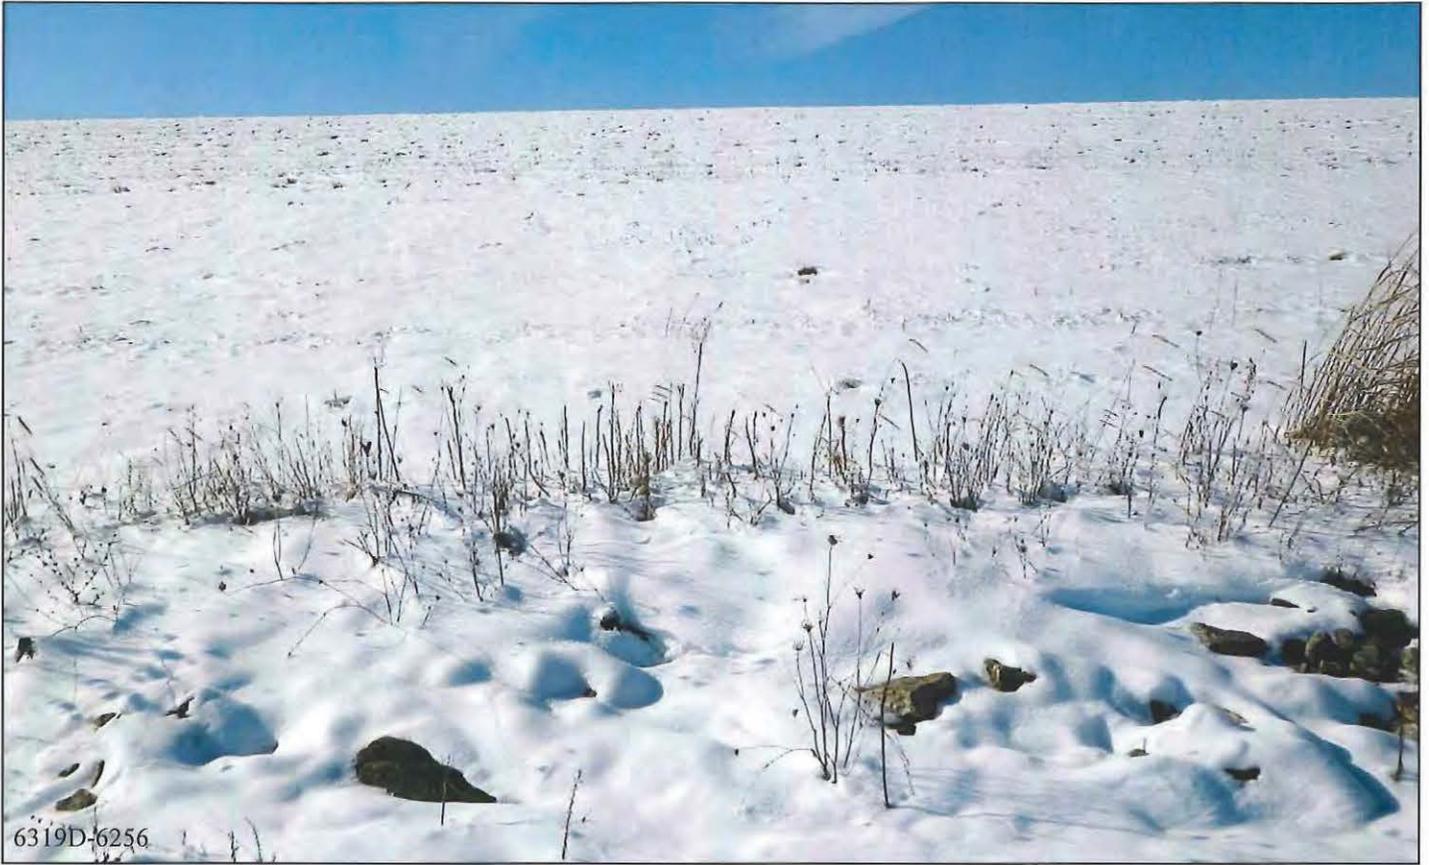
**East Face Cell 4**

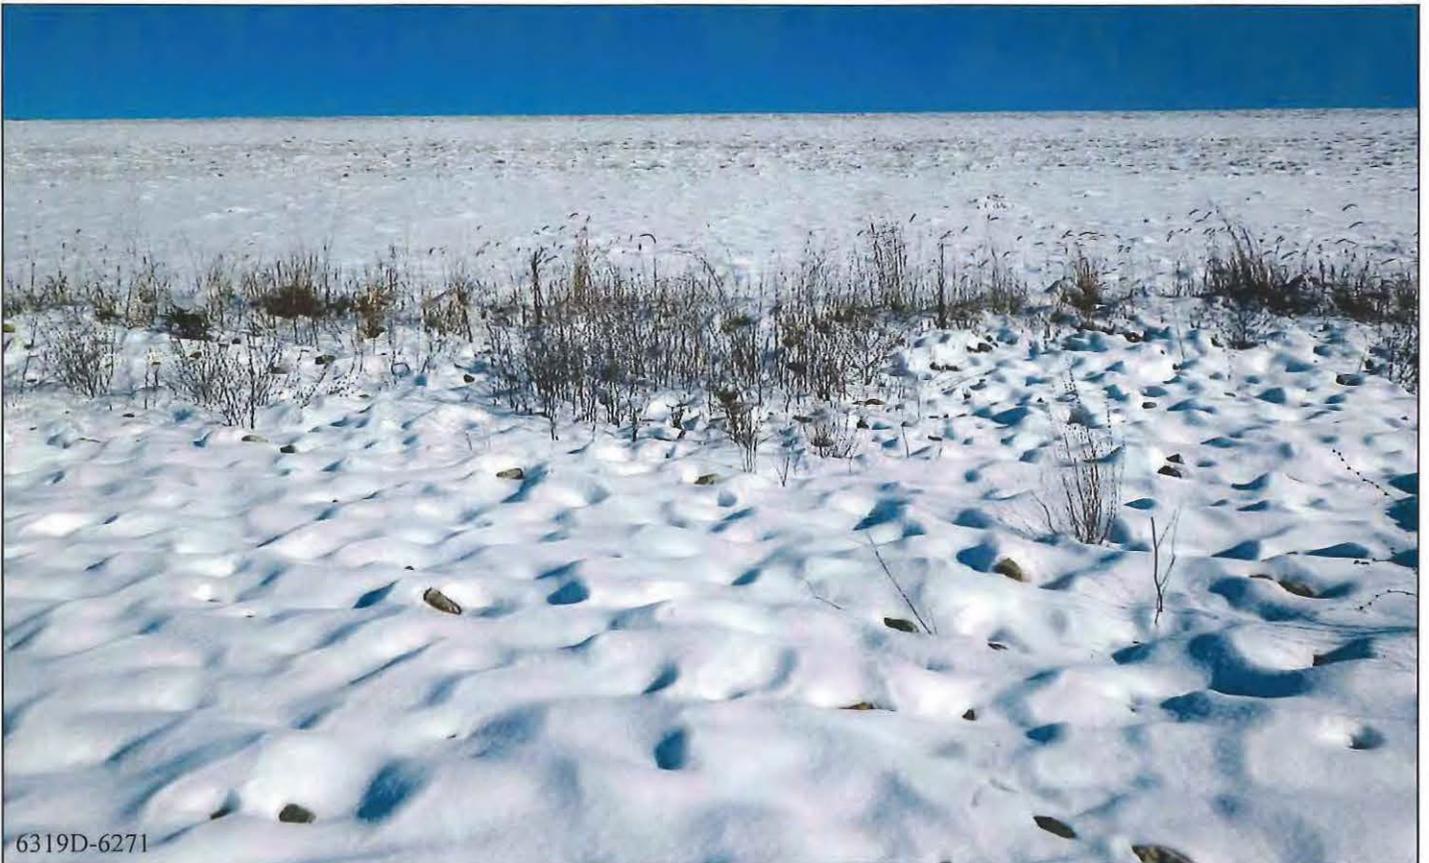
**West Face Cell 4**

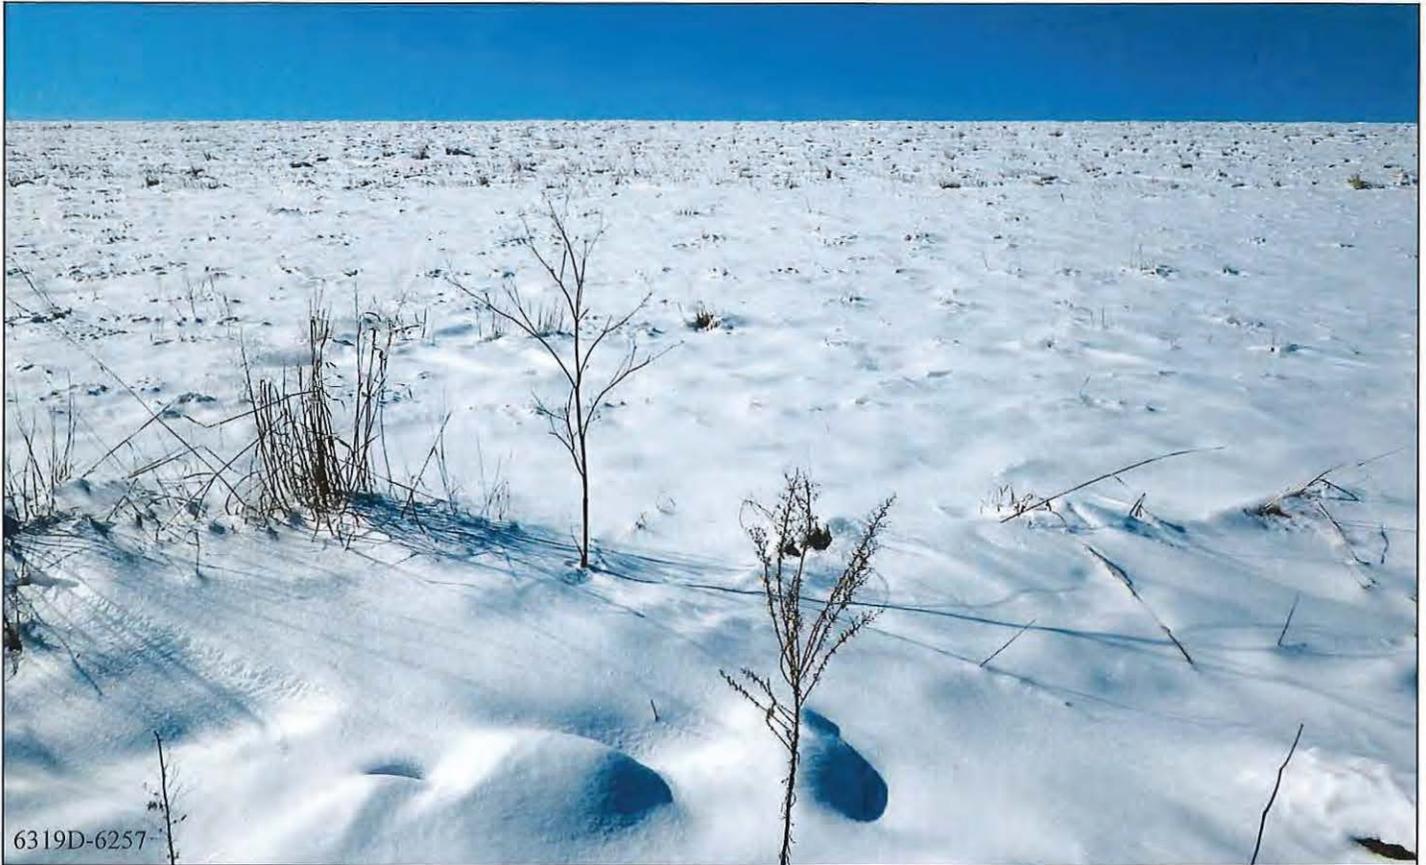
**East Face Cell 5**

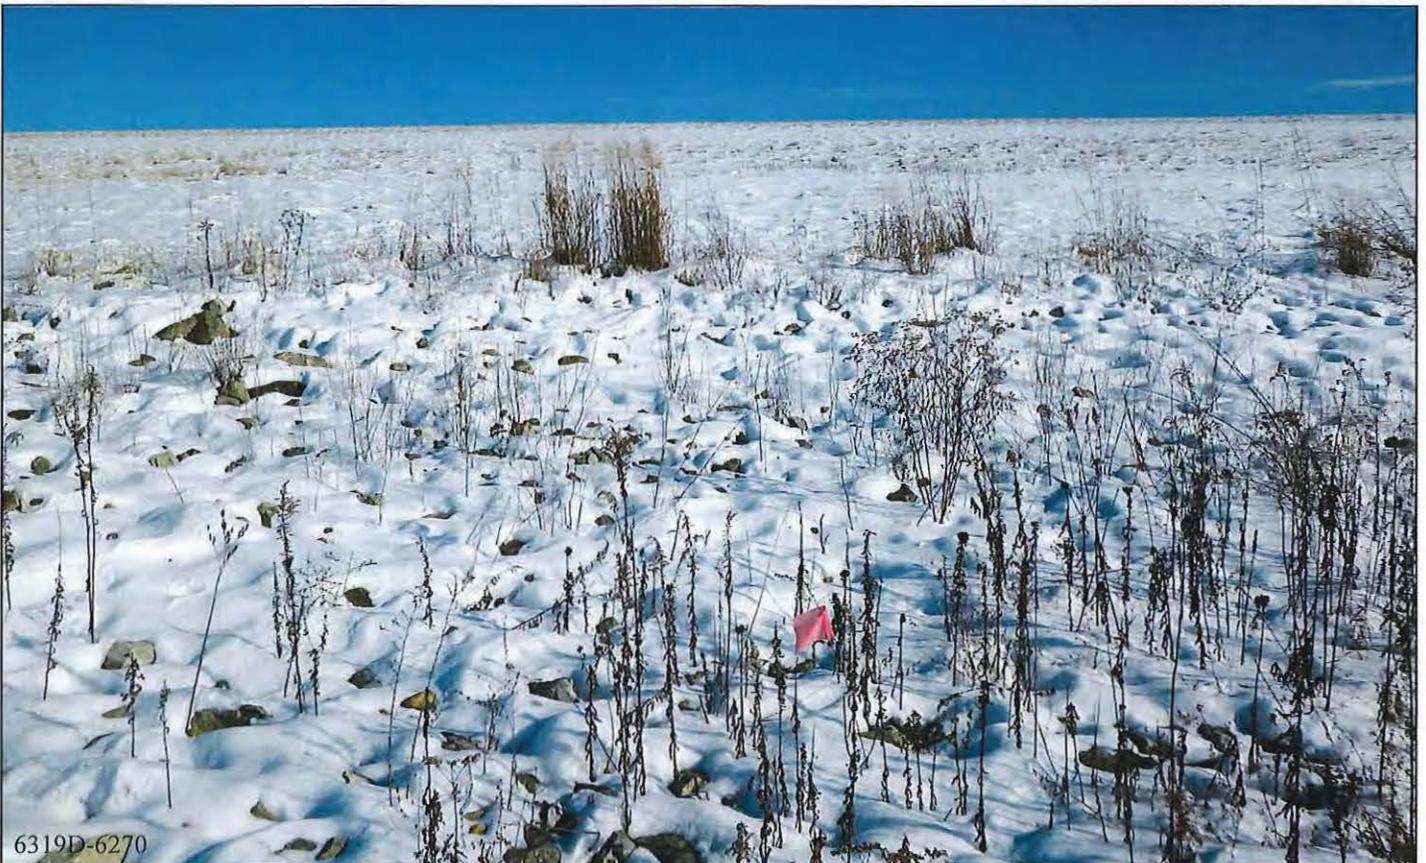
**West Face Cell 5**

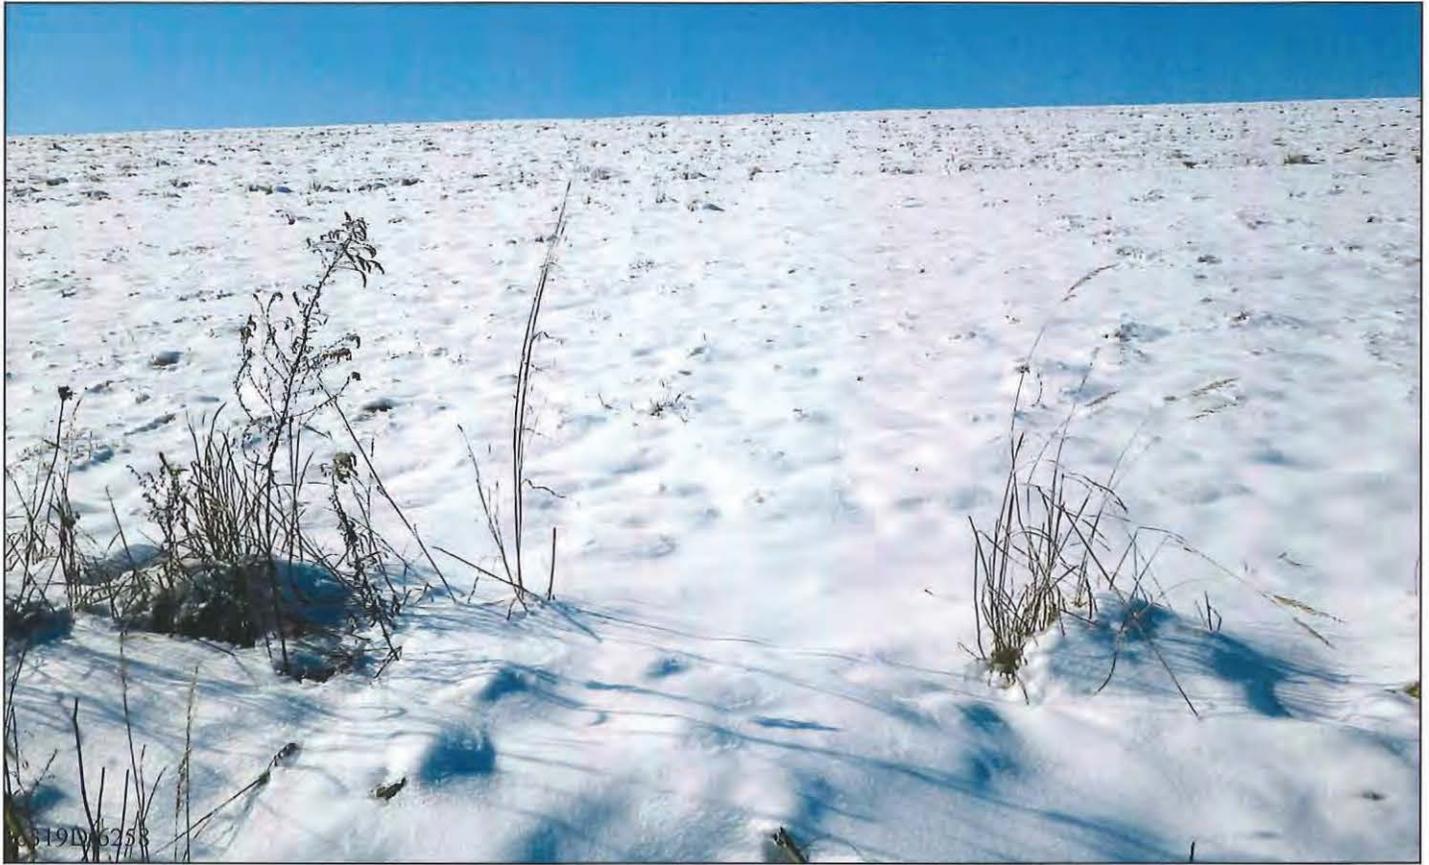
**East Face Cell 6**

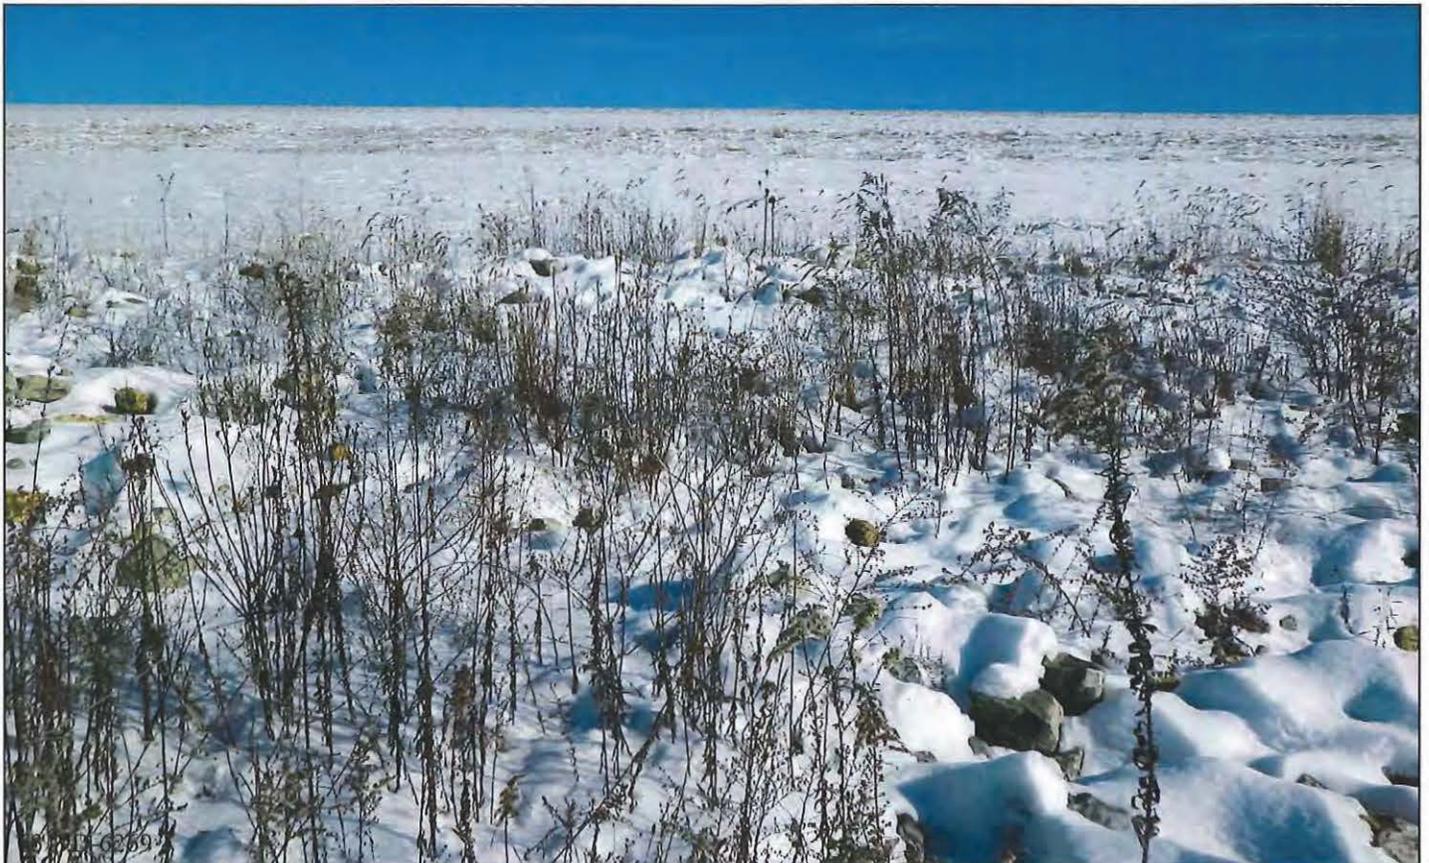
**West Face Cell 6**

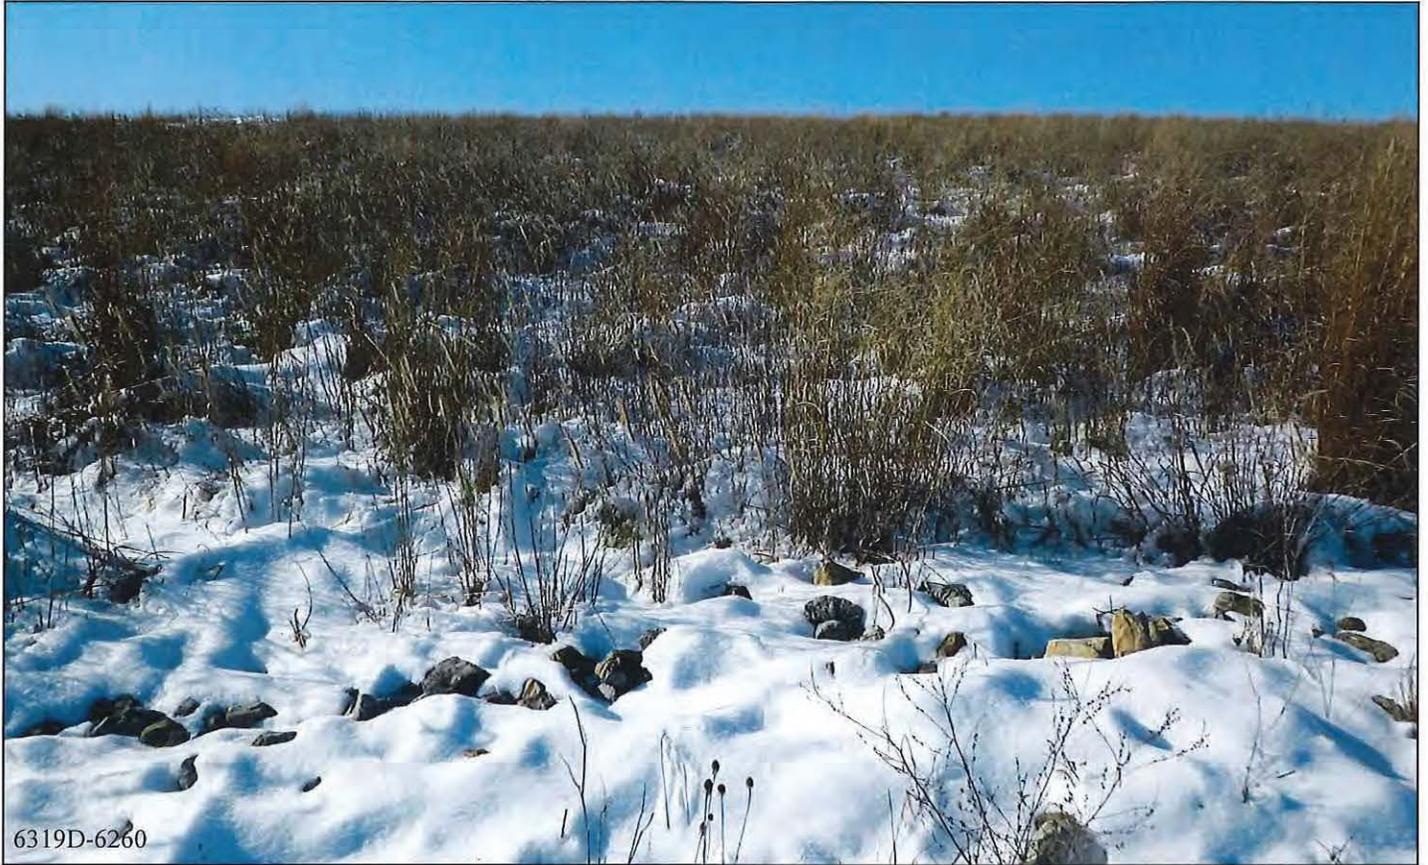
**East Face Cell 7**

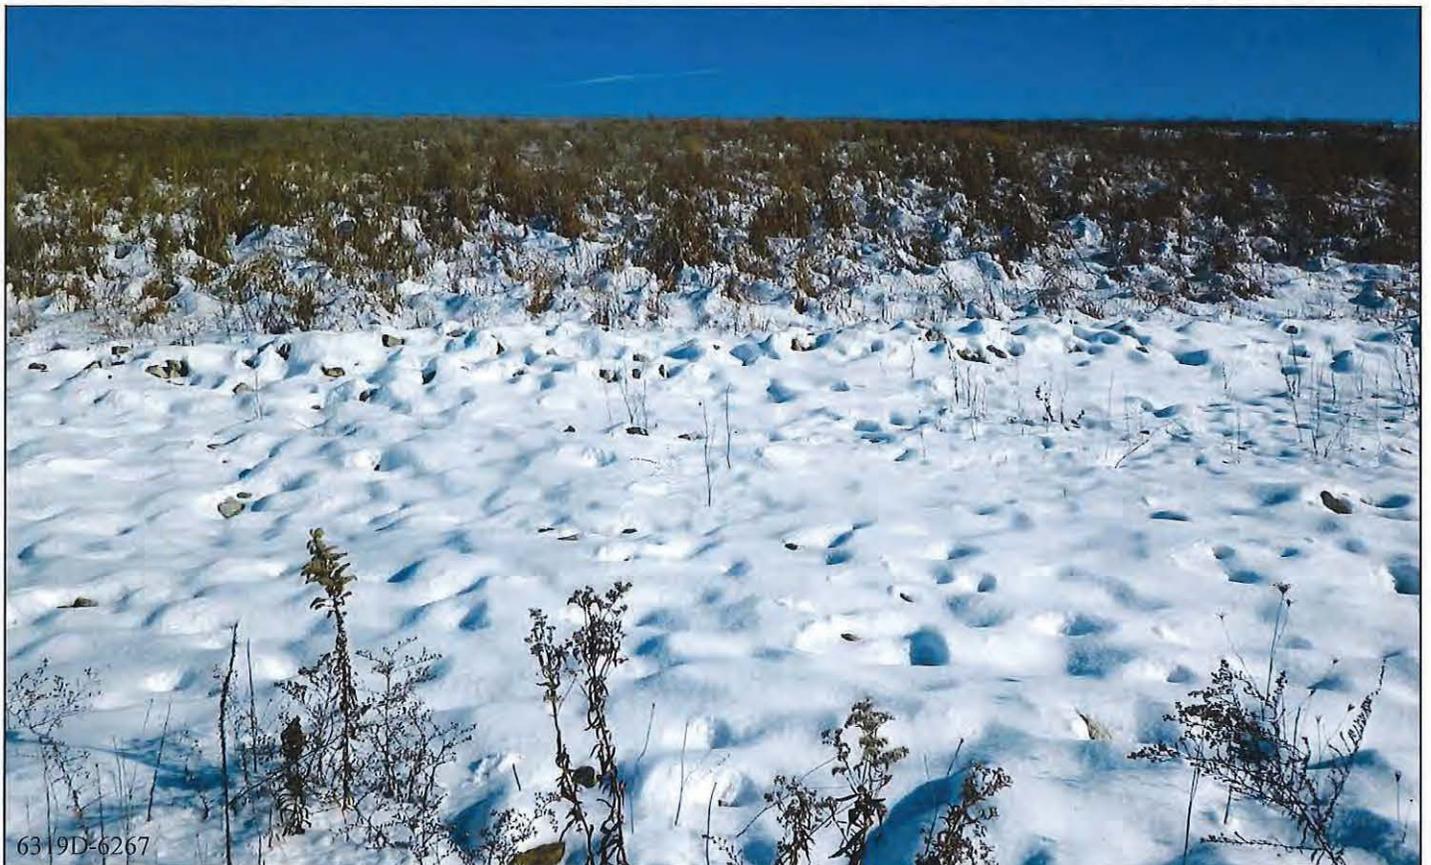
**West Face Cell 7**

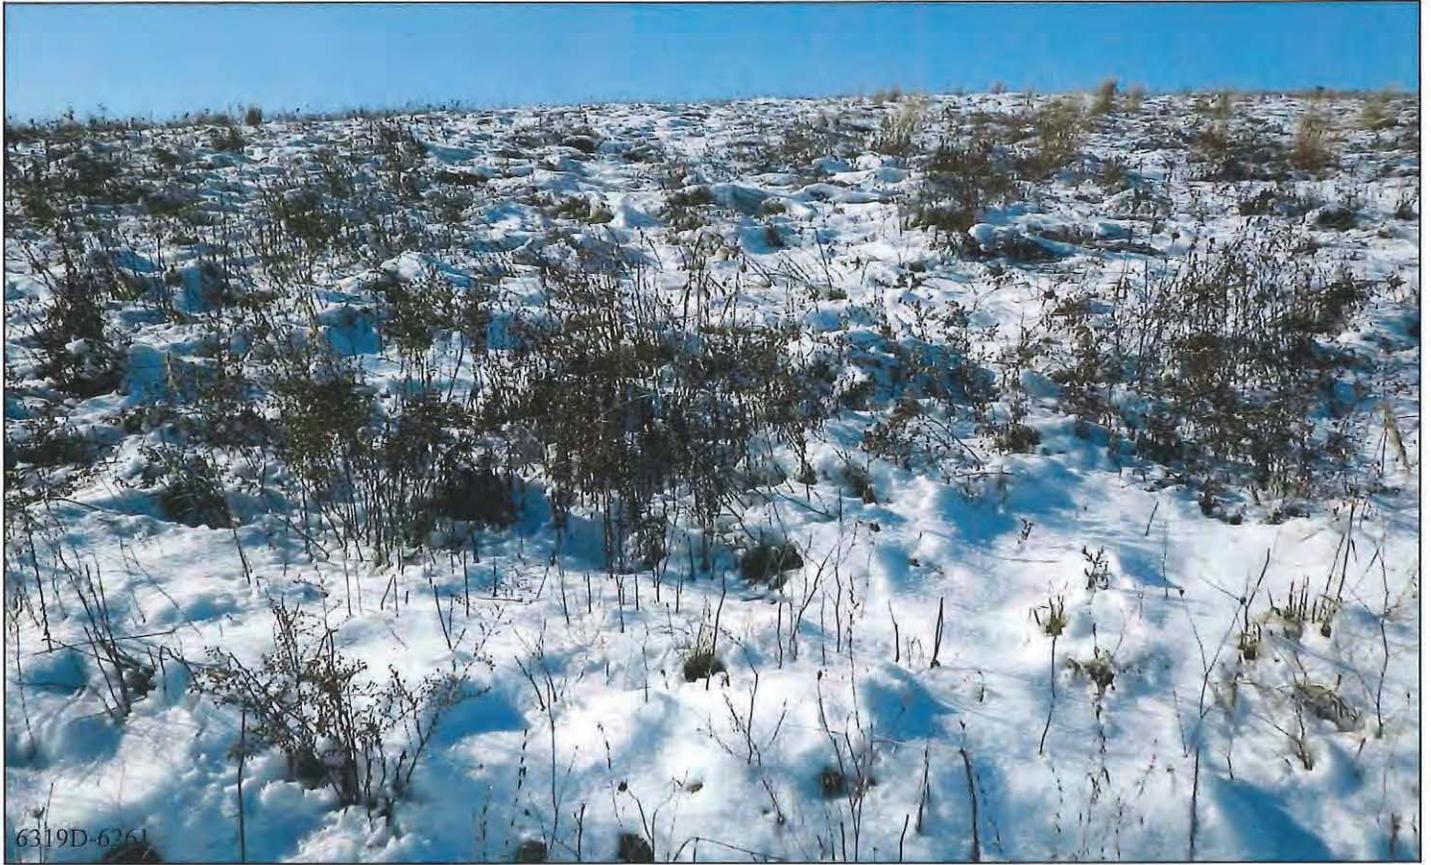
**East Face Cell 8**

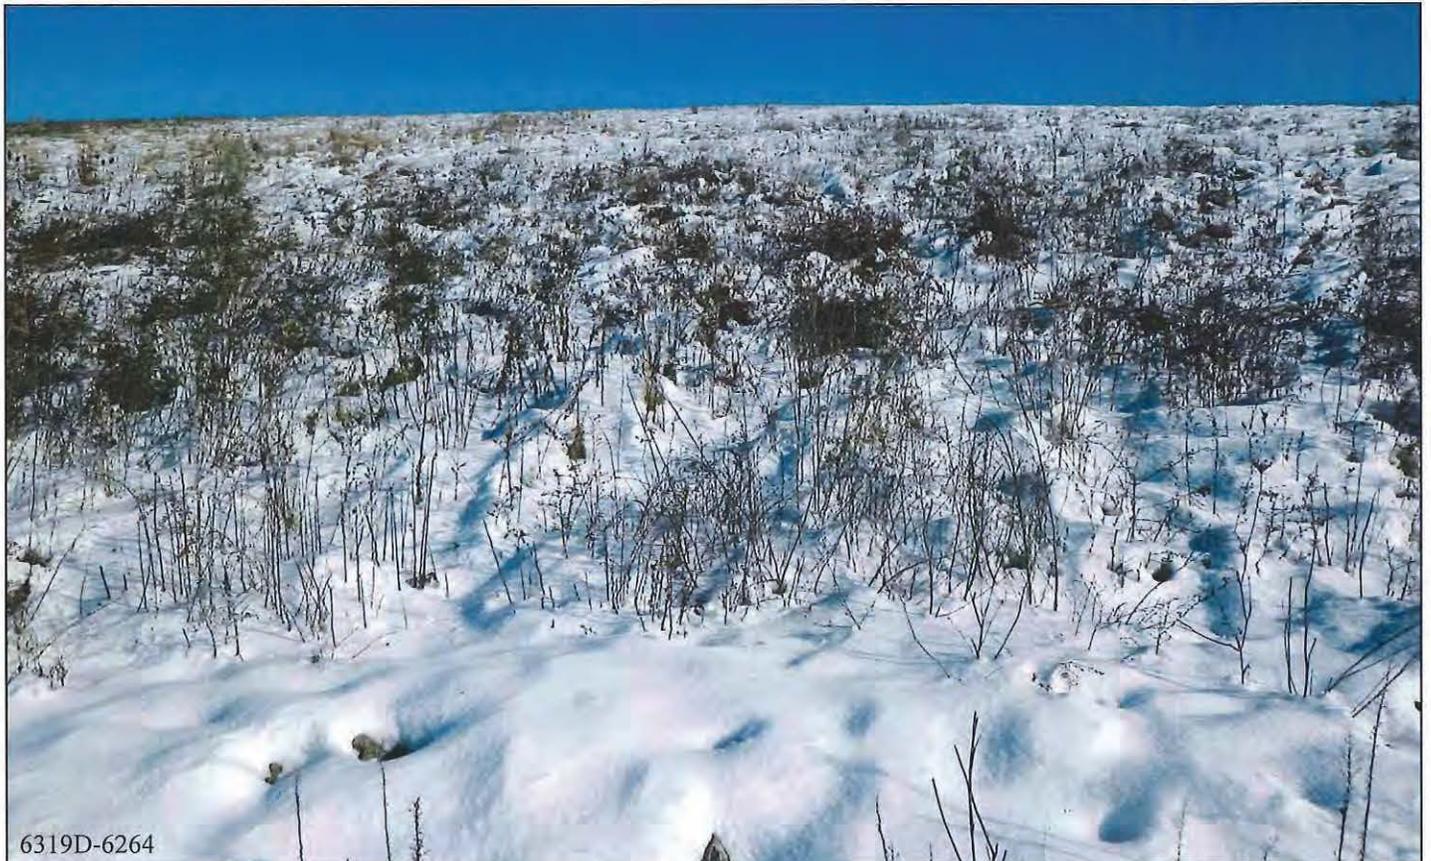
**West Face Cell 8**
