**SUBJECT: Transmittal of the December 2013 Fernald Preserve On-Site Disposal Facility  
Inspection Forms**

Fernald Preserve OSDF Walkdown Inspection Report

# On-Site Disposal Facility Inspection Report December 2013

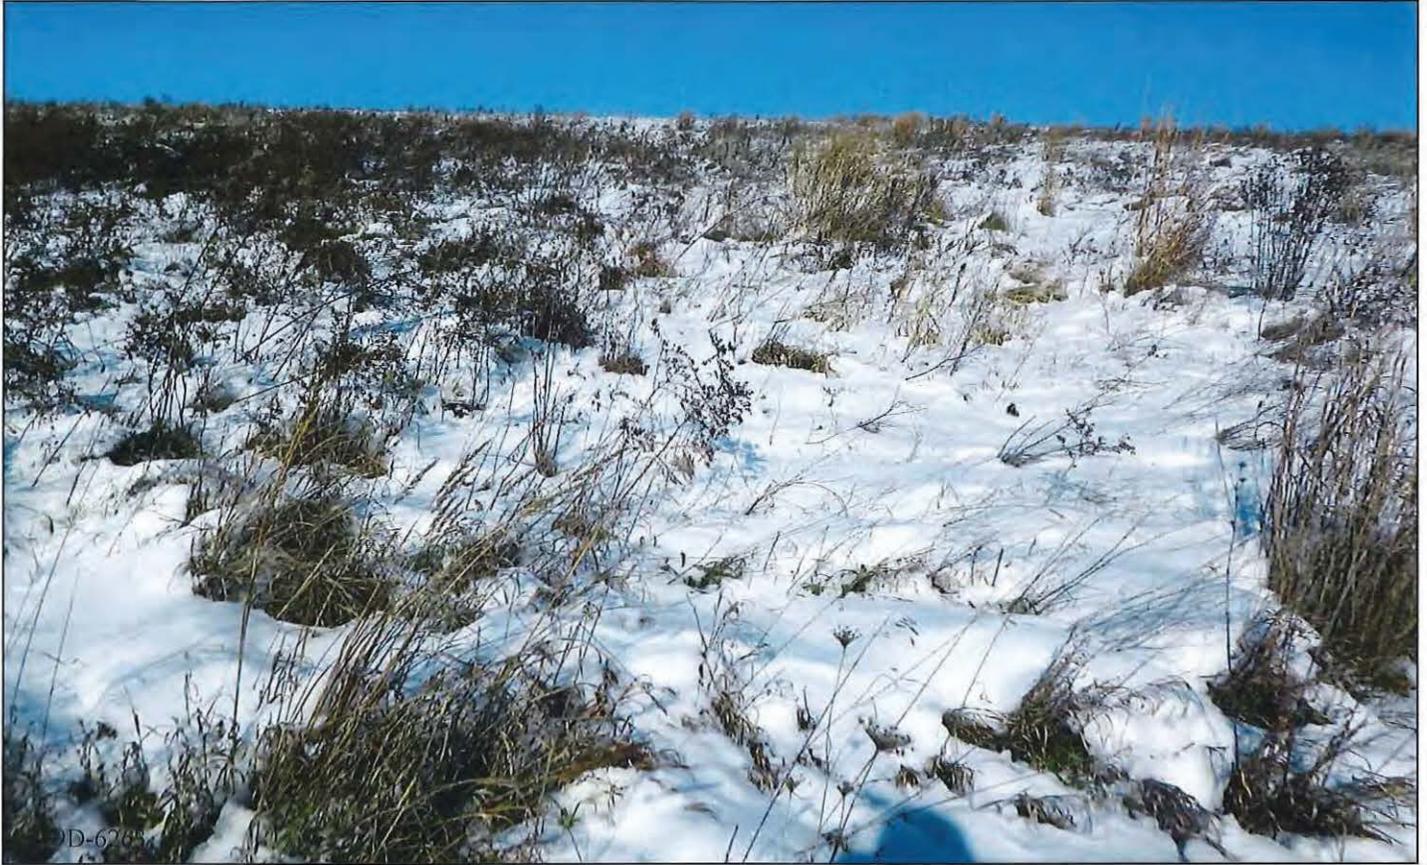
**South Face Cell 8**

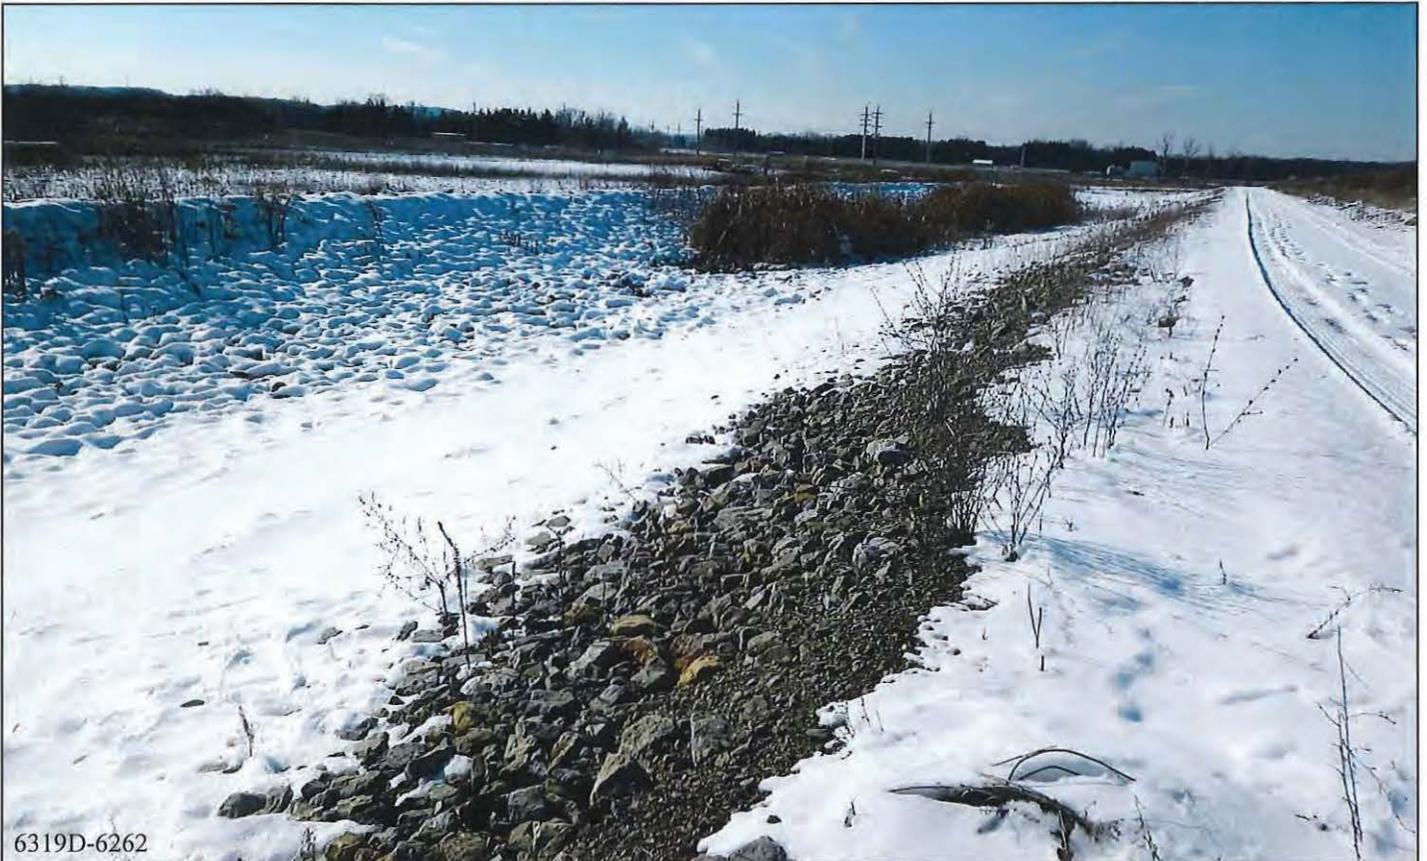
**South Drainage (looking west)**

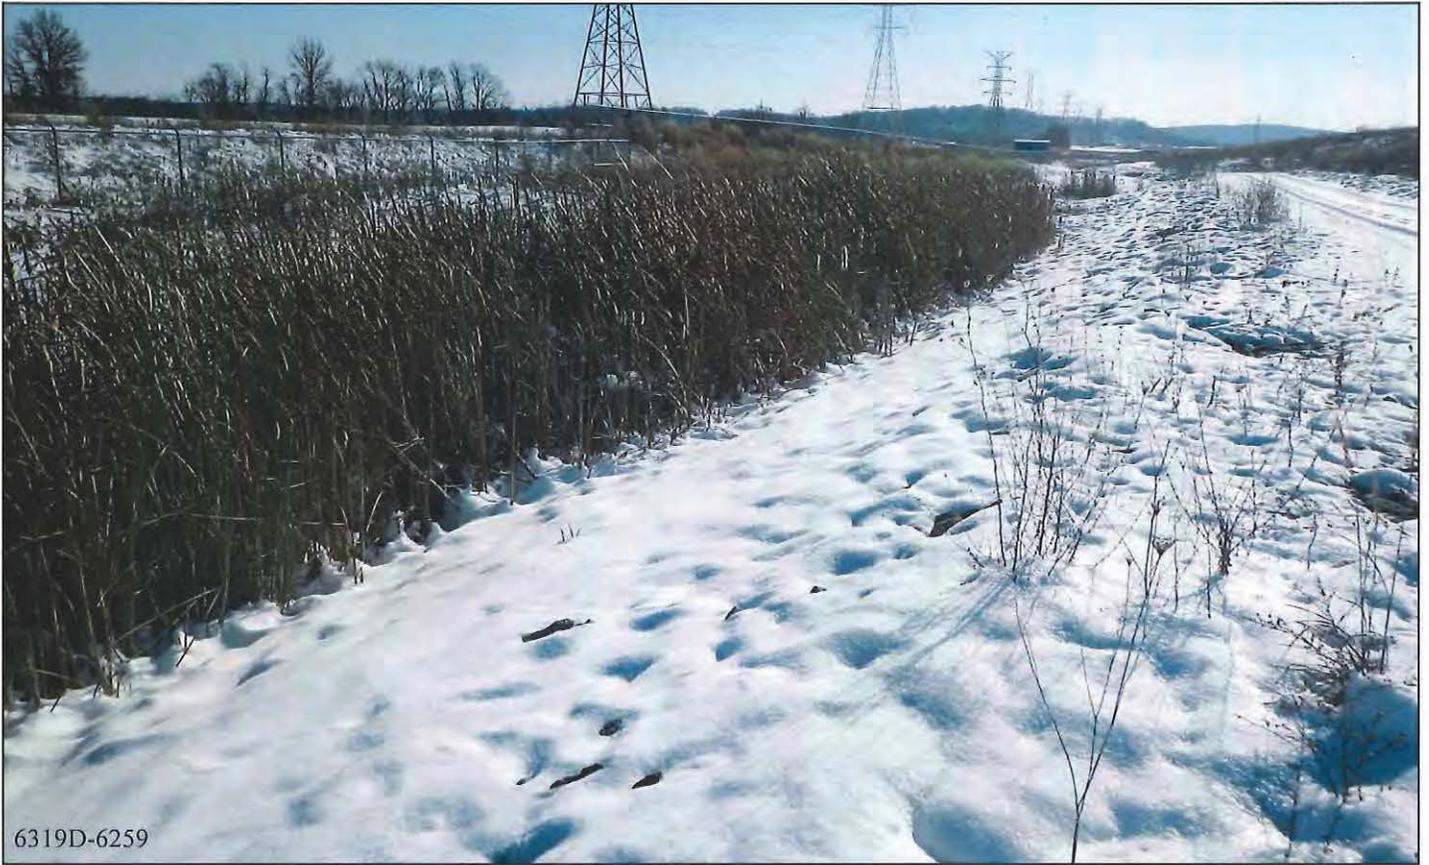
6319D-6259

**East Drainage Cell 7 (looking south)**

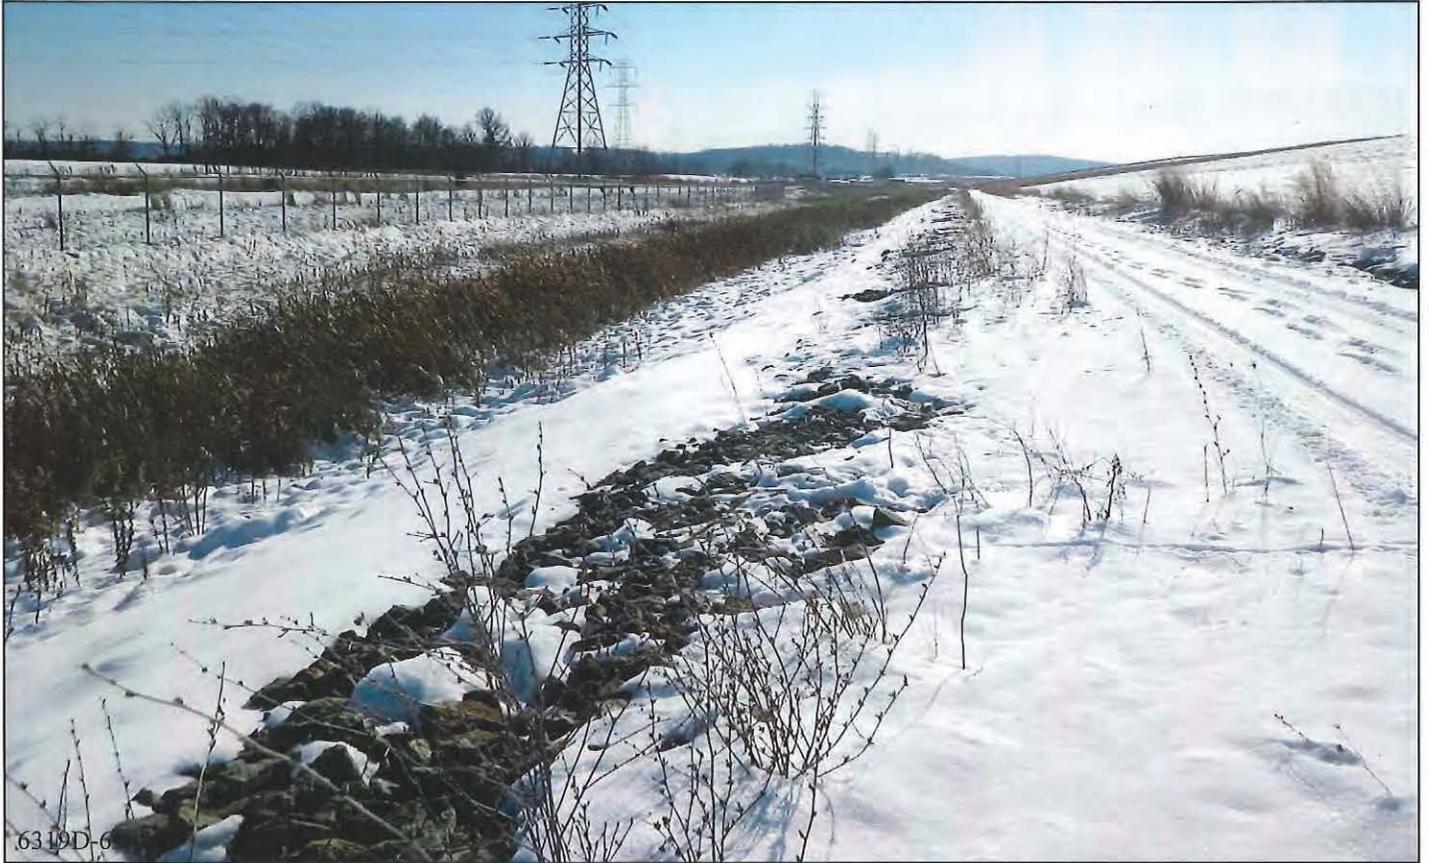
6319D-6

**East Drainage Cell 4 (looking south)**

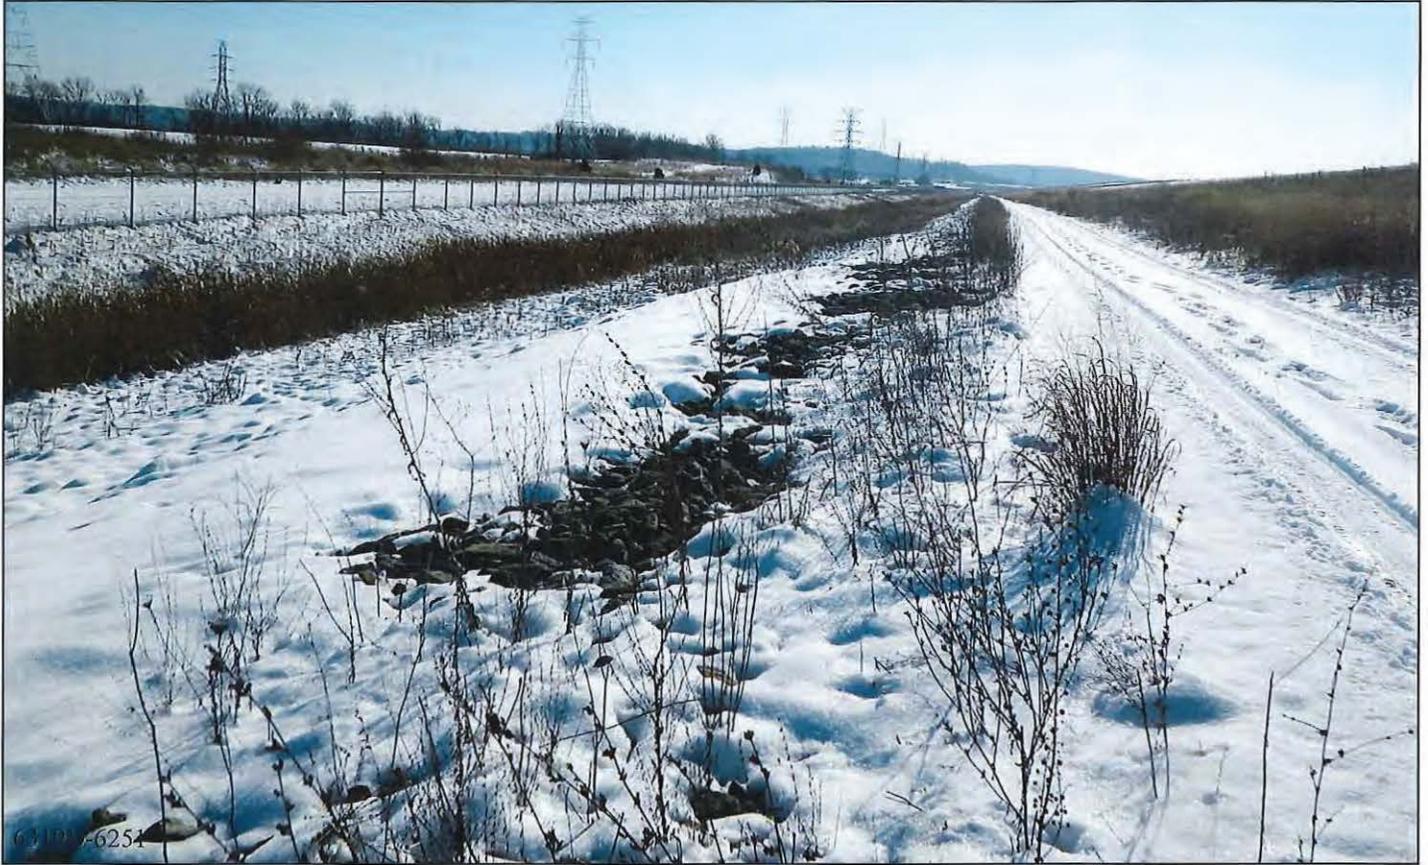
**East Drainage Cell 1 (looking south)**

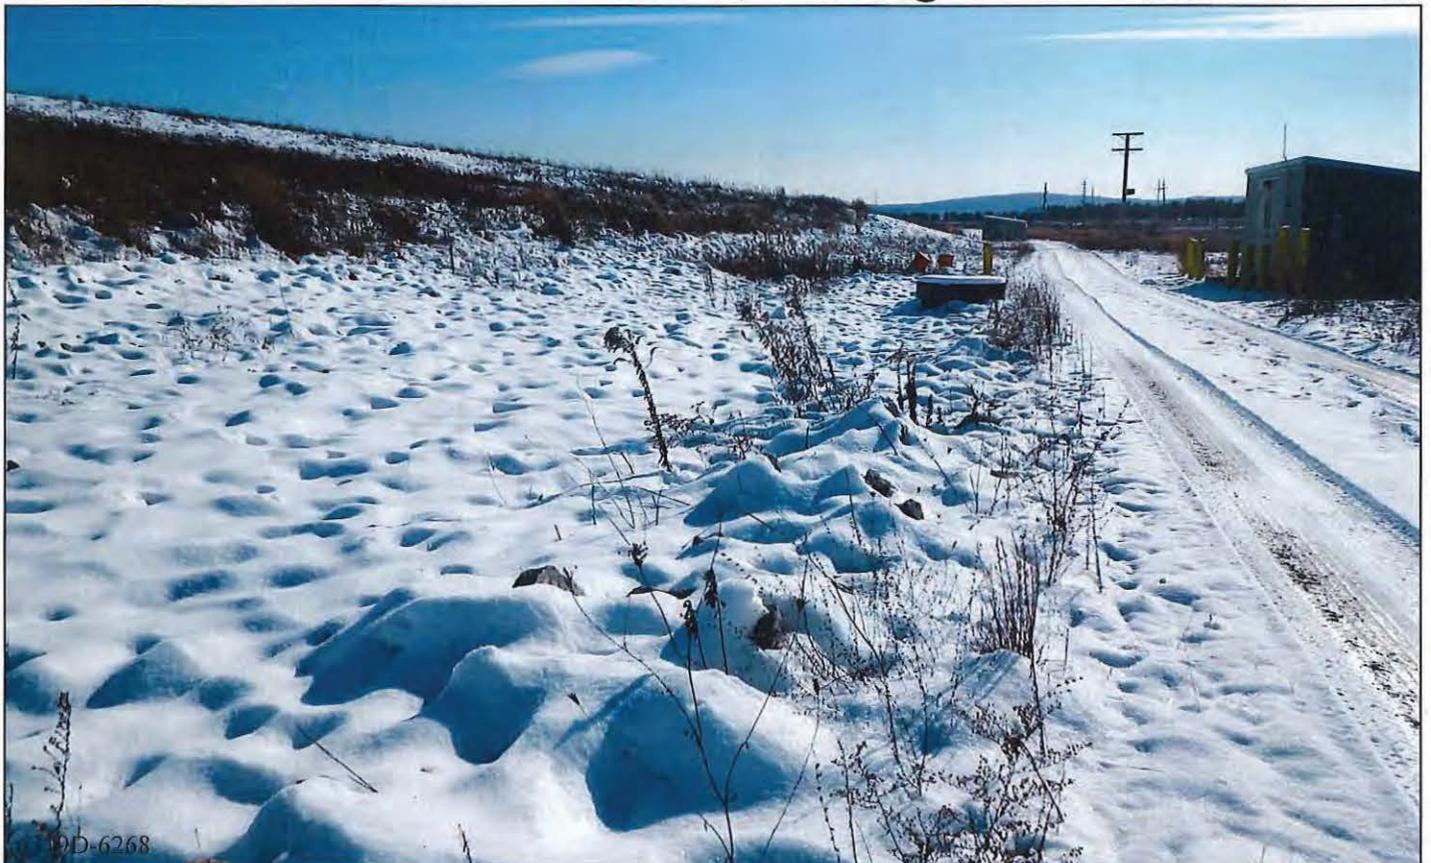
**West Inner Drainage Cell 7 (looking south)**

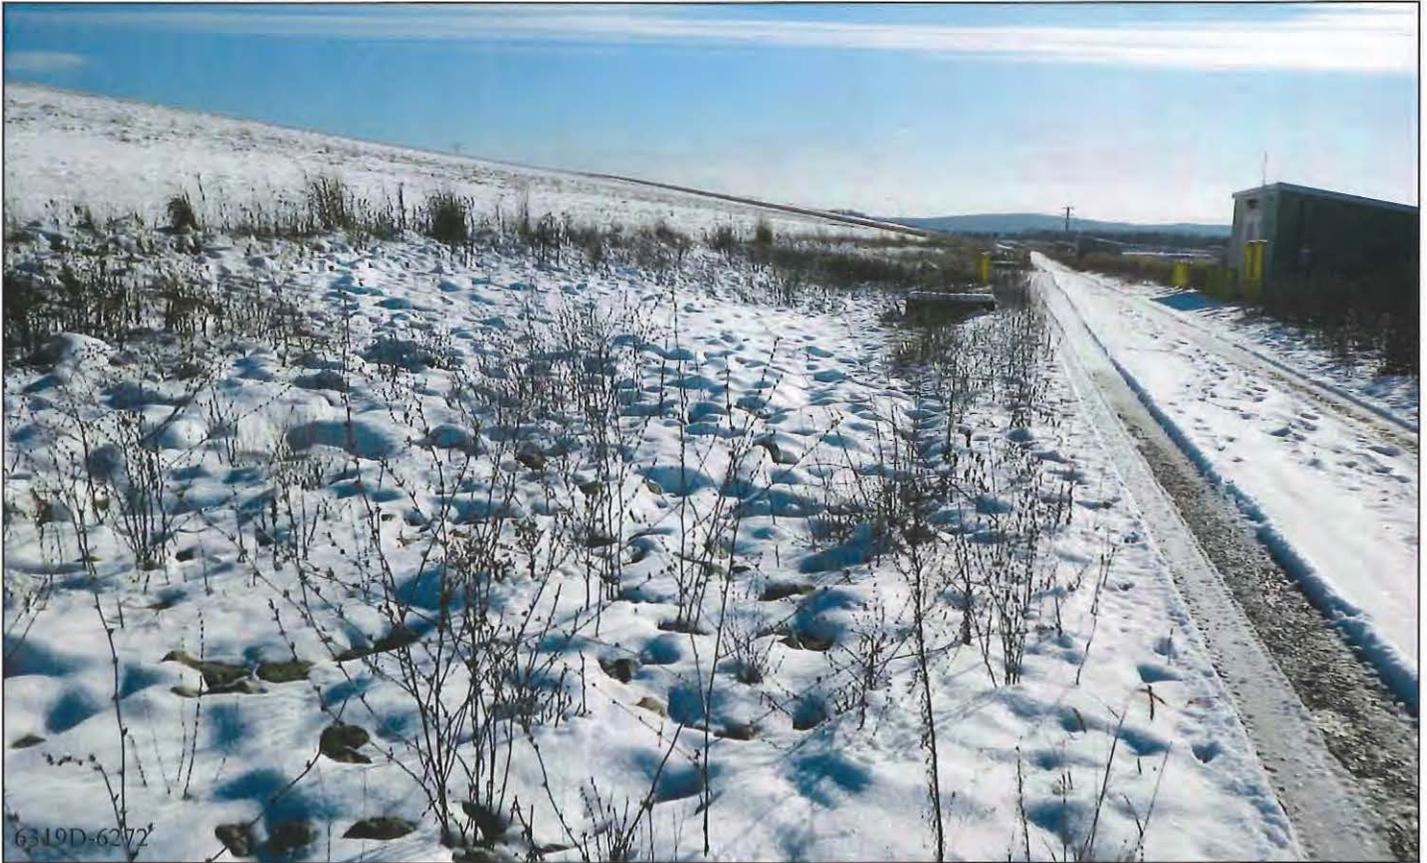
6319D-6272

**West Inner Drainage Cell 4 (looking south)**

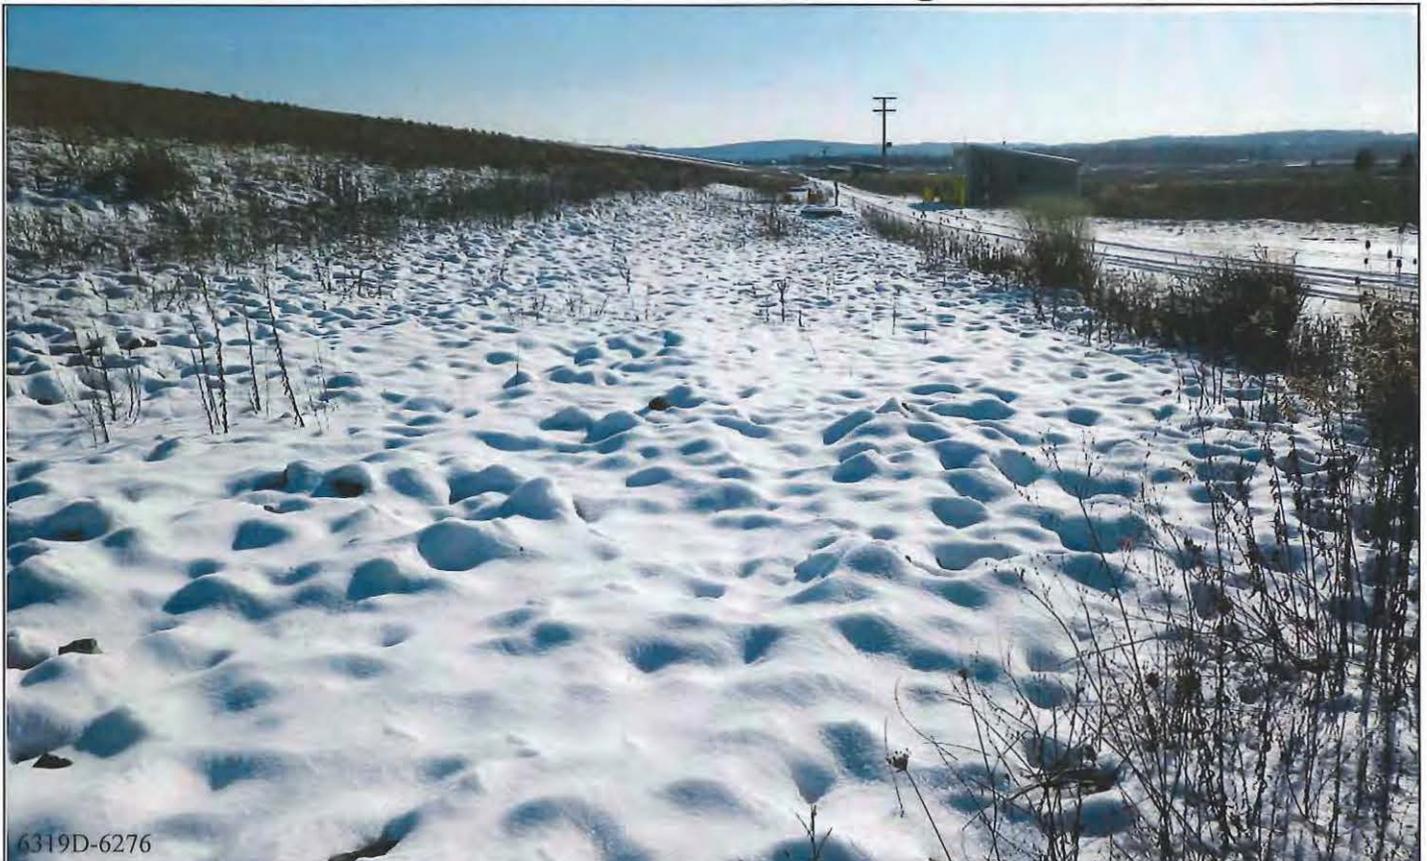
6319D-6276

**West Inner Drainage Cell 1 (looking south)**

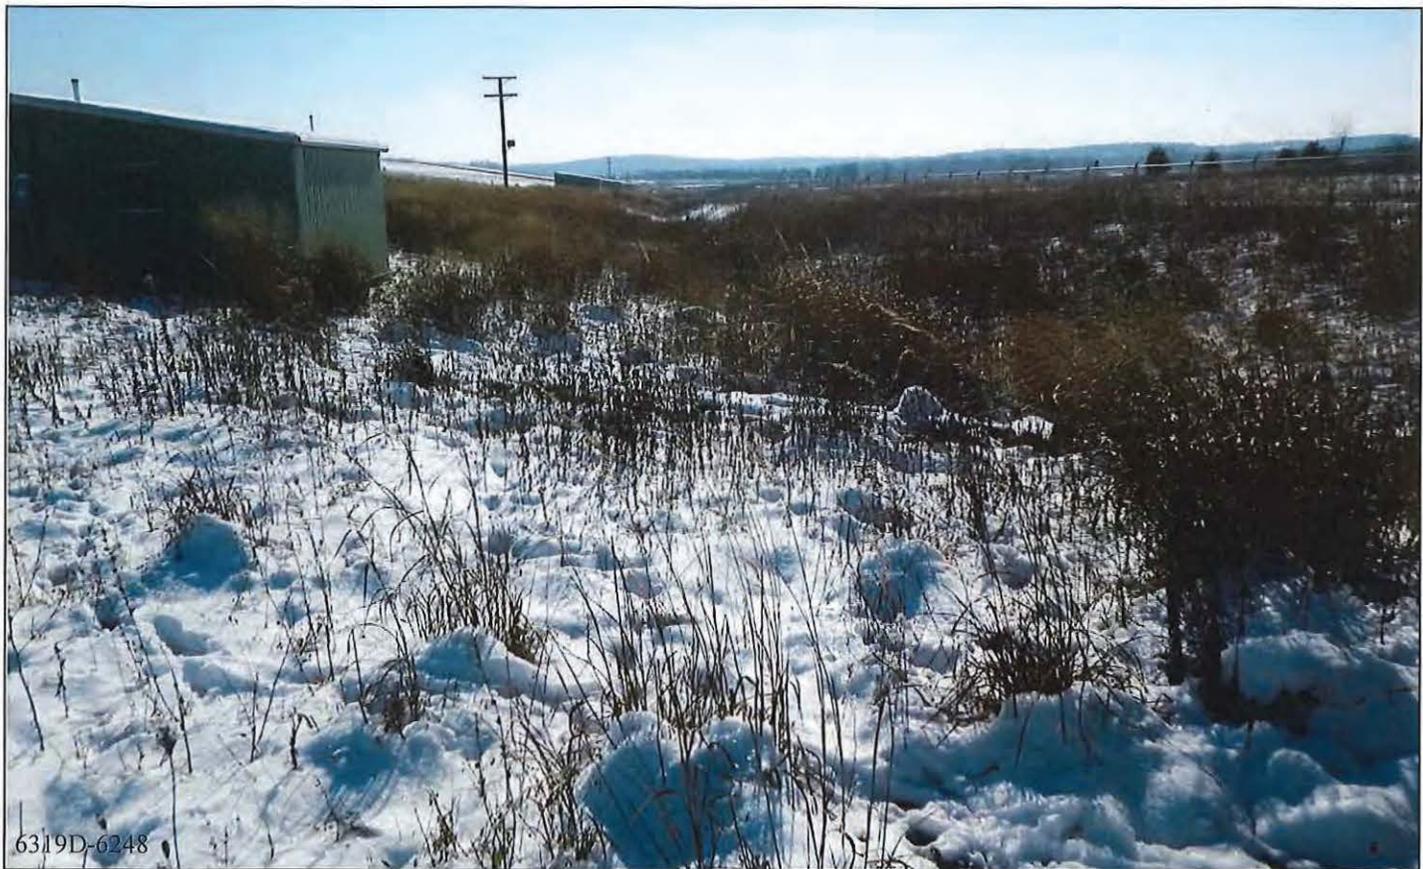
6319D-6248

**West Outer Drainage Cell 1 (looking south)**

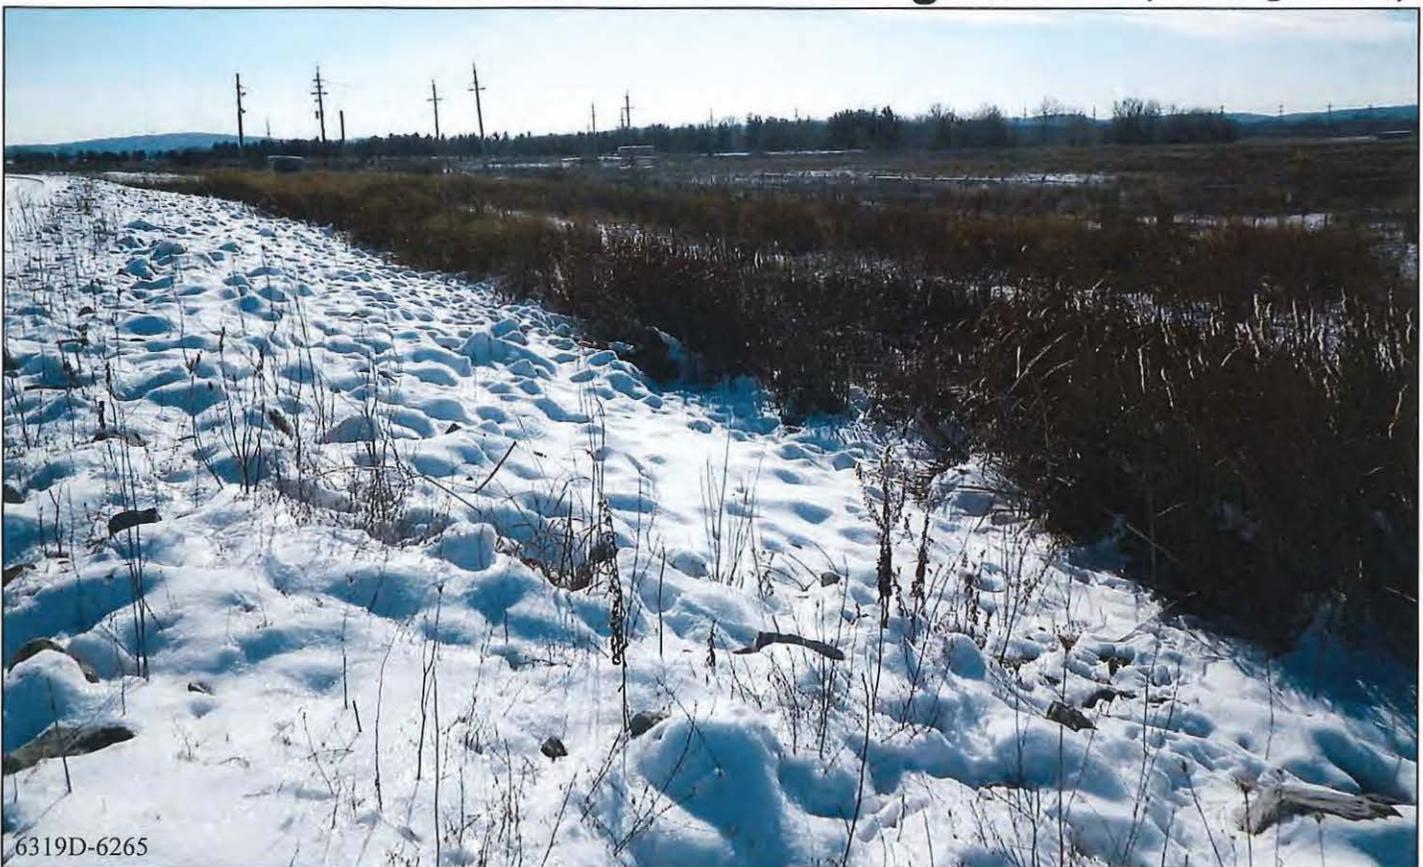
6319D-6265

**West Outer Drainage Cell 8 (looking south)**

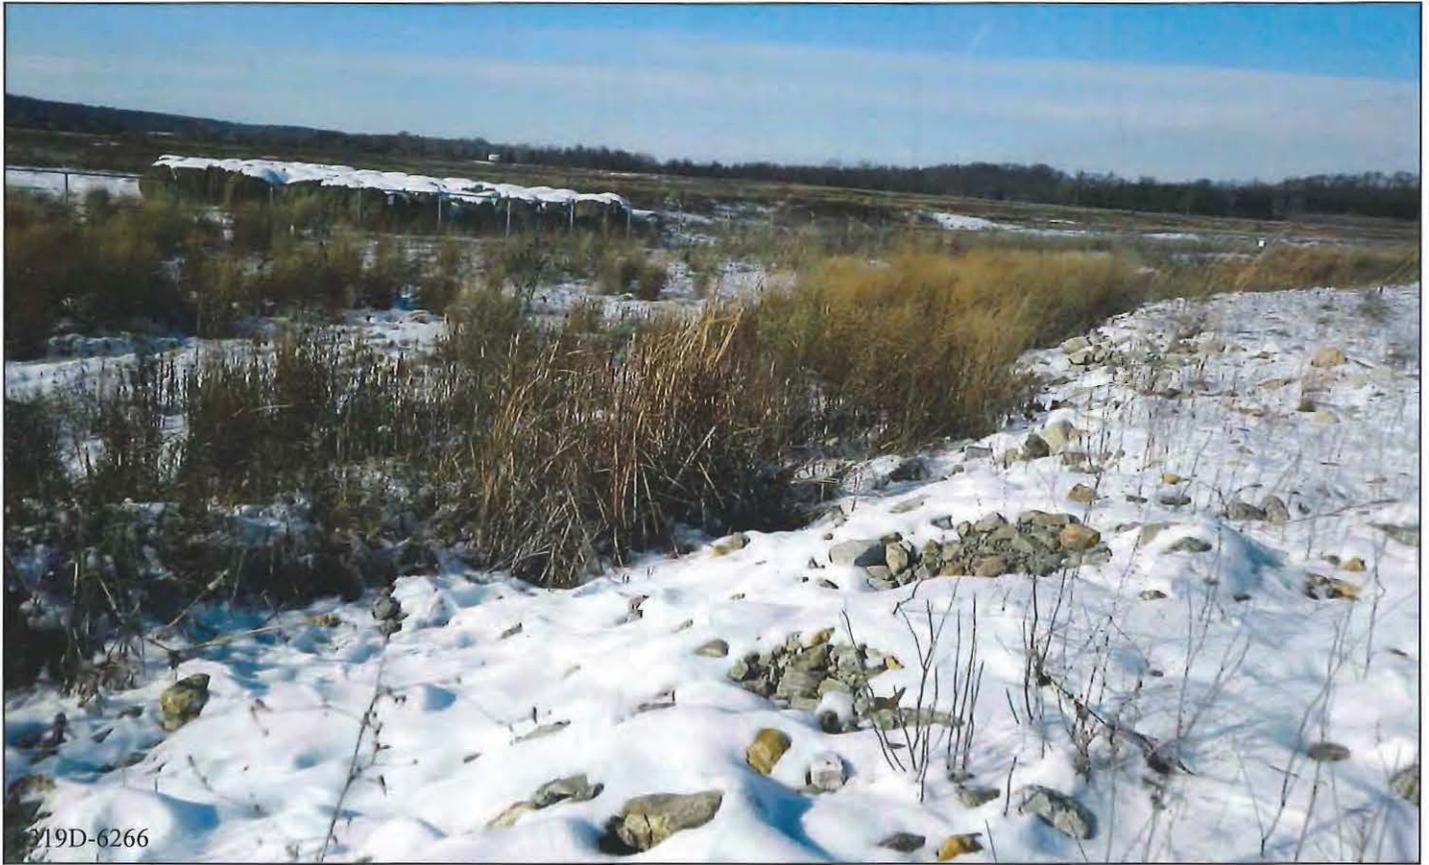
**West Outer Drainage Cell 8 (looking north)**

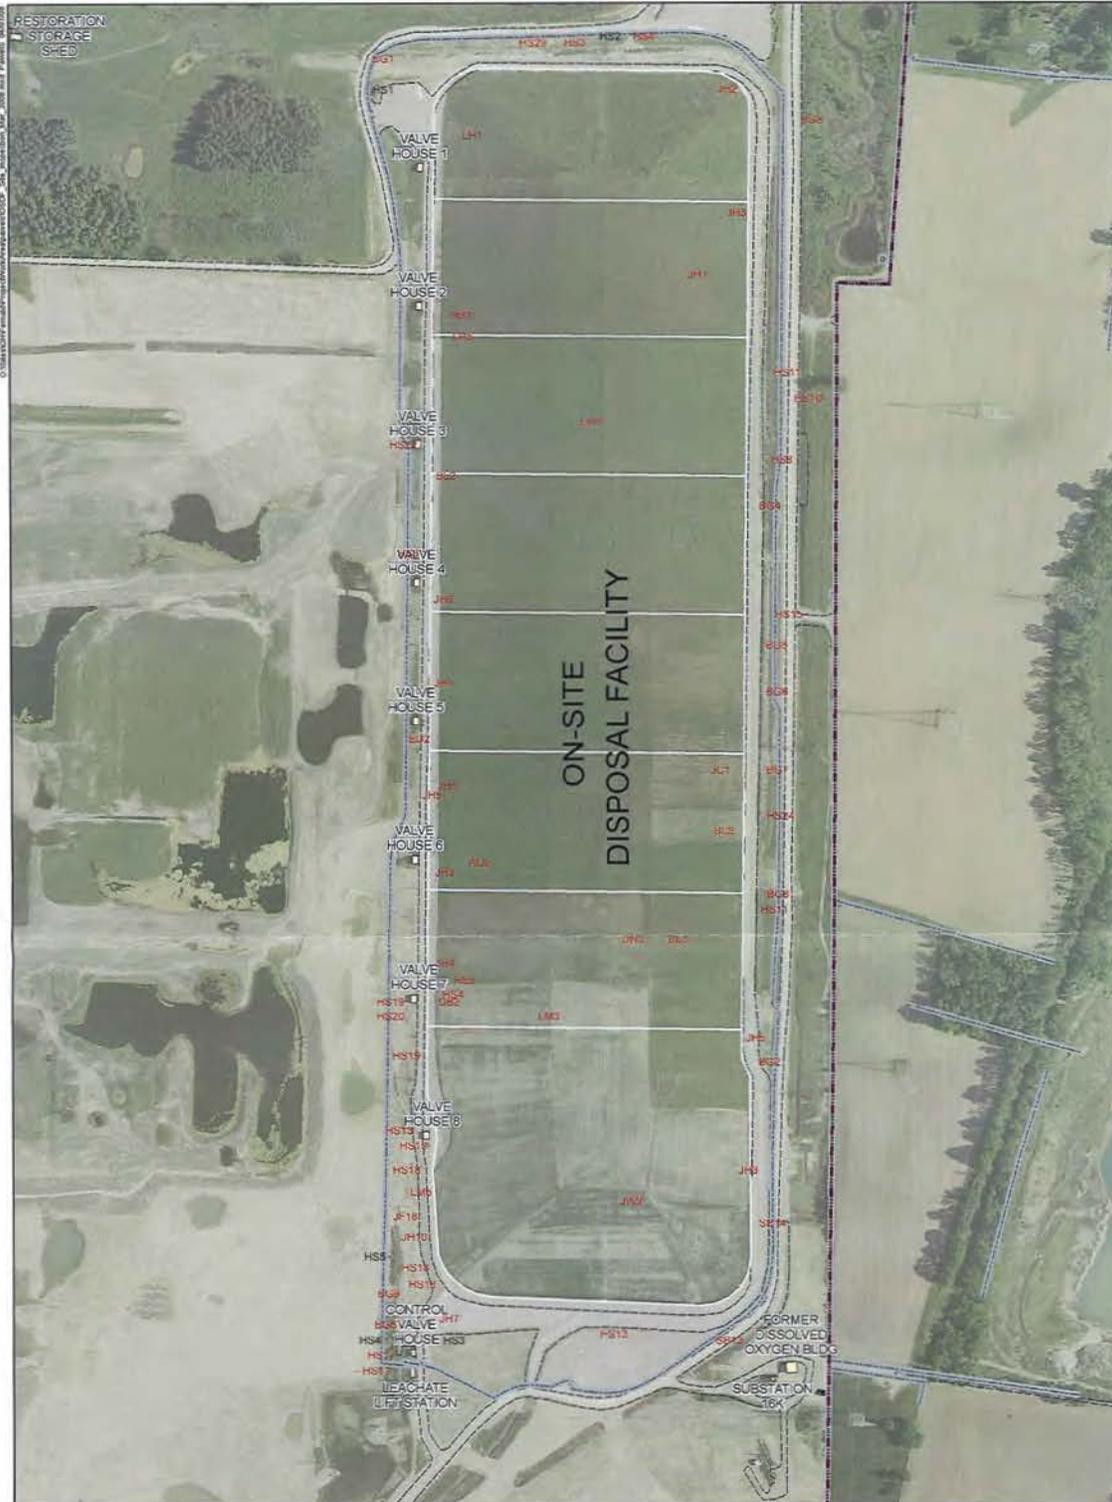
**Fernald Preserve**  
**OSDF (On-Site Disposal Facility)**  
**December 2013 Inspection Findings**  
*(Previous findings requiring follow-up or maintenance)*

Map No.	Location	GPS?	Type of Finding	Description	Photo? (File No.)
HS1	Northwest corner of parking area	No	Vegetation	Cedar tree	
HS2	North fenceline at former gate location	No	Fencing	Metal gate stop...needs removed	
HS3	South gate	No	Signage	Sign is hanging	
HS4	Southwest corner at drainage	No	Vegetation	Cedars	
HS5	100 yards north of southwest corner	No	Signage	Sign hanging
