March 19, 2014

SUBJECT: Contract No. DE-AM01-07LM00060, The S.M. Stoller Corporation, a wholly owned subsidiary of Huntington Ingalls Industries (Stoller)
Task Order LM00-502, LTS&M – Other Defense Activities
Transmittal of Task Order Deliverable: “Submit Q2 Site Inspection Letter”
Activity Code INS14-1215 – Completed: March 19, 2014

Fernald Preserve Field Walkdown Inspection Report

<p>U.S. DEPARTMENT OF ENERGY HAMILTON, OHIO</p>	<p>Site Performed by S.M. Stoller Corporation <small>Under G2E Contract No. G0-AMC-01-00000</small></p>
<p>FERNALD PRESERVE MARCH 2014 SITE INSPECTION FINDINGS</p>	
DATE PREPARED:	FILENAME:
March 19, 2014	inspection_areas_1stqt_2014_findings

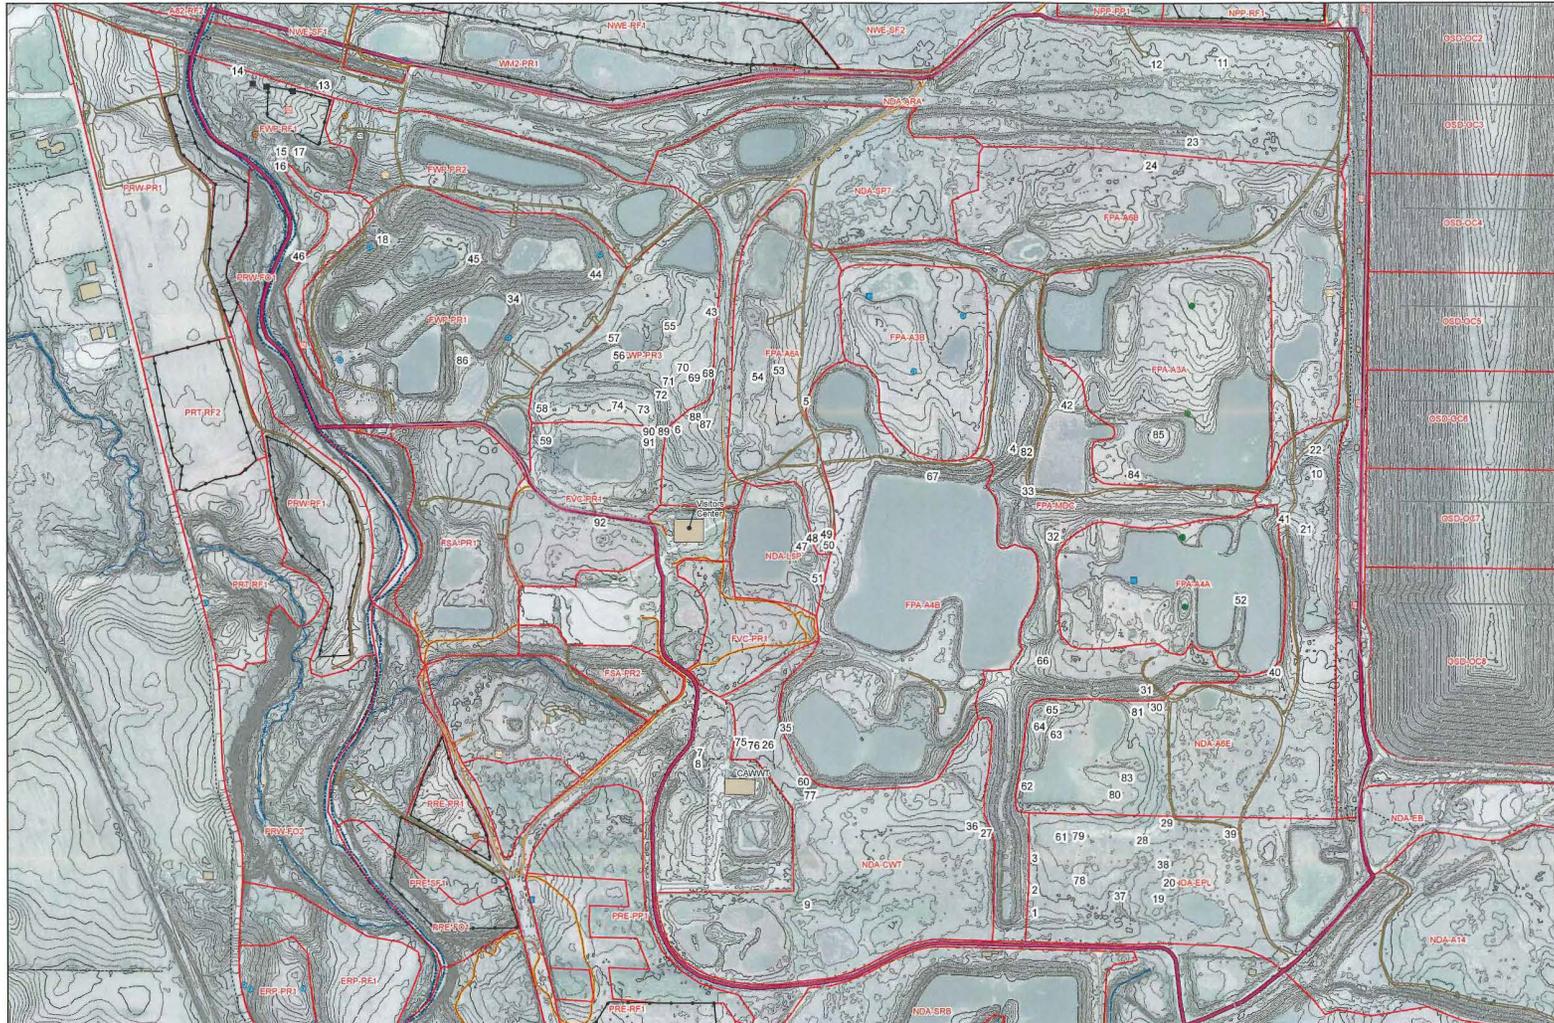
Map No.	Location	GPS?	Type of Finding	Description	Photo? (File No.)
1	East of MDC	No	Debris	Asphalt	
2	East of MDC	No	Debris	Asphalt	
3	East of MDC	No	Debris	Asphalt	
4	Next to firebreak	No	Debris	Concrete block chip	
5	West of Skillet Pond	No	Debris	Glazed tile	
6	South of serpent swale	No	Debris	Asphalt	
7	Northwest of CAWWT near drainage	No	Debris	bent corrugated metal	
8	Northwest of CAWWT near drainage	No	Debris	Power pole anchor, conduit	
9	Southeast of CAWWT fence SE corner	No	Debris	concrete chunk	
10	West of OSDF VH 6	No	Debris	Concrete	
11	Between wells 2436 and 22200	No	Debris	Concrete	
12	Between wells 2436 and 22200	No	Debris	Stainless steel debris	
13	northwest drainage corridor	No	Debris	glazed tile	
14	Northwest drainage corridor on boundary with FWP-RF1	No	Debris	Power pole top, cable

Map No.	Location	GPS?	Type of Finding	Description	Photo? (File No.)
15	North of former WPRP swale	No	Debris	Concrete	
16	North of former WPRP swale	No	Debris	Glazed brick	
17	North of former WPRP swale	No	Debris	ductile iron pipe (4" diameter)	
18	Cut in Pit 3 west berm	No	Debris	Acid brick	
19	SW of OSDF, just west of small pond	No	Debris	Concrete	
20	SW of OSDF, just northwest of small pond	No	Debris	Concrete	
21	West of OSDF VH 7	No	Debris	Concrete	
22	NW of OSDF VH 7	No	Debris	Concrete	
23	SW of OSDF VH 6	No	Debris	Concrete	
24	SW of OSDF VH3 and south of drainage	No	Debris	Concrete	
25	SW of OSDF VH3 and south of drainage	No	Debris	Concrete	
26	North of CAWWT	No	Debris	Asphalt	
27	West of MDC	No	Debris	Concrete	
28	East of MDC, SE of 5 oaks	No	Debris	Asphalt/Concrete	
29	East of MDC, East of 5 oaks	No	Debris	Concrete	
30	East of Pond/west of cell 8	No	Debris	Concrete	
31	North hillside of MDC	No	Debris	Asphalt and other debris

Map No.	Location	GPS?	Type of Finding	Description	Photo? (File No.)
33	High ground in MDC - just south of firebreak	No	Debris	Concrete	
34	Northeast bank of pond	No	Debris	concrete/fence in water	
35	NE of CAWWT	No	Erosion	Going into pond 4B	
36	West of MDC	No	Debris	HDPE chunk	
37	North of depression	No	Debris	asphalt	
38	North of access road	No	Other	plastic bag/trash	
39	west of firebreak	No	Debris	field of debris	
40	SE corner of Angel pond	No	Debris	Pile of concrete and rebar	
41	NE Angel pond at edge of rip rap	No	Debris	Debris	
42	wetland piezometer	No	Other	Piezometer down	
43	west of Hickory trail, East of swale	No	Debris	Concrete	
44	Bank of pond	No	Erosion	Fresh erosion	yes
45	bank between ponds	No	Erosion	Fresh	Yes
46	Bank of Paddys Run	No	Erosion	Bank cut at Paddy's Run	
47	West bank of community pond	No	Other	litter/trash	
48	East of community pond	No	Other	Litter/trash	
49	Ridge between ponds	No	Other	Litter/trash

Map No.	Location	GPS?	Type of Finding	Description	Photo? (File No.)
51	north edge of overflow bwtween ponds	No	Debris	small piece of ceramic piping	
52	on end of peninsula	No	Erosion	peninsula eroding	
53	northwest of skillet pond	No	Debris	concrete	
54	northwest of skillet pond	No	Debris	metal sheet	
55	east side of swale	No	Debris	debris	
56	southwest edge of wetland	No	Debris	small concrete	
57	west edge of wetland	No	Debris	concrete	
58	SE of dirt road	No	Debris	concrete	
59	West of Biowetland along culvert	No	Debris	concrete	
60	SW of pond, adjacent to pond inlet west of CAWWT	No	Debris	concrete	
61	South of 5 oaks approx 75 yards	No	Debris	concrete	
62	At water's edge, west bank of pond	No	Debris	concrete	
63	Northwest edge of pond (about 8' from water)	No	Debris	glazed tile	
64	Northwest of pond (10' from water)	No	Debris	18" x 18" concrete	
65	Northwest of pond	No	Debris	concrete	
66	SE of swan pond, about 10' east of water's edge	No	Debris	glazed tile

Map No.	Location	GPS?	Type of Finding	Description	Photo? (File No.)
68	West of Hickory trail	No	Debris	several pieces of concrete	
69	West of Hickory trail	No	Debris	several pieces of concrete	
70	West of Hickory trail	No	Debris	concrete	
71	West of Hickory trail	No	Debris	concrete	
72	Northeast of bio-wetland	No	Debris	concrete	
73	North of bio-wetland	No	Debris	concrete	
74	north of bio-wetland	No	Debris	concrete	
75	north of CAWWT	No	Debris	Building material/concrete	
76	North of CAWWT	No	Signage	Marker	
77	inlet to pond, west of CAWWT	No	Debris	concrete	
78	Midway between road and 5 oaks	No	Debris	asphalt	
79	south of 5 oaks	No	Debris	asphalt	
80	east of five oaks on east edge of pond	No	Debris	asphalt, plastic	
81	northeast corner of pond near the willows	No	Debris	concrete	
82	in drainage north of willows	No	Debris	glazed clay tile	
83	east of pond	No	Debris	tile and coal?	
84	west finger of "boot" pond	No	Fencing	overturned plant cages in the water

Map No.	Location	GPS?	Type of Finding	Description	Photo? (File No.)
86		No	Debris	piece of metal	
87	North of Visitors Center	No	Debris	Asphalt/concrete	
88	North of Visitors Center	No	Debris	Asphalt/concrete	
89	Northeast of bio-wetland	No	Debris	glazed tile, asphalt, concrete	
90	Northeast of bio-wetland	No	Debris	concrete	
91	Northeast of bio-wetland	No	Erosion	erosion	
92	West of Visitors Center	No	Debris	asphalt
