SUBJECT: Contract No. DE-AM01-07LM00060, The S.M. Stoller Corporation, a wholly owned subsidiary of Huntington Ingalls Industries (Stoller)
Task Order LM00-502, LTS&M – Other Defense Activities
Transmittal of Task Order Deliverable: “Submit Q2 Site Inspection Letter”
Activity Code INS14-1215 – Completed: March 19, 2014

Fernald Preserve Field Walkdown Inspection Report

U.S. DEPARTMENT OF ENERGY HAMILTON, OHIO	Site Prepared by S.M. Stoller Corporation <small>Under DOE Contract DE-AC05-00OR21400</small>
FERNALD PRESERVE MARCH 2014 SITE INSPECTION FINDINGS	
DATE PREPARED: March 19, 2014	FILENAME: inspection_areas_1stqtr_2014_findings

FERNALD PRESERVE MAINTENANCE AND REPAIR ACTION ITEMS
MARCH 2014 UPDATE

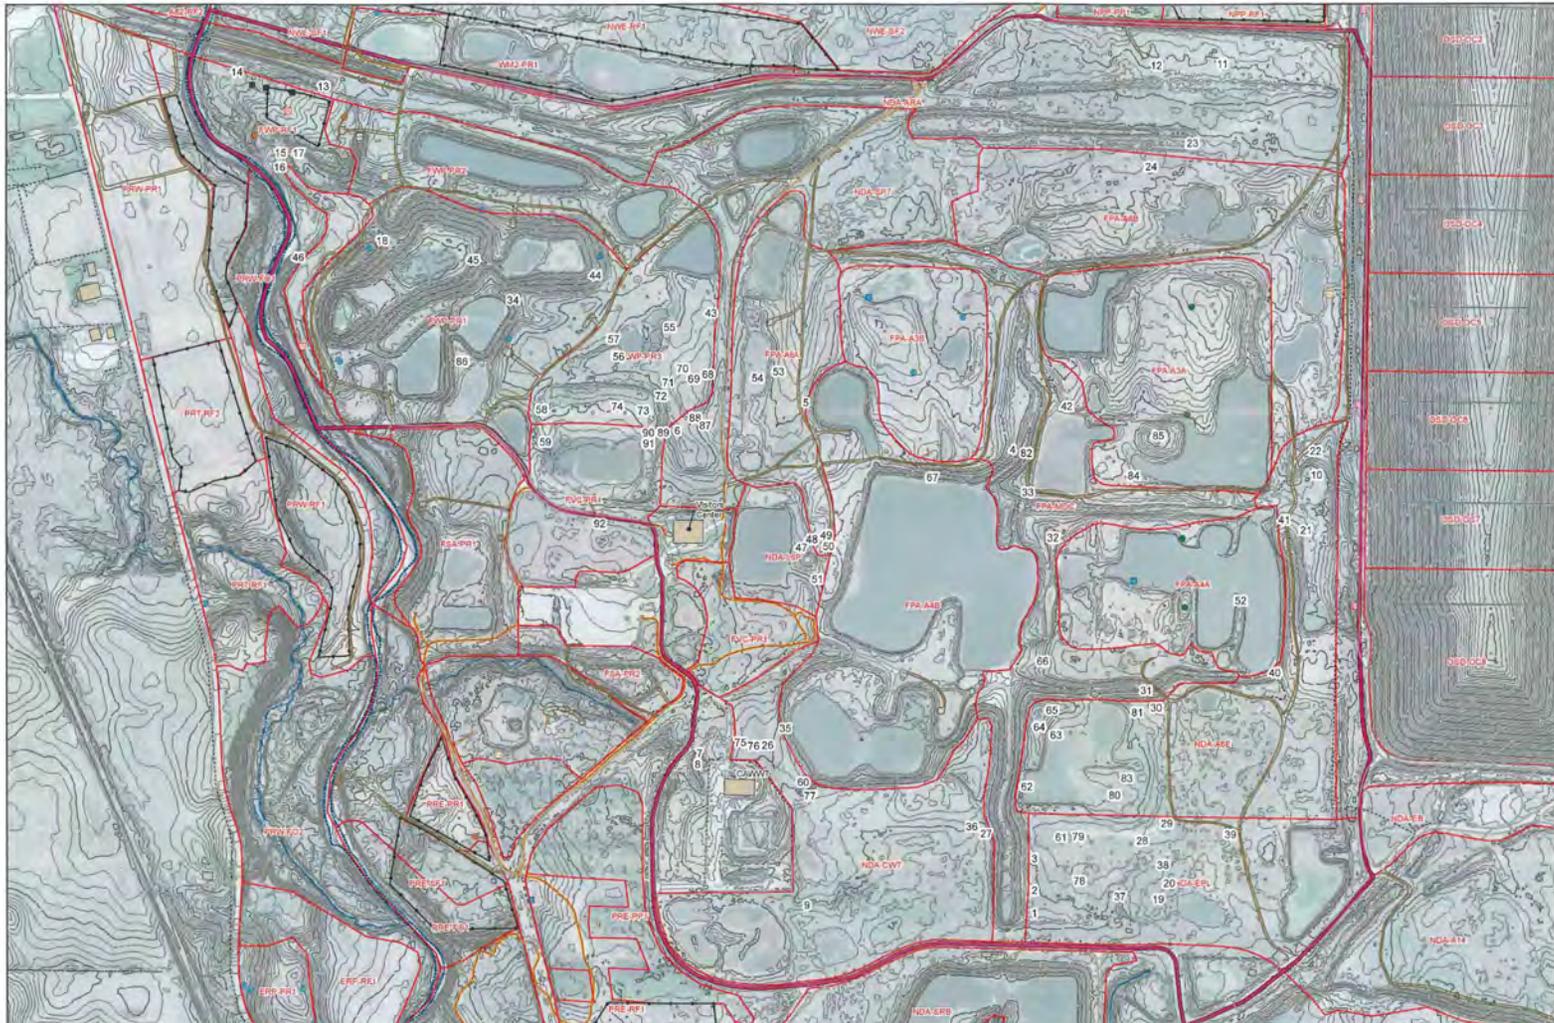
Map No.	Location	GPS?	Type of Finding	Description	Photo? (File No.)
1	East of MDC	No	Debris	Asphalt	
2	East of MDC	No	Debris	Asphalt	
3	East of MDC	No	Debris	Asphalt	
4	Next to firebreak	No	Debris	Concrete block chip	
5	West of Skillet Pond	No	Debris	Glazed tile	
6	South of serpent swale	No	Debris	Asphalt	
7	Northwest of CAWWT near drainage	No	Debris	bent corrugated metal	
8	Northwest of CAWWT near drainage	No	Debris	Power pole anchor, conduit	
9	Southeast of CAWWT fence SE corner	No	Debris	concrete chunk	
10	West of OSDF VH 6	No	Debris	Concrete	
11	Between wells 2436 and 22200	No	Debris	Concrete	
12	Between wells 2436 and 22200	No	Debris	Stainless steel debris	
13	northwest drainage corridor	No	Debris	glazed tile	
14	Northwest drainage corridor on boundary with FWP-RF1	No	Debris	Power pole top, cable

Map No.	Location	GPS?	Type of Finding	Description	Photo? (File No.)
15	North of former WPRP swale	No	Debris	Concrete	
16	North of former WPRP swale	No	Debris	Glazed brick	
17	North of former WPRP swale	No	Debris	ductile iron pipe (4" diameter)	
18	Cut in Pit 3 west berm	No	Debris	Acid brick	
19	SW of OSDF, just west of small pond	No	Debris	Concrete	
20	SW of OSDF, just northwest of small pond	No	Debris	Concrete	
21	West of OSDF VH 7	No	Debris	Concrete	
22	NW of OSDF VH 7	No	Debris	Concrete	
23	SW of OSDF VH 6	No	Debris	Concrete	
24	SW of OSDF VH3 and south of drainage	No	Debris	Concrete	
25	SW of OSDF VH3 and south of drainage	No	Debris	Concrete	
26	North of CAWWT	No	Debris	Asphalt	
27	West of MDC	No	Debris	Concrete	
28	East of MDC, SE of 5 oaks	No	Debris	Asphalt/Concrete	
29	East of MDC, East of 5 oaks	No	Debris	Concrete	
30	East of Pond/west of cell 8	No	Debris	Concrete	
31	North hillside of MDC	No	Debris	Asphalt and other debris

Map No.	Location	GPS?	Type of Finding	Description	Photo? (File No.)
33	High ground in MDC - just south of firebreak	No	Debris	Concrete	
34	Northeast bank of pond	No	Debris	concrete/fence in water	
35	NE of CAWWT	No	Erosion	Going into pond 4B	
36	West of MDC	No	Debris	HDPE chunk	
37	North of depression	No	Debris	asphalt	
38	North of access road	No	Other	plastic bag/trash	
39	west of firebreak	No	Debris	field of debris	
40	SE corner of Angel pond	No	Debris	Pile of concrete and rebar	
41	NE Angel pond at edge of rip rap	No	Debris	Debris	
42	wetland piezometer	No	Other	Piezometer down	
43	west of Hickory trail, East of swale	No	Debris	Concrete	
44	Bank of pond	No	Erosion	Fresh erosion	yes
45	bank between ponds	No	Erosion	Fresh	Yes
46	Bank of Paddys Run	No	Erosion	Bank cut at Paddy's Run	
47	West bank of community pond	No	Other	litter/trash	
48	East of community pond	No	Other	Litter/trash	
49	Ridge between ponds	No	Other	Litter/trash

Map No.	Location	GPS?	Type of Finding	Description	Photo? (File No.)
51	north edge of overflow bwtween ponds	No	Debris	small piece of ceramic piping	
52	on end of peninsula	No	Erosion	peninsula eroding	
53	northwest of skillet pond	No	Debris	concrete	
54	northwest of skillet pond	No	Debris	metal sheet	
55	east side of swale	No	Debris	debris	
56	southwest edge of wetland	No	Debris	small concrete	
57	west edge of wetland	No	Debris	concrete	
58	SE of dirt road	No	Debris	concrete	
59	West of Biowetland along culvert	No	Debris	concrete	
60	SW of pond, adjacent to pond inlet west of CAWWT	No	Debris	concrete	
61	South of 5 oaks approx 75 yards	No	Debris	concrete	
62	At water's edge, west bank of pond	No	Debris	concrete	
63	Northwest edge of pond (about 8' from water)	No	Debris	glazed tile	
64	Northwest of pond (10' from water)	No	Debris	18" x 18" concrete	
65	Northwest of pond	No	Debris	concrete	
66	SE of swan pond, about 10' east of water's edge	No	Debris	glazed tile

Map No.	Location	GPS?	Type of Finding	Description	Photo? (File No.)
68	West of Hickory trail	No	Debris	several pieces of concrete	
69	West of Hickory trail	No	Debris	several pieces of concrete	
70	West of Hickory trail	No	Debris	concrete	
71	West of Hickory trail	No	Debris	concrete	
72	Northeast of bio-wetland	No	Debris	concrete	
73	North of bio-wetland	No	Debris	concrete	
74	north of bio-wetland	No	Debris	concrete	
75	north of CAWWT	No	Debris	Building material/concrete	
76	North of CAWWT	No	Signage	Marker	
77	inlet to pond, west of CAWWT	No	Debris	concrete	
78	Midway between road and 5 oaks	No	Debris	asphalt	
79	south of 5 oaks	No	Debris	asphalt	
80	east of five oaks on east edge of pond	No	Debris	asphalt, plastic	
81	northeast corner of pond near the willows	No	Debris	concrete	
82	in drainage north of willows	No	Debris	glazed clay tile	
83	east of pond	No	Debris	tile and coal?	
84	west finger of "boot" pond	No	Fencing	overturned plant cages in the water

Map No.	Location	GPS?	Type of Finding	Description	Photo? (File No.)
86		No	Debris	piece of metal	
87	North of Visitors Center	No	Debris	Asphalt/concrete	
88	North of Visitors Center	No	Debris	Asphalt/concrete	
89	Northeast of bio-wetland	No	Debris	glazed tile, asphalt, concrete	
90	Northeast of bio-wetland	No	Debris	concrete	
91	Northeast of bio-wetland	No	Erosion	erosion	
92	West of Visitors Center	No	Debris	asphalt
