SUBJECT: Transmittal of the September 2104 Fernald Preserve On-Site Disposal Facility Inspection Forms

Fernald Preserve OSDF Walkdown Inspection Report

On-Site Disposal Facility Inspection Report September 2014

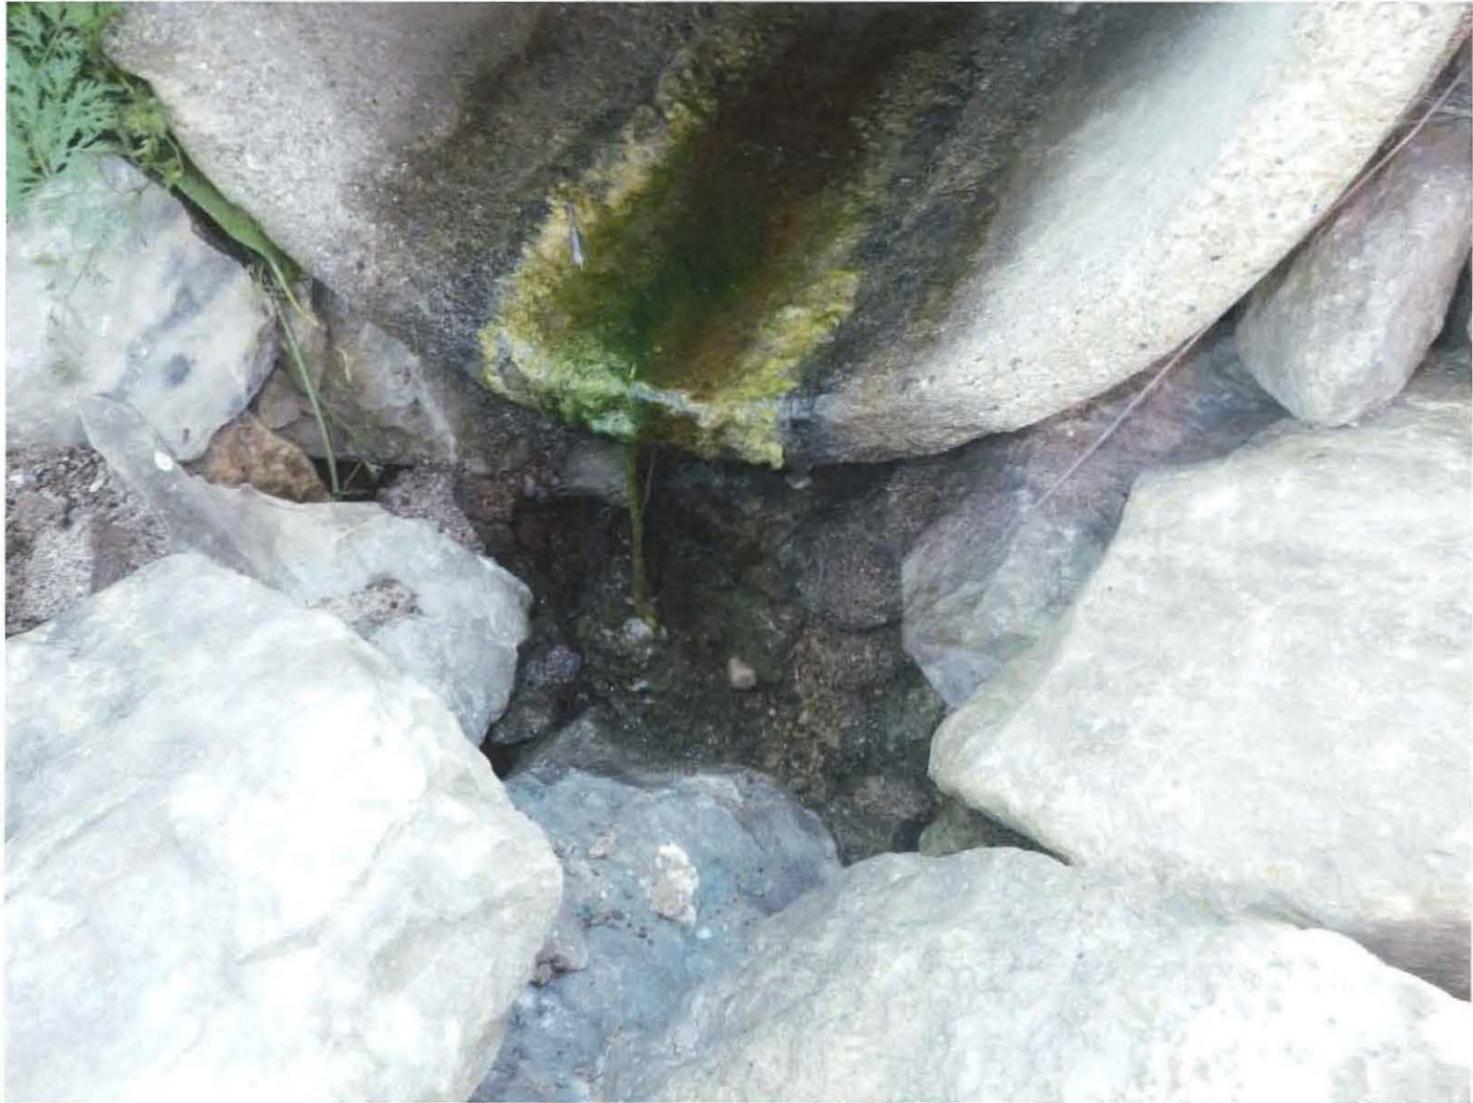
Finding Number 44

2156	At west fence behind VH1	No	Johnson grass	9/5/2014	September 2014 OSDF Inspection	42	Herbicide Applied	9/11/2014	
2157	West outer drainage between VH2 and VH3	No	teasel	9/5/2014	September 2014 OSDF Inspection	43	Herbicide Applied	9/11/2014	
2158	West fence at VH4	No	Water flow from under culvert	9/5/2014	September 2014 OSDF Inspection	44

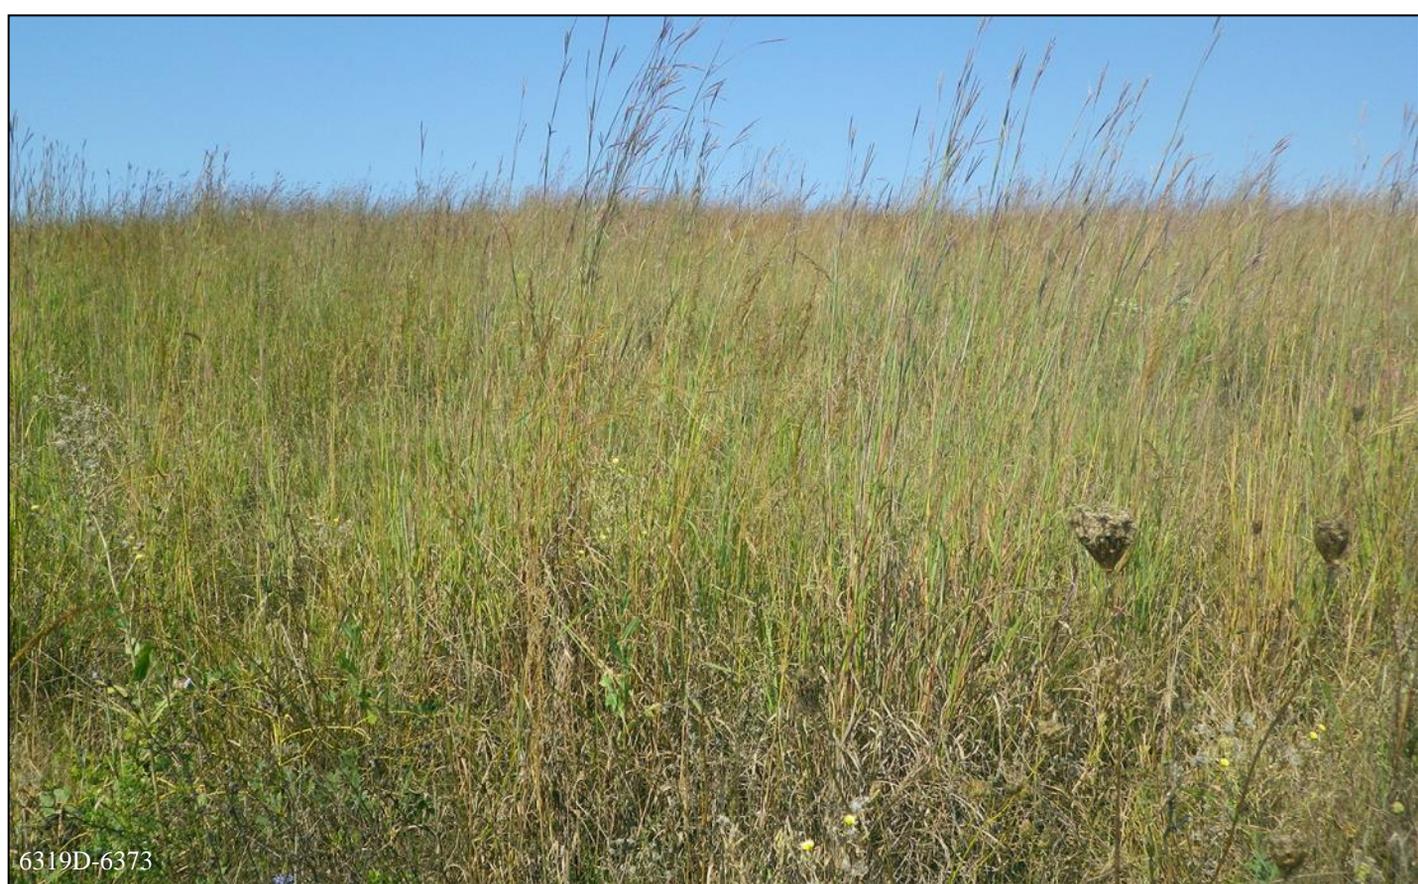
6319D-6373

East Face Cell 1

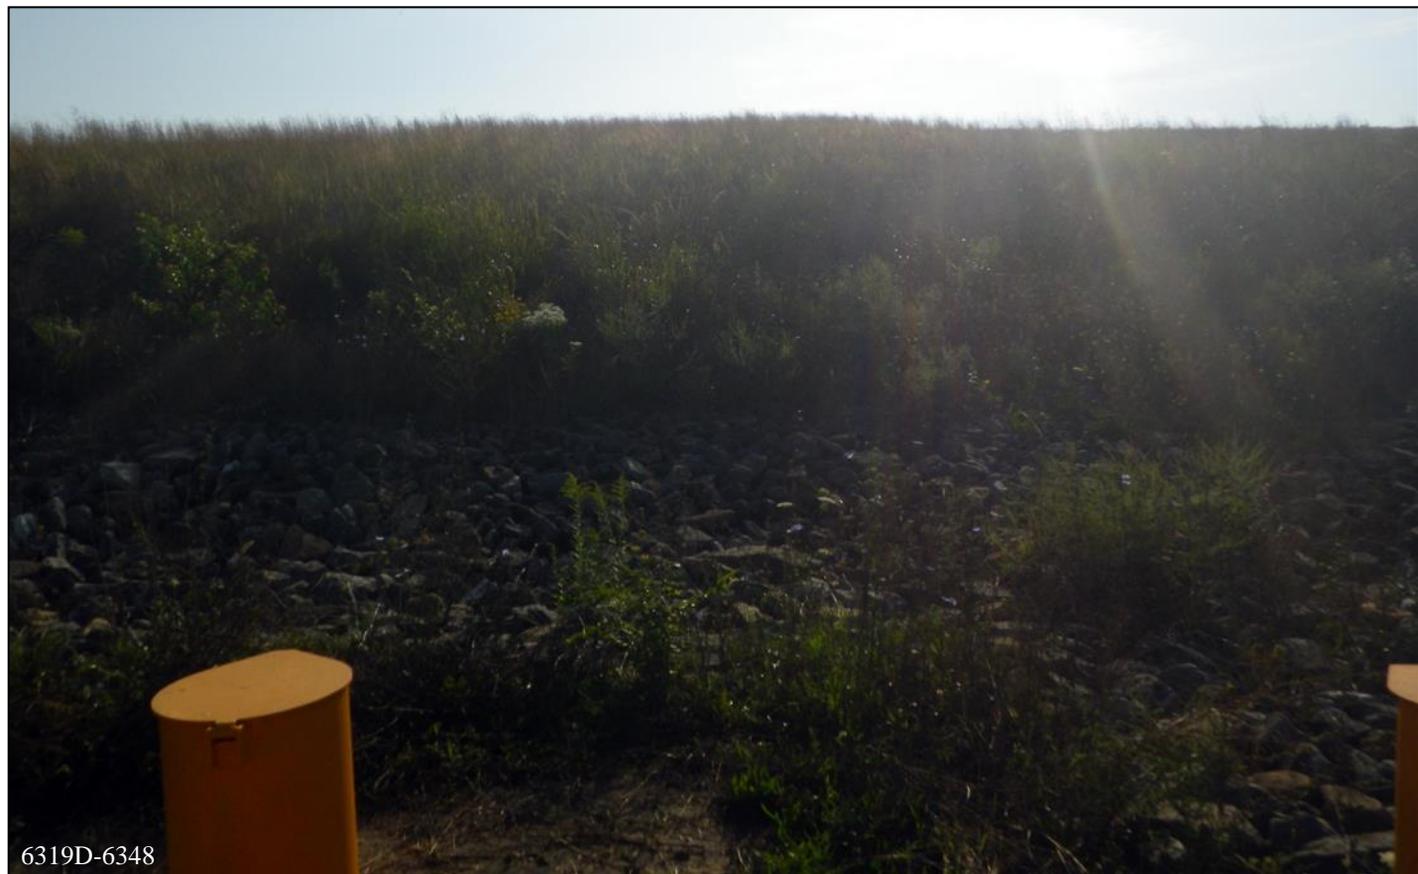
6319D-6348

West Face Cell 1

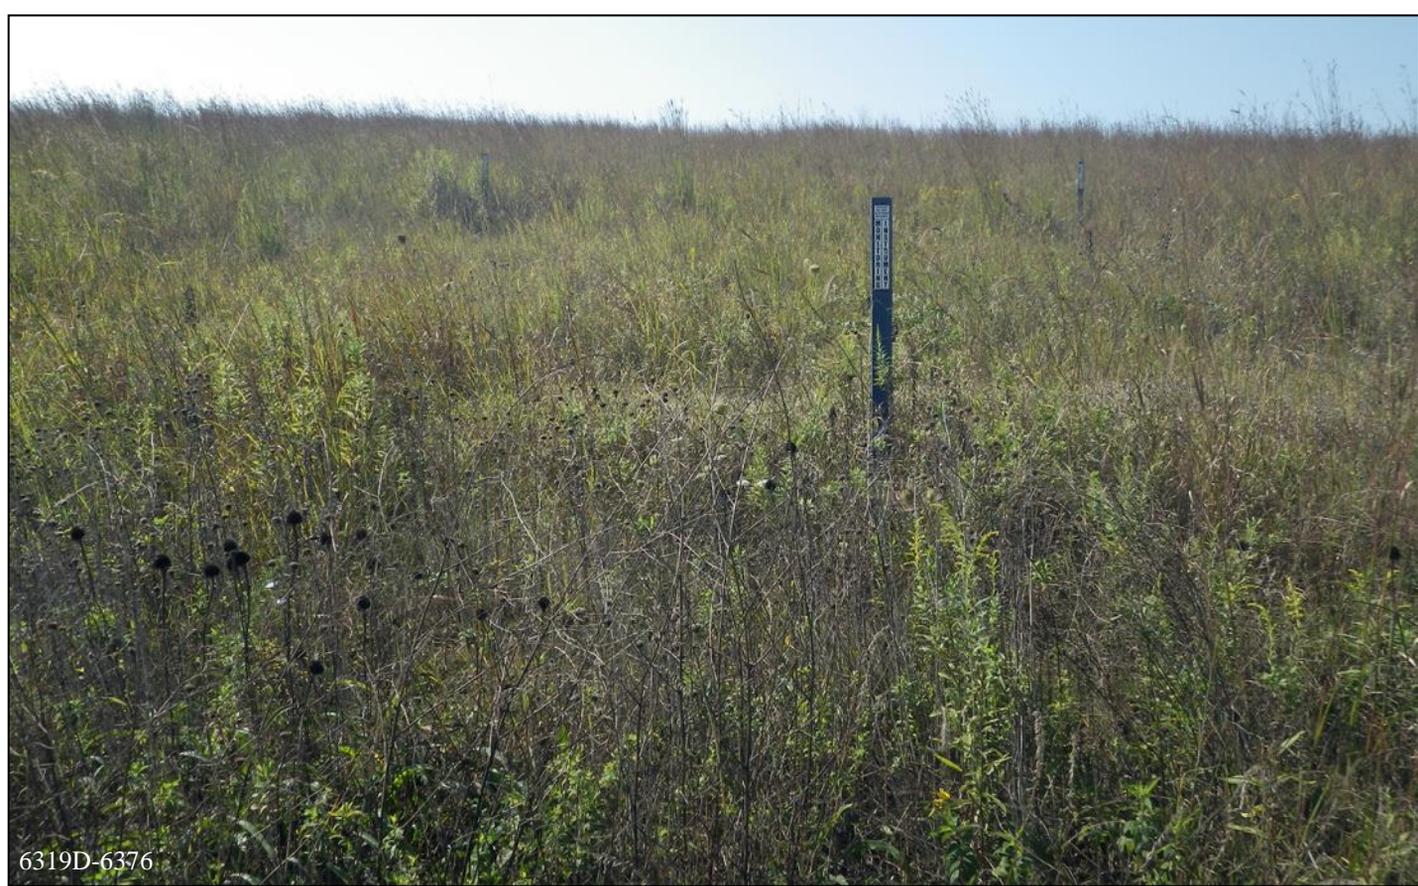
6319D-6376

North Face Cell 1

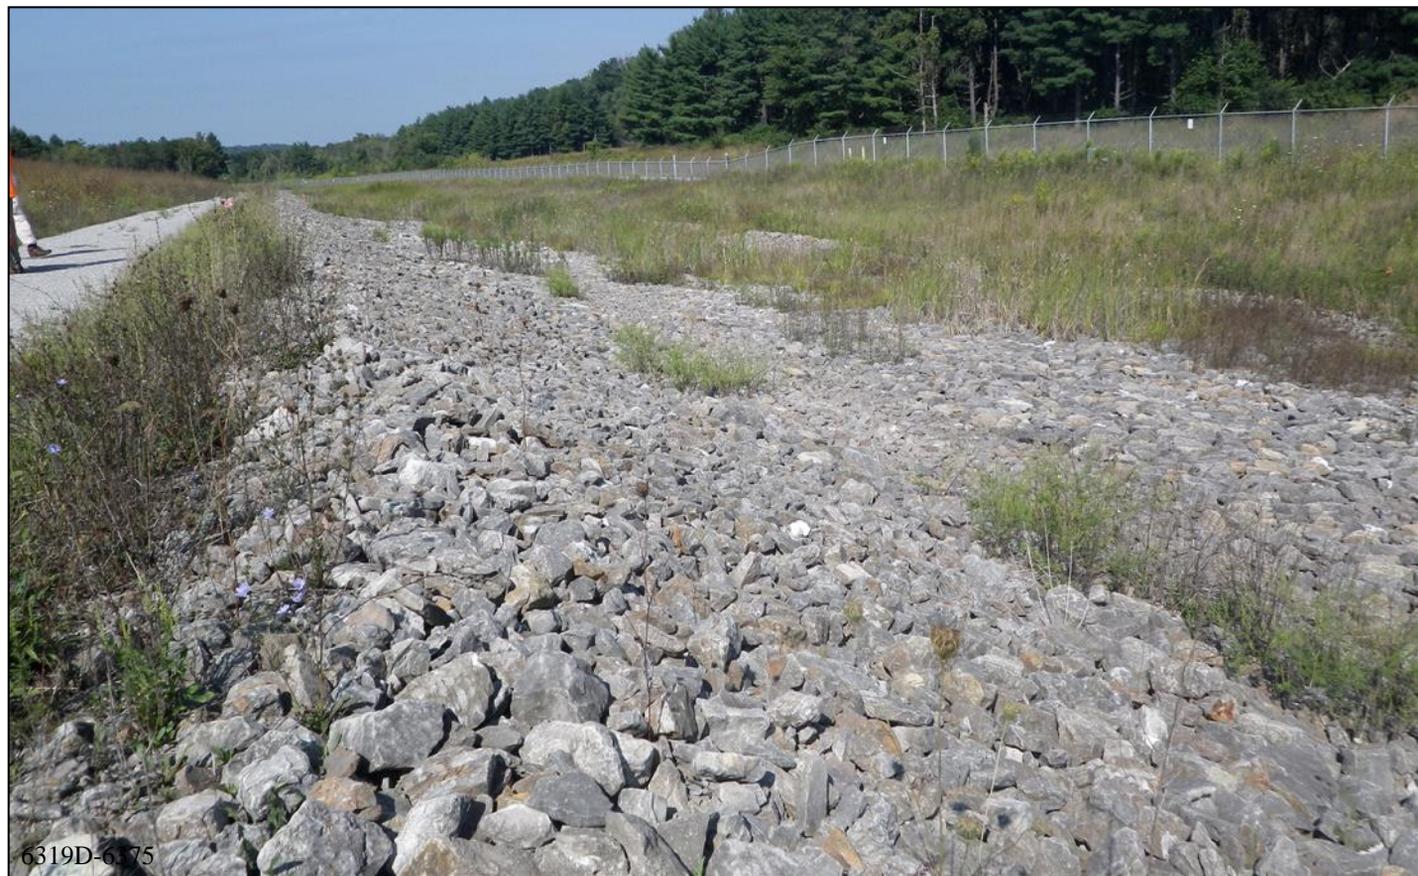
6319D-6375

North Drainage (looking west)

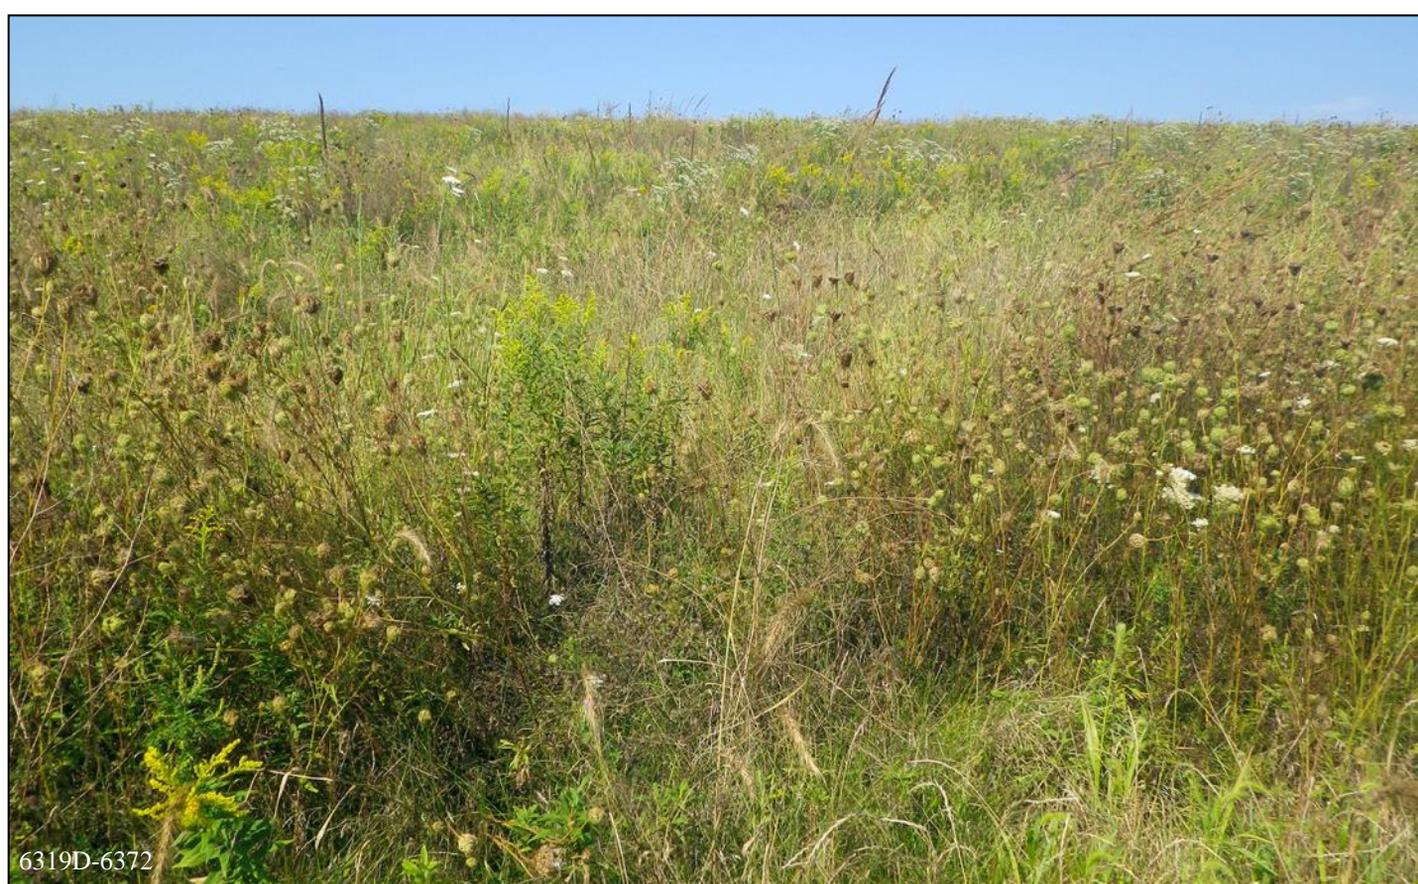
6319D-6372

East Face Cell 2

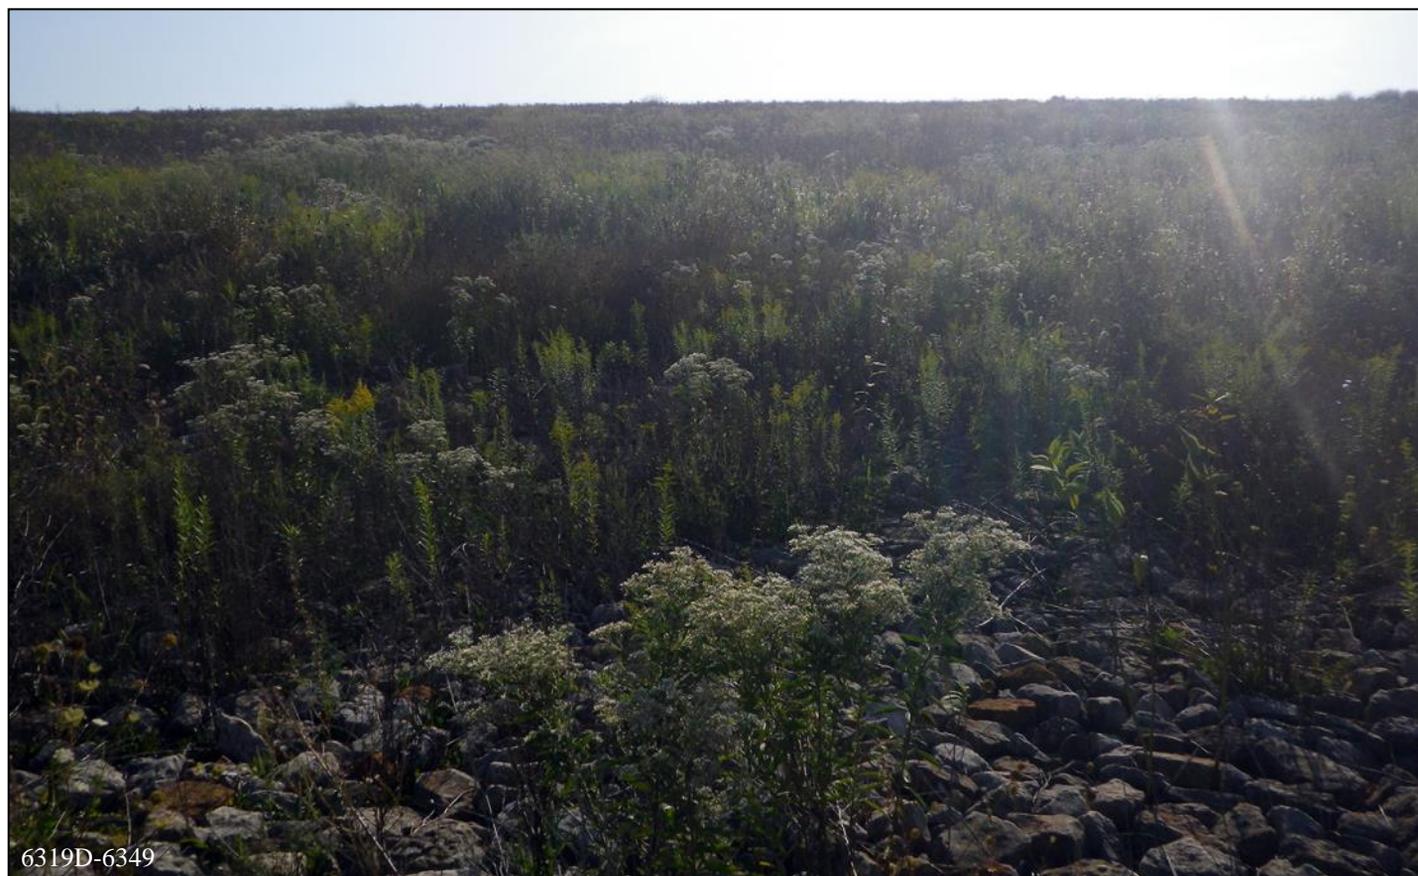
6319D-6349

West Face Cell 2

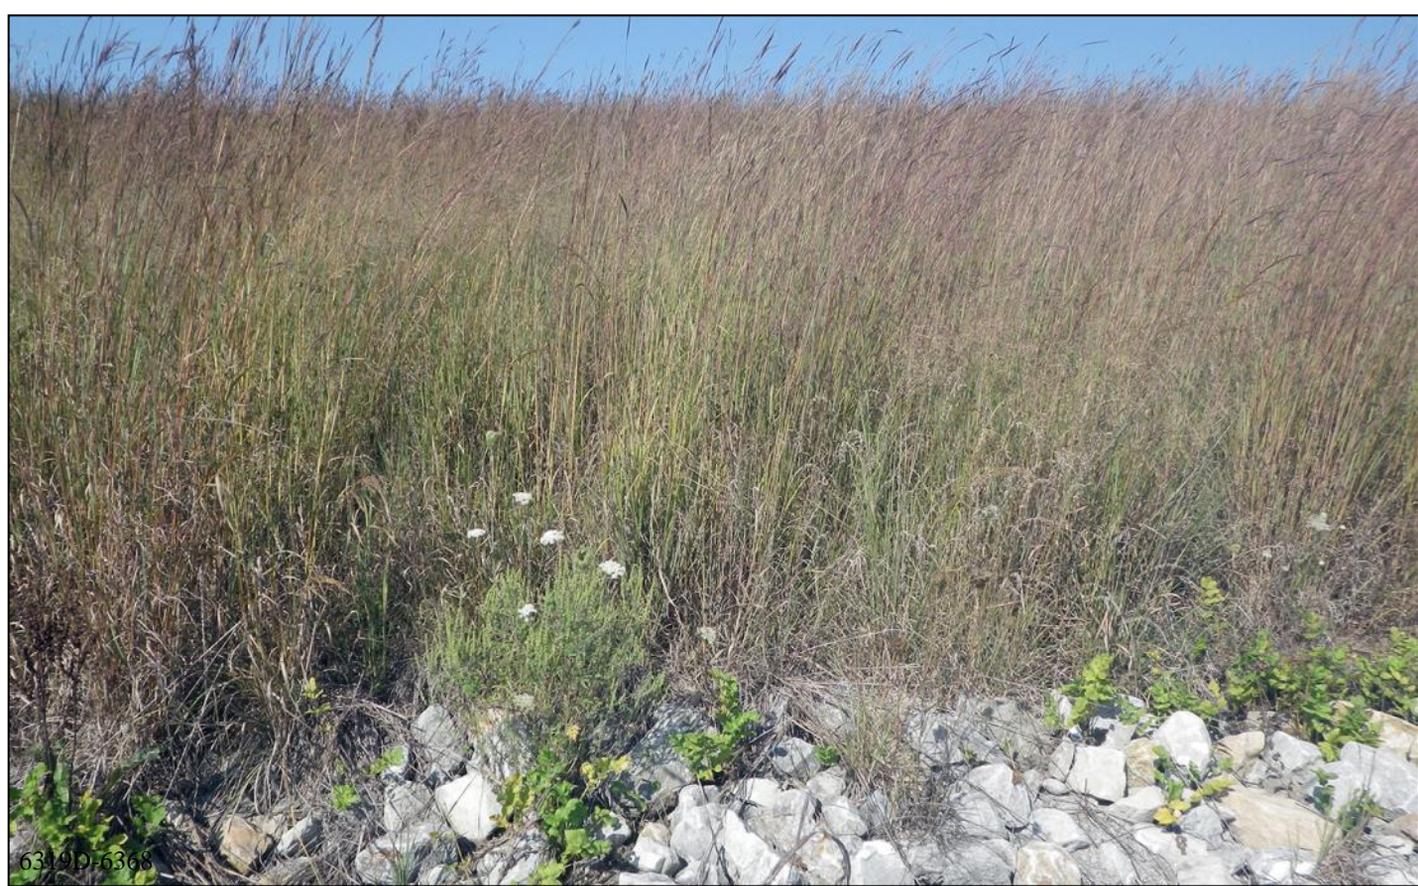
6319D-6368

East Face Cell 5

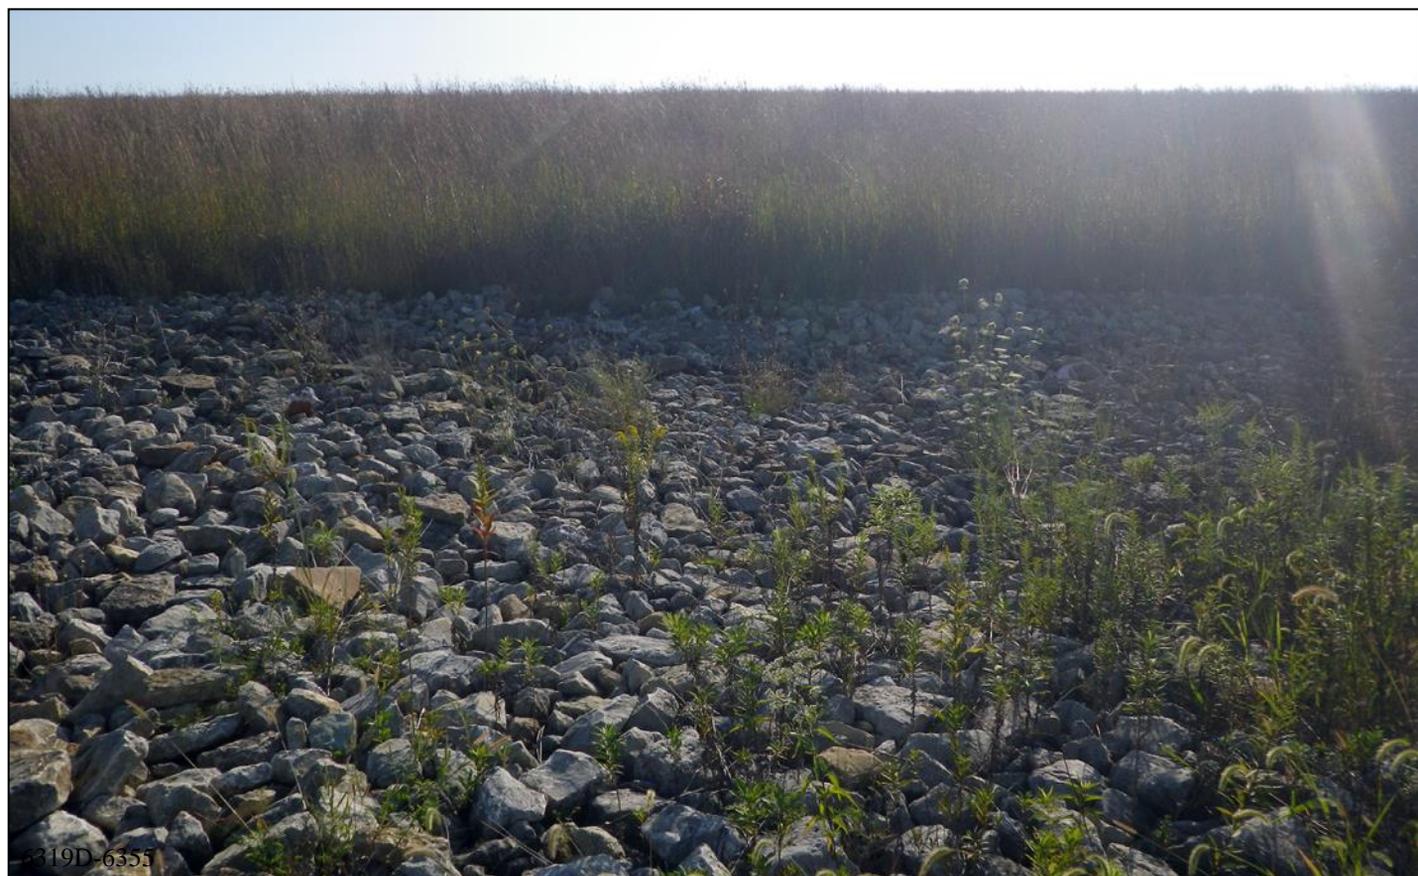
6319D-6355

West Face Cell 5

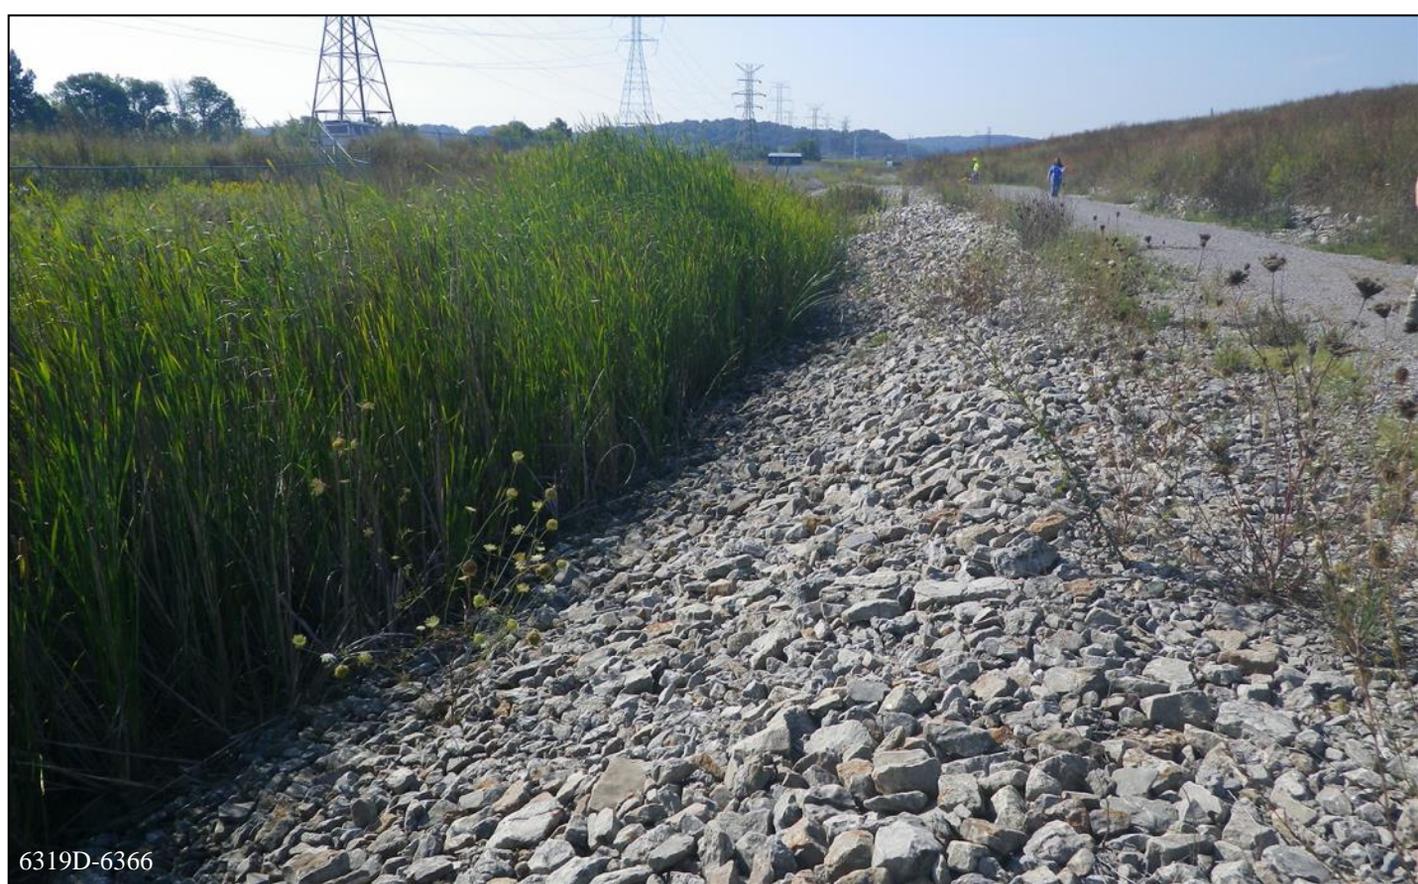
6319D-6366

East Drainage Cell 7 (looking south)

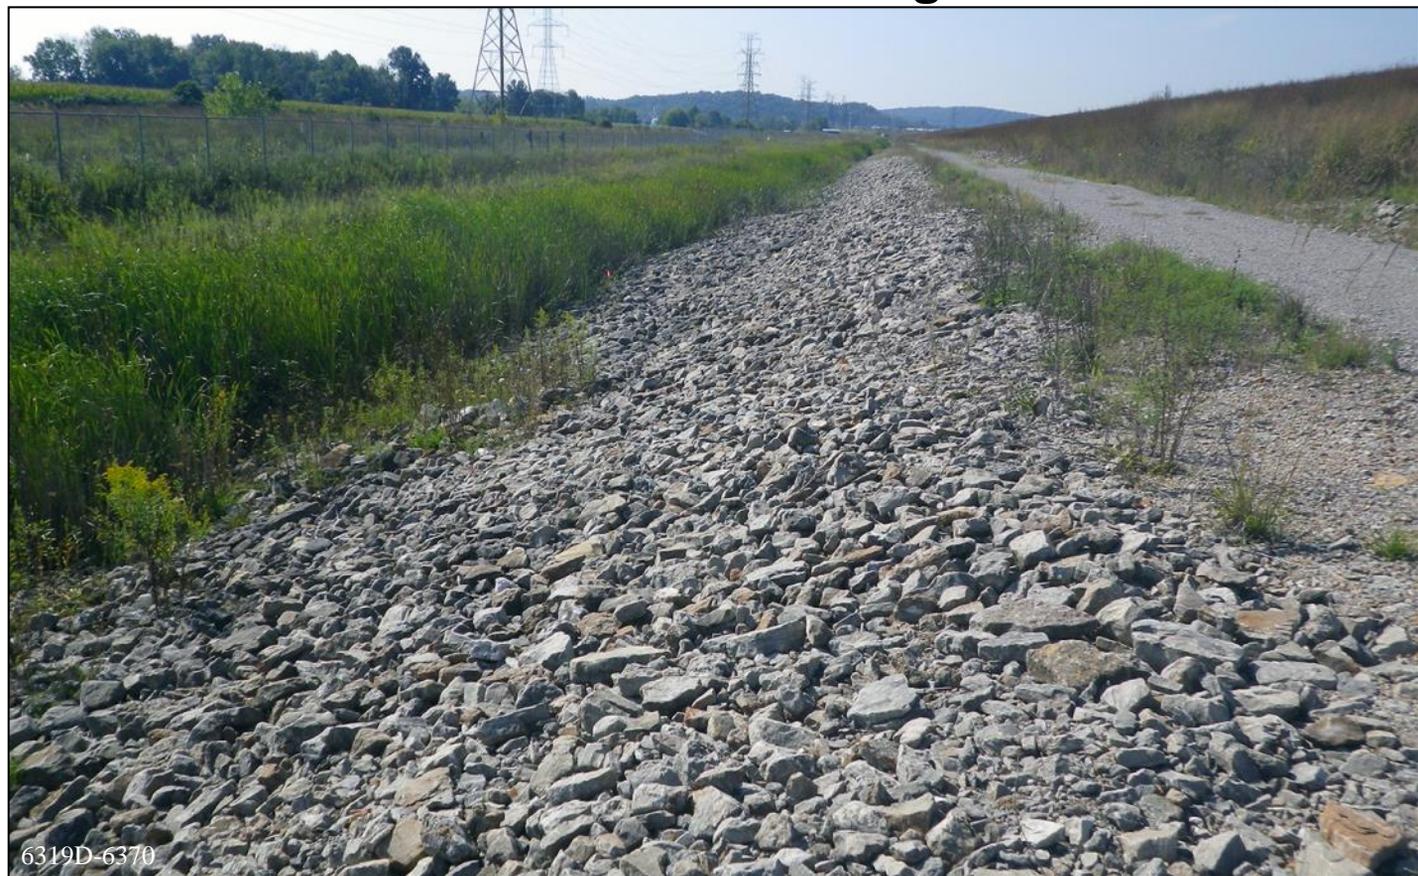
6319D-6370

East Drainage Cell 4 (looking south)

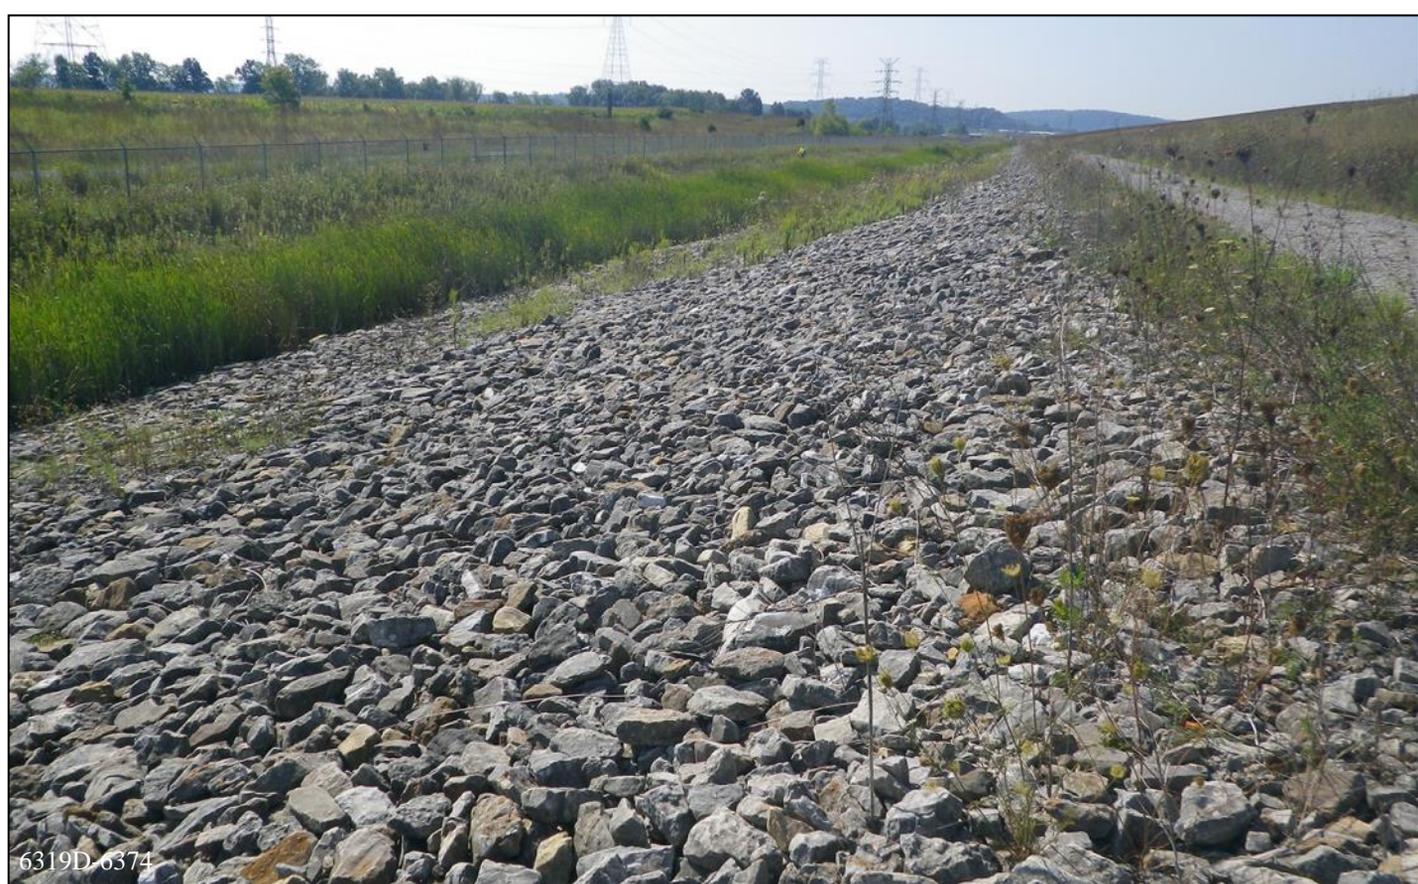
6319D-6374

East Drainage Cell 1 (looking south)

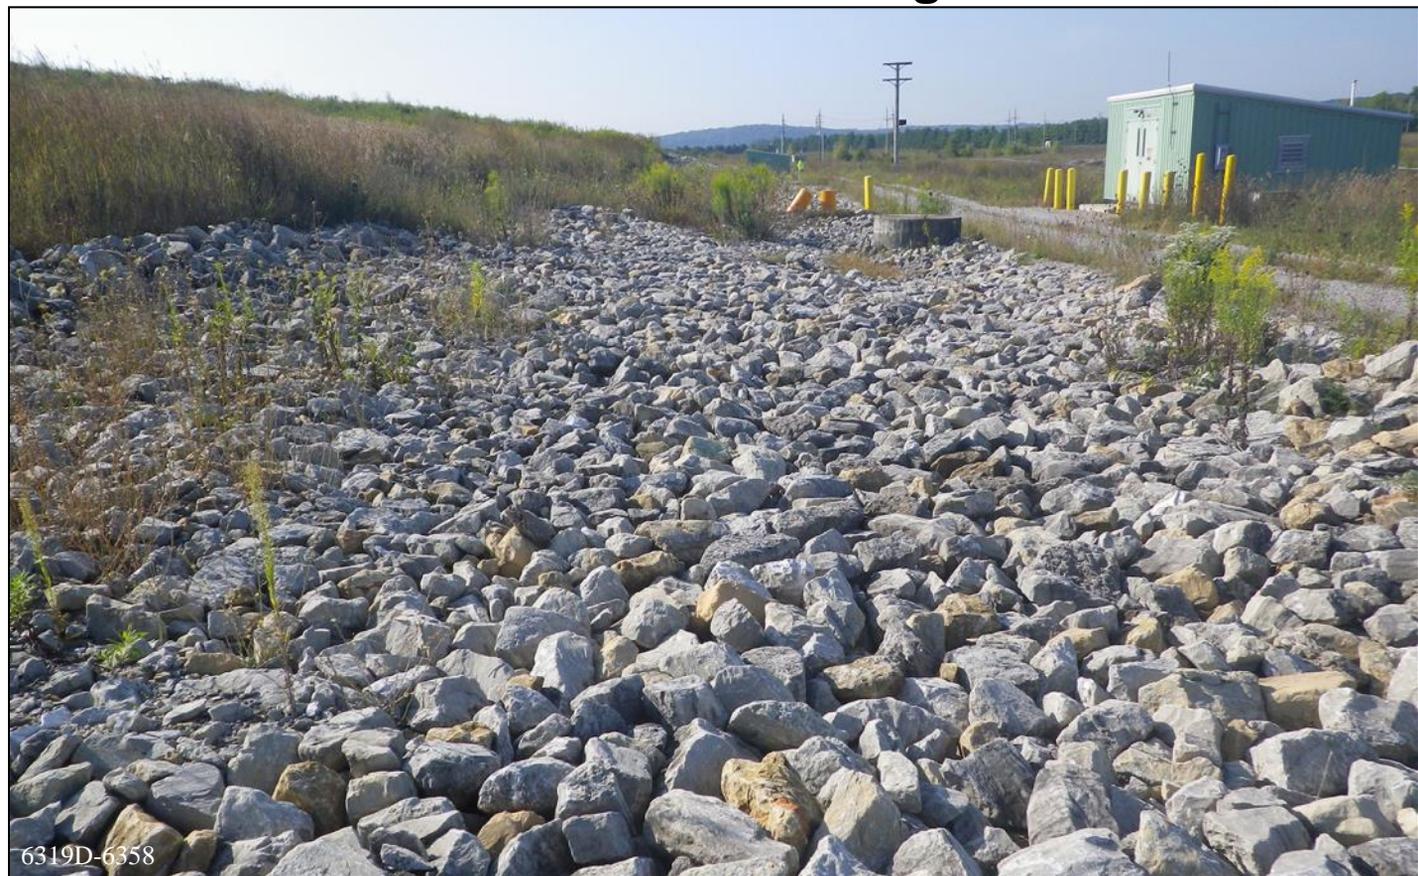
6319D-6358

West Inner Drainage Cell 7 (looking south)

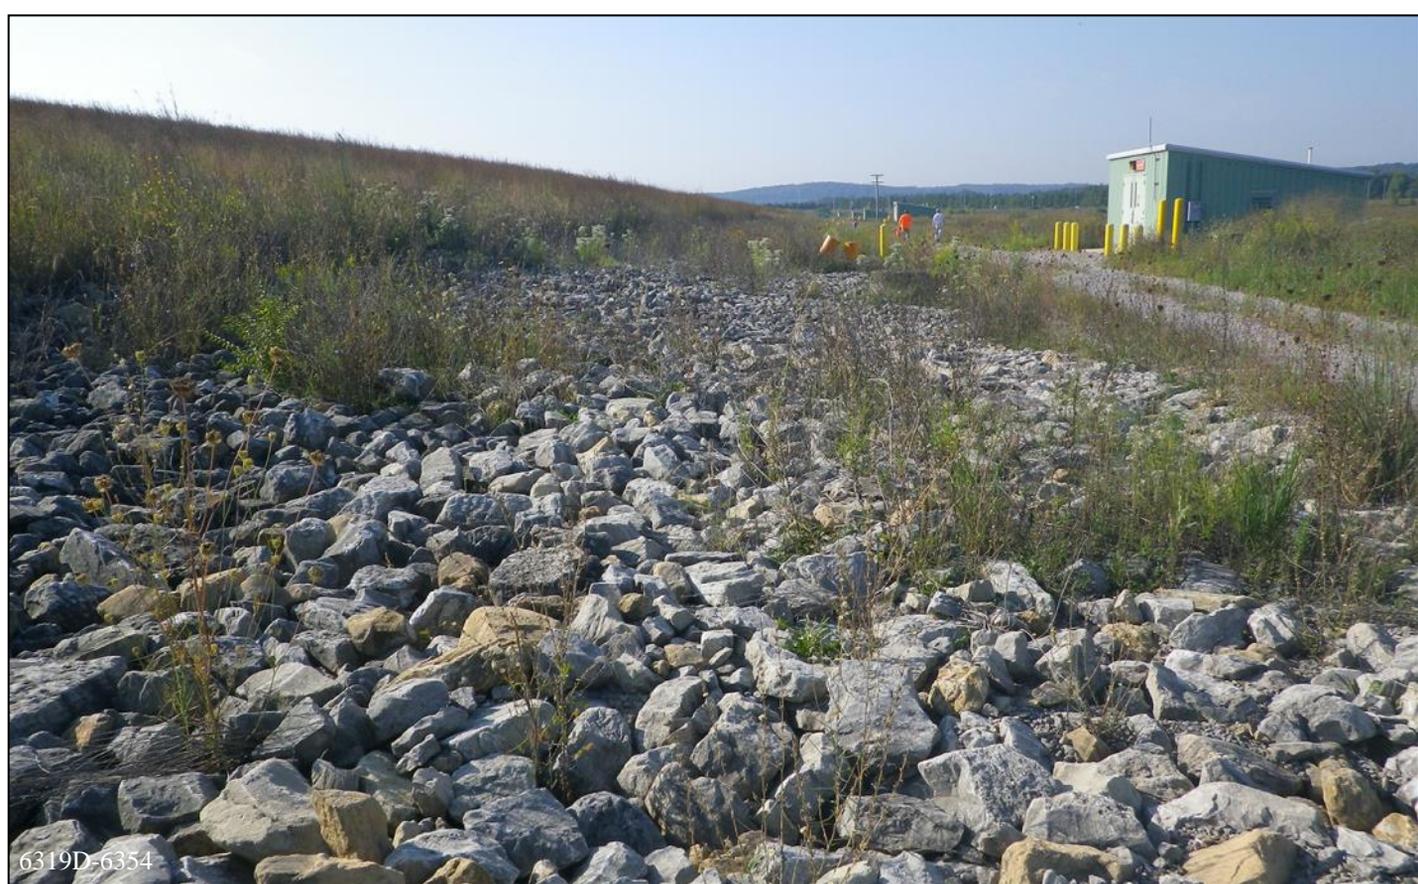
6319D-6354

West Inner Drainage Cell 4 (looking south)

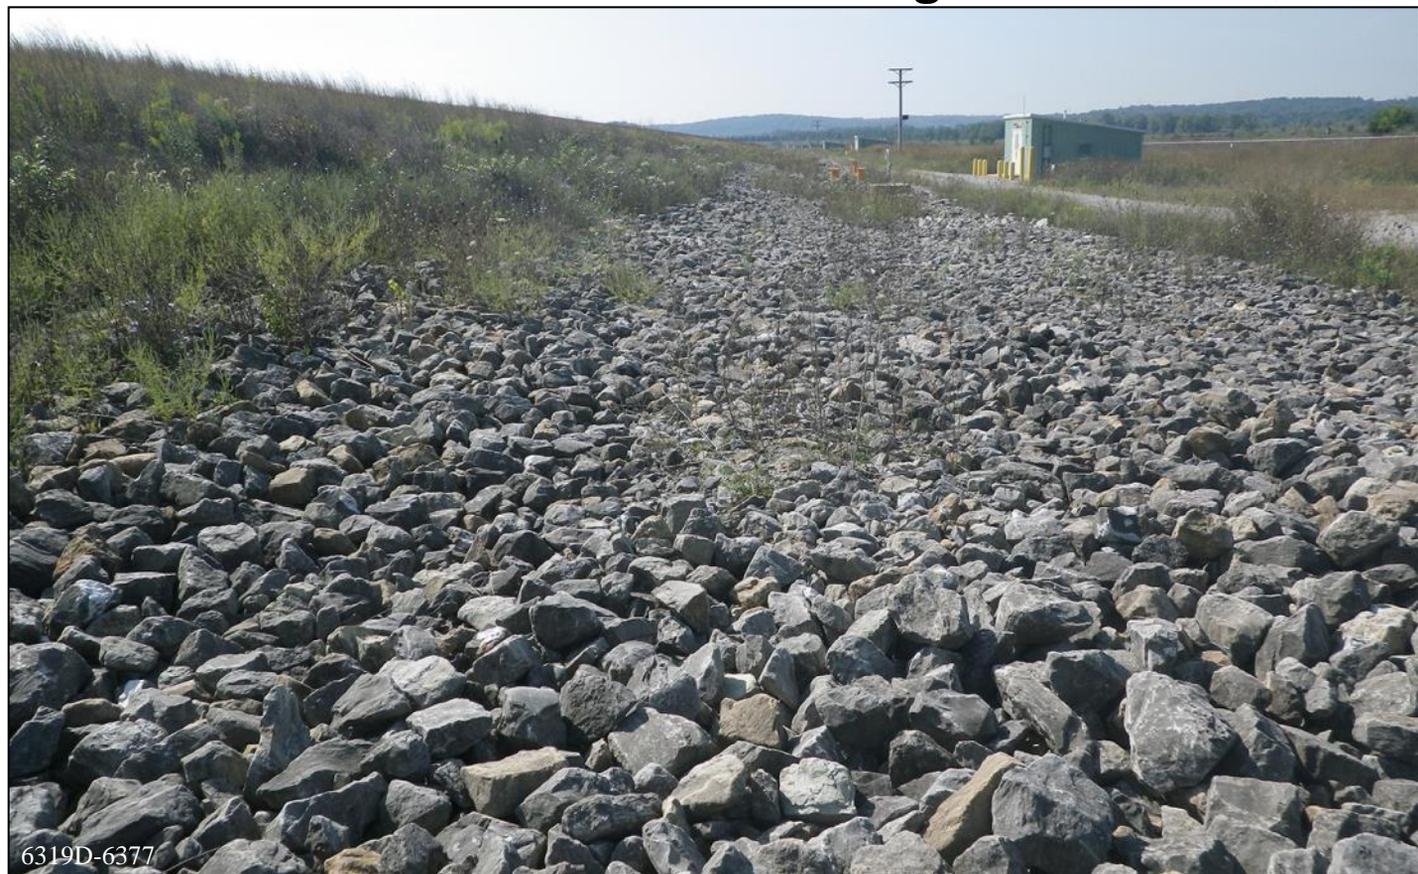
6319D-6377

West Inner Drainage Cell 1 (looking south)

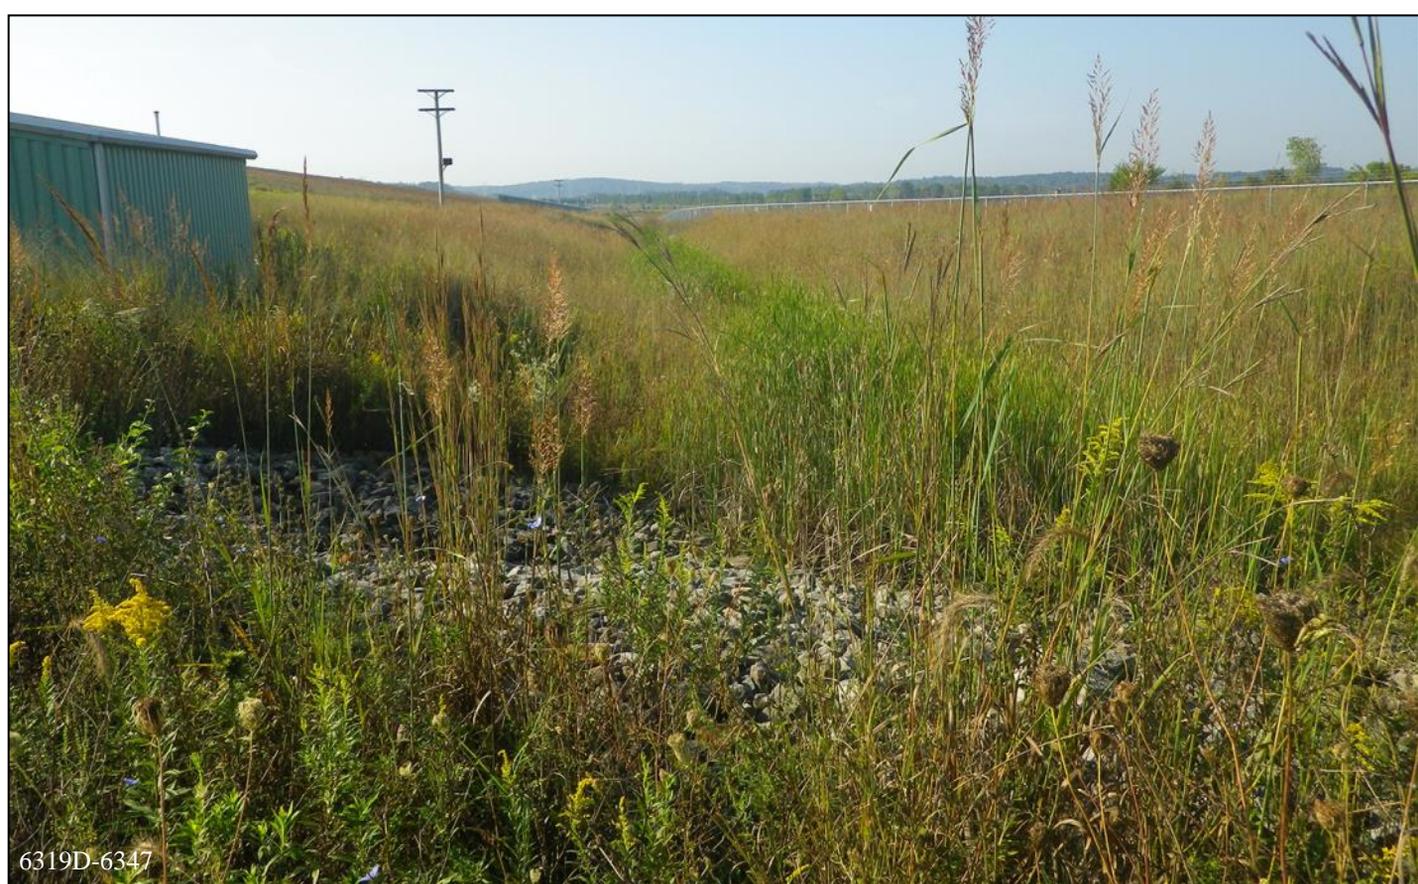
6319D-6347

West Outer Drainage Cell 1 (looking south)

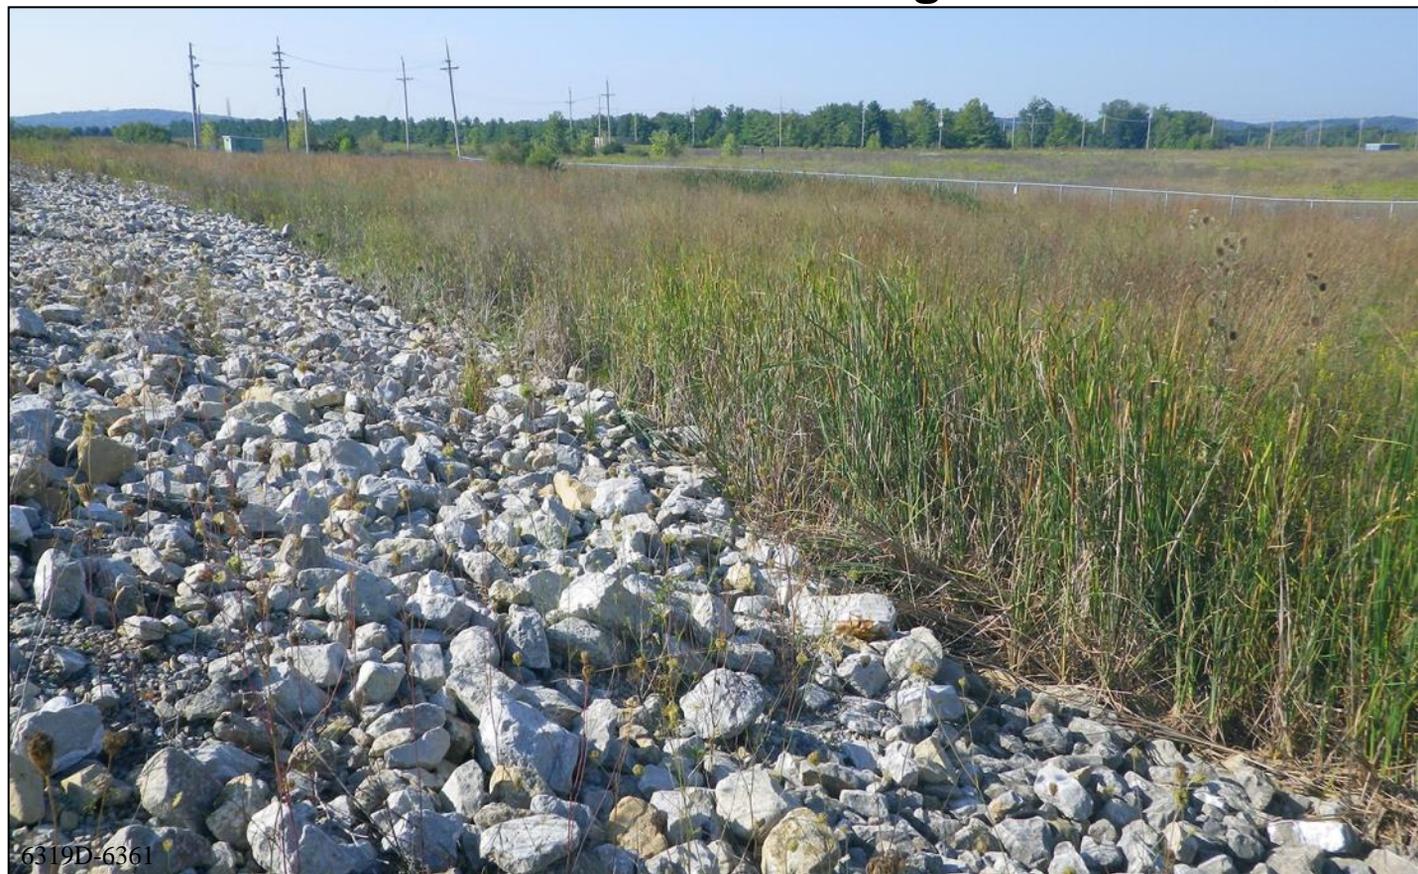
6319D-6361

West Outer Drainage Cell 8 (looking south)
