Task Assignment 101  
Control Number 15-0232

SUBJECT: Contract No. DE-LM0000415, The S.M. Stoller Corporation, a wholly owned subsidiary of Huntington Ingalls Industries (Stoller)  
Task Assignment 101 LTS&M - CERCLA/RCRA and Others  
Transmittal of Contract Deliverable: Submit Q1 site inspection letter, Submit Q1 OSDF inspection report  
Activity Code INS-1205, OSDF-1405—Completed: December 22, 2014

# **FERNALD PRESERVE**

# **Inspection Report**

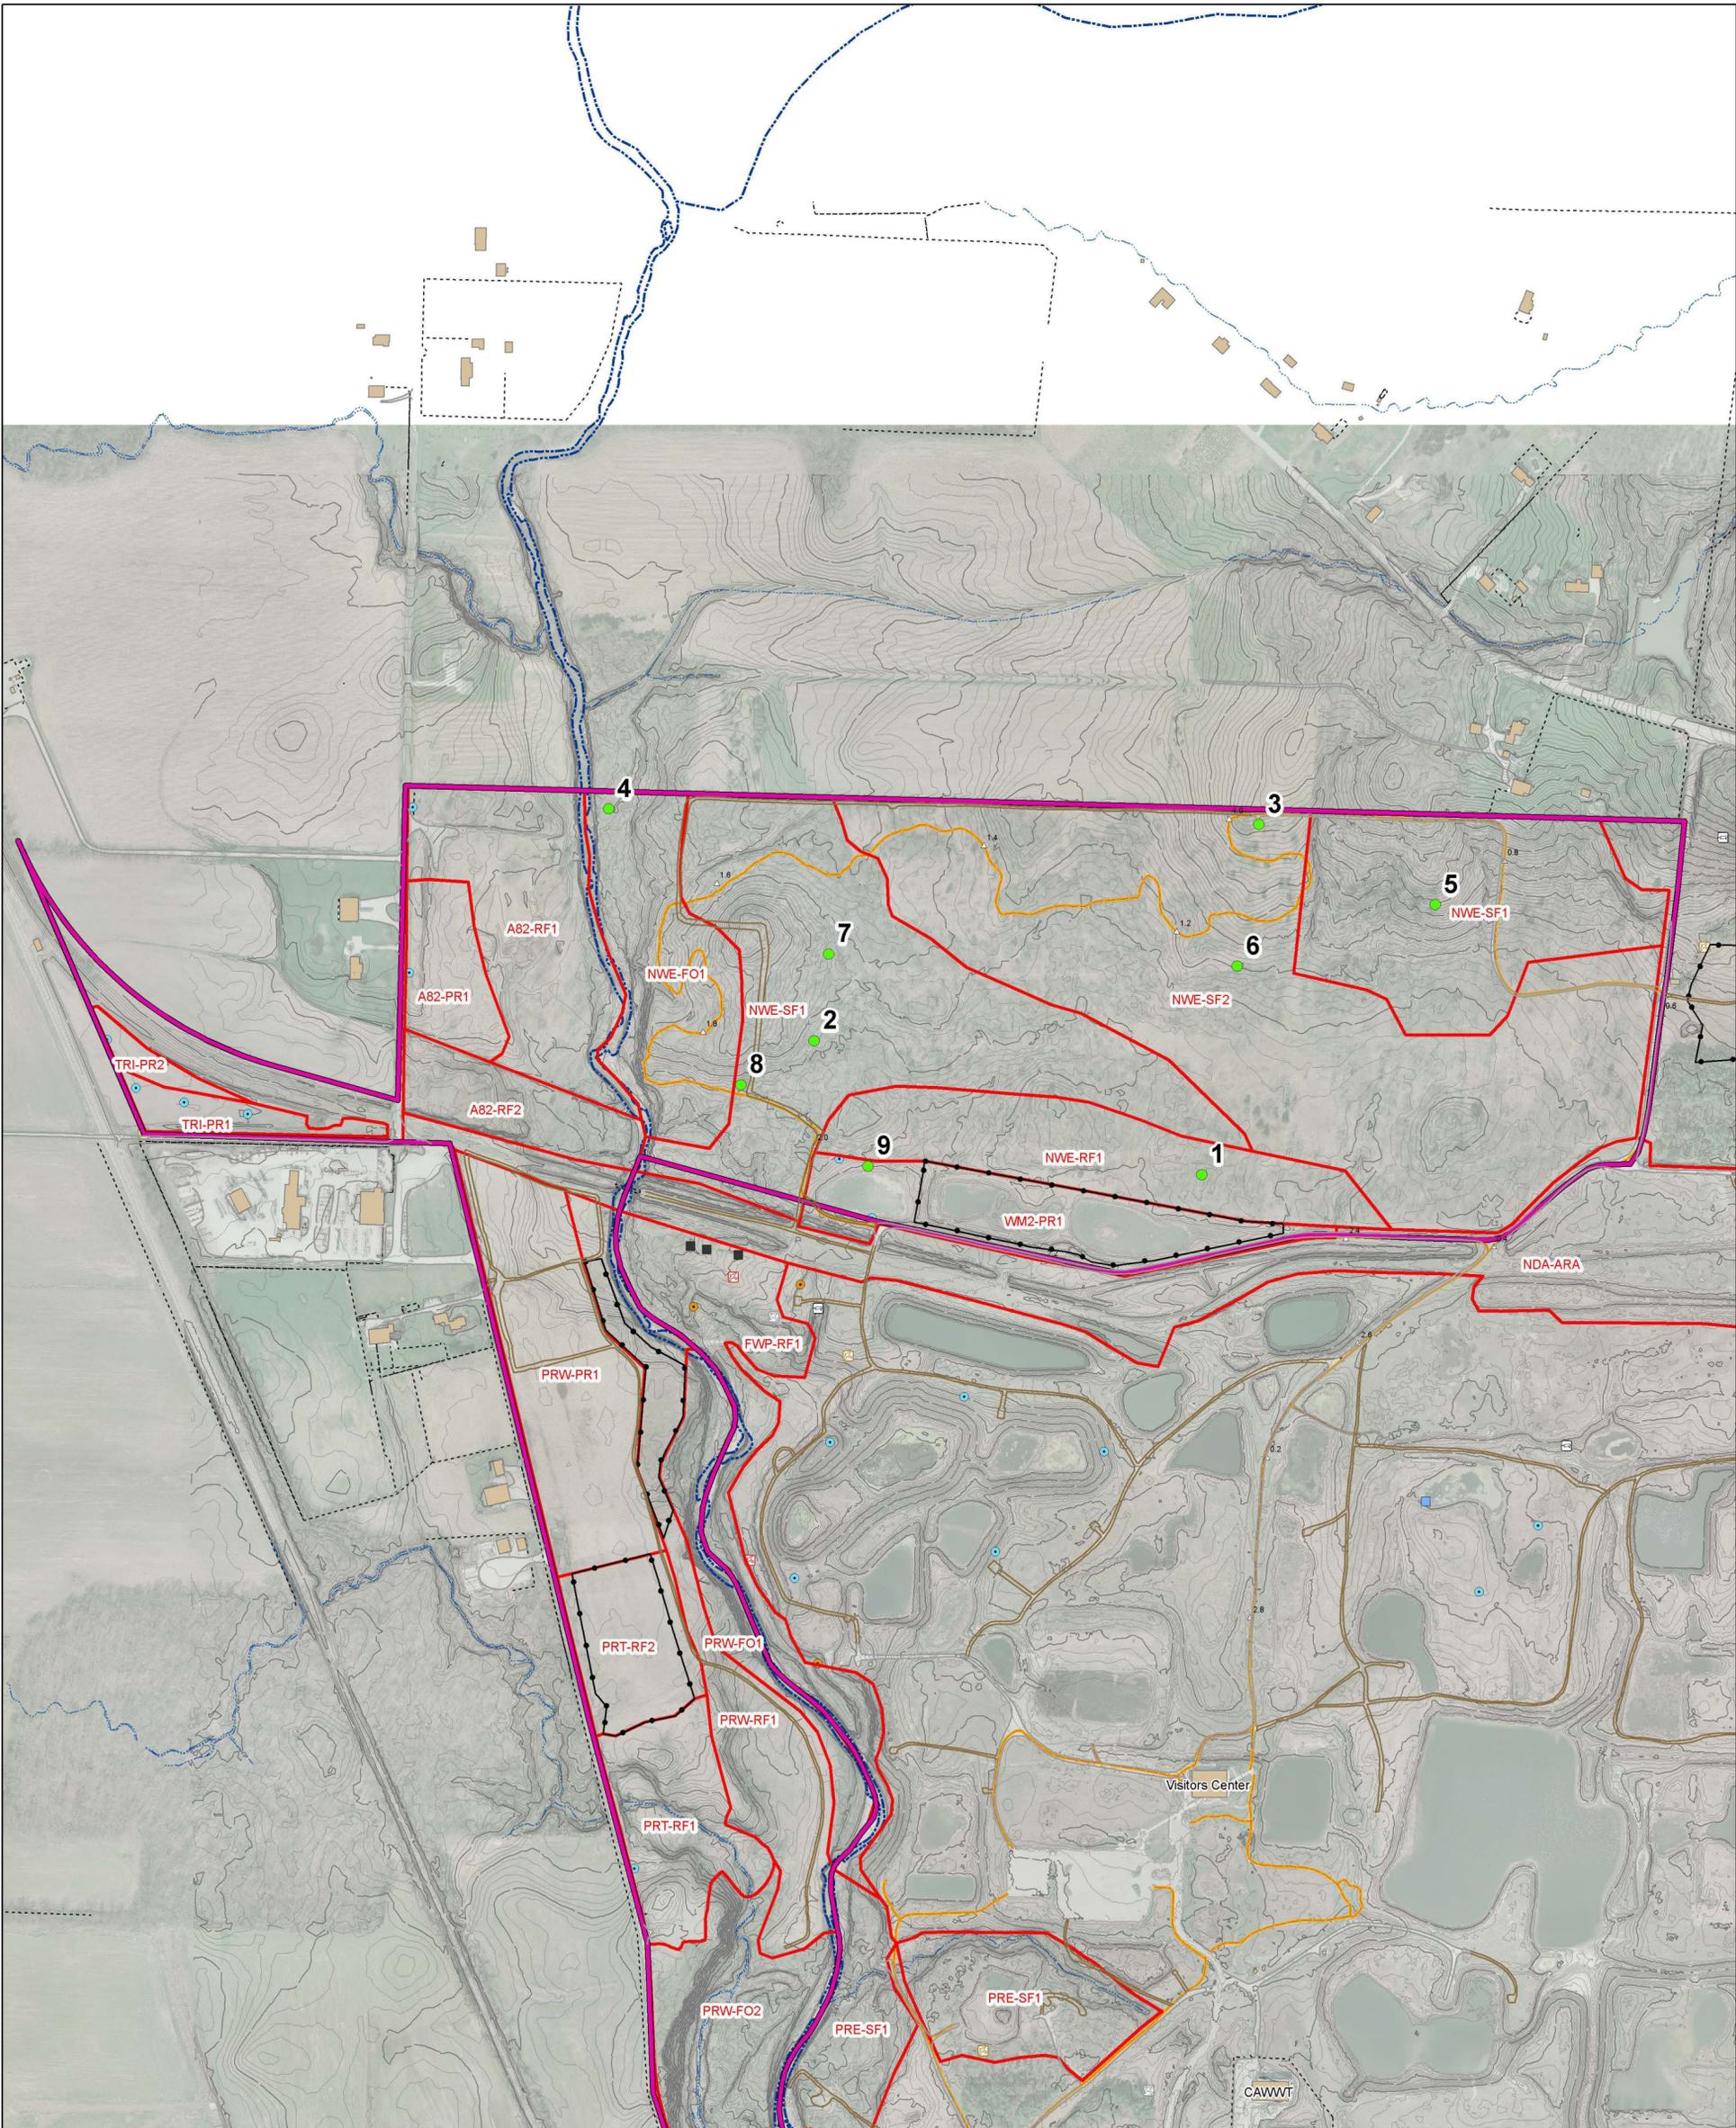
Map No.	Location	GPS?	Type of Finding	Description	Photo? (File No.)
1	North of east end of WM2	No	Vegetation	Stand of teasel	
2	East and north of service road, northwest of WM2	No	Vegetation	Pear tree	
3	Edge of Hickory trail at property line	No	Debris	old t-post	
4	Deer trail	No	Debris	Wire	
5	West of n/s section of Hickory trail	No	Vegetation	Autumn olive	
6	South of trail...just south of snag	No	Other	knife and pop can	
7	along second access cut	No	Other	Dead deer, 12 pt. buck. No obvious injury.	
8	Where (north) access road meets Hickory Trail	No	Signage	Authorized Access sign is down	
9	WM2 wetlands	No	Other	Deer cages still present

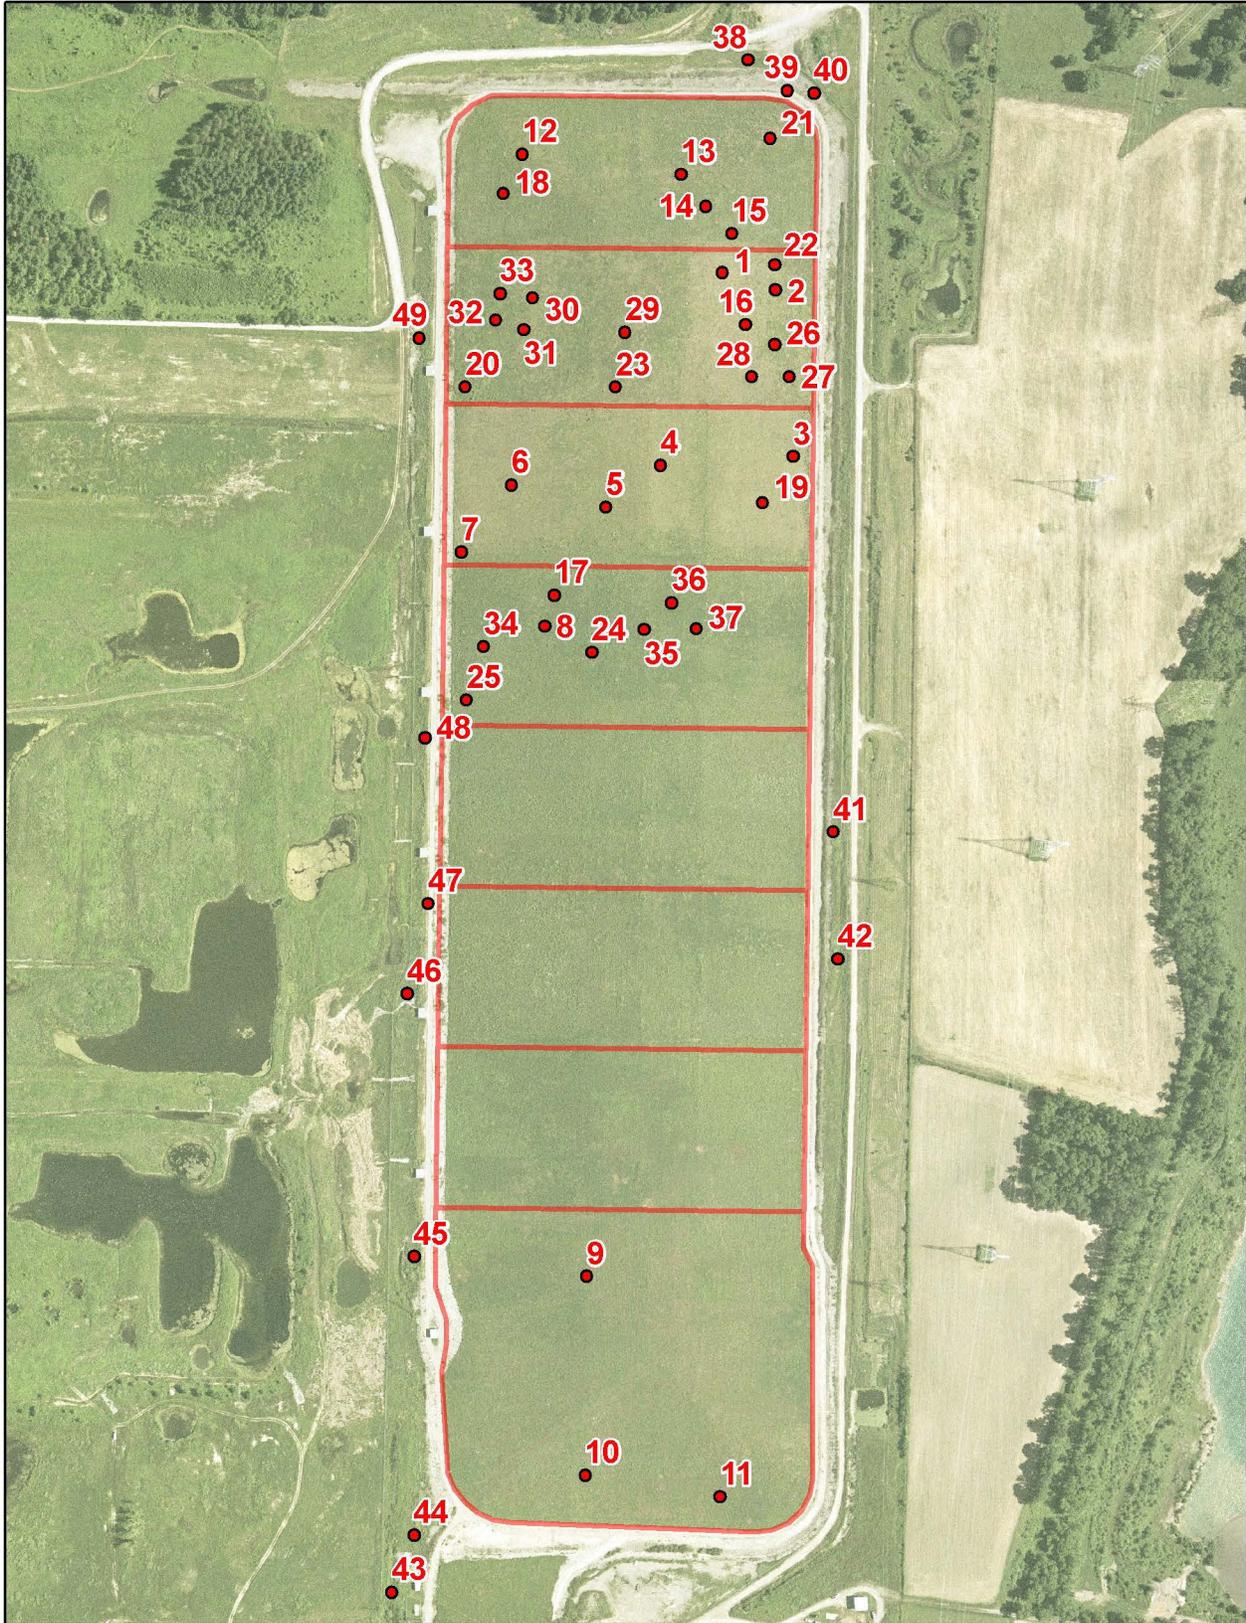
## OSDF Inspection Findings December 2014

Map No.	Location	GPS?	Type of Finding	Description	Photo? (File No.)
1	Cell 2, east 6:1, mid-way up slope	No	Vegetation	Pear tree	
2	Cell 2, east 6:1, bottom of slope	No	Vegetation	Pear trees	
3	Cell 3, east 6:1, bottom of slope	No	Vegetation	Woody vegetation	
4	Cell 3, east 6:1, midway up slope	No	Vegetation	Pear tree	
5	Cell 3 top	No	Vegetation	Honeysuckle and numerous pear	
6	Cell 3, west 6:1 slope	No	Vegetation	Many pear trees on slope	
7	Cell 3, west 6:1, bottom of slope, south end	No	Biointrusion	animal burrow	
8	Cell 4, west 6:1 slope	No	Vegetation	Pear trees	
9	Cell 8, west top	No	Rock	Stone	
10	Cell 8, south face, bottom of slope	No	Rock	Stone	
11	Cell 8, south slope, bottom east	No	Rock	stone	
12	Cell 1, northwest face near top	No	Vegetation	woody vegetation x 2	
13	Cell 1, northeast face	No	Vegetation	Pear tree x 3+	
14	Cell 1, northeast face	No	Vegetation	Pear trees x 3

Map No.	Location	GPS?	Type of Finding	Description	Photo? (File No.)
15	Cell 1, east face on south end,	No	Vegetation	Pear tree	
16	Cell 2, all of cell cap	No	Vegetation	Pear trees all over cell cap	
17	Cell 4, west slope	No	Vegetation	Bare ground	
18	Cell 1, west face above VH1	No	Vegetation	bush	
19	cell 3, east side	No	Vegetation	Pear tree	
20	Cell 2, west toe, edge of rip rap	No	Biointrusion	animal burrow	
21	Cell 1, east toe	No	Vegetation	Callery pear x 2	
22	Cell 2, east face, north end, about 20 yards up from toe	No	Vegetation	Callery pear x 2	
23	Cell 2, top, near 2/3 boundary	No	Biointrusion	rodent hole	
24	Cell 4, west 10:1, south end	No	Vegetation	Cedar tree	
25	Cell 4, west toe, south end	No	Vegetation	Cedar	
26	Cell 2, east side	No	Vegetation	Pear tree	
27	Cell 2, east side	No	Vegetation	Pear tree	
28	Cell 2, east side	No	Vegetation	Pear tree	
29	Cell 2, top	No	Vegetation	Pear tree	
30	Cell 2, west 6:1	No	Vegetation	Pear tree

31	Cell 2, west 6:1	No	Vegetation	Group of 5 pears	
32	Cell 2, west face	No	Vegetation	Group of 4 pear trees

Map No.	Location	GPS?	Type of Finding	Description	Photo? (File No.)
33	Cell 2, west face	No	Vegetation	Group of 3 pear trees	
34	Cell 4, west face	No	Vegetation	Pear tree	
35	Cell 4 top	No	Vegetation	Pear tree	
36	Cell 4, top	No	Vegetation	Pear	
37	Cell 4, top	No	Vegetation	Pear tree	
38	Northeast corner at fence	No	Vegetation	Small cedar tree	
39	Northeast corner road toe	No	Vegetation	Pear sapling and cedar	
40	Northeast corner on fence	No	Signage	Sign hanging by one wire	
41	East side fence at Cell 5	No	Fencing	Top barb arm and barb wire out	
42	east edge of rock channel at Cell 6	No	Vegetation	Pear seedling	
43	Southwest corner drainage	No	Vegetation	Woody vegetation	
44	Southwest corner mowed flat at drainage	No	Vegetation	teasel and thistle rosettes	
46	At fence behind Valve House 6	No	Fencing	cross brace on chainlink fence bent up	
47	At west fence between VH 5 and VH 6	No	Fencing	Post in fence line bent

48	West fence line at cell 4/5 boundary	No	Vegetation	Cedar tree seedling	
49	Drainage behind Valve House 2 and extending to the north	No	Vegetation	pear saplings

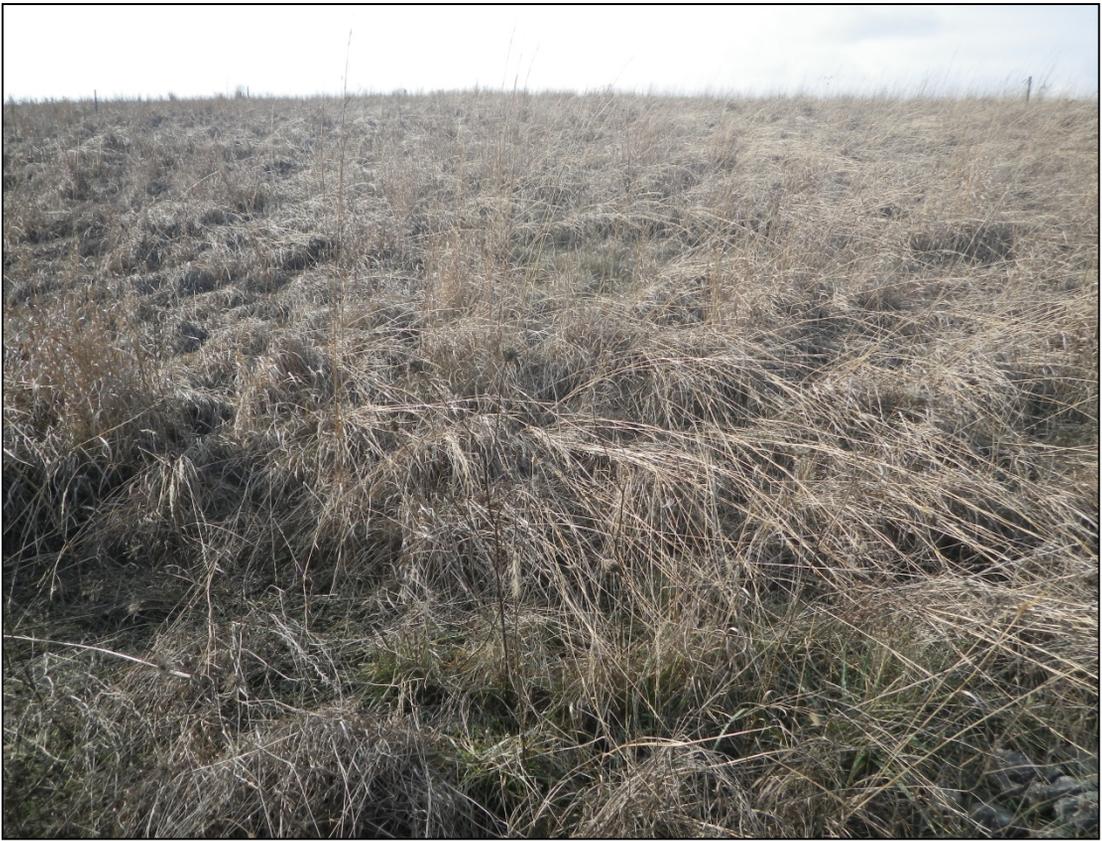
IMGP4424

**East Face Cell 1**

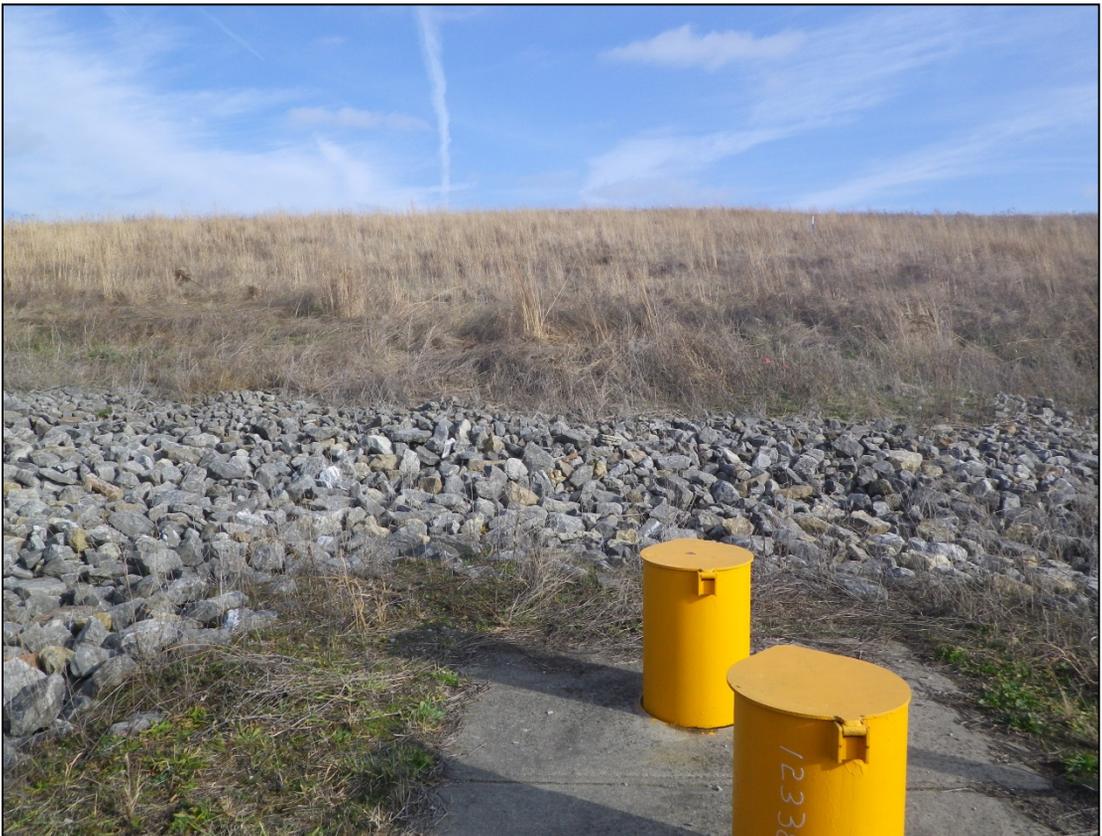
IMGP4430

**West Face Cell 1**

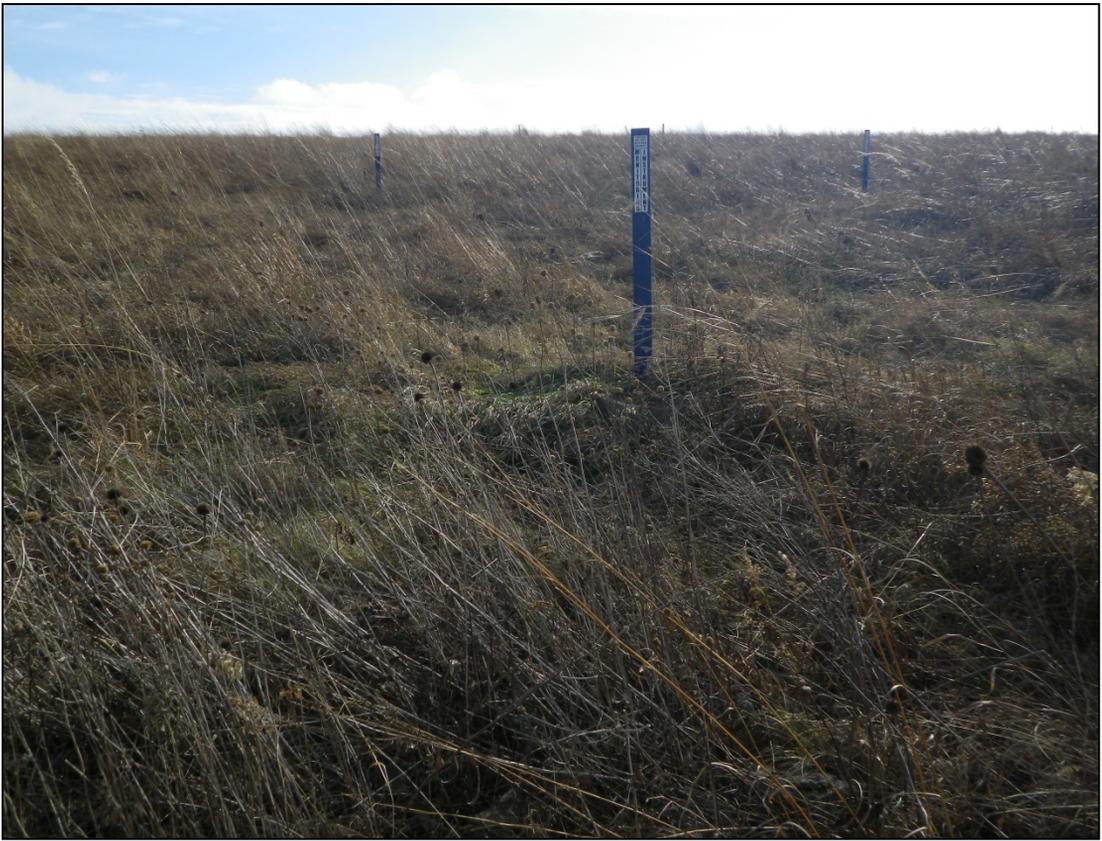
IMGP4427

**North Face Cell 1**

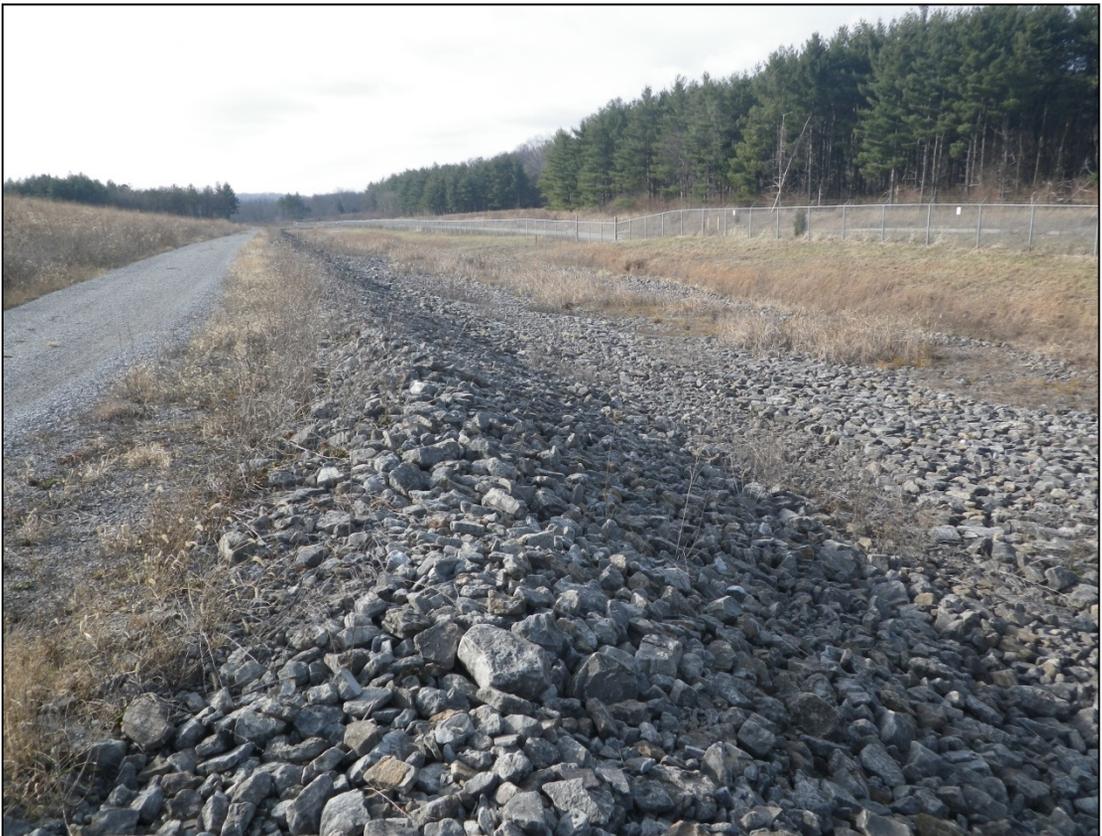
IMGP4426

**North Drainage (looking west)**

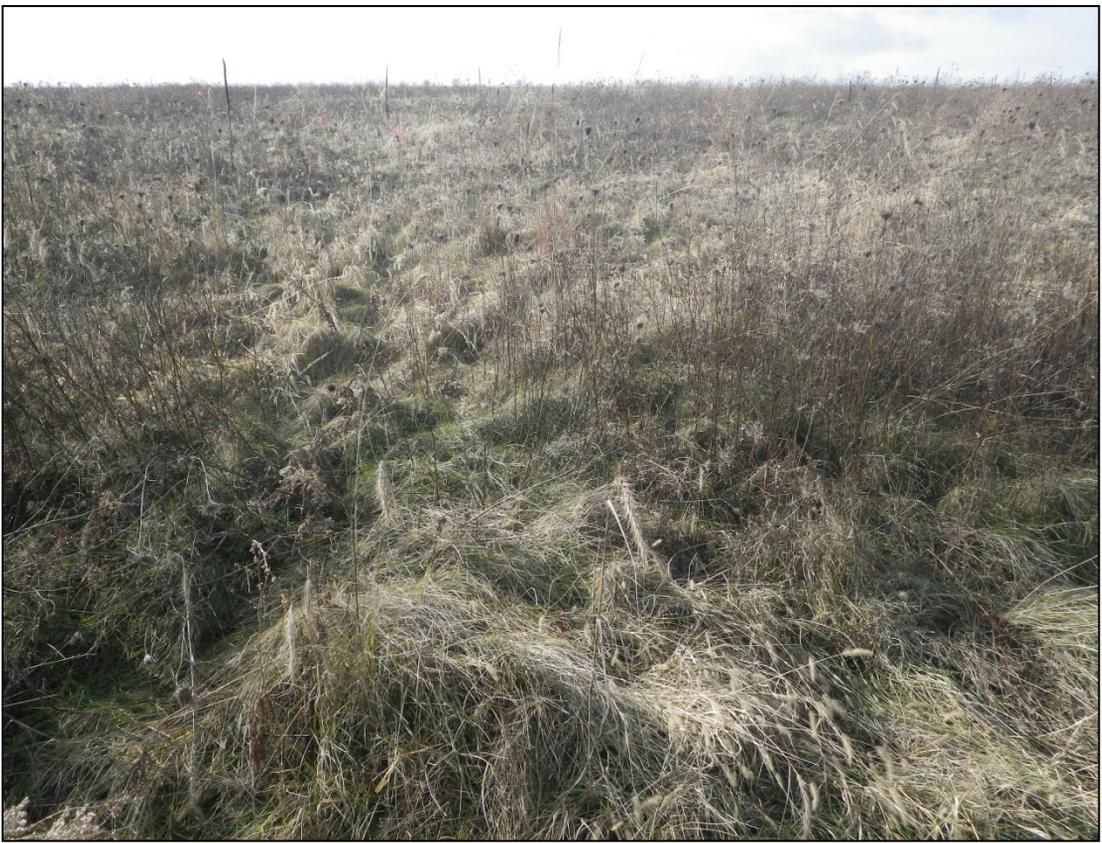
IMGP4423

**East Face Cell 2**

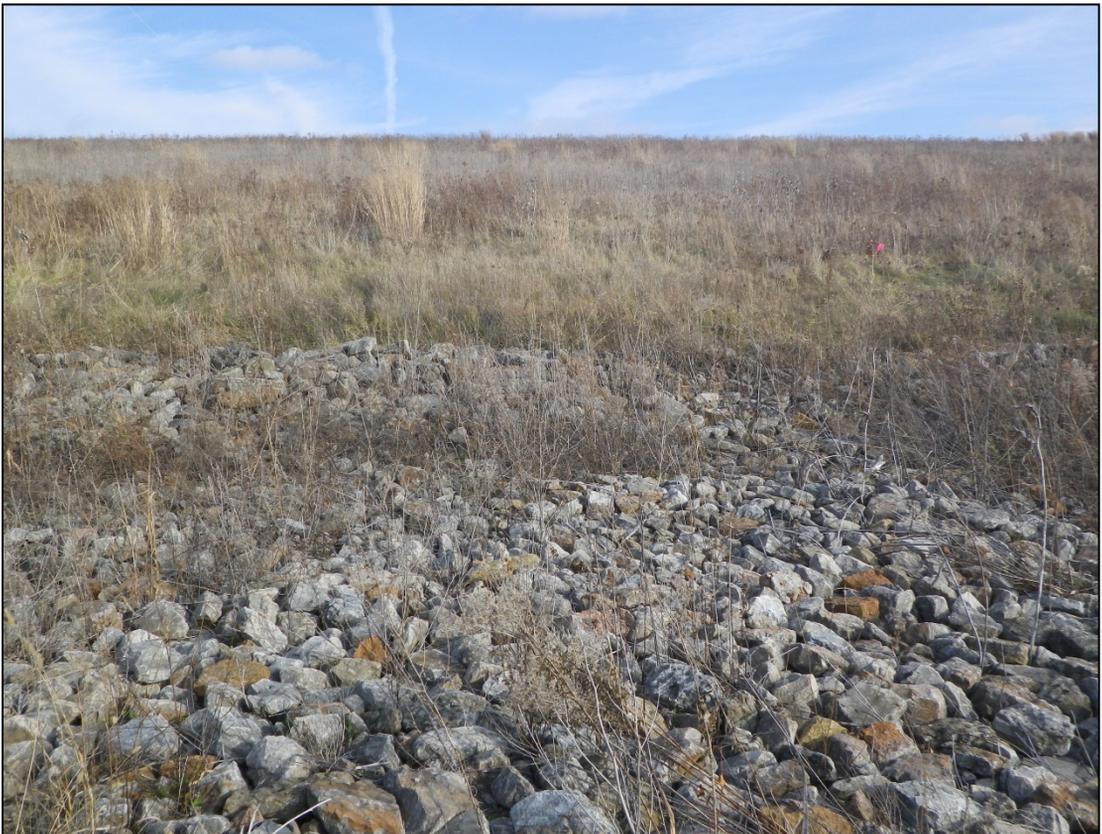
IMGP4431

**West Face Cell 2**

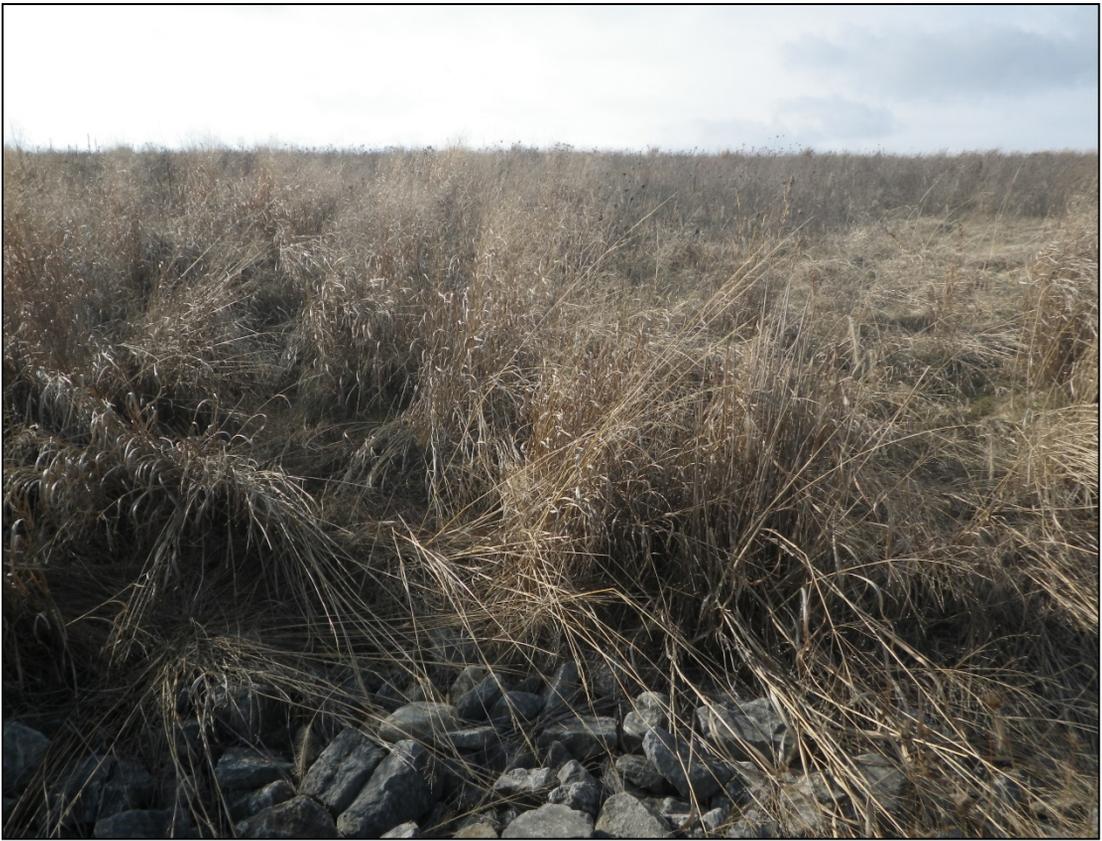
IMGP4422

**East Face Cell 3**

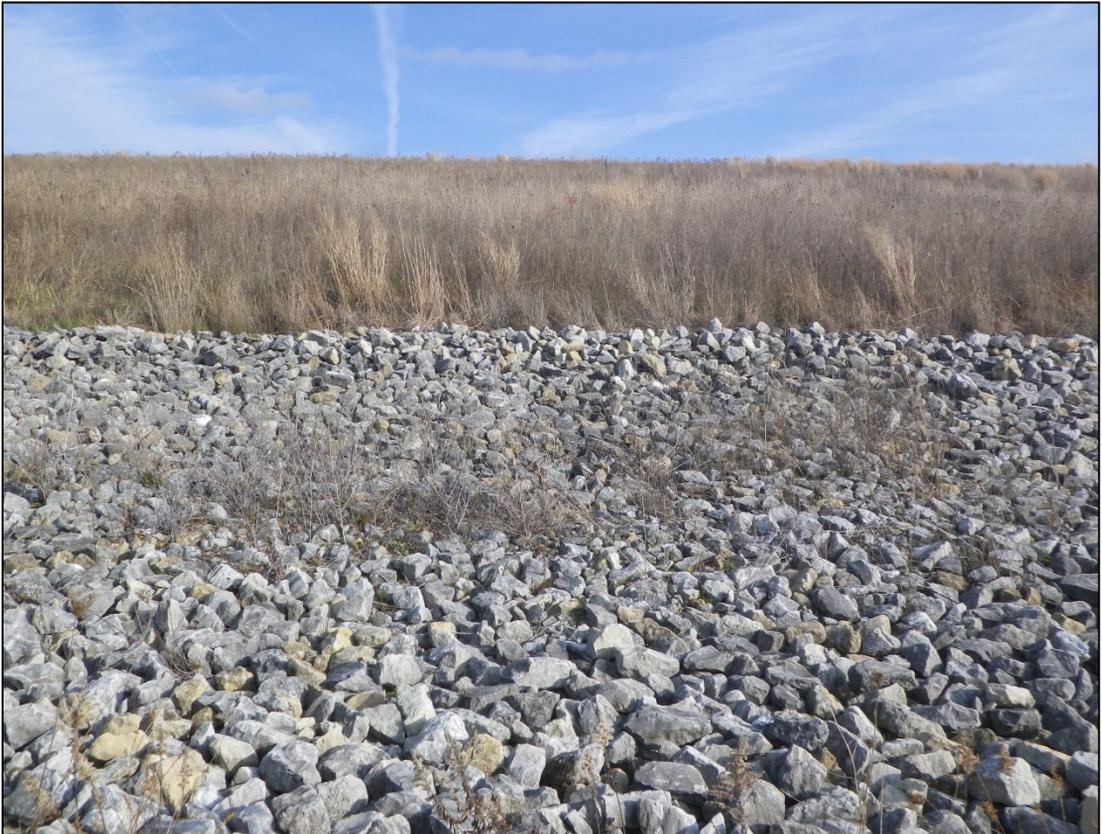
IMGP4432

**West Face Cell 3**

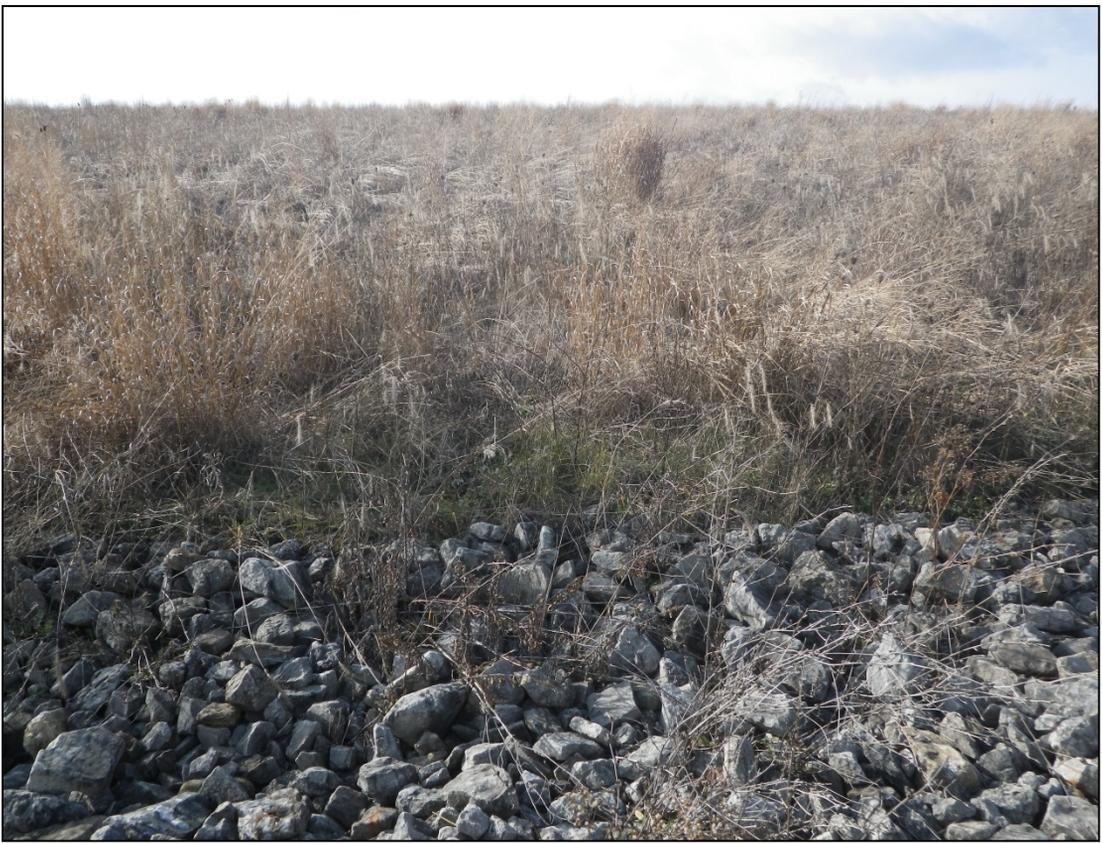
IMGP4420

**East Face Cell 4**

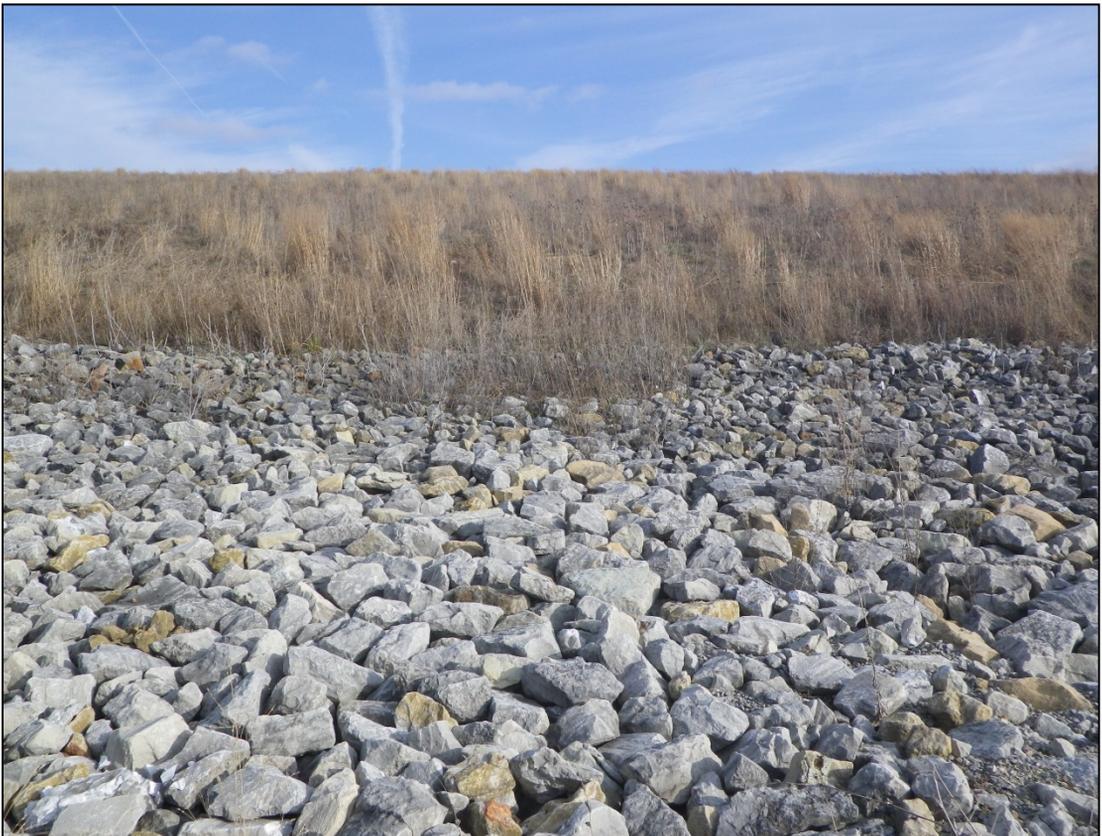
IMGP4434

**West Face Cell 4**

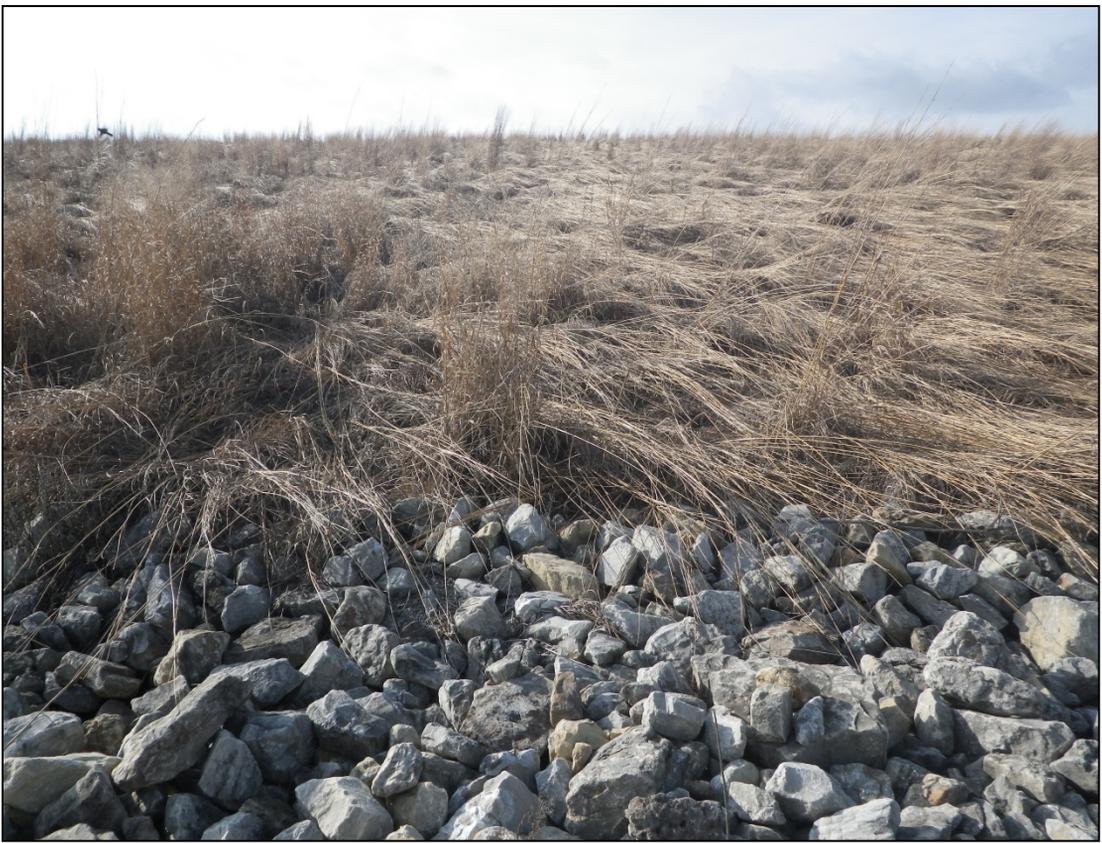
IMGP4419

**East Face Cell 5**

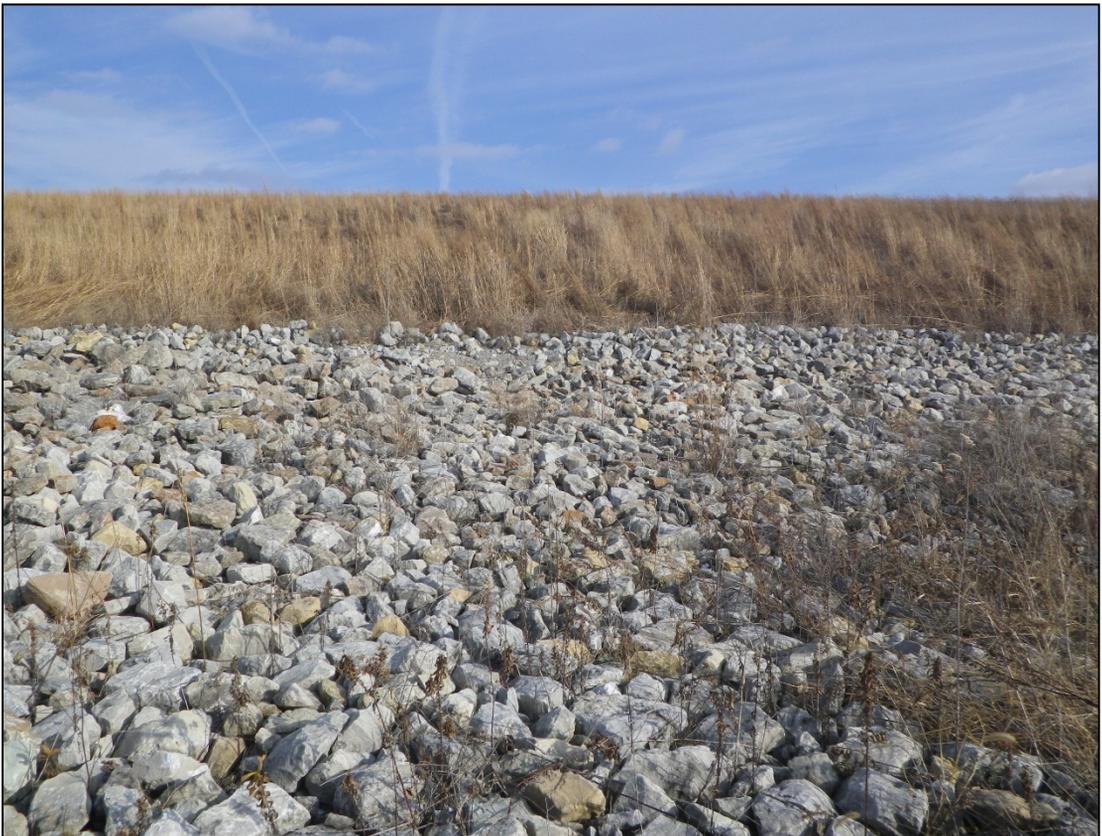
IMGP4435

**West Face Cell 5**

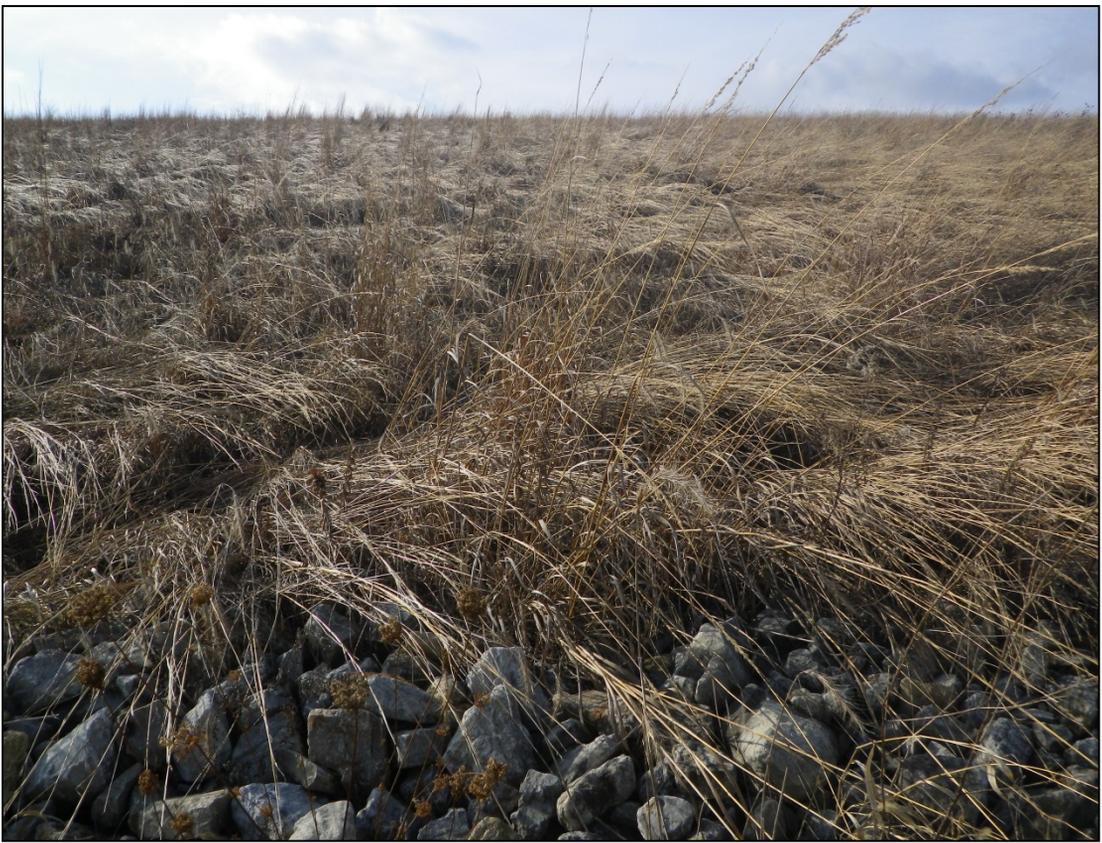
IMGP4418

**East Face Cell 6**

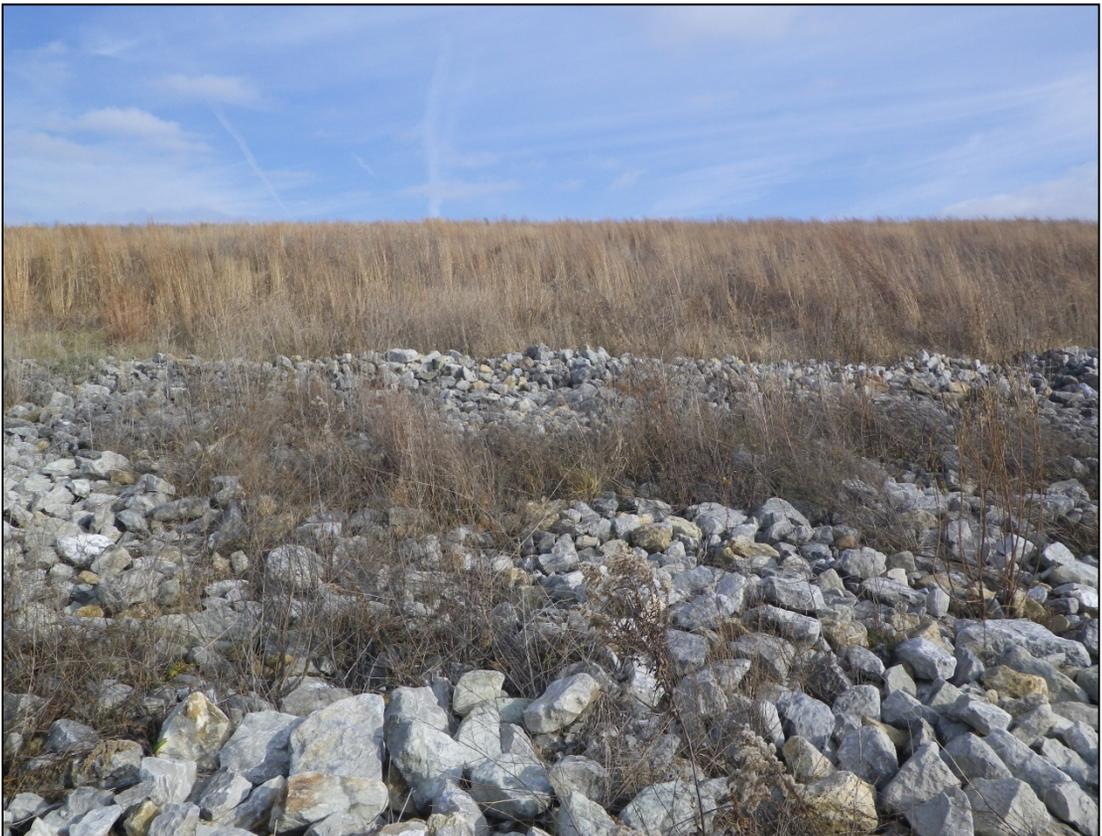
IMGP4436

**West Face Cell 6**

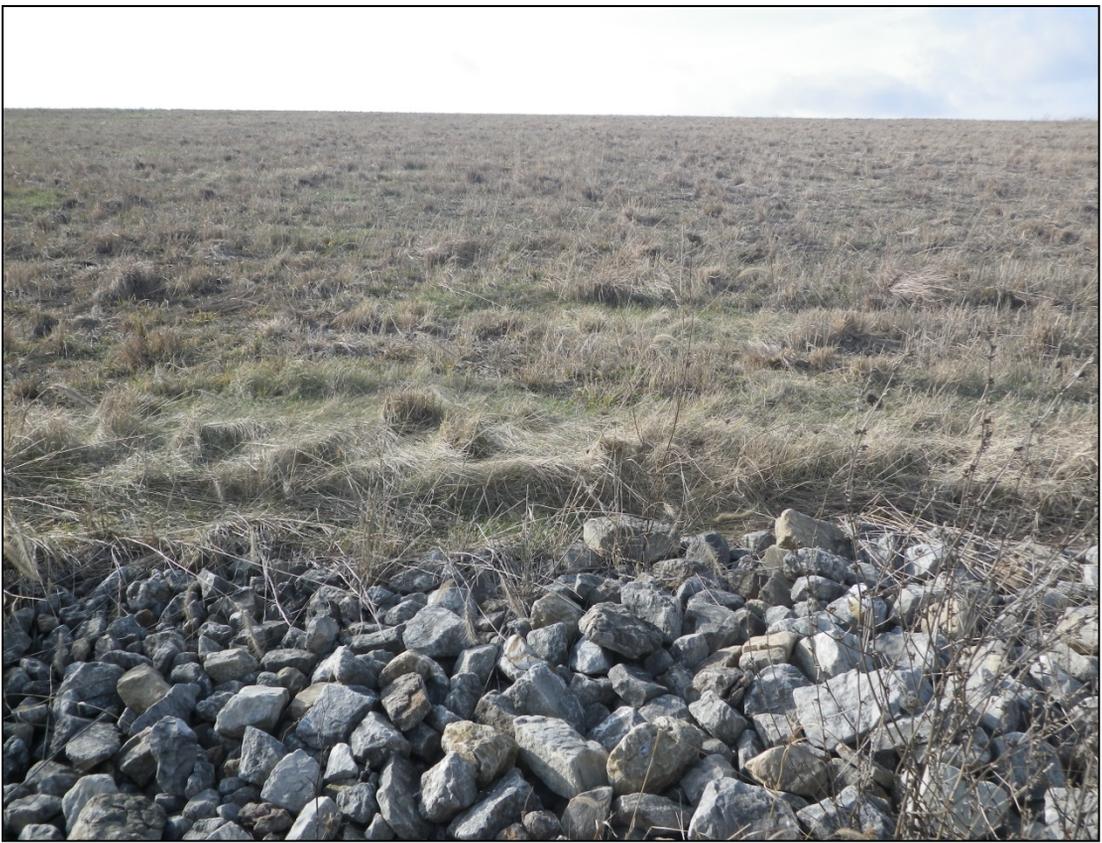
IMGP4416

**East Face Cell 7**

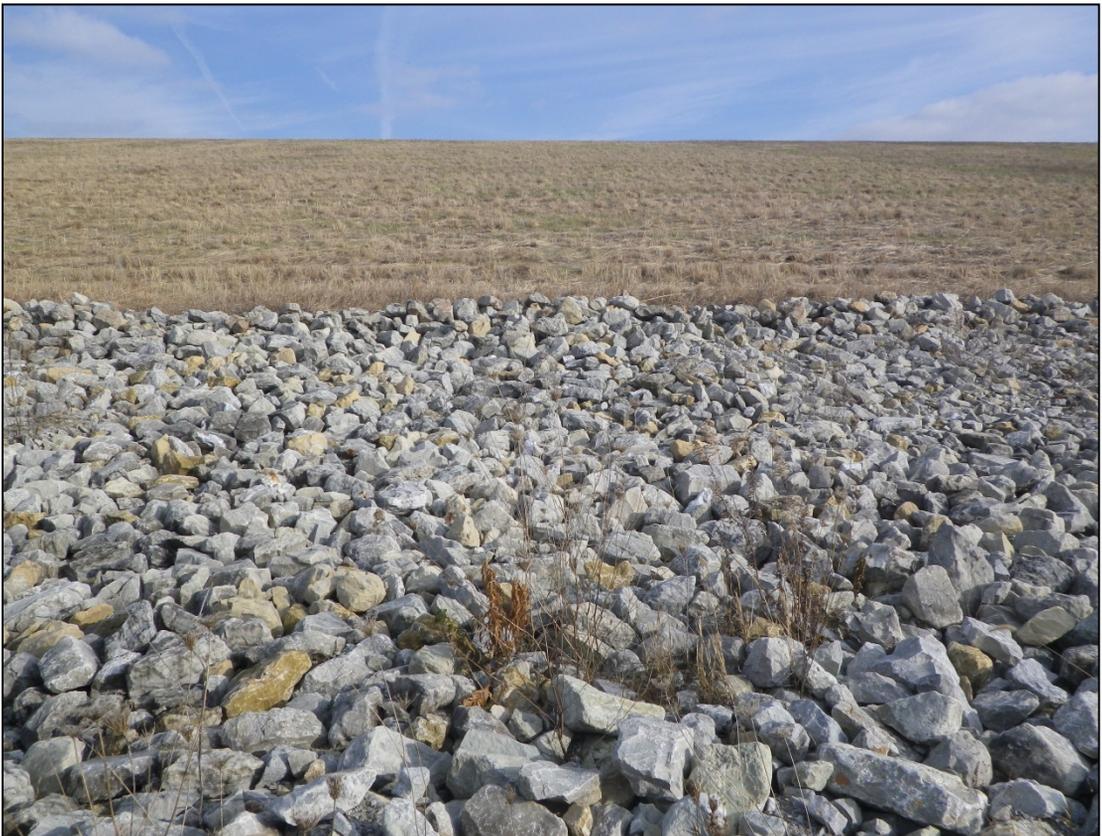
IMGP4437

**West Face Cell 7**

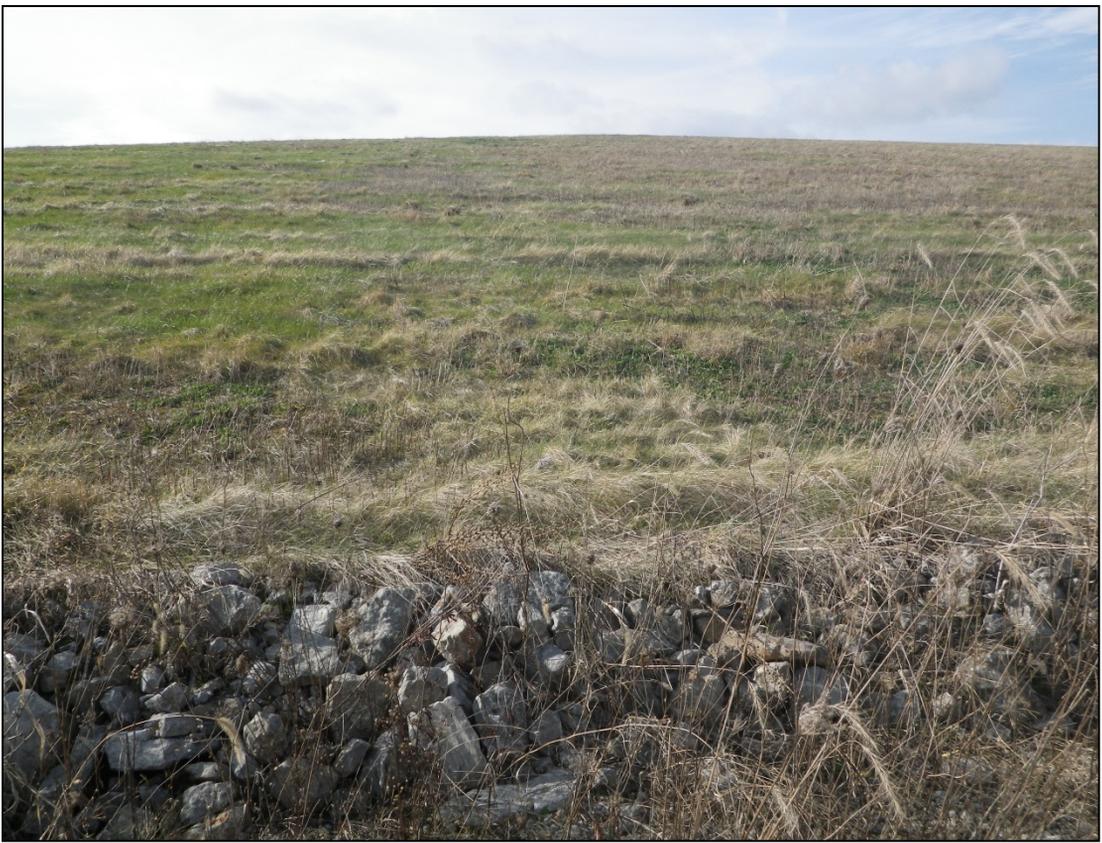
IMGP4415

**East Face Cell 8**
