Task Assignment 101  
Control Number 15-0232

SUBJECT: Contract No. DE-LM0000415, The S.M. Stoller Corporation, a wholly owned subsidiary of Huntington Ingalls Industries (Stoller)  
Task Assignment 101 LTS&M - CERCLA/RCRA and Others  
Transmittal of Contract Deliverable: Submit Q1 site inspection letter, Submit Q1 OSDF inspection report  
Activity Code INS-1205, OSDF-1405—Completed: December 22, 2014

# **FERNALD PRESERVE**

# **Inspection Report**

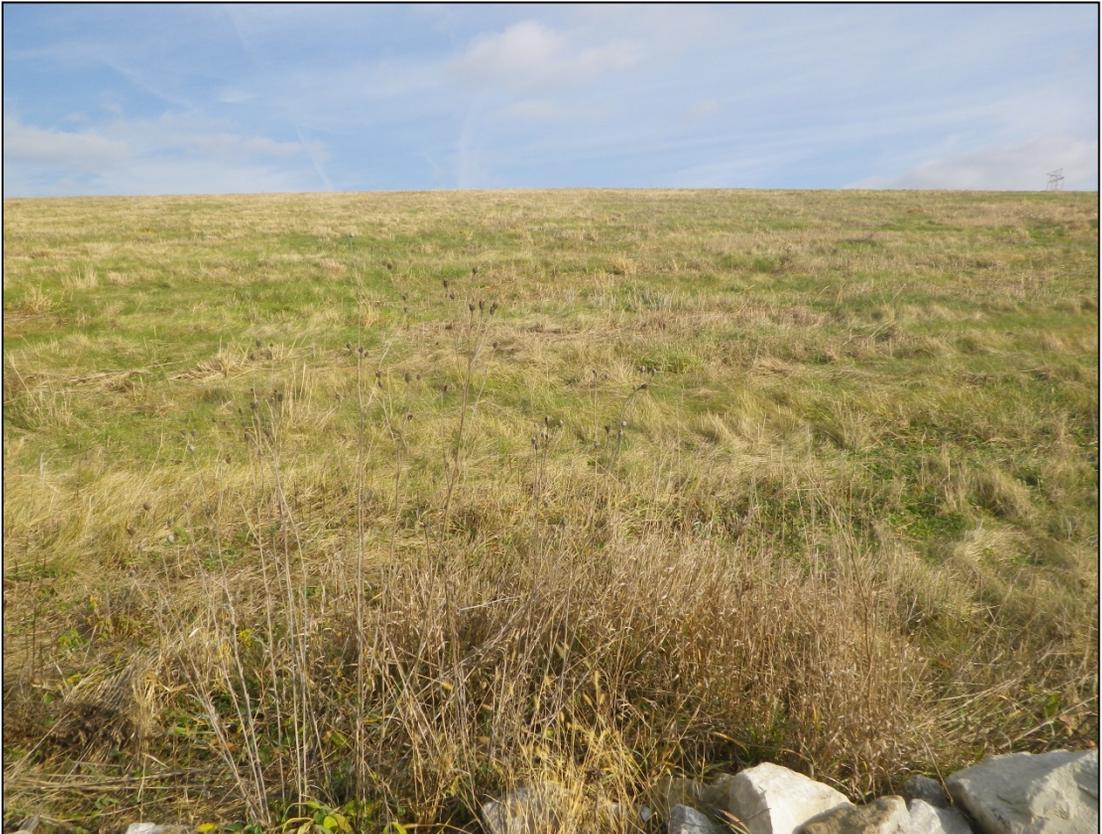
IMGP4439

**West Face Cell 8**

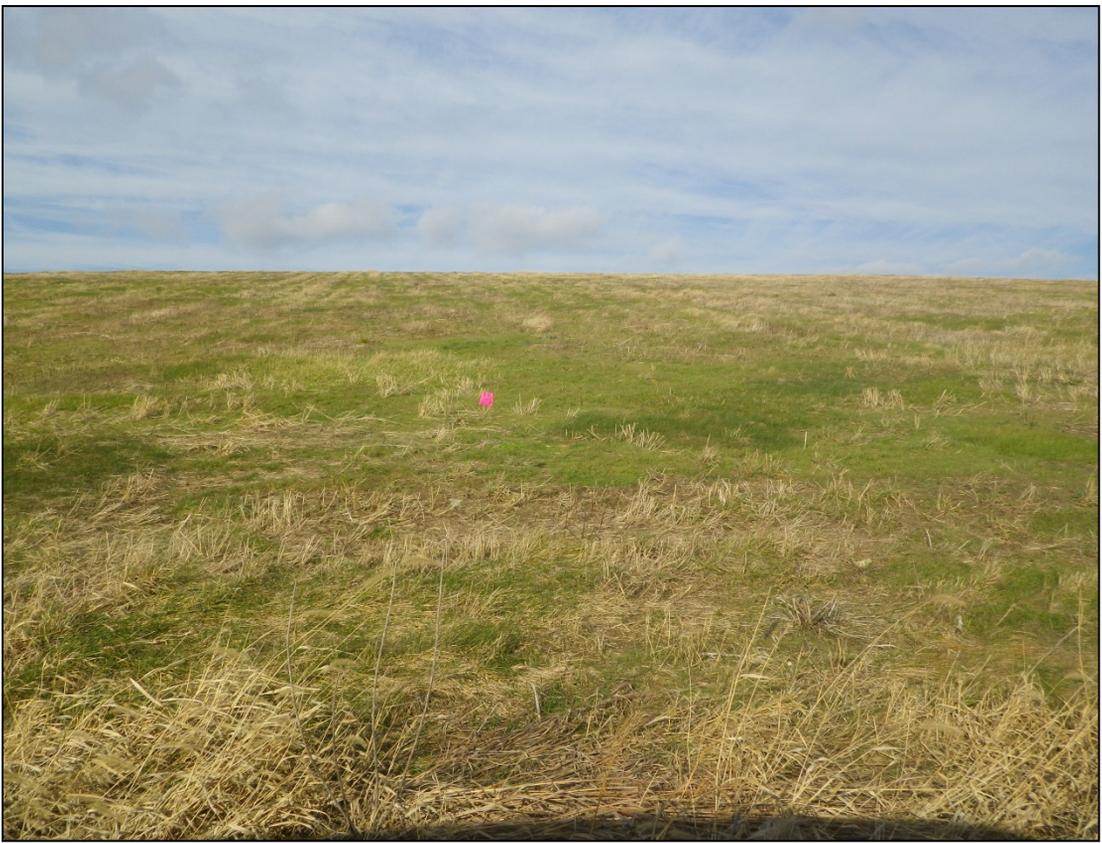
IMGP4413

## South Face Cell 8

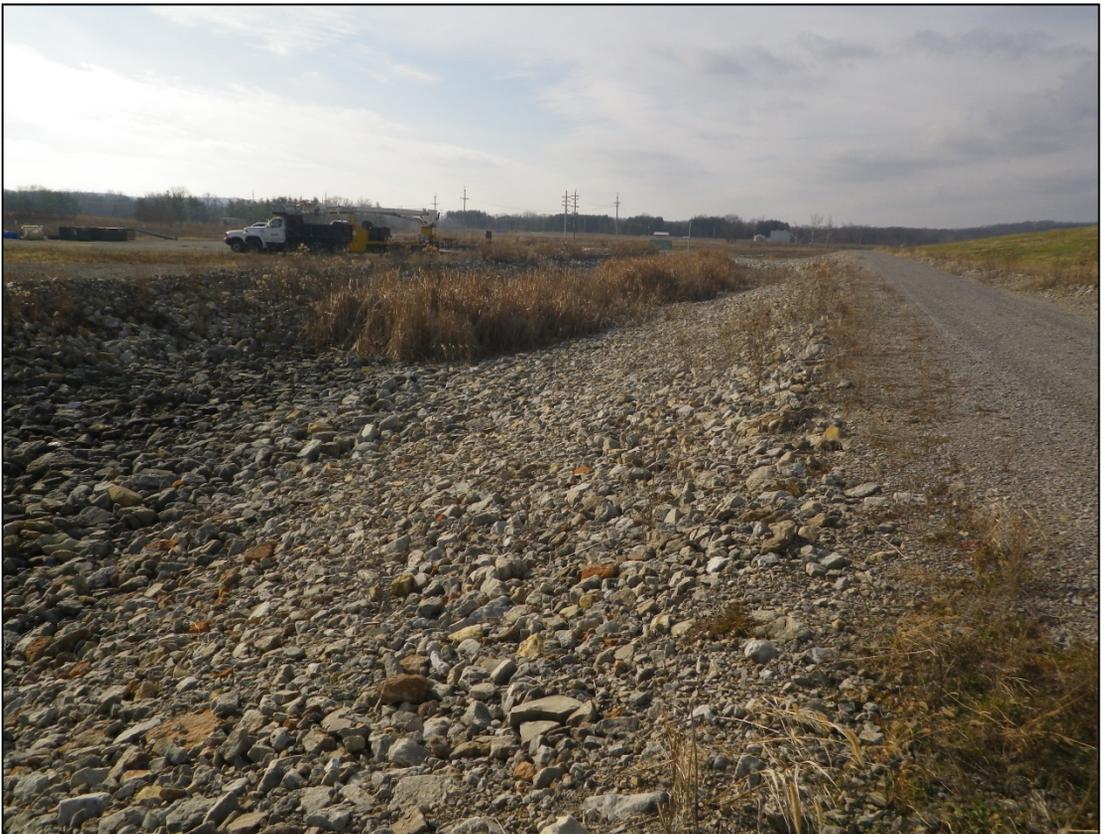
IMGP4414

## South Drainage (looking west)

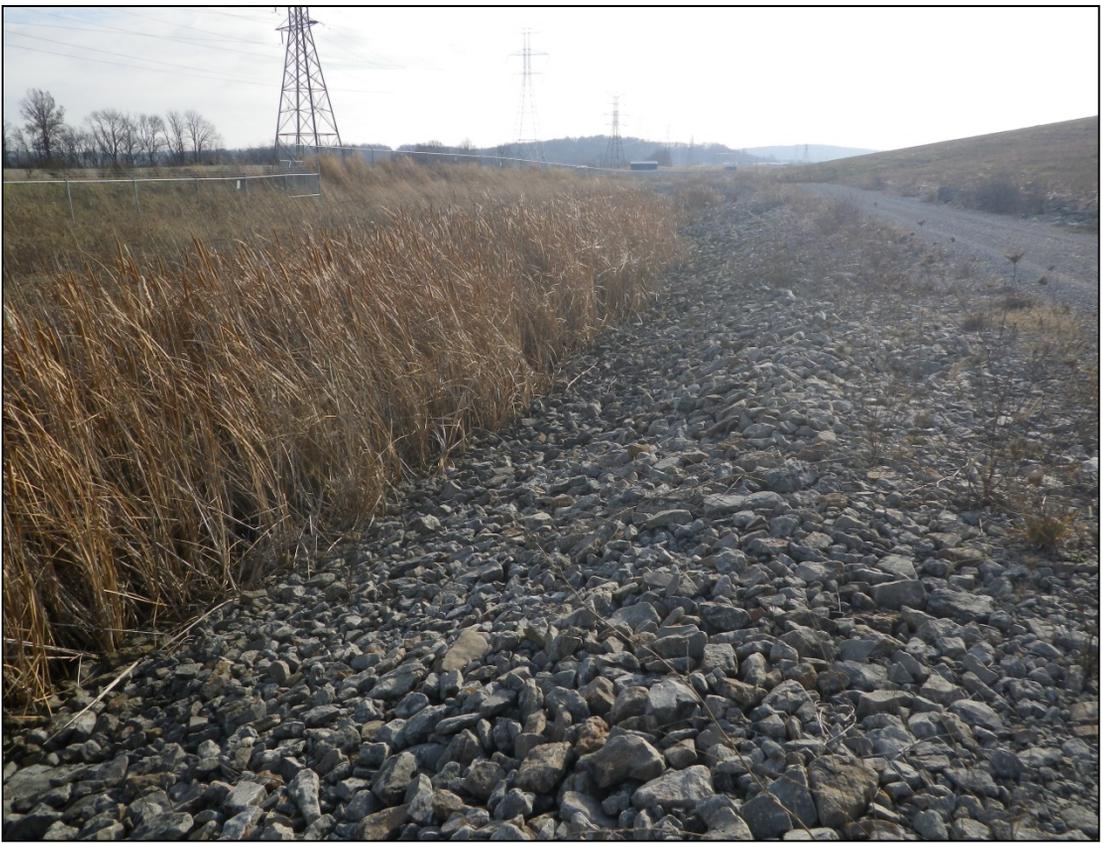
IMGP4417

**East Drainage Cell 7 (looking south)**

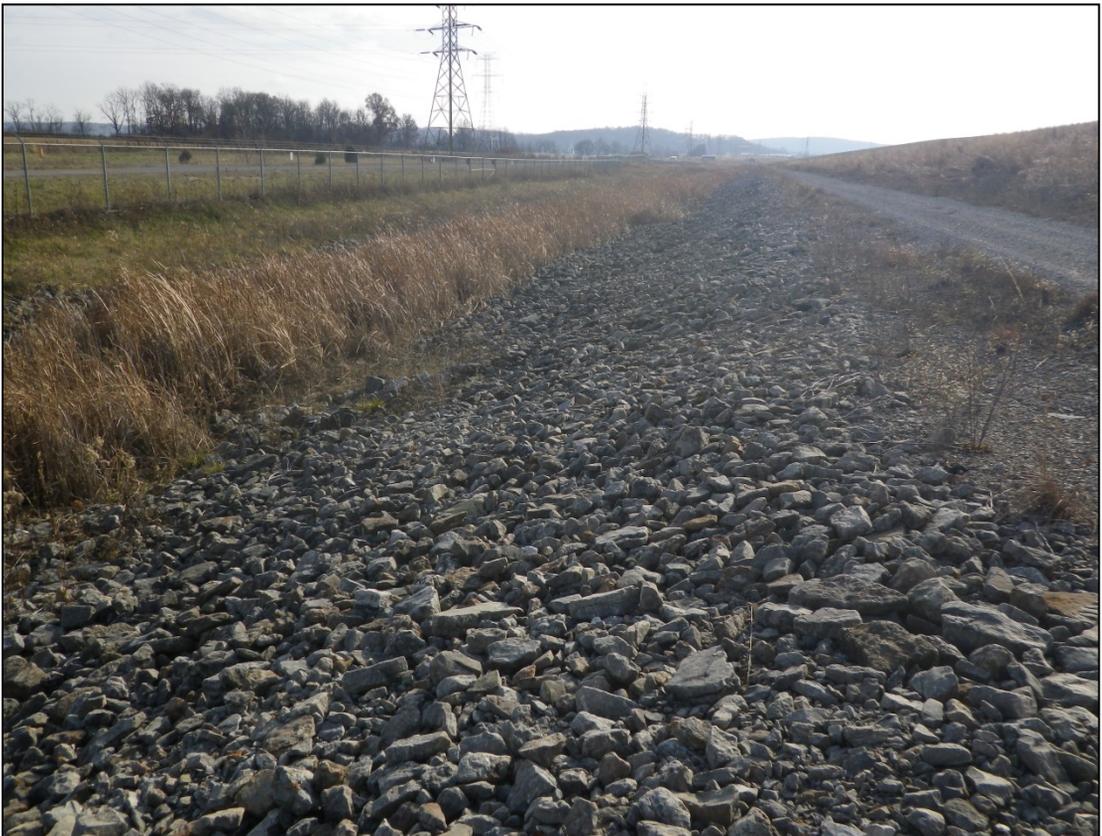
IMGP4421

**East Drainage Cell 4 (looking south)**

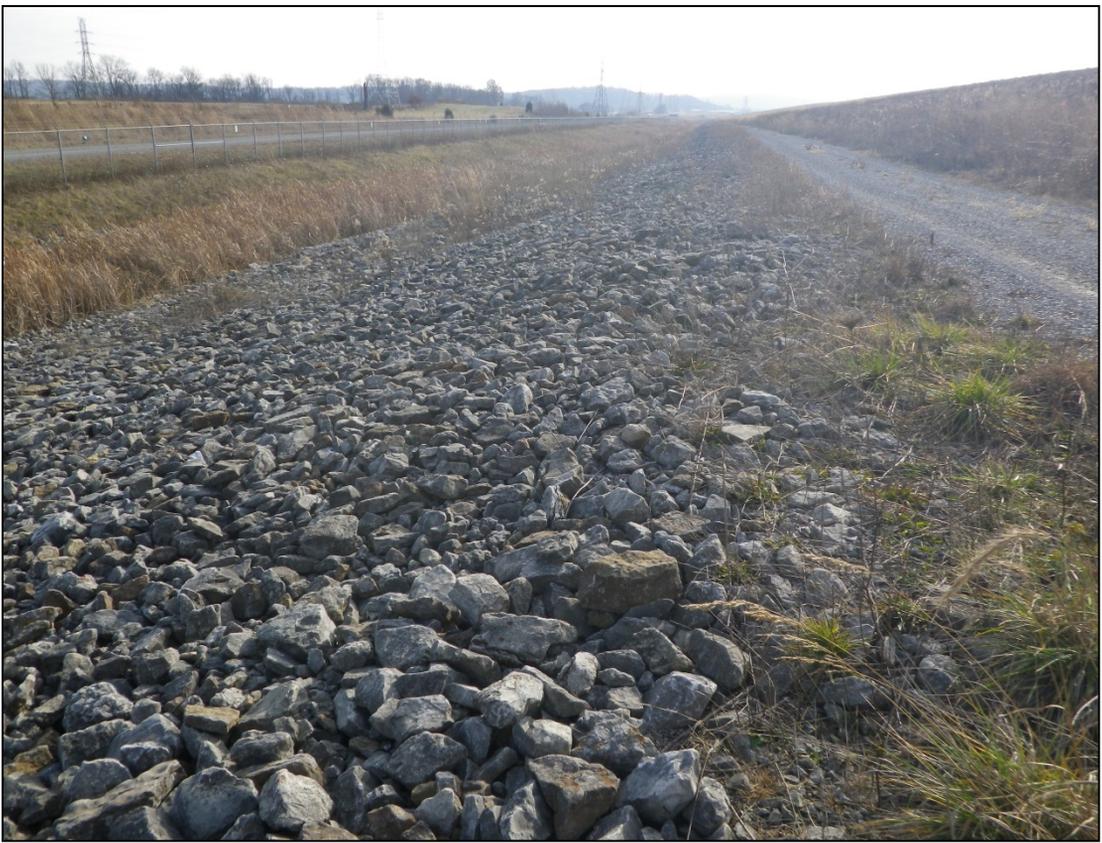
IMG4425

**East Drainage Cell 1 (looking south)**

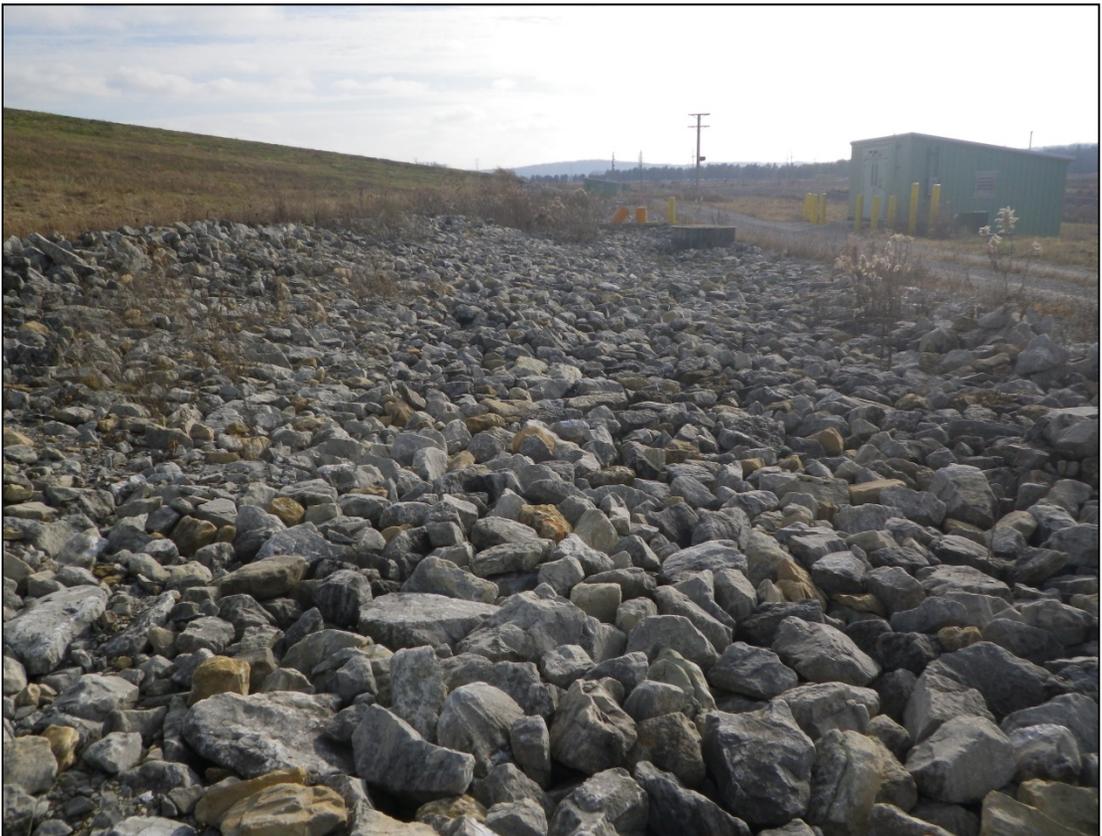
IMG4438

**West Inner Drainage Cell 7 (looking south)**

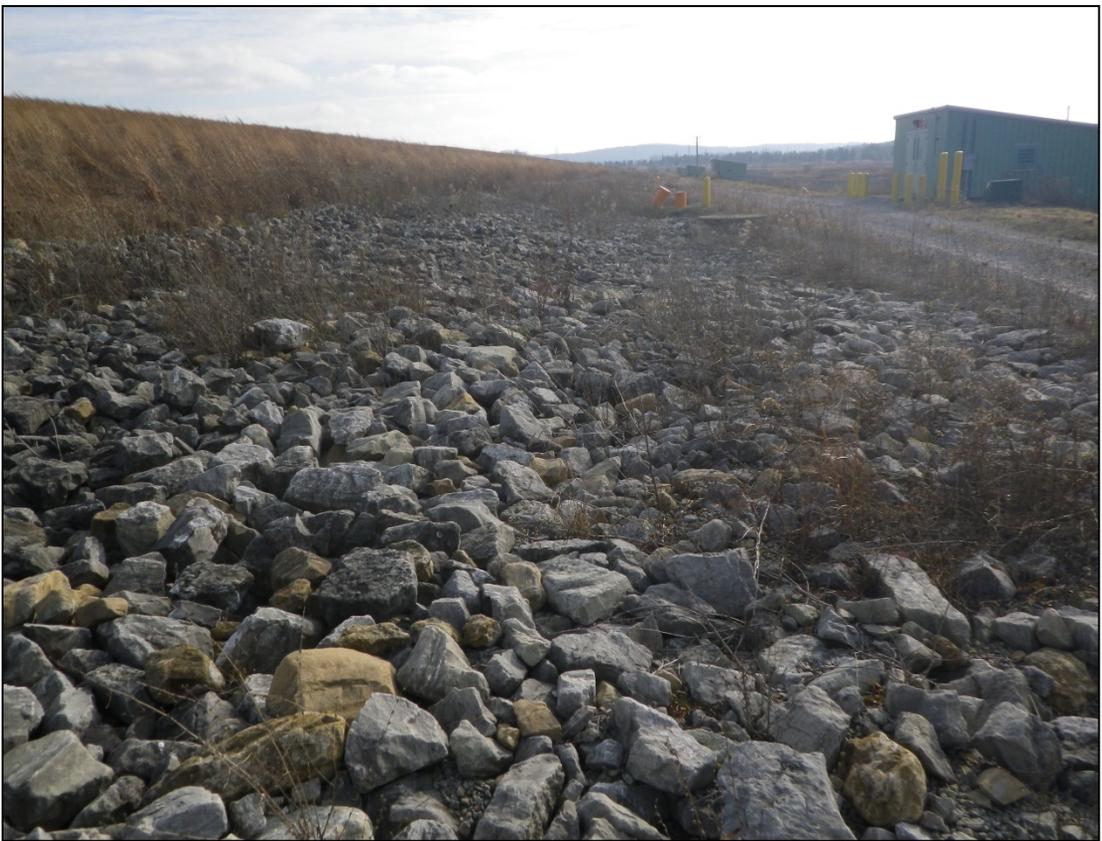
IMGP4434

**West Inner Drainage Cell 4 (looking south)**

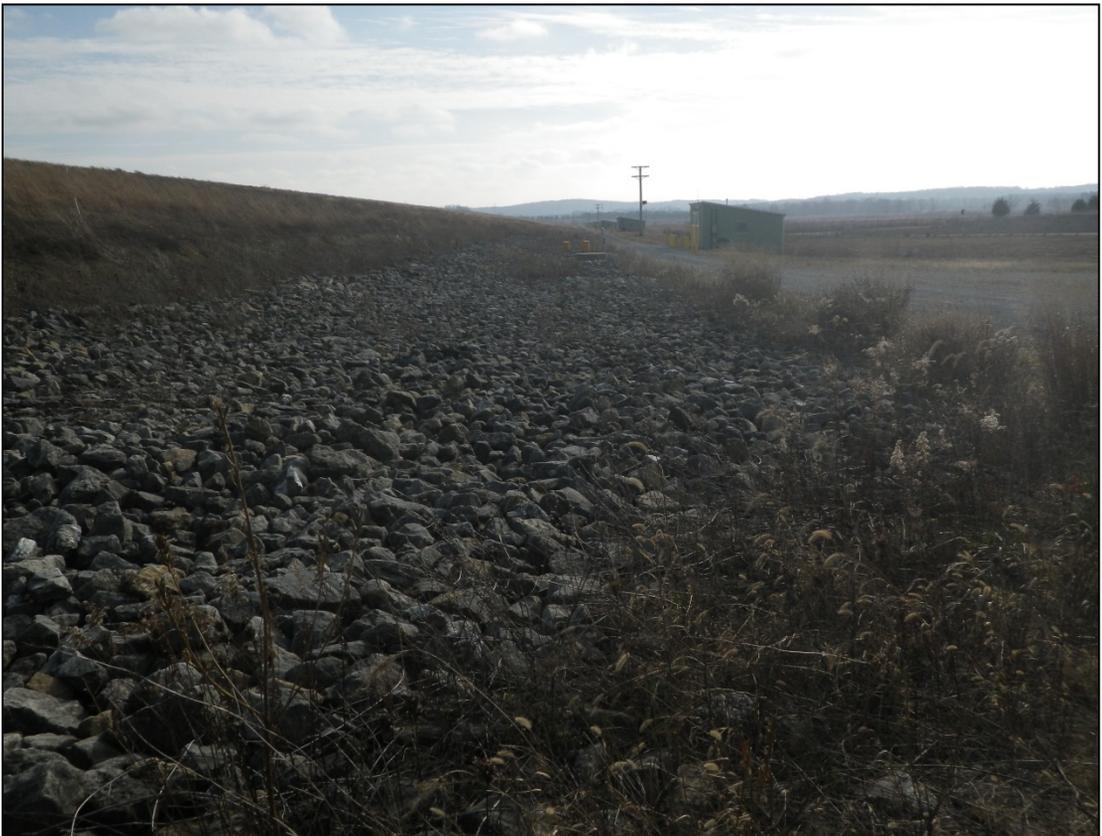
IMGP4428

**West Inner Drainage Cell 1 (looking south)**

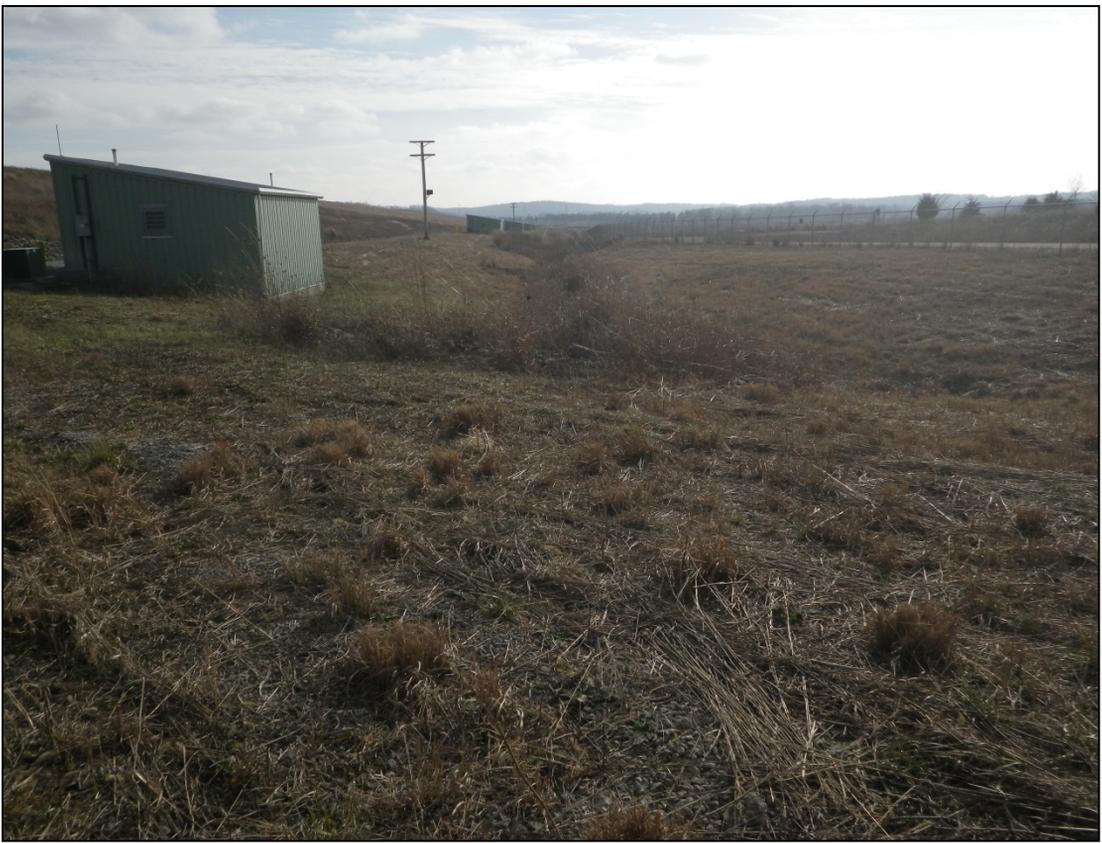
IMGP4429

**West Outer Drainage Cell 1 (looking south)**

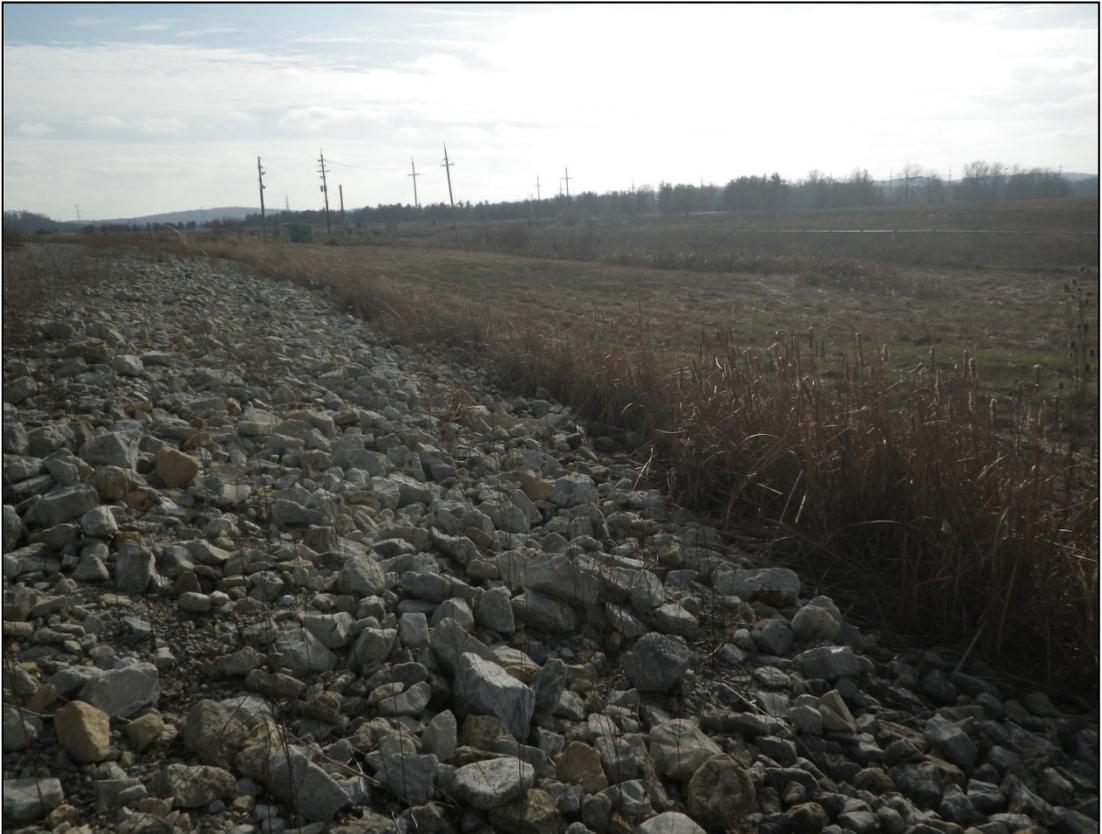
IMGP4440

**West Outer Drainage Cell 8 (looking south)**

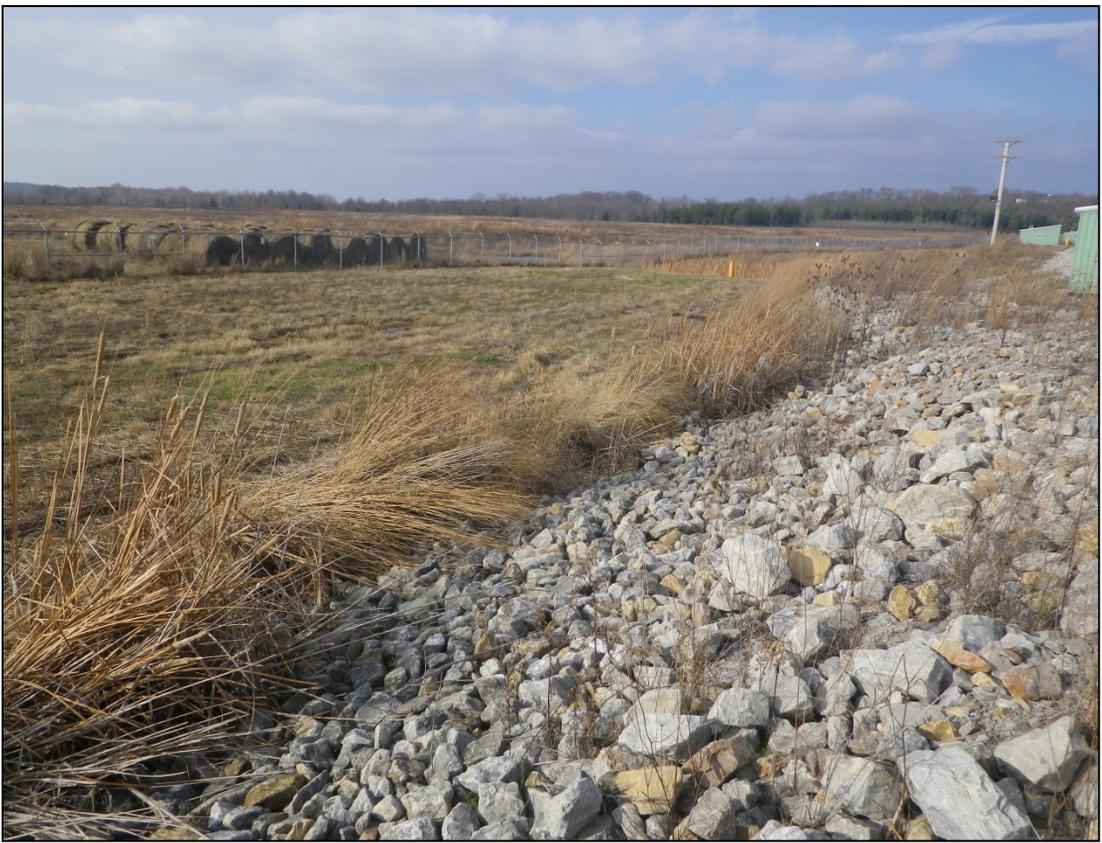
IMG4441

**West Outer Drainage Cell 8 (looking north)**
