Environmental Restoration Program

CHROMIUM TRENCH REMOVAL SITE EVALUATION OPERABLE UNIT 2

**MOUND PLANT
MIAMISBURG, OHIO**

May 1995

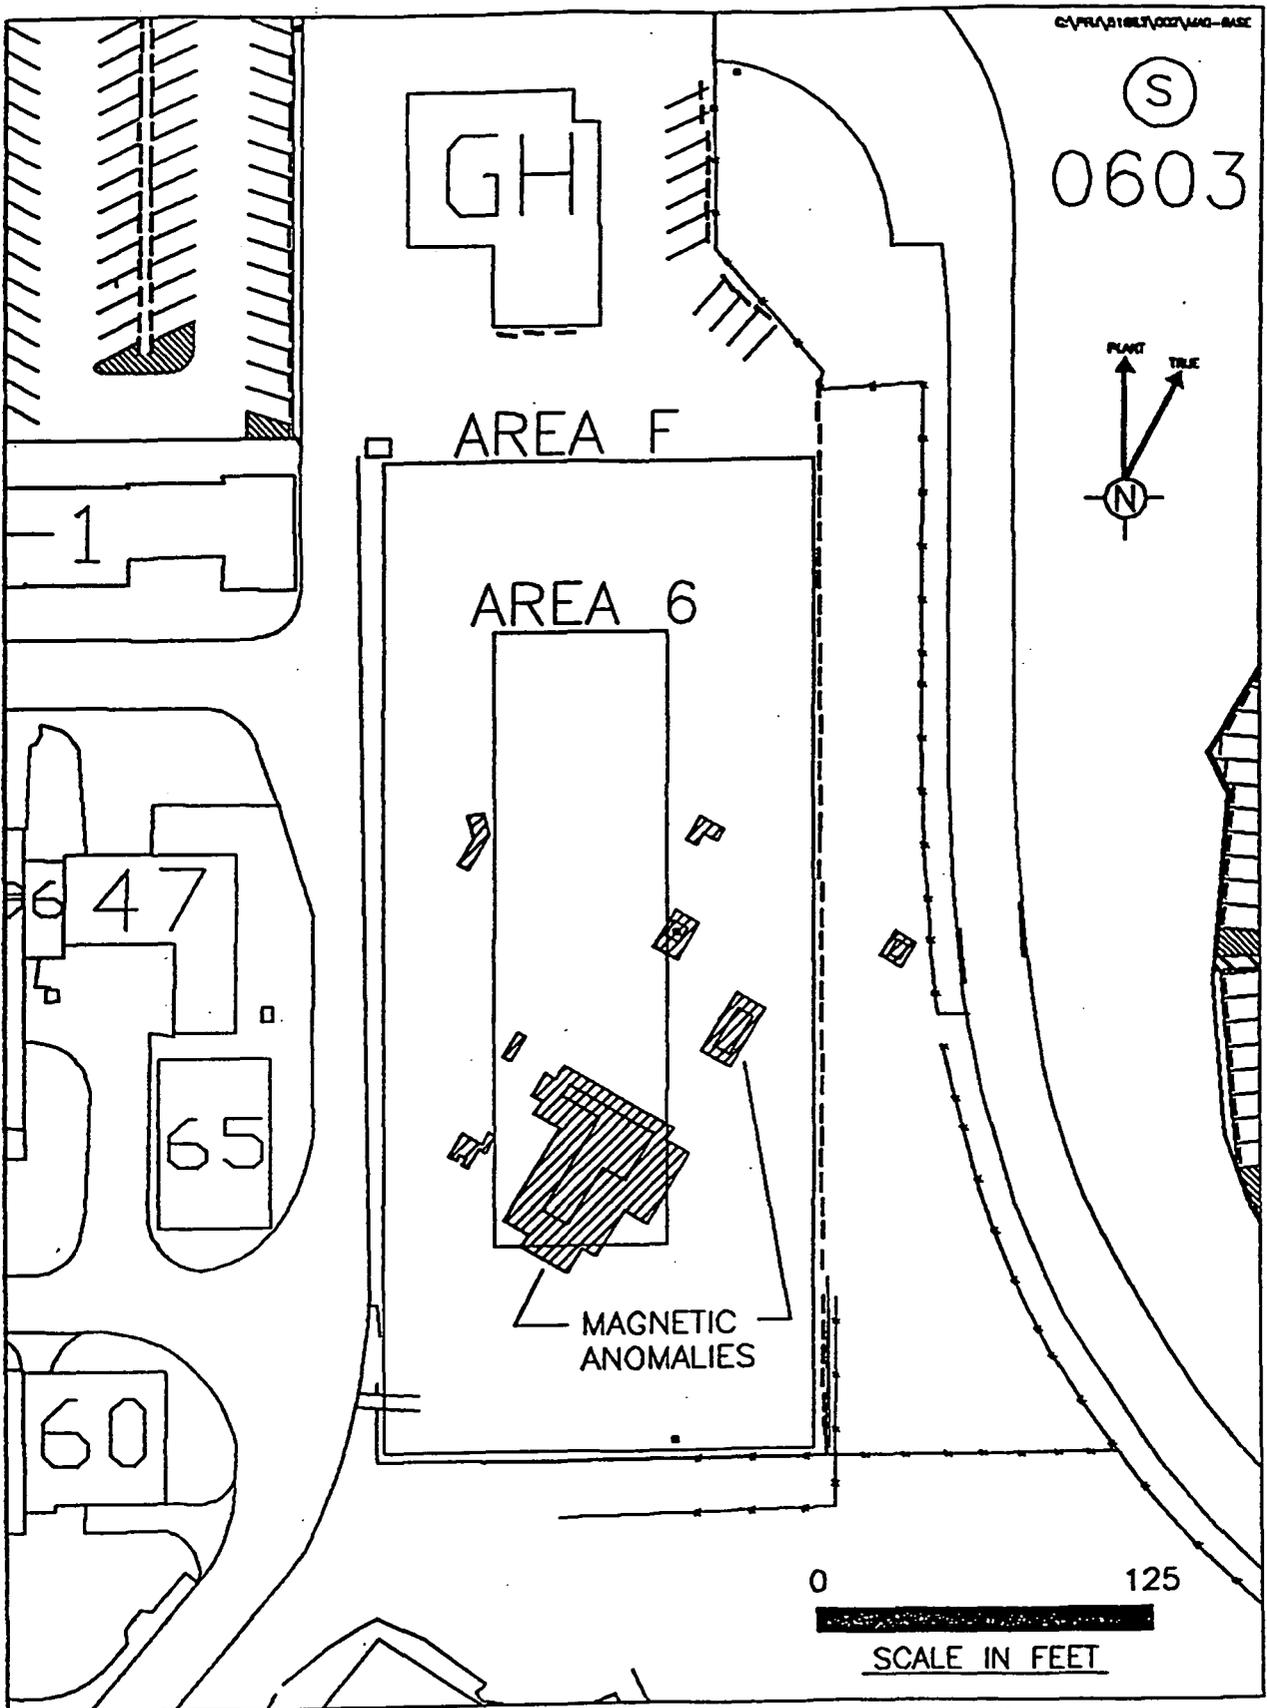
Figure 3.1. Interpretive Map of Magnetic Anomalies in Area 6

During a magnetic survey of Area 6, (DOE 1990) one large and seven smaller anomalies were detected in the area (Figure 3.1). The largest anomaly is believed to be the chromium trench, located in the south-central portion of Area 6. Magnetometer surveys detect ferromagnetic materials (such as steel and iron) which have magnetic susceptibilities that are several orders of magnitude higher than magnetic susceptibilities of common earth materials. Reportedly, only three crushed 55 gallon drums, a washing machine, and the possibility of two additional drums with chromium solution are buried in the trench. The size of the largest anomaly suggest that a greater amount of ferrous material was placed in the trench than reported. The other anomalies may represent small groupings of drums, construction debris, or other ferrous materials that may be contributing to the overall impact of the chromium trench on the environment (DOE 1990).

Current information fails to accurately pinpoint the exact location of the trench. Information gathered during a magnetic survey of Area 6 (chromium trench) located one large anomaly approximately 40x70 feet and seven other anomalies of smaller proportions in the area. Based on the reported size of the trench, the large anomaly may be the chromium trench. The magnetic survey suggest a much larger magnetic source in the chromium trench than would be expected from only the chromium plating solution, drums of contaminated sand, and a washing machine. In past investigations the chromium trench was reported to be covered with 30 feet of fill. Topographic maps indicate that there may be as little as 15 feet of fill covering the trench. The other magnetic anomalies in this area may vary in depth from a few feet to 30 feet under the present ground surface. At this time, the source of the smaller anomalies is unknown. It appears from their random locations in the subsurface area that they were disposed of at different times and depths during the construction of the GH Building parking lot.
