MOUND PLANT Potential Release Site Package PRS # 410

MOUND PLANT POTENTIAL RELEASE SITE PACKAGE

PRS 410

**MOUND PLANT
PRS 410
Soil Contamination - Fuel Oil**

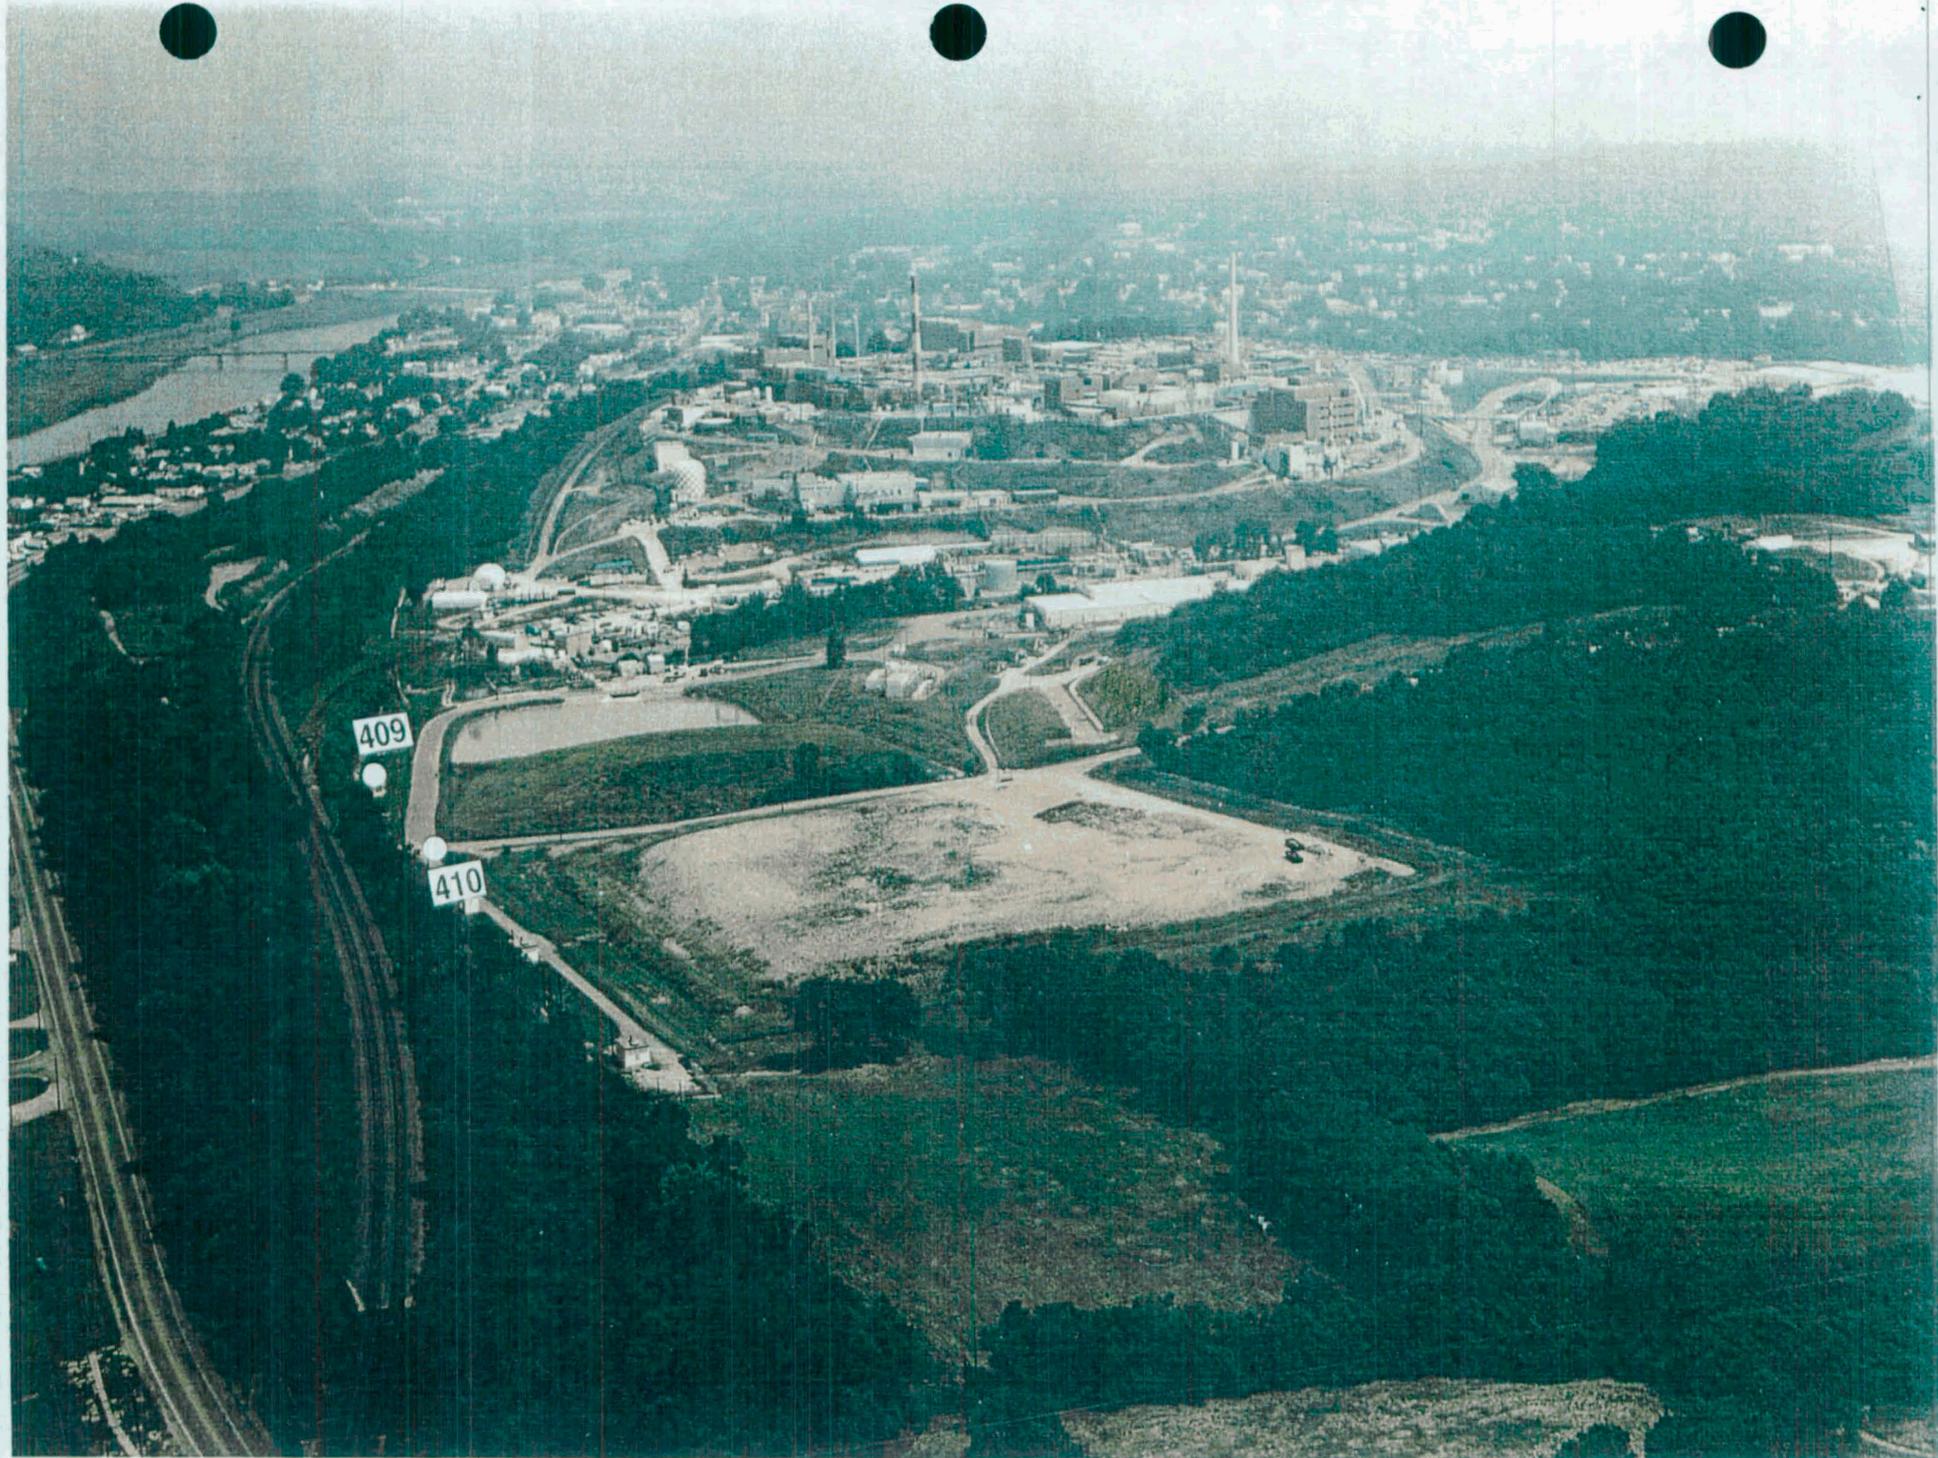
PRS 410 is a gravel/soils area located in the vicinity of the road which runs east to west between the OU1 landfill and the Spoils Area.^{1,3} The contamination was discovered when an aroma of diesel fuel was encountered during the removal and replacement of an underground drainage pipe from beneath the road.^{1,3} The road is scheduled to be asphalt paved to its original condition in the spring of 1997.² Currently (February, 1997), PRS 410 has been filled with clean gravel.²

During the work to remove and replace the drainage pipe an aroma resembling diesel fuel was encountered at approximately an eight inch depth in a graveled culvert. A FIDLER survey of the area detected no radioactive contamination.^{1,3}

During the excavation all visible signs of contamination were removed from the immediate area around the culvert. However, no effort was made to investigate contamination potential beyond the boundary of the drainage control project, and no verification sampling was performed in the area of visible staining that was removed. Based on odor and soil appearance the contamination extends beyond the original excavation.

The Core Team originally recommended Further Assessment for PRS 410. Subsequently, the cost of further investigation versus the cost of removing the potentially contaminated soils was evaluated. Cost estimates indicate that the cost of removal is not significantly greater than the cost of further assessment at PRS 310. Additionally Further Assessment findings may indicate the need for a Response (removal) Action, resulting in costs associated with both Further Assessment and Response Action. Therefore, the Core Team recommends a RESPONSE ACTION as a more cost-effective course of action for PRS 410.
