MOUND PLANT

Potential Release Site Package

PRS # 405

**MOUND PLANT
PRS 405
Soil Contamination – Building 23**

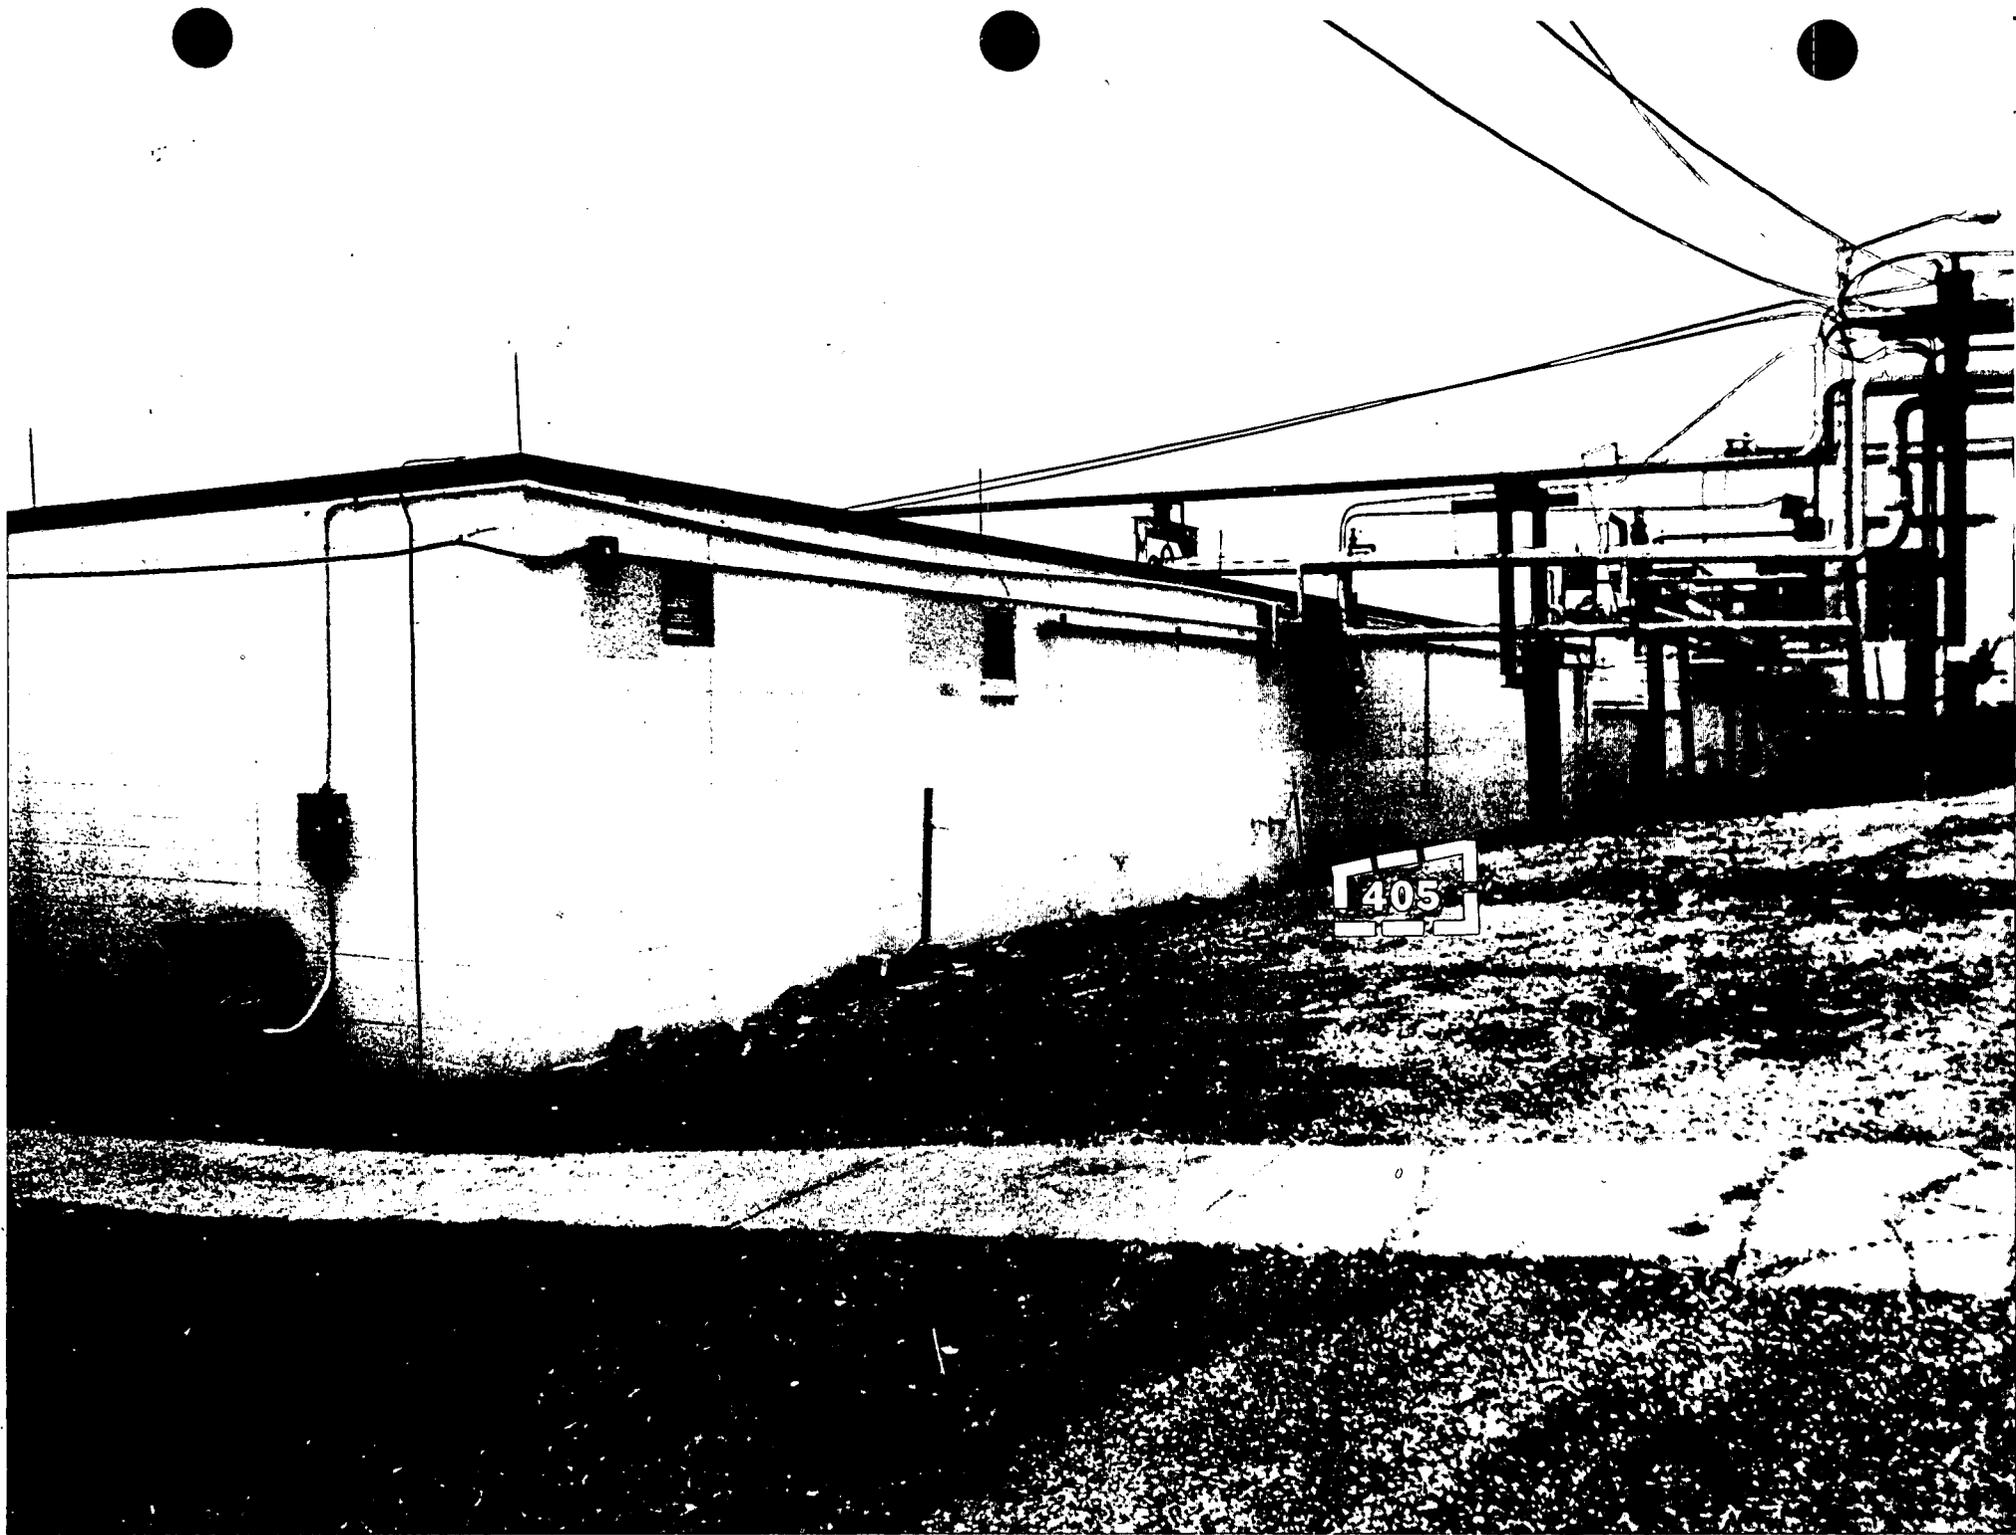
Potential Release Site (PRS) 405 is a soil area located approximately 5 feet north of Building 23 (Waste Management Facility) at the east end of that building. PRS 405 was identified during construction activities in June 1994.² The contaminant of concern during construction was an oily substance.

- No PCB contamination was detected.⁴
- The maximum radionuclide concentrations detected were Plutonium-238 at 110 pCi/g and Thorium-232 at 6.8 pCi/g.⁵ Pu-238 exceeded the Mound Plant ALARA of 25 pCi/g and Th-232 exceeds the regulatory limit of 5 pCi/g.

The Core Team originally recommended Further Assessment for PRS 405. Subsequently, the cost of further investigation versus the cost of removing the potentially contaminated soils was evaluated. Cost estimates indicate that the cost of removal is not significantly greater than the cost of further assessment at PRS 405. Additionally Further Assessment findings may indicate the need for a Response (removal) Action, resulting in costs associated with both Further Assessment and Response Action. Therefore, the Core Team recommends a RESPONSE ACTION as a more cost-effective course of action for PRS 405.

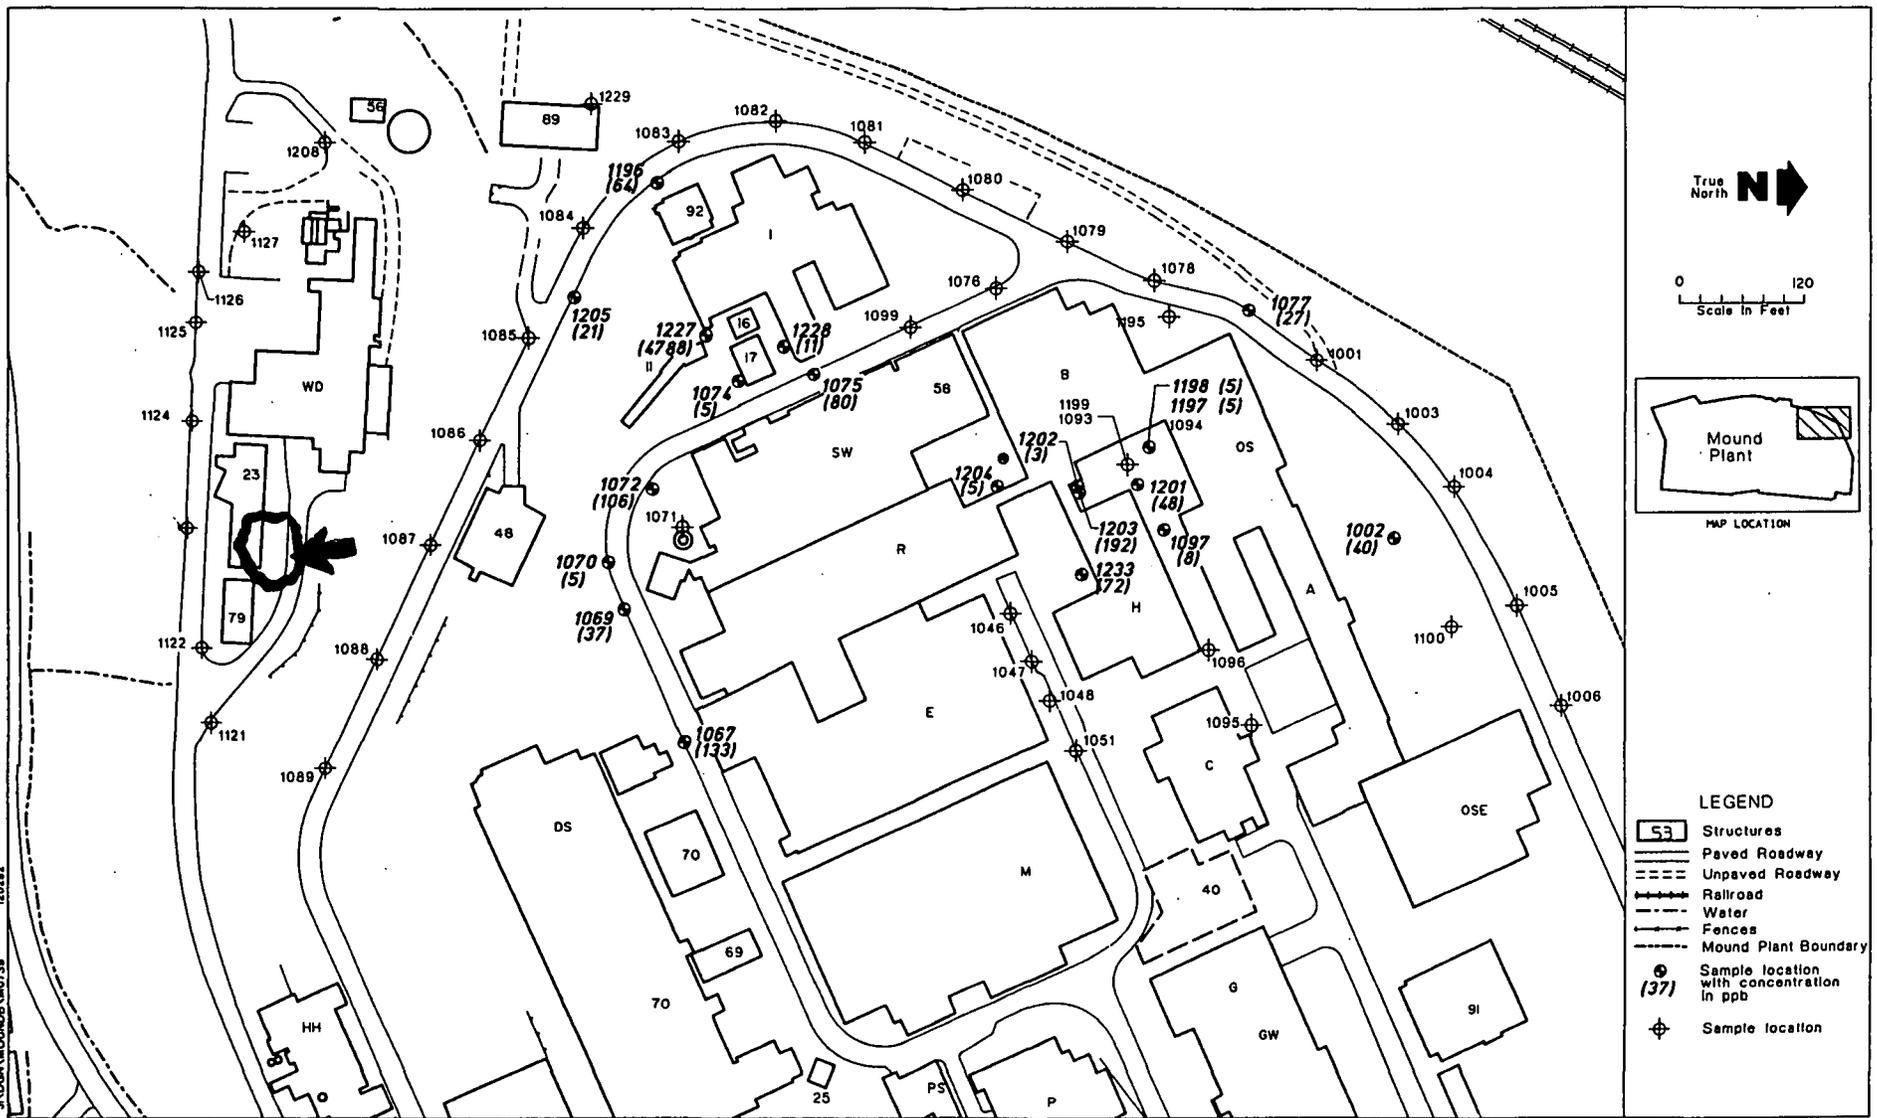
- Toluene was detected, but the ambient blank also contained toluene. The presence or absence of toluene could not be determined.

Figure 2.19. Toluene detection map for Main Hill West.
