Miamisburg Closure Project CLOSEOUT REPORT

Building 89 (Demolition)

Final
July 2003

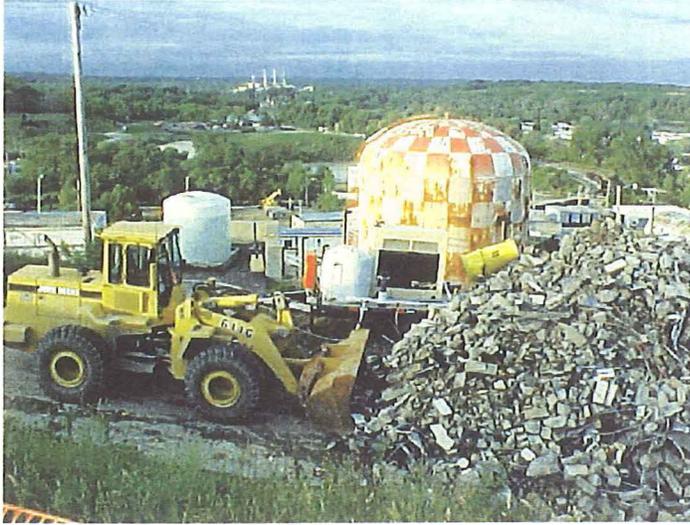
Bldg. 89 Debris Loadout

Initially some building debris was taken to the onsite concrete crusher, but after encountering a greater than expected volume of reinforcing bars in the concrete, the majority of the building debris was loaded into haulers and taken to a local sanitary landfill.
