Miamisburg Closure Project CLOSEOUT REPORT

Building 47

(Demolition)

Final
May 2004

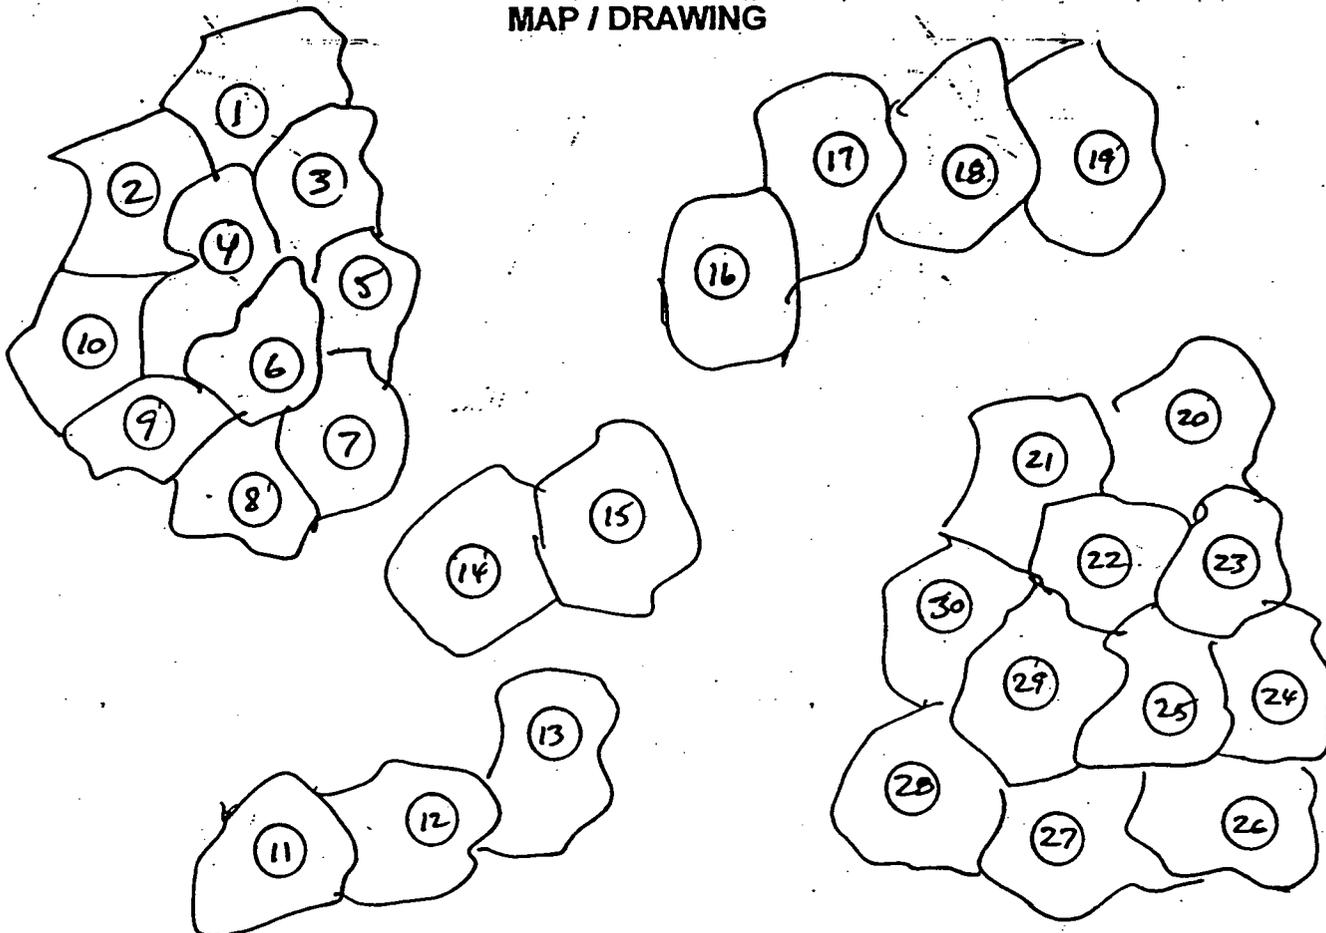
- NOTE: BICRON FIDLER USED FOR INDICATION ONLY. RESULTS WERE NON-DETECTABLE.
- INTEGRATED READING TAKEN IF AUDIBLE ALPHA DETECTED ALL RESULTS:
 $<100 \text{ dpm}/100\text{cm}^2$ ALPHA AND $<5\text{K dpm}/100\text{cm}^2$ BETA NO AUDIBLE DETECTED
