ER/WM-044/05
January 26, 2005

SUBJECT: Contract No. DE-AC24-03OH20152
Statement of Work Requirement 055 - Regulator Reports
GUARD POST 8, CLOSEOUT REPORT, FINAL

Miamisburg Closure Project
CLOSEOUT REPORT
Guard Post 8
(Demolition)
Final
January 2005

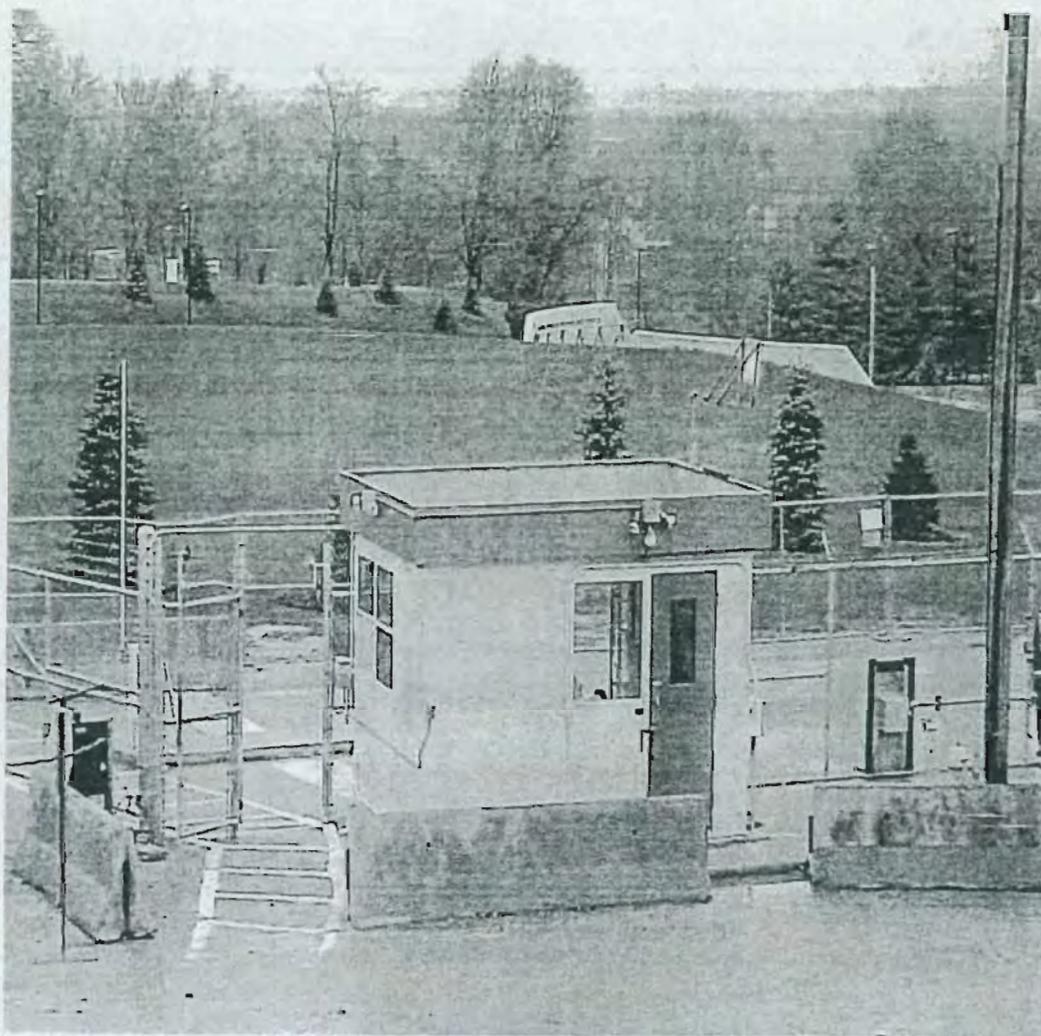
Guard Post 8 Prior to Demolition

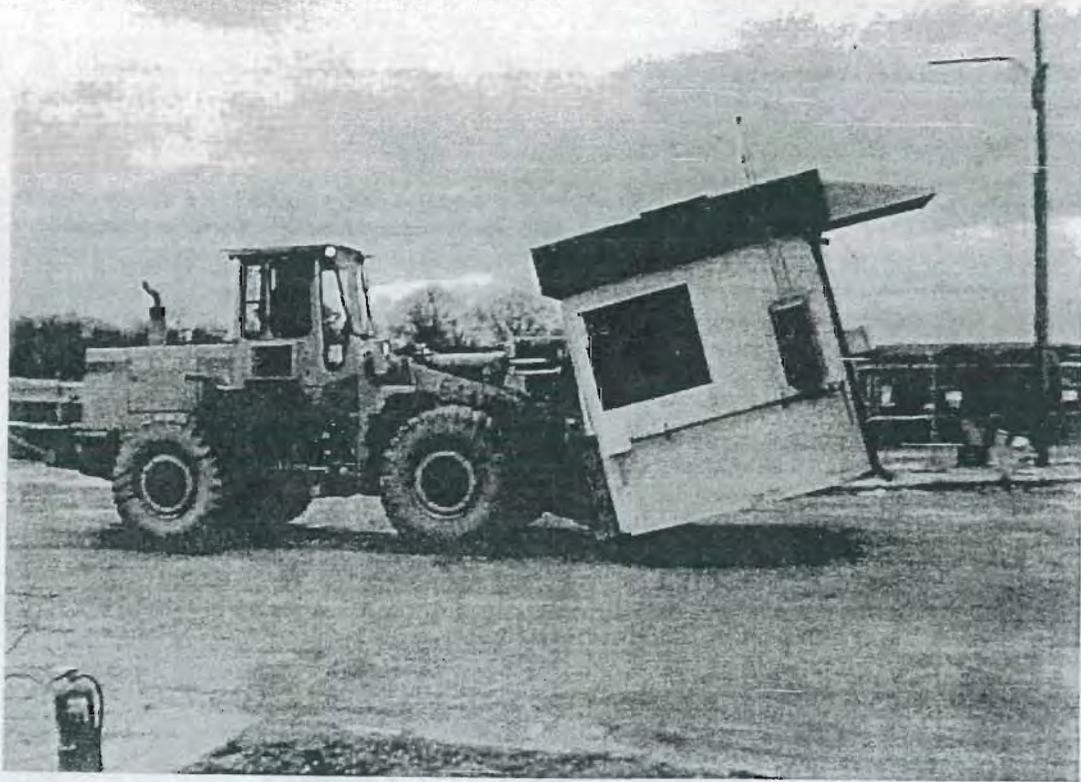
Guard Post 8 During Demolition

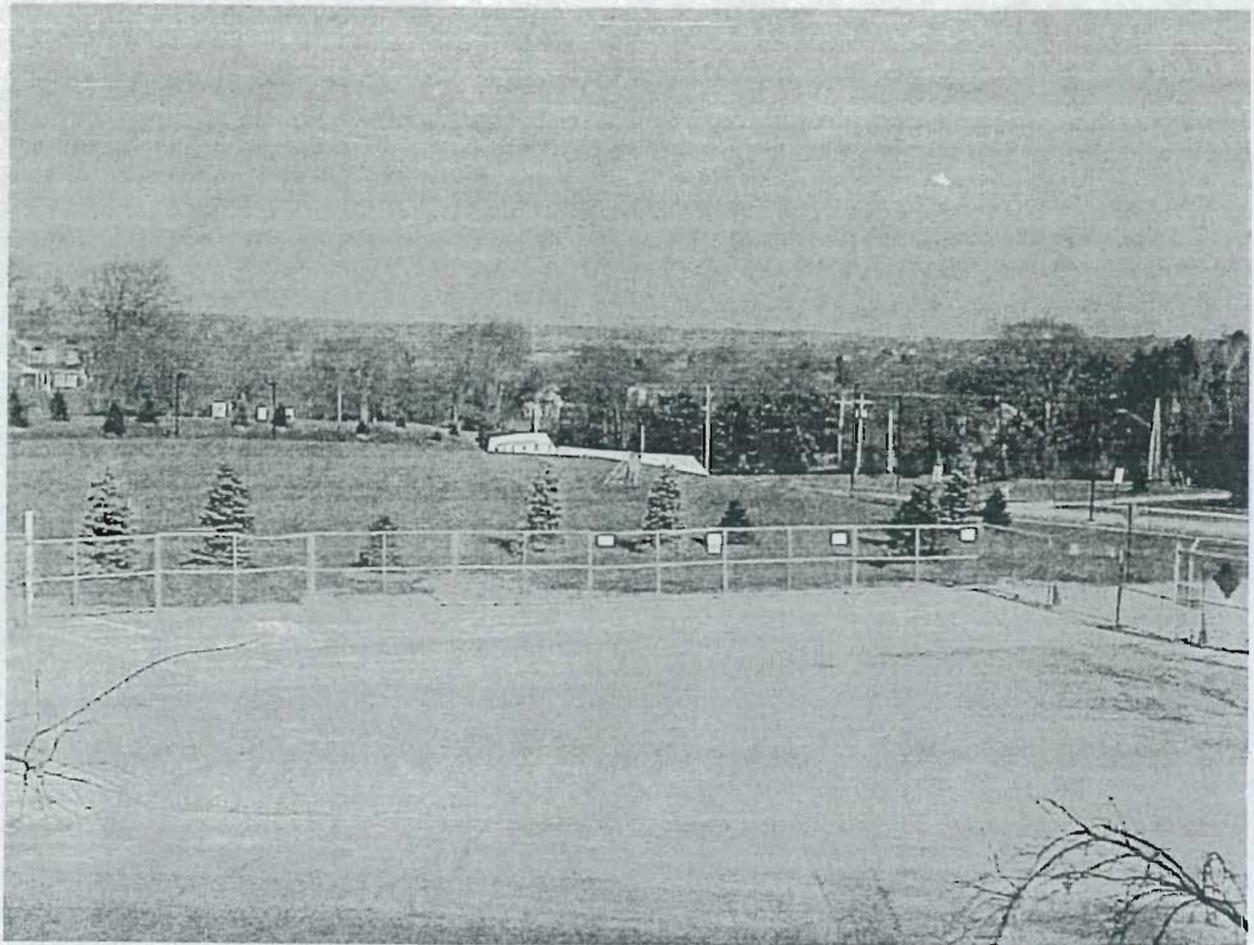
Guard Post 8 Post Demolition

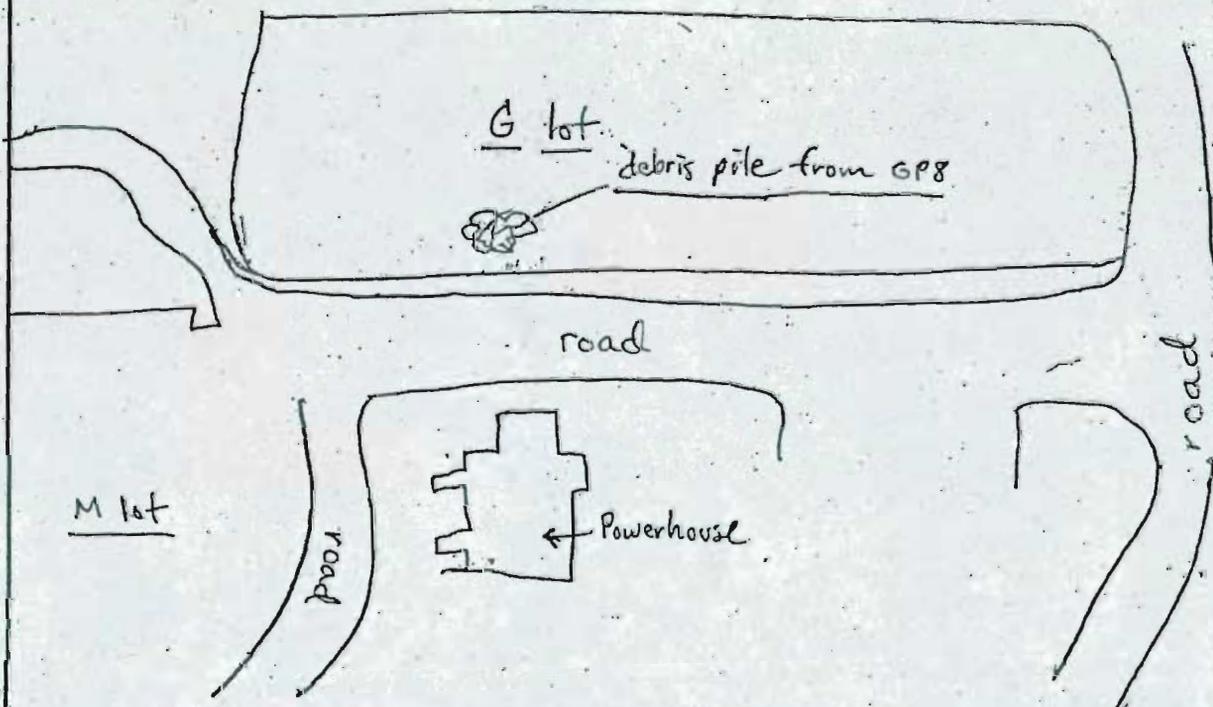
* Various smears and direct scans performed on debris pile. on 12/13/04

Integrated count taken IF audible detected. NO audible detected.
 ALL direct readings <100dpm/100cm² Alpha and <5000dpm/100cm² Beta
