**PRE-DEMOLITION SURVEY REPORT (PDSR)**

**BUILDING B771/774, Roof**

**REVISION 1**

**April 7, 2004**

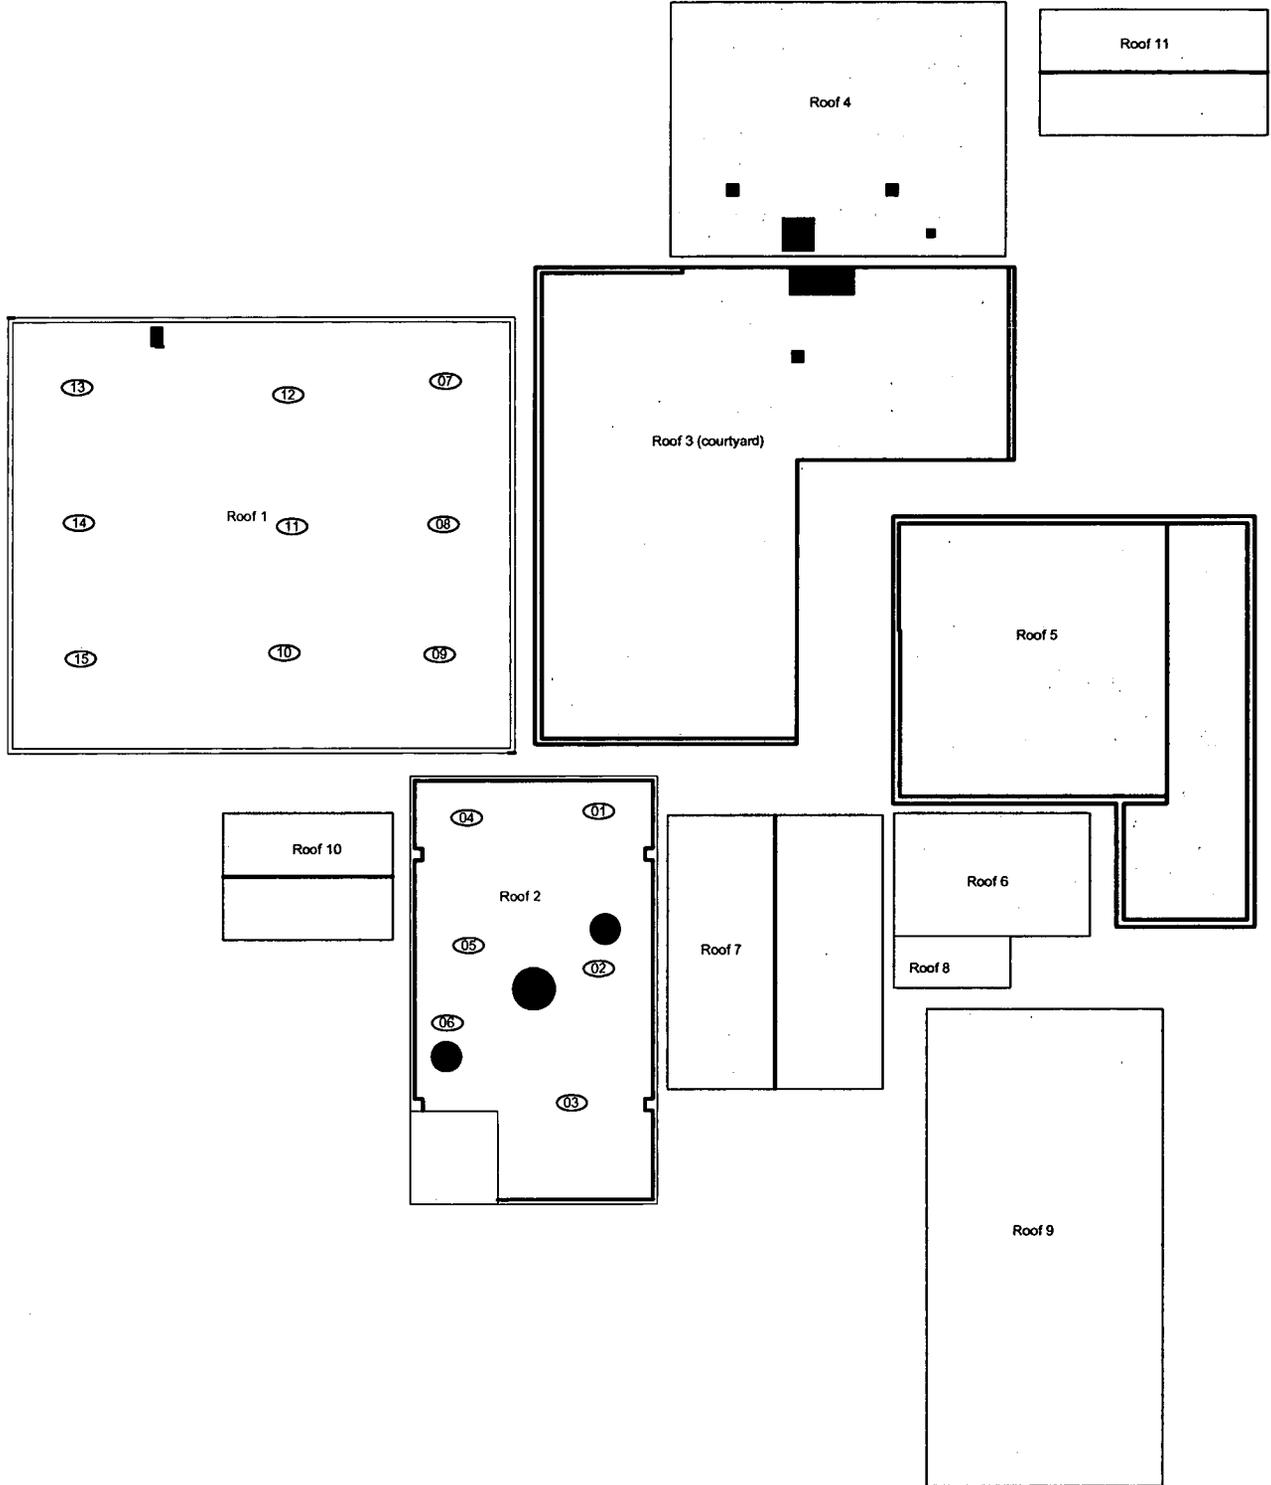
**SURVEY UNIT 771103 - MAP 1 OF 1**

**Comments:** Surveys 1-15 taken on base of roof. Surveys 16-30 taken on top of tar media. The "a priori" MDA for the SAC-4 is 10 dpm/100cm<sup>2</sup> (from PDSP, Rev. 1, Section 5.1). An additional 15 bias RSA and TSA were taken on the roof on flat spots.

Comments: Surveys 1-15 taken on top of tar media. Surveys 16-30 taken on base of roof, 31-45 Bias locations with flat surfaces.

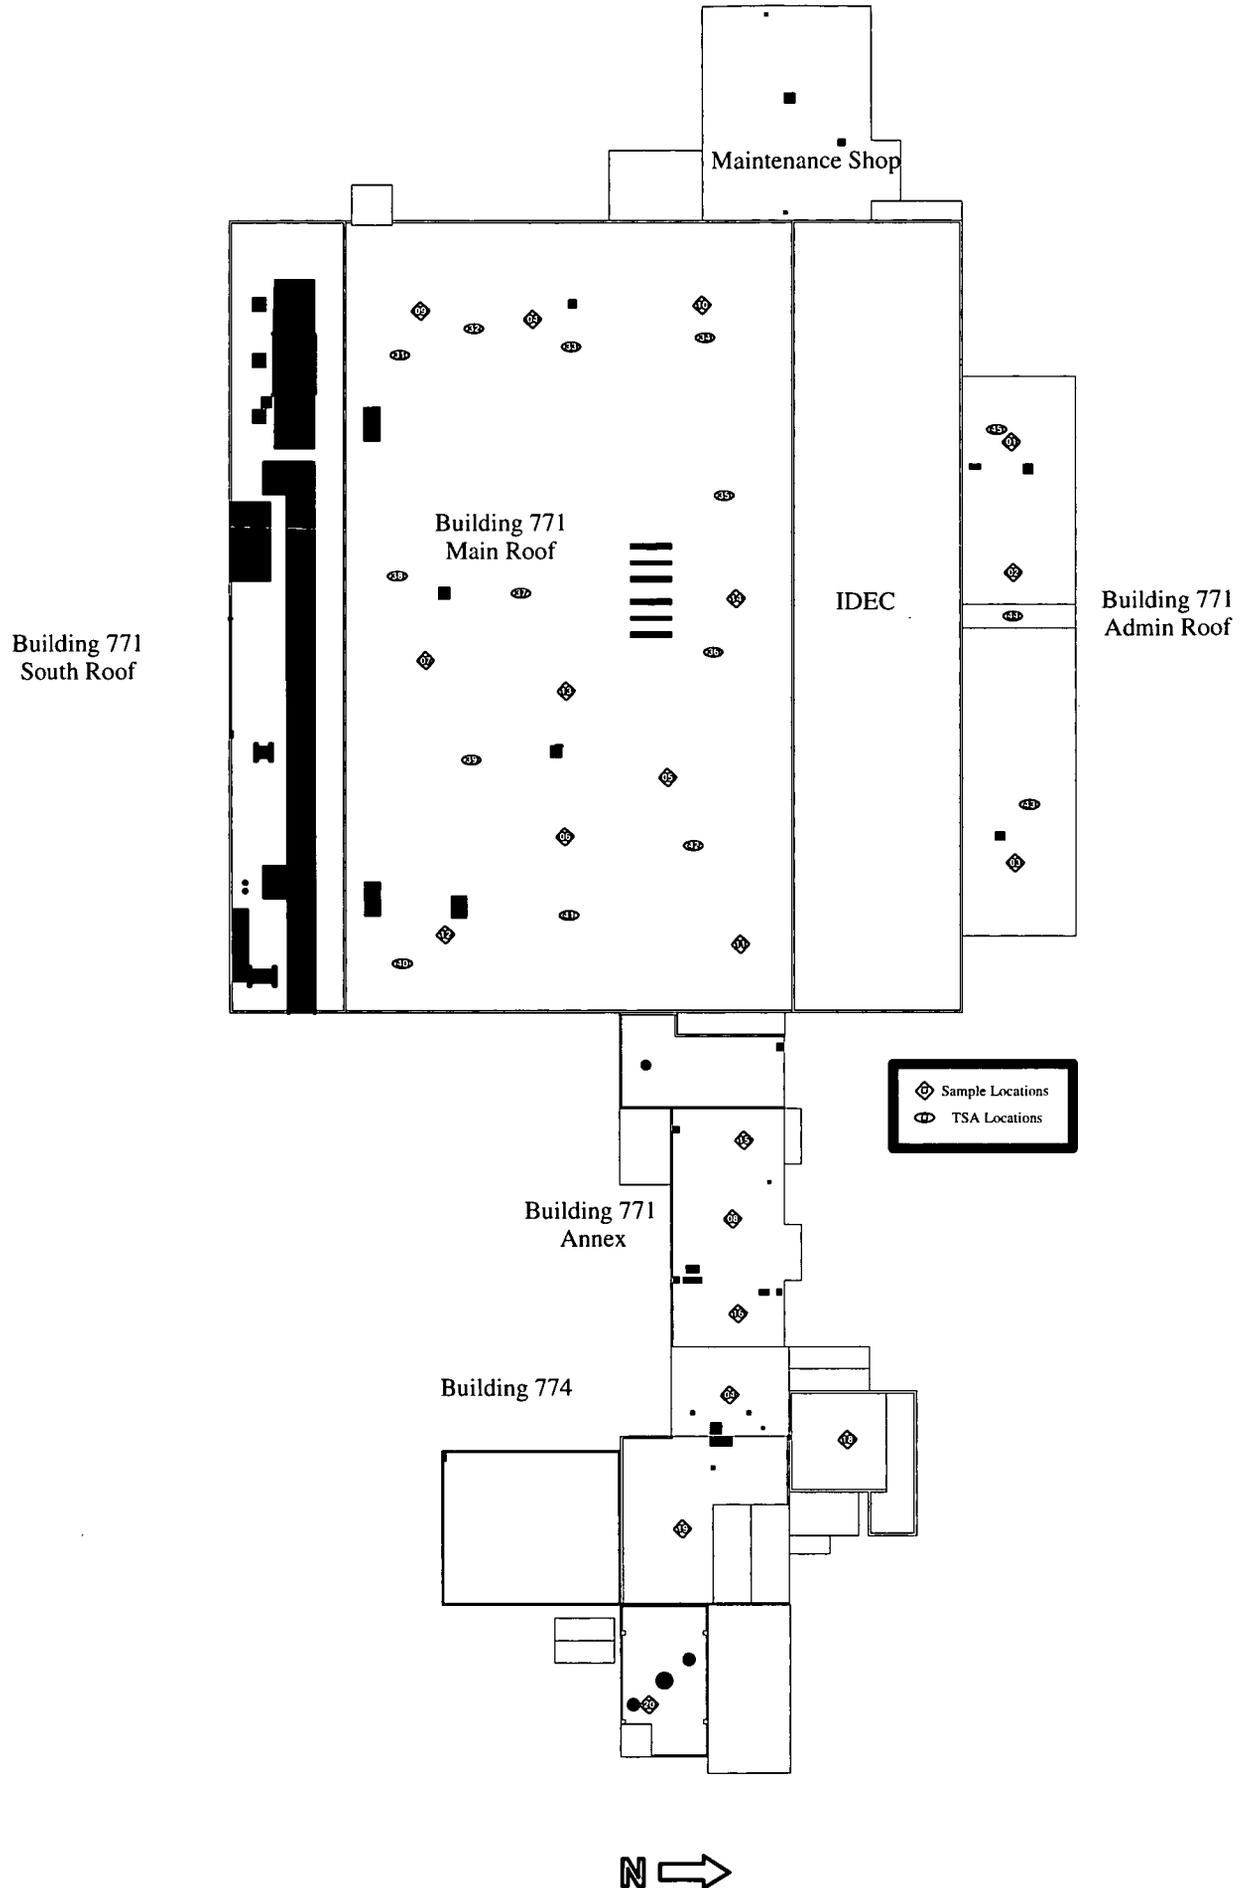
# Building 771/774 Roof Sample Locations

Twenty (20) biased media samples were collected on the B771 roof in December of 2000. Based on the conservative method of bringing all the activity in a media sample to the surface, three (3) of the original biased twenty (20) samples exceeded 100 dpm/100 cm<sup>2</sup>, but were less than 300 dpm/100 cm<sup>2</sup>. The results were likely skewed due to high sample weight (maximum pCi/g result 0.34 pCi/g Am and Pu, sample mass at same location 470 grams). The three (3) elevated locations were resampled in 2003. Per the RFETS Regulatory Contact Record dated November 5, 2003, in order to minimize skewness of the data each roof layer was separated and analyzed separately. In addition, the samples were allowed to dry. All resample results at these locations were less than the DCGLw of 100 dpm/100cm<sup>2</sup>. The original three (3) elevated location results out of twenty (20) total samples were replaced with the updated data. Since these three (3) locations were replaced with seven (7) samples, a total of twenty-four (24) total samples were reported. Refer to the map in Attachment B for sample locations.

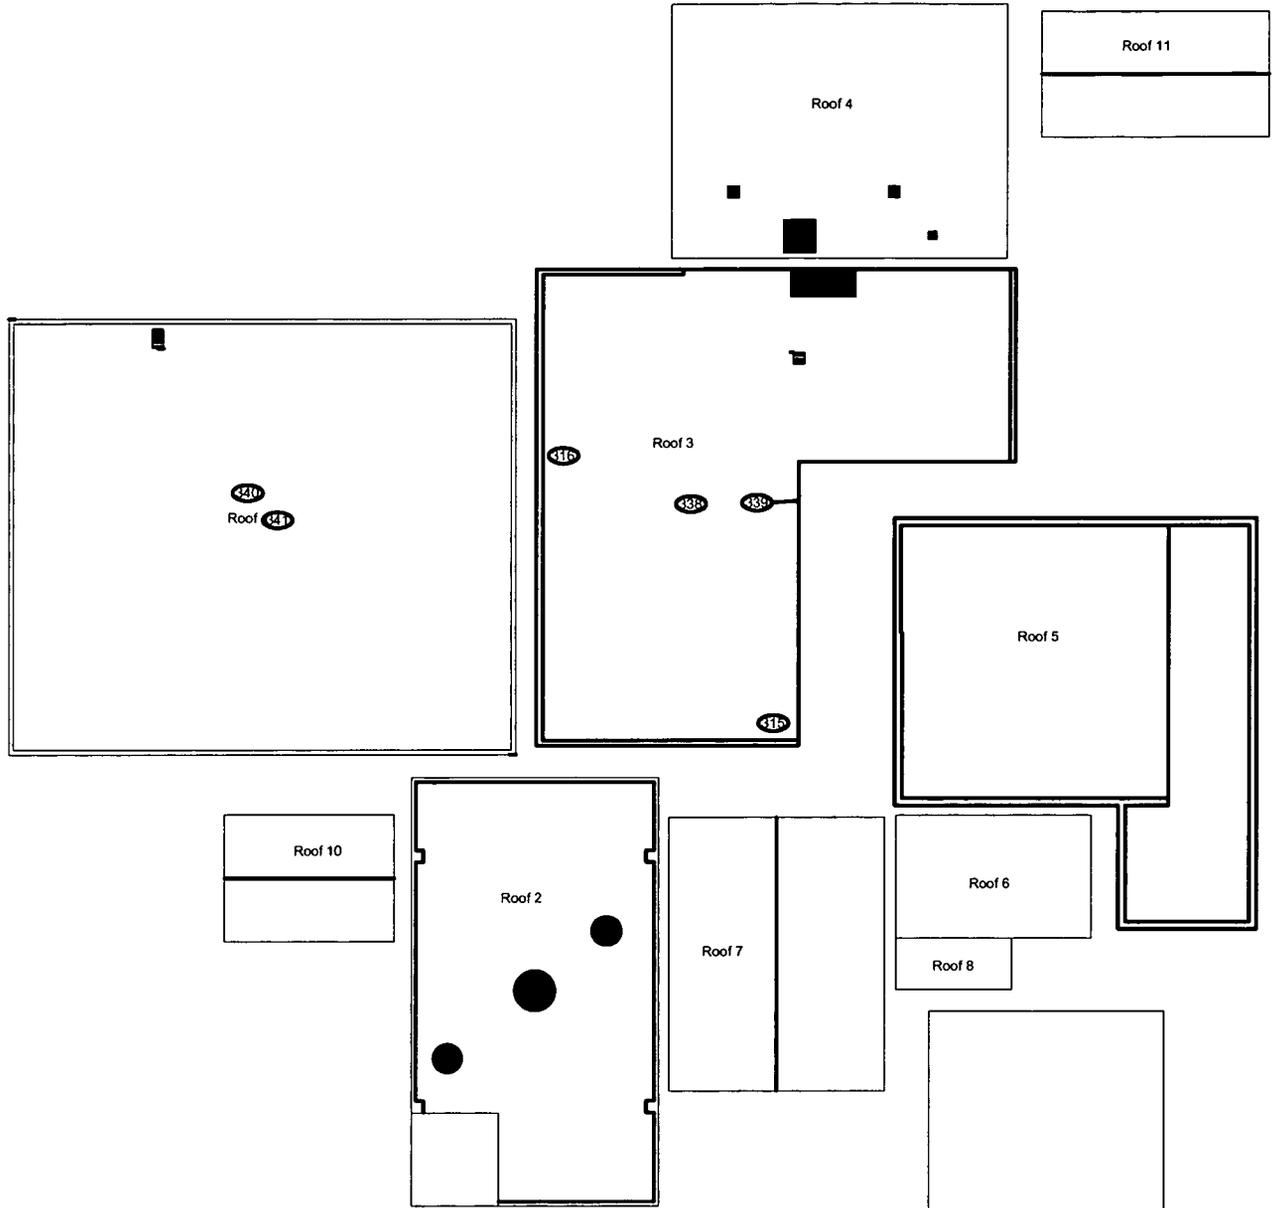
**Building: 774**  
**Description: Roof Complex**

Asbestos containing building material is present in the building 774 roof (Refer to Attachment B for sampling locations and results). Approximately 2250 square feet of asbestos containing roofing material, and 600 square feet silver painted tar impregnated built up roofing, as well as roof flashing is still present on the 774 roof. The material is non-friable and will be removed during building demolition and disposed of as non-friable asbestos sanitary waste.

Location	Sample Number	Description	Result
	771-12-27-2000-MS-315	TSI mud on ch water pipe elbow	20.0% chry
	771-12-27-2000-MS-316	White TSI block on a steam pipe	23.0% chry
	771-01-04-2001-MS-338	Built-up roofing	ND
	771-01-04-2001-MS-339	Silver painted roof flashing	6.0% chry
	771-01-04-2001-MS-340	Silver paint Black fibrous tar	6.0% chry 35.0% chry
	771-01-04-2001-MS-341	Silver painted rock	3.0% chry

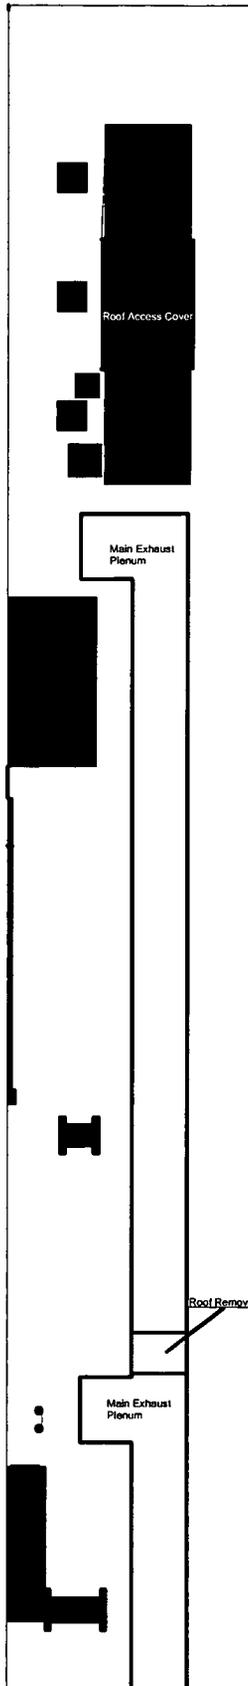
An approximately 100 ft<sup>2</sup> section of the metal corrugated roof covering the B771 main plenum exhaust tunnel was contaminated from a spill occurring during D&D operations. This occurred in September of 2002 during the removal of a waste oil transfer line originating in B776 and terminating in B774 (IWCP T0109841). Although the spill was immediately cleaned up and removable contamination levels were <20 dpm/100cm<sup>2</sup>,

fixed contamination, with a range of 174 to 423 dpm/100cm<sup>2</sup>, remains on this section of roof. This section of roof was excluded from this survey unit and will be disposed of as radioactive waste. Refer to Attachment E for location of area to be removed.
