ASBESTOS CHARACTERIZATION REPORT

**BUILDINGS 776 & 777
SECONDARY BUILDINGS**

**ROCKY FLATS ENVIRONMENTAL
TECHNOLOGY SITE**

**Foothills Environmental, Inc.
2801 Youngfield St., Ste. 300
Golden, CO 80401**

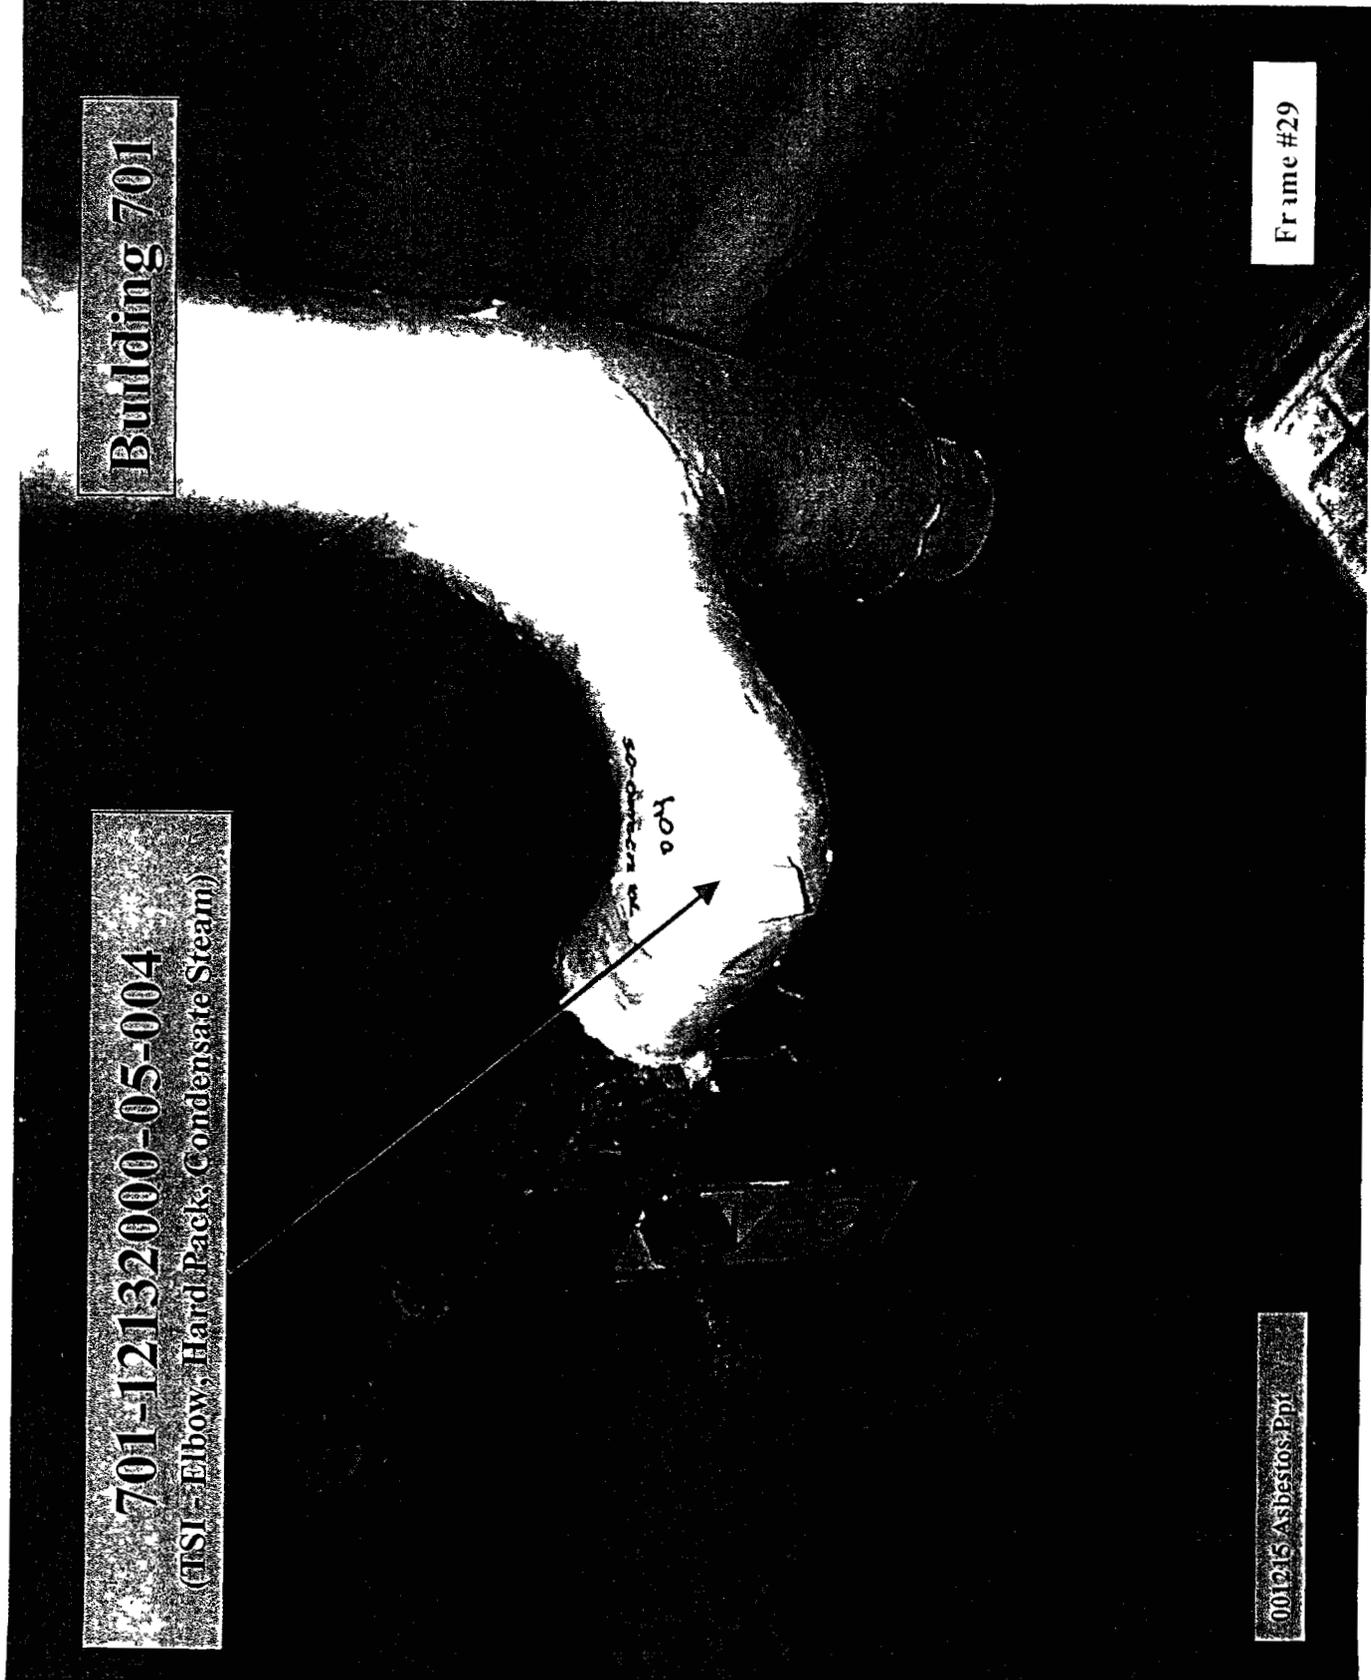
Building 701

701-12132000-05-004

(FISI - Elbow, Hard Pack, Condensate Steam)

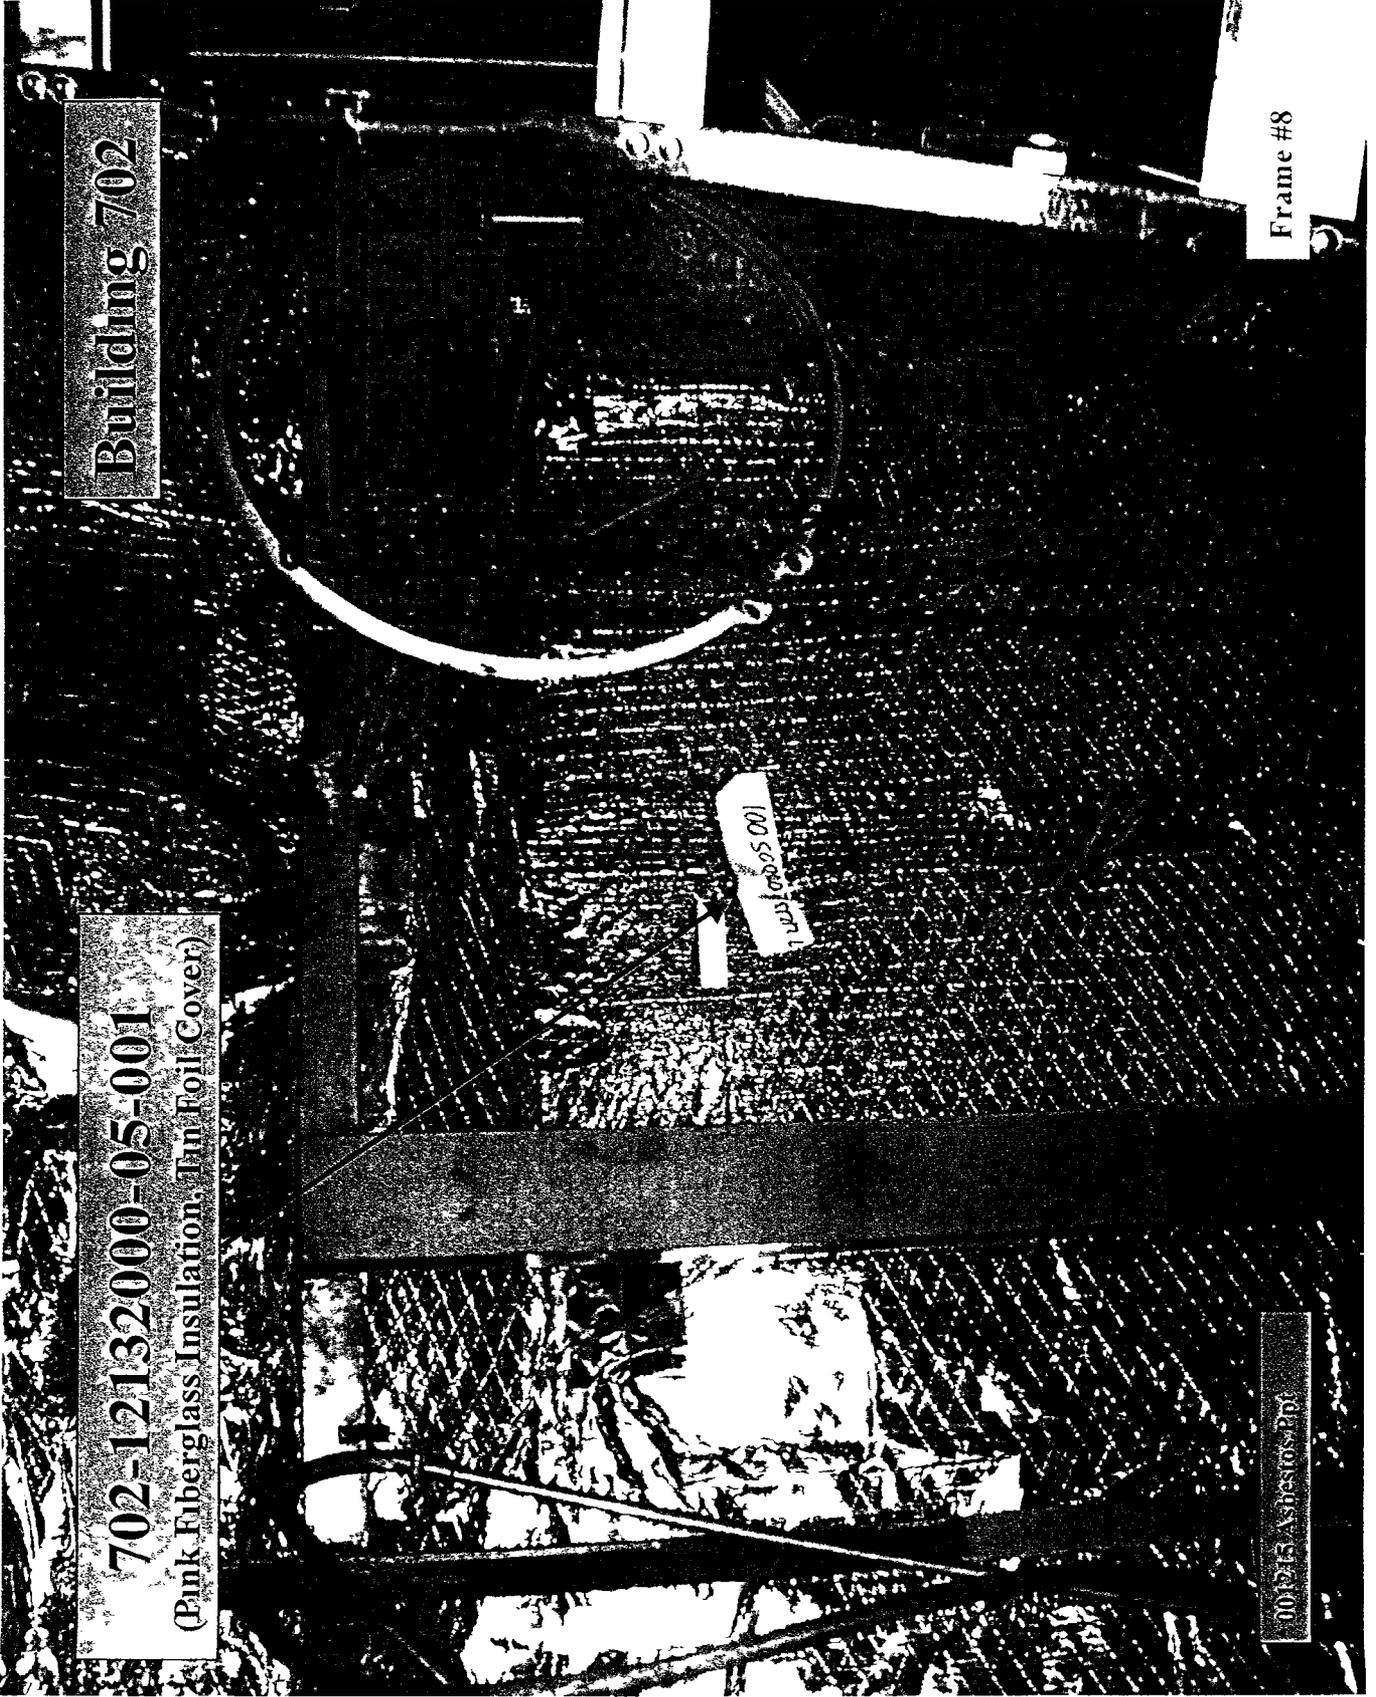
Building 702

702-12132000-05-001

(Pink Fiberglass Insulation, Tin Foil Cover)

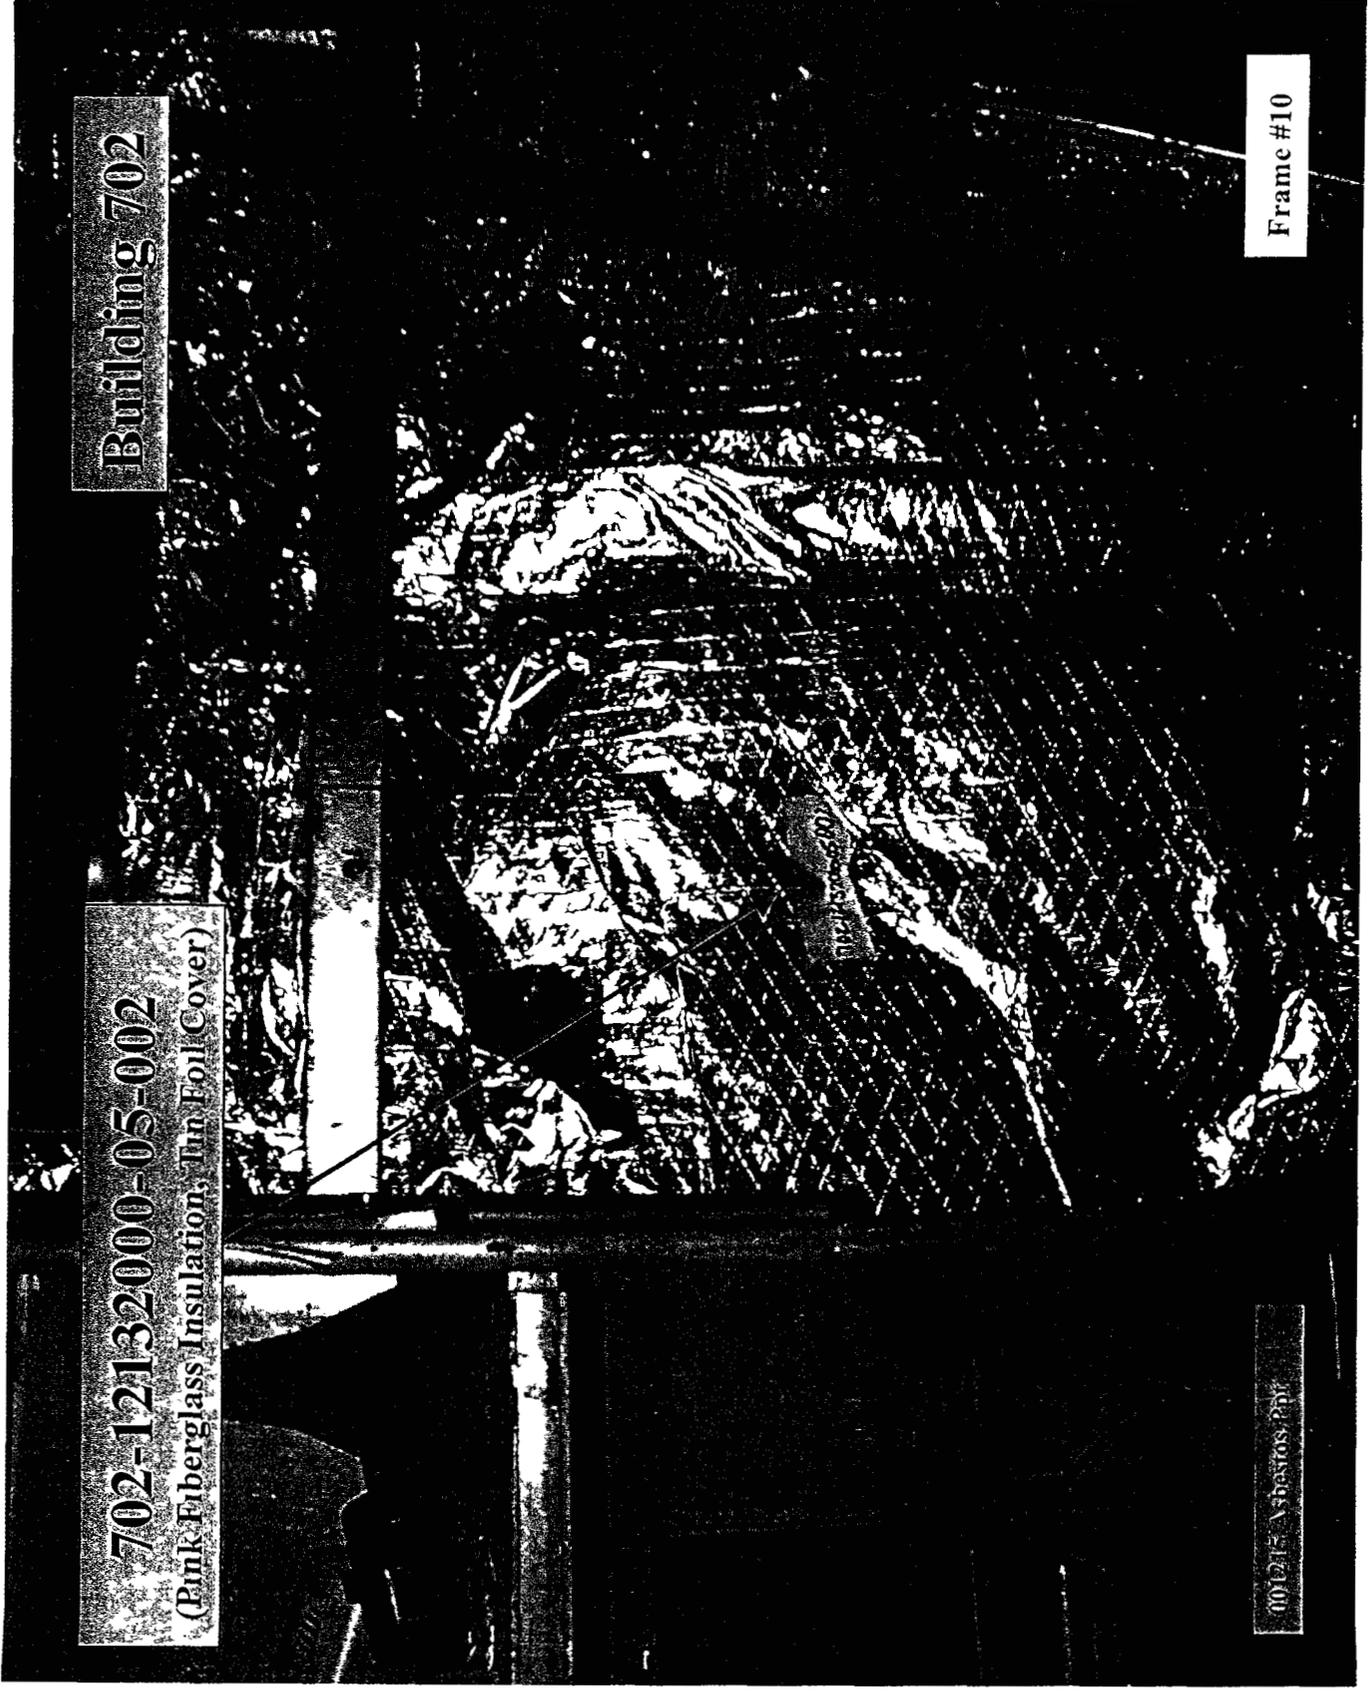
Building 702

702-12132000-05-002

(Pink Fiberglass Insulation, Tin Foil Cover)

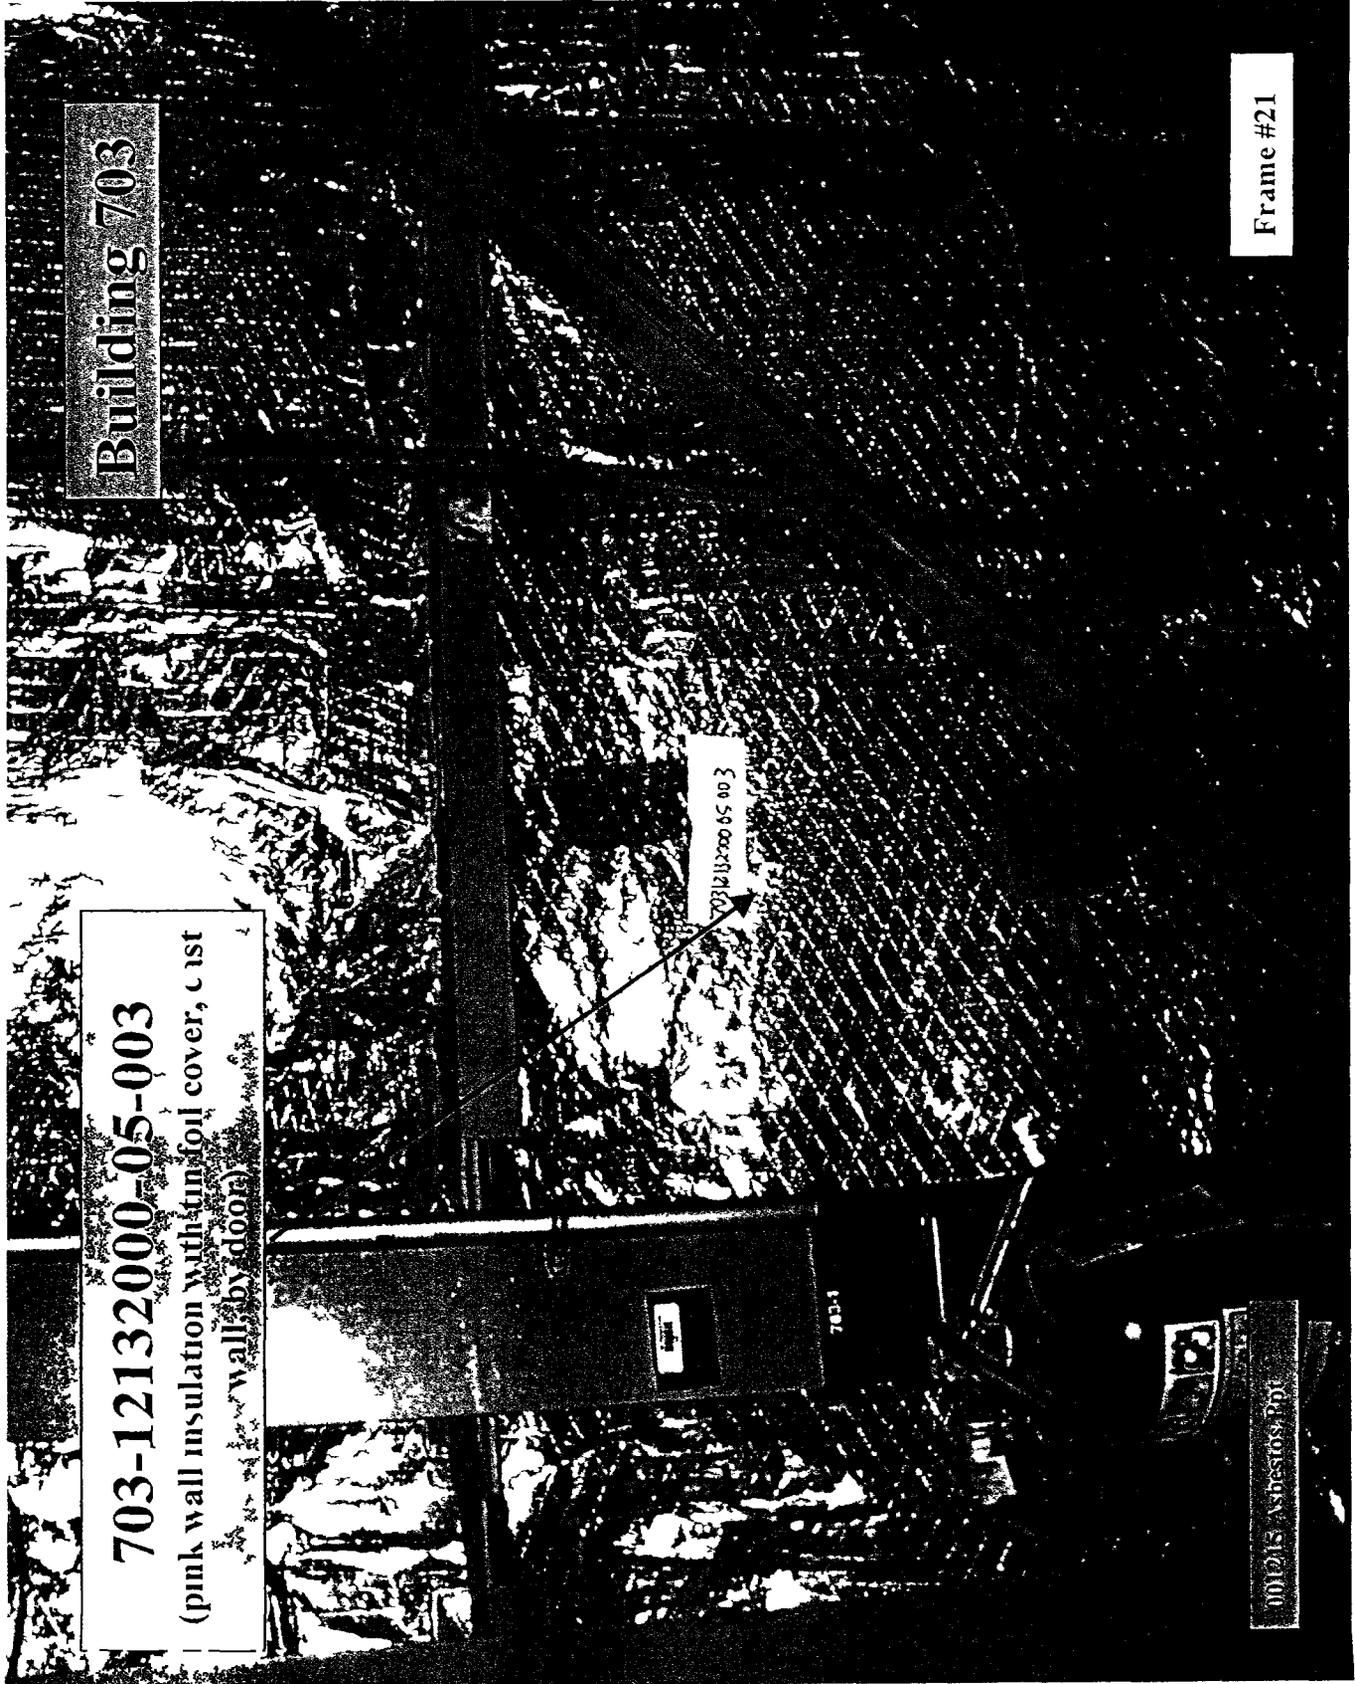
Building 703

703-12132000-05-003

(pink wall insulation with tin foil cover, cist wall, by door)

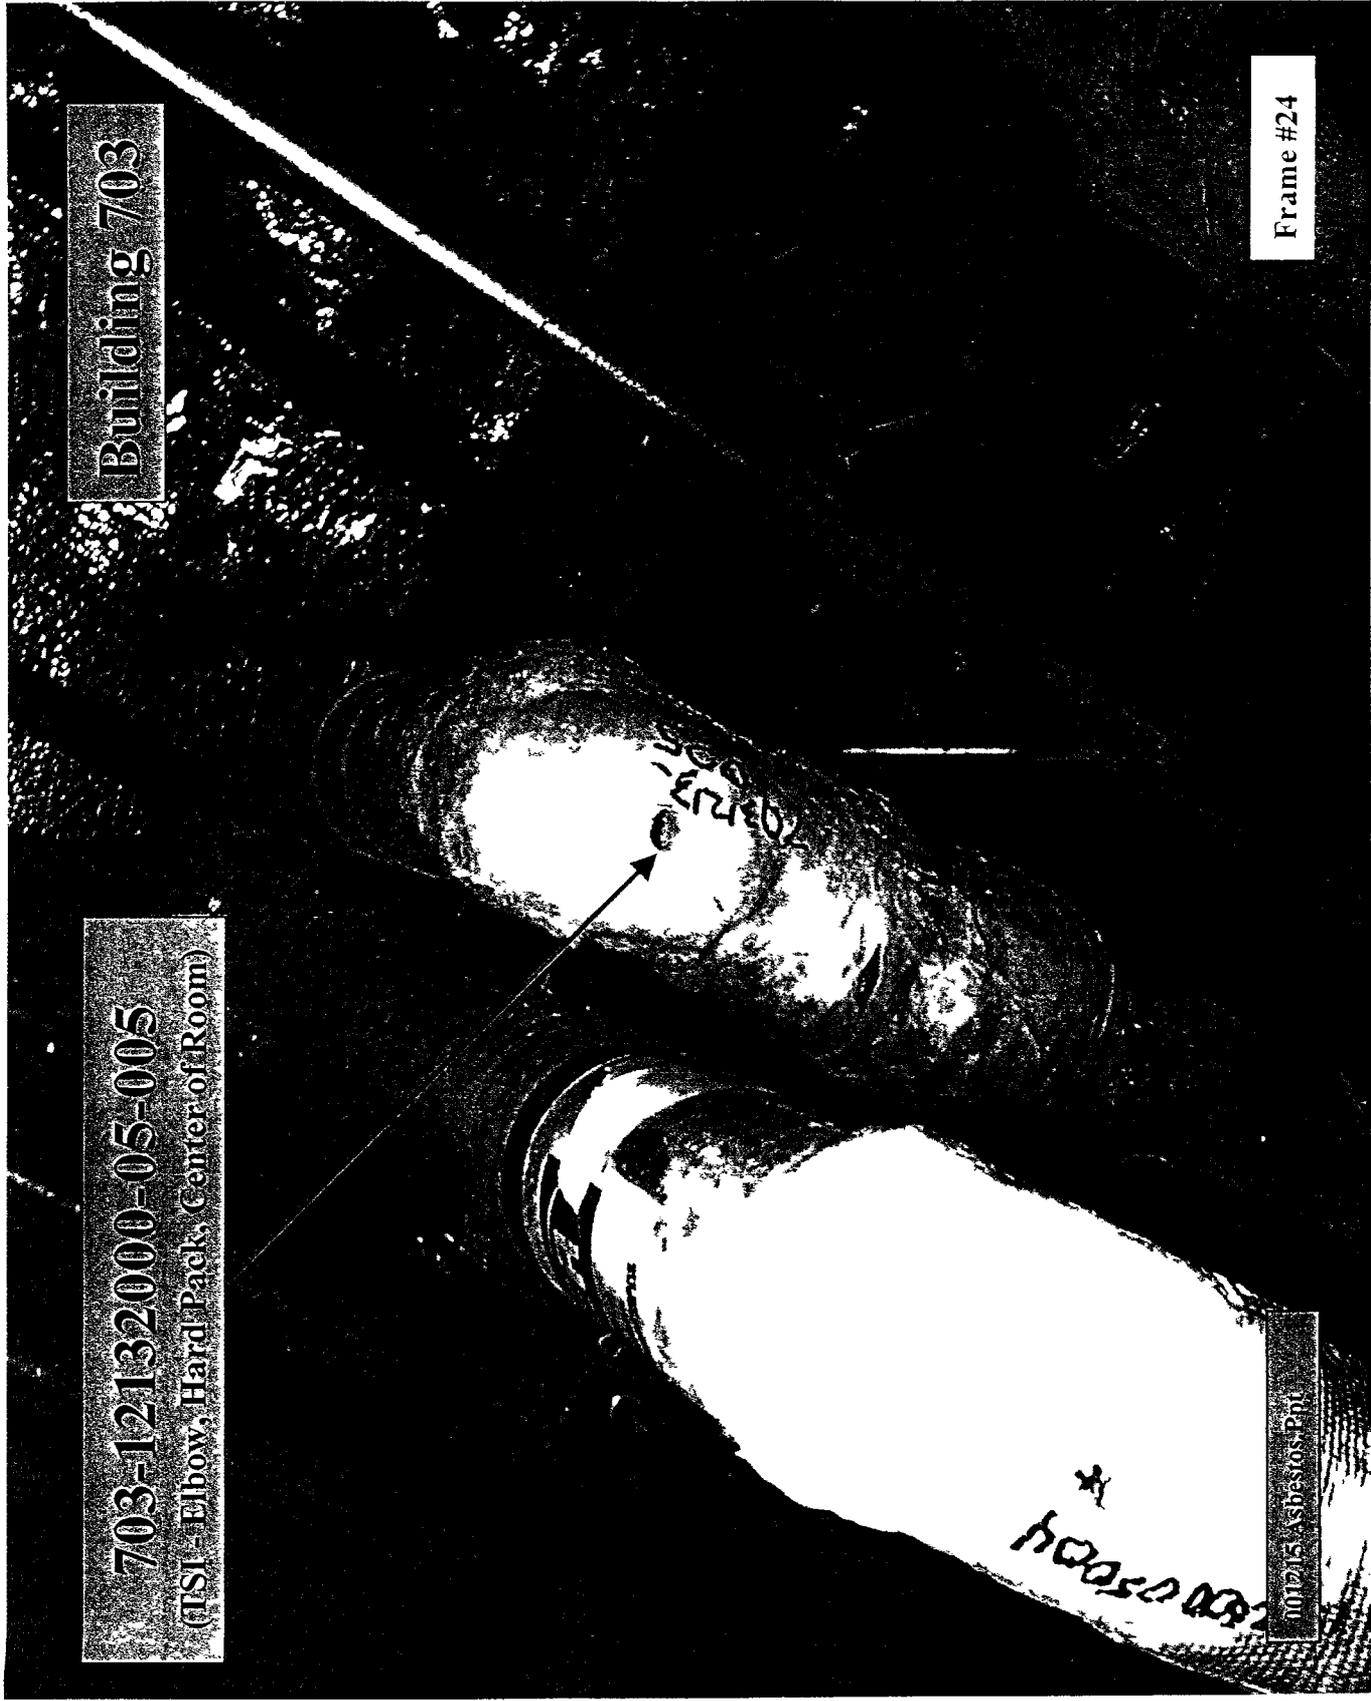
Building 703

703-12132000-05-005

(TST - Elbow, Hard Pack, Center of Room)

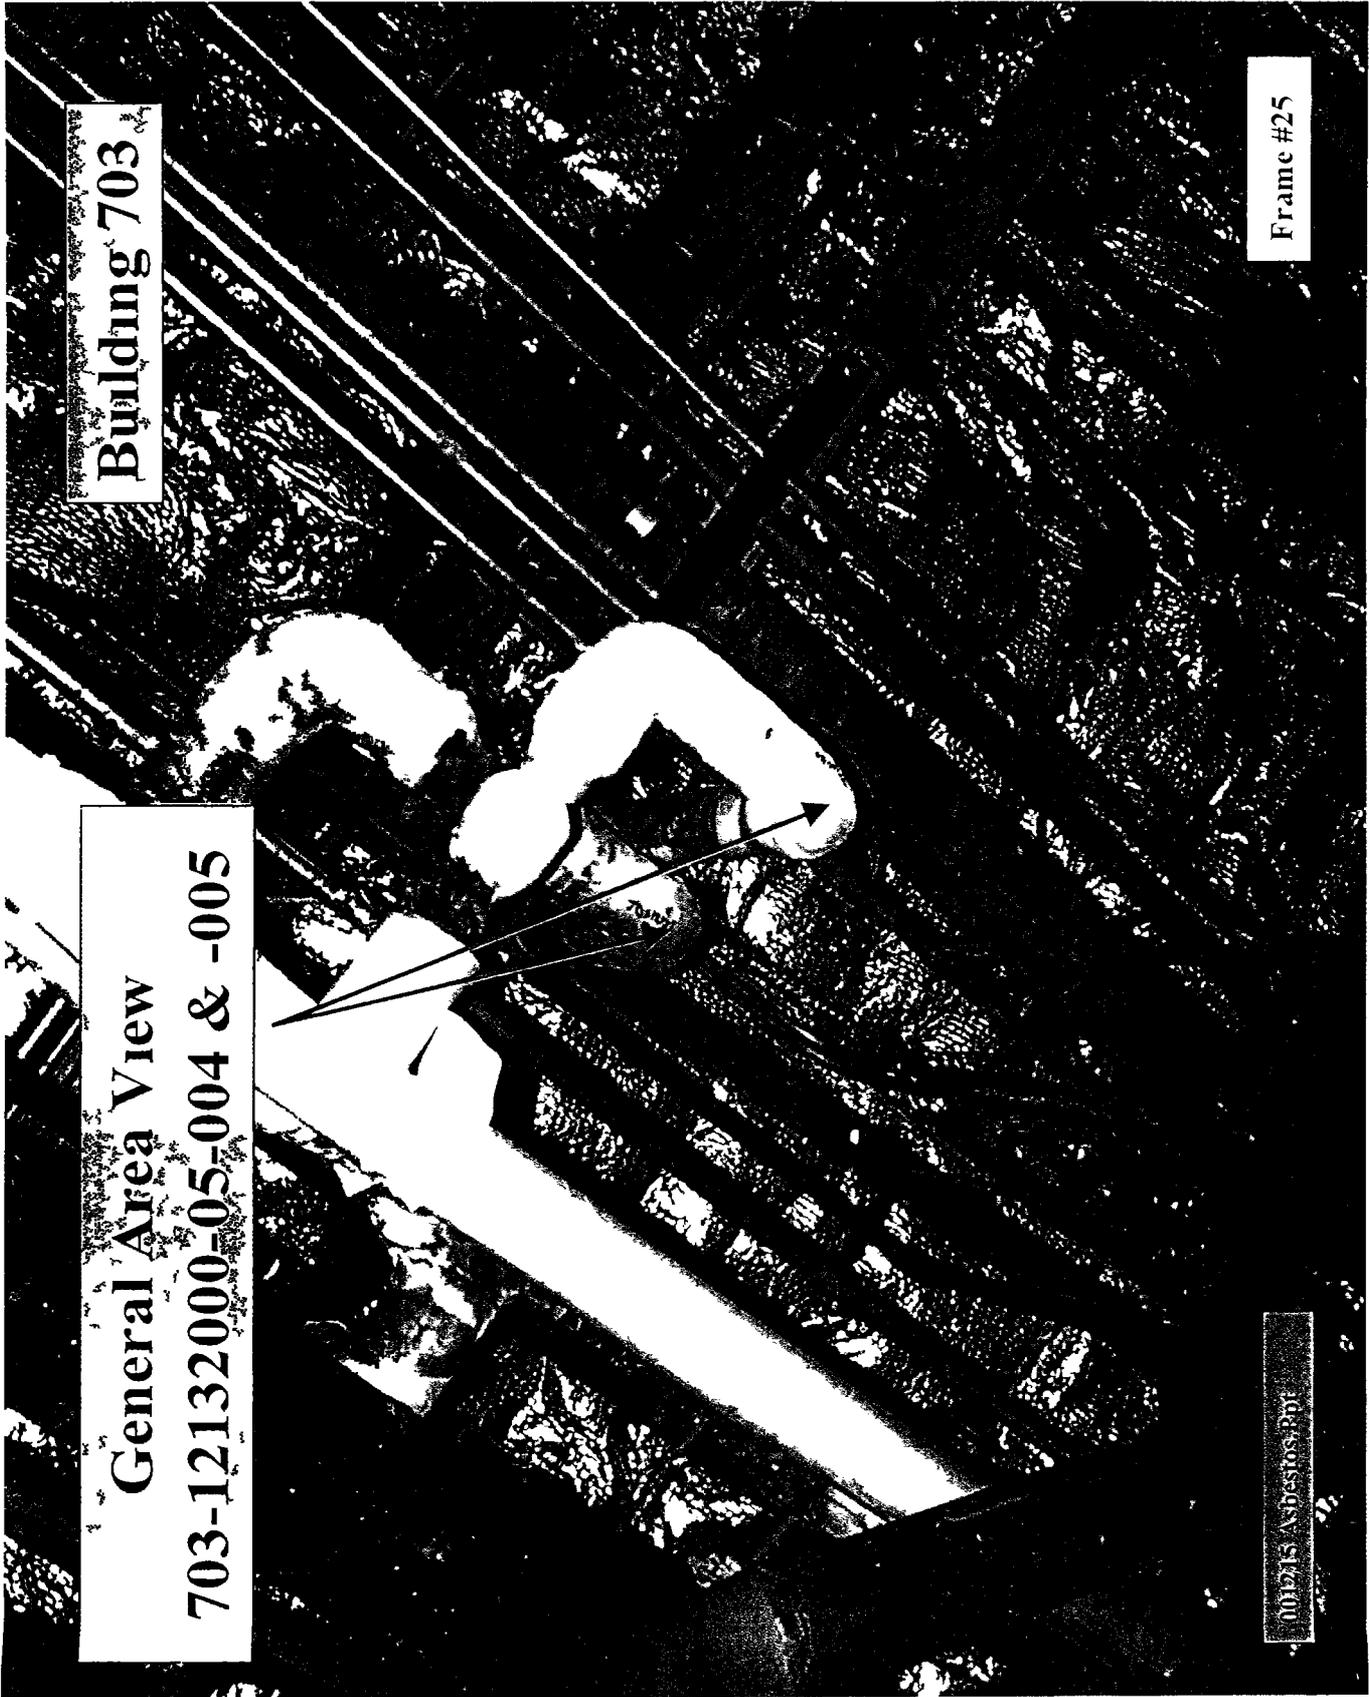
Building 703

General Area View

703-12132000-05-004 & -005

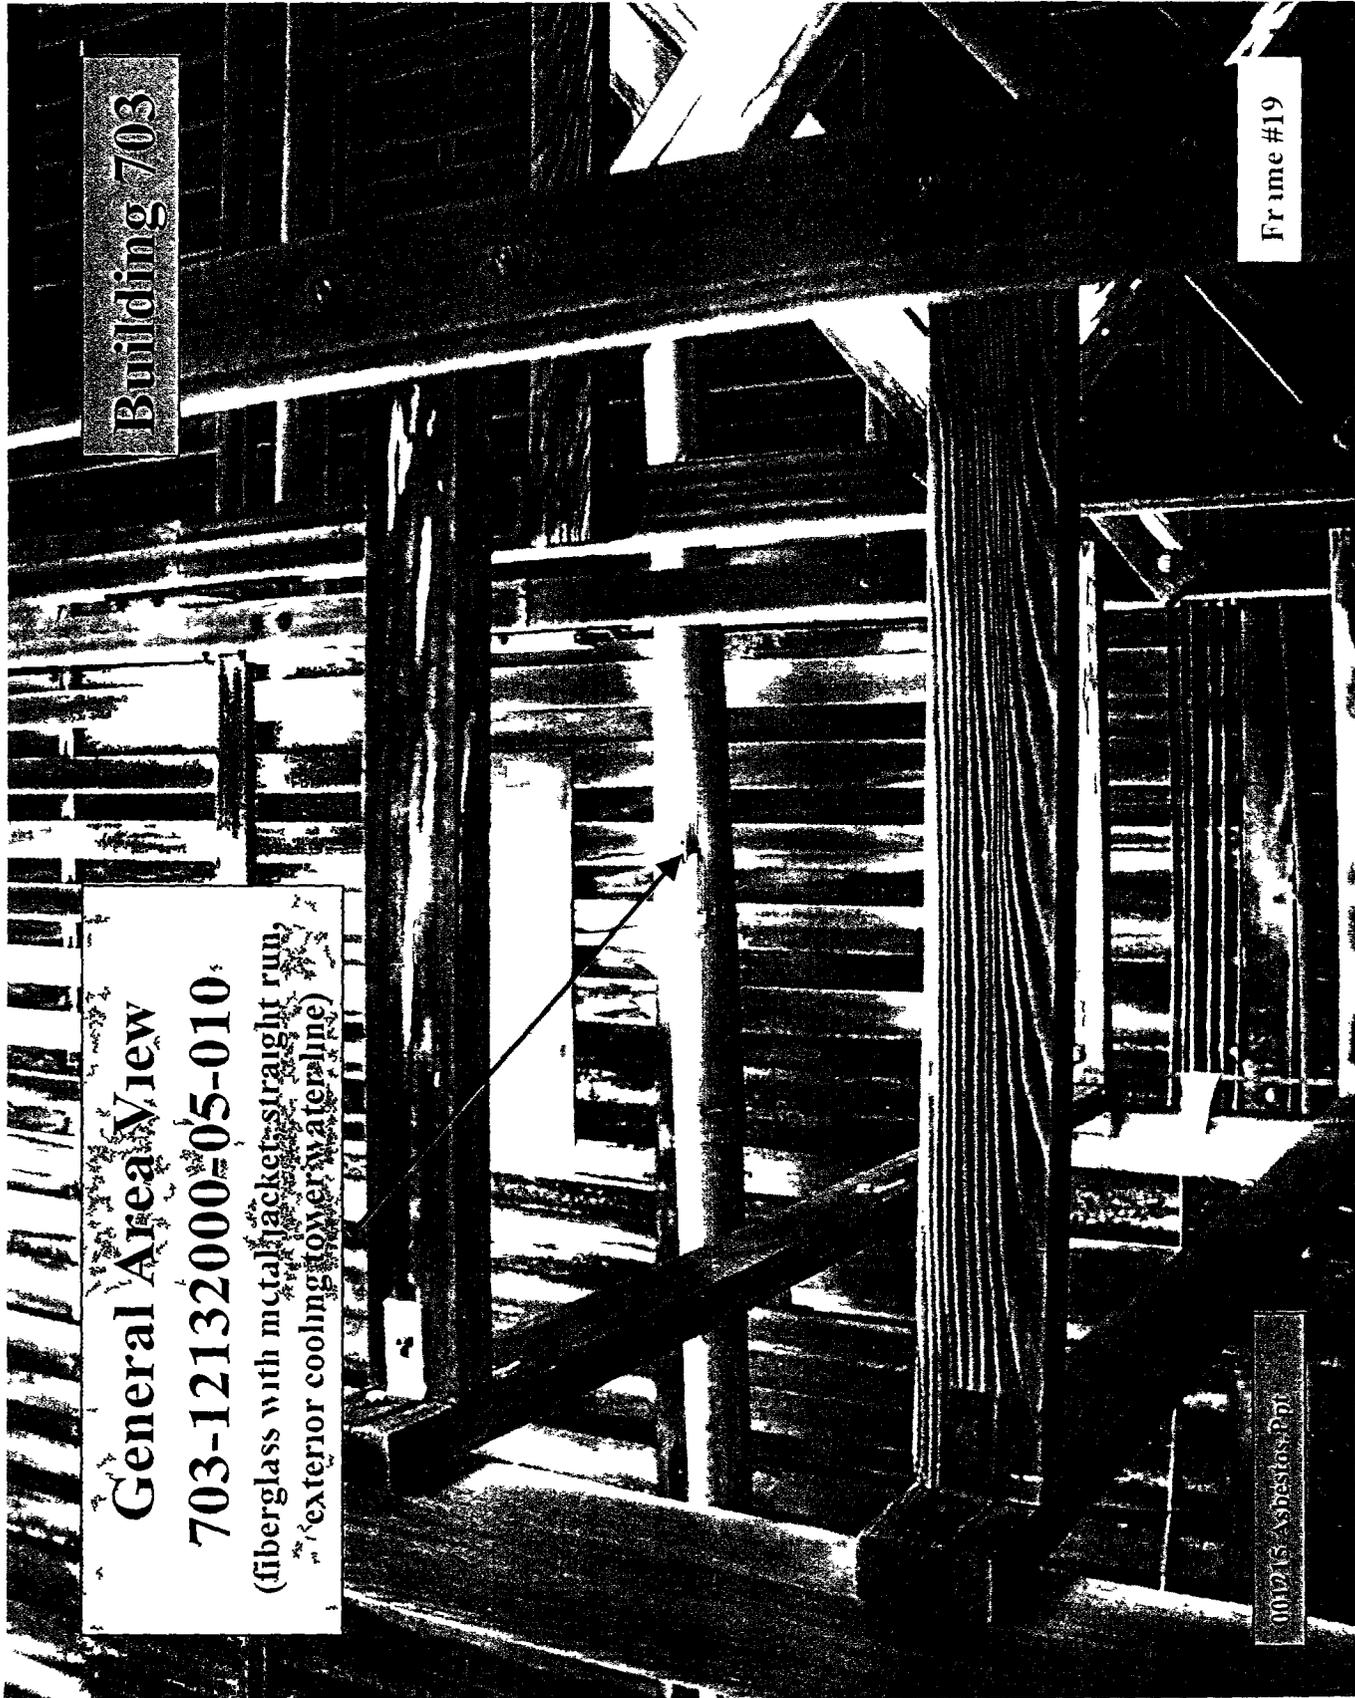
Building 703

General Area View

703-12132000-05-010

(fiberglass with metal jacket, straight run
exterior cooling tower waterline)

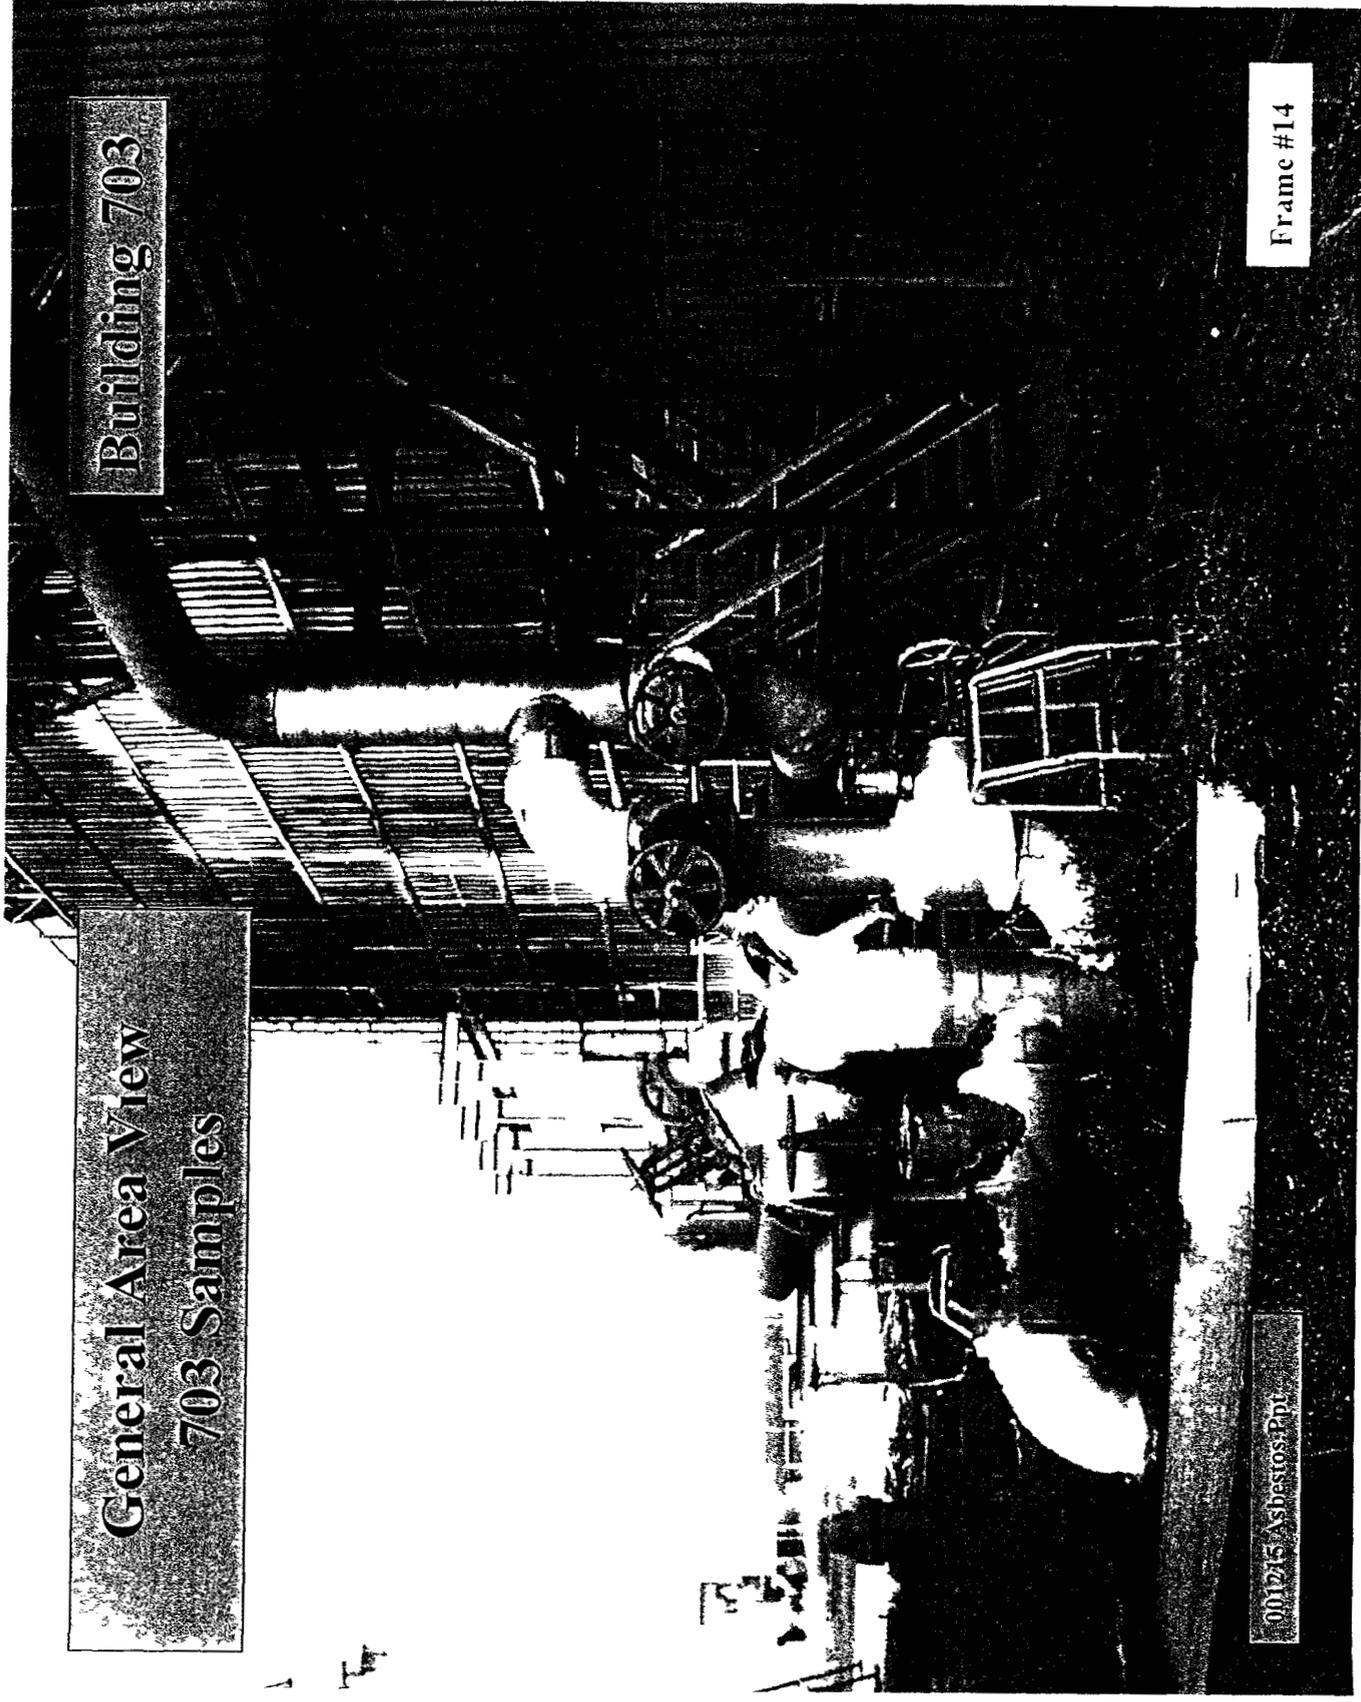
Building 703

General Area View
703 Samples
