ASBESTOS CHARACTERIZATION REPORT

BUILDINGS 776 & 777

ROCKY FLATS ENVIRONMENTAL TECHNOLOGY SITE

Foothills Environmental, Inc.
2801 Youngfield St., Ste. 300
Golden, CO 80401

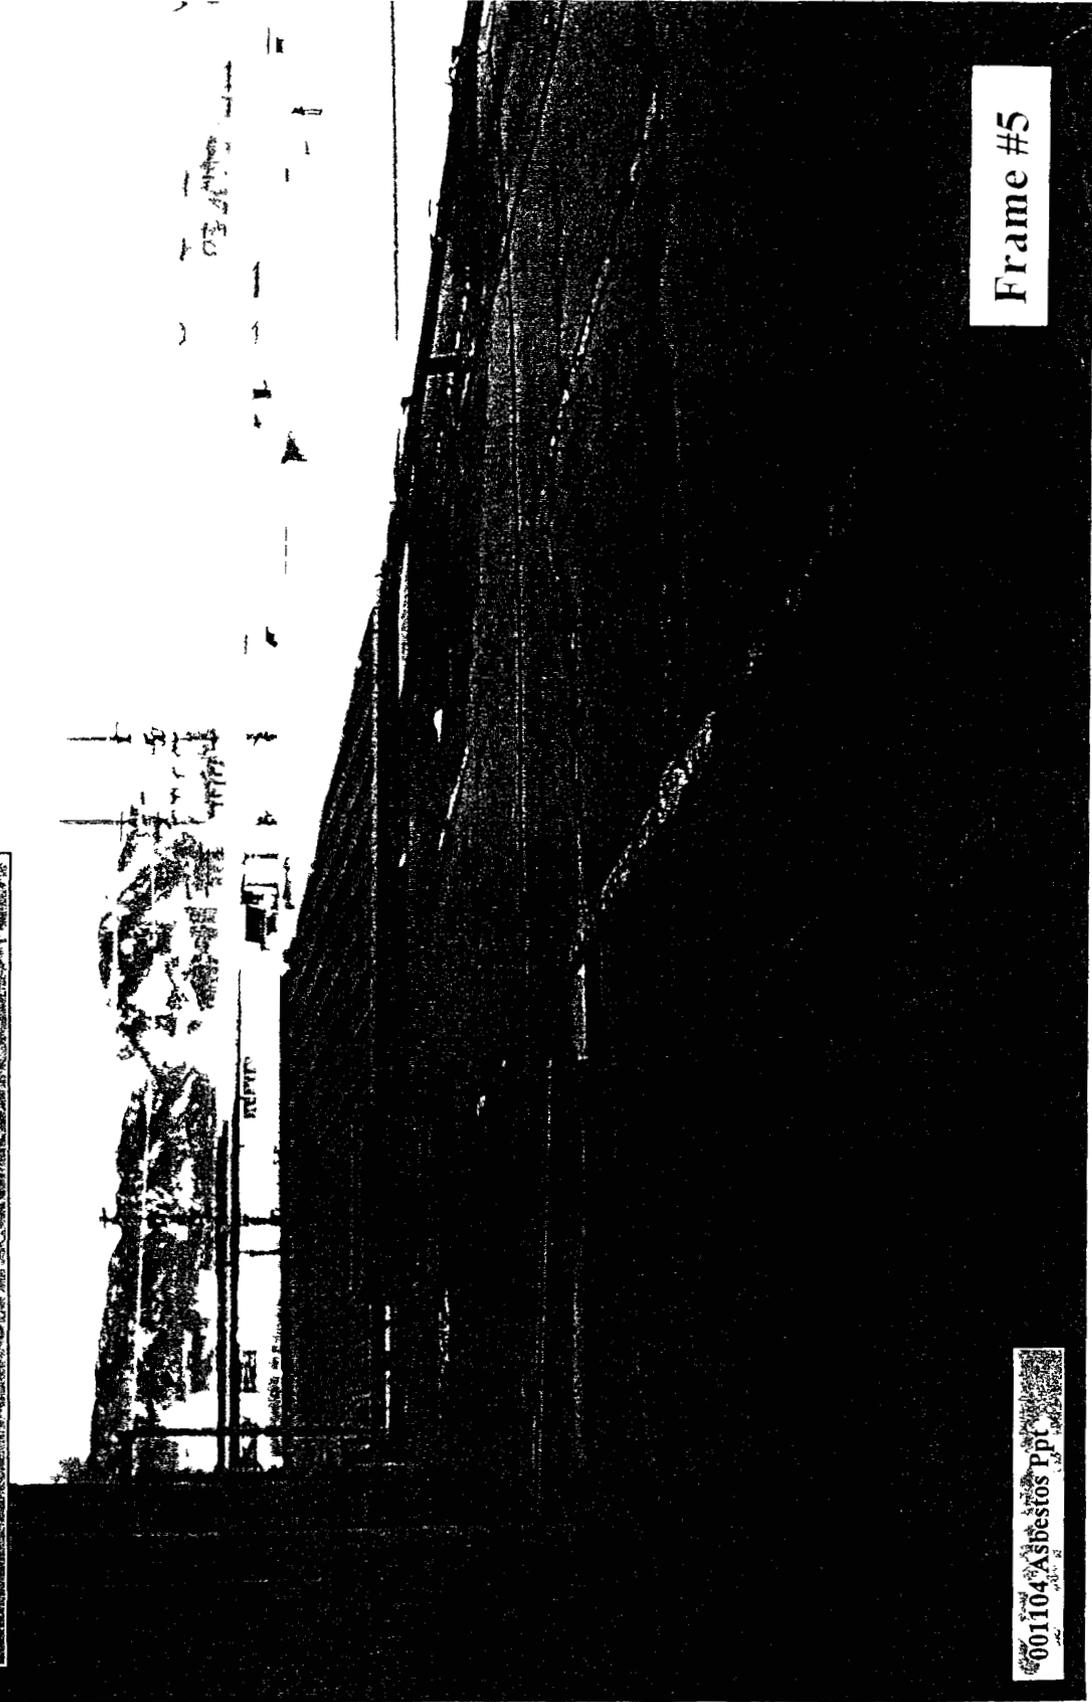
(View Looking West)

Samples 776-11042000-05-001 thru -004 were taken in this area of the roof.
