RF/RMRS-97-091.UN

Asbestos Characterization Report For The 779 Cluster Project

October 1997

**ASBESTOS CHARACTERIZATION REPORT
FOR THE 779 CLUSTER DECOMMISSIONING PROJECT**

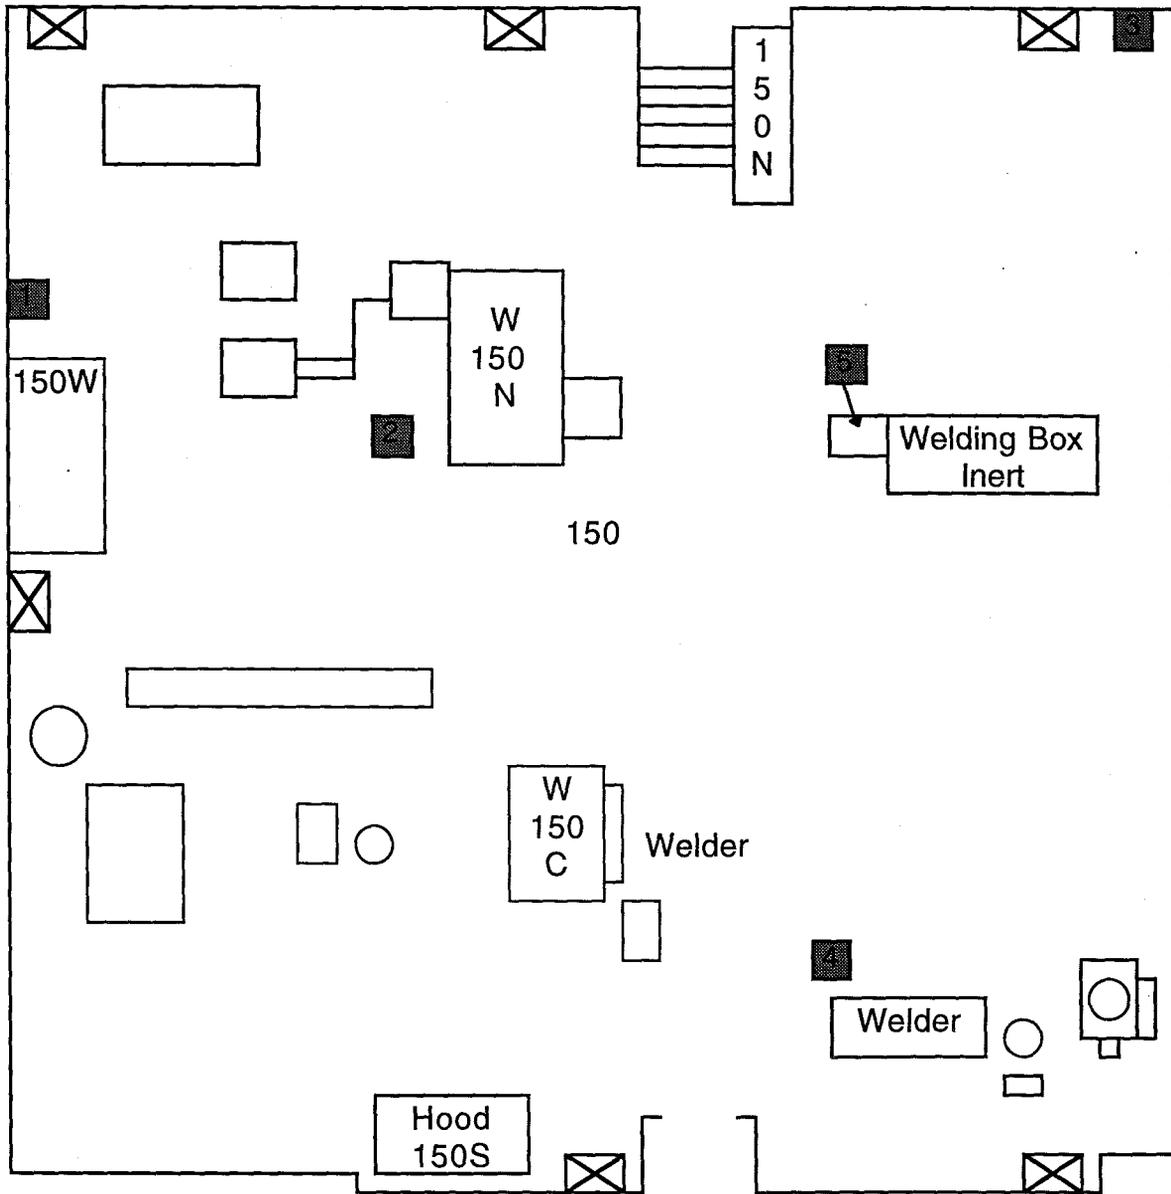
Asbestos 779 Report Plan 01

| 1 | 779-970515-MS-050 | Drywall, tape, J.C. (TR) |

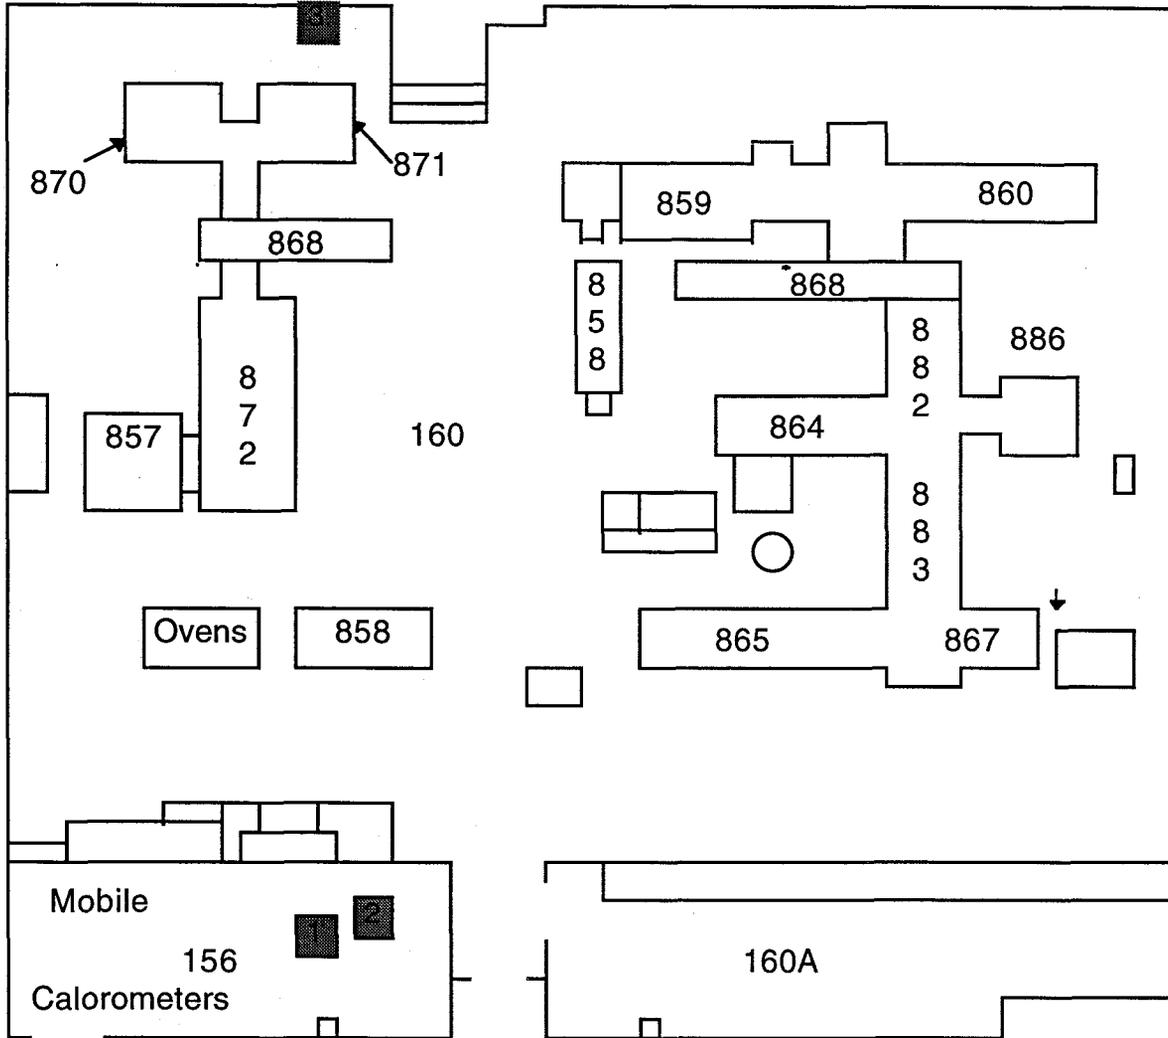
Asbestos 779 Report Plan 4

| 1 | 779-970515-MS-054 | 12" White, green mottled floor tile (8%) |

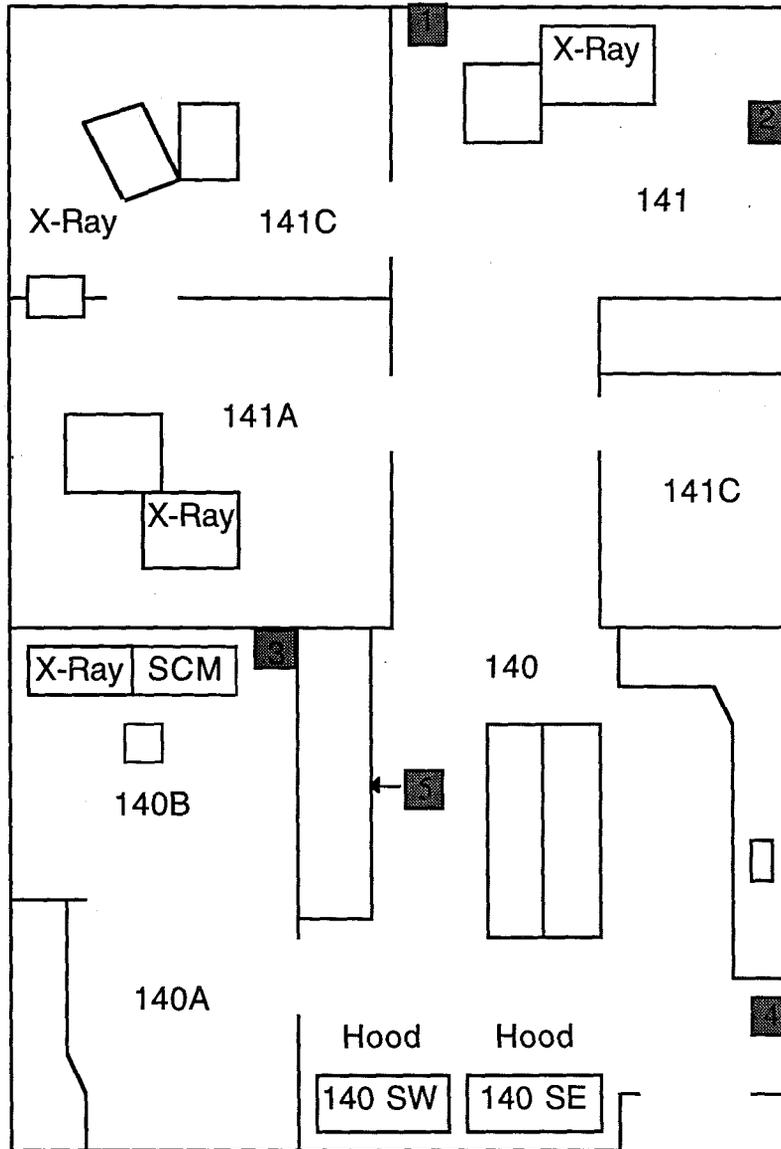
Asbestos 779 Report Plan 5

1	779-970605-MS-162	Drywall, tape, J.C. (ND)
2	779-970605-MS-163	Drywall, tape, J.C. patch (ND)
3	779-970605-MS-164	4" charcoal cove base (ND)
4	779-970605-MS-165	TSI mud, process pipe (12)
5	779-970605-MS-166	2" black cove base (ND)

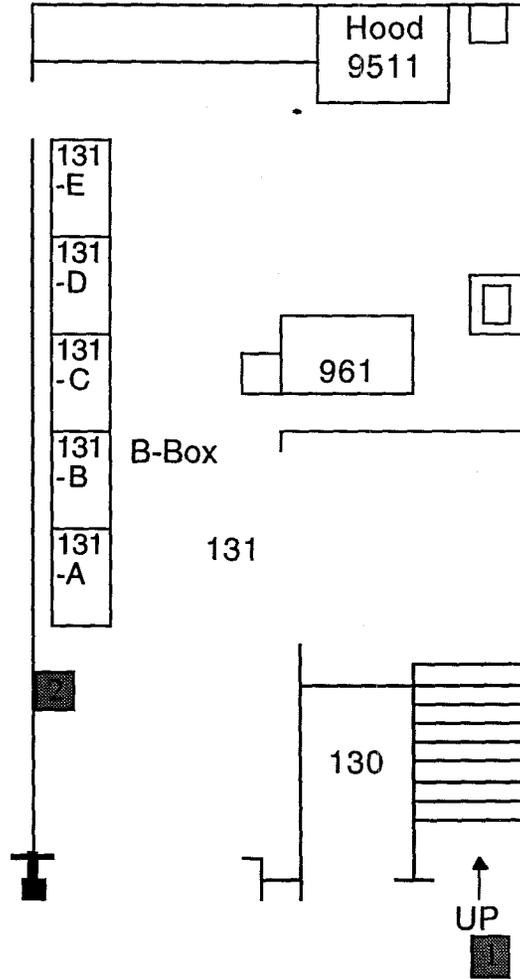
Floor Plan
1.1.06.14.04.03.05.01.08

- 1 779-970506-MS-005
- 2 779-970605-MS-168

Tan floor tile/black mastic (4%, 10%)
6" black cove base (ND)

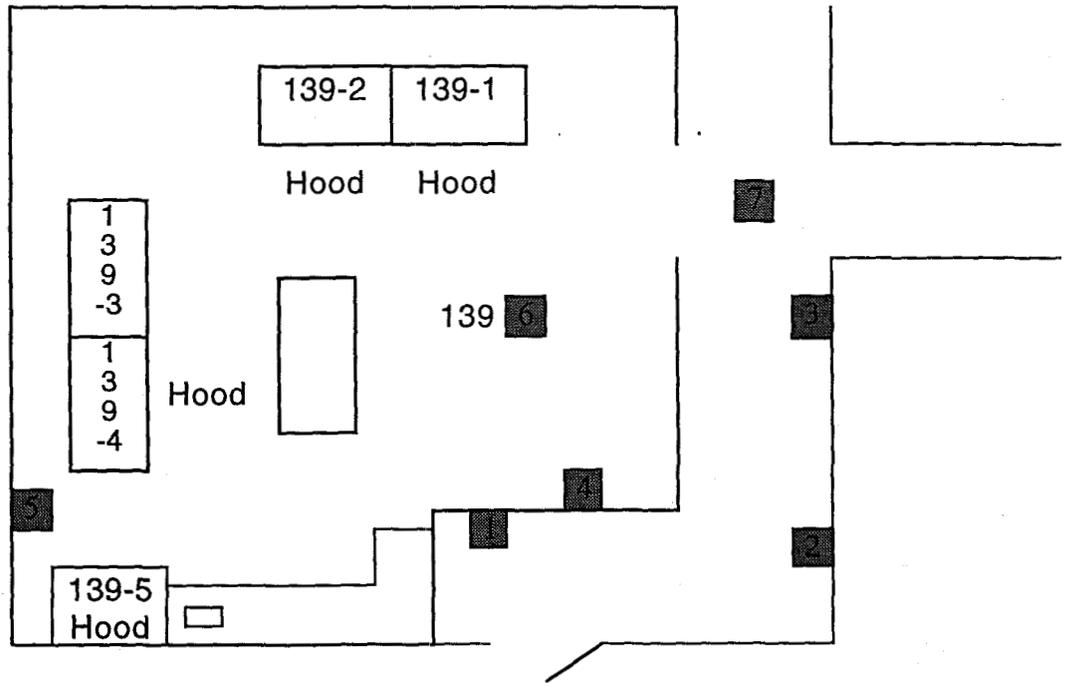
Floor Plan
1.1.06.14.04.03.05.01.09

1	779-970605-MS-156	Drywall, tape, J.C. (.5%)
2	779-970605-MS-157	Drywall, tape, J.C. (TR)
3	779-970605-MS-158	Drywall, tape, J.C. (.75%)
4	779-970605-MS-159	Drywall, tape, J.C. (TR)
5	779-970605-MS-160	Wall plaster, foam (ND)
6	779-970605-MS-161	Poured yellow/black flooring (ND)
7	779-970605-MS-169	2x4 ceiling tile long grooves (ND)

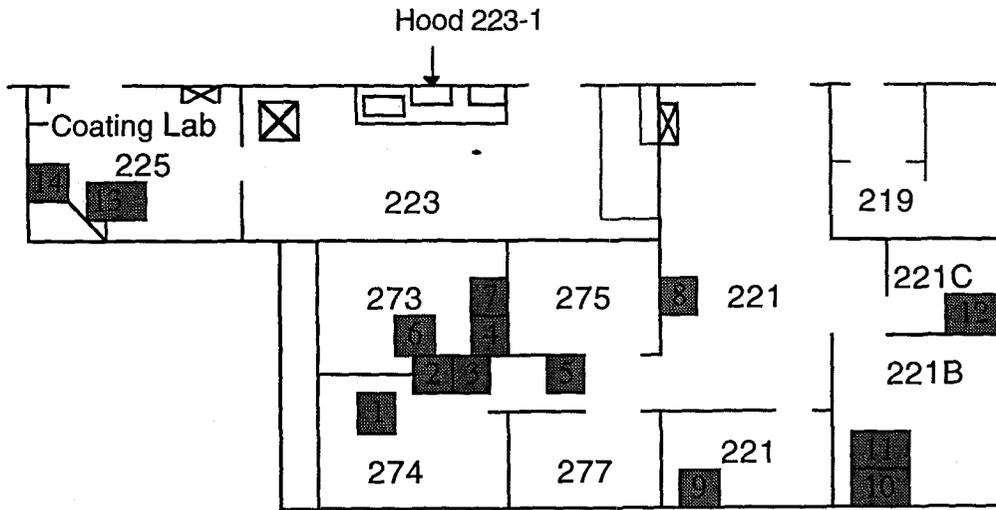
Floor Plan
1.1.06.14.04.03.05.01.10

1	779-970610-MS-172	2X4 Ceiling tile shallow pits (ND)
2	779-970610-MS-173	Drywall, tape, J.C. (2.0%)
3	779-970610-MS-174(QC)	Drywall, tape, J.C. (.25%)
4	779-970610-MS-175	Drywall, tape, J.C. (.5%)
5	779-970610-MS-176	Drywall, tape, J.C. (.75%)
6	779-970610-MS-177	12" white/grey floor tile (5% tile)
7	779-970610-MS-178	4" Khaki cove base (ND)
8	779-970610-MS-179	Wall plaster (ND)
9	779-970610-MS-180	Wall plaster (ND)
10	779-970610-MS-181	Wall plaster, brown drywall (ND)
11	779-970610-MS-182(QC)	Wall plaster drywall (ND)
12	779-970610-MS-183	2x4 Ceiling tile lt pin holes (ND)
13	779-970610-MS-184	Wall plaster skim on cinderblock (ND)
14	779-970610-MS-185	Wall plaster and foam (ND)

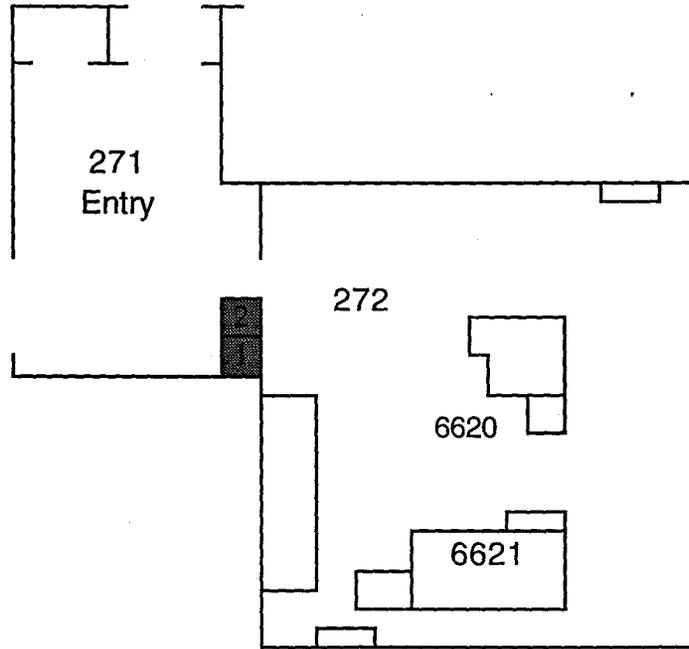
Floor Plan
1.1.06.14.04.03.05.01.11

- 1
- 2

779-970610-MS-189 Drywall (brown) tape, J.C. (.75%)
779-970610-MS-190 Drywall (brown) tape, J.C. (1.75%)
(QC)

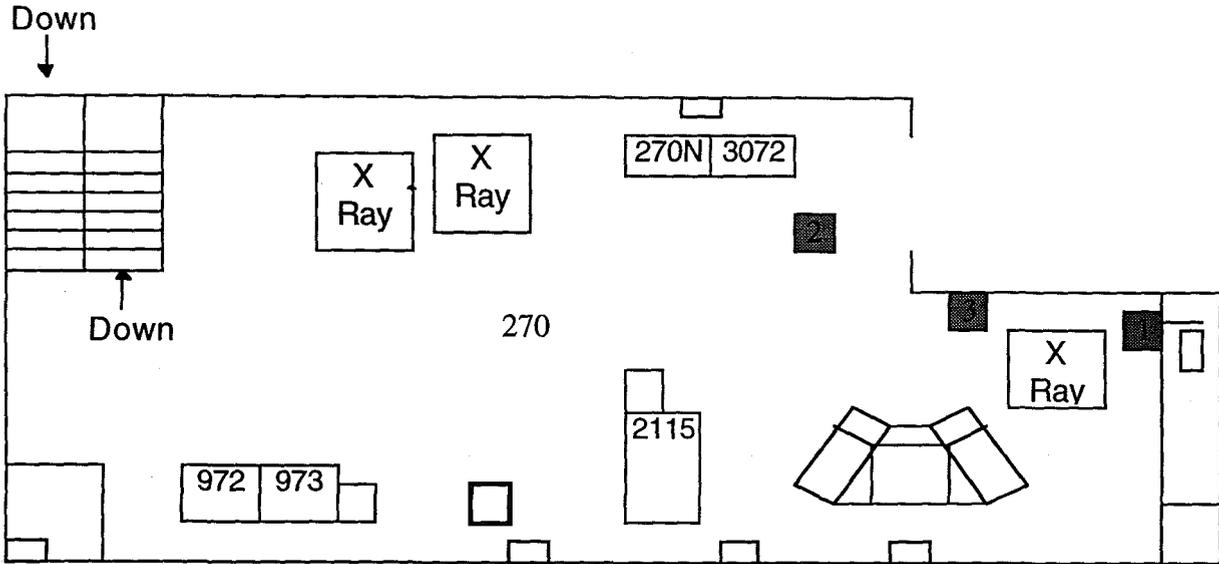
Floor Plan
1.1.06.14.04.03.05.01.15

| 1 | 779-970610-MS-186 | TSI VBM process pipe (15%) |
| 3 | 779-970610-MS-188 | Drywall (brown) tape, J.C. (TR) |

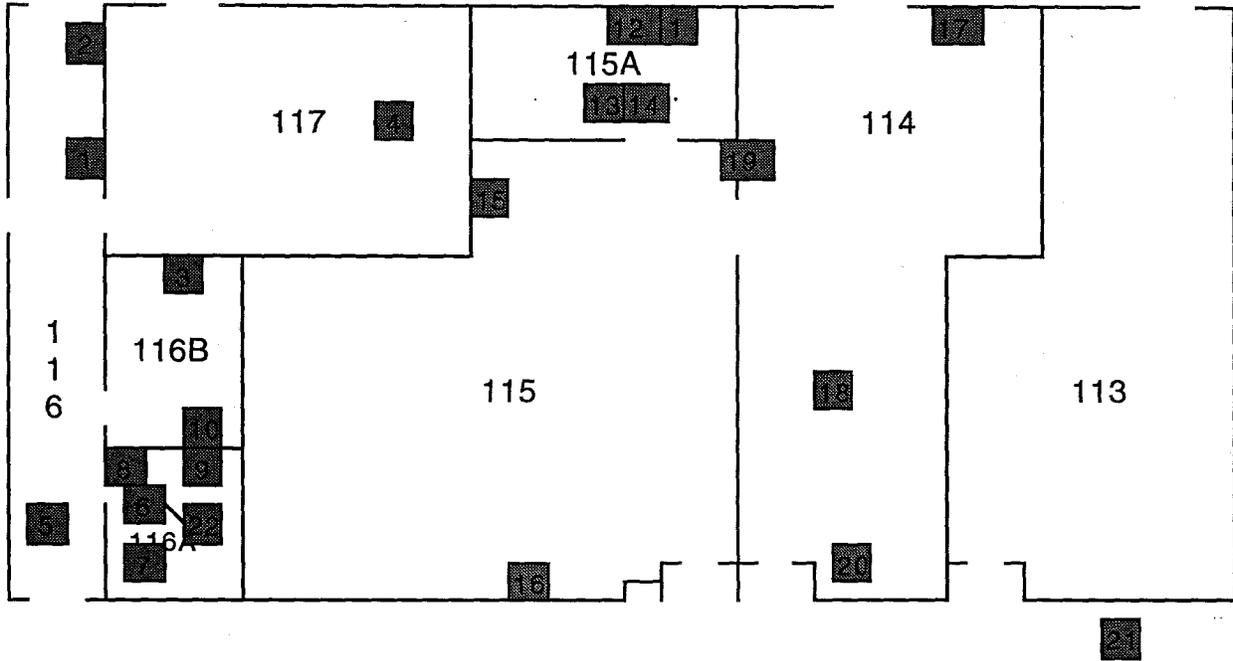
Floor Plan
1.1.06.14.04.03.05.01.21

1	779-970513-MS-025	Wall plaster and foam (ND)
2	779-970513-MS-026	Wall plaster and foam (ND)
3	779-970513-MS-031	Wall plaster and foam (ND)
4	779-970513-MS-032	TSI block on diesel exhaust (20%)
5	779-970513-MS-033	TSI mud on HWS pipe (20%)
6	779-970515-MS-036	2x4 ceiling tile l.g. (4%)
7	779-970515-MS-037	2x4 ceiling tile b.t. (ND)
8	779-970515-MS-038	Drywall, tape, J.C. (2% J.C.)
9	779-970515-MS-039	Drywall, tape, J.C. (ND)
10	779-970515-MS-040	Drywall, tape, J.C. (3%)
11	779-970515-MS-041	Drywall, tape, J.C. (ND)
12	779-970515-MS-042	Wall plaster (2%)
13	779-970515-MS-043	9" light brown floor tile/black mastic (2% tile)
14	779-970515-MS-044	9" light brown floor tile/black mastic (2% tile)
15	779-970515-MS-045	Wall plaster and foam (1%)
16	779-970515-MS-046	TSI mud sanwaste pipe (25%)
17	779-970515-MS-047	Wall plaster and foam (3%)
18	779-970515-MS-048	12" wht. grey mottled floor tile/yellow mastic (2% tile)

19	779-970515-MS-049	Duct/wall penetration filler (65%)
20	779-970515-MS-209	9" tan/brown floor tile (5%)
21	779-970515-MS-212	2x4 ceiling tile long grooves shallow (ND)
22	779-970619-MS-233 (QC)	2x4 ceiling tile shallow long grooves (.25%)

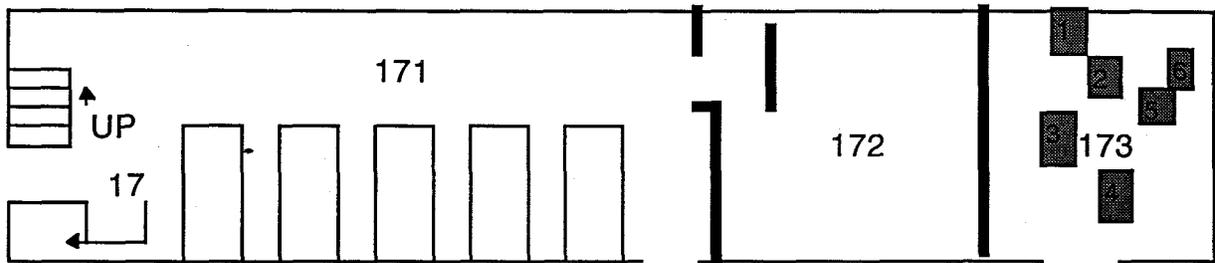
Floor Plan
1.1.06.14.04.03.05.01.22

1	779-970616-MS-203	TSI mud, SS pipe (ND)
2	779-970616-MS-204	TSI mud, S valve (15%)
3	779-970616-MS-205	TSI mud, S valve (ND)
4	779-970616-MS-206	TSI mud, fiberglass, SS pipe (15%)
5	779-970616-MS-207	TSI mud, refrig pipe (ND)
6	779-970616-MS-208	TSI wrap refrig line (ND)

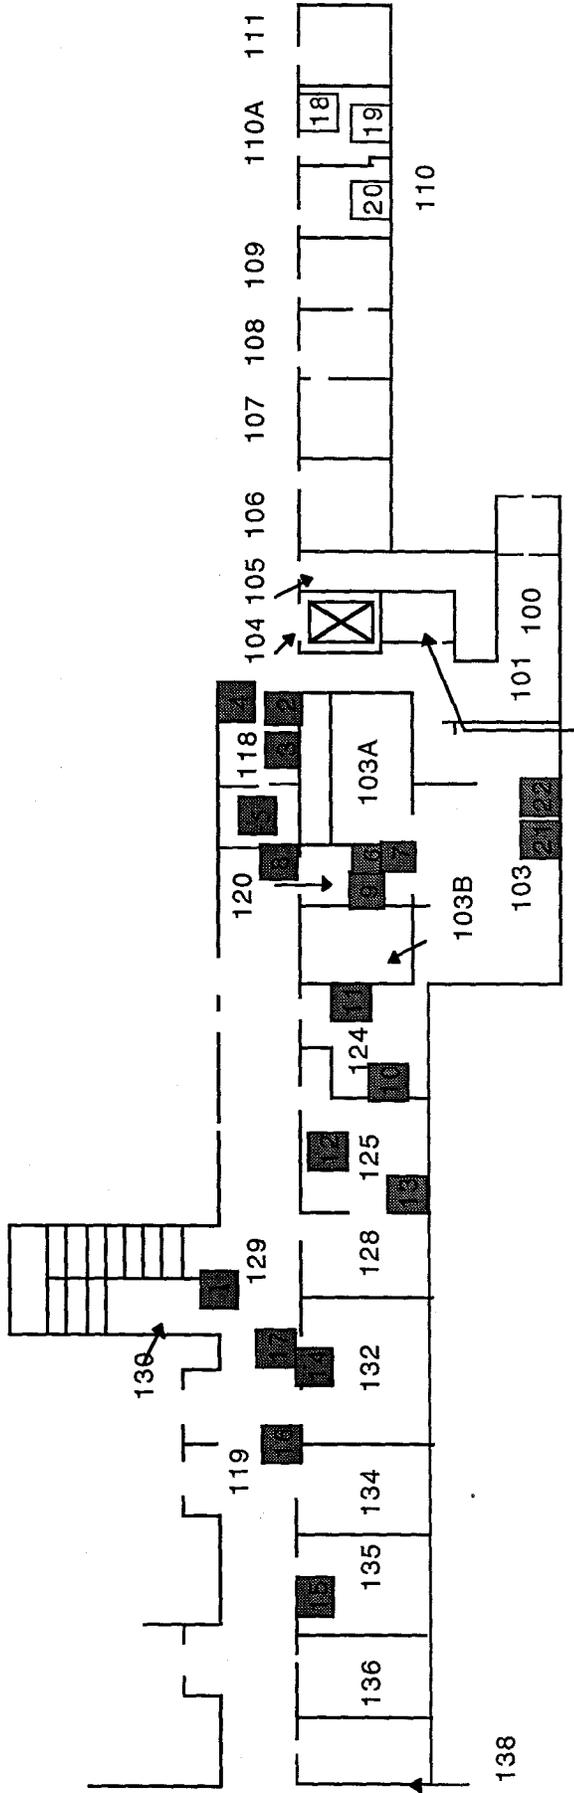
Floor Plan
1.1.06.14.04.03.05.01.23

- 779-970520-MS-064 12" white-tan-brown floor w/black mastic (3% both)
- 779-970604-MS-129 4" black cove base (ND)
- 779-970604-MS-130 12" white-grey-tan mottle floor tile/tan floor tile (15%)
- 779-970604-MS-131 Drywall, tape, J.C., ceiling (ND)
- 779-970604-MS-132 Drywall, tape, J.C., ceiling (ND)
- 779-970604-MS-146 TSI mud, pipe DHWS (ND)
- 779-970604-MS-147 TSI mud, pipe DHWR (15%)
- 779-970604-MS-148 Drywall, tape, J.C. (ND)
- 779-970604-MS-149 Anti skid flooring (ND)
- 779-970604-MS-150 Drywall, 1" flat metal joints (ND)
- 779-970605-MS-151 Wall plaster on metal lathe (ND)
- 779-970605-MS-152 Poured grey-green floor (ND)
- 779-970605-MS-153 Cementitious board, 2" metal joints (35%)
- 779-970605-MS-154 "Techtiem" wallboard, coarse fiber (ND)
- 779-970605-MS-155 4" black cove base (TR)
- 779-970605-MS-170 2x4 ceiling tile long grooves (ND)

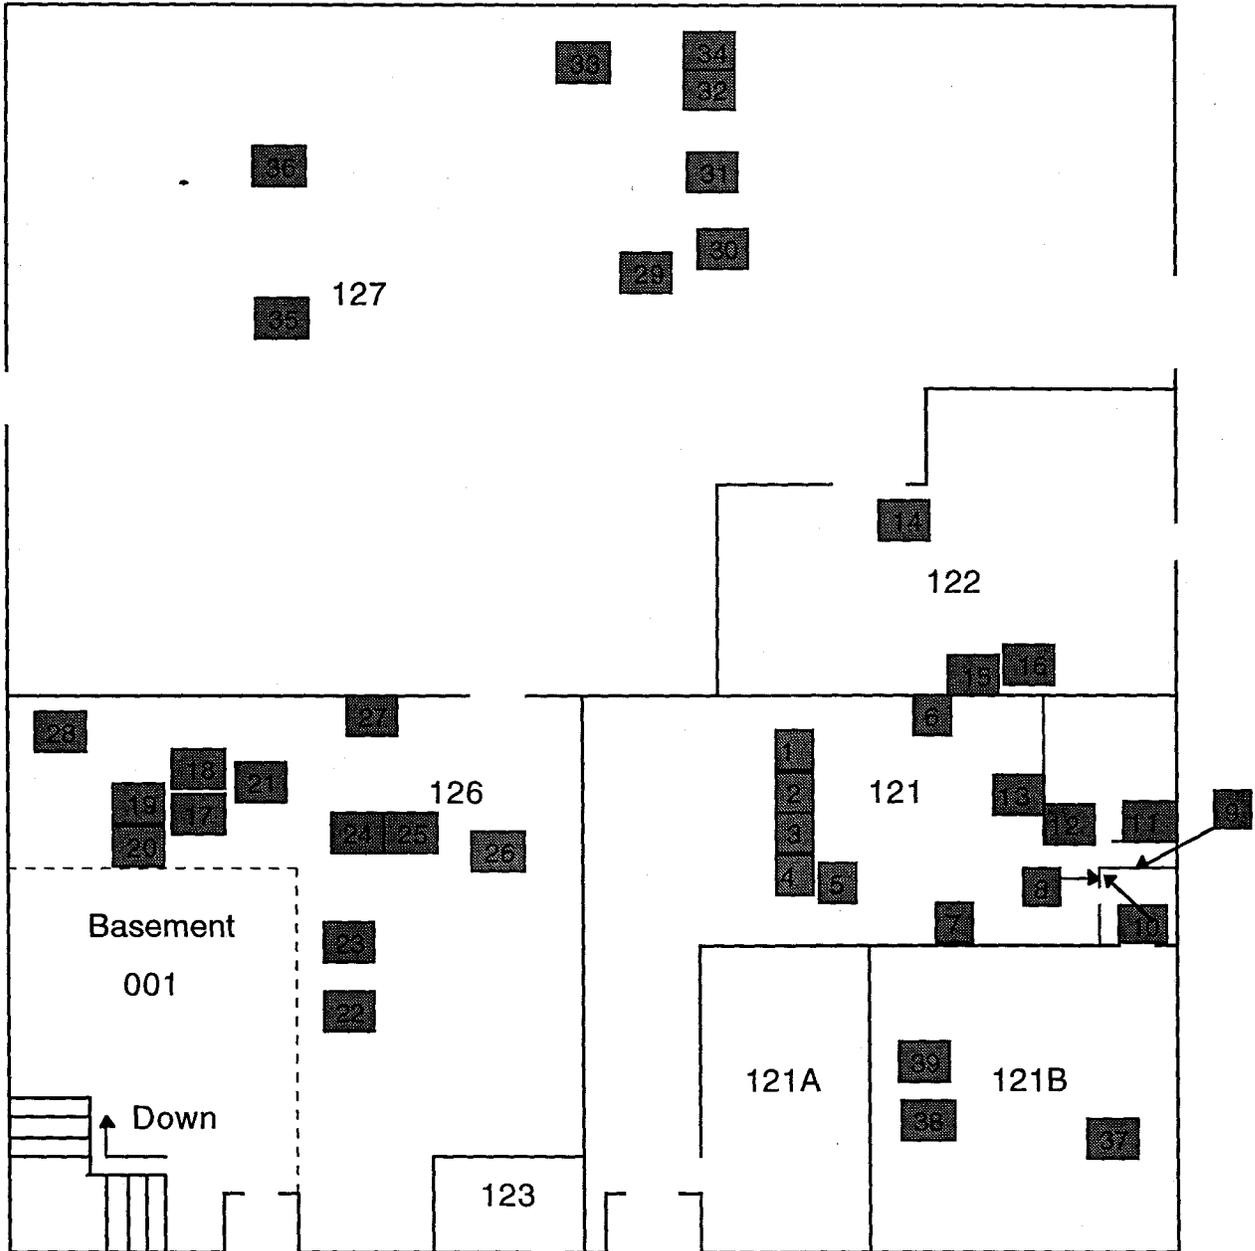
Floor Plan
1.1.06.14.04.03.05.01.24

1	779-970506-MS-006	TSI mud; 1" chiller pipe (20%)
2	779-970506-MS-007	TSI mud; 4" HWR pipe (18%)
3	779-970506-MS-008	TSI VBM; 6" DCW pipe (ND)
4	779-970506-MS-009	TSI block; 10" steam pipe (21%)
5	779-970506-MS-010	TSI mud; 10" steam supply pipe (15%)
6	779-970506-MS-011	Wall plaster (ND)
7	779-970506-MS-012	Wall panel/1/2" joints (35%)
8	779-970506-MS-013	Drywall, tape, J.C. (ND)
9	779-970506-MS-014	Drywall, tape, J.C. (ND)
10	779-970506-MS-015	Drywall, tape, J.C. (ND)
11	779-970506-MS-016	Drywall, tape, J.C. (ND)
12	779-970506-MS-017	Drywall, tape, J.C. (ND)
13	779-970506-MS-018	Drywall, tape, J.C. (ND)
14	779-970506-MS-022	Ceiling Drywall (3% mud)
15	779-970513-MS-023	4" brown cove base (ND)

34	779-970528-MS-123	TSI mud, canvass, fiberglass-pipe (15%)
35	779-970528-MS-124	TSI mud, canvass, fiberglass-duct (ND)
36	779-970528-MS-125	TSI mud, canvass, fiberglass-duct (ND)
37	779-970604-MS-126	Drywall, tape, J.C. (ND)
38	779-970604-MS-127	Drywall, tape, J.C. (ND)
39	779-970604-MS-128	Drywall, tape, J.C. (ND)

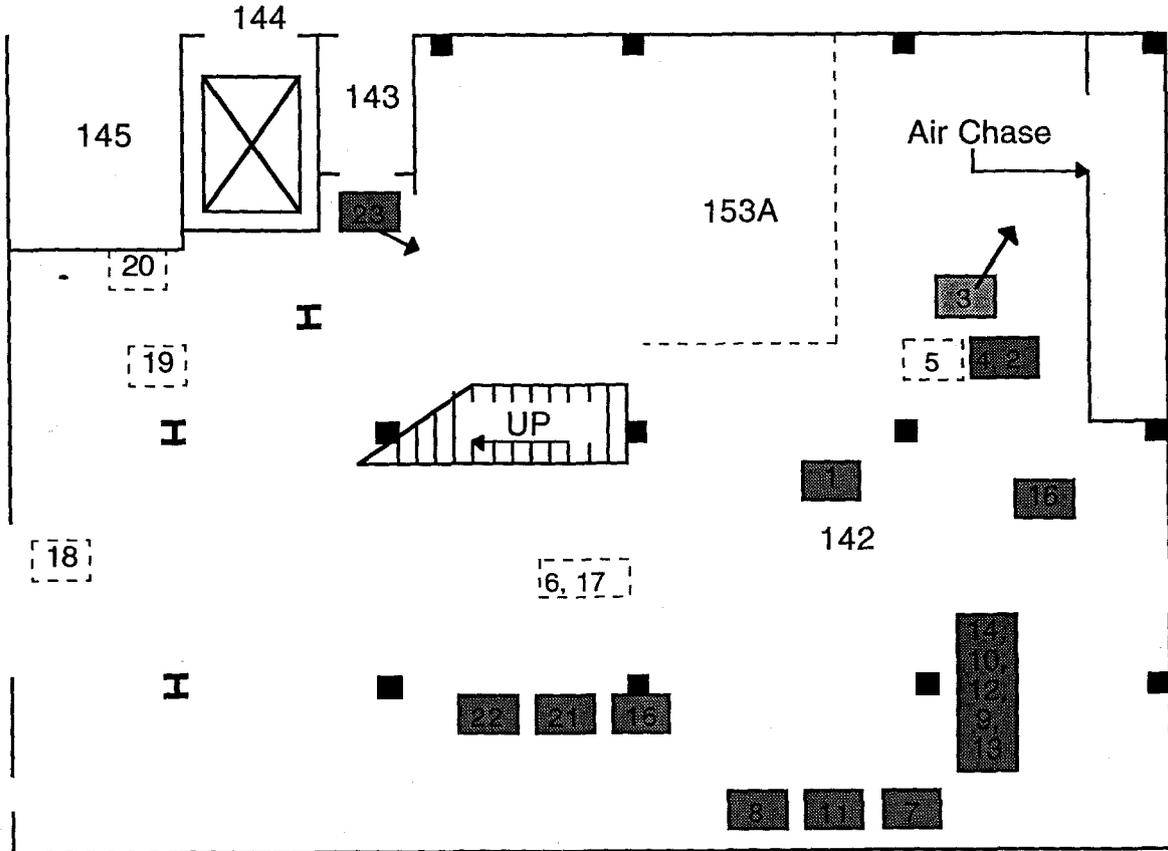
Asbestos 779 Report Plan 25

1	779-970527-MS-095	TSI block and mud (15%)
2	779-970527-MS-096	TSI canvass and mud (85%)
3	779-970527-MS-097	TSI canvass/paper (85%)
4	779-970527-MS-098	TSI canvass, mud, fiberglass (85%)
5	779-970527-MS-099	TSI canvass, mud, fiberglass (85%)
6	779-970527-MS-100	TSI canvass, mud, fiberglass (15%)
7	779-970528-MS-101	Silverpaint, paper, foam (50%)
8	779-970528-MS-102	Silverpaint, paper, foam (50%)
9	779-970528-MS-103	Silverpaint, paper, foam (50%)
10	779-970528-MS-104	Silverpaint, paper, foam, (50%)
11	779-970528-MS-105	Silverpaint, paper, foam (60%)
12	779-970528-MS-106	Silverpaint, paper, foam (60%)
13	779-970528-MS-107	White mastic canvass, block (10%)
14	779-970528-MS-108	White mastic paper, foam (ND)
15	779-970528-MS-109	White mastic canvass, block (80%)
16	779-970528-MS-110	Silverpaint, paper, foam (60%)
17	779-970528-MS-111	TSI canvass, mud, fiberglass (80%)
18	779-970528-MS-112	Drywall, tape, J.C. (ND)

19	779-970527-MS-113	Drywall, tape, J.C. (.25%)
20	779-970527-MS-114	Drywall, tape, J.C. (.25%)
21	779-970527-MS-115	TSI mastic block housing (70%)
22	779-970527-MS-116	TSI mastic, mud, fiberglass (65%)
23	779-970527-MS-117	Drywall, tape, J.C. (TR)

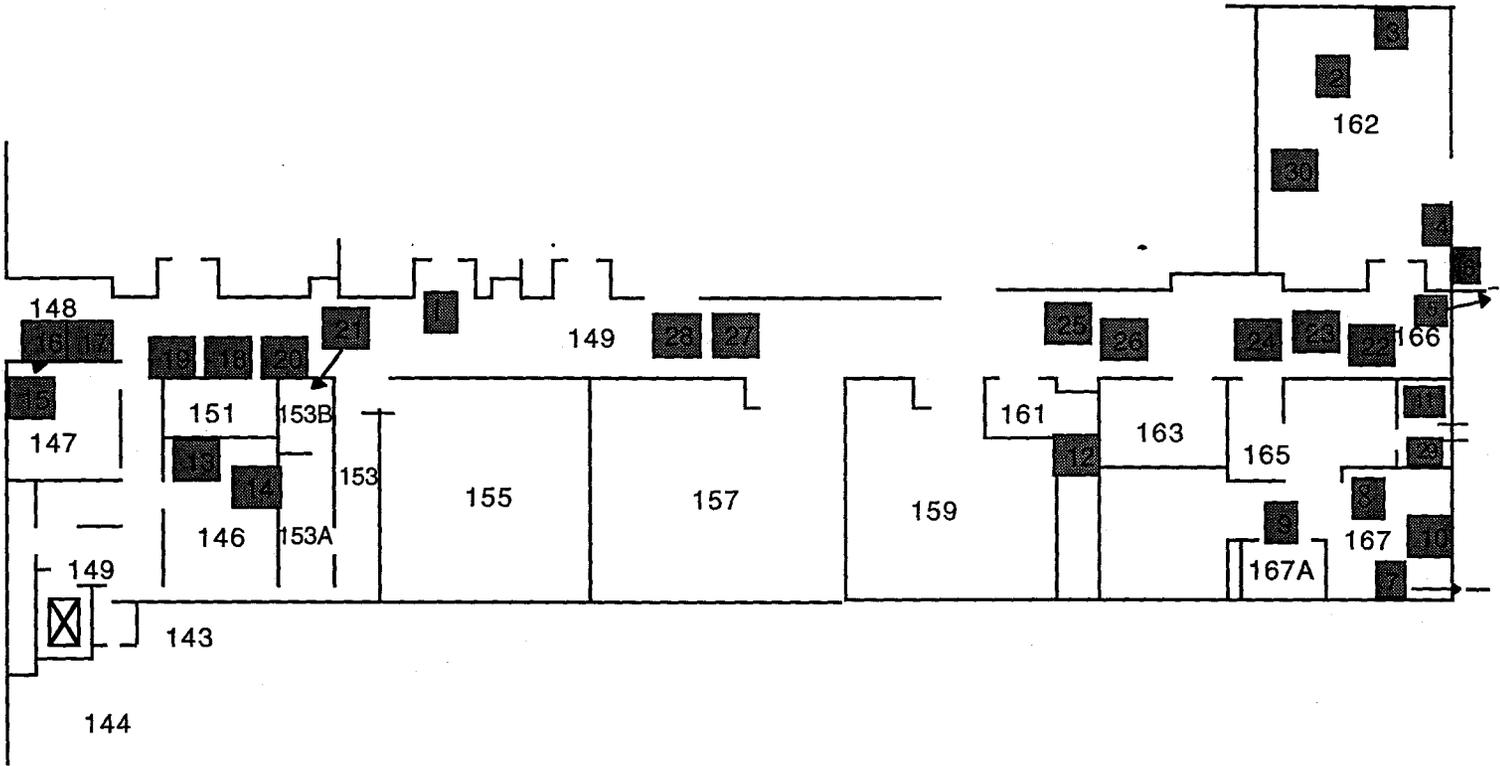
Floor Plan
1.1.06.14.04.03.05.01.26

1	779-970314-MA-001	12" tile tan/brack mastic (3%, 8%)
2	779-970425-MS-002	TSI mud insulation (ND)
3	779-970425-MS-003	Drywall, tape and joint compound (2.75% in J.C.)
4	779-970425-MS-004	Drywall, tape and joint compound (2.5% in J.C.)
5	779-970506-MS-019	Corrugated cement board (18%)
6	779-970513-MS-020	Drywall, tape and J.C. (.75% J.C.)
7	779-9705013-MS-021	Caulk (ND)
8	779-970513-MS-027	2x4 ceiling tile (ND)
9	779-970516-MS-028	Ceiling drywall (1.5% J.C.)
10	779-970513-MS-029	Drywall, tape, J. C. (1.75% J.C.)
11	779-970513-MS-030	12" tan floor tile (5% tile)
12	779-970515-MS-057	TSI mud DHW pipe (10%)
13	779-970522-MS-079	Drywall, tape, J.C. (T.R. in J.C.)
14	779-970522-MS-080	4" khaki cove base (ND)
15	779-970522-MS-081	Drywall, tape, J.C. (.75% in J.C.)
16	779-970522-MS-082	Drywall on cinderblock (.25% in J.C.)
17	779-970522-MS-083	Drywall, tape, J.C. (ND)
18	779-970522-MS084	Drywall, tape, J.C. (ND)

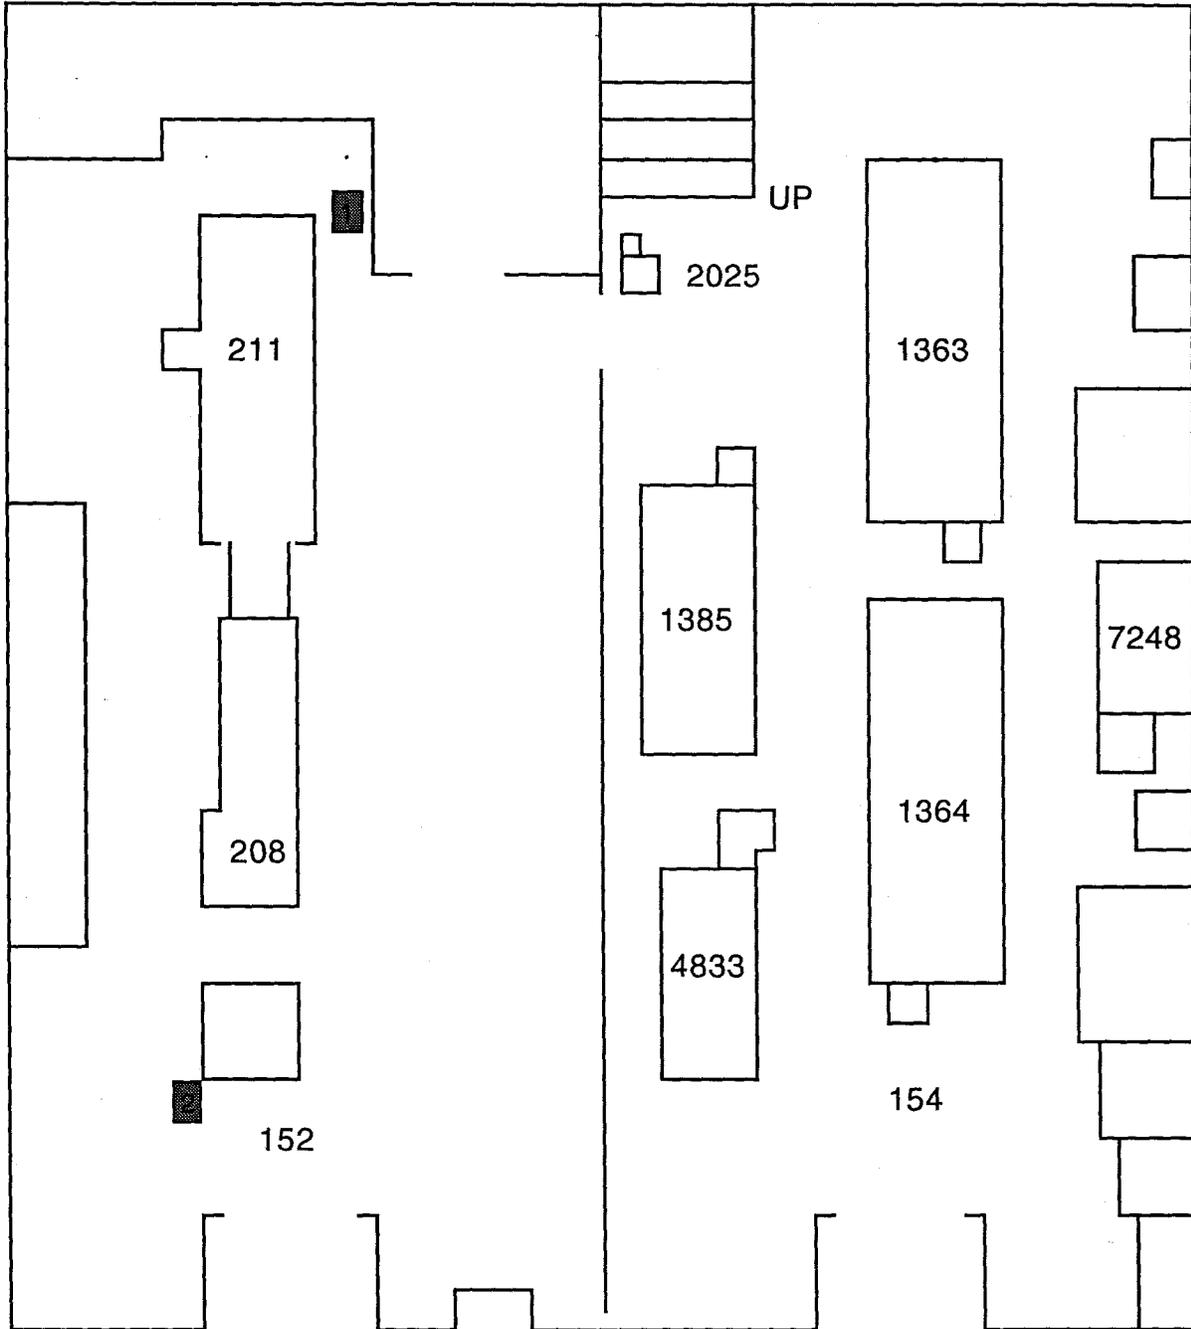
Floor Plan
1.1.06.14.04.03.05.01.27

1	779-970515-MS-058	Poured floor lt. brown (ND)
2	779-970515-MS-059	TSI mud HW pipe hanger (10%)
