MEMBRANE FAILURE AT THE OPERABLE UNIT NUMBER 2 (OU-2) FIELD TREATABILITY UNIT (FTU) ON NOVEMBER 15, 1993 - NMH-651-93

**MEMBRANE FAILURE RESULTING IN
SHUTDOWN OF OPERATIONS AT THE
OPERABLE UNIT NUMBER 2 FIELD
TREATABILITY UNIT**

November 30, 1993

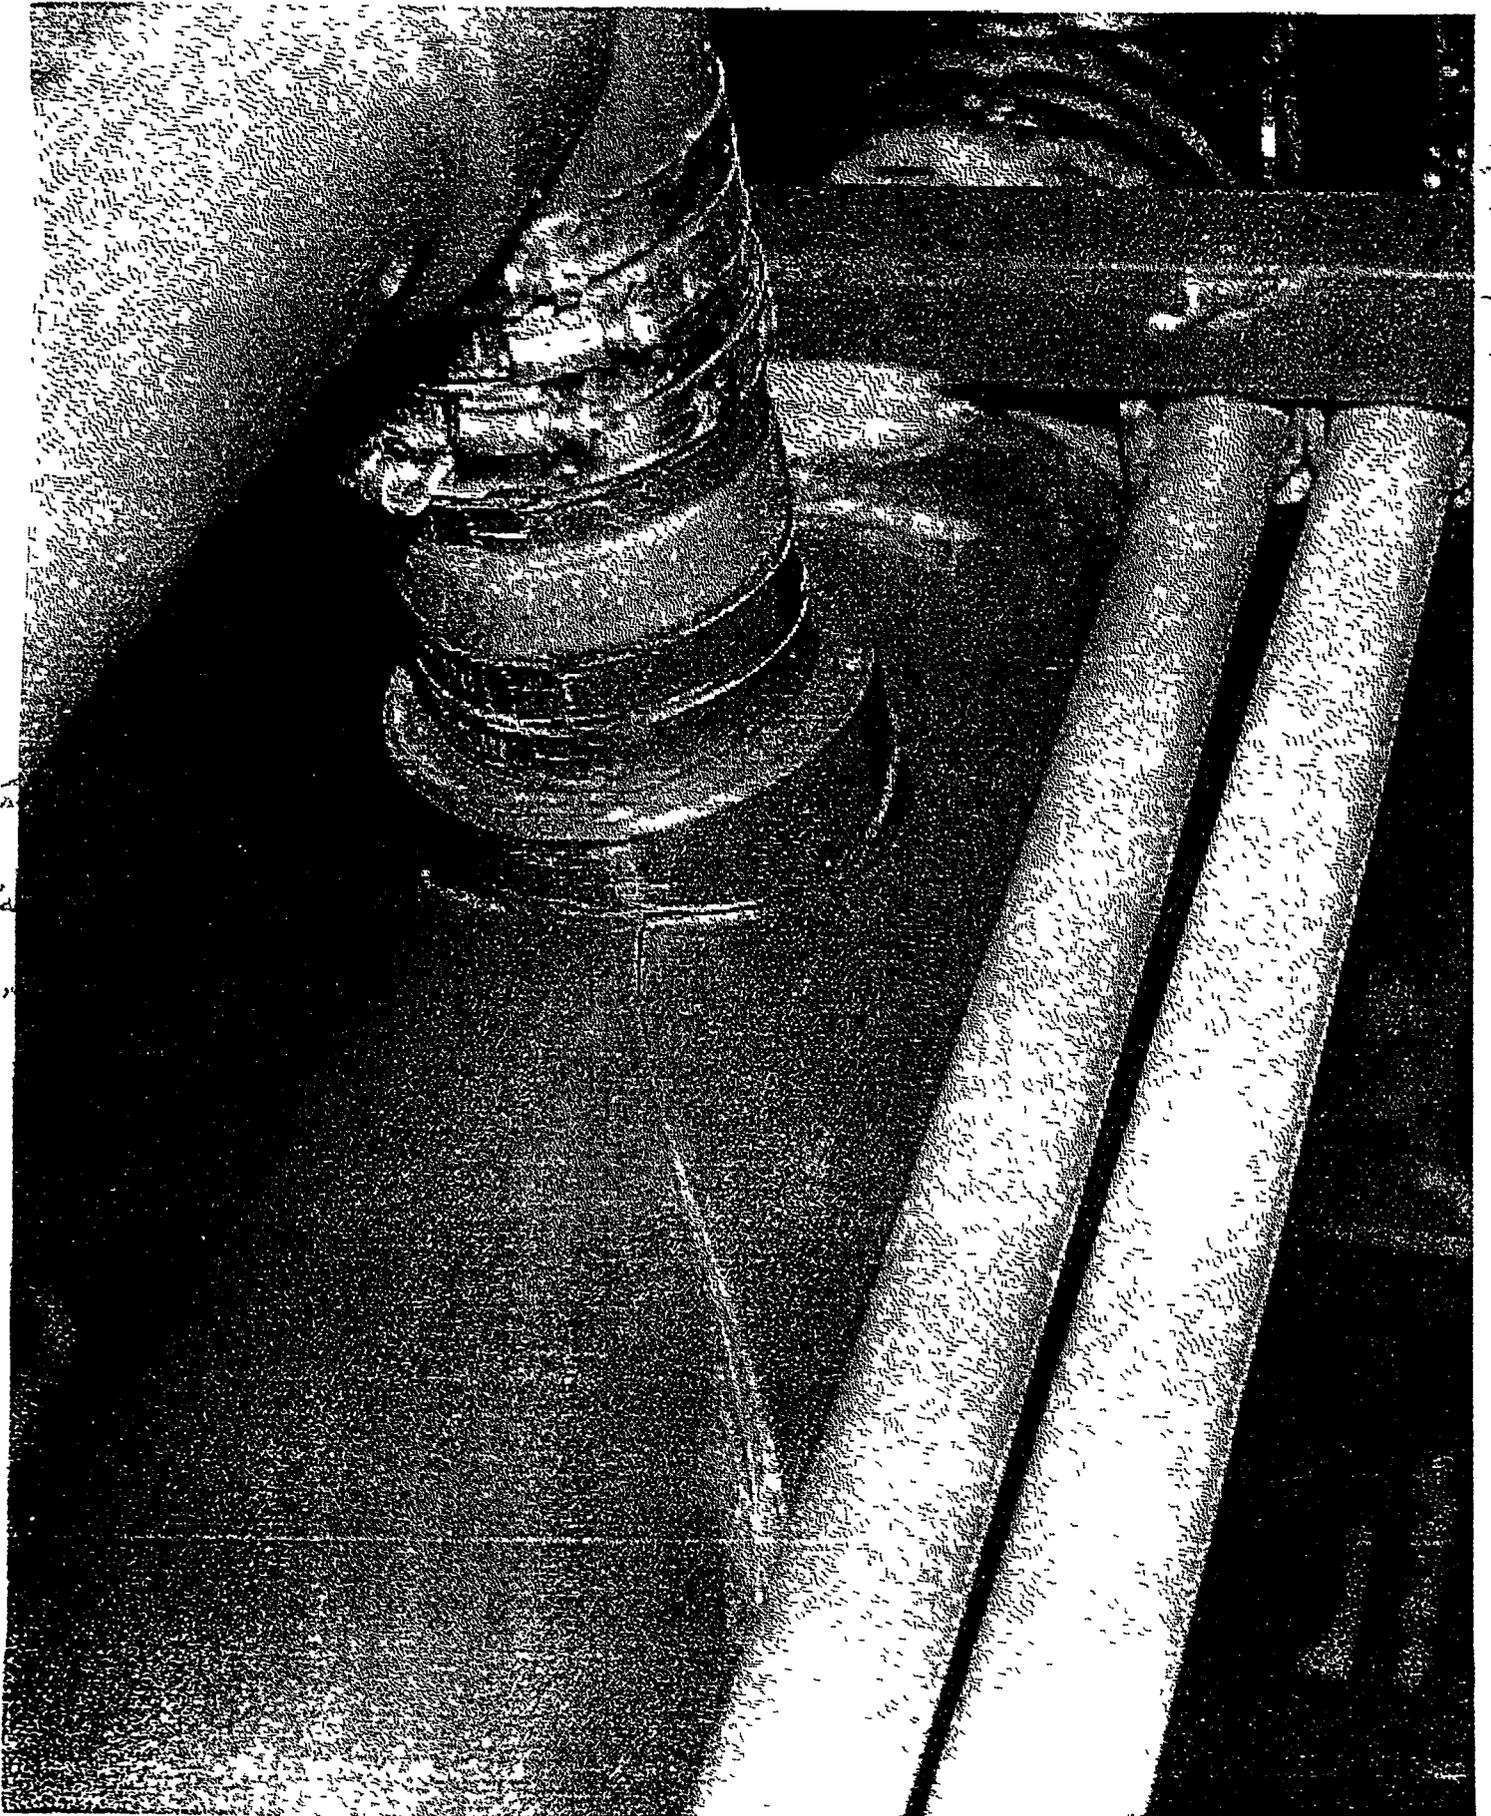
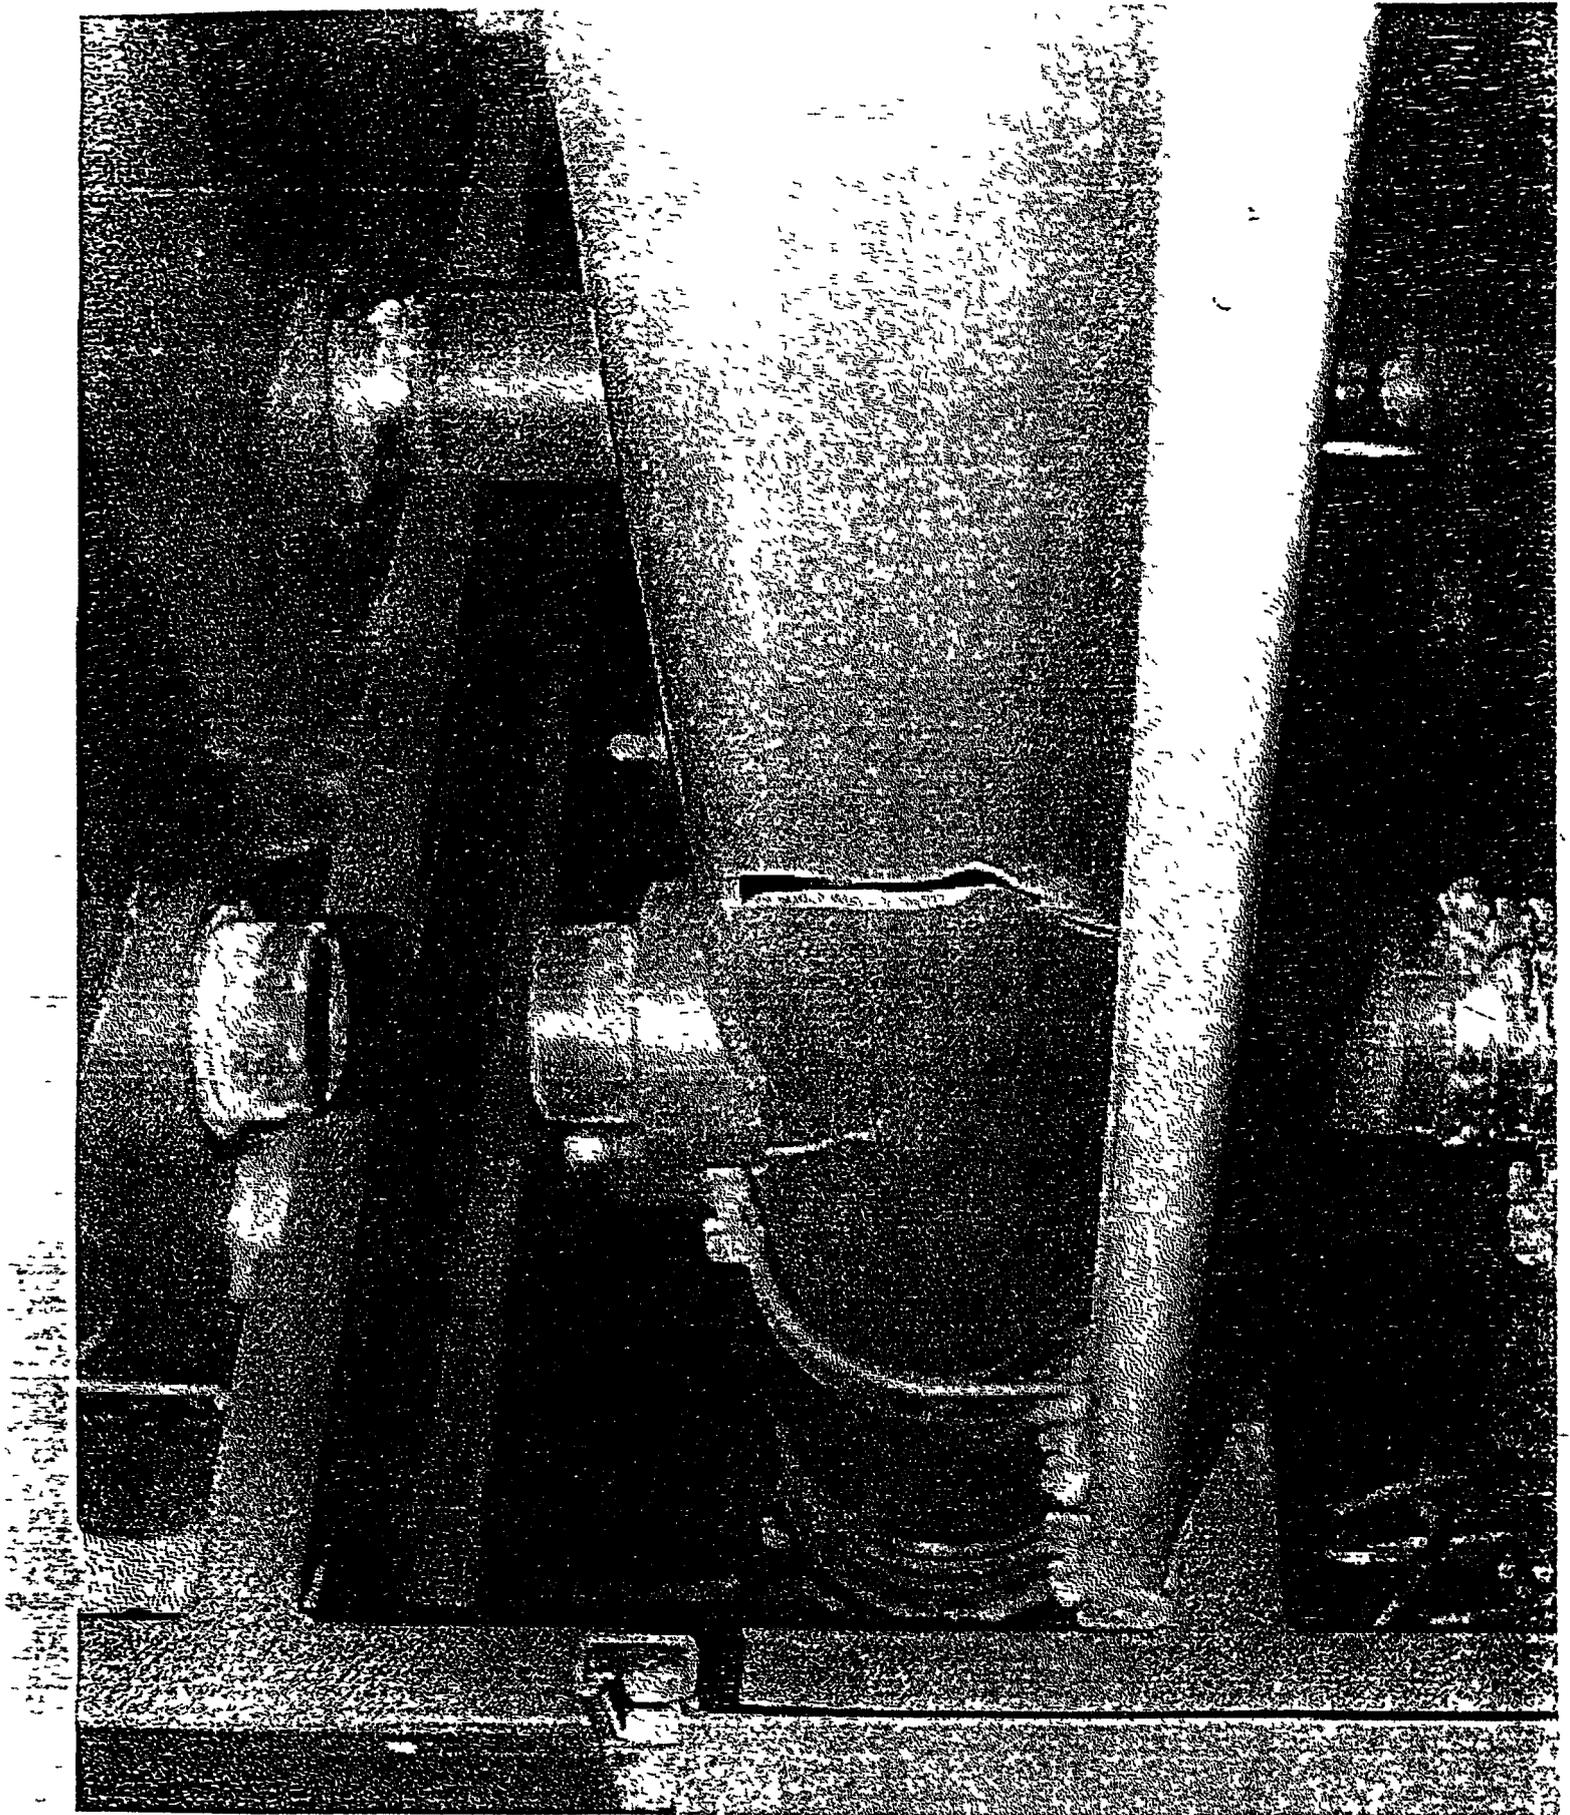
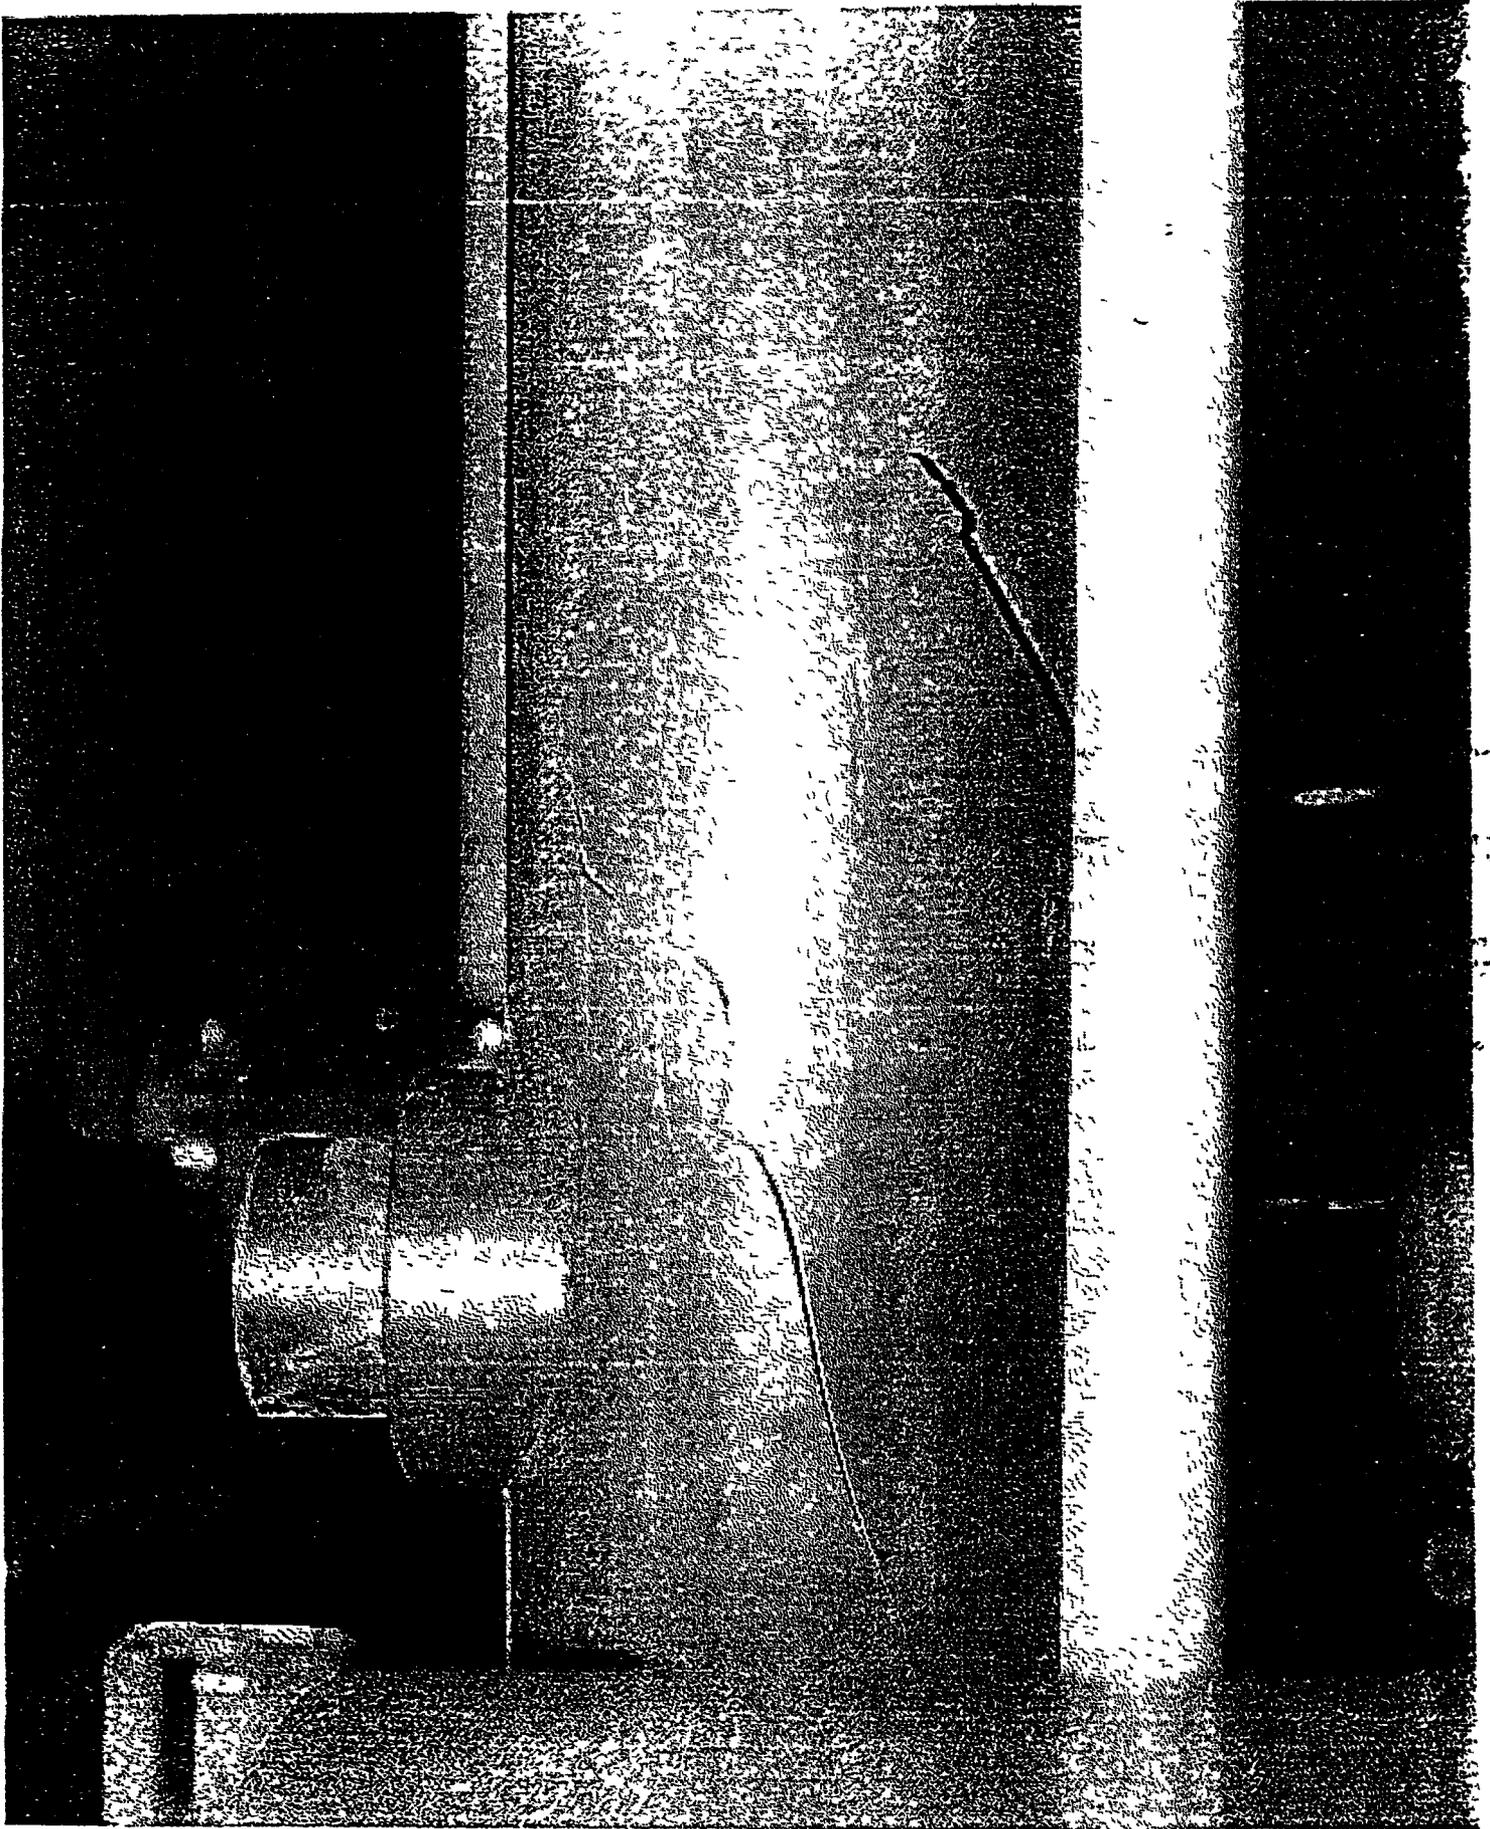
**PHOTOGRAPHS
OF
MEMBRANE FAILURE**

17 00 hrs	Radiological Engineering (J L Anderson) briefed of occurrence, and determined that there was no radiological concern. As a precaution, radiological and VOC monitoring was performed (no detectable contaminants).
	17 00 hrs	Subcontractor began pumping water from secondary containment into the concentration tank (TK-8), located in Trailer T900A. Began to clean trailer.
	17 05 hrs	Cause of spill identified as a material failure of the blank membrane. Appendix B shows photographs of the failure.

The blank membrane failed as a result of a material failure in the 6" PVC piping The cause of the material failure appears to be a weak glued fitting The fitting failed at 46 psi, (normal operating pressure), which is below the rated working pressure of 180 psi for the membrane It is assumed that the poor glue fitting was initially capable of operating at the rated pressures, but due to nearly continuous operation of the facility for the last nineteen months, mechanical vibrations have most likely caused fatigue to occur at the weak fitting in the membrane

The cause of the membrane rupture was a material failure of the 6" PVC blank membrane The failure occurred at normal operating pressures, well below the maximum operating pressure of the pipe Normal preventative maintenance could not have caught the problem prior to failure, as when the pipe failed it gave no warning (leaks) As a result of the membrane failing, a solids flush could not be performed, causing the upper membranes to become clogged All efforts were made to bring the facility back to an operable status, but due to the extent of the clogged membranes it took several days to perform the work During the shutdown, additional membranes were ordered and installed in the microfiltration system to increase the capacity of the system, reduce chemical use, and reduce periods of non-collection
