TRANSMITTAL OF CLOSE-OUT REPORT FOR TRAILER T117A -- FEG-041-03

Type 1 Facility Closeout Report

TRANSMITTAL OF CLOSE-OUT REPORT FOR BUILDING 116 -- FEG-042-03

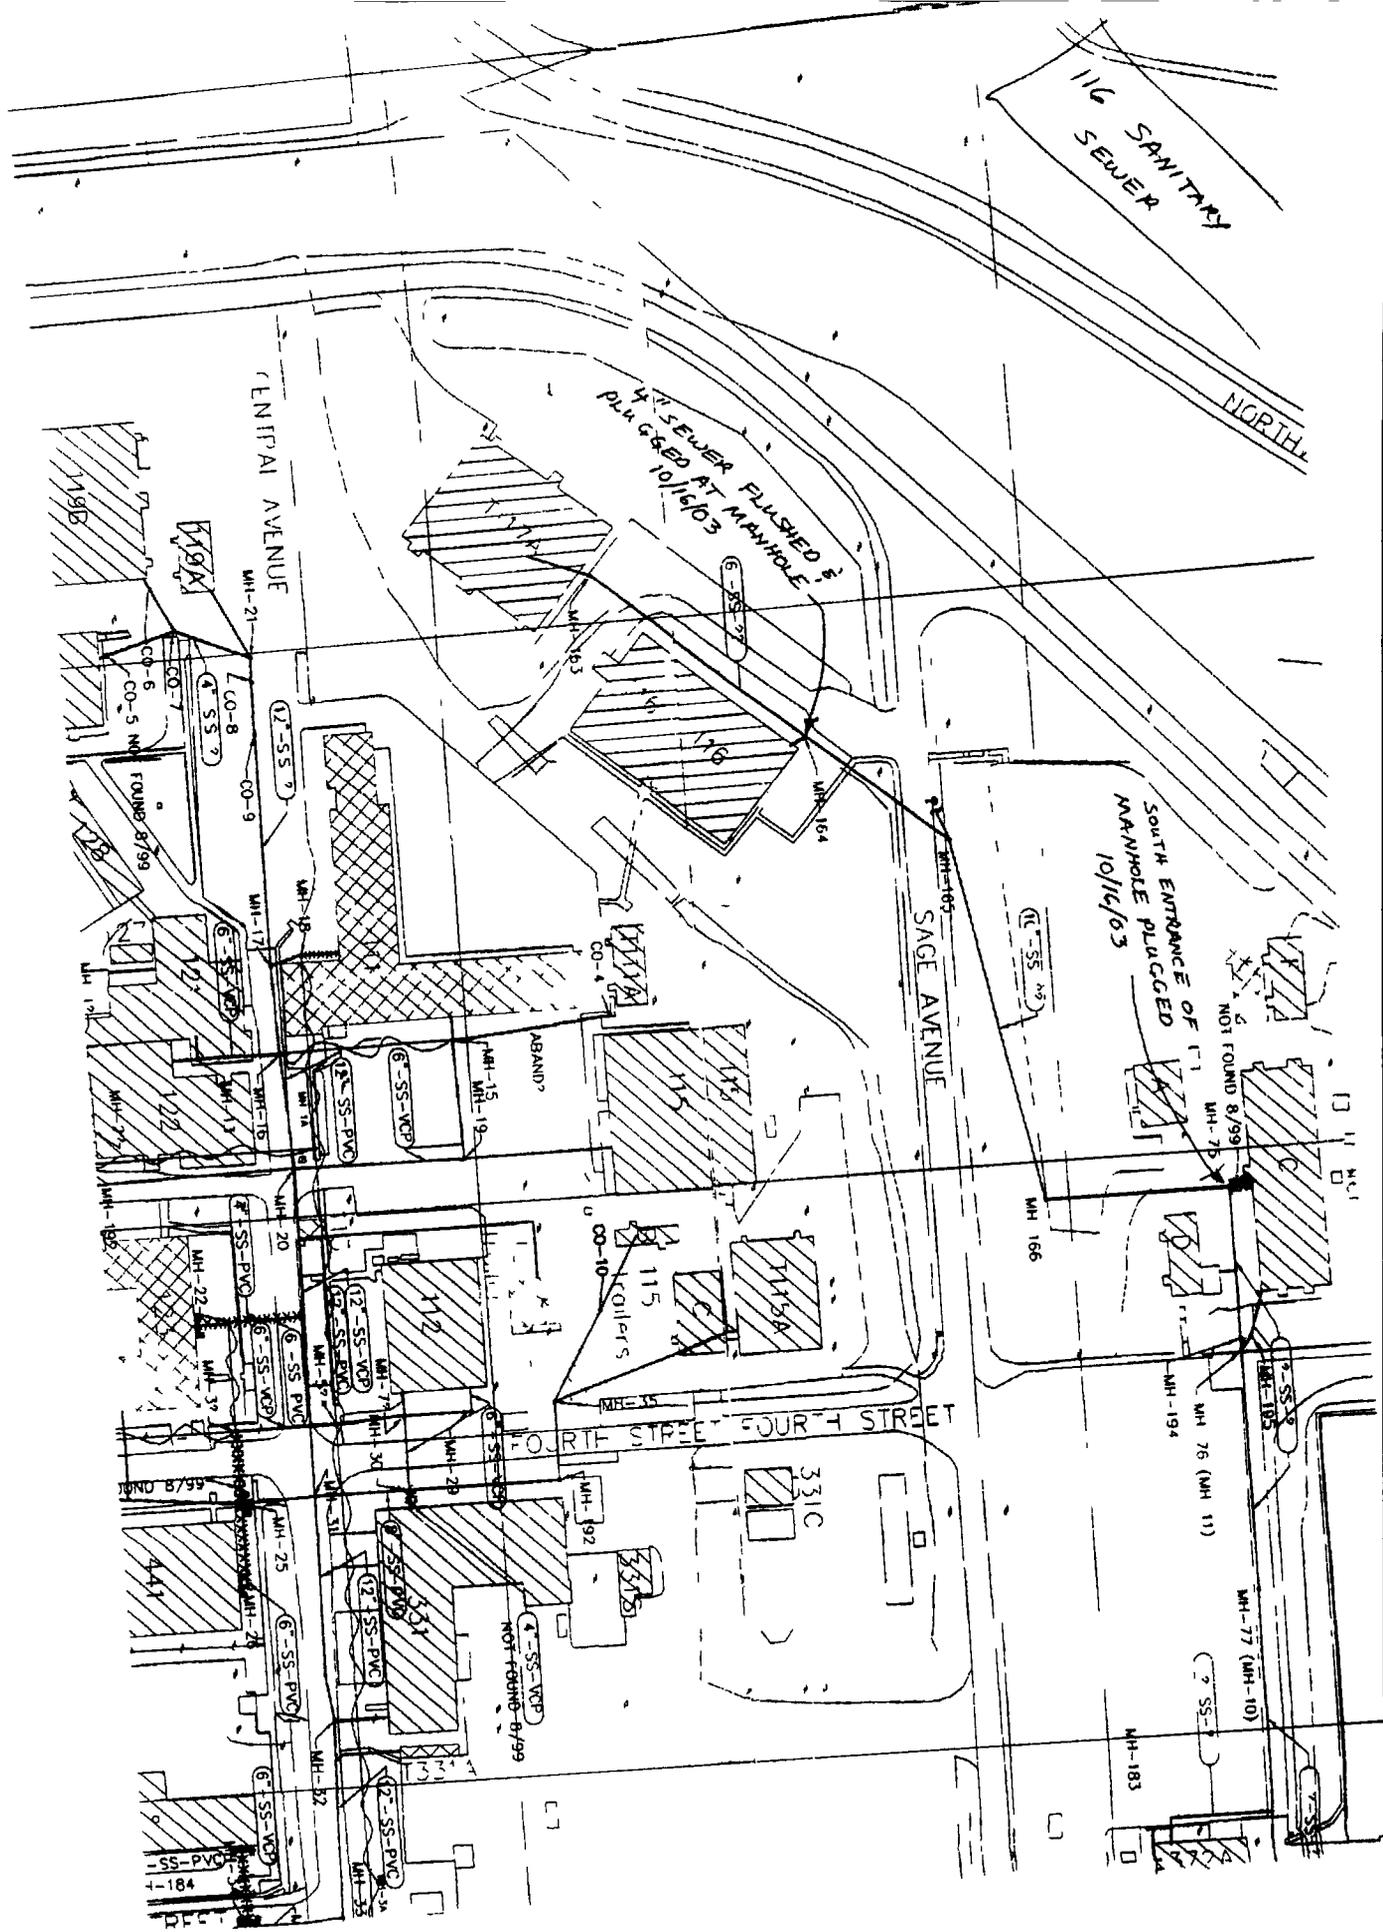
116 SANITARY SEWER

1/2" SEWER FLUSHED & PLUGGED AT MANHOLE 10/16/03

SOUTH ENTRANCE OF MANHOLE PLUGGED 10/16/03

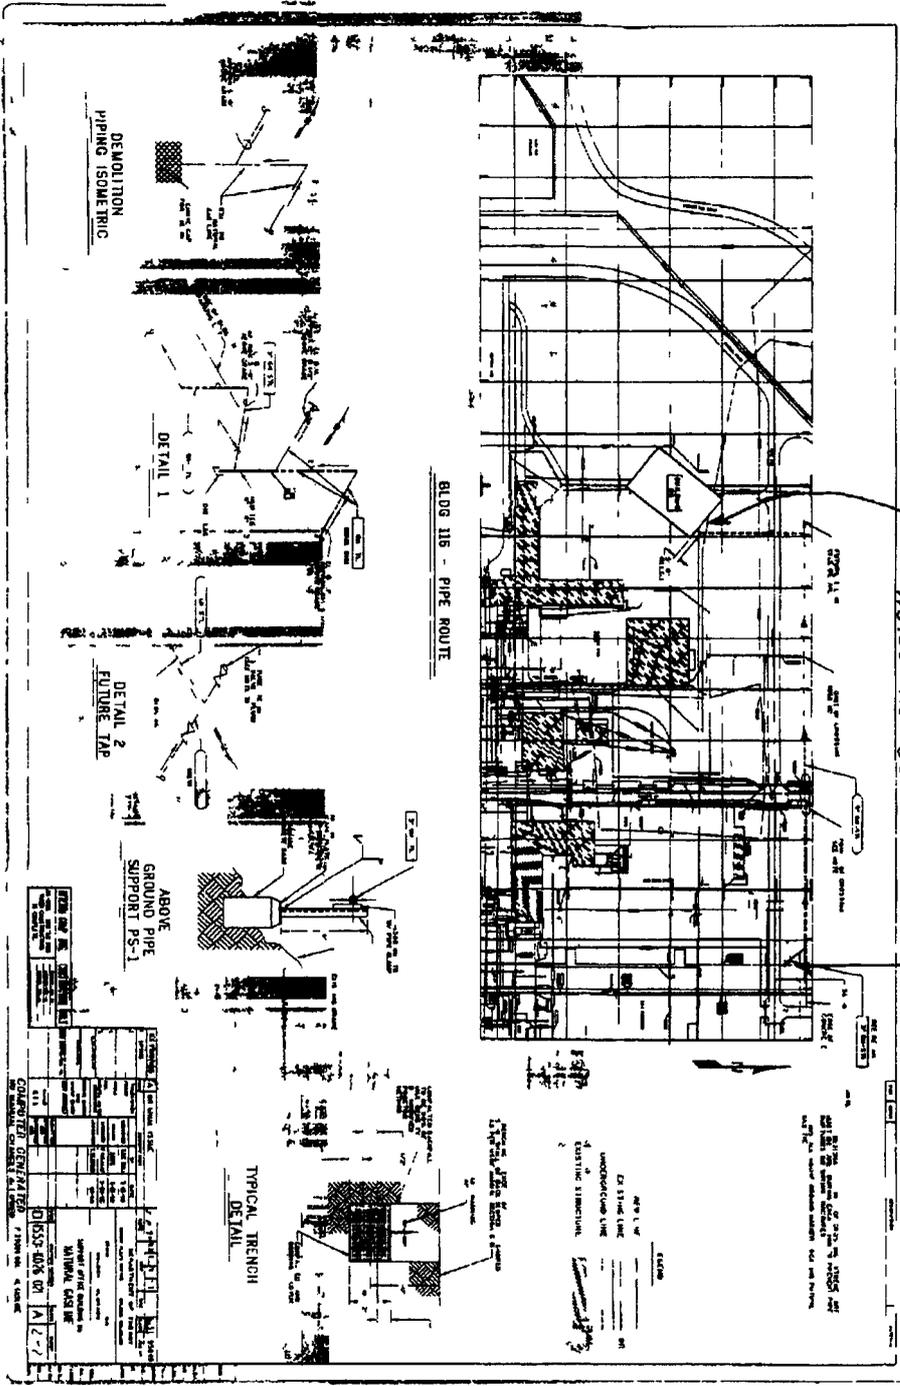
NATURAL GAS
 B116

GAS LINE PURGED &
 ABANDONED IN PLACE
 12/2/02,
 REMOVED & BELOW
 GRADE NOV 03

3" GAS LINE AIR
 CAPPED ABOVE GROUND
 12/12/02
