**POTENTIAL INCIDENTS  
OF CONCERN**

**4, 6, 9, 11, 14, 15, 17, 18,  
41, 42, 44, 47, AND 57**

**ACTION/NO ACTION  
RECOMMENDATIONS**

**May 6, 2004**

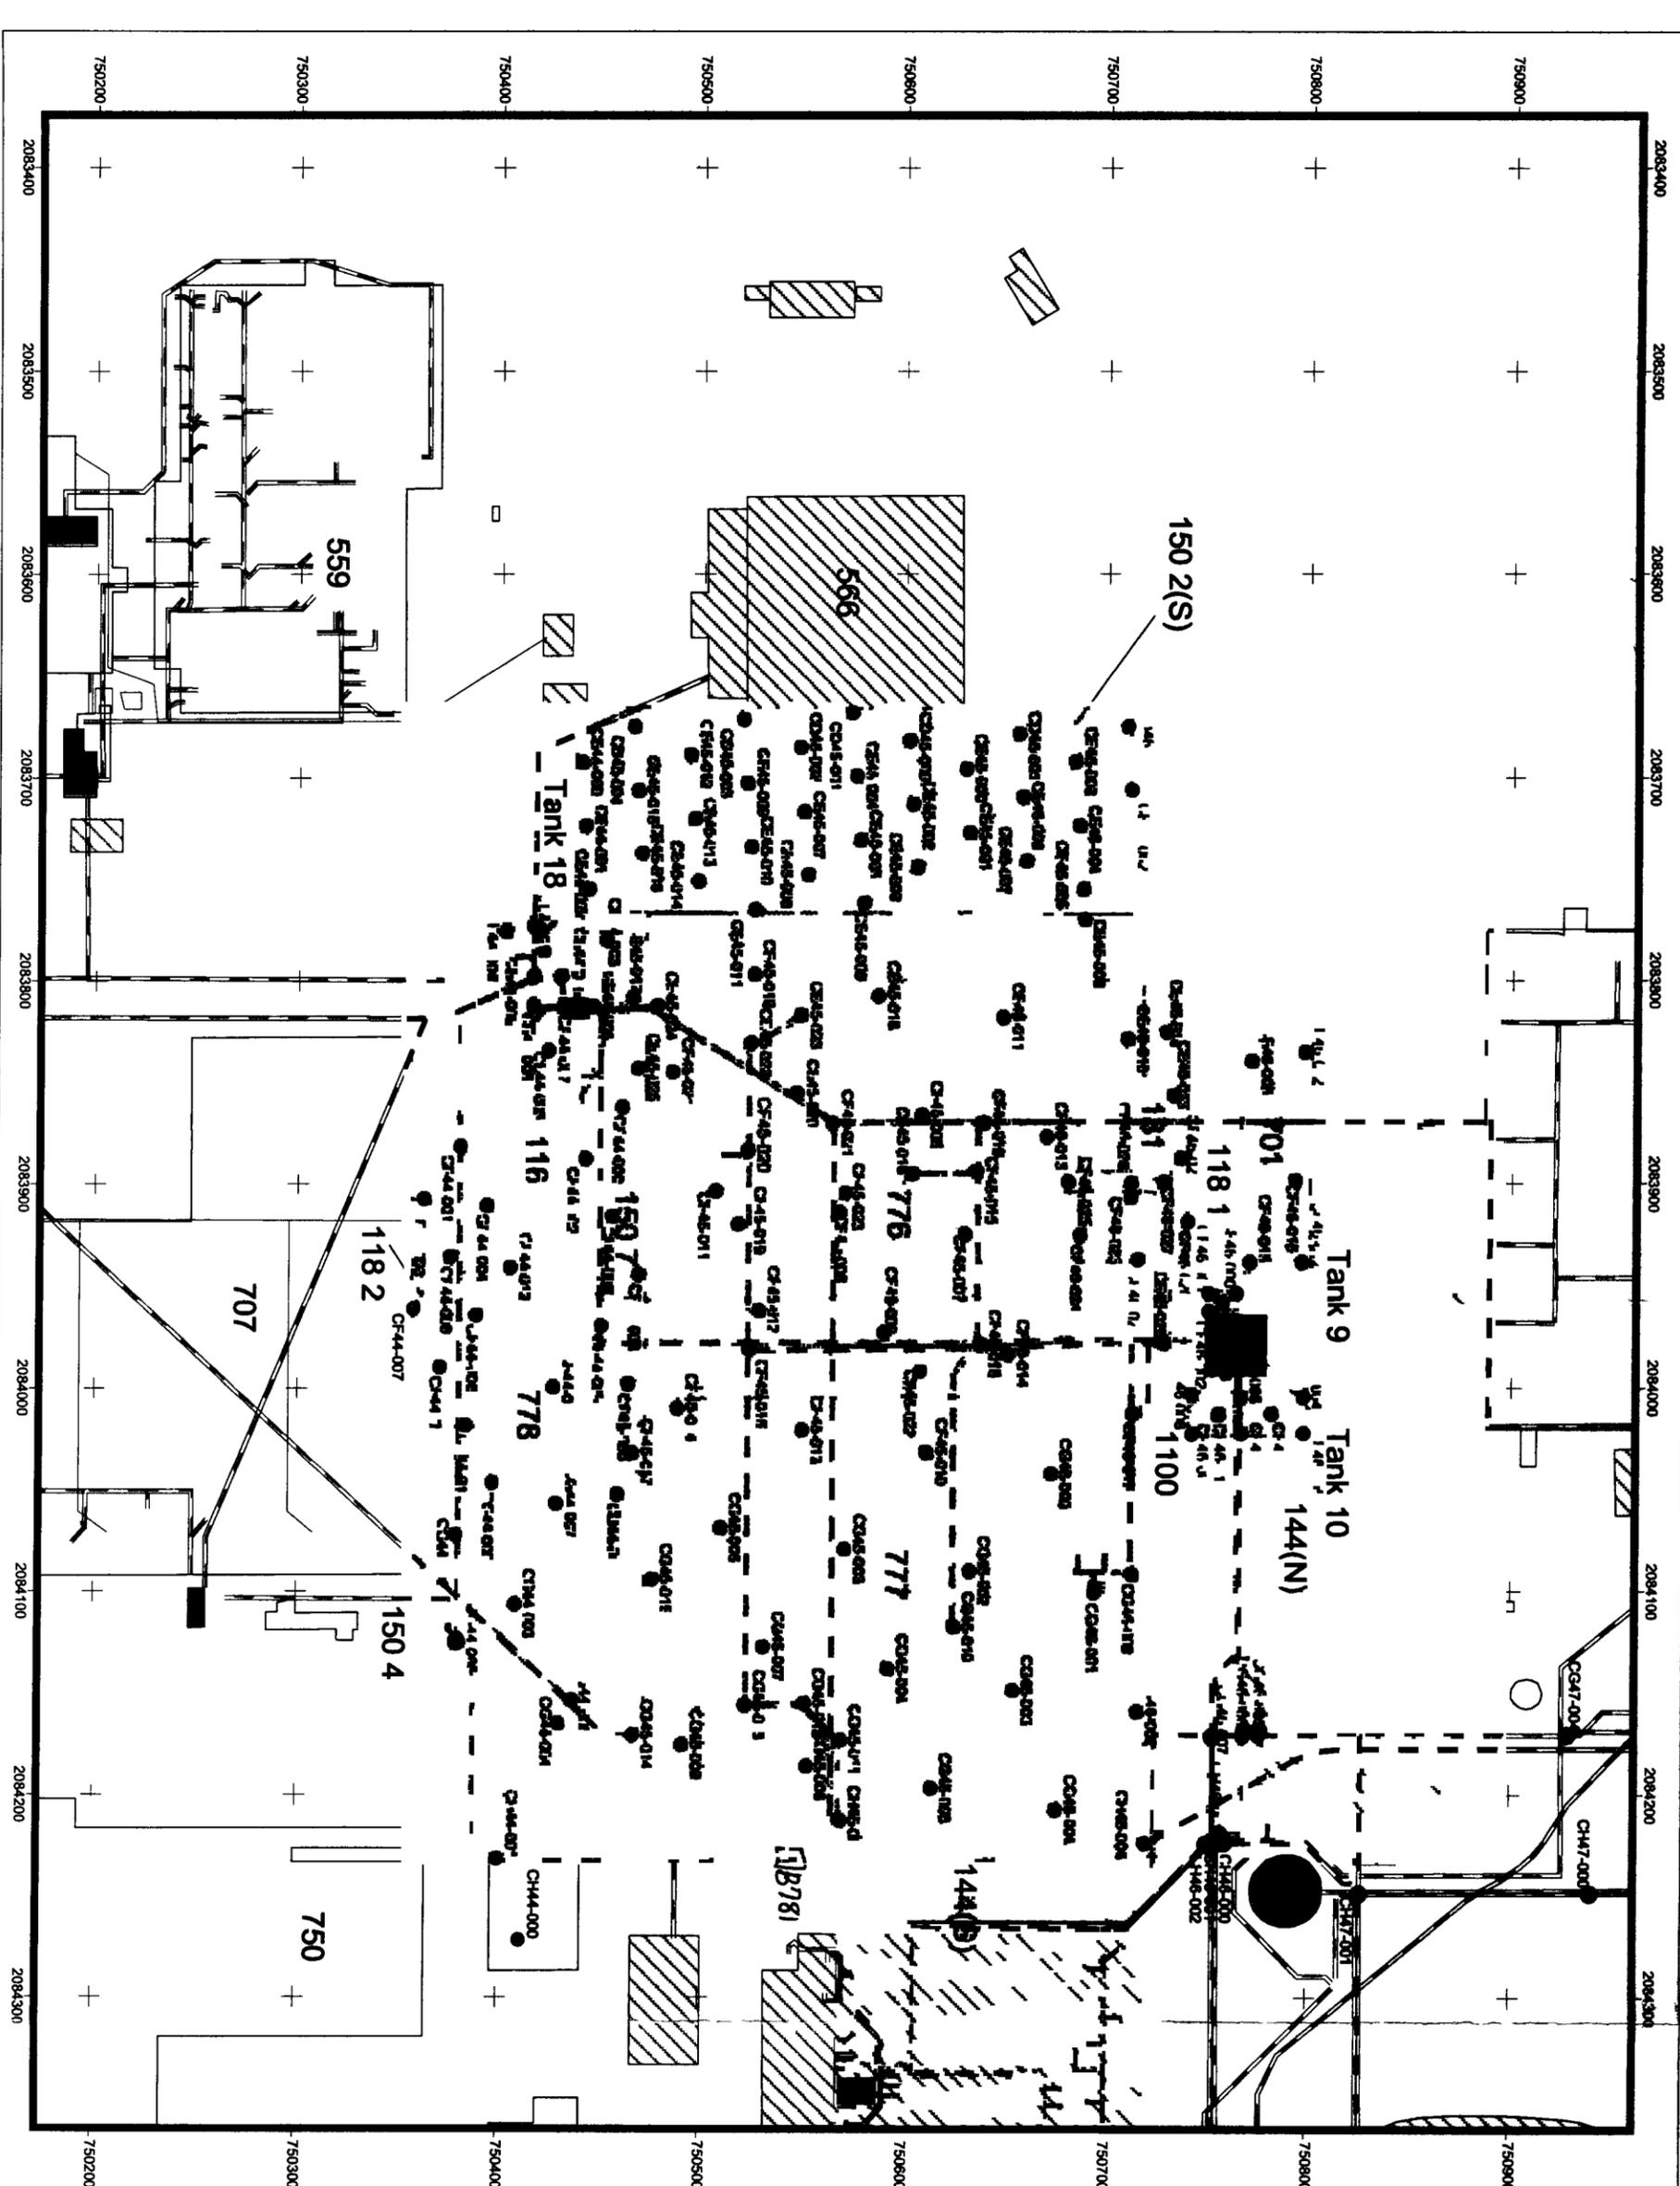
**Figure 5**  
**Proposed Sampling Locations**  
**for IHSS Group 700-3**

Although Buildings 776/777 subsurface soil was sampled in accordance with IASAP Addendum IA-03-04 (IHSS Group 700-3), a sample was not collected below or near Building 781 (see attached map). However, considering the recent information gathered on the spill, sampling of the soil would not have been necessary.
