RE: Final Closeout Report for IHSS Groups 100-4 and 100-5

RE: Approval of RCRA Closure Plan for Components of Unit 40 located in Building 123

6.0 CONCLUSION AND CLOSURE CERTIFICATION

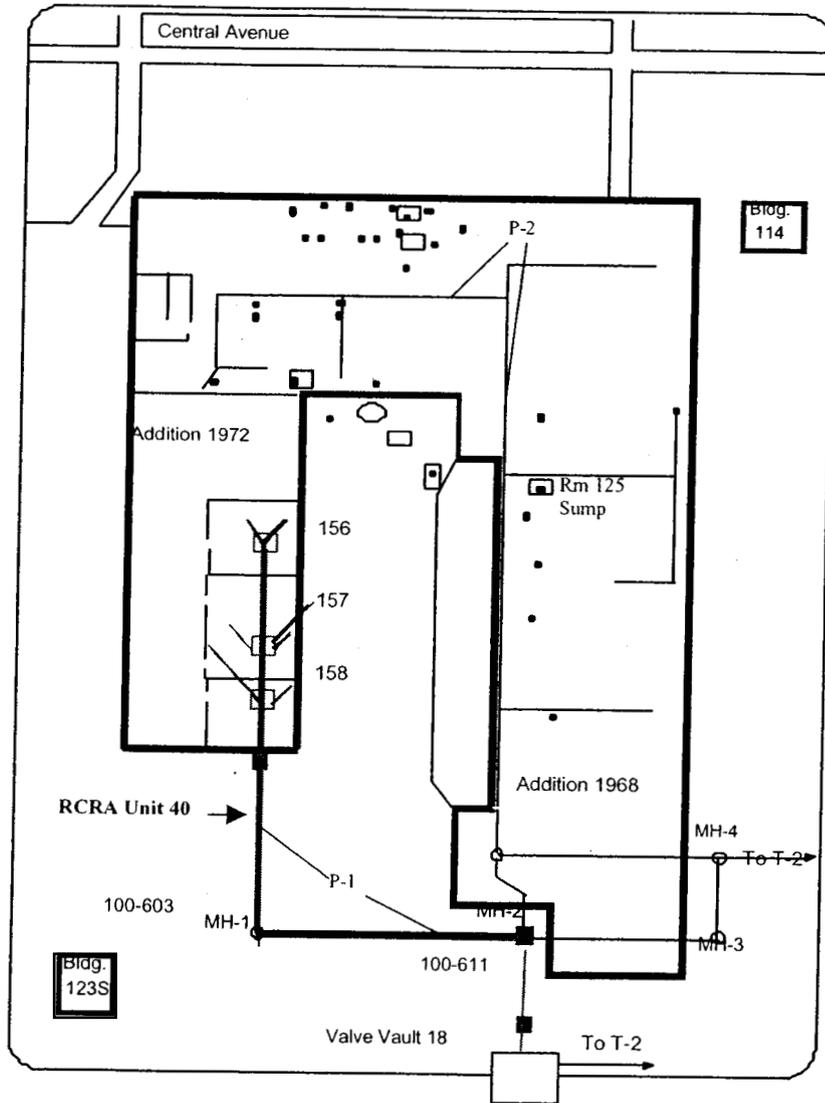
Figure 14
 UBC 123 RCRA Unit 40

RCRA Unit 40 process waste lines were excavated and removed from the sumps to MH-2. The remaining pipeline south of MH-2 to Valve Vault 18 could not be removed because of infrastructure constraints. The location of this pipeline is shown on Figure 15. The sump (waste pumping station), reported to be in Room 125, was not found. The following portions of RCRA Unit 40 were removed:

RCRA closure accelerated action objectives were to remove all sumps and process waste lines associated with RCRA Unit 40, shown in Figure 14, within the IHSS Group 100-4 AOC. Sumps located in the former Rooms 156, 157, and 158 were removed along with more than 1 foot of soil around and beneath the sumps. Pipelines between former Rooms 156 and 157 sump locations and more than 1 foot of soil around and beneath the pipelines was excavated. Additionally, approximately 40 feet of associated 4-inch diameter stainless steel pipeline was excavated. Contamination was not detected on sumps or associated pipeline.

Confirmation samples were collected from the soil beneath each sump location, and one was collected in the pipeline trench between the Room 156 and 157 sump locations. Confirmation sampling locations are BU38-0002, BU38-0003, BU38-0004, BU38-0005, BU38-0006, BU38-0007, BU38-0008 and the Central Point of Southern PWL. Soil samples were analyzed for radionuclides only because they could be used as an indication of sump or pipeline leaks.

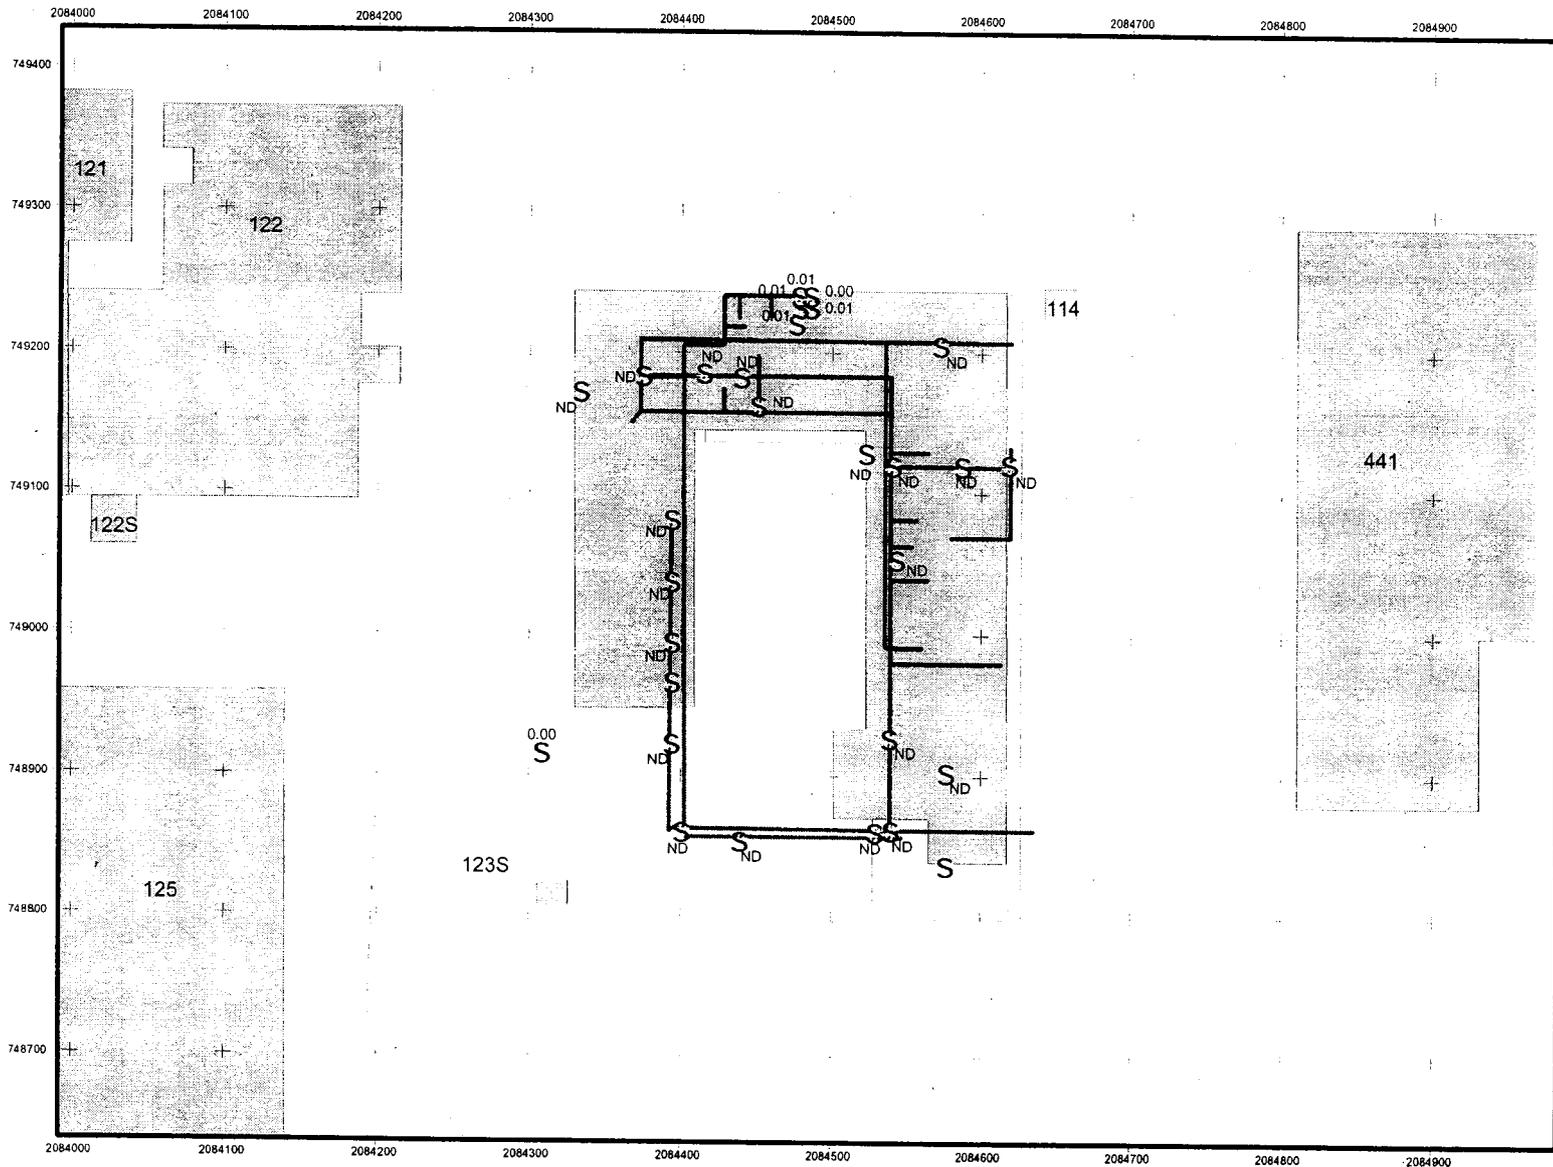
Figure 13
RFCA Tier II
Nonradionuclide
Sum of Ratios

Location	Tier II SOR Radionuclides	Tier II SOR Nonradionuclides
BU38-0002	0.13	NA
BU38-0003	0.01	NA
BU38-0004	0.14	NA
BU38-0005	0.01	NA
BU38-0006	0.01	NA
BU38-0007	0.00	NA
BU38-0008	0.00	NA
BU38-0009	NA	0.00
BU39-0001	0.15	NA
BU39-0003	0.13	NA
BU39-0004	0.13	NA
BU39-0005	0.12	NA
BU39-0006	NA	0.01
BU39-0007	NA	0.00
BU39-0008	NA	0.01
BU39-0012	NA	0.01
BU39-0013	NA	0.01
BV39-0001	0.13	NA
BV39-0003	0.18	NA
123 Emergency Southeastern Process Line	0.13	NA
123 Pad Soil Sample	0.12	NA
B123 Metal Manhole	0.12	NA
Source Well Pipe	0.13	NA
West of Manhole 2	0.01	NA
Central Point on Southern PWL	0.13	NA
Eastern Process Line	0.14	NA
Northern Process Line	0.13	NA
Source Pit	0.12	NA
Southeast Slab	0.13	NA

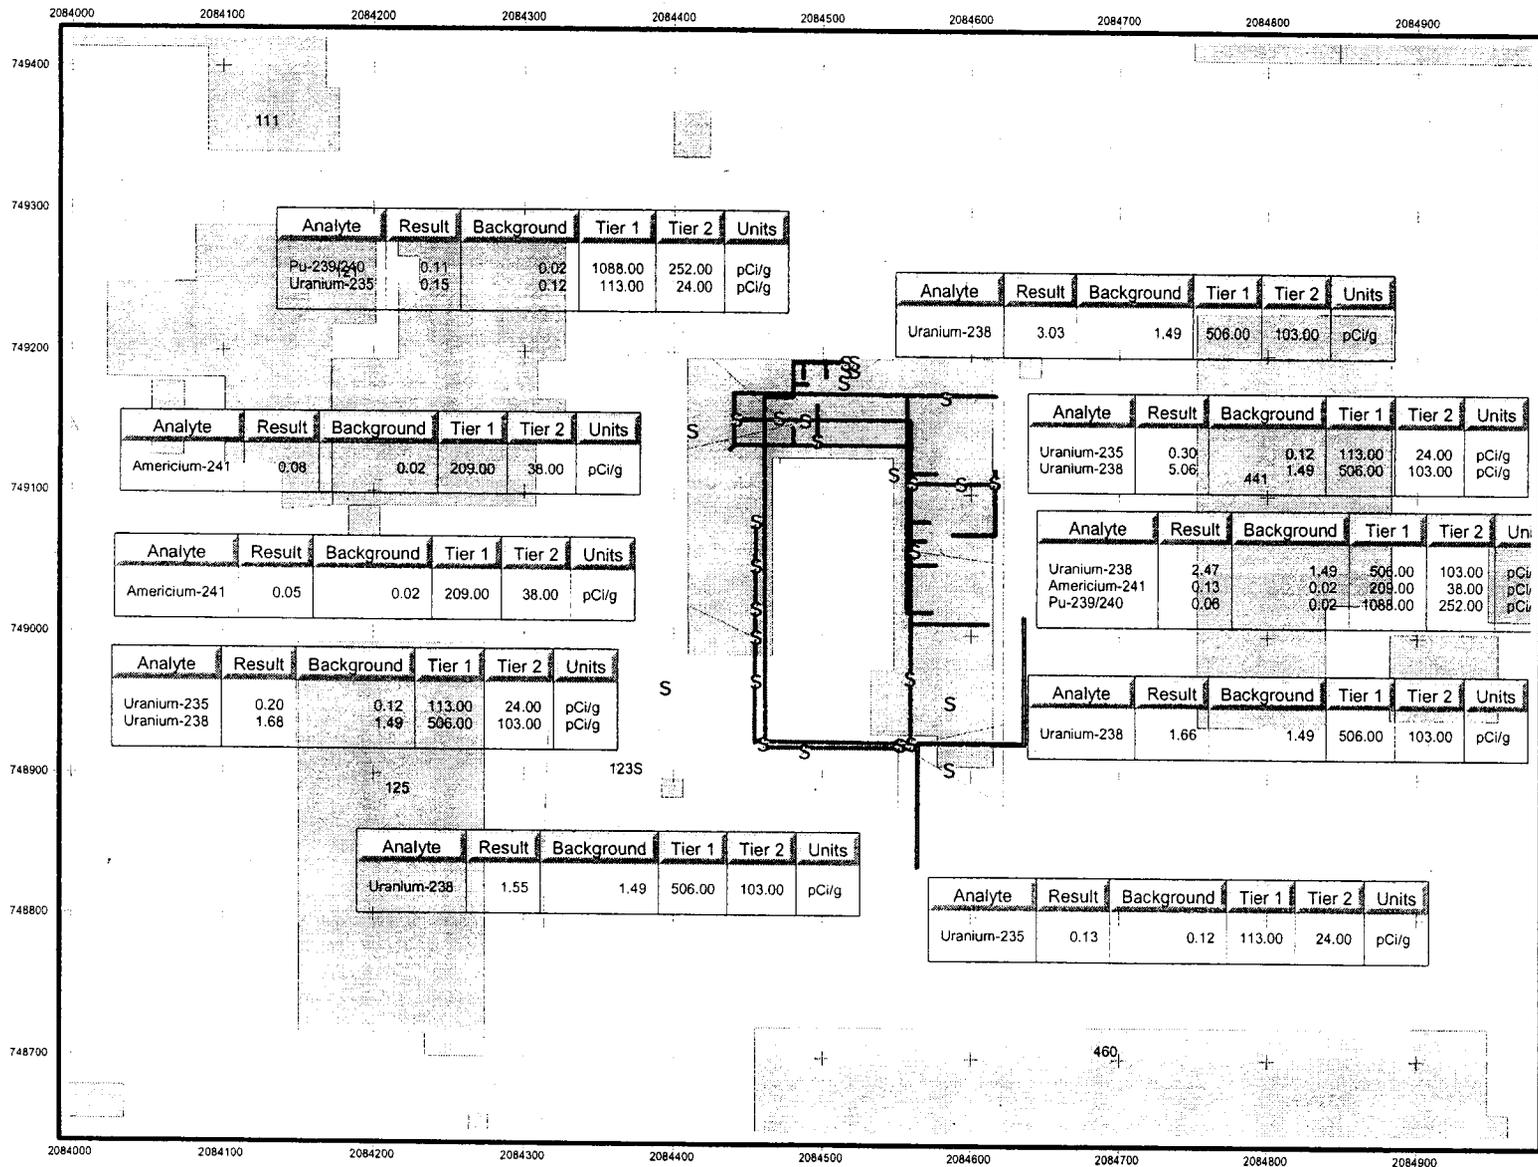
Figure 11
Confirmation Sampling Results
Greater Than Background Plus
Two Standard Deviations or
Method Detection Limits

If elevated radionuclides were detected, additional analyses for metals could be required. As indicated in Table 6, americium-241 is slightly greater than background plus two standard deviations at one location, uranium-235 is slightly greater than background plus two standard deviations at one location, and uranium-238 is slightly greater than background plus two standard deviations in two locations. These data indicate that the sumps and pipelines had not leaked. Results for analytes greater than background plus two standard deviations are shown on Figure 11 and summarized in Table 6. The full data set is presented in Appendix B

IHSS Group	IHSS/PAC/UBC Site	Location Code	Analyte	Result (pCi/g)	Background Plus Two Standard Deviations (pCi/g)	Tier I AL (pCi/g)	Tier II AL (pCi/g)
100-4	UBC 123 – Radiological Health Physics Laboratory IHSS 100-148 – Waste Leaks	BU38-0002	Uranium-238	1.66	1.49	506.00	103.00
		BU38-0002	Uranium-238	1.66	1.49	506.00	103.00
		BU38-0004	Uranium-235	0.20	0.12	113.00	24.00
			Uranium-238	1.68	1.49	506.00	103.00
		BU38-0005	Americium-241	0.05	0.02	209.00	38.00
		BU39-0001	Uranium-238	3.03	1.49	506.00	103.00
		BU39-0004	Americium-241	0.08	0.02	209.00	38.00
		BU39-0011	Uranium-238	3.09	1.49	506.00	103.00
		BV39-0003	Uranium-235	0.30	0.12	113.00	24.00
			Uranium-235	0.23	0.12	113.00	24.00
			Uranium-238	3.70	1.49	506.00	103.00
			Uranium-238	5.06	1.49	506.00	103.00
		Central Point on Southern PWL	Uranium-238	1.55	1.49	506.00	103.00
		Eastern Process Line	Americium-241	0.13	0.02	209.00	38.00
			Plutonium-239/240	0.06	0.02	1,088.00	252.00
