**FRENCH DRAIN
GEOTECHNICAL INVESTIGATION**

**U.S. DEPARTMENT OF ENERGY
Rocky Flats Plant
Golden, Colorado**

EG&G ROCKY FLATS, INC.

5 OCTOBER 1990

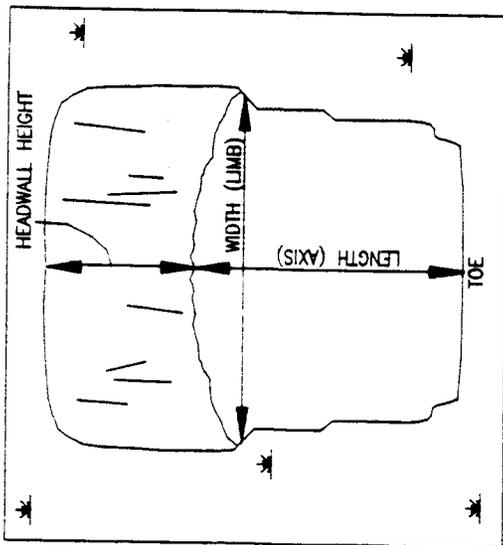
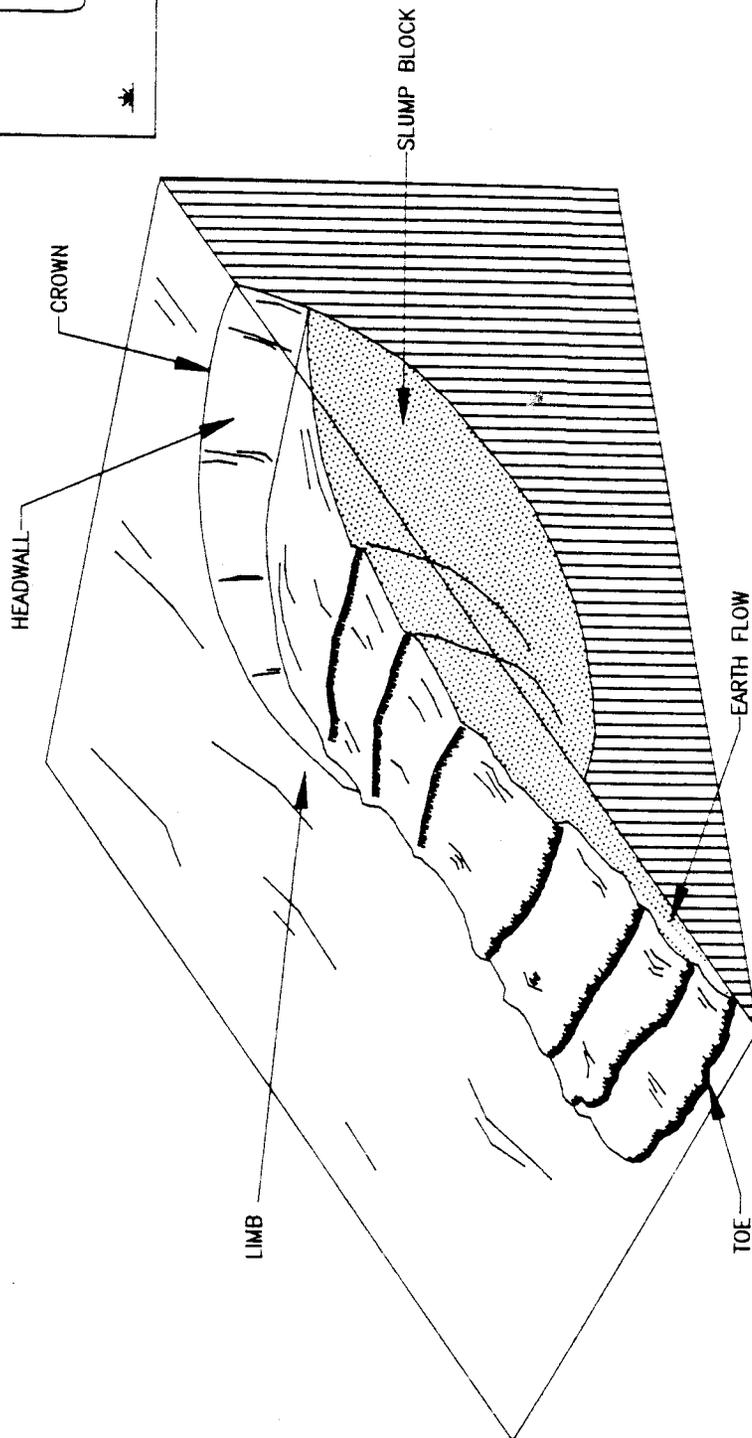
FIGURE 4-1
SLUMP FEATURES

Slumps were mapped in the Rock Creek, Walnut Creek, and Woman Creek drainages (Plate 2). This mapping was restricted to active or recent slump features and distinct, older, weathered slumps where the headwall, base or toe, and lateral boundary could be easily distinguished. Such conditions were most common in the upper narrow valleys. Older "healed" slumps could also be inferred in the broader valleys based on hummocky topography, but these were generally not mapped during this study.

slump that represented the original slope. The apparent critical slope angle, (i.e., the local maximum slope inclination which the soil and rock materials underlying the slope can support without failure), was determined. Volume calculations were based on measurements of the length, width, and headwall height using a steel tape. The slump length is the distance from the base of the headwall to the toe of the slump. The width is the distance between the limbs of the scarp at the points where they were parallel to slump movement direction. The headwall height was measured from the base to the crown of the headwall scarp at the central axis of the slump. Only one slump feature observed in the Woman Creek area was directly measured (WMCN5), because access to other slumps in that drainage was restricted. However, qualitative observations and estimates of slump dimensions were possible from outside the restricted area.

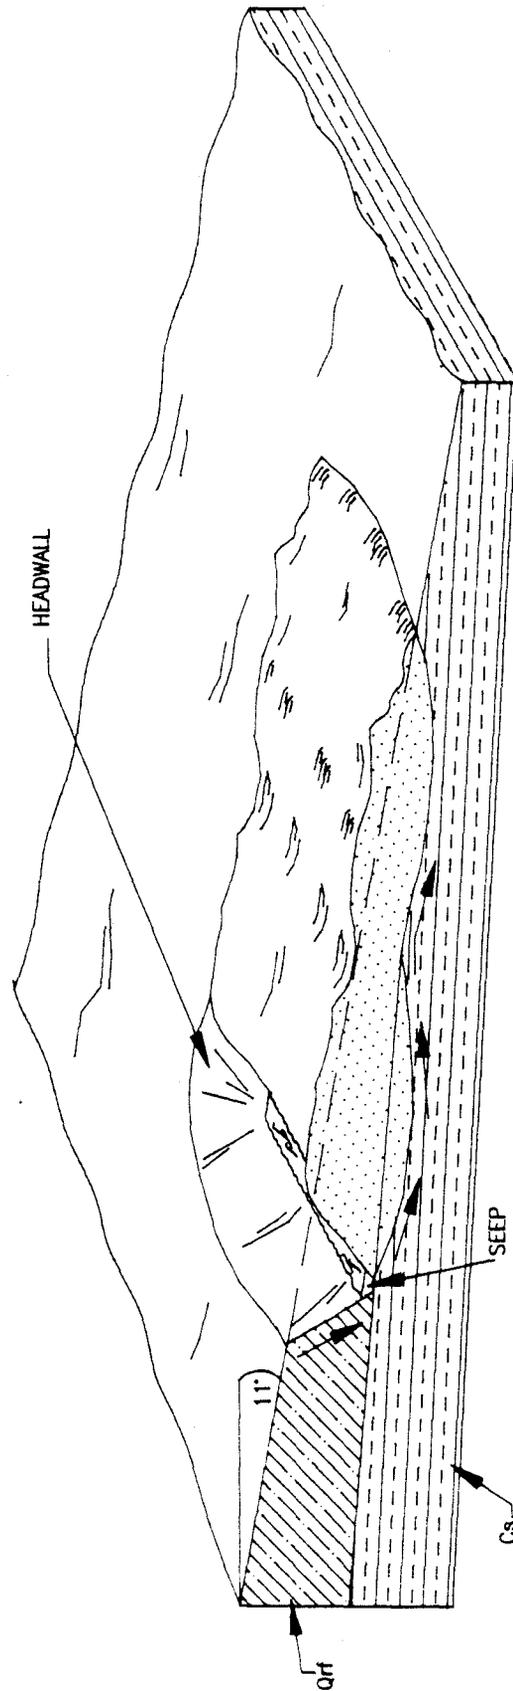
FIGURE 4-3
TYPE B SLUMP
SEEP AT HEADWALL BASE

Rock Creek drainage (RCN3-RCN8 and RCS1, RCS2, and RCS4), and one was mapped in the Woman Creek drainage (WMCN3). The apparent critical slope dip angle for type B slumps ranged from 11 degrees for RCN6 to 28 degrees for RCS4 (Table 4-2). Volumes ranged from 19,200 cubic feet for RCS1 to 3,530,000 cubic feet for RCS4. The lower slope dip angle and larger slump volume indicate that saturation of the slope facilitates slumping.

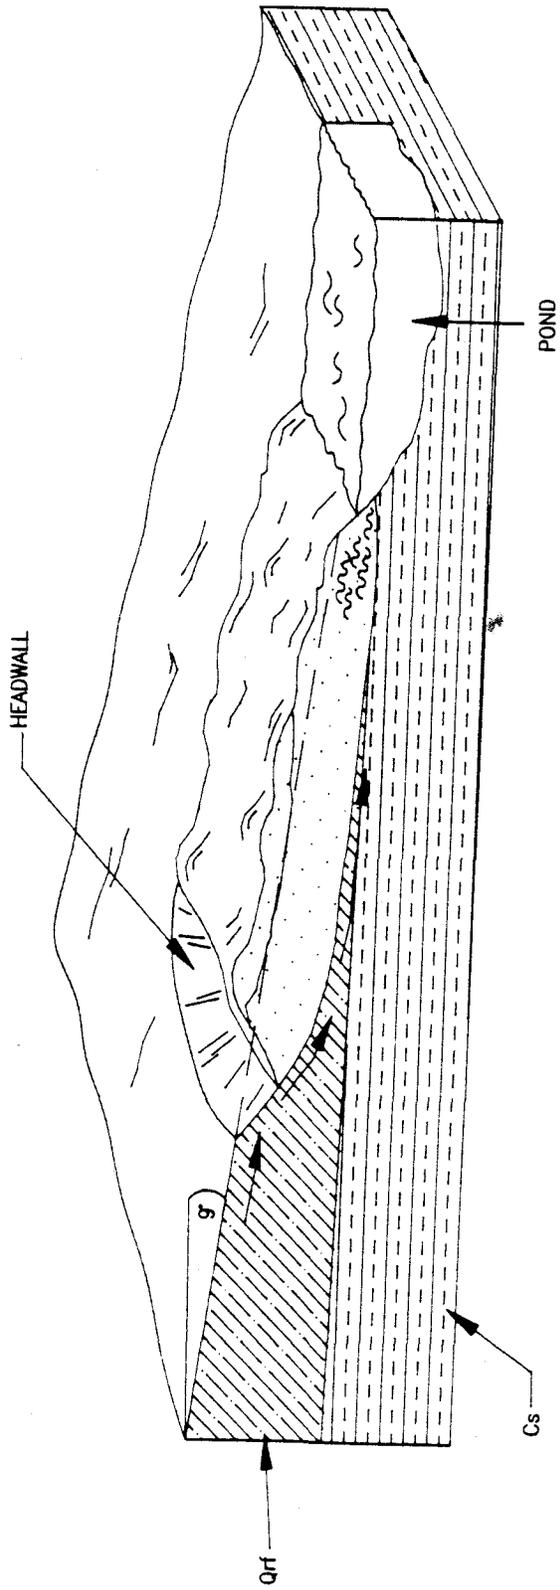
FIGURE 4-4
TYPE C SLUMP
SATURATION AT BASE OF TOE

Type C slumps involve slopes which terminate in a pond or other features which indicate possible saturation at the toe or base of the slump (Figure 4-4). Other characteristics were the same as that of type A and B slumps. All three type C slumps were in the South Walnut Creek drainage (SWCS1, SWCS5, and SWCS6). The apparent critical slope dip angle ranged from 9 degrees, measured at SWCS1, to 11 degrees measured at SWCS5 and SWCS6 (Table 4-3). Volumes range from 1625 cubic feet at SWCS6 to 30,800 cubic feet at SWCS1. The low volumes are attributed to the localized nature of conditions which define this slump type. The saturation of the slope toe is responsible for slope destabilization, resulting in low critical angles for type C slumps.

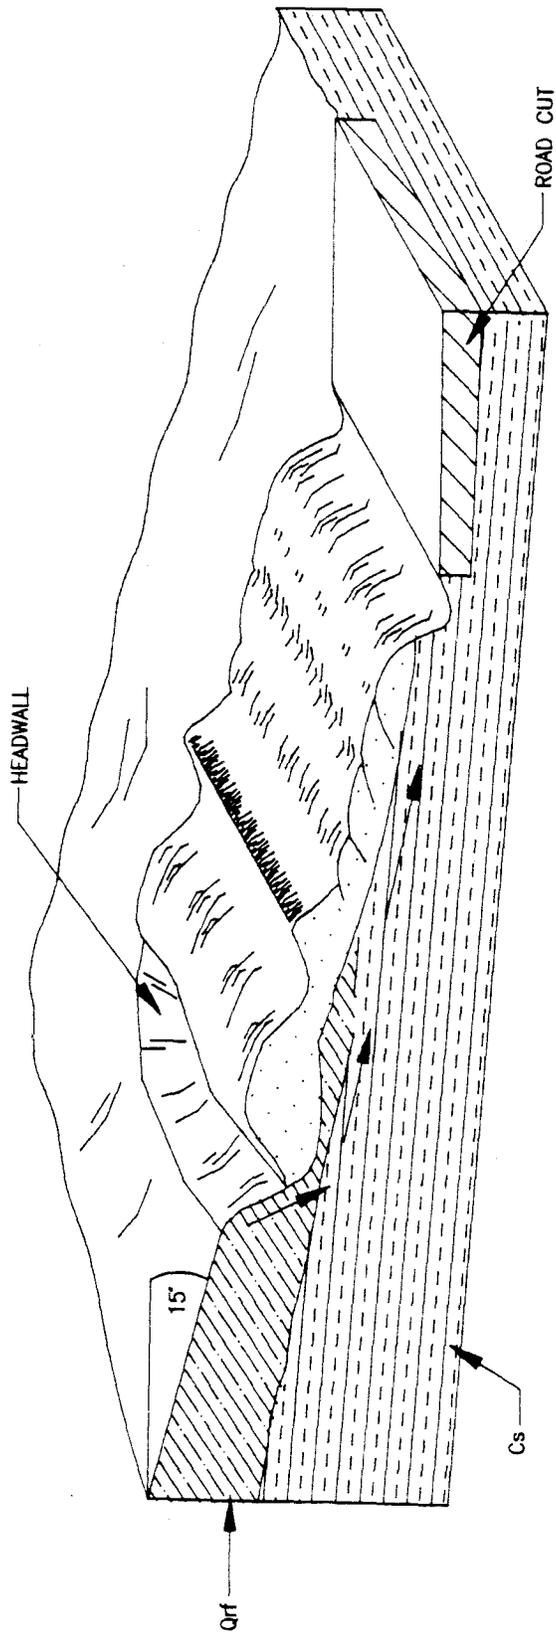
FIGURE 4-5
TYPE D SLUMP
ROAD CUT

Type D slumps involve slopes which were activated by the presence of road cuts and/or drainage ditches across or at the base of the slope, or by slope overloading due to fill placement and saturation of permeable fill materials (Figure 4-5). Construction activities commonly undercut the base of slopes and thereby remove the support that the toe provides for upslope mass (Figure 4-6). Associated vegetation removal can also enhance erosion, facilitating slope saturation and/or causing oversteepening. Excess mass of artificial fill, and the relatively rapid saturation of permeable fill materials, can further destabilize slopes that have been subject to construction activity. Of the twelve type D slumps which were identified, six were in the South Walnut Creek drainage (SWCN1-SWCN3 and SWCS2-SWCS4), four were in the North Walnut Creek drainage (WCN1, WCN2, WCN6 and WCN7), and two were in the Woman Creek drainage (WMCN1 and WMCN5). The apparent critical slope dip angle ranged from 15 degrees, measured at slumps WCN2 and WCN6 to 32 degrees measured at slumps SWCN1 and SWCN3 (Table 4-4). Volumes ranged from 110 cubic feet at WMCN5 to 965,000 cubic feet at SWCS2.

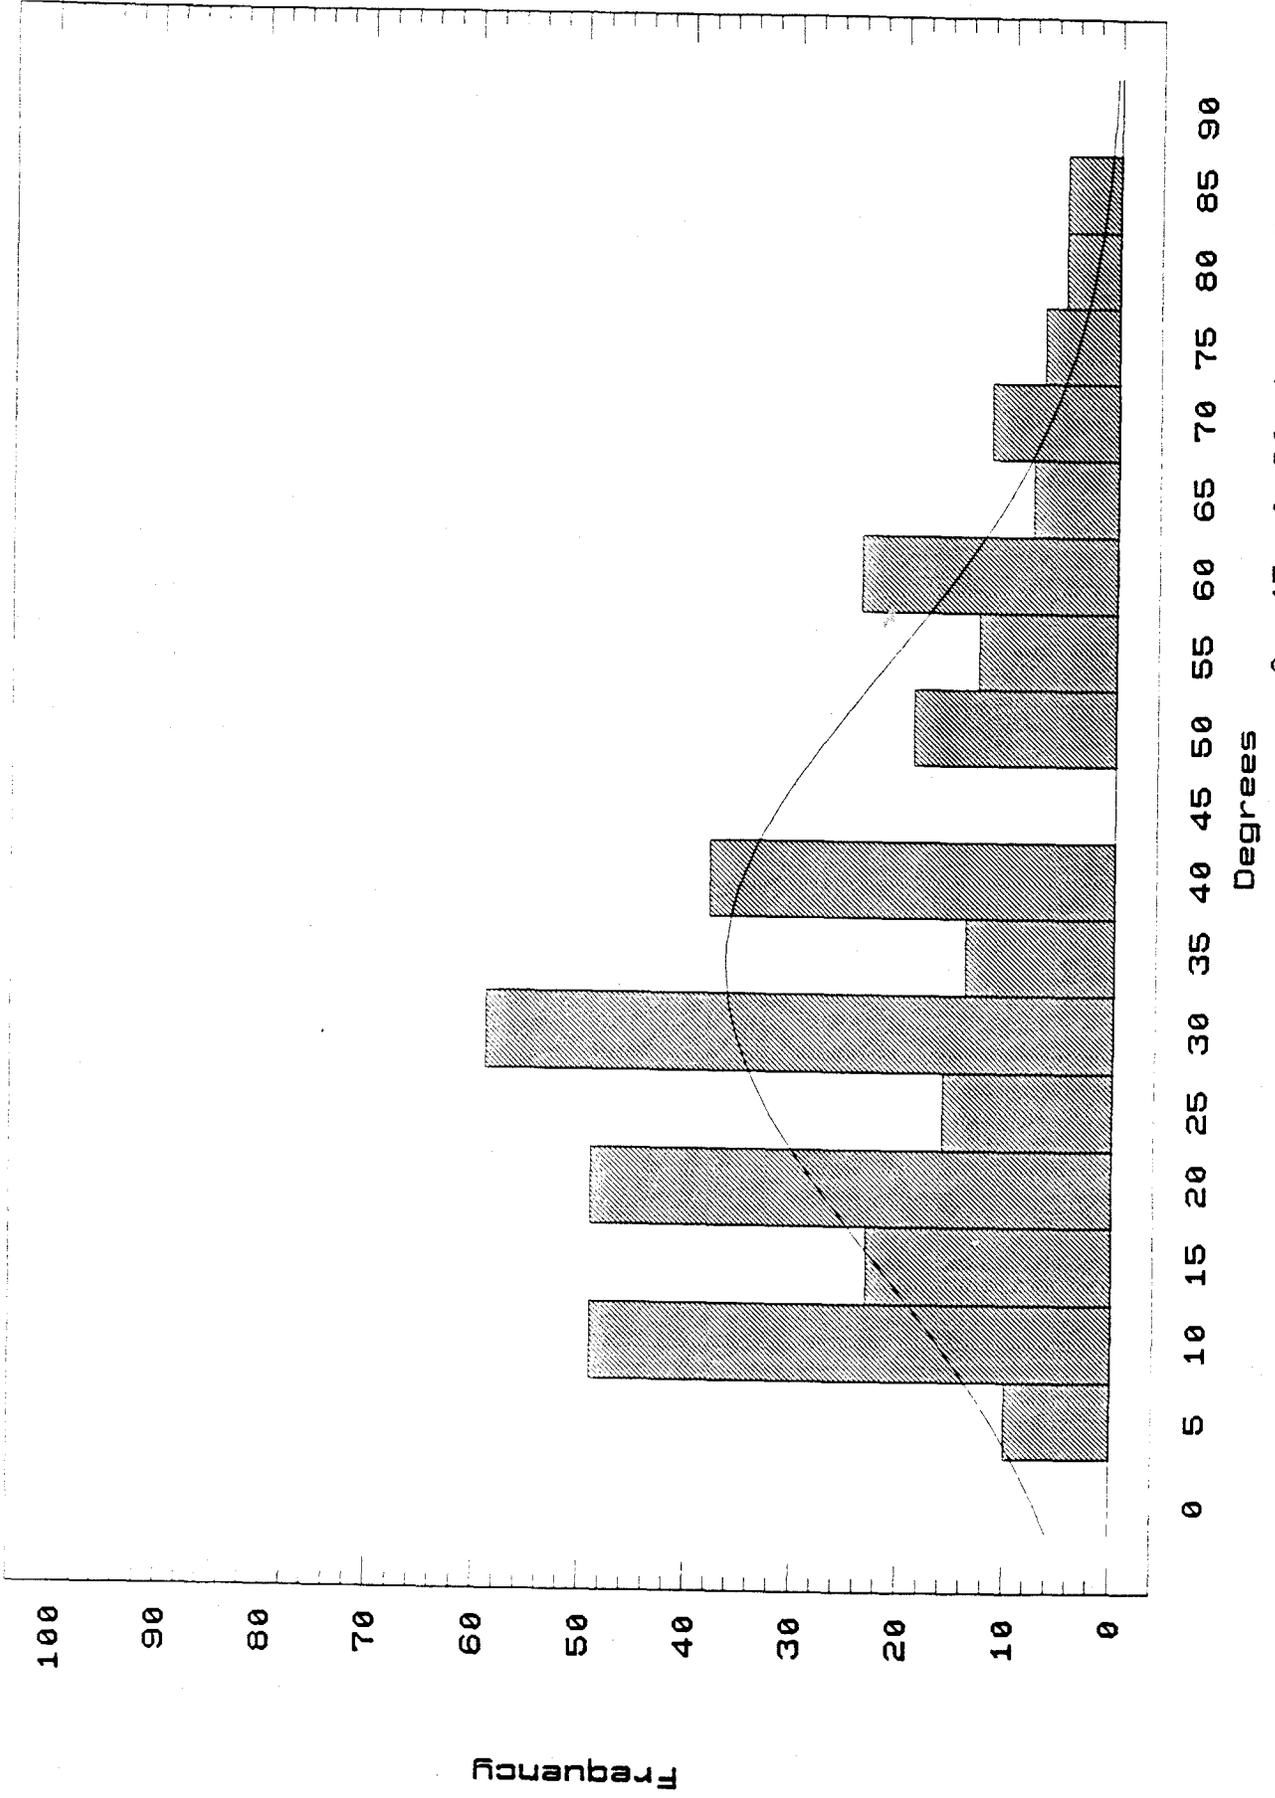
FIG 4-8

Fracture frequency distributions taken from the fracture intercepts noted on the boring logs are duplicated on Figure 4-8. It should be emphasized that the fracture orientation on the boring logs is in respect to vertical orientation (i.e., a horizontal fracture is 90 degree). Figure 4-8 is presented using a horizontal orientation as will be encountered in the field. The major fracture trend at the french drain site is currently unknown. However, it is assumed that fractures are primary a result of stress relief along drainage margins. This assumed orientation is relatively unfavorable for slope stability since proposed construction slopes will trend close to drainage orientation. Additionally, average fracture dip is relatively low (33 degree) which adds instability to slopes of higher angles. For these reasons, known fractures are expected to cause some stability problems. However, the influence of fractures will be evaluated in more detail as development of the trench progresses, thus allowing a more precise interpretation of the nature, location and effect on construction of fractures.

Angles are in respect to horizontal
0, 45, & 90 degree fractures were mechanical and omitted as data.

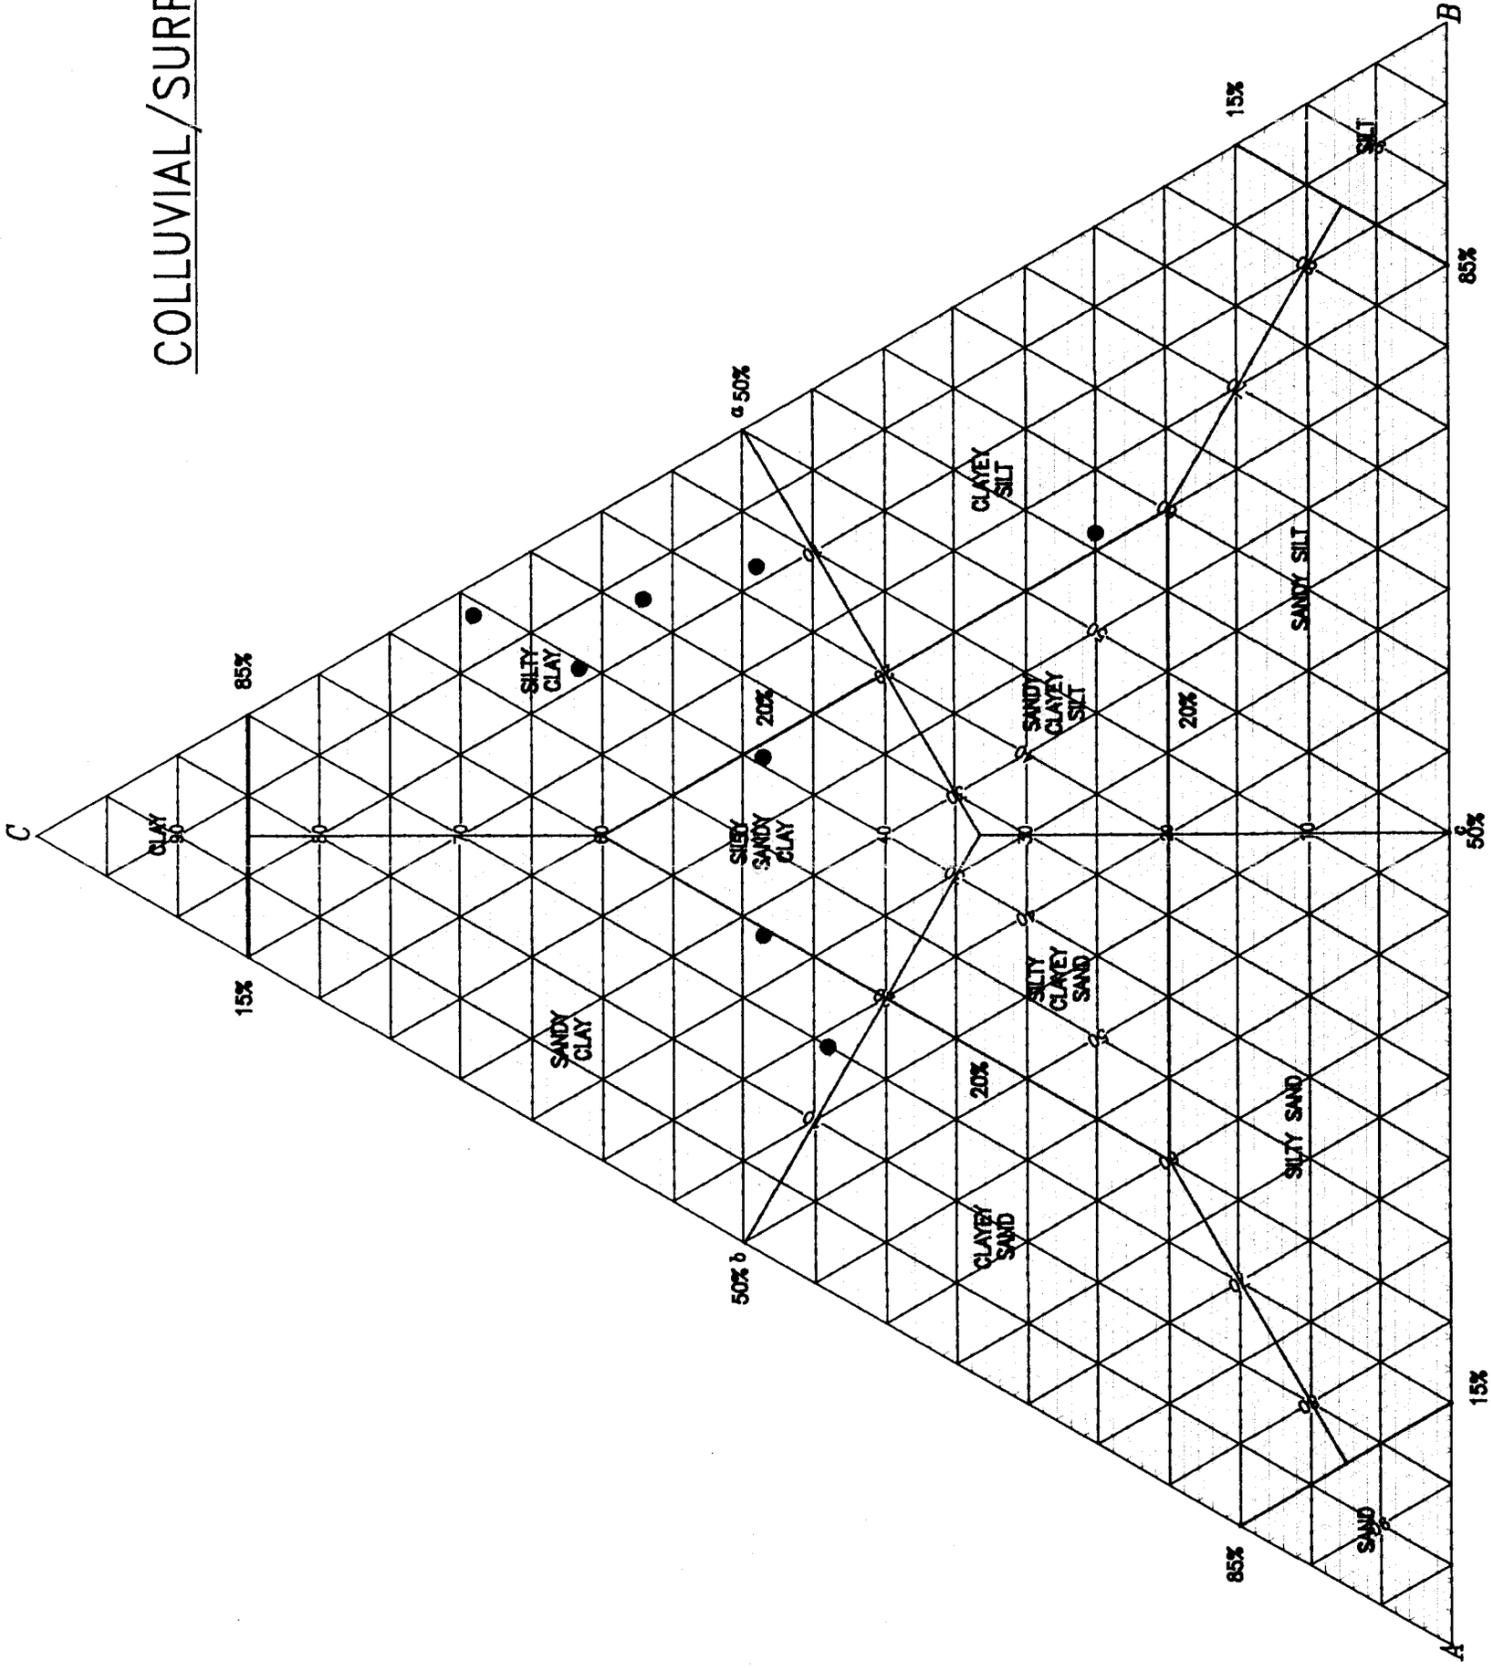
FIGURE 3-1
 TEXTURAL CLASSIFICATION CHART OF THE
 ALLUVIAL/COLLUVIAL GRAIN SIZE/HYDROMETER RESULTS

Surficial materials observed on the 881 Hillside generally consist of clay with occasional sand and gravel lenses. Geotechnical grain size analysis of these materials reflects the field log observation (Figure 3-1).

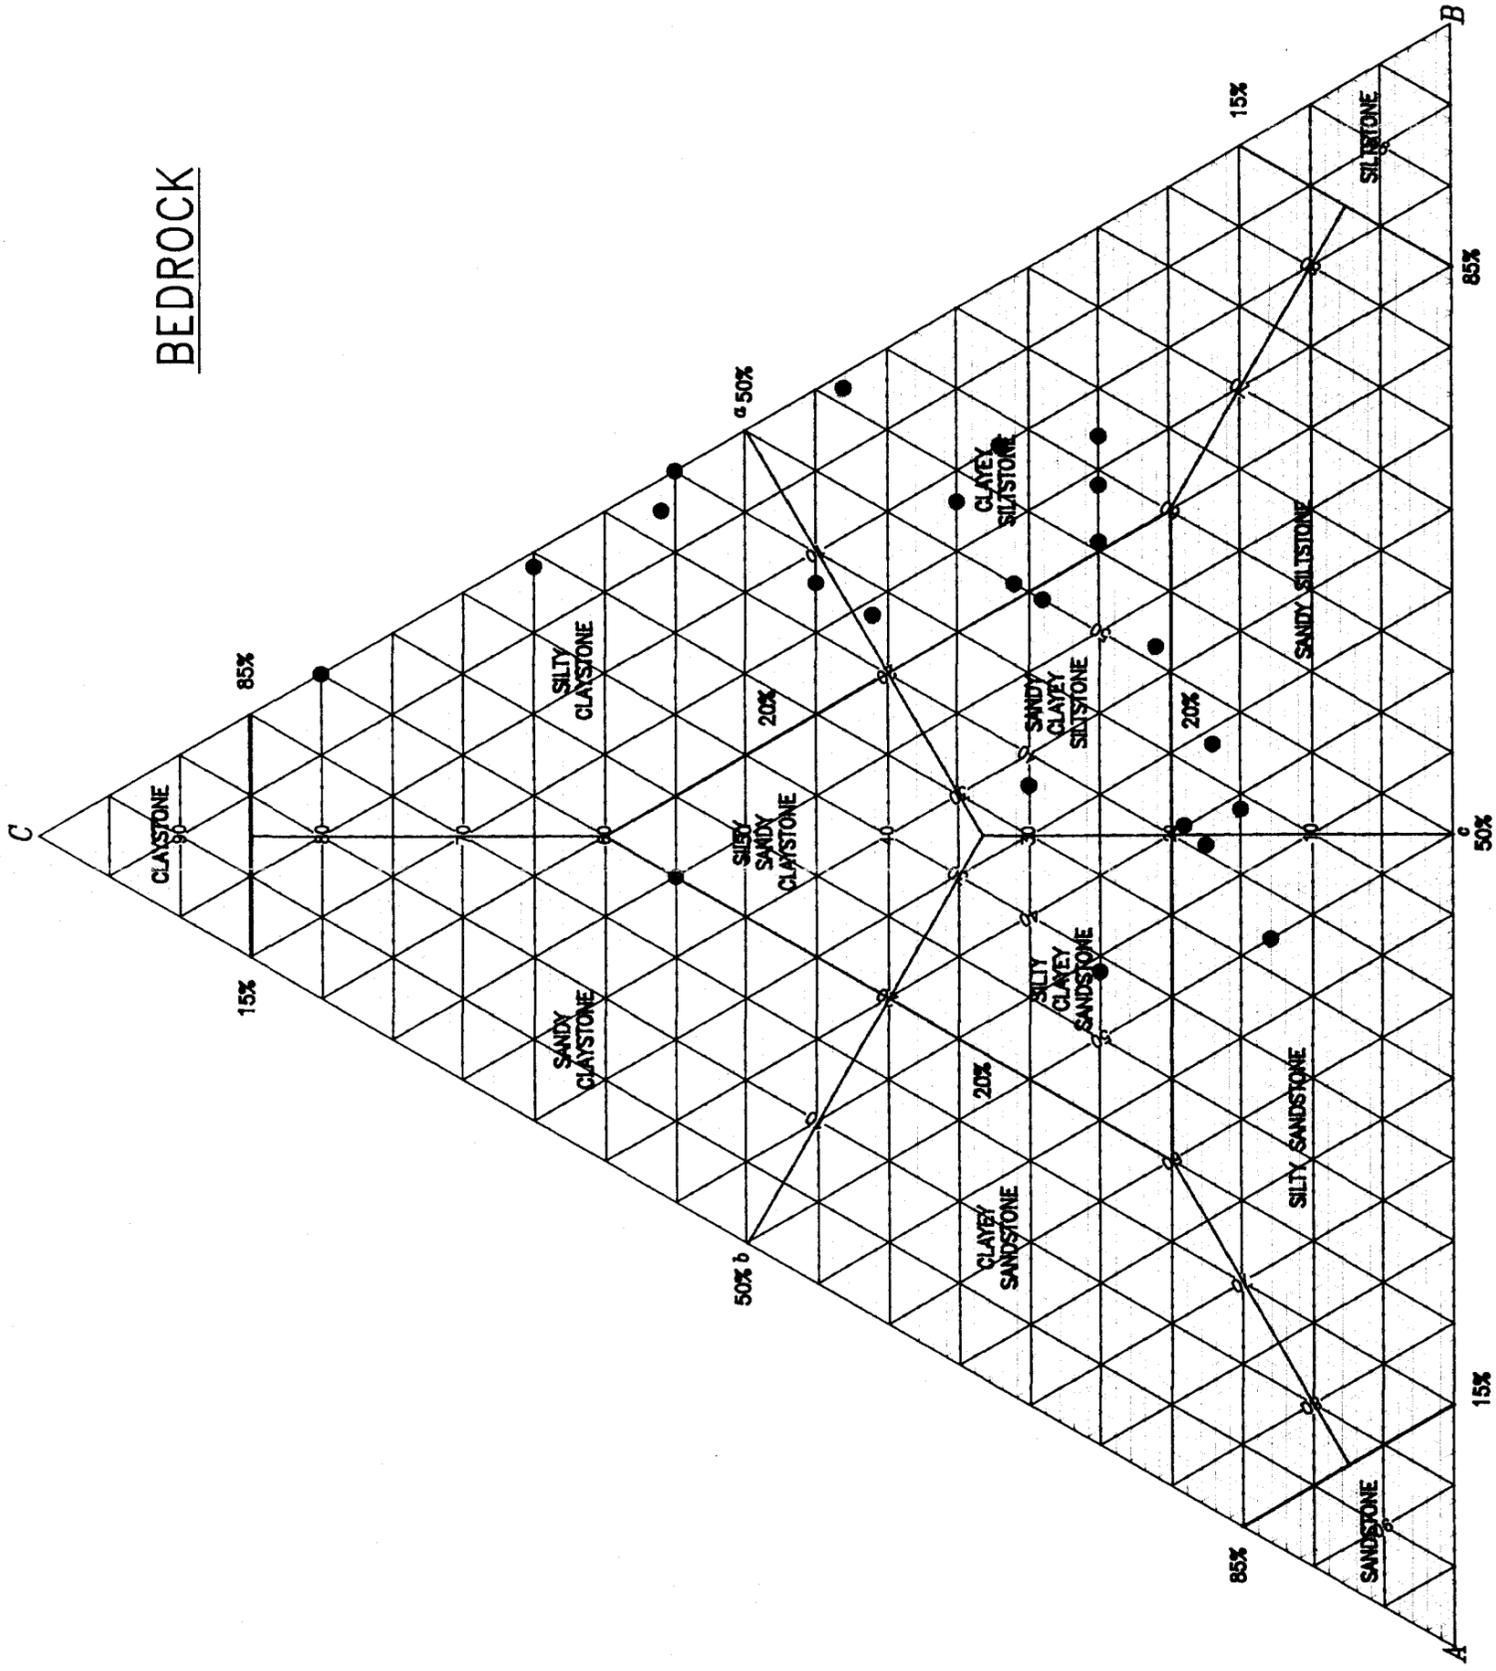
FIGURE 3-2
TEXTURAL CLASSIFICATION CHART OF THE
BEDROCK GRAIN SIZE/HYDROMETER RESULTS

The predominant bedrock lithologies encountered during drilling were claystones and siltstones. It should be noted that permeable, well-sorted sandstones were not observed. Grain size/hydrometer sample analysis was performed to confirm the presence or absence of sandstone. This selective sampling thus skewed the results toward the more coarse-sized fraction (Figure 3-2). Actual sandstone to claystone/siltstone ratios could be assumed to be substantially less than the 13 percent (3 sandstones out of 24 claystones/siltstones) presented on Figure 3-2.
