RCRA CONTINGENCY PLAN
Implementation Report No. 93-002

RCRA CONTINGENCY PLAN
IMPLEMENTATION REPORT
ROCKY FLATS PLANT
EPA ID NUMBER CO7890010526

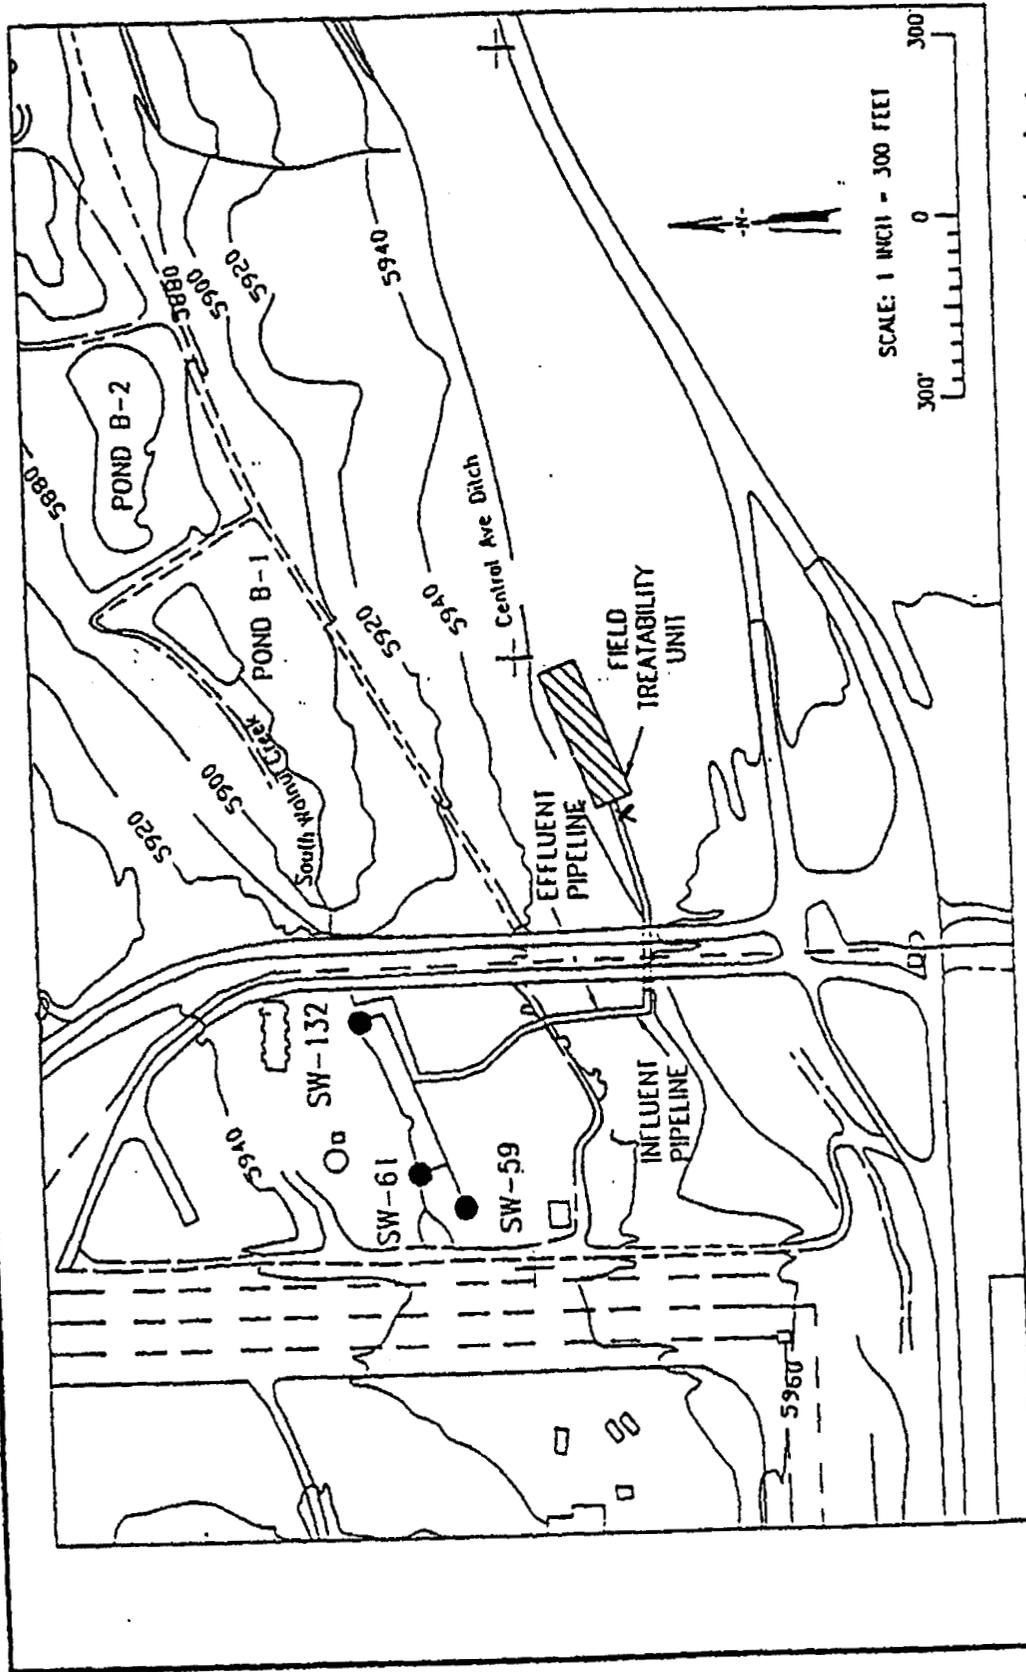
FIGURE
2.1-1

A release of water from an influent pipe system leading from Walnut Creek to the treatment system occurred due to a clamp failure in the primary line. The release occurred at 3:10 p.m. on Tuesday, March 9, 1993. An employee of Riedel Environmental Services discovered the release from an influent water line in response to an alarm signaling that a release had occurred. The line in question has secondary containment. The line was found to be leaking from a connection in the line when a retaining clamp failed under normal operating pressure. The surge in pressure in the secondary containment line caused a rupture at an elbow causing the release.

Approximately 50 gallons of contaminated surface water was released to the area west of the treatment system (see Figure 2). No immediate action was taken to recover this material. The tables reflect the findings of 56 samples taken from May 29, 1991, to February 13, 1992 (refer to Tables 1 and 2). The material was sampled for dissolved metals and volatile organic compounds to determine the types of constituents in the influent water. All dissolved metals are below the regulatory limit for toxicity under the RCRA regulations. F001 listed hazardous waste constituents that have been detected are carbon tetrachloride, tetrachloroethene and trichloroethene. These "F" listed constituents are also characteristic hazardous waste for the characteristic of toxicity. The highest observations of these constituents are below the regulatory limit for toxicity. Additionally, chromium and 1,2-dichloroethene which are also hazardous wastes for the characteristic of toxicity have been detected but not in amounts that are above the regulatory limit for a characteristic waste under the RCRA regulations. Due to the presence of F001 constituents in the influent water and due to the fact that the EPA requires surface water and other media which contains listed hazardous

X approx location of leak/spill

The clamp that failed was replaced. The system was returned to normal operation within 3 hours. The daily inspections of the pipeline are continuing. Representatives from CDH and EPA, Region VIII were notified prior to resuming operations.
