**DATE:** April 22, 1994  
**SUBJECT:** Salt-Buster Demonstration  
**TO:** Frazer Lockhart, MSA Program Manager

Operation of the salt-buster which will be used to break down the layer of metallic salts in the 207C pond.

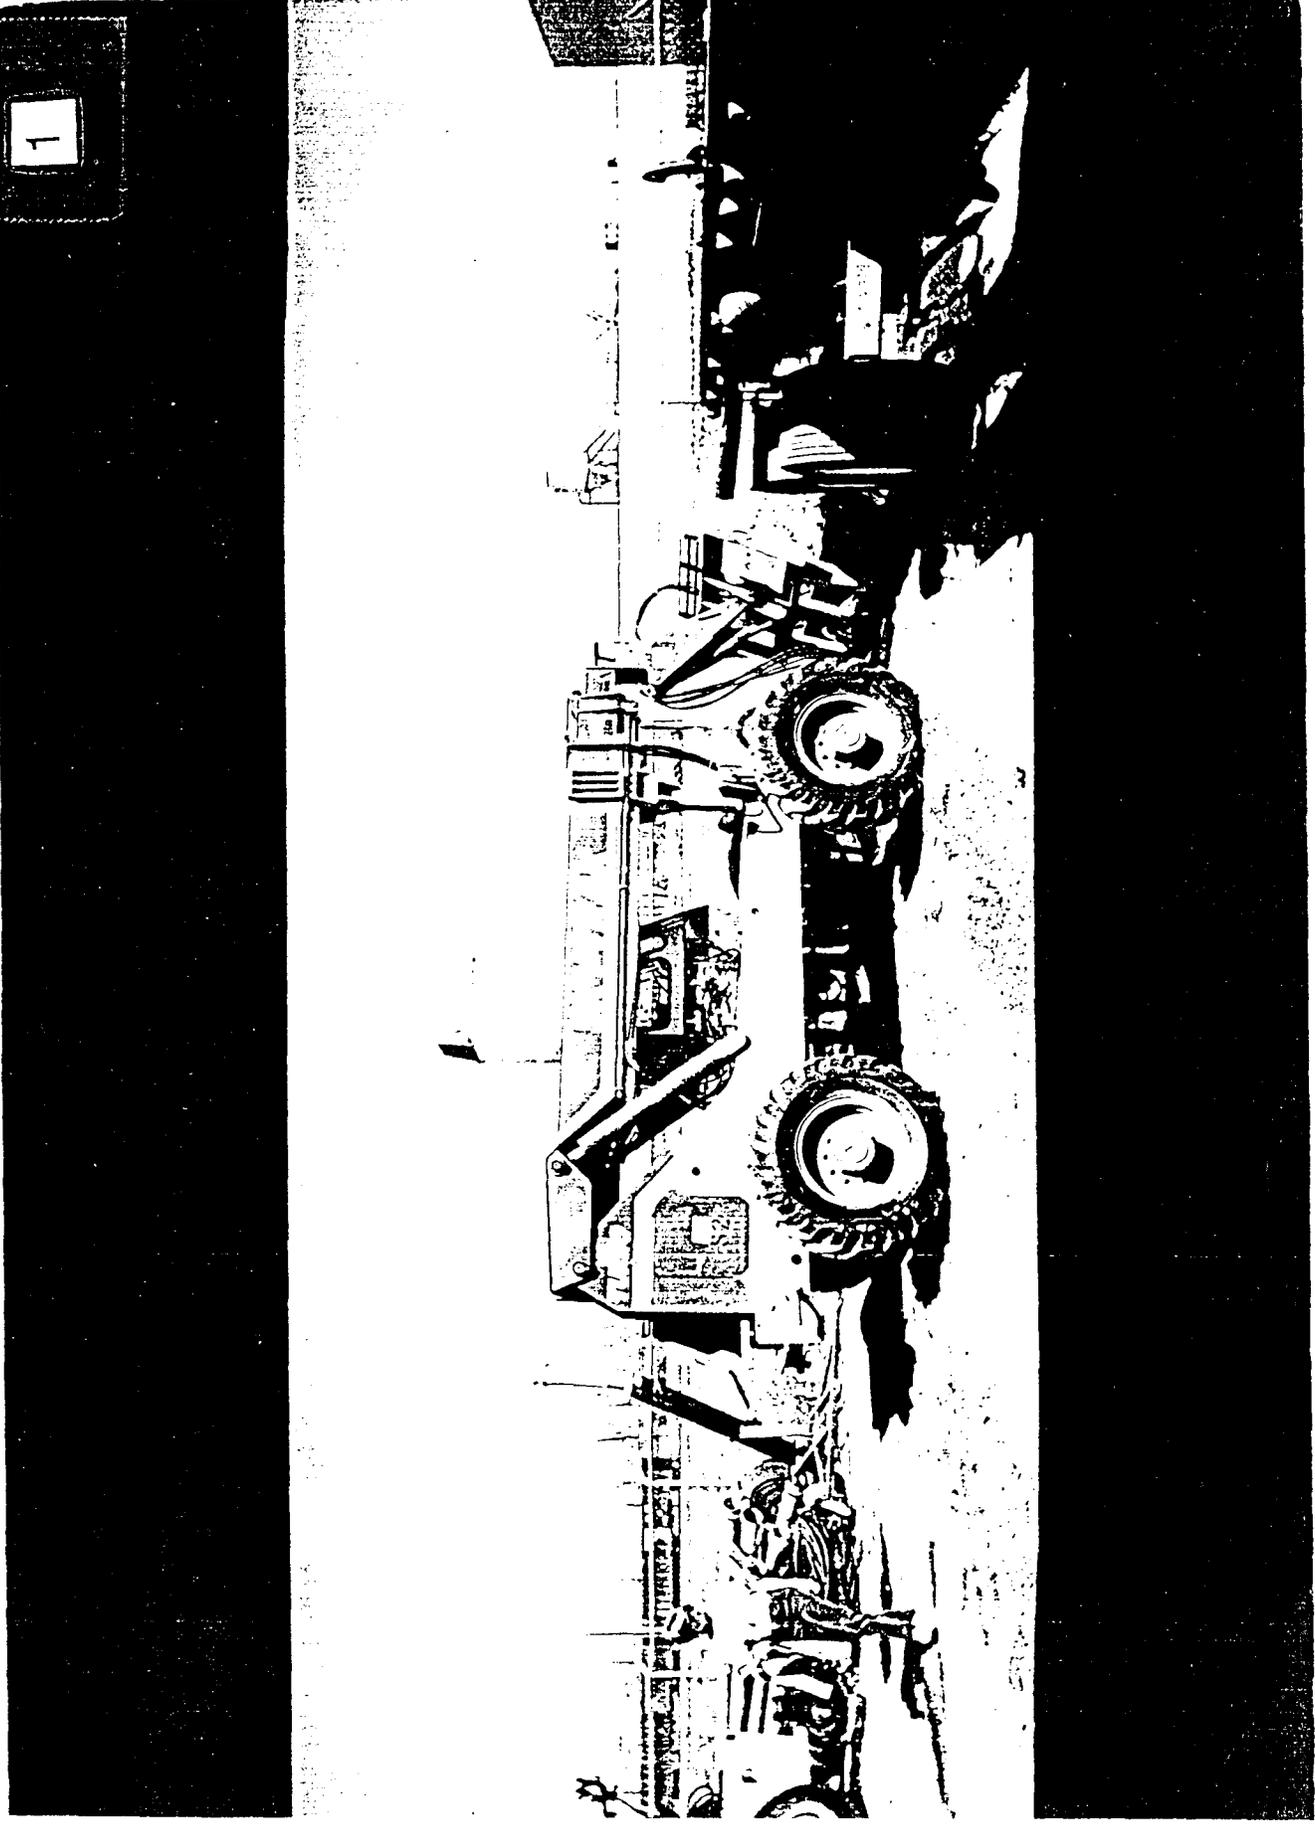
1

The salt buster is approximately 28 feet in length (photo #1). Operation of the vehicle will be provided by one driver and one or two spotters. (continued on next page)

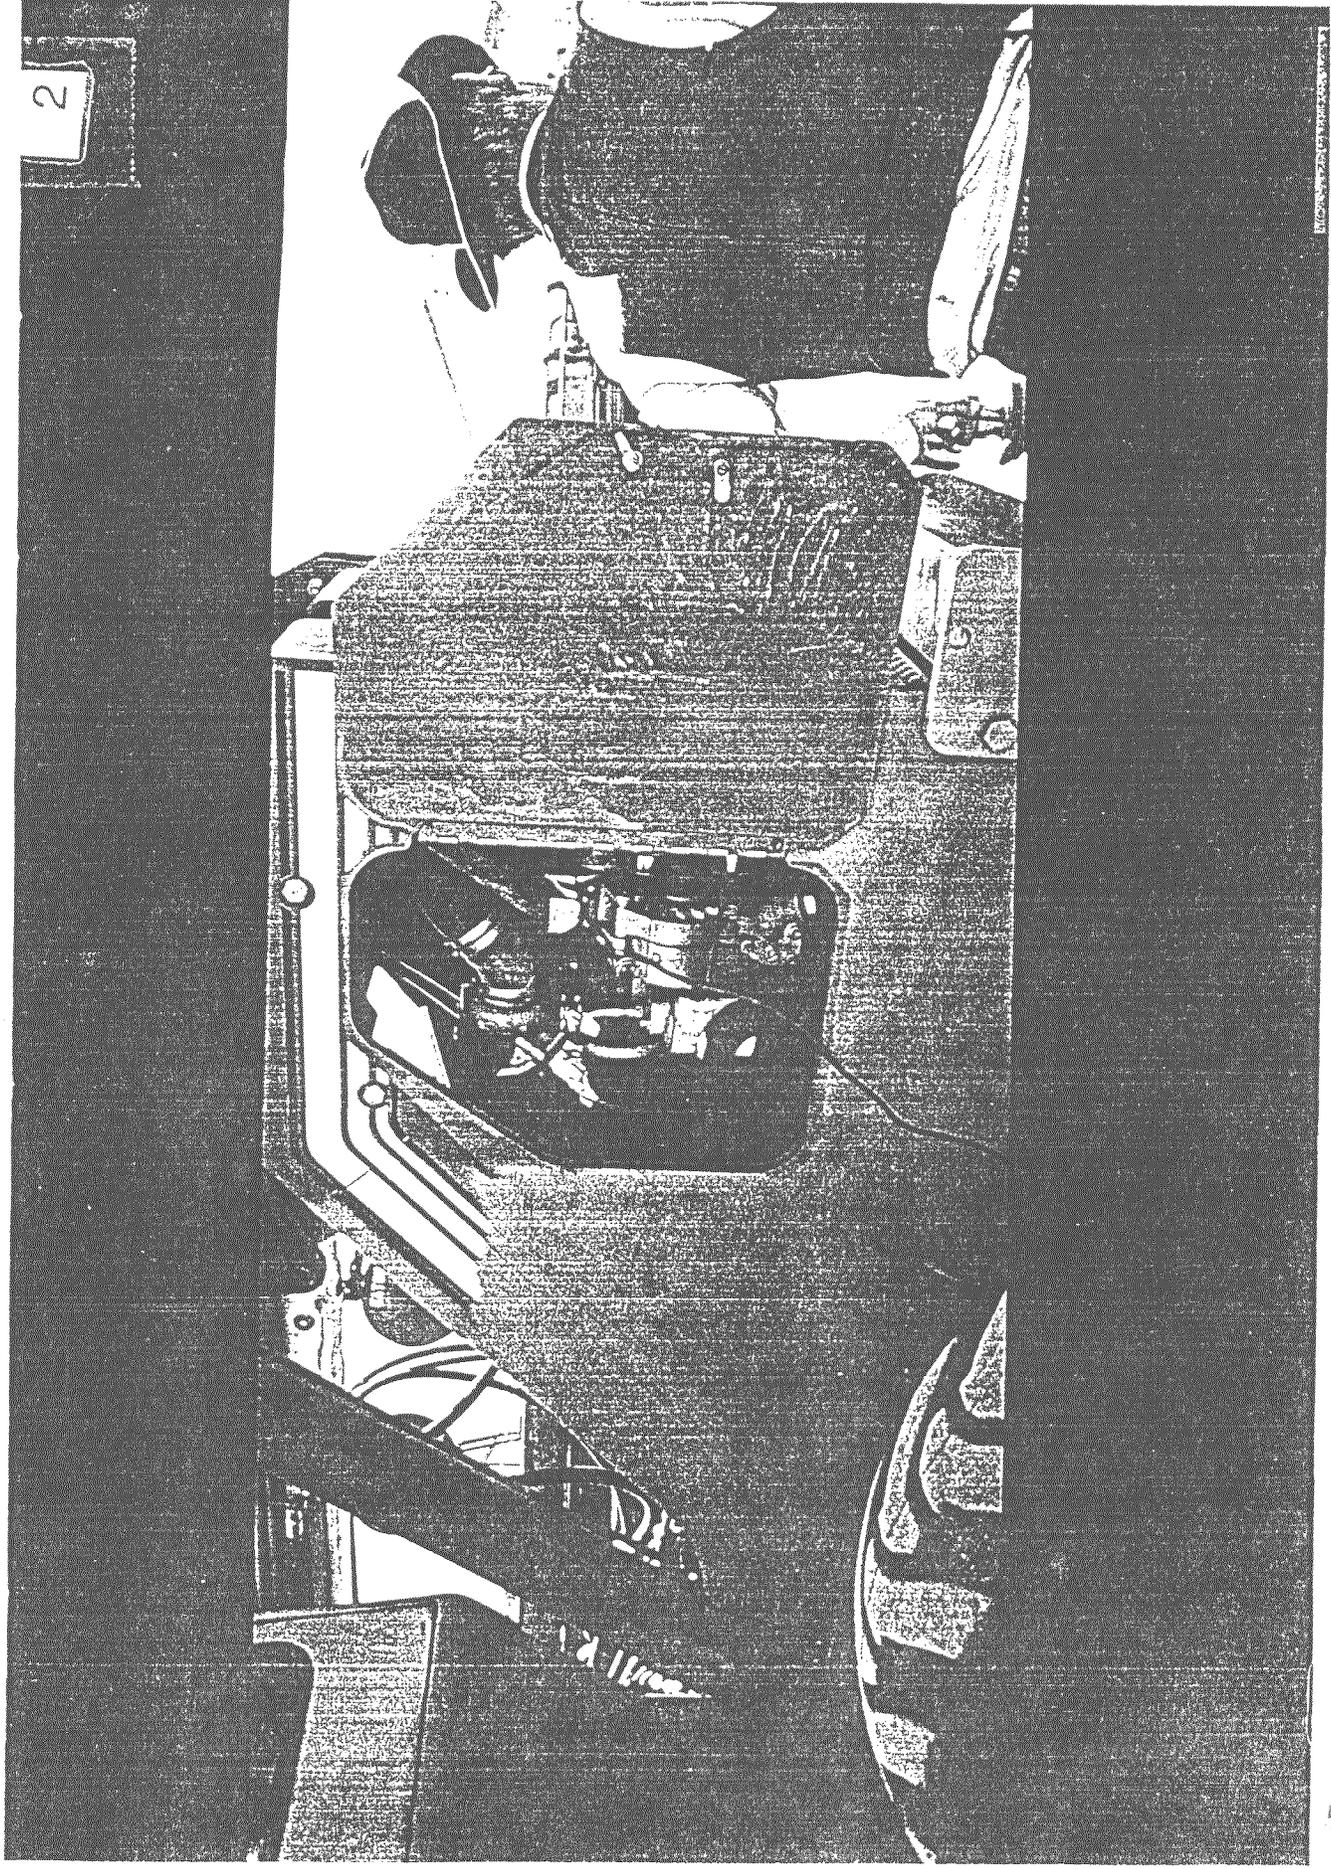
2

The vehicle operates by means of a diesel engine (photo #2) and two hydraulic pumps (photo #3). The engine compartment is located on the left side of the vehicle adjacent to the cab. Some of the wires/hoses had duct tape on them. There is no air conditioning in the cab. The cab has been retrofitted with a HEPA filter system on top to filter and circulate the incoming air (photo #4). The air will continue to circulate even if the engine is turned off. The source of power is a 110 volt converter, powered by the main battery. The floor of the cab is approximately 36" from ground level. The rubber seal for around the door is approximately 33" from ground level (photo #5). The vehicle can be operated by means of 2-wheel, 4-wheel, or "crab" steering.

The vehicle must be in prime operating condition. Duct tape and other temporary repairs should be corrected.

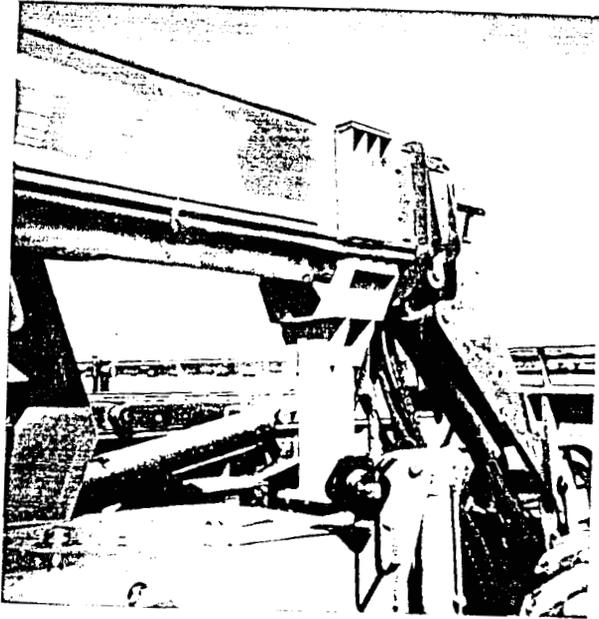
6

The hydraulic lift is supported by a gray, Y-shaped brace that provides an automatic stopping point (photo #6). This device was installed to prevent the roto-mill planer from extending below a certain point that could endanger the integrity of the liner.

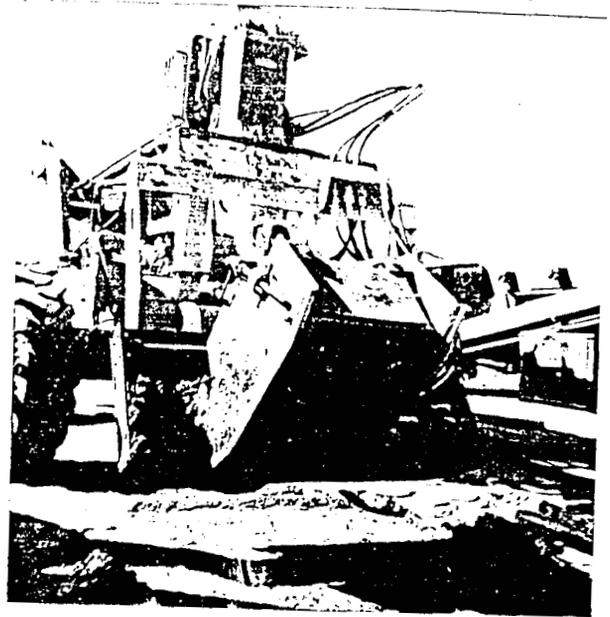
7

The roto-mill planer contains a rotating attachment with rows of carbide tips (photos #7 and #8). The planer can be changed out, using quick disconnect couplings for a brush-type attachment when only a few inches of salt remain (photo #9). The rotating device can operate at a maximum speed of 100 rpm and can dig a maximum of 4-1/2 inches deep. The planer depth is controlled by manually turning two red-handled levers located on the side of the unit (photo #10). The depth will probably be maintained at 2-1/2 inches (photo #11). A kerf will be dug that is approximately 48 inches wide and 20 feet long. This kerf will be done in two separate passes of 24 inches wide (photo #12). After a layer is broken up it will be removed by means of the vacuum truck.
