Operation Inspection Report
for
Department of Energy

Date of Inspection September 21, 1994

Dam Name Dams A-4, B-5 & C-2

Department of Energy (Facility Name) Rocky Flats

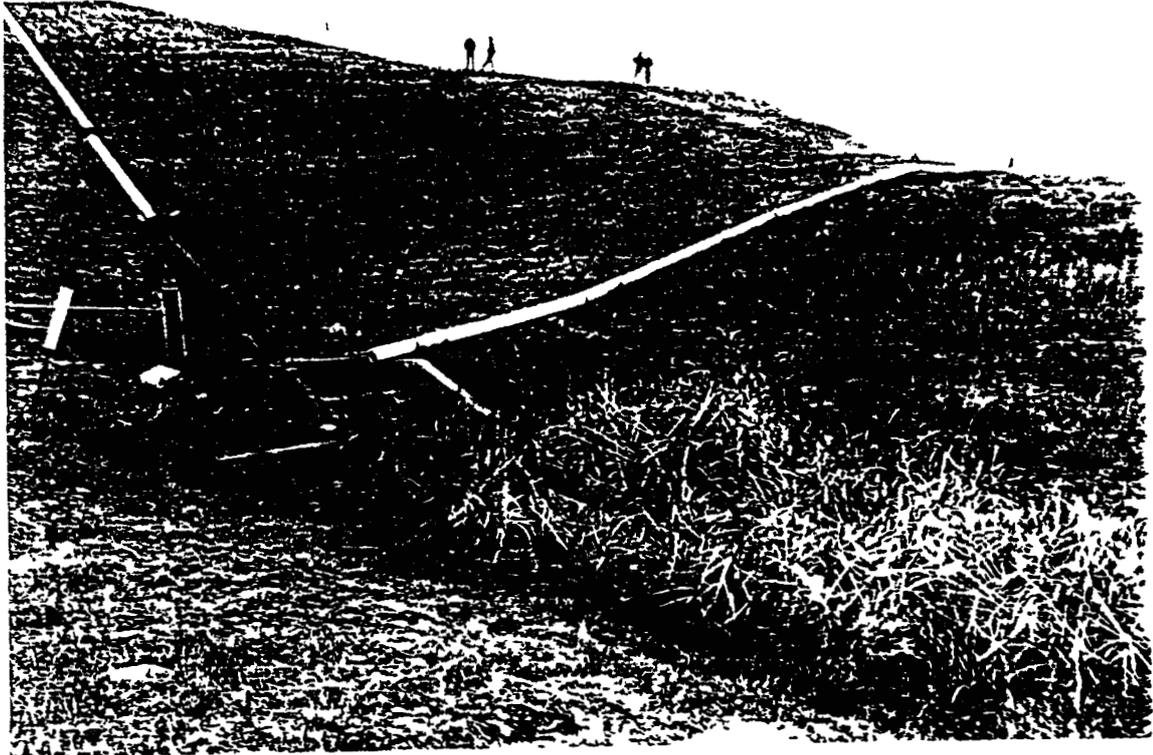
The outlet works consists of an 18-inch (46 cm) reinforced concrete pipe (RCP), which discharges into a concrete stilling basin. Heavy vegetative growth in and around the outlet structure (Photo 9) prevented the observation of any telltale signs of piping around the outlet pipe. The visible portion of the structure, however, appeared in a good condition. No cracks or spalls in the concrete were noted. The outlet works channel also had heavy vegetation growth (Photo 10). The shut-off gate is located at the downstream end of the conduit. This is not a desirable feature since the conduit is continuously pressurized which greatly increases the risk of leakage through pipe joints which could cause piping along the outside of the conduit.

Photo 9. View of Outlet Works of Pond A-4 Dam. Note heavy vegetation.

(1) Heavy vegetation growth in the outlet structure area prevents proper inspection for piping along the outlet pile. This as well as vegetation on the upstream face near the crest level should be cut back.

(3) It is recommended that the existing outlet gate be operated on an annual basis. Also an outlet works gate should be installed on the upstream side of the outlet works to reduce risk of piping along the outside of the conduit.

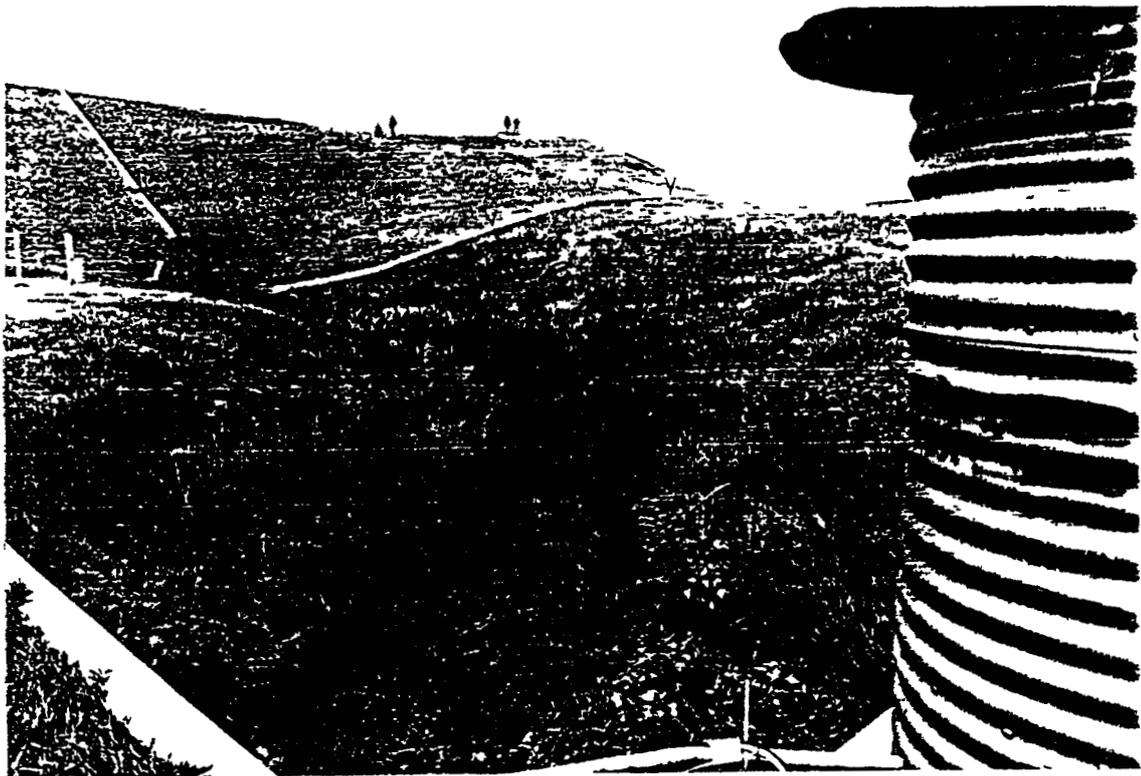
Photo 10. View of Outlet Works Channel, Full of vegetation

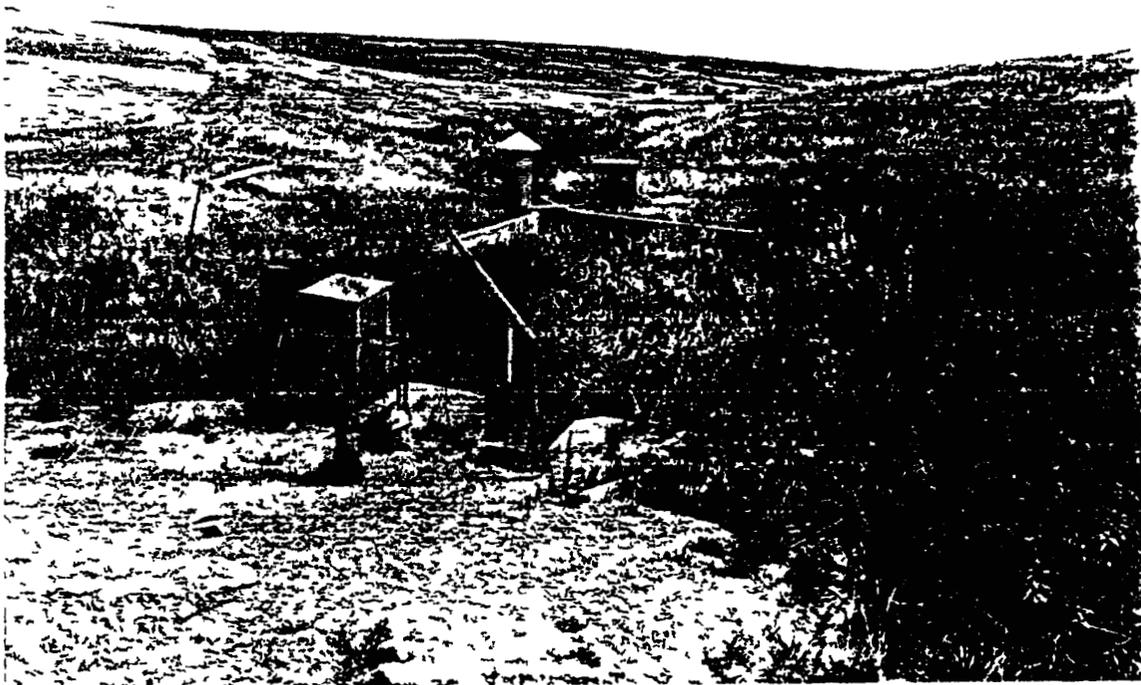
As for Dam A-4, excessive vegetation was also observed near the outlet area and the channel (Photos 14 & 15). The concrete of the outlet structure appeared to be in a good condition.

Photo 14. View of the Outlet Works of Pond B-5 Dam looking north east

Photo 15. Another view of the outlet works, looking south west
The loose soil seen is from installation of
piezometer

(1) Excessive vegetation growth exists in and around the outlet structure. It should be cut back.

(3) An upstream gate for the outlet conduit should be installed and the existing downstream gate be operated on annual basis

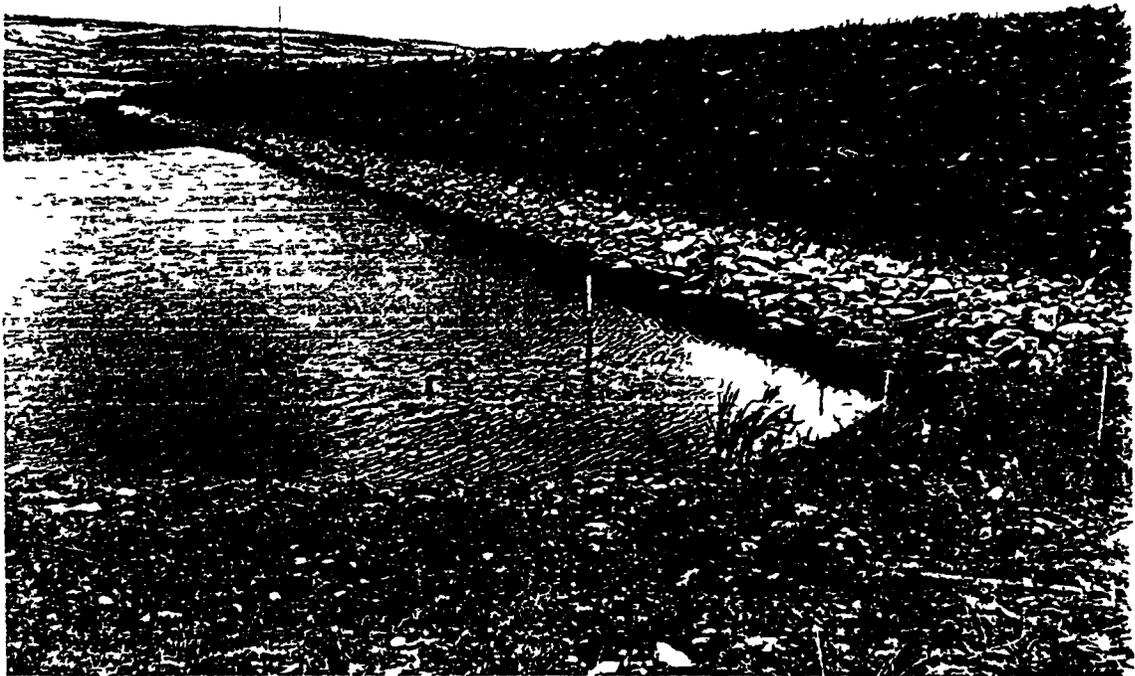
Photo 17. View of upstream slope of Pond C-2 Dam looking north east. Slope lines appeared neat with no visible degradation

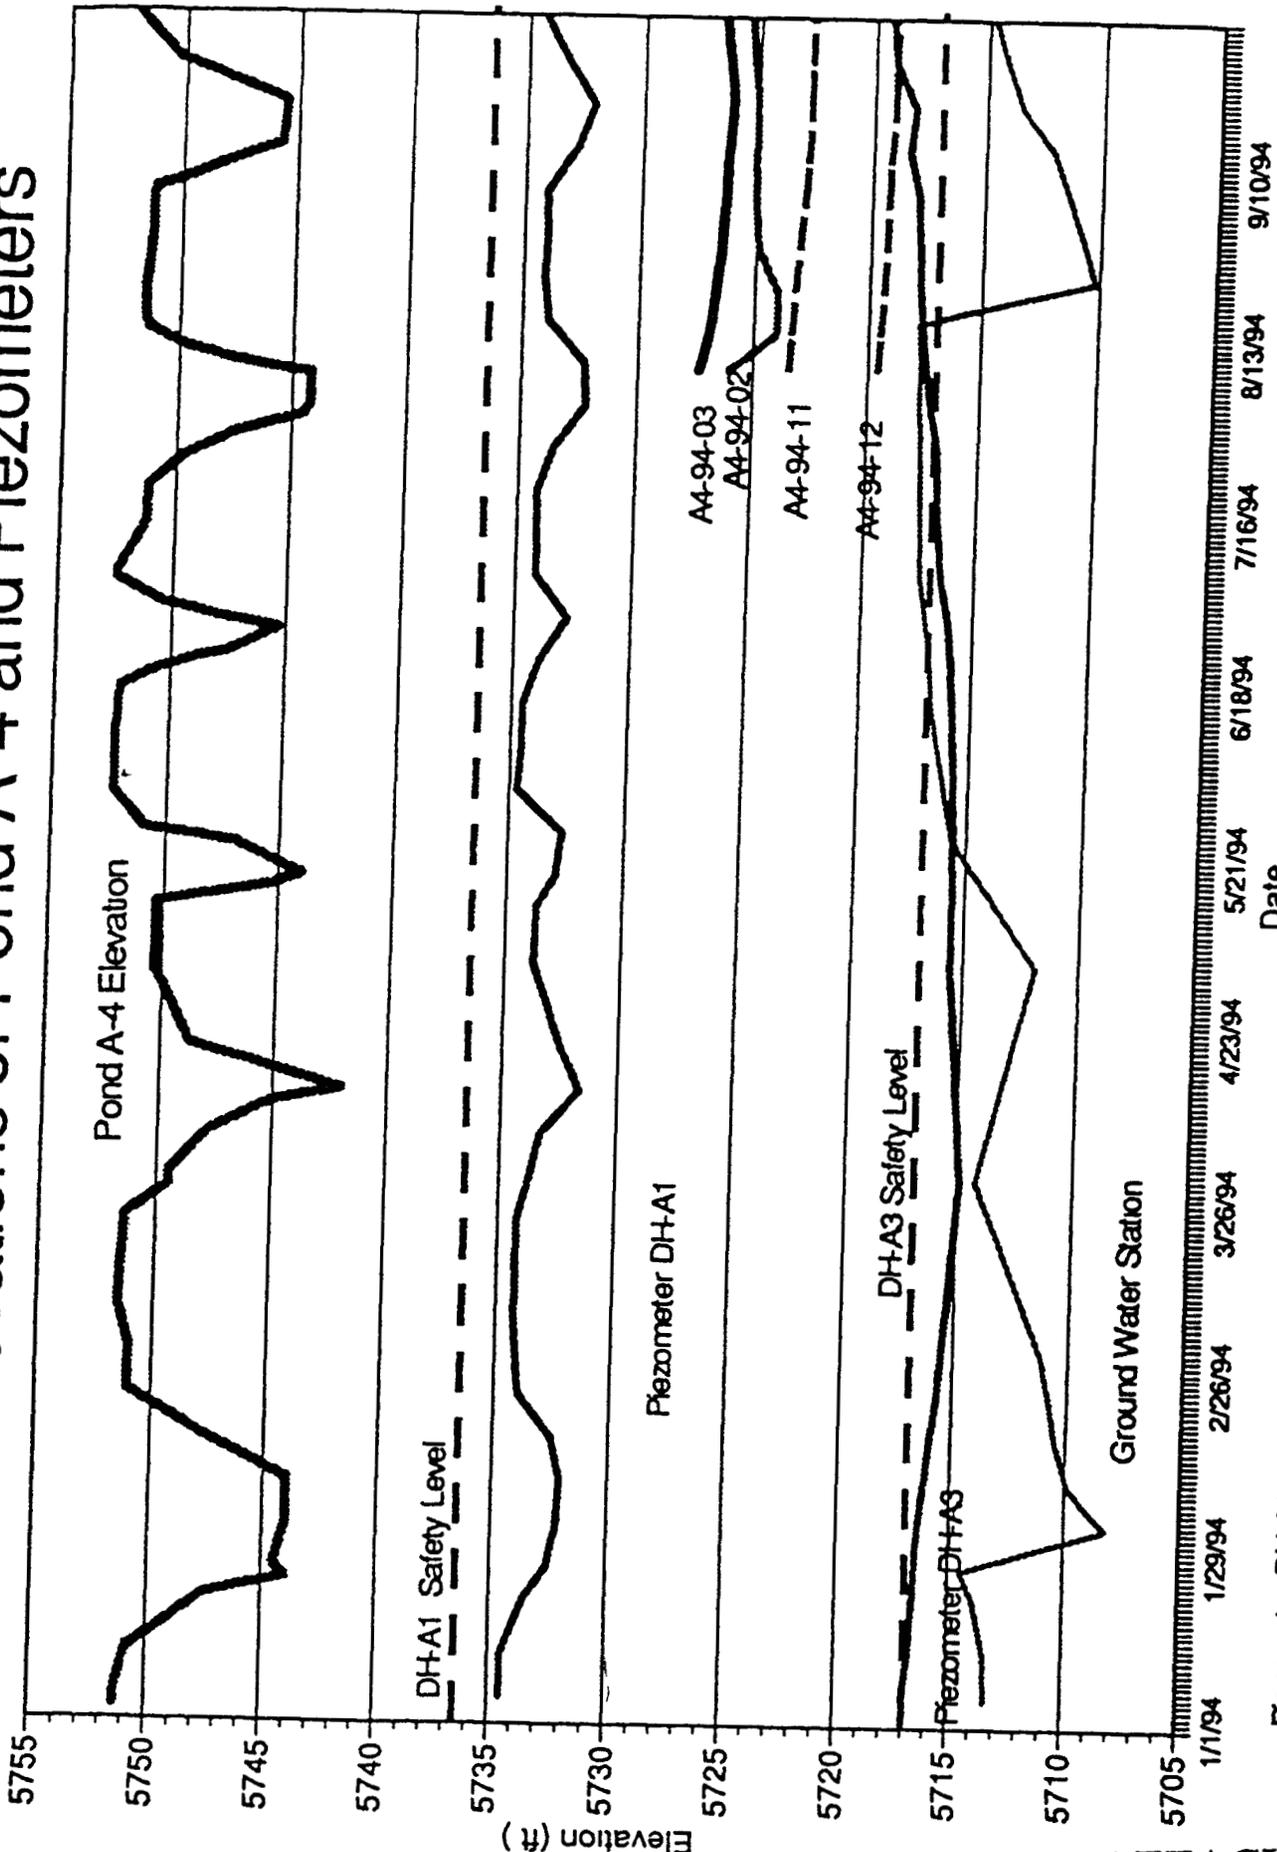
1994 Elevations of Pond A-4 and Piezometers

Dam A-4 Four new piezometers were installed in July, 1994. Two of these, A4-94-02 and A4-94-03 are at the crest and the other two, A4-94-11 and A4-94-12 are at the toe of the dam. Enough data from these four piezometers have not been collected to indicate any definite correlation with the pond level. In fact, during the period of 8/8/94 to 8/15/94, the reservoir level rose by 7 feet, but the piezometer readings did not respond. Actually, for A4-94-03, it went down by a couple of feet. We shall need to have more data before any conclusions can be drawn. Perhaps the instruments also need to be checked to see if these are functioning properly.

Piezometer DH-A1 is on the crest of the dam, and Piezometer DH-A3 is on the toe of the dam. Both are centrally located. The Groundwater station is on the toe of the dam, approximately 100 yards north of the dam's center. A4-94-02 is dry, measurement indicates bottom of well, fluctuations may be caused by human error measuring line slack

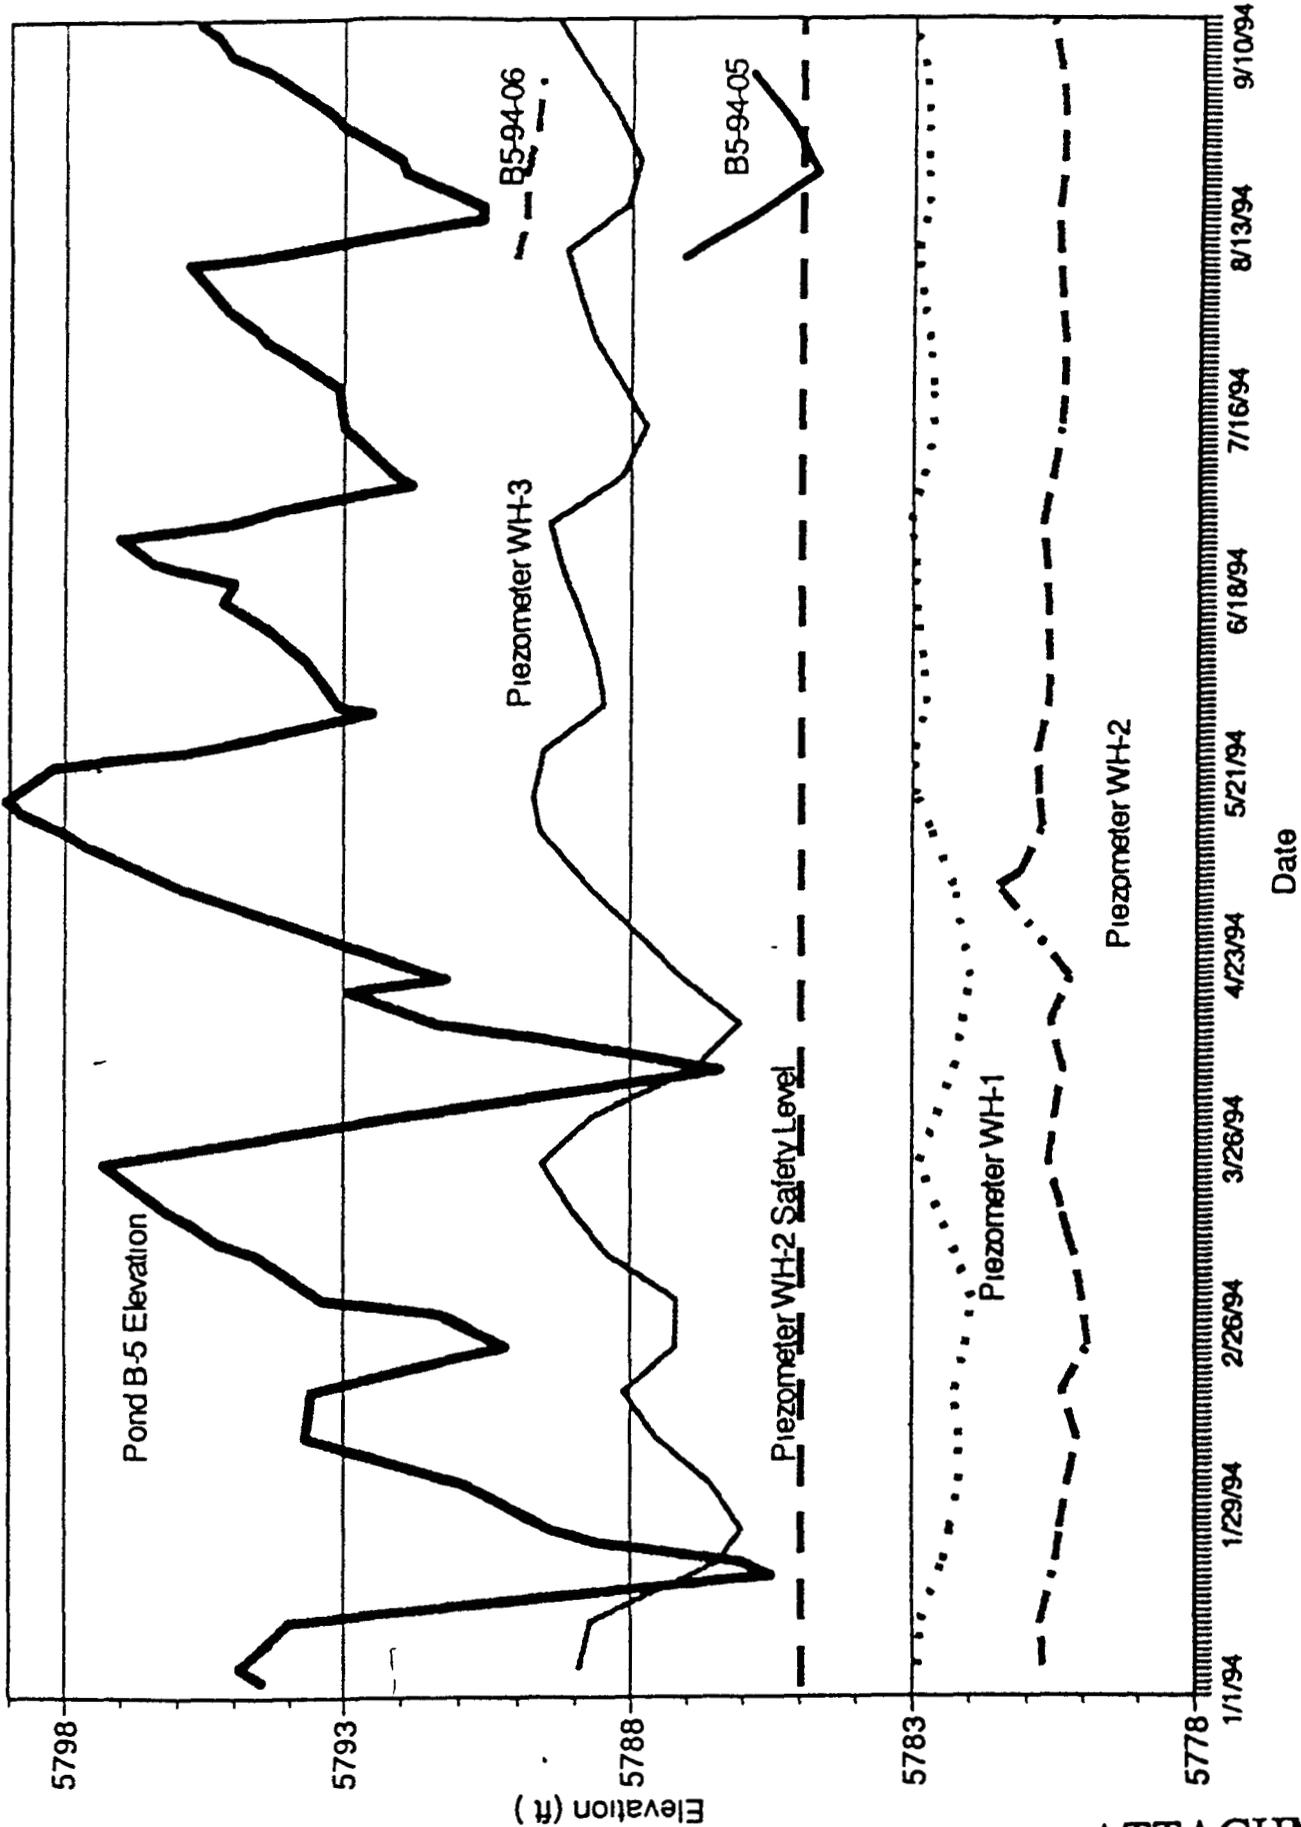
1994 Elevations of Pond B-5 and Crest Piezometers

Piezometer WH-2 is the central crest piezometer. Piezometers WH-1 and WH-3 are located north and south of Piezometer WH-2, respectively.

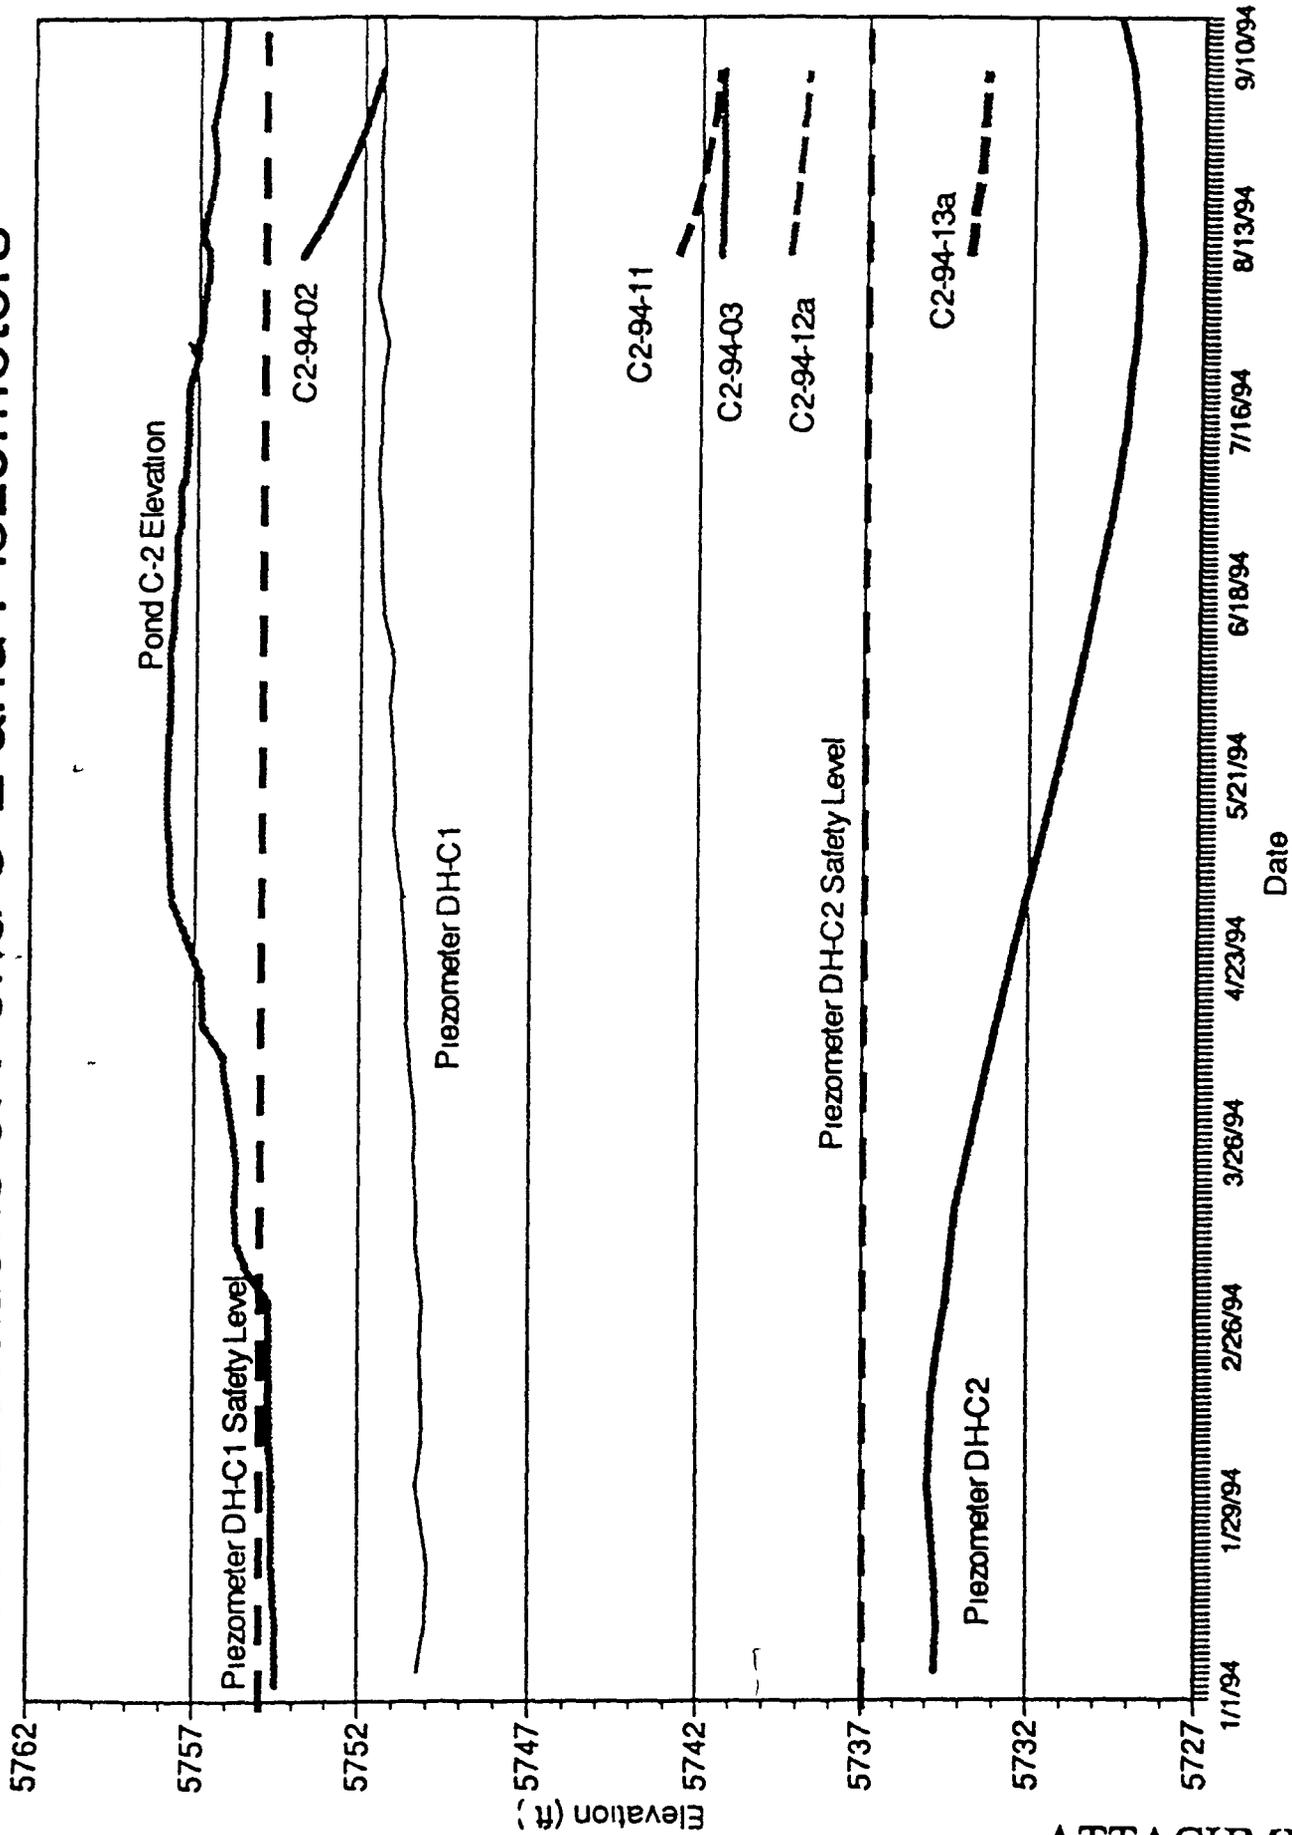
1994 Elevations of Pond C-2 and Piezometers

Piezometer DH-C1 is on the crest of the dam, and Piezometer DH-C2 is on the toe of the dam. Both are centrally located.
