Department of Energy  
Office of Legacy Management

SUBJECT: Status Report of Steps Taken Regarding Monitoring Results at Surface Water Point of Evaluation (POE) SW027

# **Report of Steps Taken Regarding Monitoring Results at Surface Water Point of Evaluation (POE) SW027**

## **August 31, 2010**

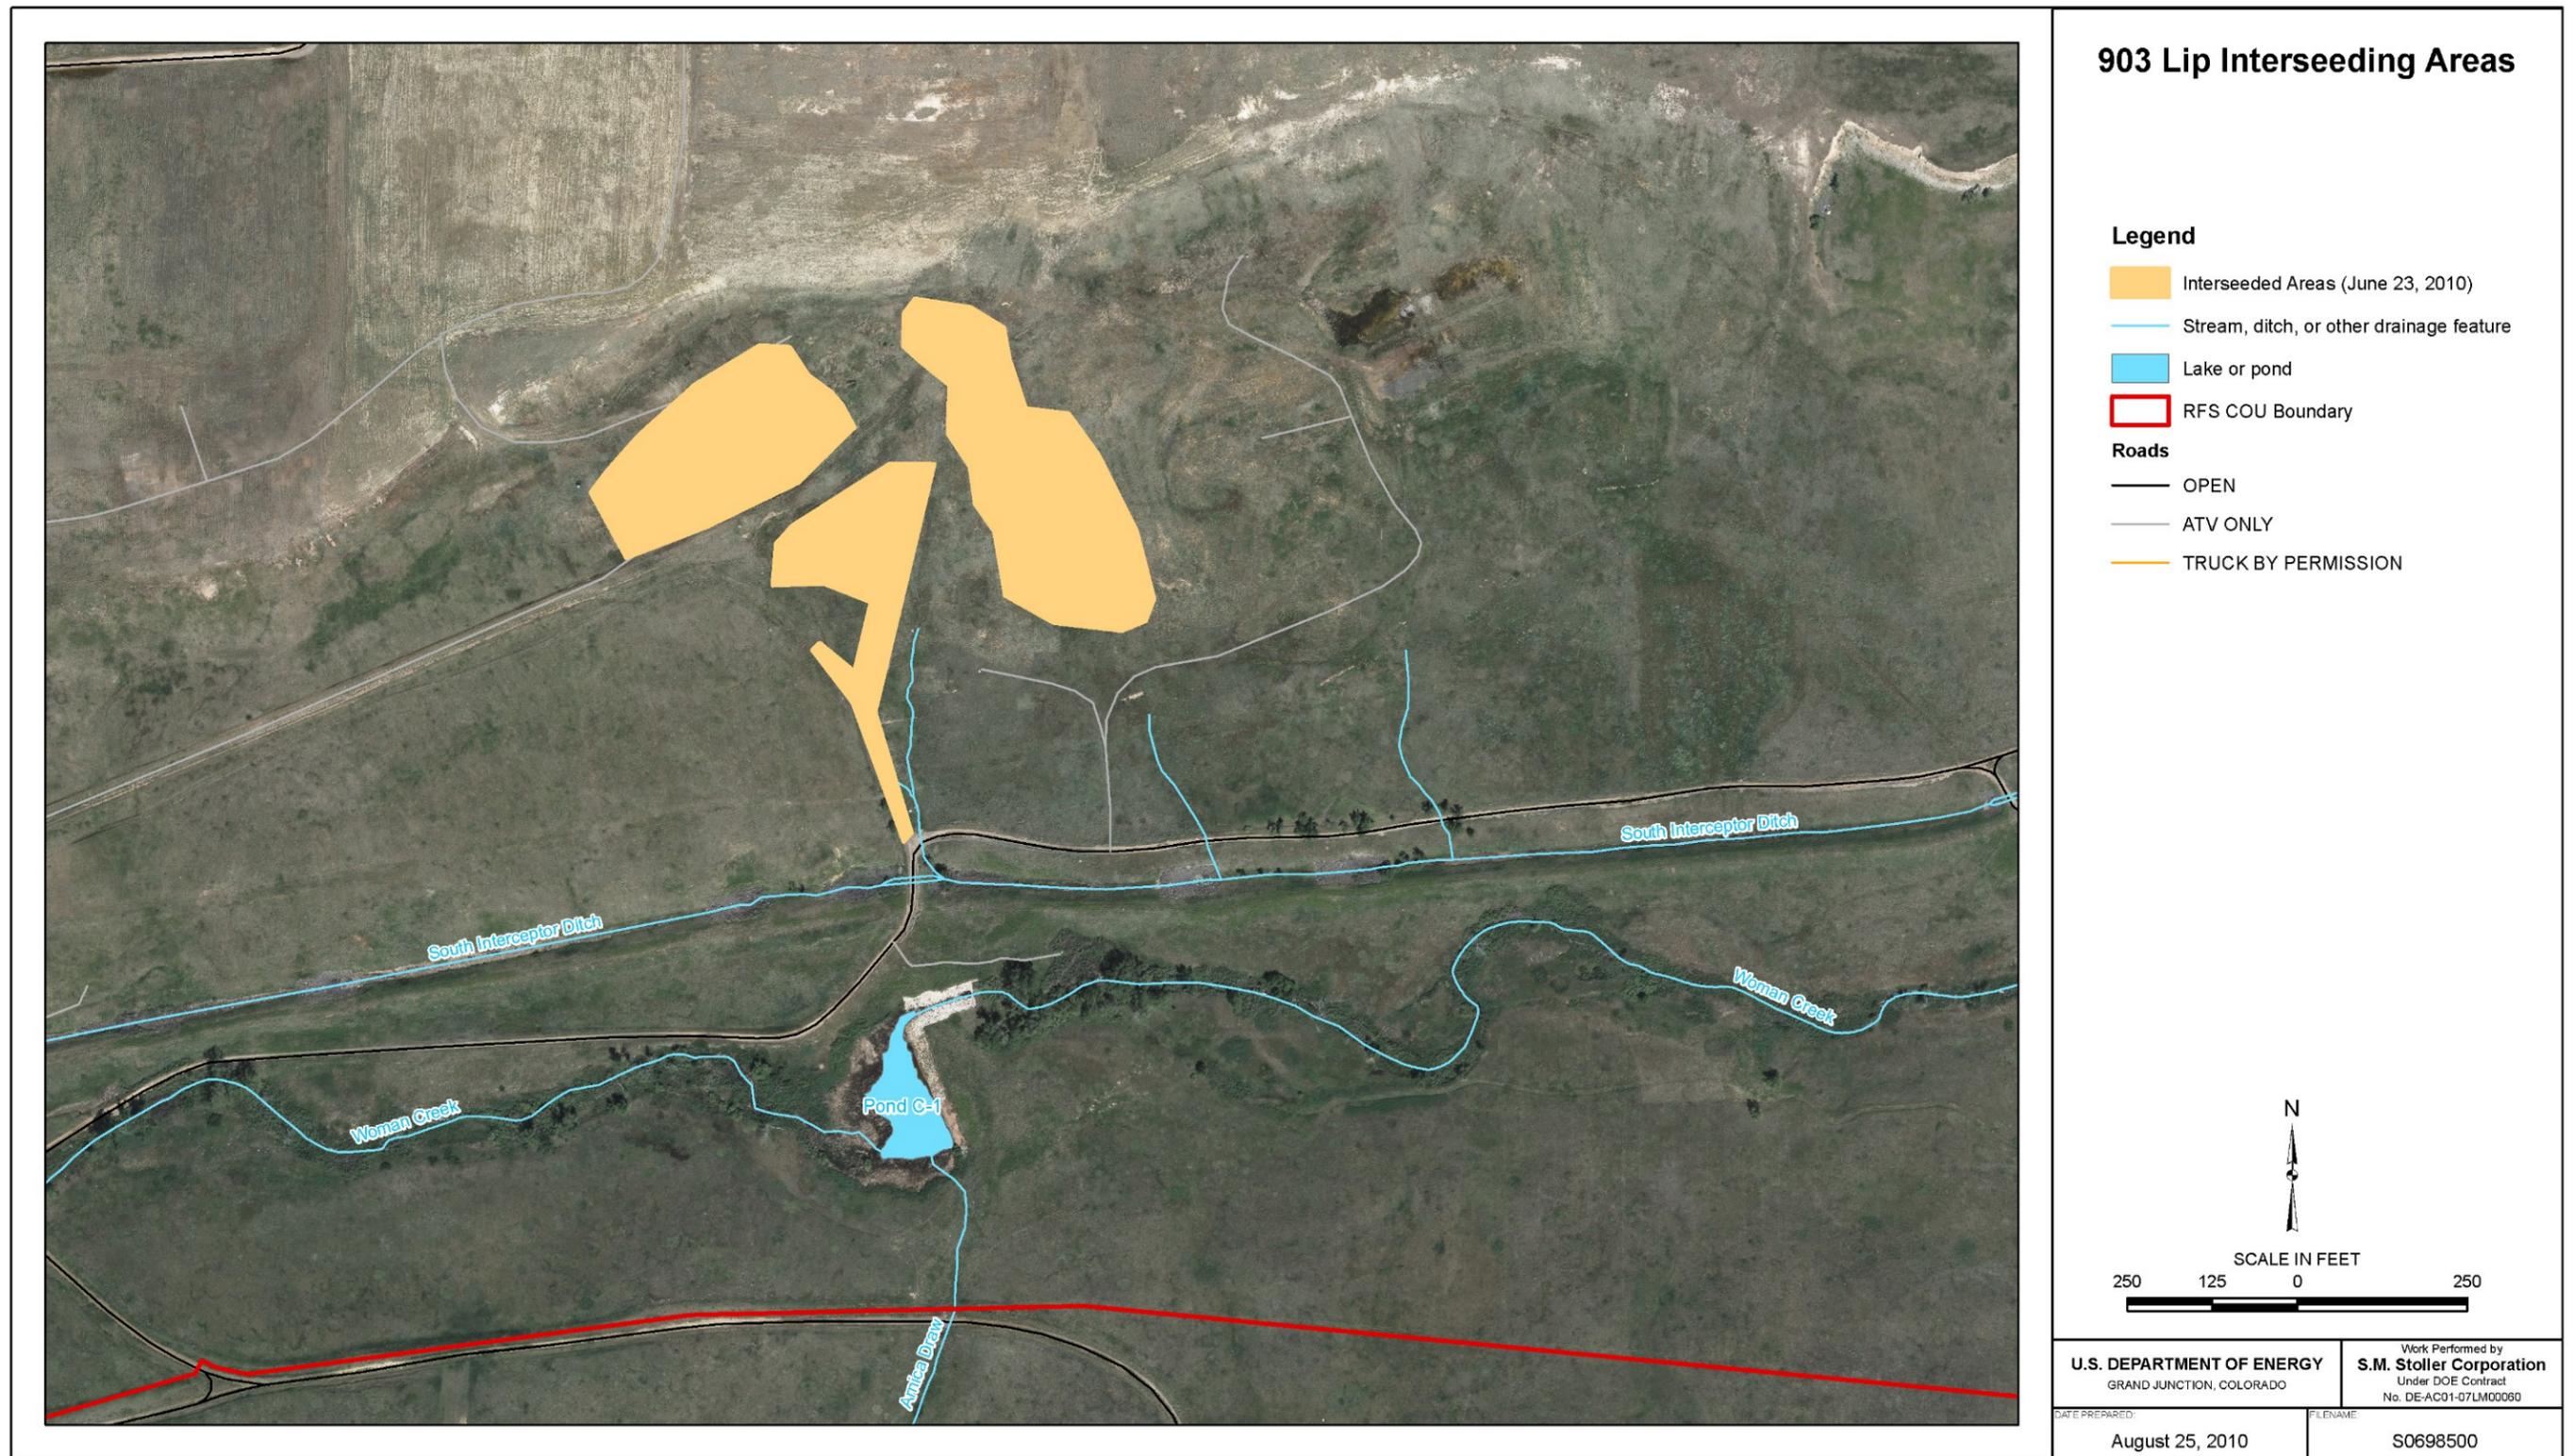
Figure 3. Interseeding Areas

Steps to improve vegetation cover will take time to be effective. Implementation of these steps began on June 23, 2010, when several areas were interseeded, as shown on Figure 3. Figure 4 shows potential locations for additional wattles.

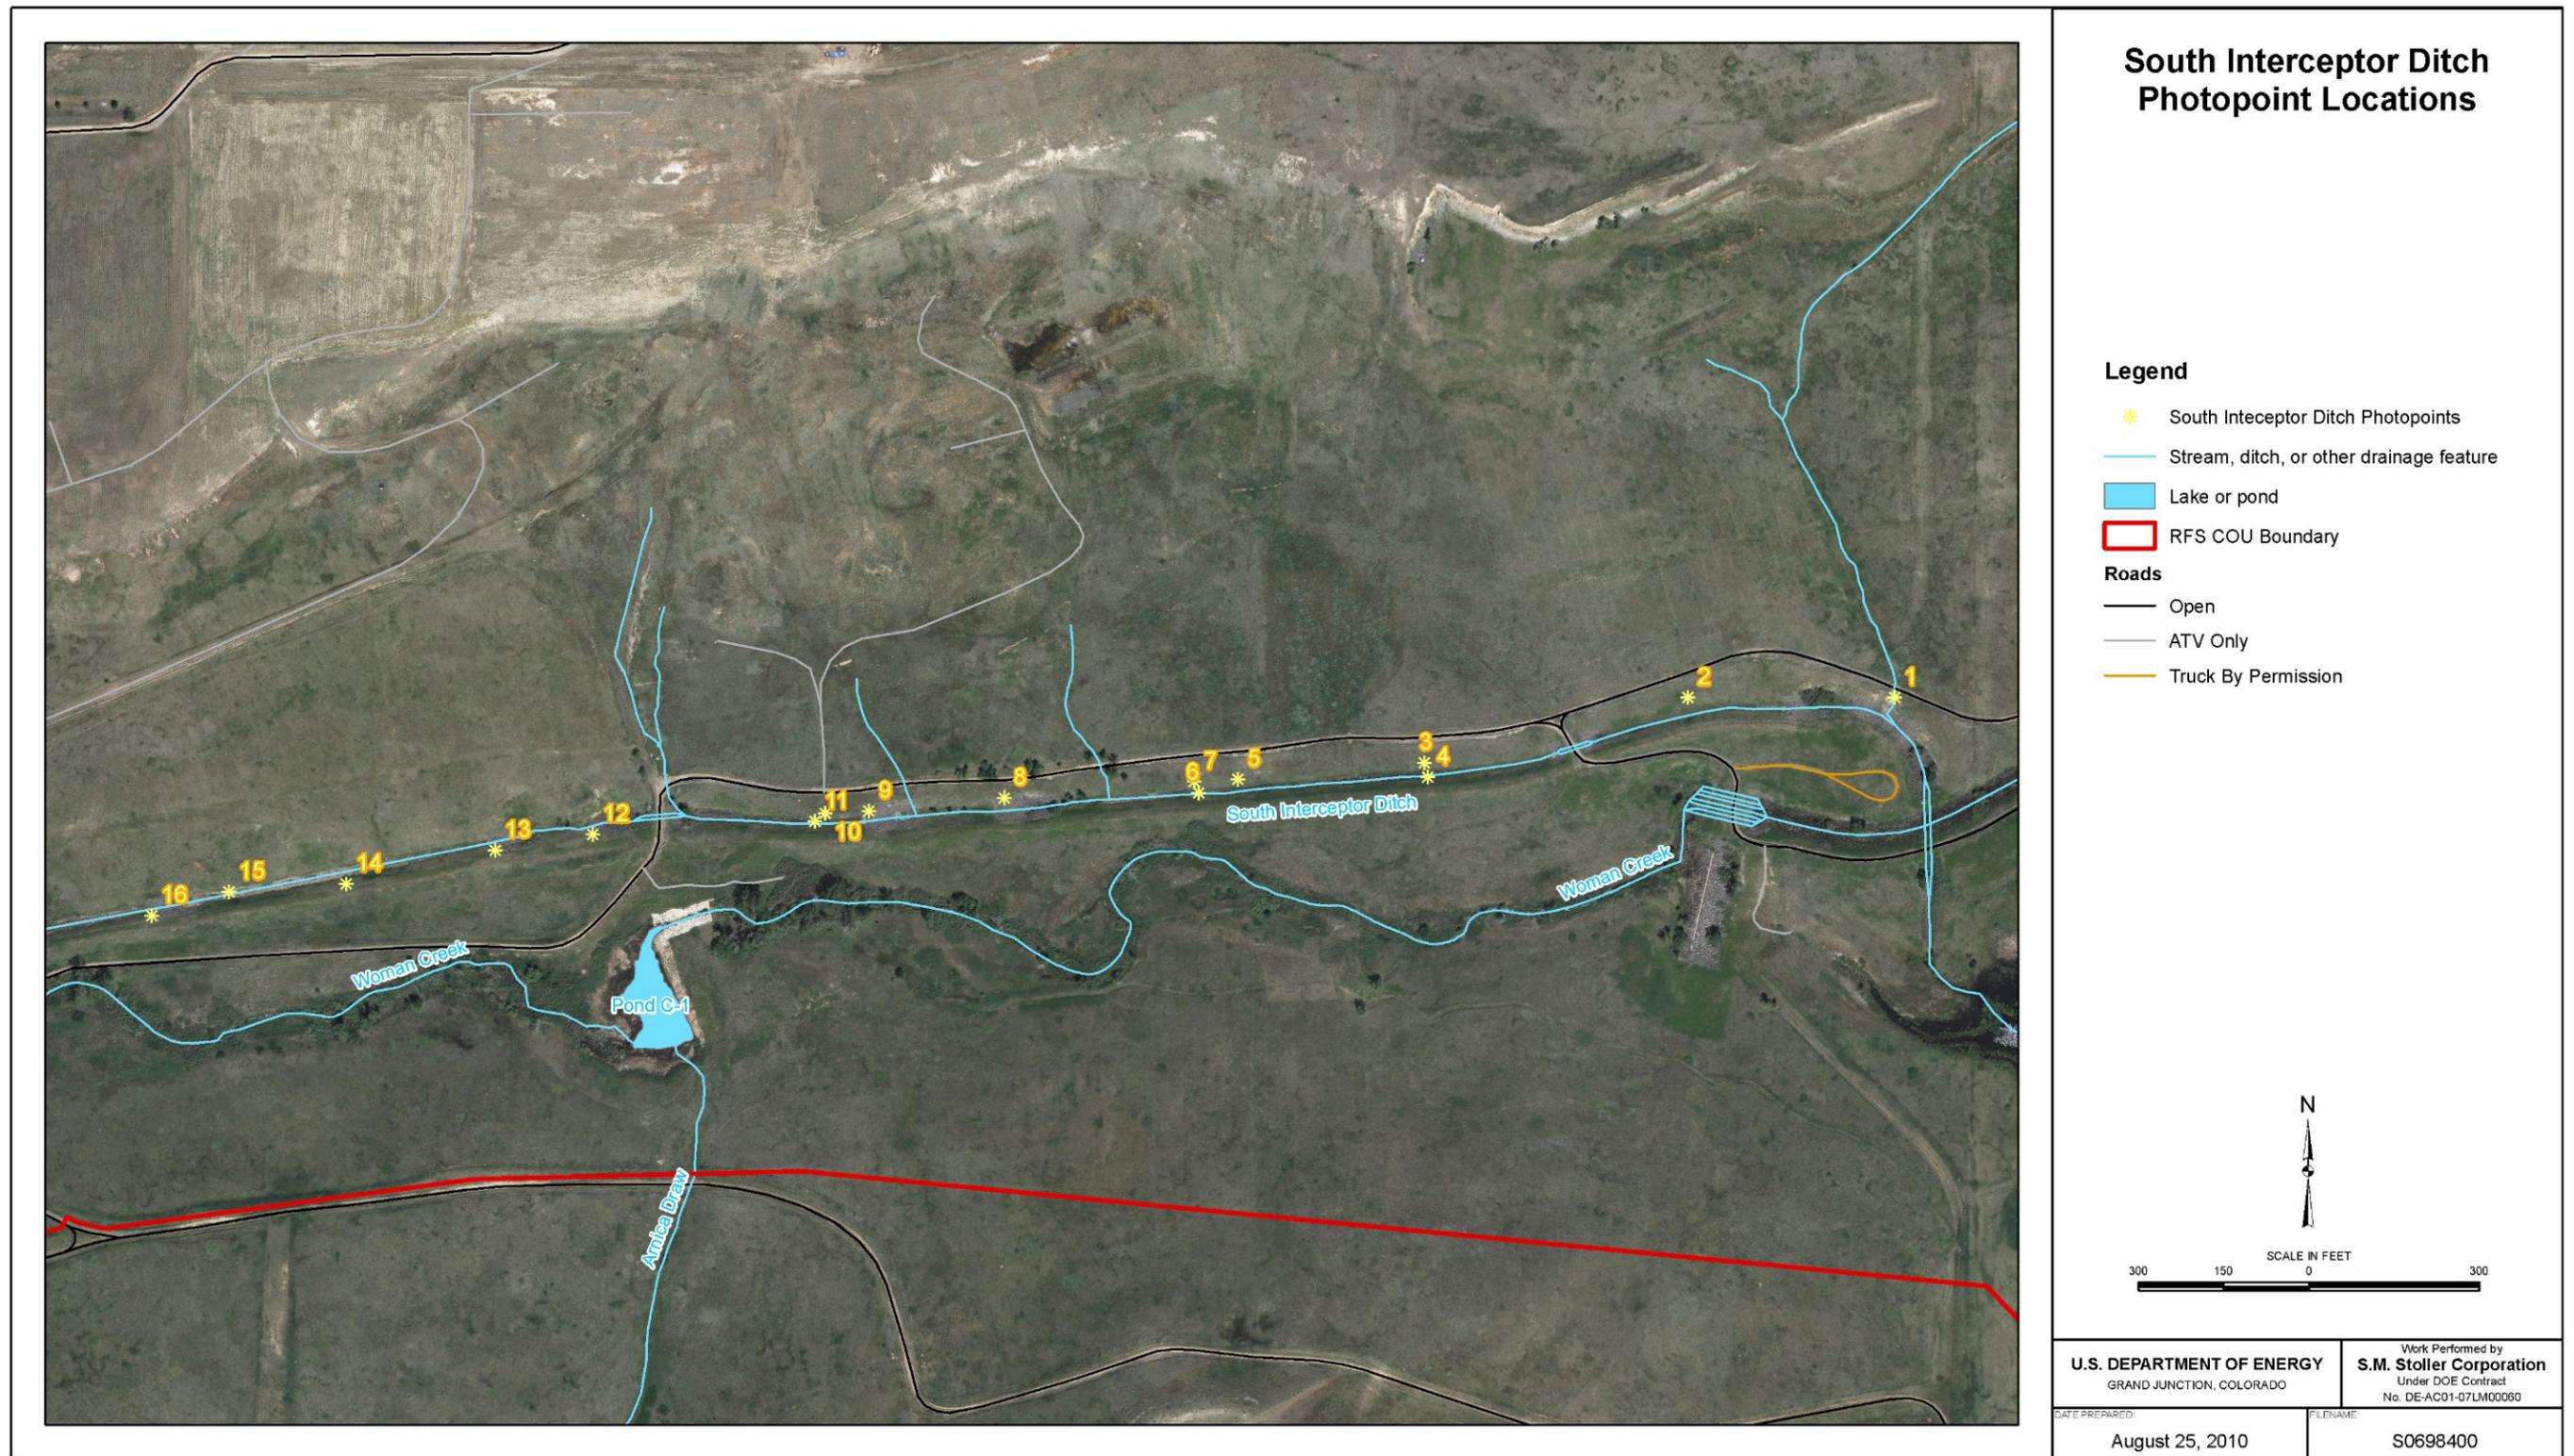
Figure 5. SID Photopoints

The SID channel is covered with areas of riprap, vegetation, and vegetation debris, which limit movement of sediment within the SID. Site personnel inspected areas of the SID during the June visits and conducted an additional walk-down of the SID area on August 23, 2010. The conditions in the SID were documented during the August visit with photographs taken from locations identified by field global-positioning system coordinates. Figure 5 shows the photograph (Photopoint) locations. Figures 6, 7, and 8 are photographs that illustrate the types of cover in the SID channel. Inspectors also noted that the SID channel banks had good stands of vegetation, and there were no conditions that indicate significant erosion, such as gullying or washouts, or conditions that are precursors to significant erosion on the channel banks.

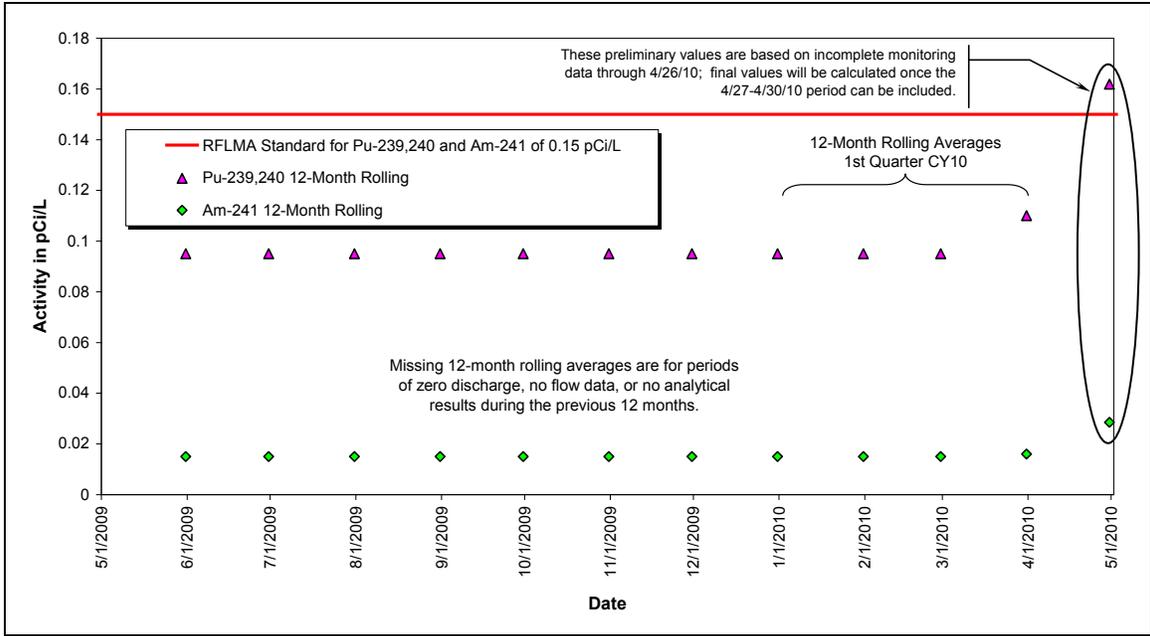
Figure 6. Data for SW027

Although there is normally no water flowing at SW027, heavy runoff during late April 2010 generated the two highest analytical results. Plutonium concentration in a subsequent sample collected April 26, 2010, was 0.029 pCi/L, which indicates that Pu levels have decreased. Sampling at SW027 is accomplished using automated samplers that collect continuous flow-paced composites; the composites are filled based on the availability of water flow. The SW027 composite that was started on April 27, 2010, is still in progress as of August 31, because the composite bottle does not yet contain enough sample volume to conduct a valid analysis. Therefore, the 12-month rolling average for the end of April 2010 cannot be calculated at this time. However, based on the results available through April 26, 2010, DOE has made preliminary notification that the April 2010 12-month rolling average for Pu is expected to be just above the 0.15 pCi/L standard. Figure 6 shows the 12-month rolling average calculated for SW027 with sample results up to April 26, 2010.

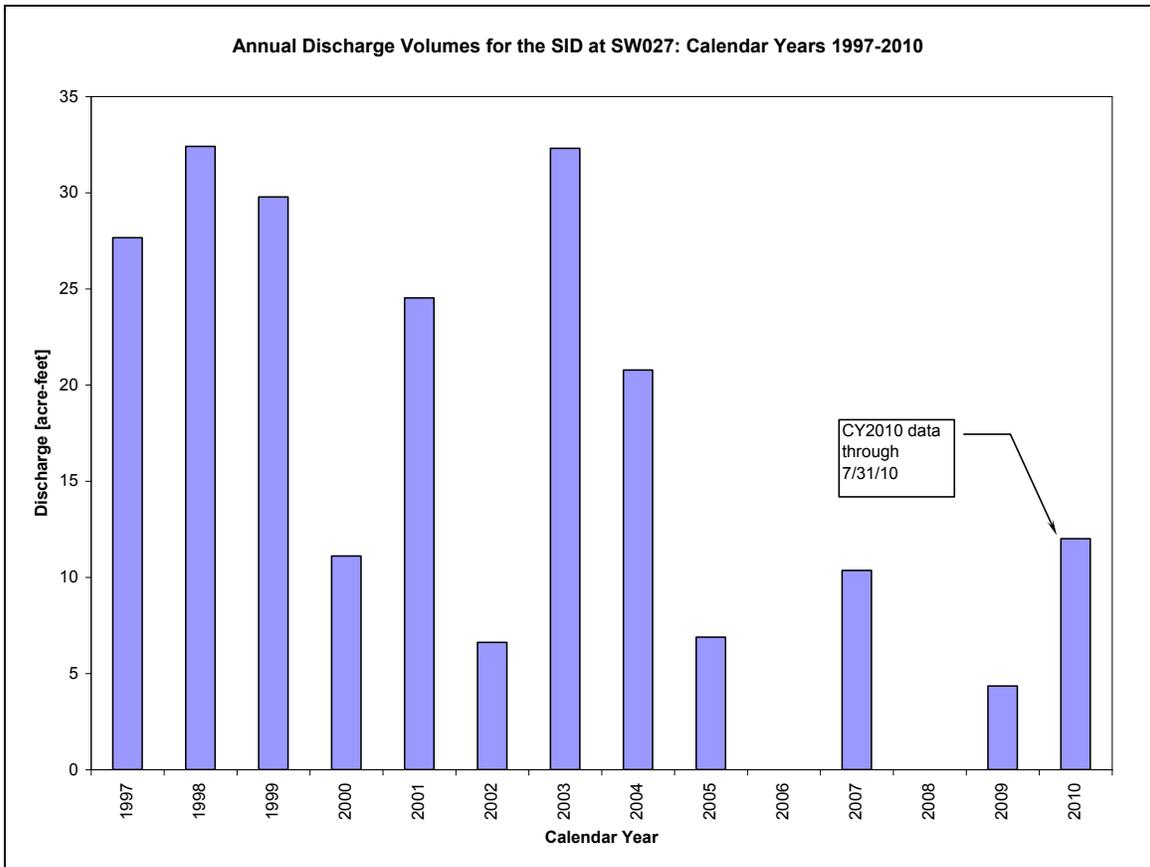
Figure 7. Flows at SW027

Figure 7 shows discharge volumes at SW027, and Figure 8 shows 12-month rolling average results at SW027. While the recent SW027 results indicate that the RFLMA standard for Pu will be exceeded when the April 2010, 12-month rolling average can be calculated, these results are within historical variability and do not indicate a previously unknown source or transport mechanism.

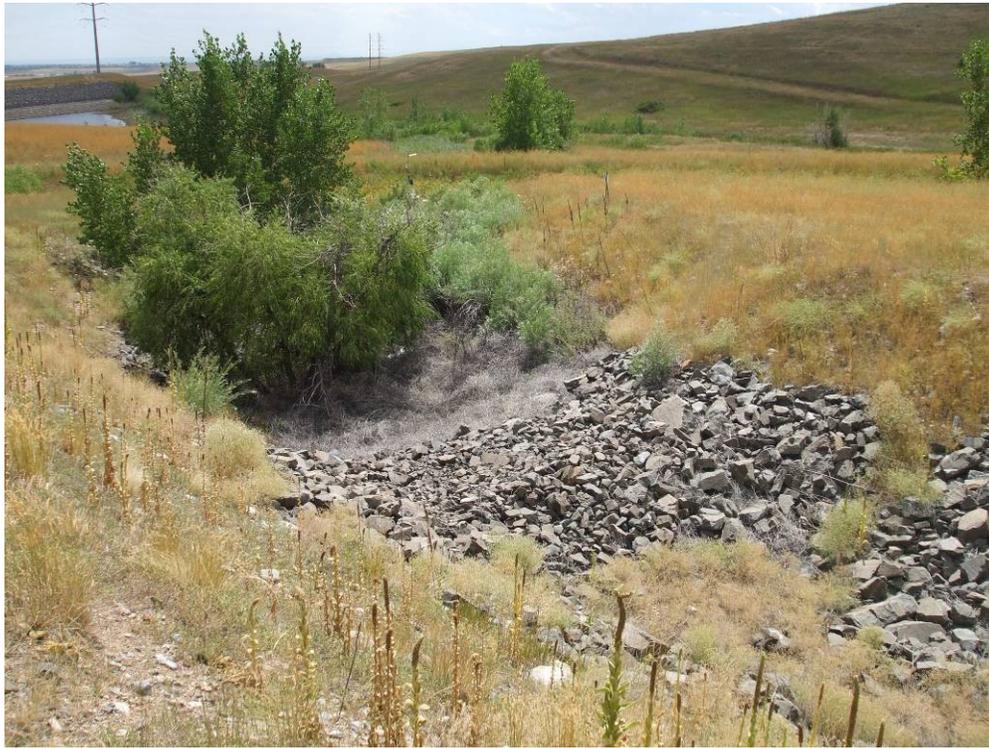
Much of the litter and the riprap, which has litter in the spaces between the rocks, appear to form natural erosion matting. Site personnel are evaluating where additional erosion controls, such as reseeded or installation of permanent erosion matting, might be used for localized areas in the SID and are evaluating the approach to installing these items, where recommended.

*Figure 9. SID Photopoint Location 1—Riprap and Vegetation Litter*

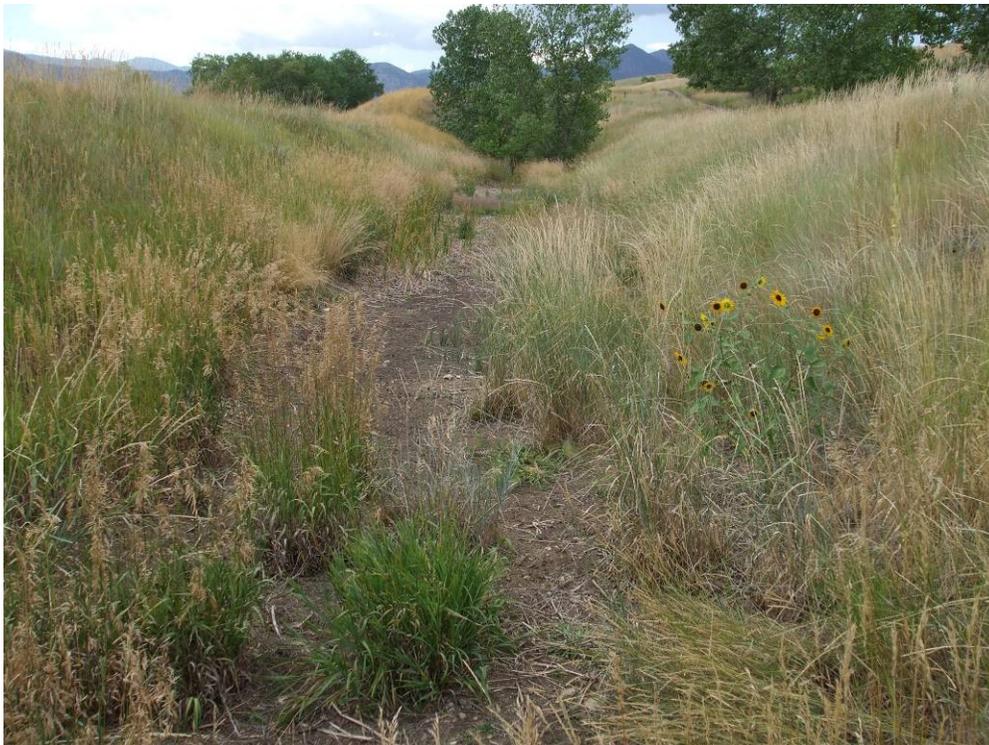
*Figure 10. SID Photopoint Location 6—Minimal Cover in Channel*

- Install erosion matting and interseeding in localized areas where vegetation cover is sparse.
- Reseed in localized areas in the SID where wetland vegetation no longer thrives.
- Evaluate placement of erosion matting in localized areas of the SID and install any recommended matting when conditions are appropriate (likely in late winter or early spring 2011).

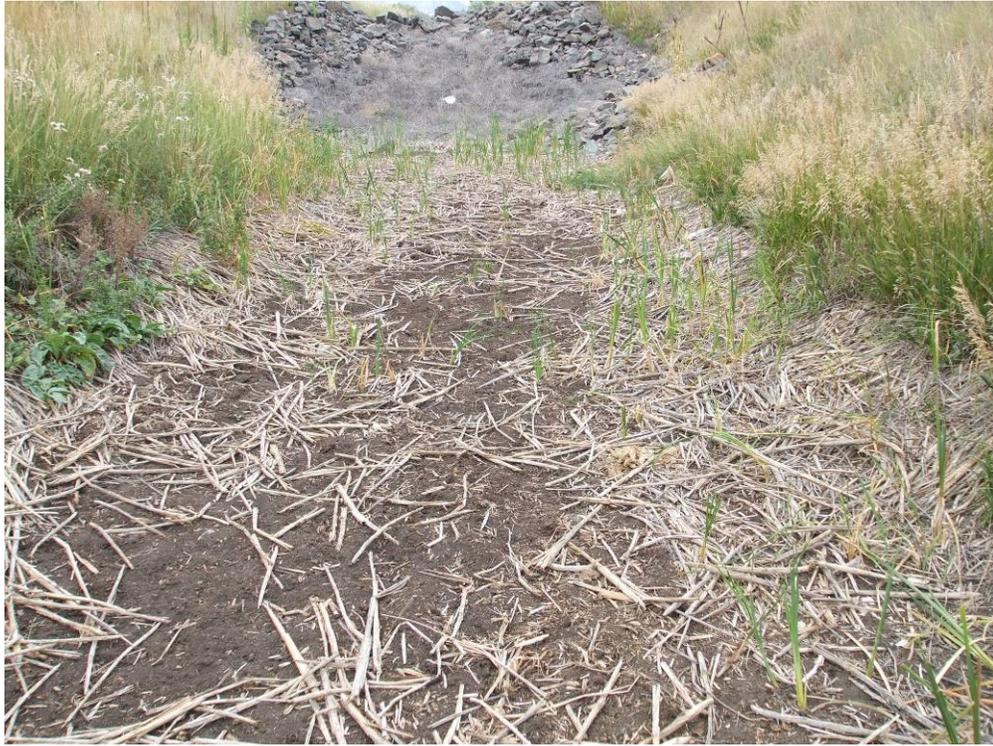
The generally reduced flow of water in the SID relative to pre-closure conditions was apparent in areas that previously supported wetland-type vegetation. The wetland plants are no longer thriving, and dead stands and litter now occupy these locations. These areas will be reseeded at the appropriate times with vegetation more suitable to the drier conditions.

*Figure 11. SID Photopoint Location 15—Dead Wetland Vegetation Litter*

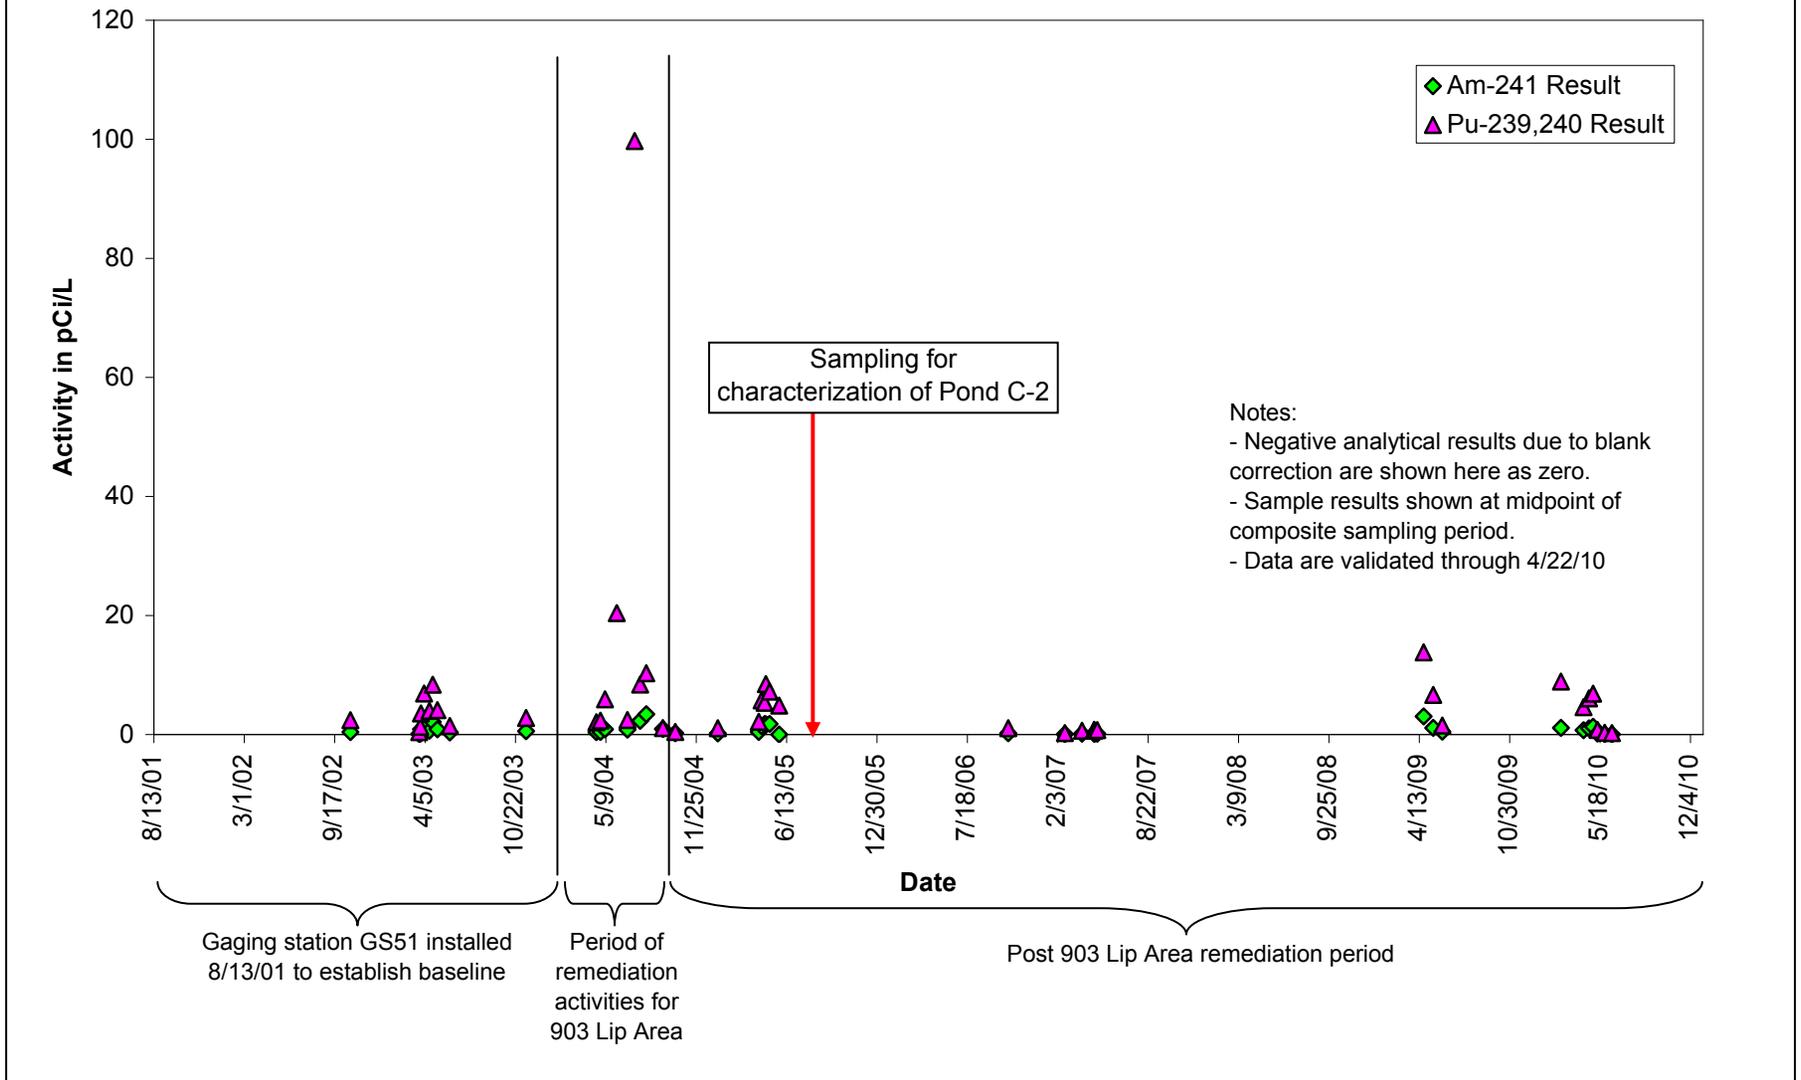
Figure 12. GS51 Data

The review does not indicate any unexpected source of Pu at GS51, and no upward trends are evident. Figures 9 and 10 provide the graphs of data reviewed.
