# environmental inventory

A HISTORICAL SUMMATION OF ENVIRONMENTAL  
INCIDENTS AFFECTING SOILS AT OR NEAR THE  
U.S.AEC ROCKY FLATS PLANT.

J. B. OWEN

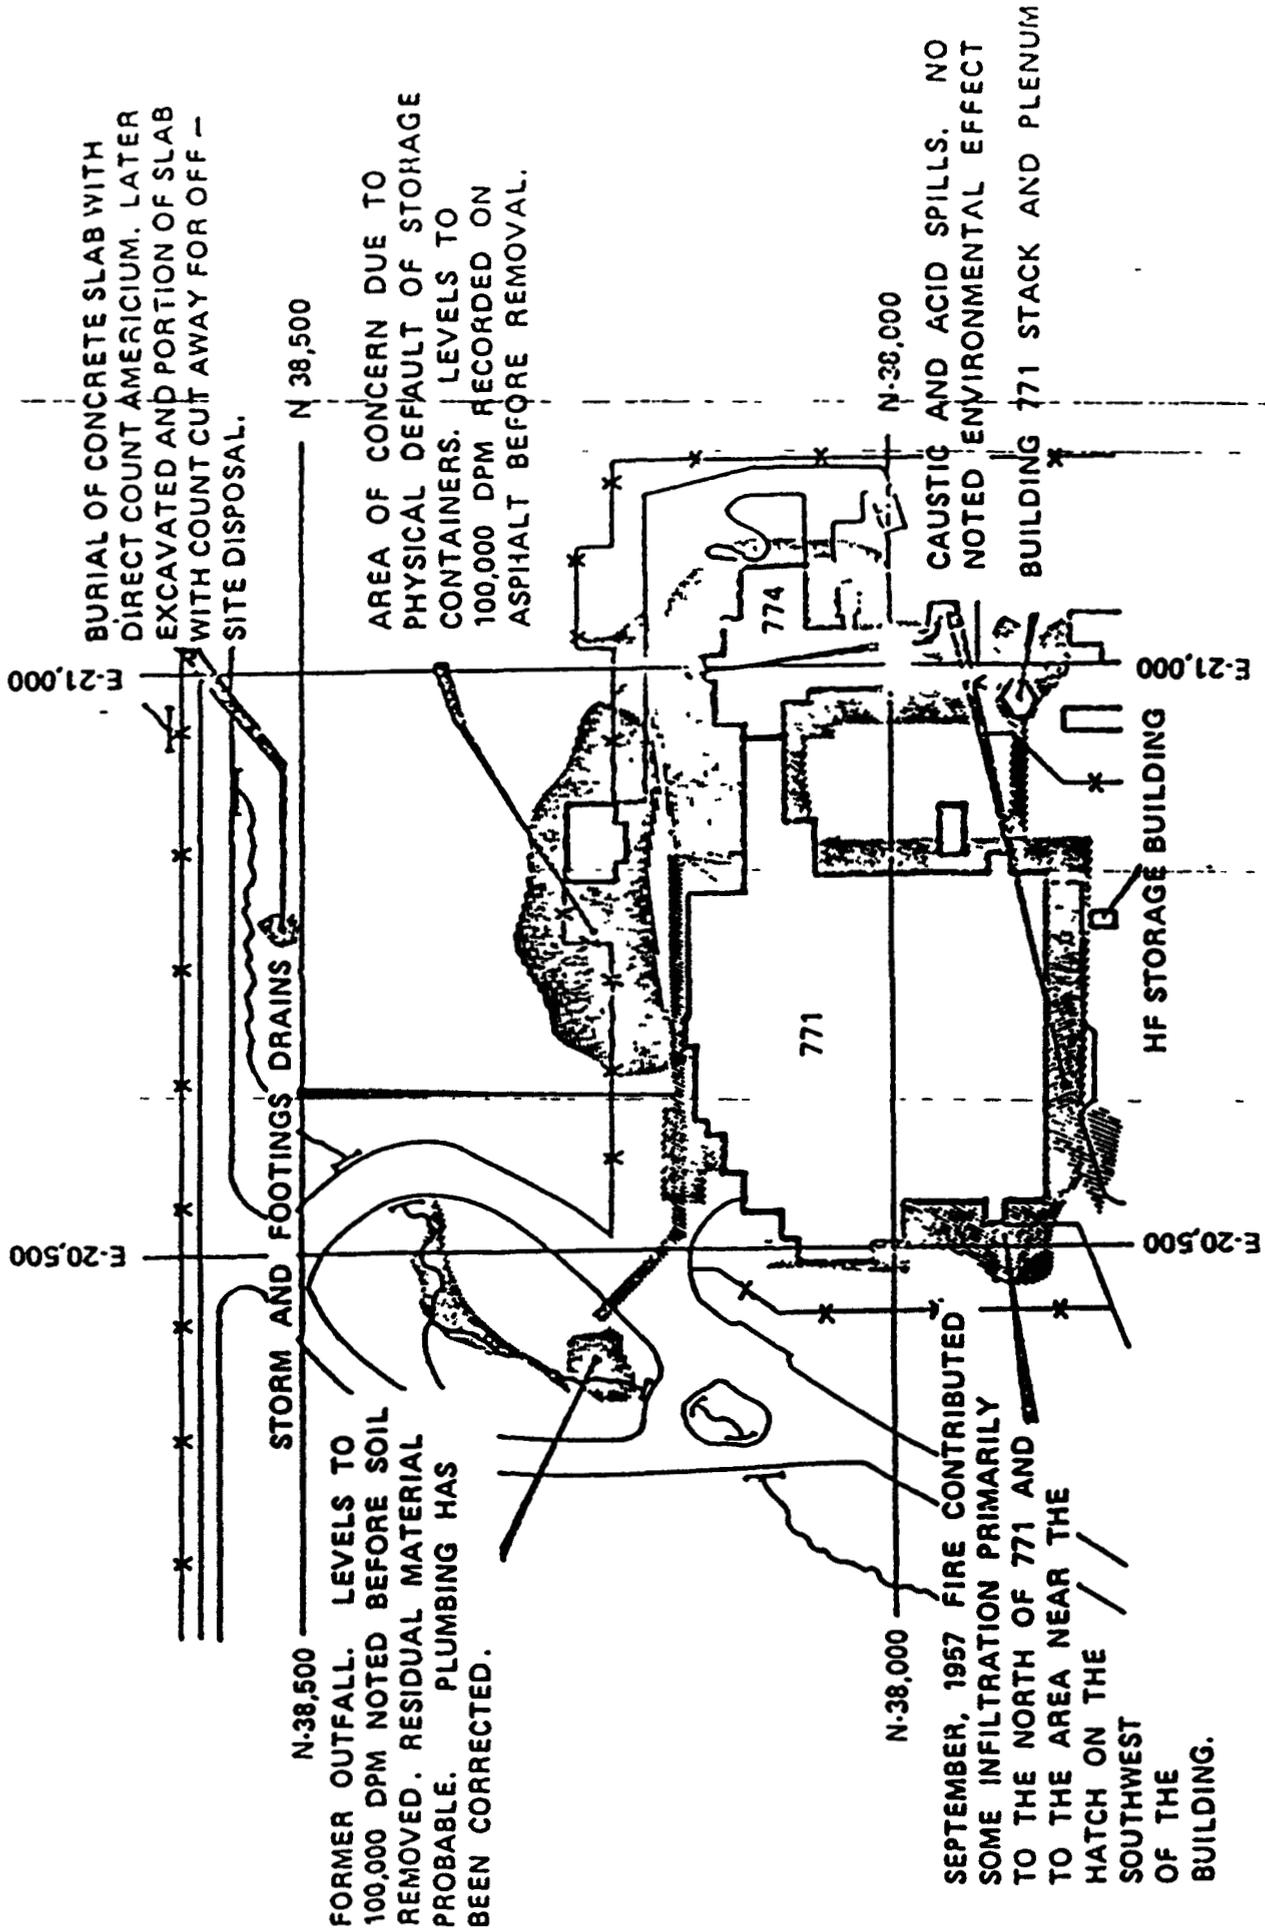
BURIAL OF CONCRETE SLAB WITH DIRECT COUNT AMERICIUM. LATER EXCAVATED AND PORTION OF SLAB WITH COUNT CUT AWAY FOR OFF-SITE DISPOSAL.

CAUSTIC AND ACID SPILLS. NO NOTED ENVIRONMENTAL EFFECT BUILDING 771 STACK AND PLENUM

FORMER OUTFALL. LEVELS TO 100,000 DPM NOTED BEFORE SOIL REMOVED. RESIDUAL MATERIAL PROBABLE. PLUMBING HAS BEEN CORRECTED.

SEPTEMBER, 1957 FIRE CONTRIBUTED SOME INFILTRATION PRIMARILY TO THE NORTH OF 771 AND TO THE AREA NEAR THE HATCH ON THE SOUTHWEST OF THE BUILDING.

This map gives an arbitrary indication of possible affected areas as a result of operational incidents and accidents in the Buildings 770-771-774 area. As indicated, low level nitrate and radioactive infiltration is expected. Soil samples of the area justify this low-level assumption, with plutonium values ranging from undetectable to 64.9 dpm/g.

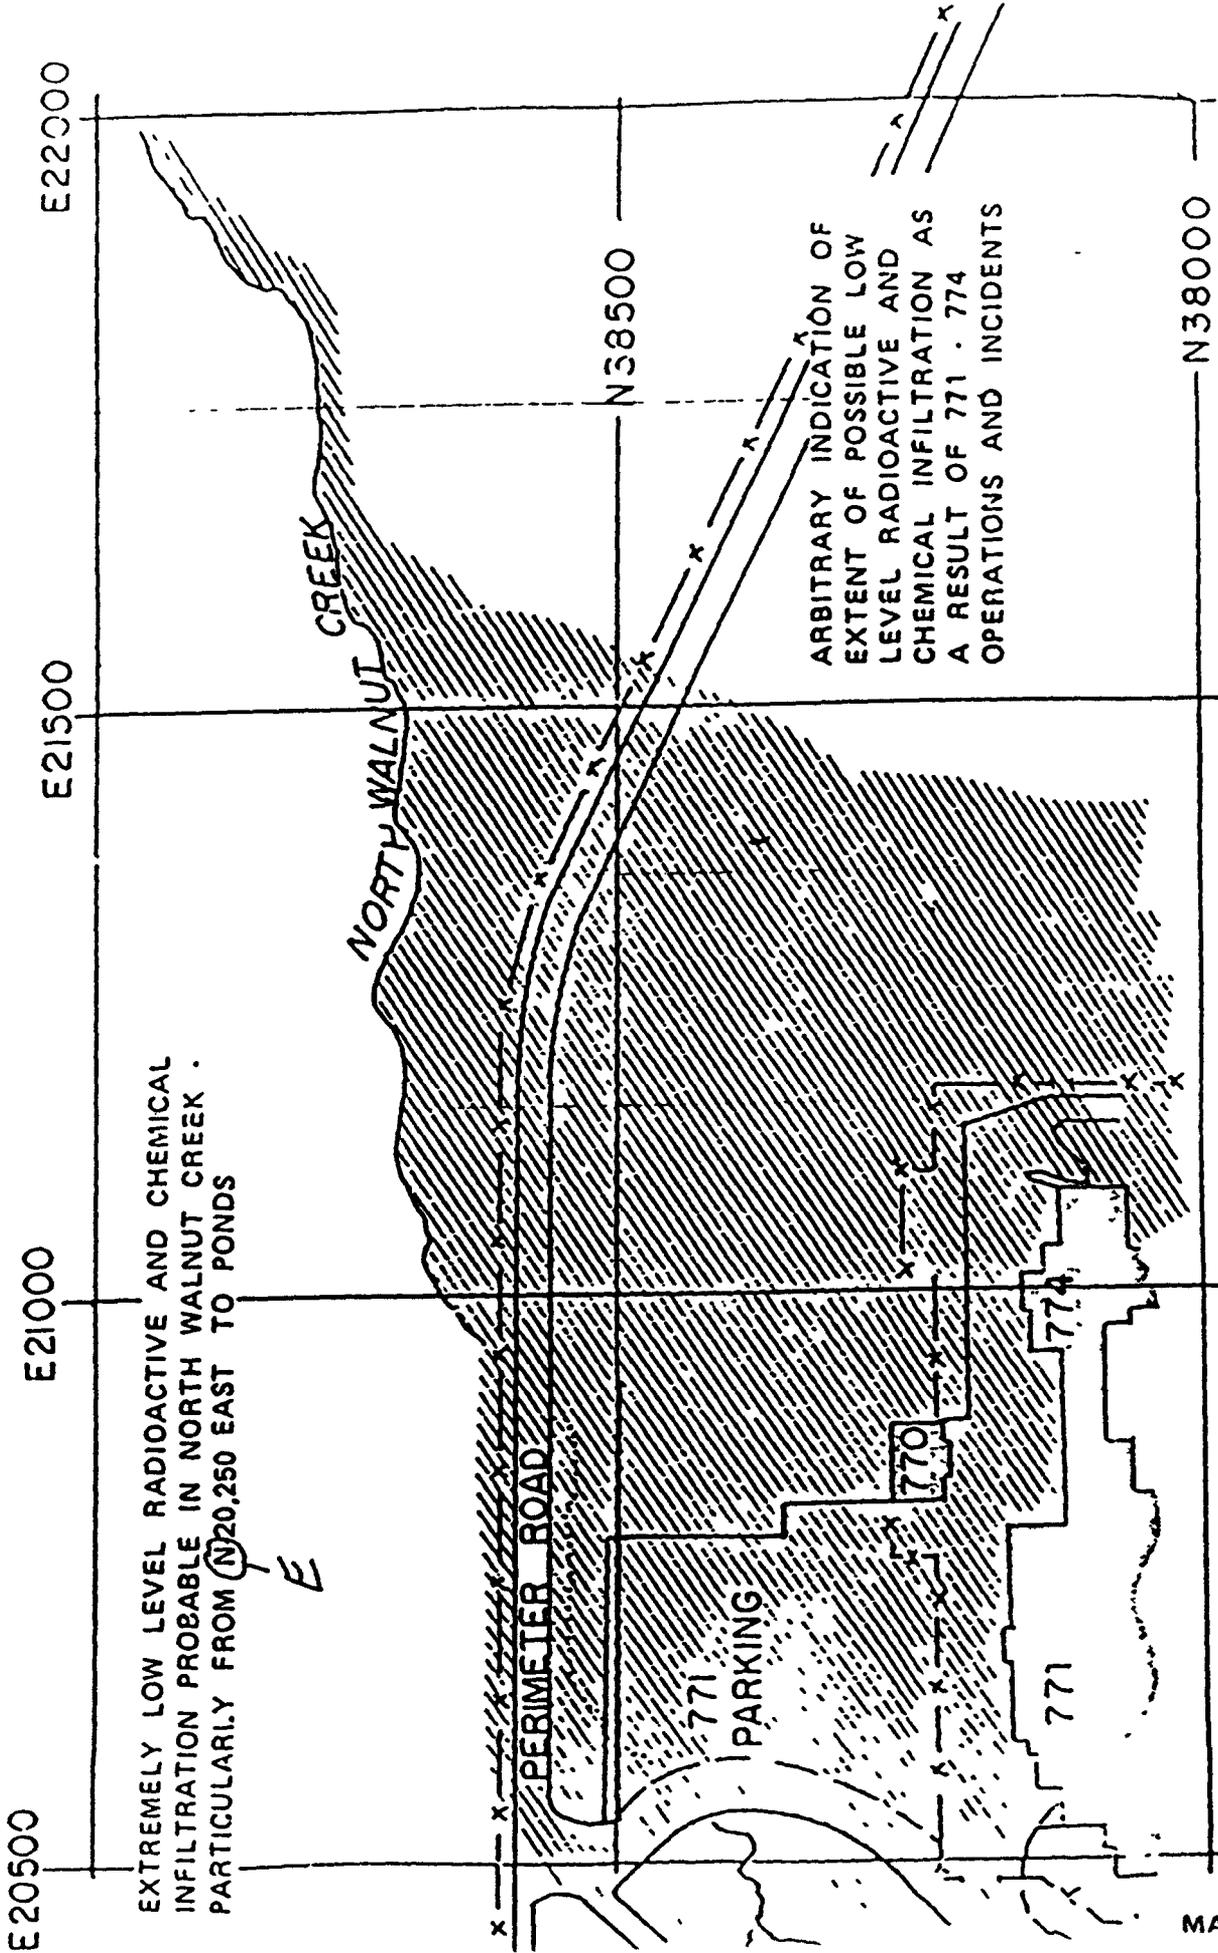
EXTREMELY LOW LEVEL RADIOACTIVE AND CHEMICAL  
INFILTRATION PROBABLE IN NORTH WALNUT CREEK .  
PARTICULARLY FROM N20,250 EAST TO PONDS

ARBITRARY INDICATION OF  
EXTENT OF POSSIBLE LOW  
LEVEL RADIOACTIVE AND  
CHEMICAL INFILTRATION AS  
A RESULT OF 771 - 774  
OPERATIONS AND INCIDENTS

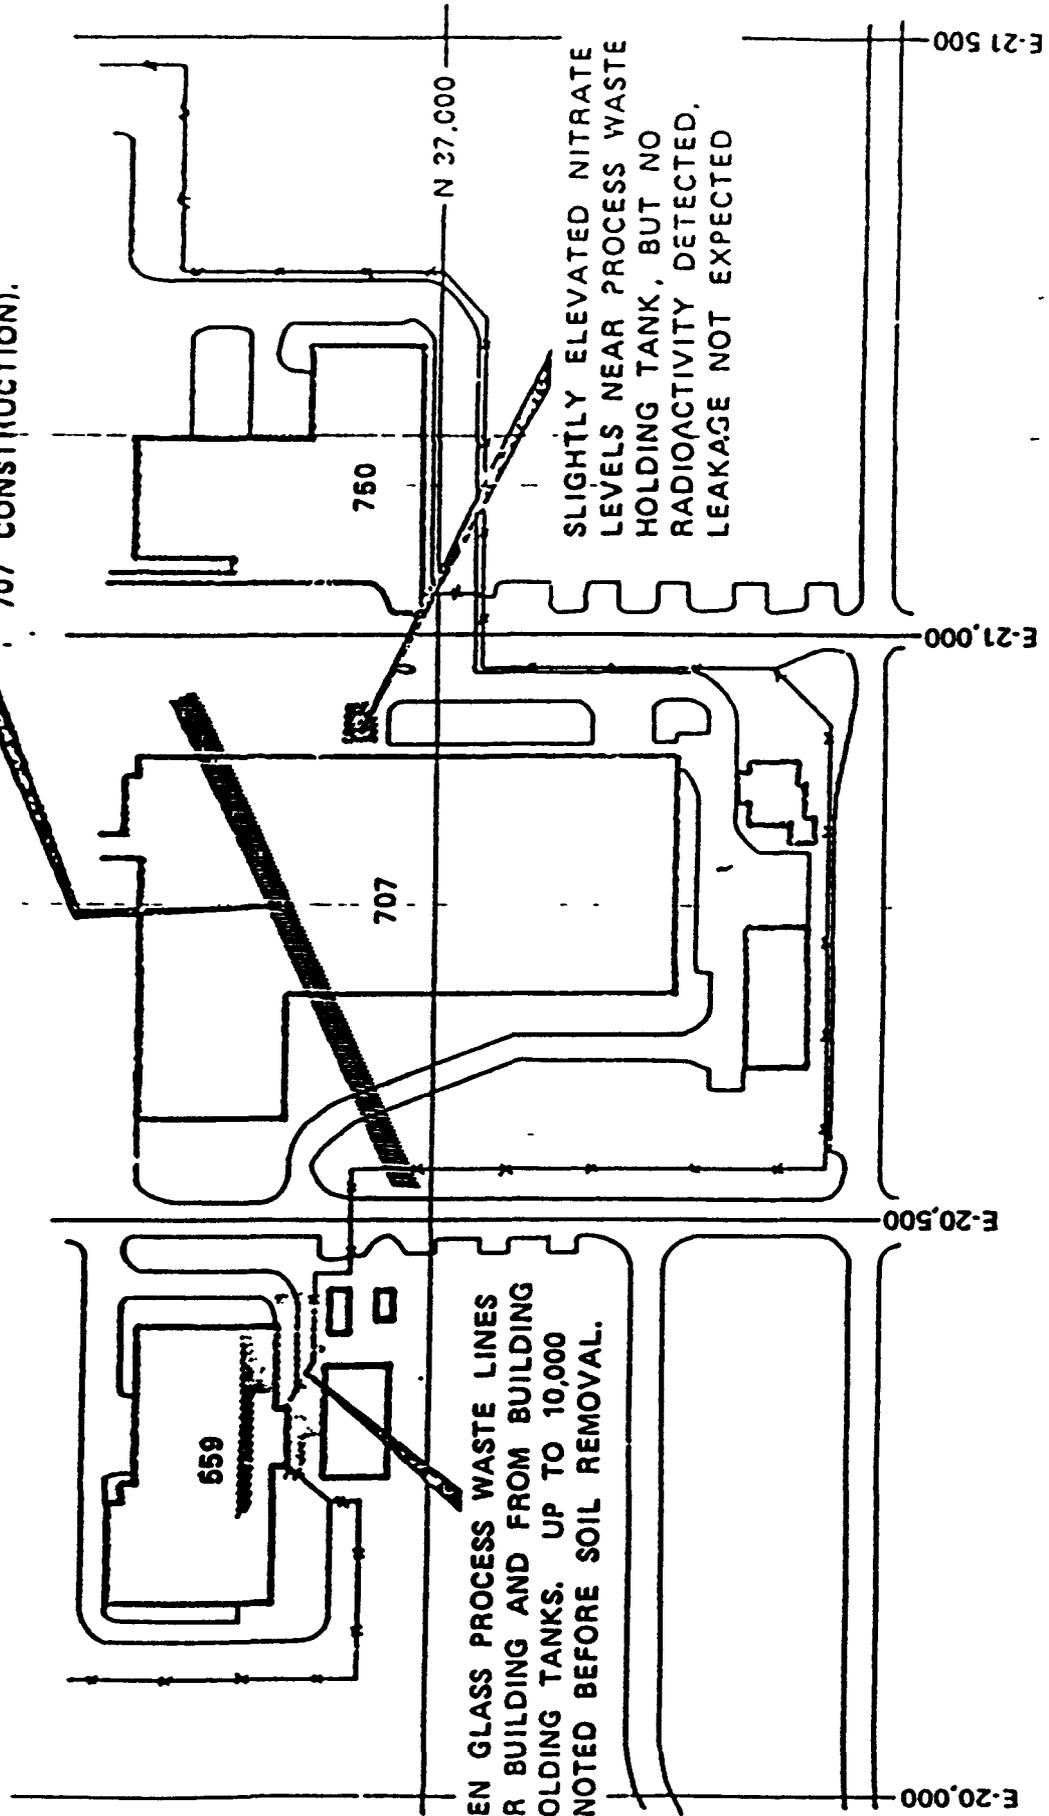
The Service Laboratory Facility, Building 559, began operation in March 1968. Original process waste pipelines under the building were made of Pyrex<sup>®</sup> glass to combat a persistent corrosion problem. Operations ~~and natural settling of the building~~ have resulted in several breaks in this glass line, which are discussed ~~in conjunction with Map 14.~~

BROKEN GLASS PROCESS WASTE LINES  
UNDER BUILDING AND FROM BUILDING  
TO HOLDING TANKS. UP TO 10,000  
DPM NOTED BEFORE SOIL REMOVAL.

SLIGHTLY ELEVATED NITRATE  
LEVELS NEAR PROCESS WASTE  
HOLDING TANK, BUT NO  
RADIOACTIVITY DETECTED.  
LEAKAGE NOT EXPECTED

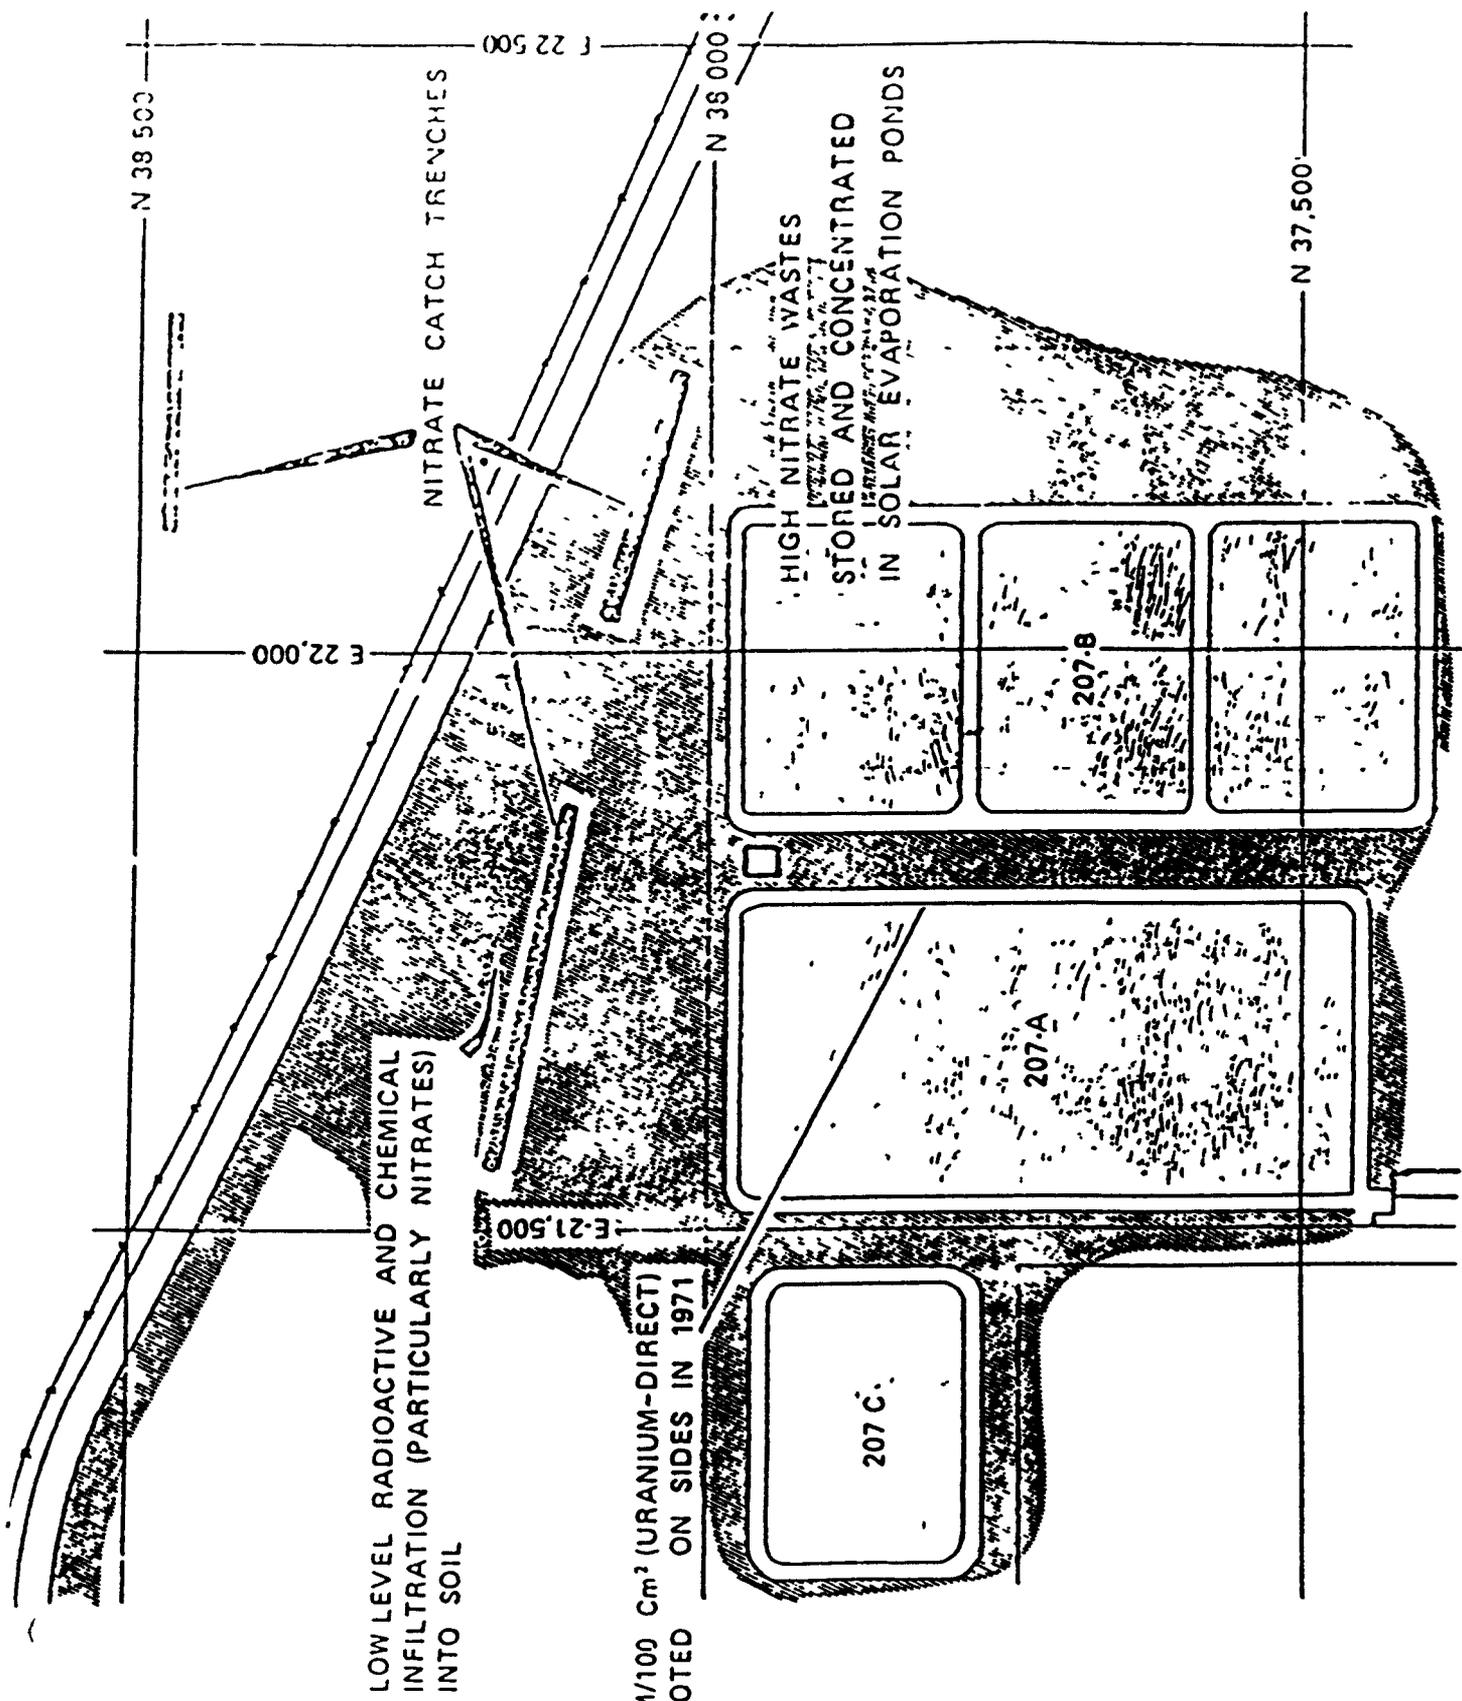
Since the plant's inception, high-nitrate wastes have been concentrated (by evaporation) in a series of solar-evaporation ponds and over a 20-year time span, some loss of integrity occurred. The leaks resulted in some infiltration, primarily chemical, of the soil under and around these ponds. High winds have also contributed some spread of material. A continuous program of cleaning and sealing the ponds has been necessary. In June of 1971, 30,000 dpm/100 cm<sup>2</sup> were noted at the high watermark on the west side of Pond 207-A, contributed mostly by uranium. Thus, in addition to nitrates, low level radioactive permeation of the soil is probable.

LOW LEVEL RADIOACTIVE AND CHEMICAL  
INFILTRATION (PARTICULARLY NITRATES)  
INTO SOIL

30,000 D/M/100 Cm<sup>3</sup> (URANIUM-DIRECT)  
NOTED ON SIDES IN 1971

HIGH NITRATE WASTES  
STORED AND CONCENTRATED  
IN SOLAR EVAPORATION PONDS

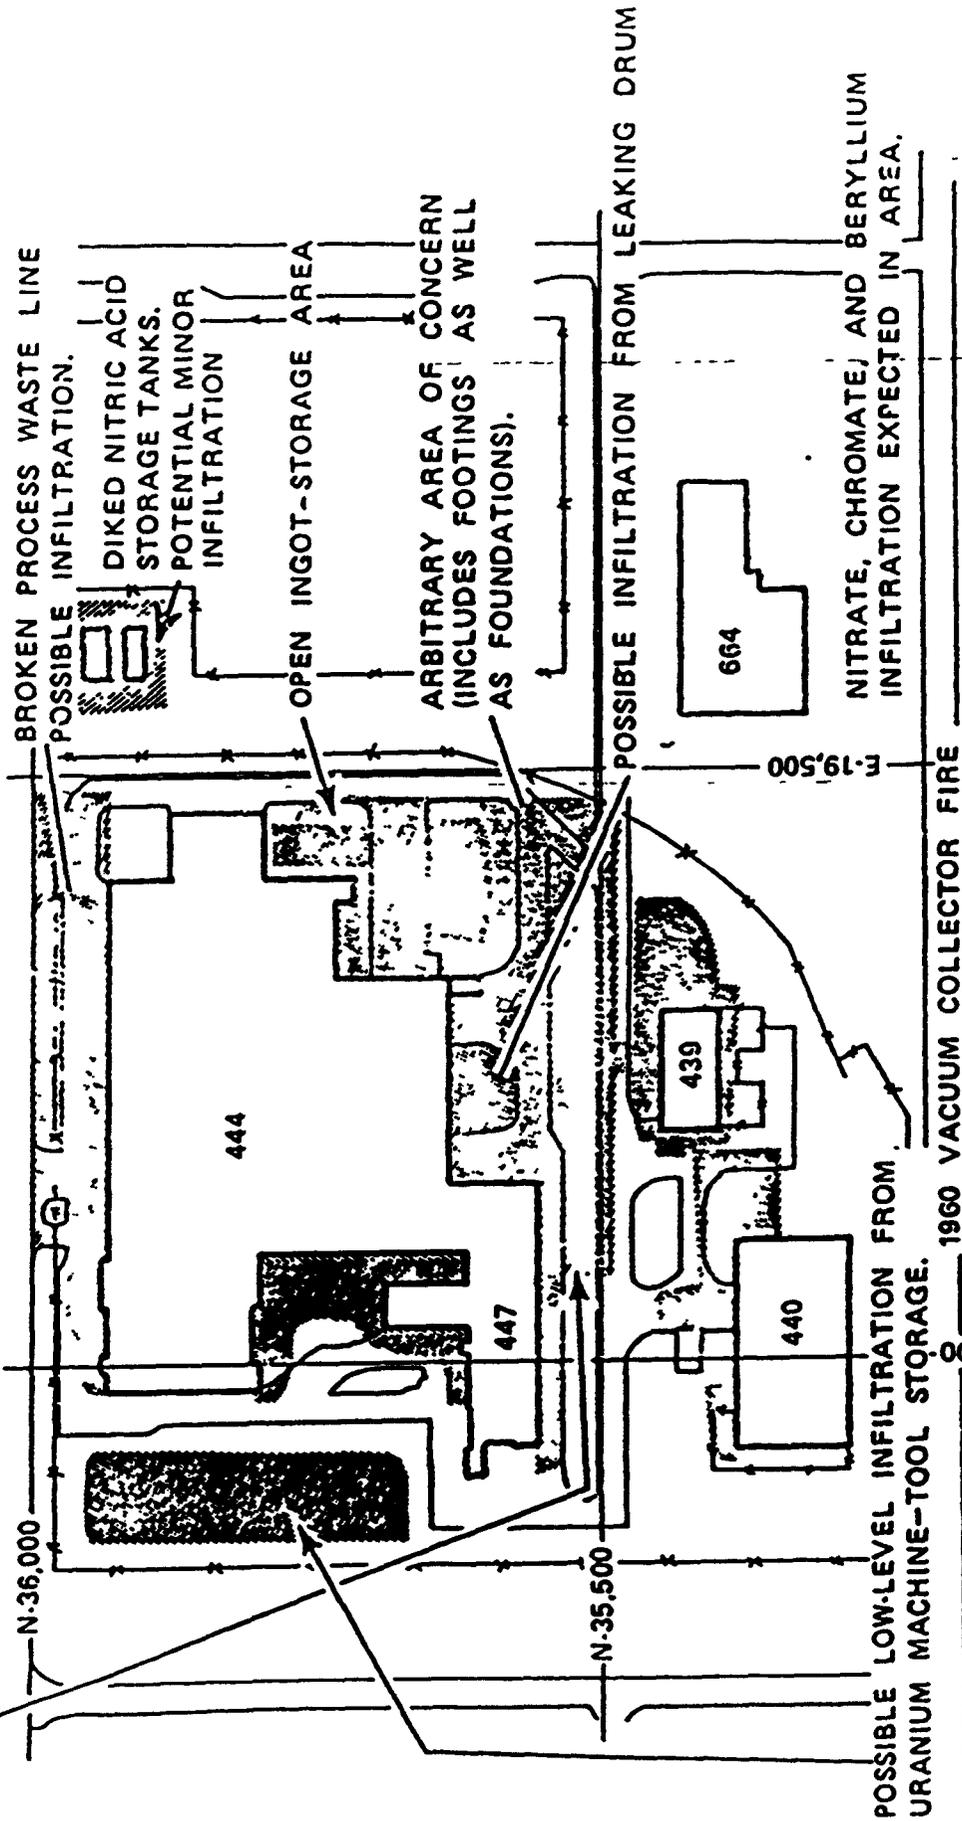
MAP G.

-- -- -- In 1953, high winds blew the lids off waste drums and uranium was released to the dock, driveway, and surrounding grounds. Direct count as high as 7,500 dpm/100 cm<sup>2</sup> and smears as high as 350 dpm were reported. The docks and sidewalks were cleaned up and the driveway areas seal-coated. A broken process waste line (June 1966) north of the building resulted in some possible infiltration as did leaking storage drums south of the building. An open ingot storage area east of Building 444 and a metal storage area south of the building have undoubtedly resulted in low-level infiltration of the soil, as has a uranium machine tool storage area west of the building.

In May 1960, a vacuum collector fire in Building 447 resulted in approximately 44  $\mu$ Ci depleted uranium deposited on the roof of the building. In December 1962, a uranium/beryllium release from Building 444 (due to use of an unfiltered hood) was noted.

1953 INCIDENT RELEASED URANIUM TO DOCK, SIDEWAYS AND DRIVEWAYS,  
CLEANED AND/OR SEAL-COATED.

1960 VACUUM COLLECTOR FIRE (447) AND 1962 RELEASE FROM UNFILTERED HOOD (444) HAVE PROBABLY ADDED TO LEVELS IN THE VICINITY OF THESE BUILDINGS.

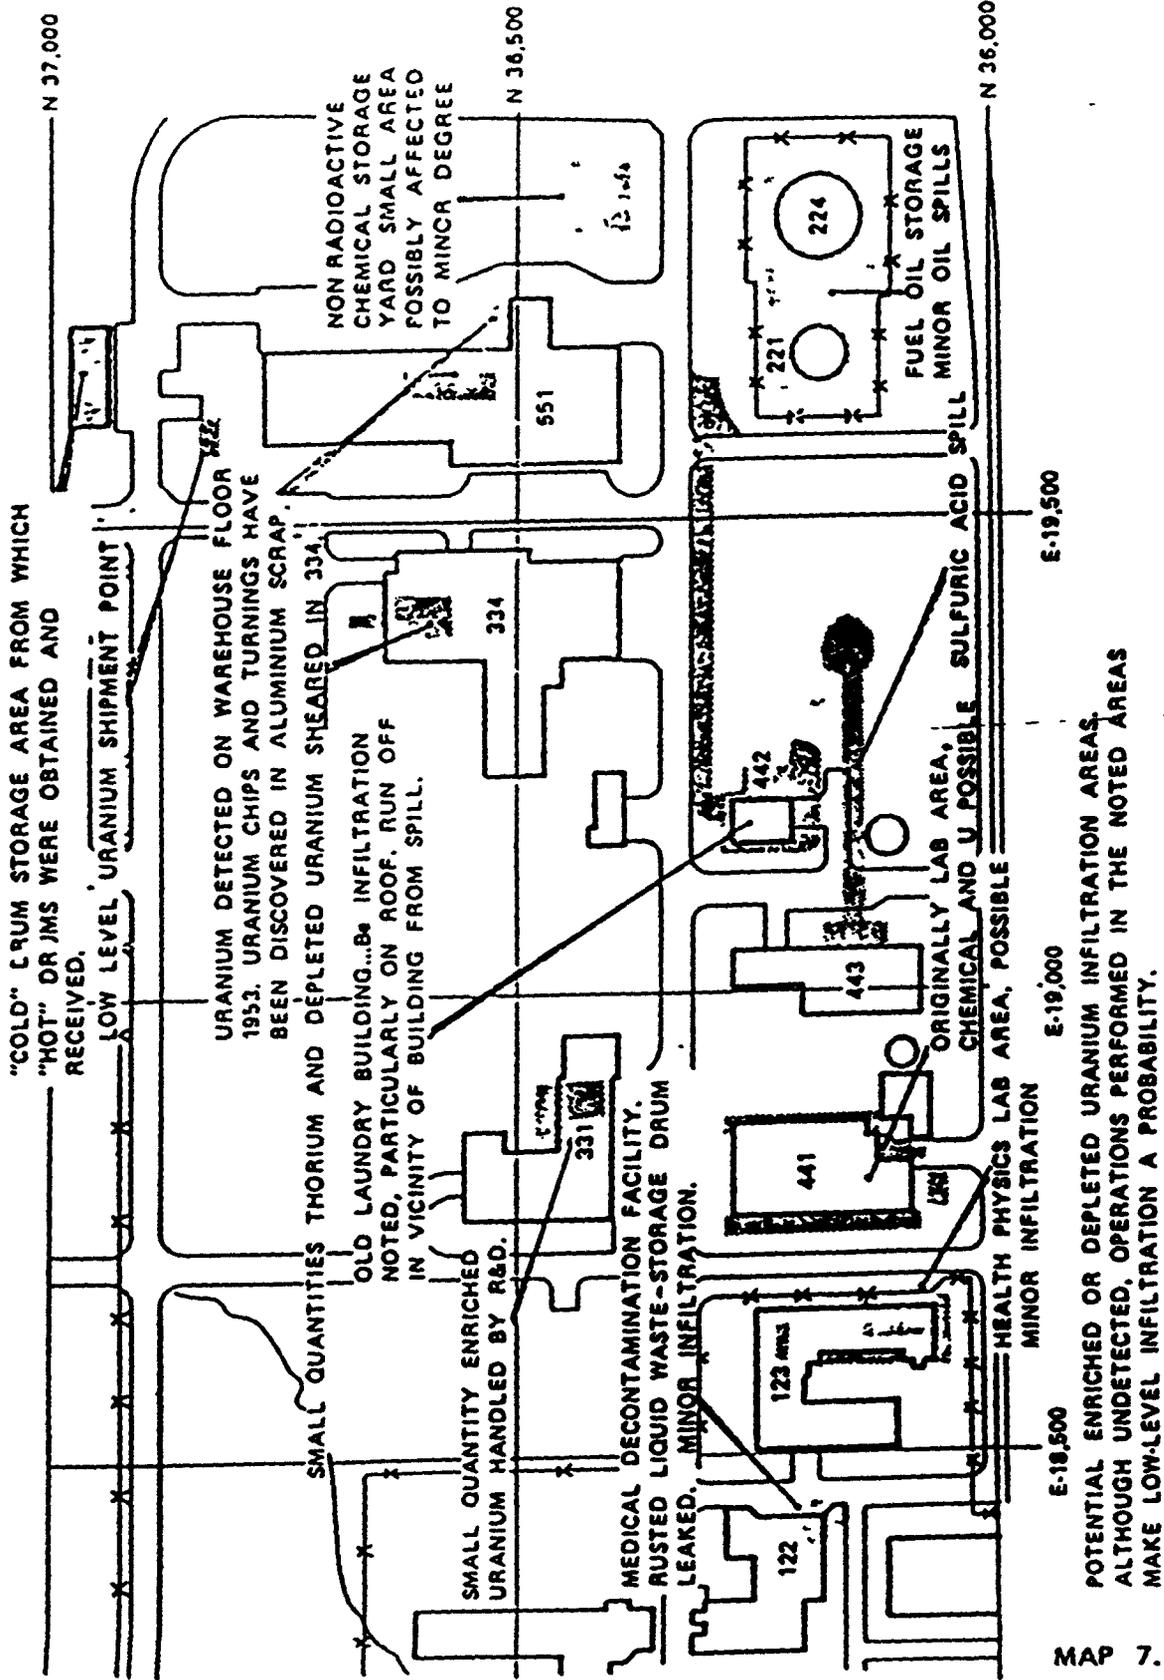
MAP 7.

POTENTIAL ENRICHED OR DEPLETED URANIUM INFILTRATION AREAS.  
 ALTHOUGH UNDETECTED, OPERATIONS PERFORMED IN THE NOTED AREAS  
 MAKE LOW-LEVEL INFILTRATION A PROBABILITY.

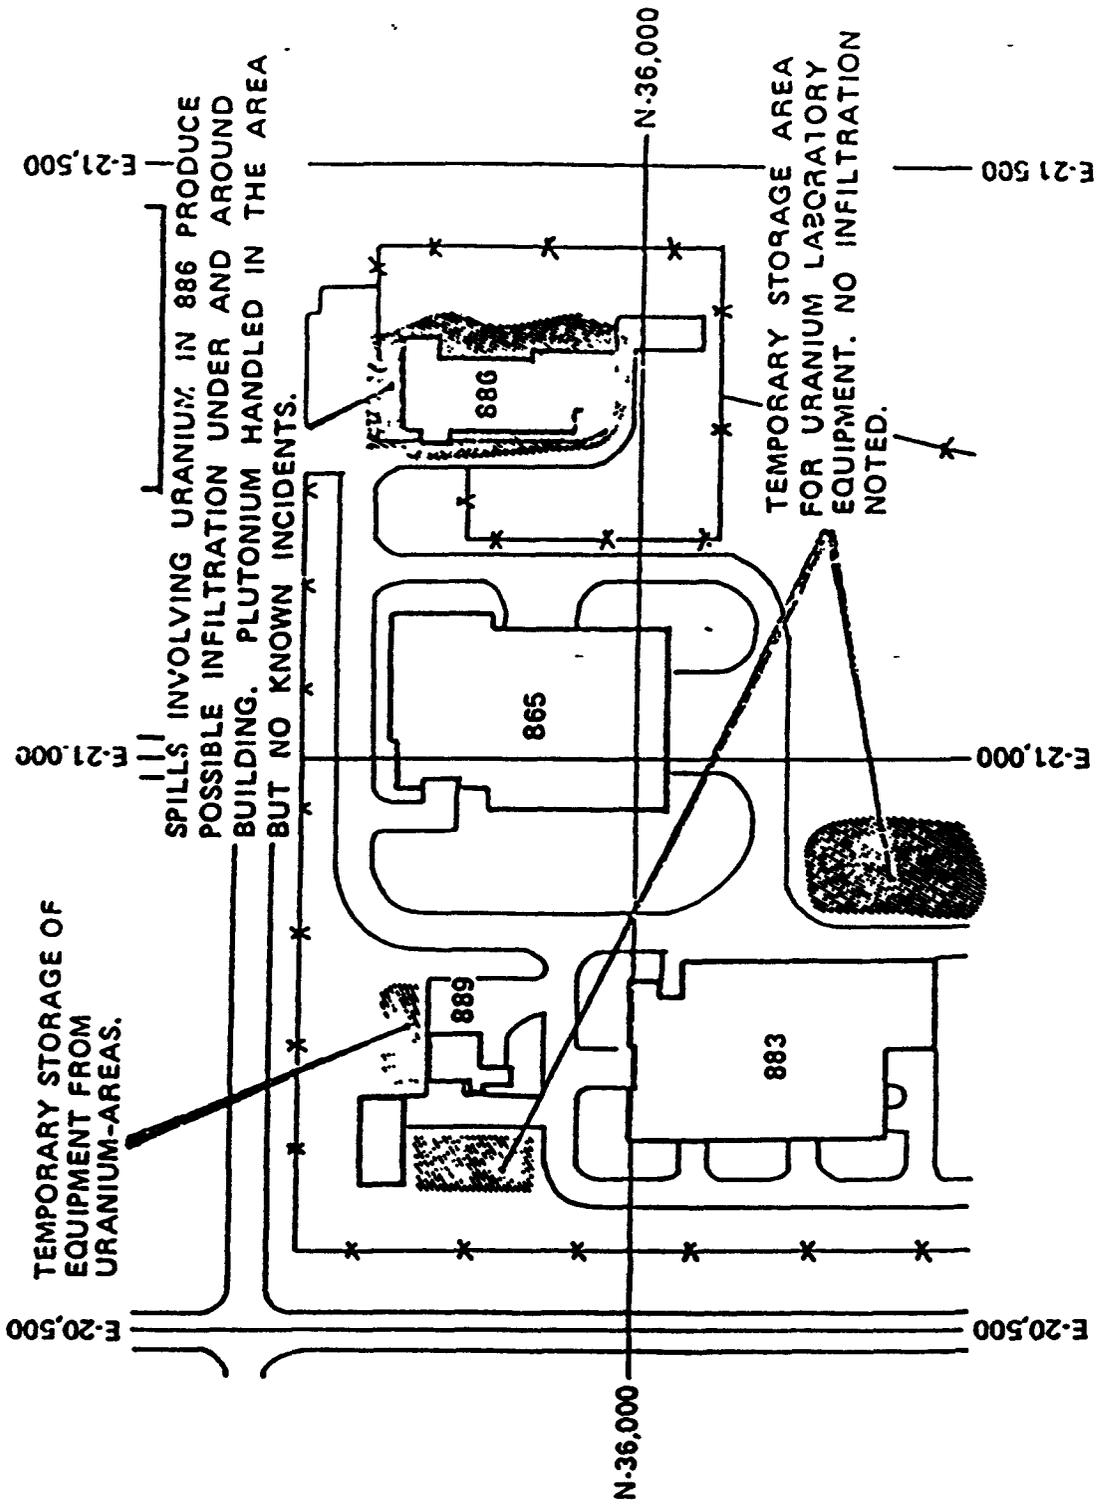
MAP 8.

Due to the nature of operations in these buildings, soil infiltration is expected to some degree under and possibly around these buildings. Spills involving uranium in Building 886 have occurred, with an inherent possibility of substructure infiltration. No specific incidents have been documented in the other buildings (with the exception of a January 1969 incident wherein the roofing was blown off Building 889 with no environmental effect). At one time, however, some equipment from a uranium laboratory was stored outside (just east) of Building 883 and west of Building 889. Present practice includes temporary storage of equipment from uranium areas on a pad north of Building 889 prior to processing. Therefore, these would also be areas of interest, although no incident or infiltration has been noted.

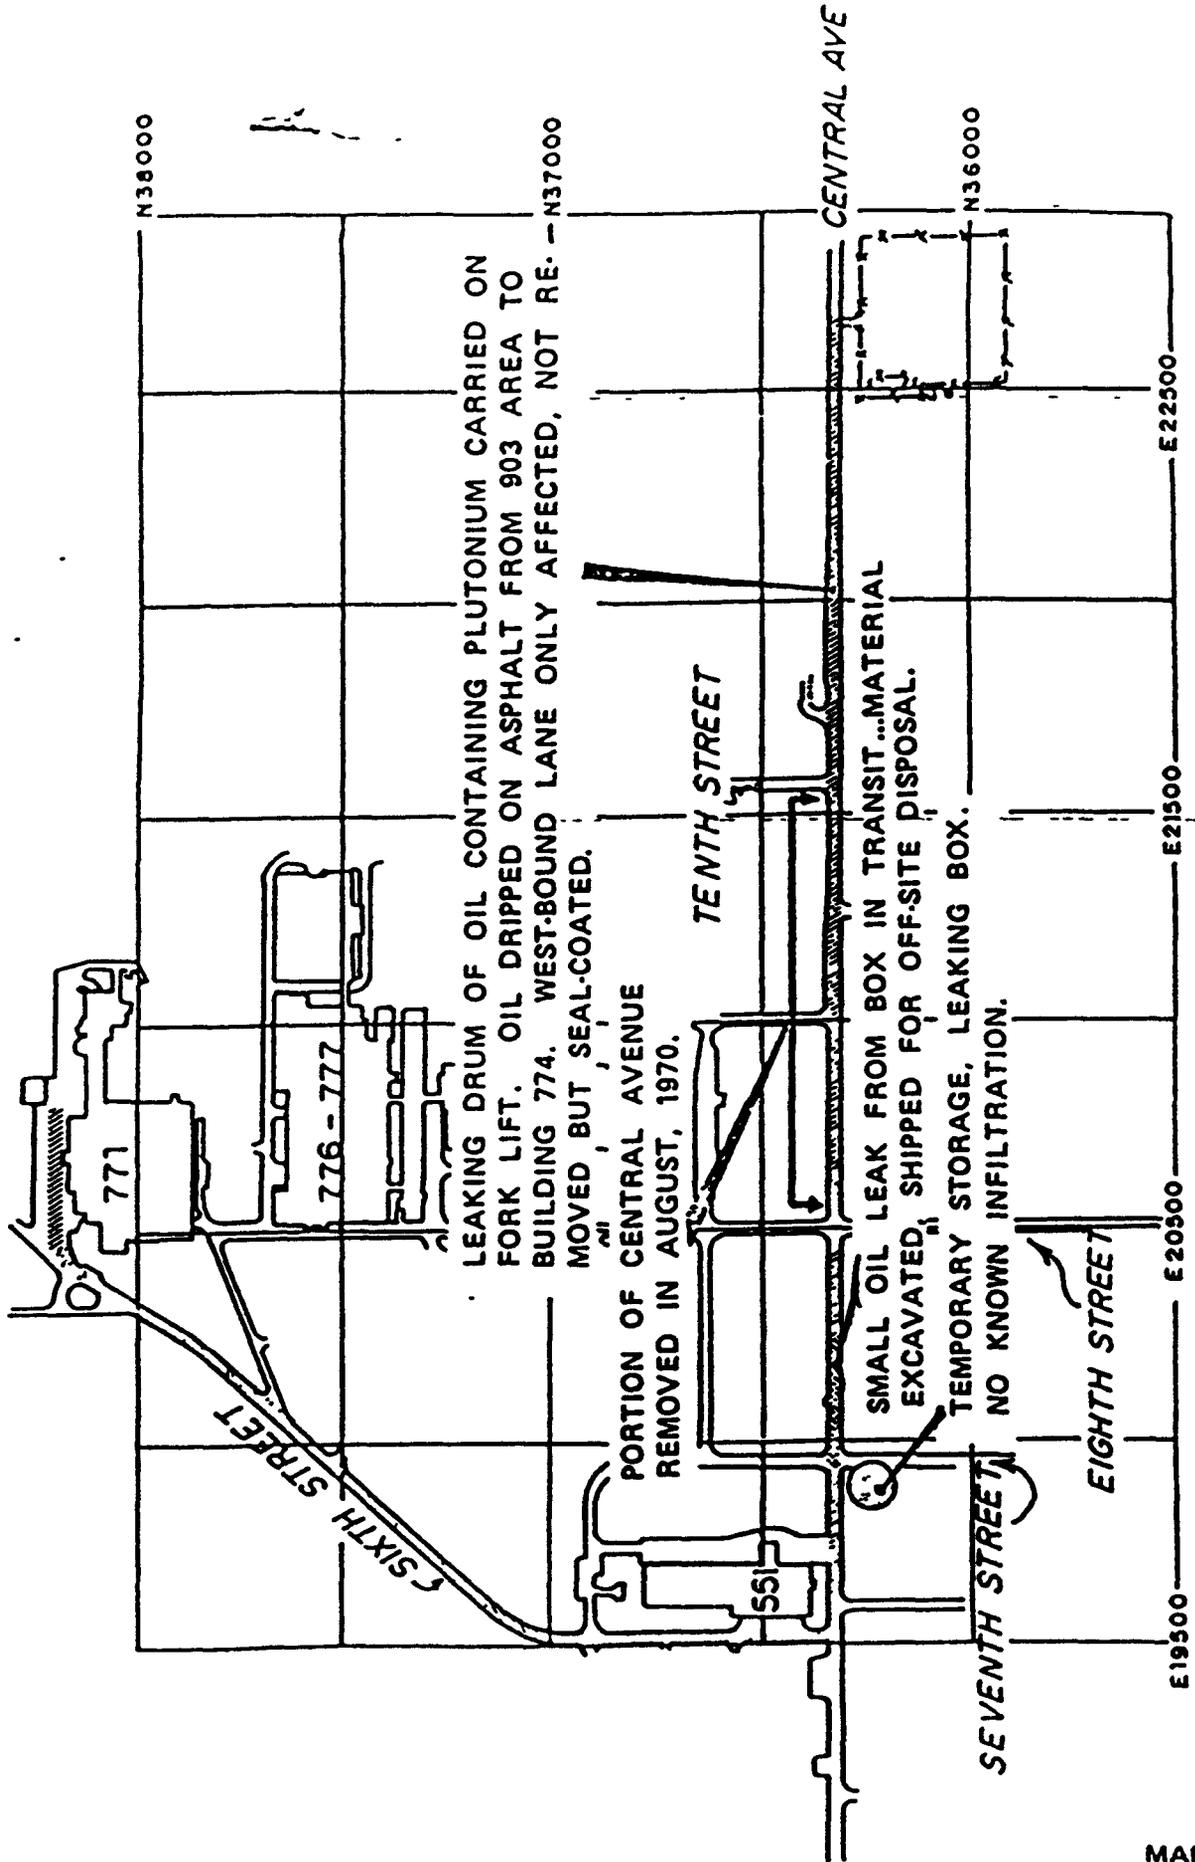
Incidents involving radioactive infiltration of roadways have been noted. In May 1965, a box containing radioactive waste from Building 776 was moved to the Storage Area near Building 663. Intermittent leakage from that box affected a strip of asphalt about 18 inches wide which was removed from the roadway. The box was stored on plastic sheeting (at Seventh and Central) until removal could be effected. No known infiltration resulted from that storage. In June 1968, a leaking drum in transit from the 903 Area to Building 774 resulted in approximately 140,000 dpm/100 cm<sup>2</sup> on the west bound lane of Central Avenue to and along Sixth Avenue. The entire affected roadway was seal-coated. Some low-level material was spread to the ditch on the west side of Central Avenue. In August 1970, one section of the roadway between Eighth and Tenth Streets was removed and placed in the previously described asphalt dump.

ROADWAYS OF CONCERN.
