Historical Release Report *(Interim Update)*

Response to Comments
for
HRR Annual Updates (1997, 1998, 1999)

Kaiser-Hill Company, L.L.C.

**Response to Comments and Meeting Agreements
for the
Historical Release Report (HRR)
PAC Narratives Submitted for No Further Action in 1997, 1998 and 1999**

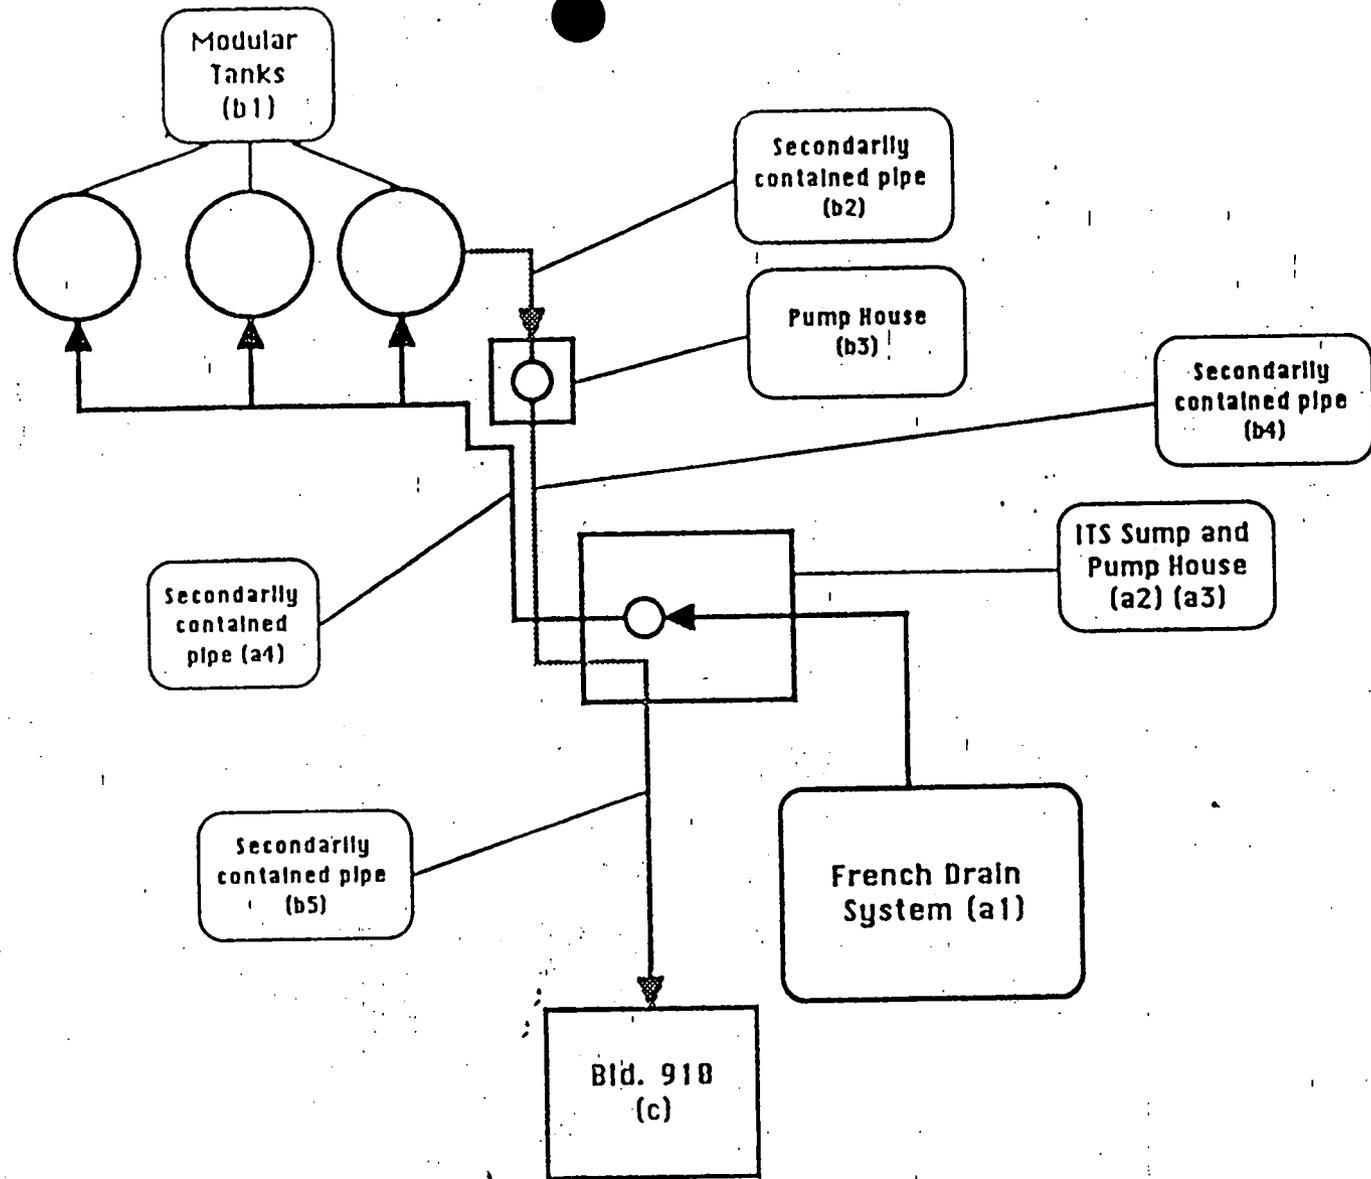
FIGURE 2

A hazardous waste incident occurred on July 20, 1993. The incident involved the Interceptor Trench (ITS) and ancillary equipment associated with the Modular Tanks and Building 910 Treatment System (RCRA Unit No. 38). The incident involved a failure of a primary pipe and secondary containment system and resulted in a spill/leak of hazardous waste. The incident was discovered at approximately 1:30 p.m. Hazardous waste was being pumped from the Modular Tanks to the Building 910 treatment facility when a primary transfer pipe failed, causing waste to leak/ spill into the secondary containment pipe. The released material filled the secondary containment pipe causing hazardous waste to spill from the secondary containment pipe into the modular tank pumphouse secondary containment. In addition, the excessive amount of waste in the transfer piping secondary containment caused a hose connection on the secondary containment pipe to fail and resulted in a leak of hazardous waste into the ITS sump.

Prior to 1:00 p.m. on July 20, 1993, a leak occurred in the primary containment piping (reference Figure 2 - item (b4)) located between the modular tanks and the ITS sump (reference Figure 2 - item a2) which allowed waste to leak into the secondary containment. Due to the location of the leak in the pipeline, the hazardous waste that leaked into the secondary containment overflowed back into the Modular Tank pumphouse (reference Figure 2 - item b3) and also gravity-drained through a failed hose connection on the secondary containment piping (reference Figure 2 - item a2). The failed hose connection is located within the ITS sump. The ITS sump is equipped with an automatic level controls and the material that spilled into the ITS sump was pumped back into the Modular Tanks. The hazardous waste that overflowed into the Modular Tank pumphouse was fully contained in the pumphouse secondary containment. When the liquid level in the pumphouse secondary containment rose, the leak detection system was activated, the local alarm was activated, and the pumps were automatically shut down. The remote alarm via telemetry to Building 374 did not, however, function. Problems had occurred previously and this alarm was not reliable; therefore, it had not been considered operational and compensatory measures were in place to perform daily checks of the local alarm panel. This deficiency had been identified as an open item to be corrected.

The released material is, however, RCRA F-listed hazardous waste. In accordance with 6 CCR 1007-3, the pumping operation at the ITS sump is considered a waste generation point (reference Figure 2 - item a3). At this point (reference Figure 2 - item a3), the surface/ ground water is recharacterized as RCRA F Listed hazardous waste because the "contained in" rule is operable. The applicable EPA waste codes are F001, F002, F003, F005, F006 F007, and F009.

- 5.) In accordance with 6 CCR 1007-3 Part 264.196 (e)(3) - Repair of the affected system: The system will be returned to service as soon as the necessary repairs are completed. The following actions will be completed prior to returning the system to operation:

- Repair the primary transfer line,
 - Repair or modify the portion of the secondary containment of the transfer line (the hose connection) within the ITS sump that

failed and resulted in the leak of hazardous waste from the secondary containment system, and

- Retest the primary line following the repair.

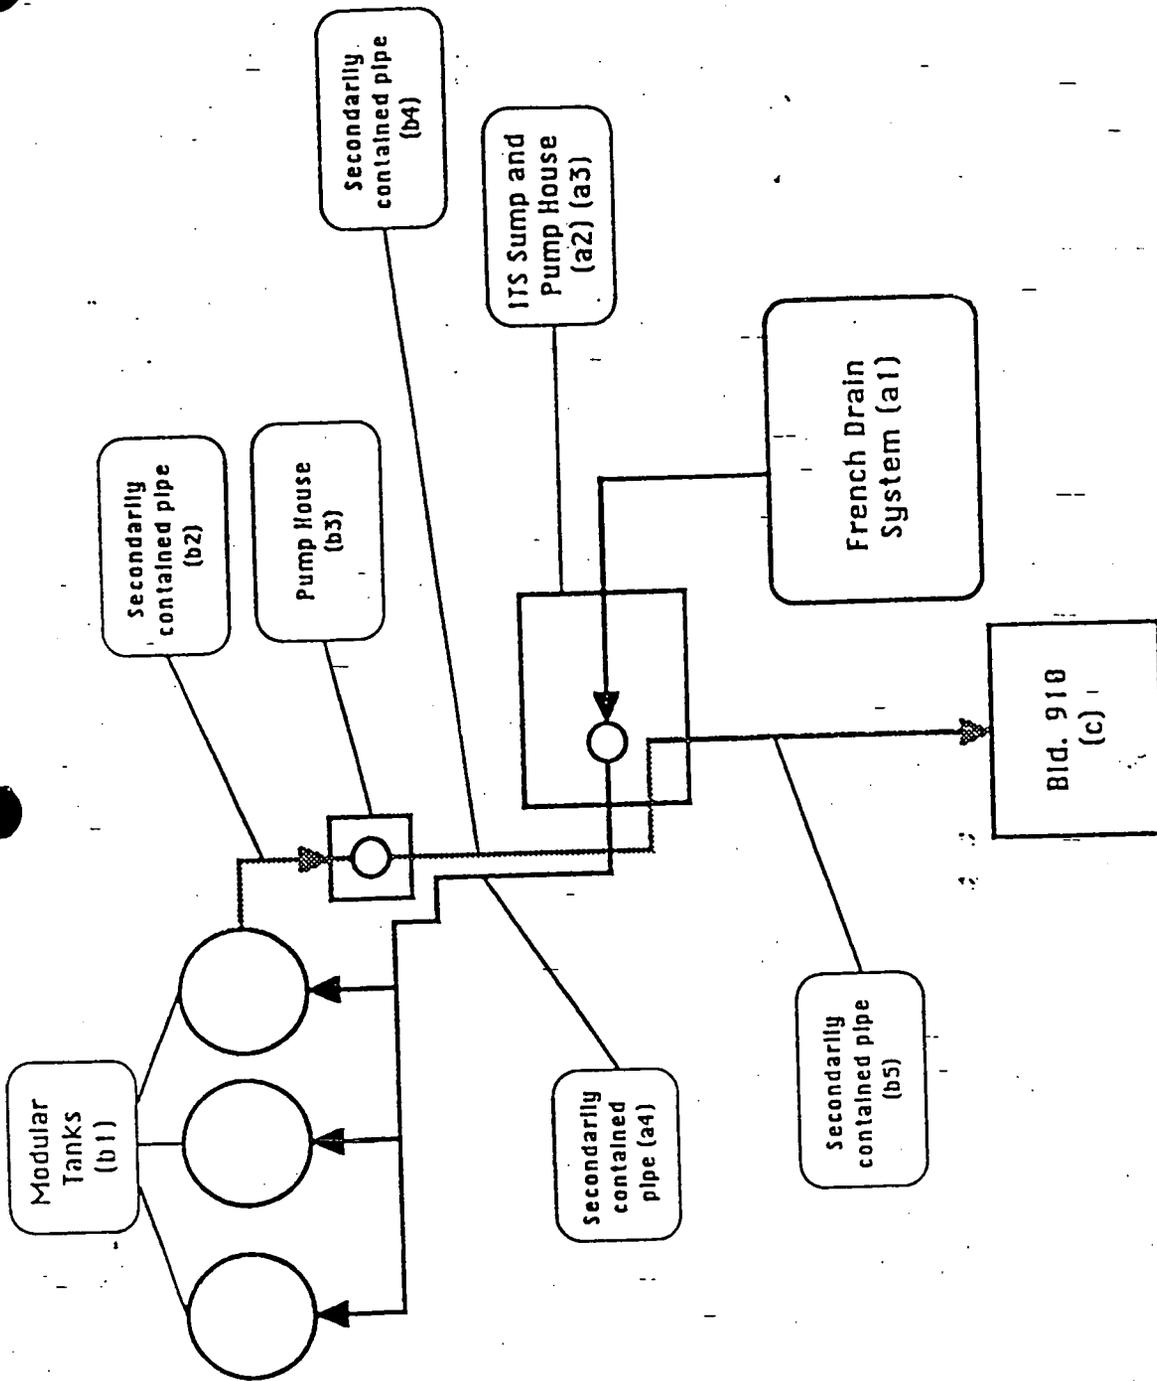
FIGURE 2

A hazardous waste incident occurred on July 20, 1993. The incident involved the Interceptor Trench (ITS) and ancillary equipment associated with the Modular Tanks and Building 910 Treatment System (RCRA Unit No. 38). The incident involved a failure of a primary pipe and secondary containment system and resulted in a spill/leak of hazardous waste. The incident was discovered at approximately 1:30 p.m. Hazardous waste was being pumped from the Modular Tanks to the Building 910 treatment facility when a primary transfer pipe failed, causing waste to leak/spill into the secondary containment pipe. The released material filled the secondary containment pipe causing hazardous waste to spill from the secondary containment pipe into the modular tank pumphouse secondary containment. In addition, the excessive amount of waste in the transfer piping secondary containment caused a hose connection on the secondary containment pipe to fail and resulted in a leak of hazardous waste into the ITS sump.

Prior to 1:00 p.m. on July 20, 1993, a leak occurred in the primary containment piping (reference Figure 2 - item (b4)) located between the modular tanks and the ITS sump (reference Figure 2 - item a2) which allowed waste to leak into the secondary containment. Due to the location of the leak in the pipeline, the hazardous waste that leaked into the secondary containment overflowed back into the Modular Tank pumphouse (reference Figure 2 - item b3) and also gravity-drained through a failed hose connection on the secondary containment piping (reference Figure 2 - item a2). The failed hose connection is located within the ITS sump. The ITS sump is equipped with an automatic level controls and the material that spilled into the ITS sump was pumped back into the Modular Tanks. The hazardous waste that overflowed into the Modular Tank pumphouse was fully contained in the pumphouse secondary containment. When the liquid level in the pumphouse secondary containment rose, the leak detection system was activated, the local alarm was activated, and the pumps were automatically shut down. The remote alarm via telemetry to Building 374 did not, however, function. Problems had occurred previously and this alarm was not reliable; therefore, it had not been considered operational and compensatory measures were in place to perform daily checks of the local alarm panel. This deficiency had been identified as an open item to be corrected.
