**Closeout Report
for Surface Water Station
SW056 Outfall**

November 2005

This Closeout Report summarizes accelerated action activities conducted at the surface water station SW056 outfall, located at the Rocky Flats Environmental Technology Site (RFETS or Site), Golden, Colorado. Activities were planned and executed in accordance with the Environmental Restoration (ER) Rocky Flats Cleanup Agreement (RFCA) Standard Operating Protocol (RSOP) for Routine Soil Remediation (ER RSOP) Modification 1 (DOE 2003a). Notification of the planned characterization and removal activities was provided in ER RSOP Notification #05-09 (DOE 2005a).

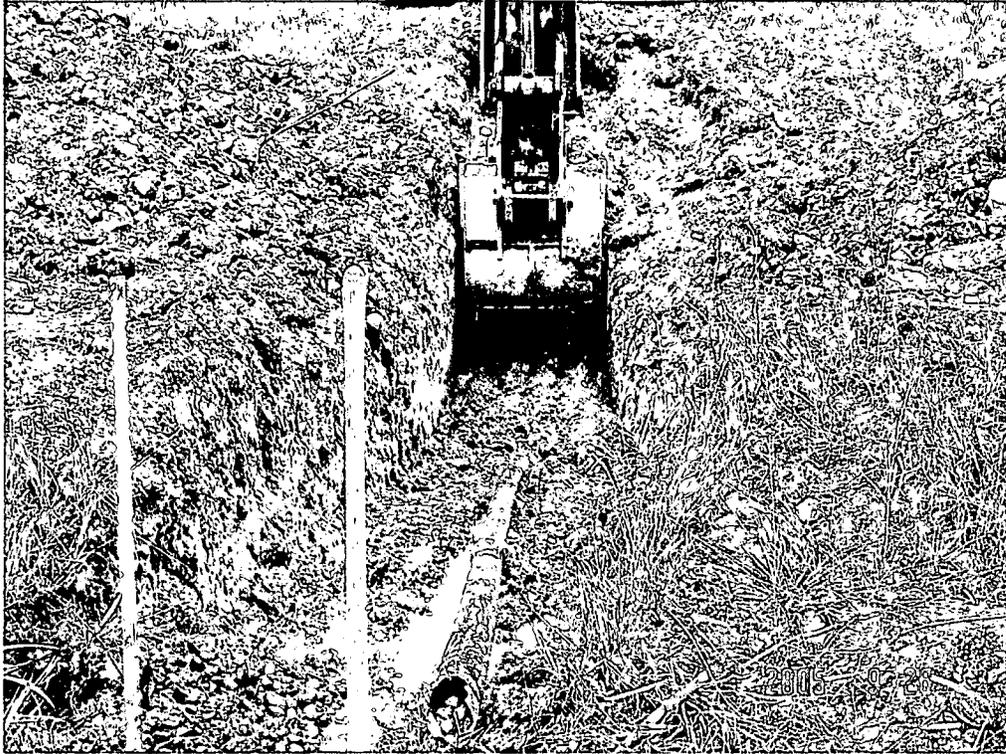
1. Excavation proceeding from the outfall of SW056. Red stake marks northern extent of pipe prior to excavation.

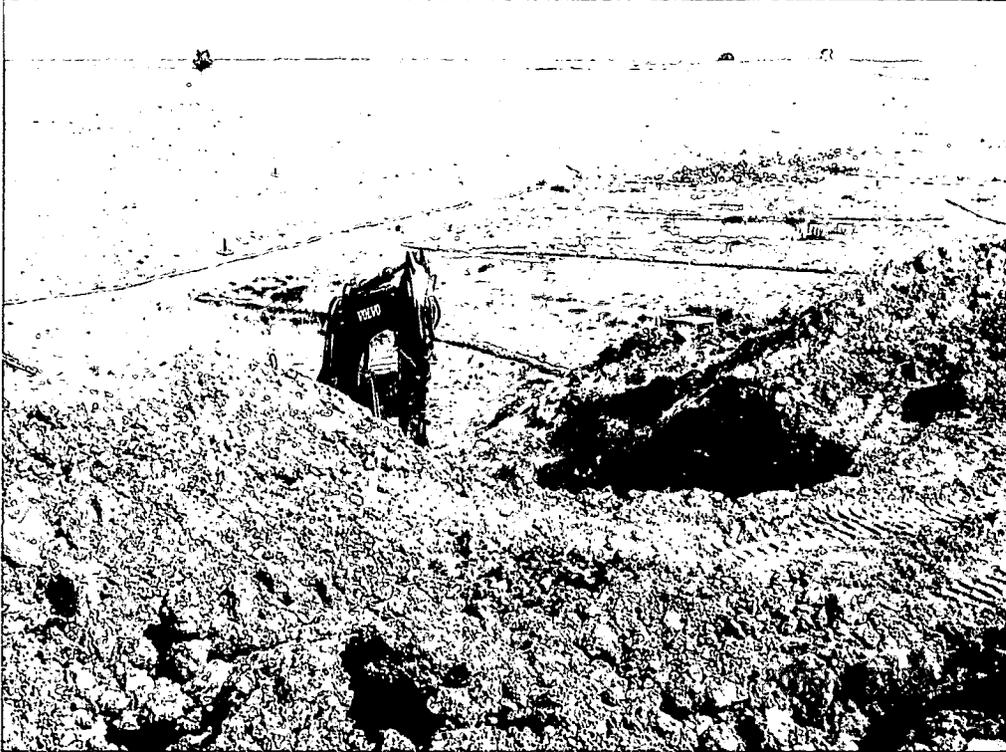
5. Excavation proceeding from the north.
