**ANNUAL REPORT
FOR THE
ROCKY FLATS ENVIRONMENTAL TECHNOLOGY
SITE
GROUNDWATER PLUME TREATMENT SYSTEMS
January through December 2002**

May 2, 2003

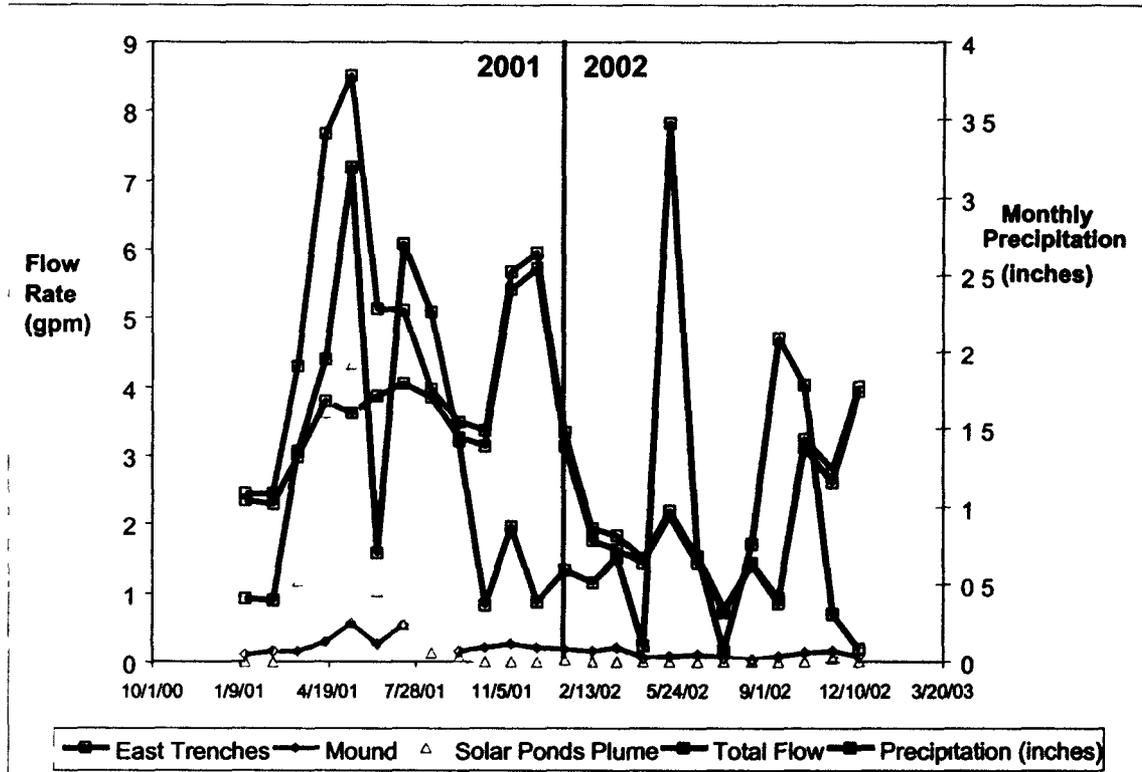
Figure 2. Comparison of Monthly Precipitation to the Average Monthly Flow Rate for Mound Site Plume, East Trenches Plume, and Solar Ponds Plume Treatment Systems

Figure 2 shows the average monthly flow rate for the Mound Site Plume, East Trenches, and Solar Ponds Treatment Systems compared to precipitation. The effects of the drought can be seen. Although in the past the Mound Site Plume Treatment System was responsive to precipitation events, as can be seen from Figure 2, the response might have been dampened due to effects of the drought. This is particularly noticeable in July, when there were some significant rainstorms but little was seen going into the treatment systems. This may be a result of more runoff and less infiltration due to the dry soils and lack of vegetation, plus absorption by the dry soils.

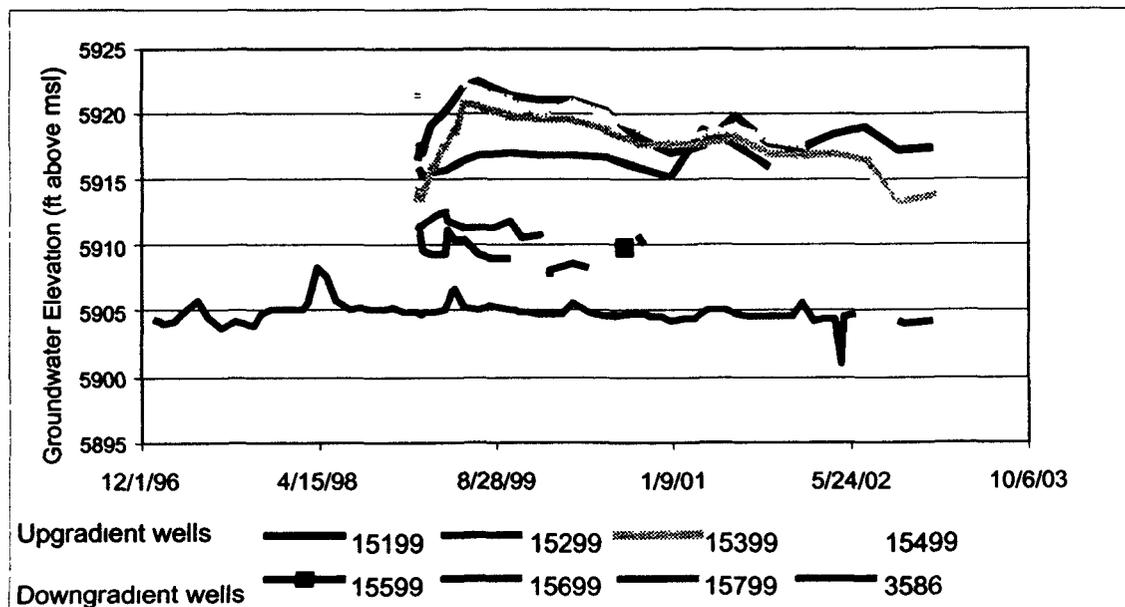
Figure 4. Mound Site Plume Water Elevations

The groundwater elevation in Well 15199, at the eastern edge of the collection trench, is about seven to 10 feet higher than downgradient Wells 15799 and 15599. At the center of the downgradient area, Well 15699 has a lower groundwater elevation, indicating that a gradient exists from the outside edge of the capture area toward the center of the downgradient area. Although there is a steep hydraulic gradient, groundwater flow is minimal because there is little groundwater in the area. Based on groundwater elevation differences, the collection system appears to be working as designed.

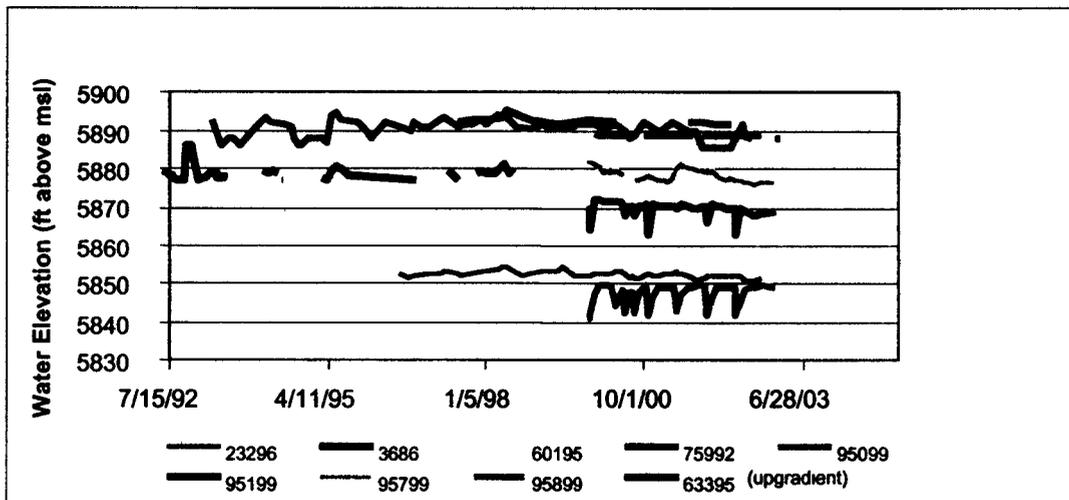
Figure 8. East Trenches Plume System Water Elevations

North of the trench, water elevations continue to demonstrate a strong downgradient trend to the north and east, with the groundwater elevations at the piezometers within the collection trench generally 10 feet higher than the corresponding piezometers downgradient of the collection trench. As can be seen in Figure 8, the groundwater elevation difference between Piezometers 95799 and 95899 show that there is a strong hydraulic gradient to the east, toward the collection sump. While Piezometer 95699 is dry all of the time, it is evident from treatment system flow rates that water is flowing through this part of the collection trench.

The collection trench appears to be effective in cutting off downgradient flow. Well 95299 is always dry, proving that there is no groundwater flow from the ponds or from groundwater bypassing the trench. Toward the middle of the collection trench, at Well 95199, groundwater elevations are influenced by Pond B-2 and the nearby South Walnut Creek. Pond B-2 is isolated from the main drainage system and only collects local area drainage. Pond water is usually not discharged but is allowed to evaporate or infiltrate into the ground. Because of this, the Pond B-2 water level rises when there are precipitation events. The fluctuations seen in the groundwater elevations for Well 95199 also appear to be the result of precipitation events and reflect influence of Pond B-2 on this area.

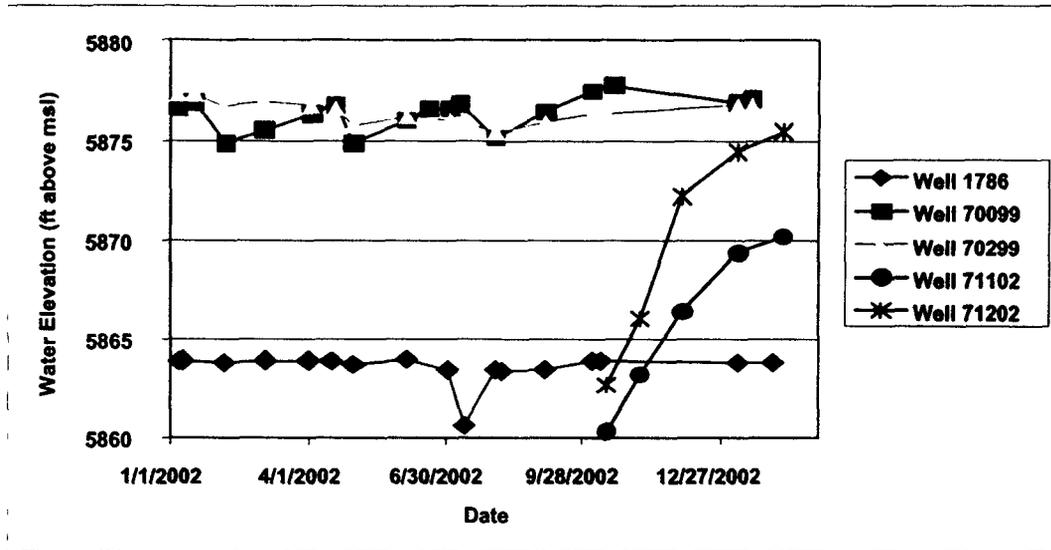
Figure 16. Solar Ponds Plume System 2002 Downgradient Well Water Elevations

As show in Table 8, and on Figure 16, the groundwater elevations in the downgradient wells, colluvial Well 70099, bedrock Well 70299, and Well 1786 adjacent to South Walnut Creek, were relatively stable during CY2002. Groundwater elevations in the two new piezometers (Piezometers 71102 and 71202) increased six to 10 feet since installation. This initial rise may be a result of the water levels equilibrating in the tight formations after well installation. By December 2002, the groundwater elevations in the new piezometers were still lower than those seen within the collection trench and the immediately downgradient wells (Wells 70099 and 70299).

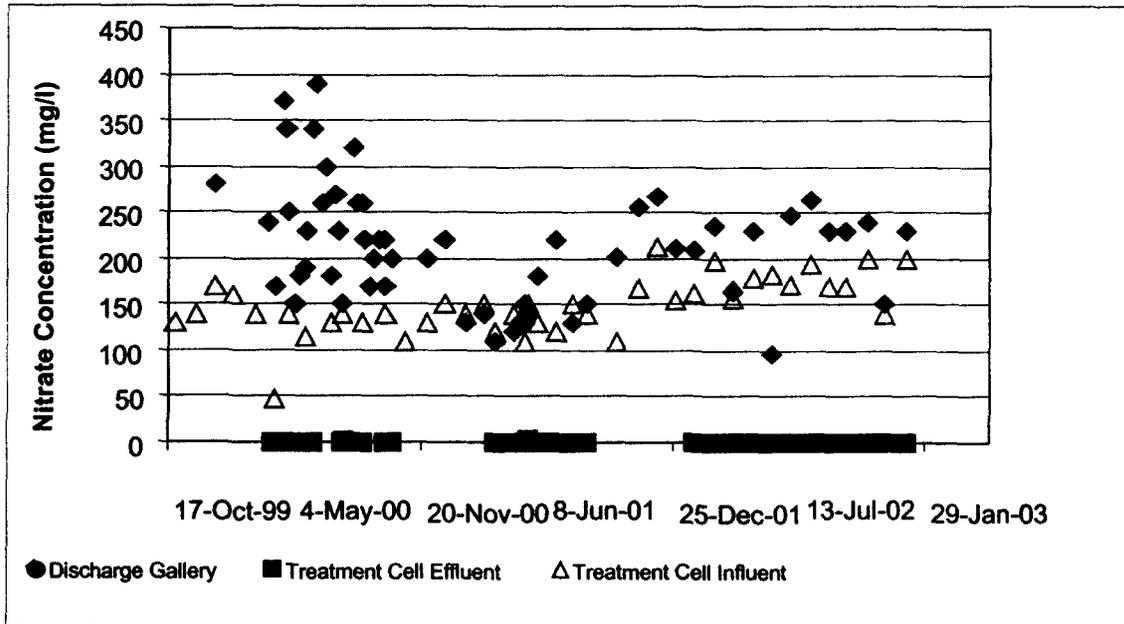
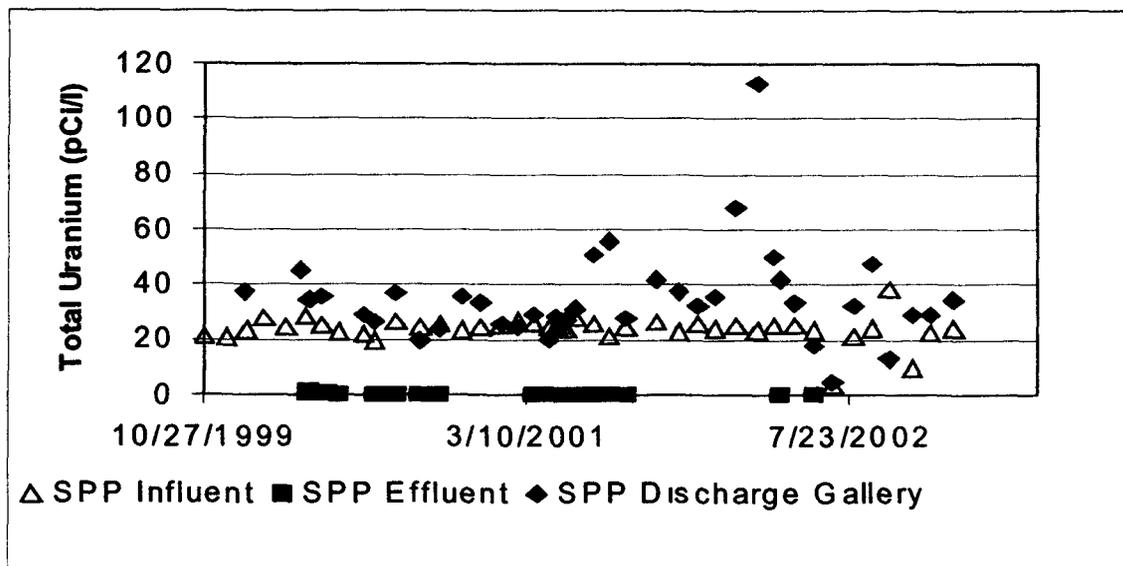
Figures 17 and 18 show the changes in uranium and nitrate since the system was installed. Influent and discharge gallery nitrate concentrations were above average for the year, most likely because of drought conditions. Uranium influent activities ranged widely, between 3.18 and 38.4 pCi/l. Although the higher values might be attributable to drought, the cause for the lower values is uncertain, but may indicate a problem with laboratory analysis. The discharge gallery uranium activities ranged between 4.58 and 112.86 pCi/l. The higher values appear to be attributable to the addition of the MST water. The lowest value corresponds to the lowest value in the influent.

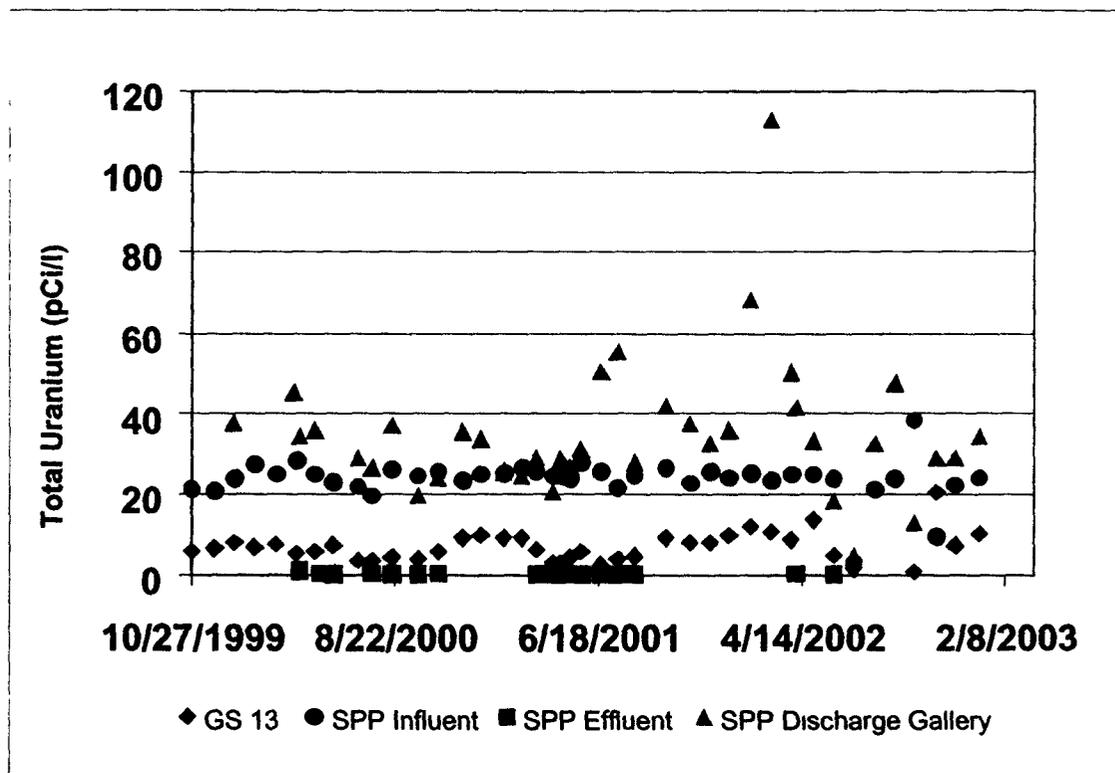
Figure 20. Uranium Activities in Solar Ponds Surface Water Locations

As indicated in Table 11 and depicted in Figure 20, uranium activities at GS13 varied greatly during the year and were sporadically above 10 pCi/l However, sample results from the outfall to Pond A-4 (i.e., GS11, the RFCA point-of-compliance [POC] for uranium), remained below 10 pCi/L throughout the year Outfall sampling occurs during discharge events, which occurred only three times in CY2002 Samples were collected May 16th, May 20th and October 24th Total uranium activities were 3 059 pCi/l, 2 662 pCi/l and 1 475 pCi/l, respectively, well below the standard and within the range of historical uranium activities for this location

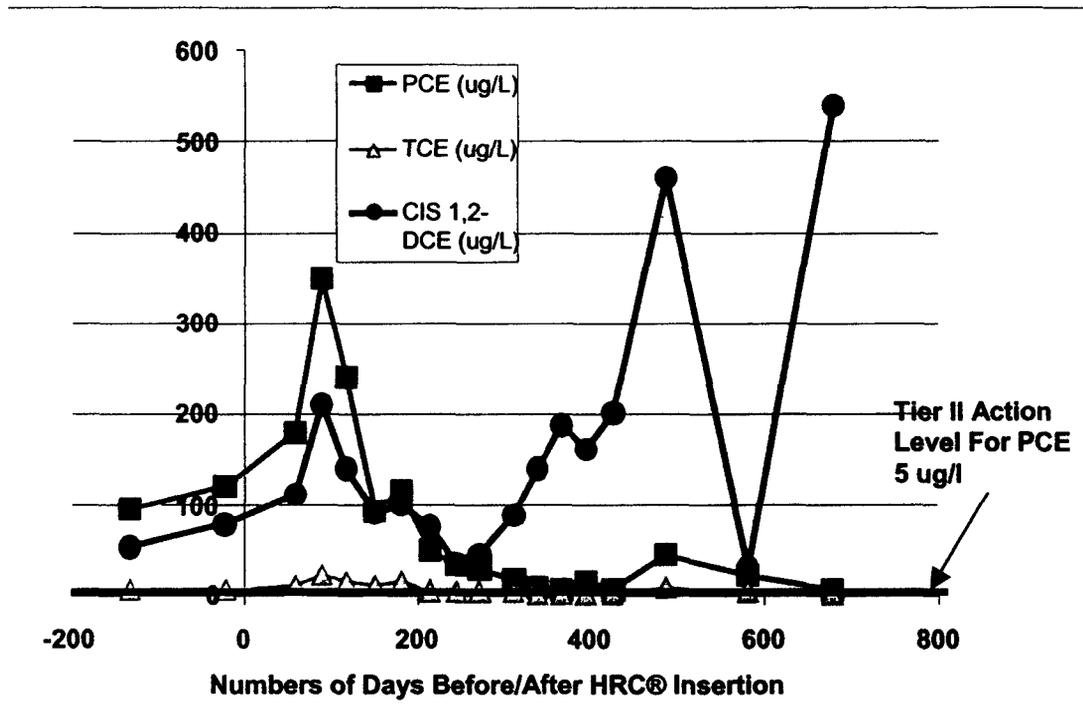
Figure 24. Tetrachloroethene and Degradation Products Concentration versus Time in Well 30900

As shown in Table 17 and on Figure 24, concentrations of tetrachloroethene, trichloroethene, and cis 1,2-dichloroethene in the source area well (Well 30900) increased after insertion of the HRC®, then decreased. Trichloroethene and cis 1,2-dichloroethene are common degradation products of tetrachloroethene. According to Regensis, approximately 70 to 80 percent of project sites see an initial increase in VOC concentrations before a downward trend is observed. It was anticipated that this downward trend would continue, however, the cycle repeated itself when the water table rose again in the Spring of 2002. It is anticipated that the cycle will repeat again in CY2003, especially since the water table did not rise as much in CY2002 as it does in normal precipitation years, due to the drought. As indicated on Figure 25, data from the downgradient well (Well 31001) show a similar overall pattern.

The initial, expected increase in tetrachloroethene in groundwater was most likely due to one or a combination of the following conditions:

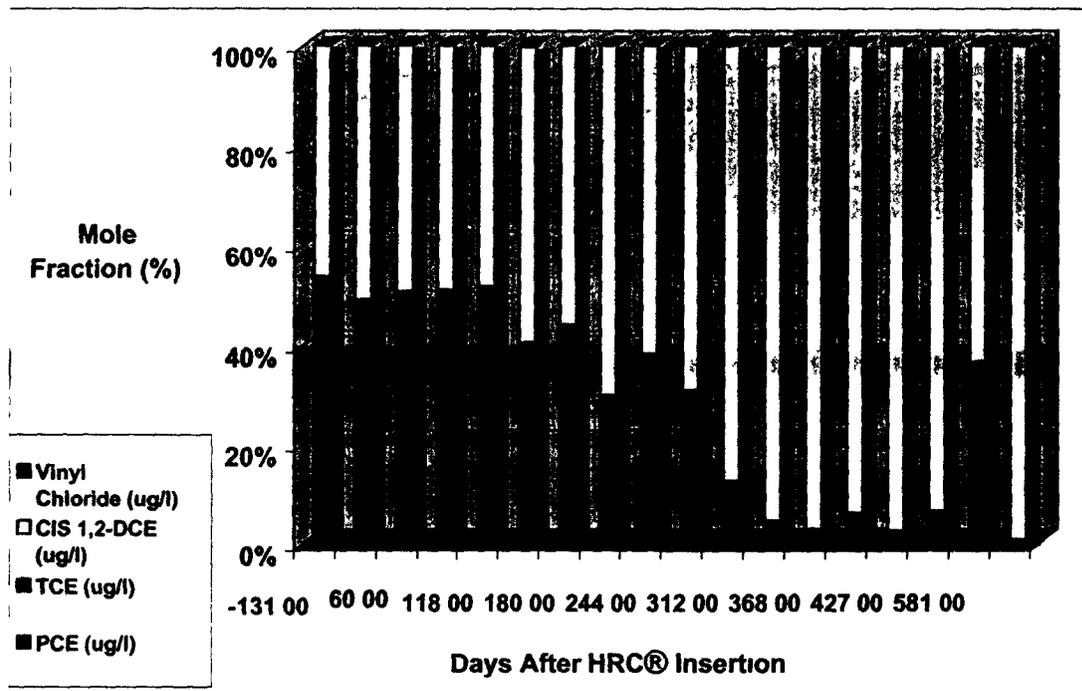
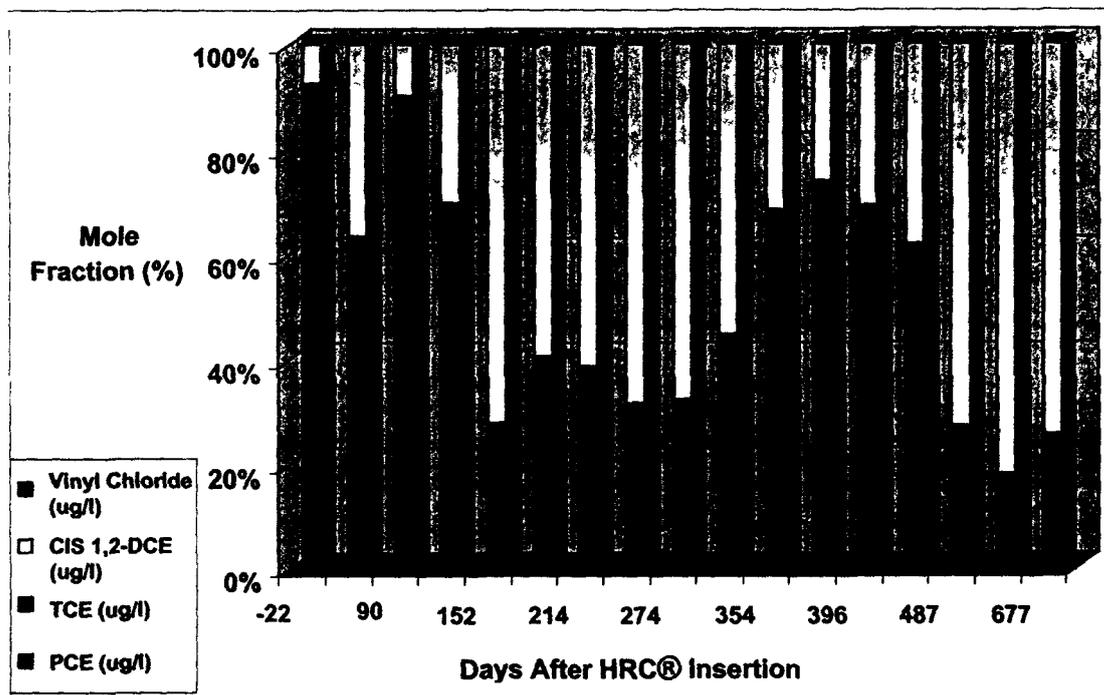
As shown in Table 17, the presence of other degradation products such as trans 1,2-dichloroethene, 1,1-dichloroethene and vinyl chloride demonstrates that degradation is occurring because these contaminants were not associated with releases at the PU&D Yard. The increase in the ratio of degradation products relative to tetrachloroethene concentrations confirms that degradation is occurring. Figures 27 and 28 show this increase in degradation products over time.
