Appendix A
Inspection Checklists
and Photographs

CAU 417: CNTA UC-1 CENTRAL MUD PIT COVER, POST-CLOSURE INSPECTION CHECKLIST

Inspection Date: JUNE 15, 2010

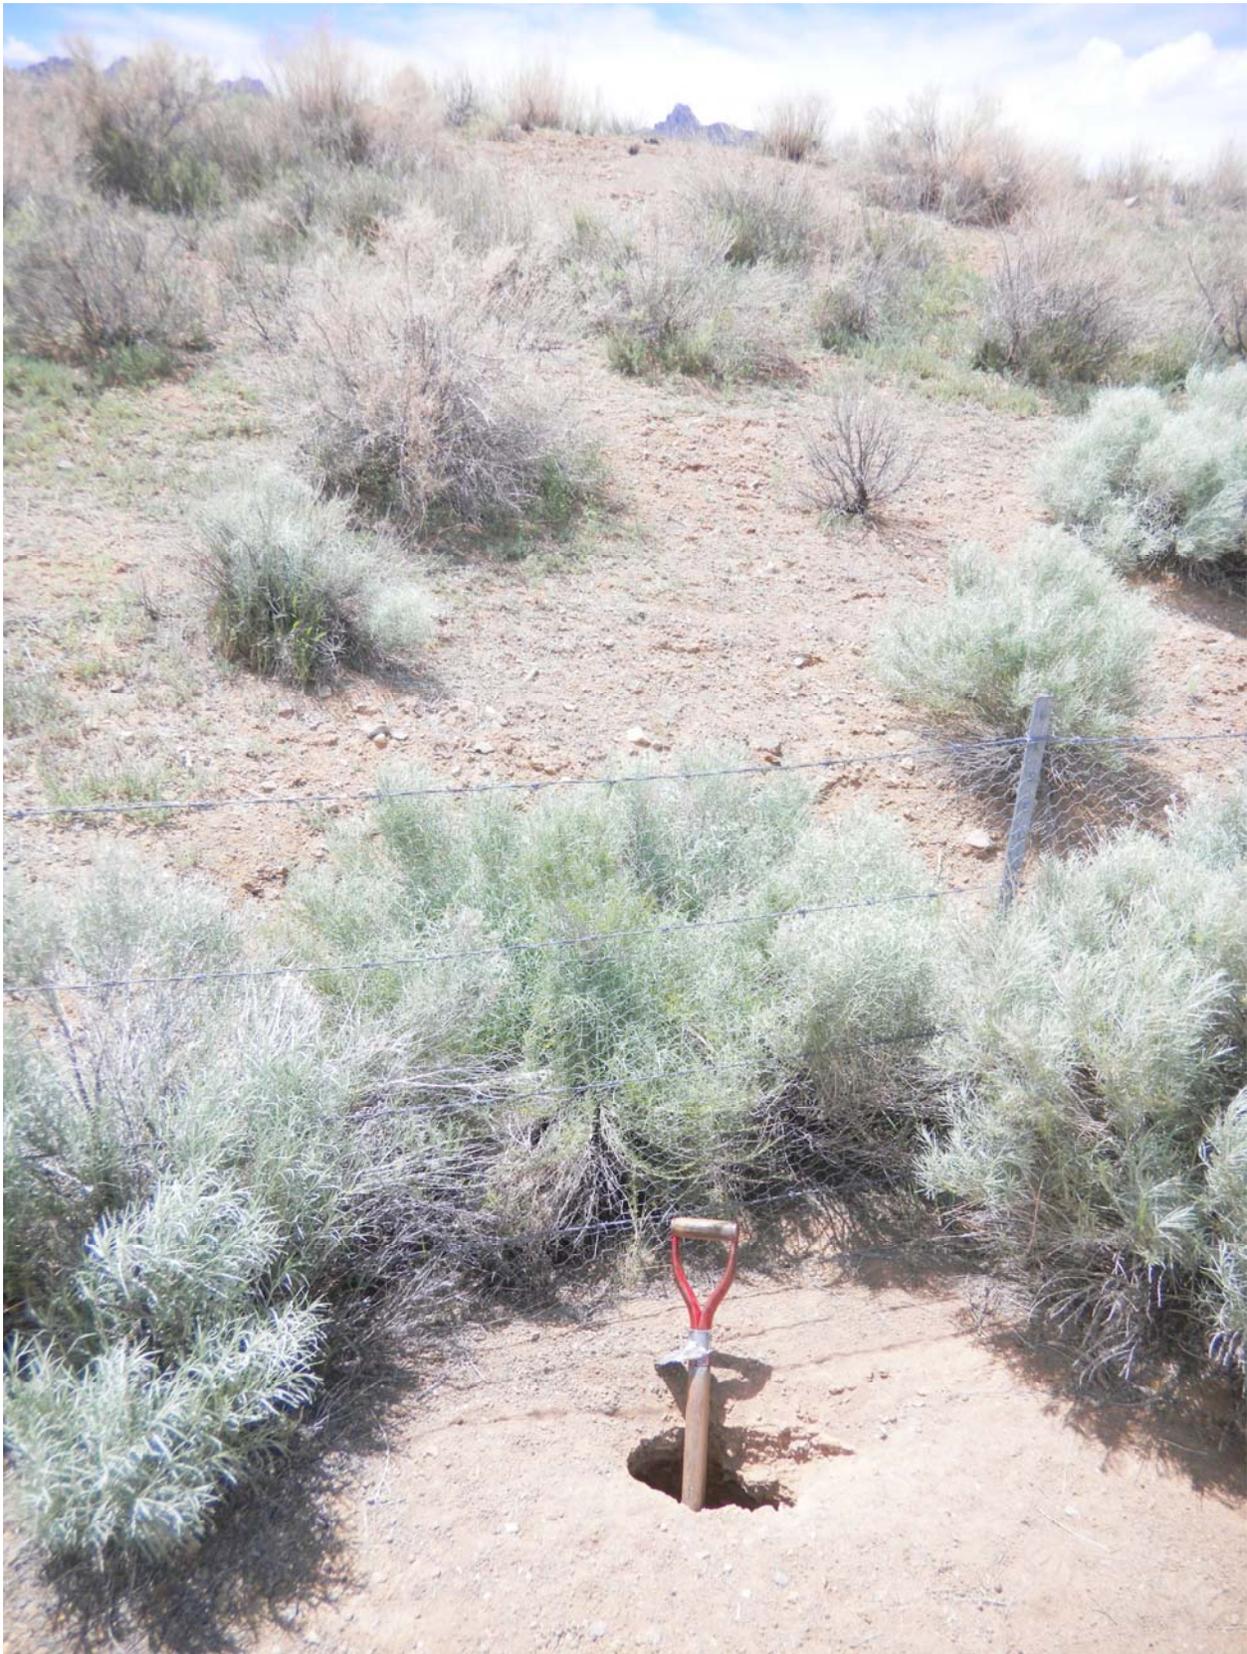
c.	Is there evidence of erosion around the cap (wind or water)?	✓		Piping featured observed near eastern portion of cap, outside fence.
d.	Is there evidence of animal burrowing?		✓

6.	Rationale for field conclusions: Overall integrity of the site is good. Only one small tensional crack filled this time. A small hole (1.5 ft in diameter) noted outside of fence east of the cap was observed. Appears to be piping erosion in the channel adjacent the cap. The hole was filled in with dirt and one bag of bentonite hole plug was mixed in with the backfill dirt.

Photograph 13. UC-1, Possible piping structure near east toe of cap

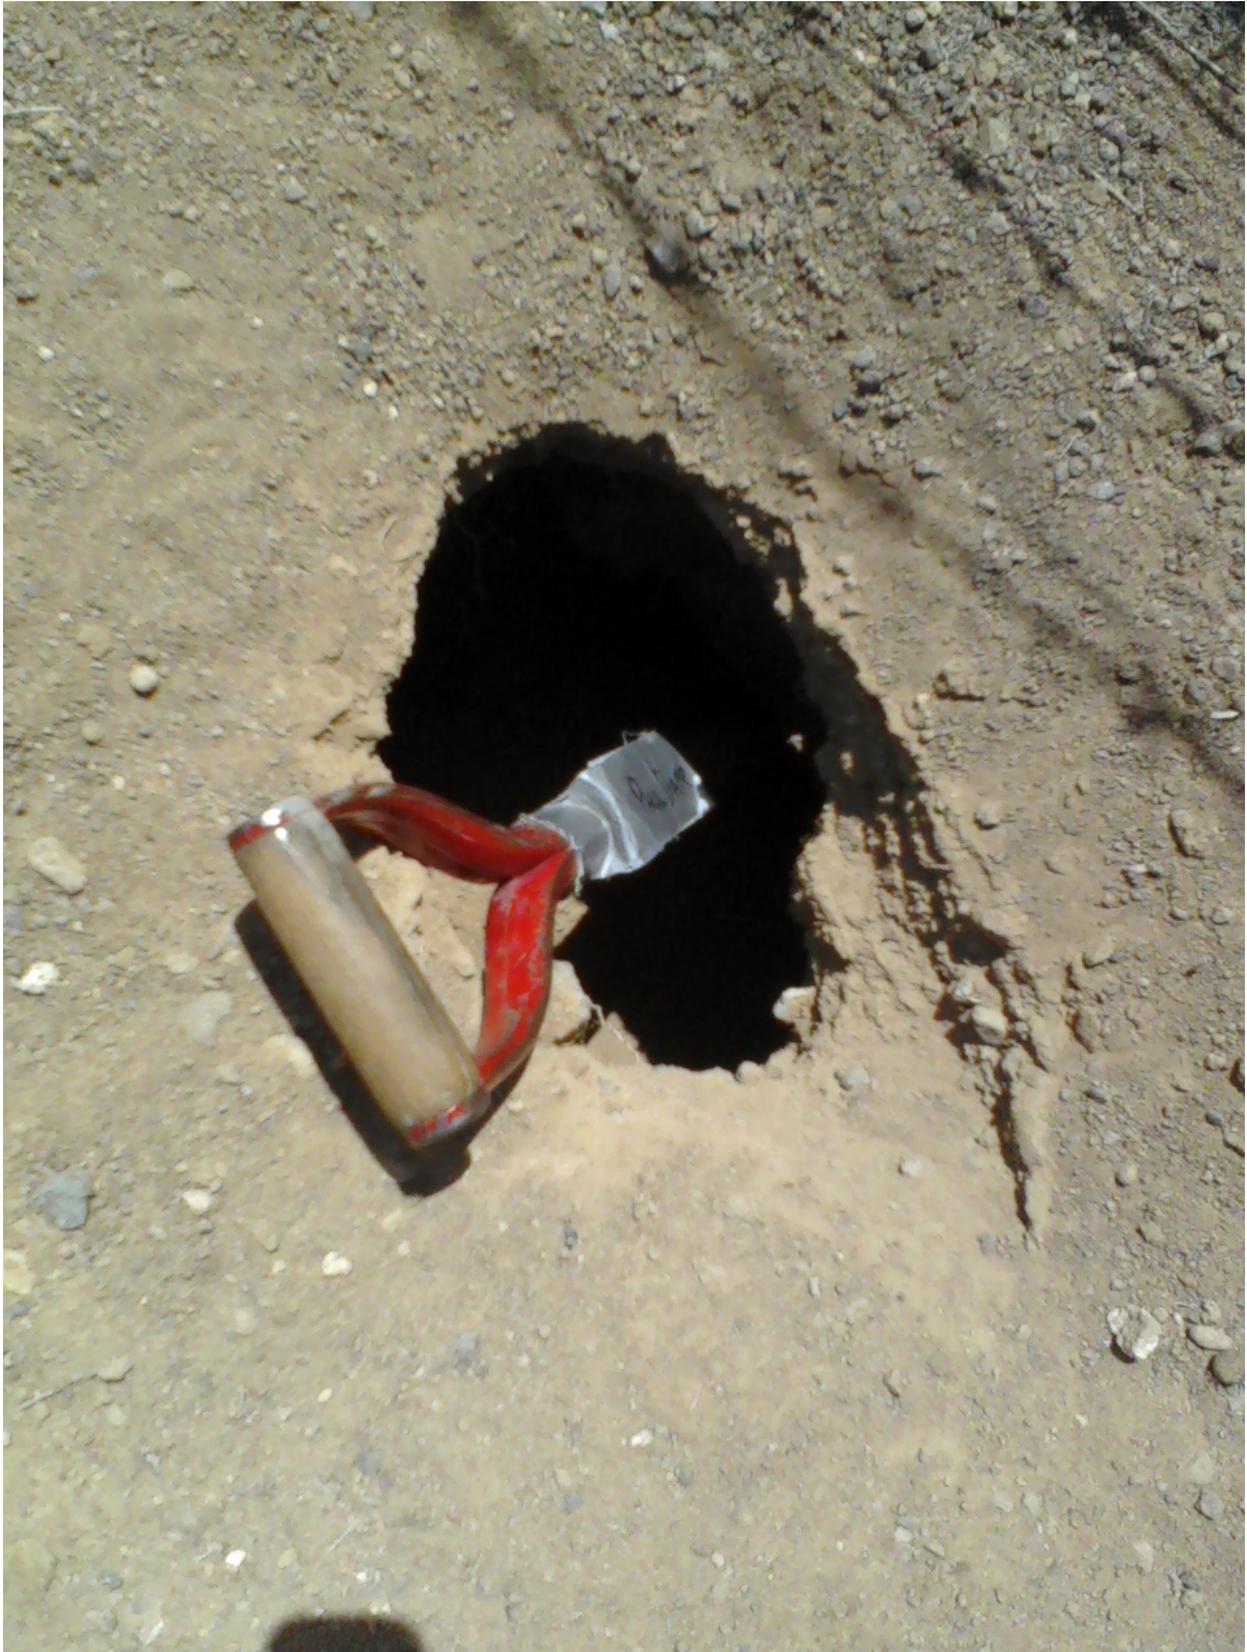
Photograph 14. UC-1, Possible piping structure near east toe of cap

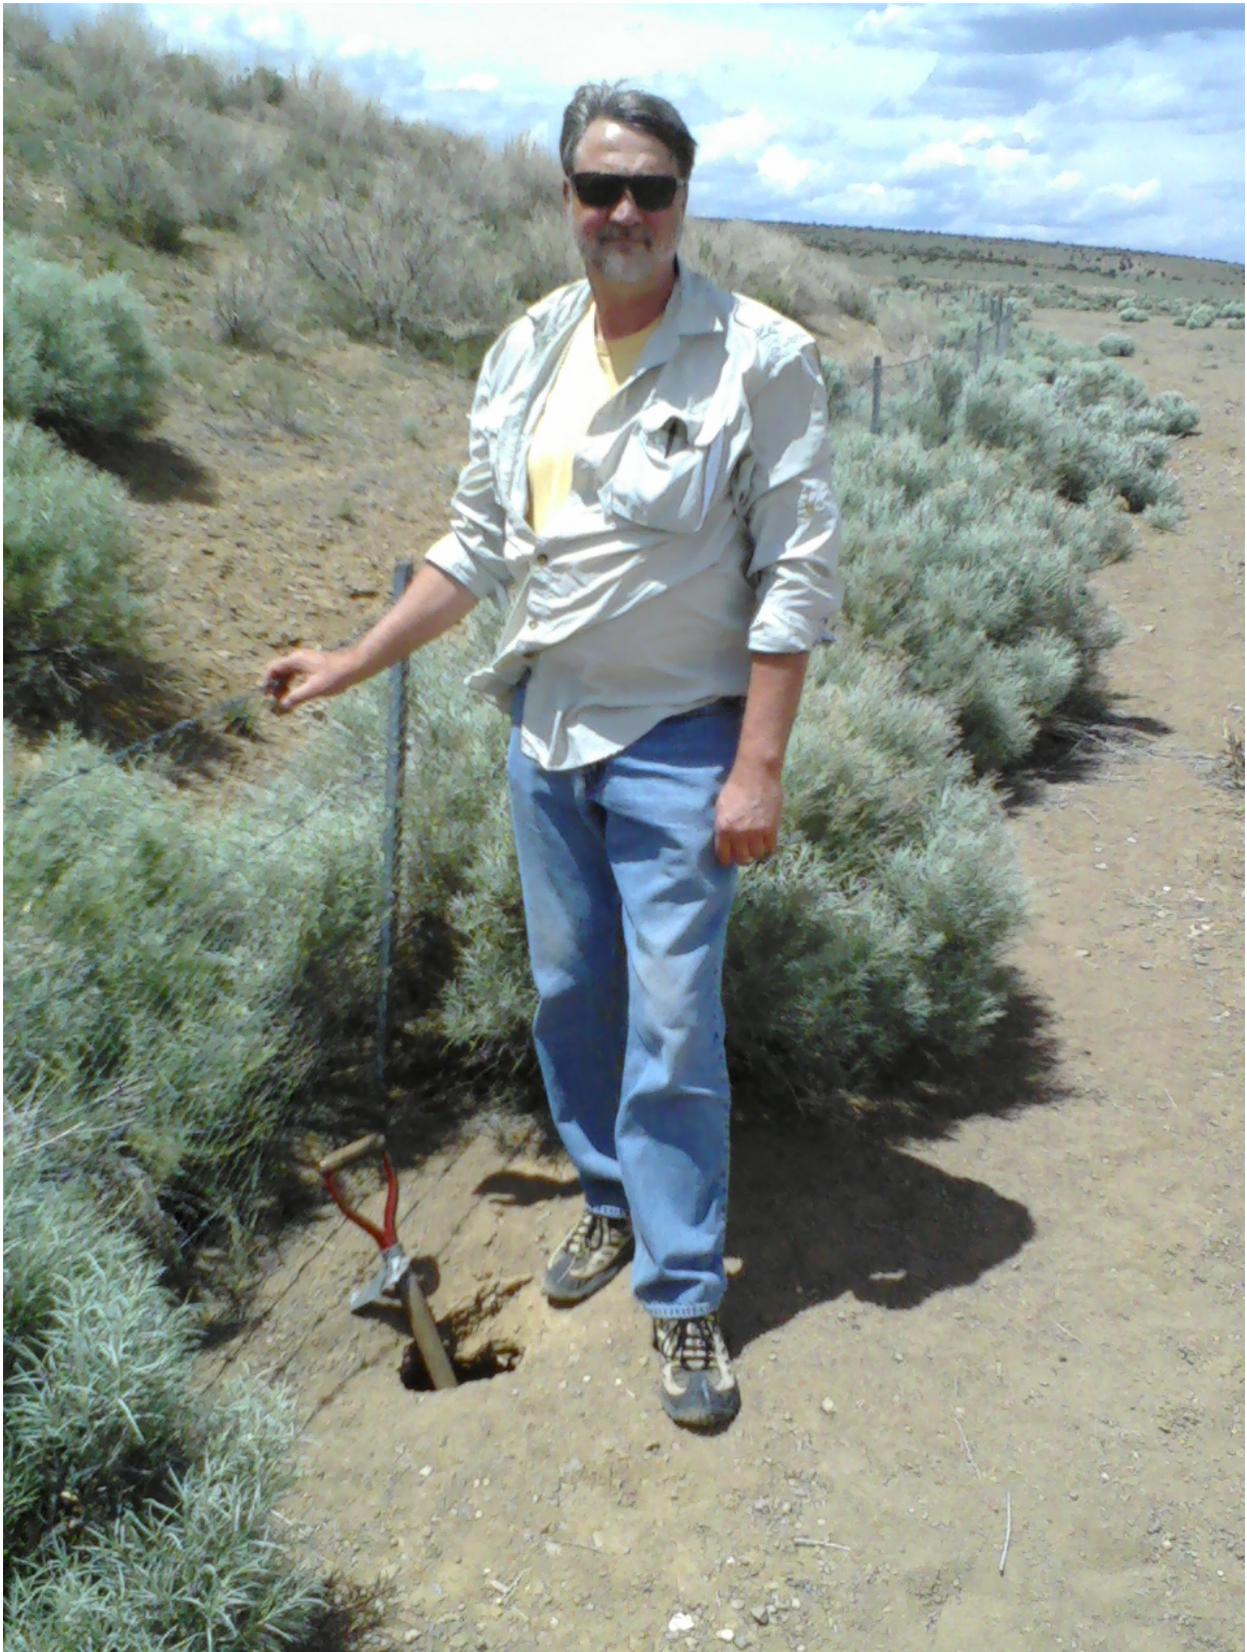
Photograph 15. UC-1, Possible piping structure near east toe of cap
