# 2006 Annual Inspection of the Monticello Mill Tailings (USDOE) and Monticello Radioactively Contaminated Properties Sites

December 2006

U.S. Department  
of Energy

## Office of Legacy Management

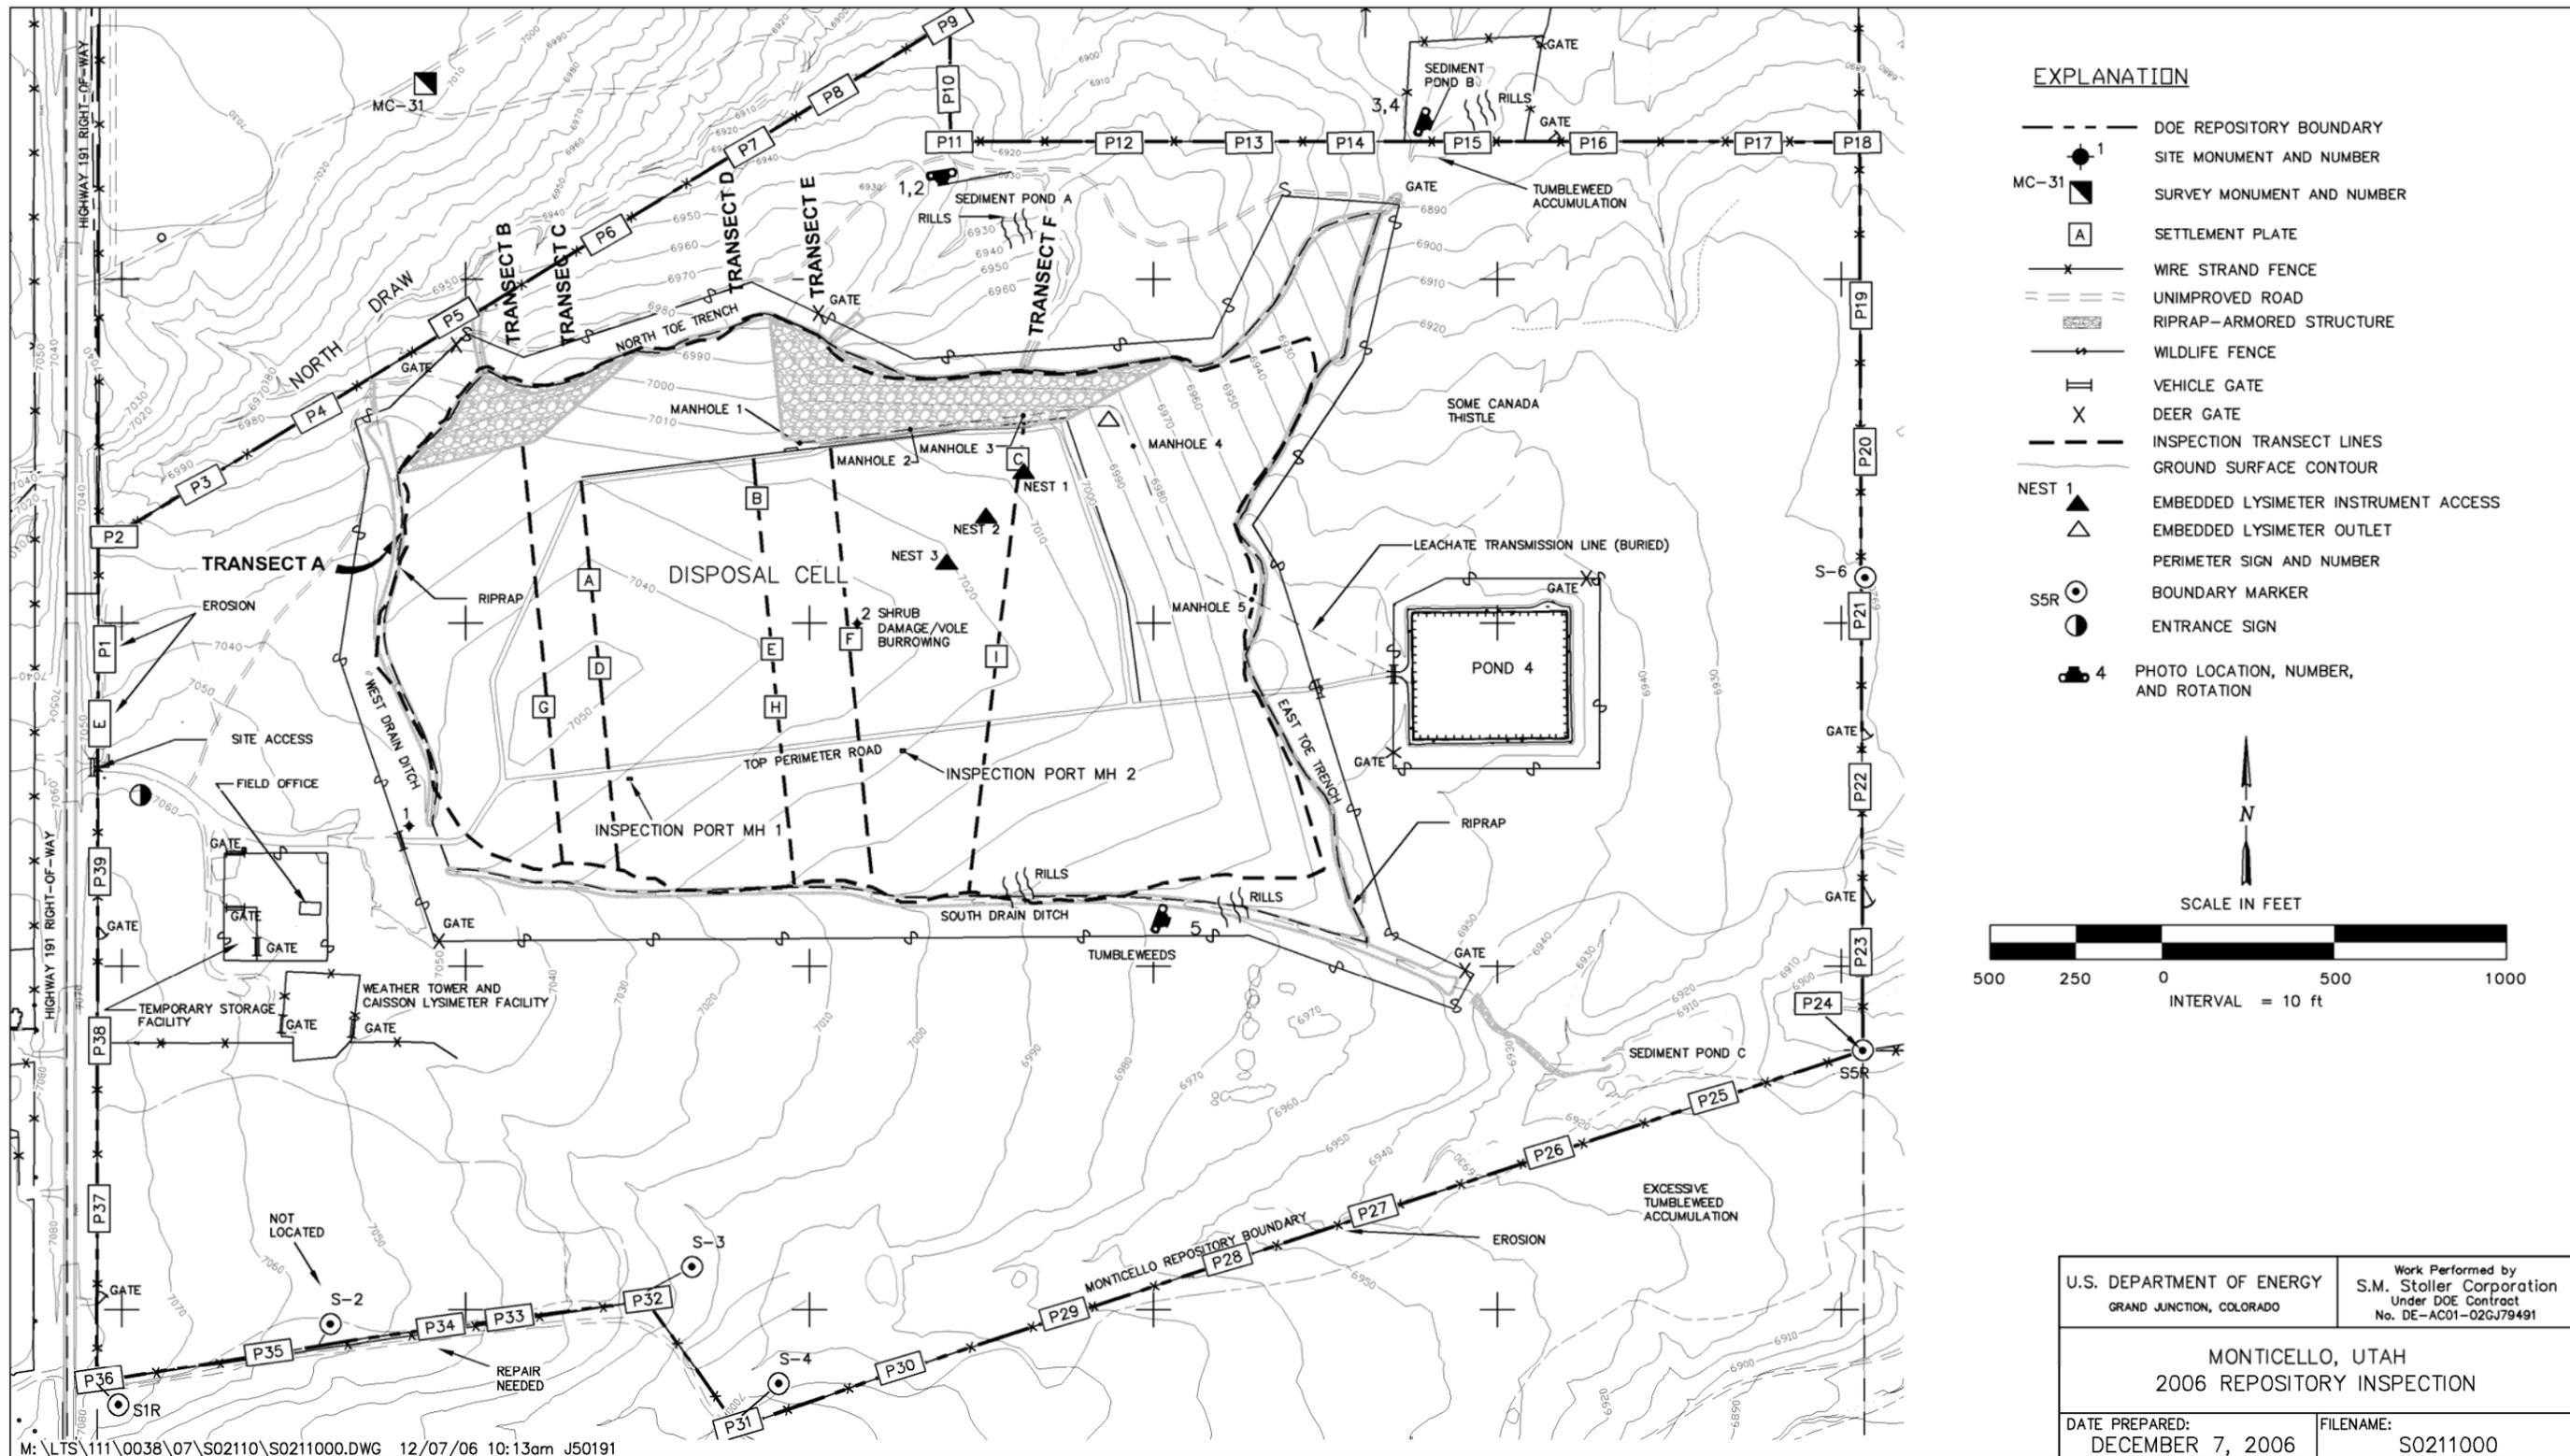
Figure 6. Inspection Findings: Monticello Repository

The LM representative will repair or replace perimeter sign P34.

The LM representative will monitor the gully between signs E and P1 and at P27. Gully repair may be required if fence integrity becomes threatened.

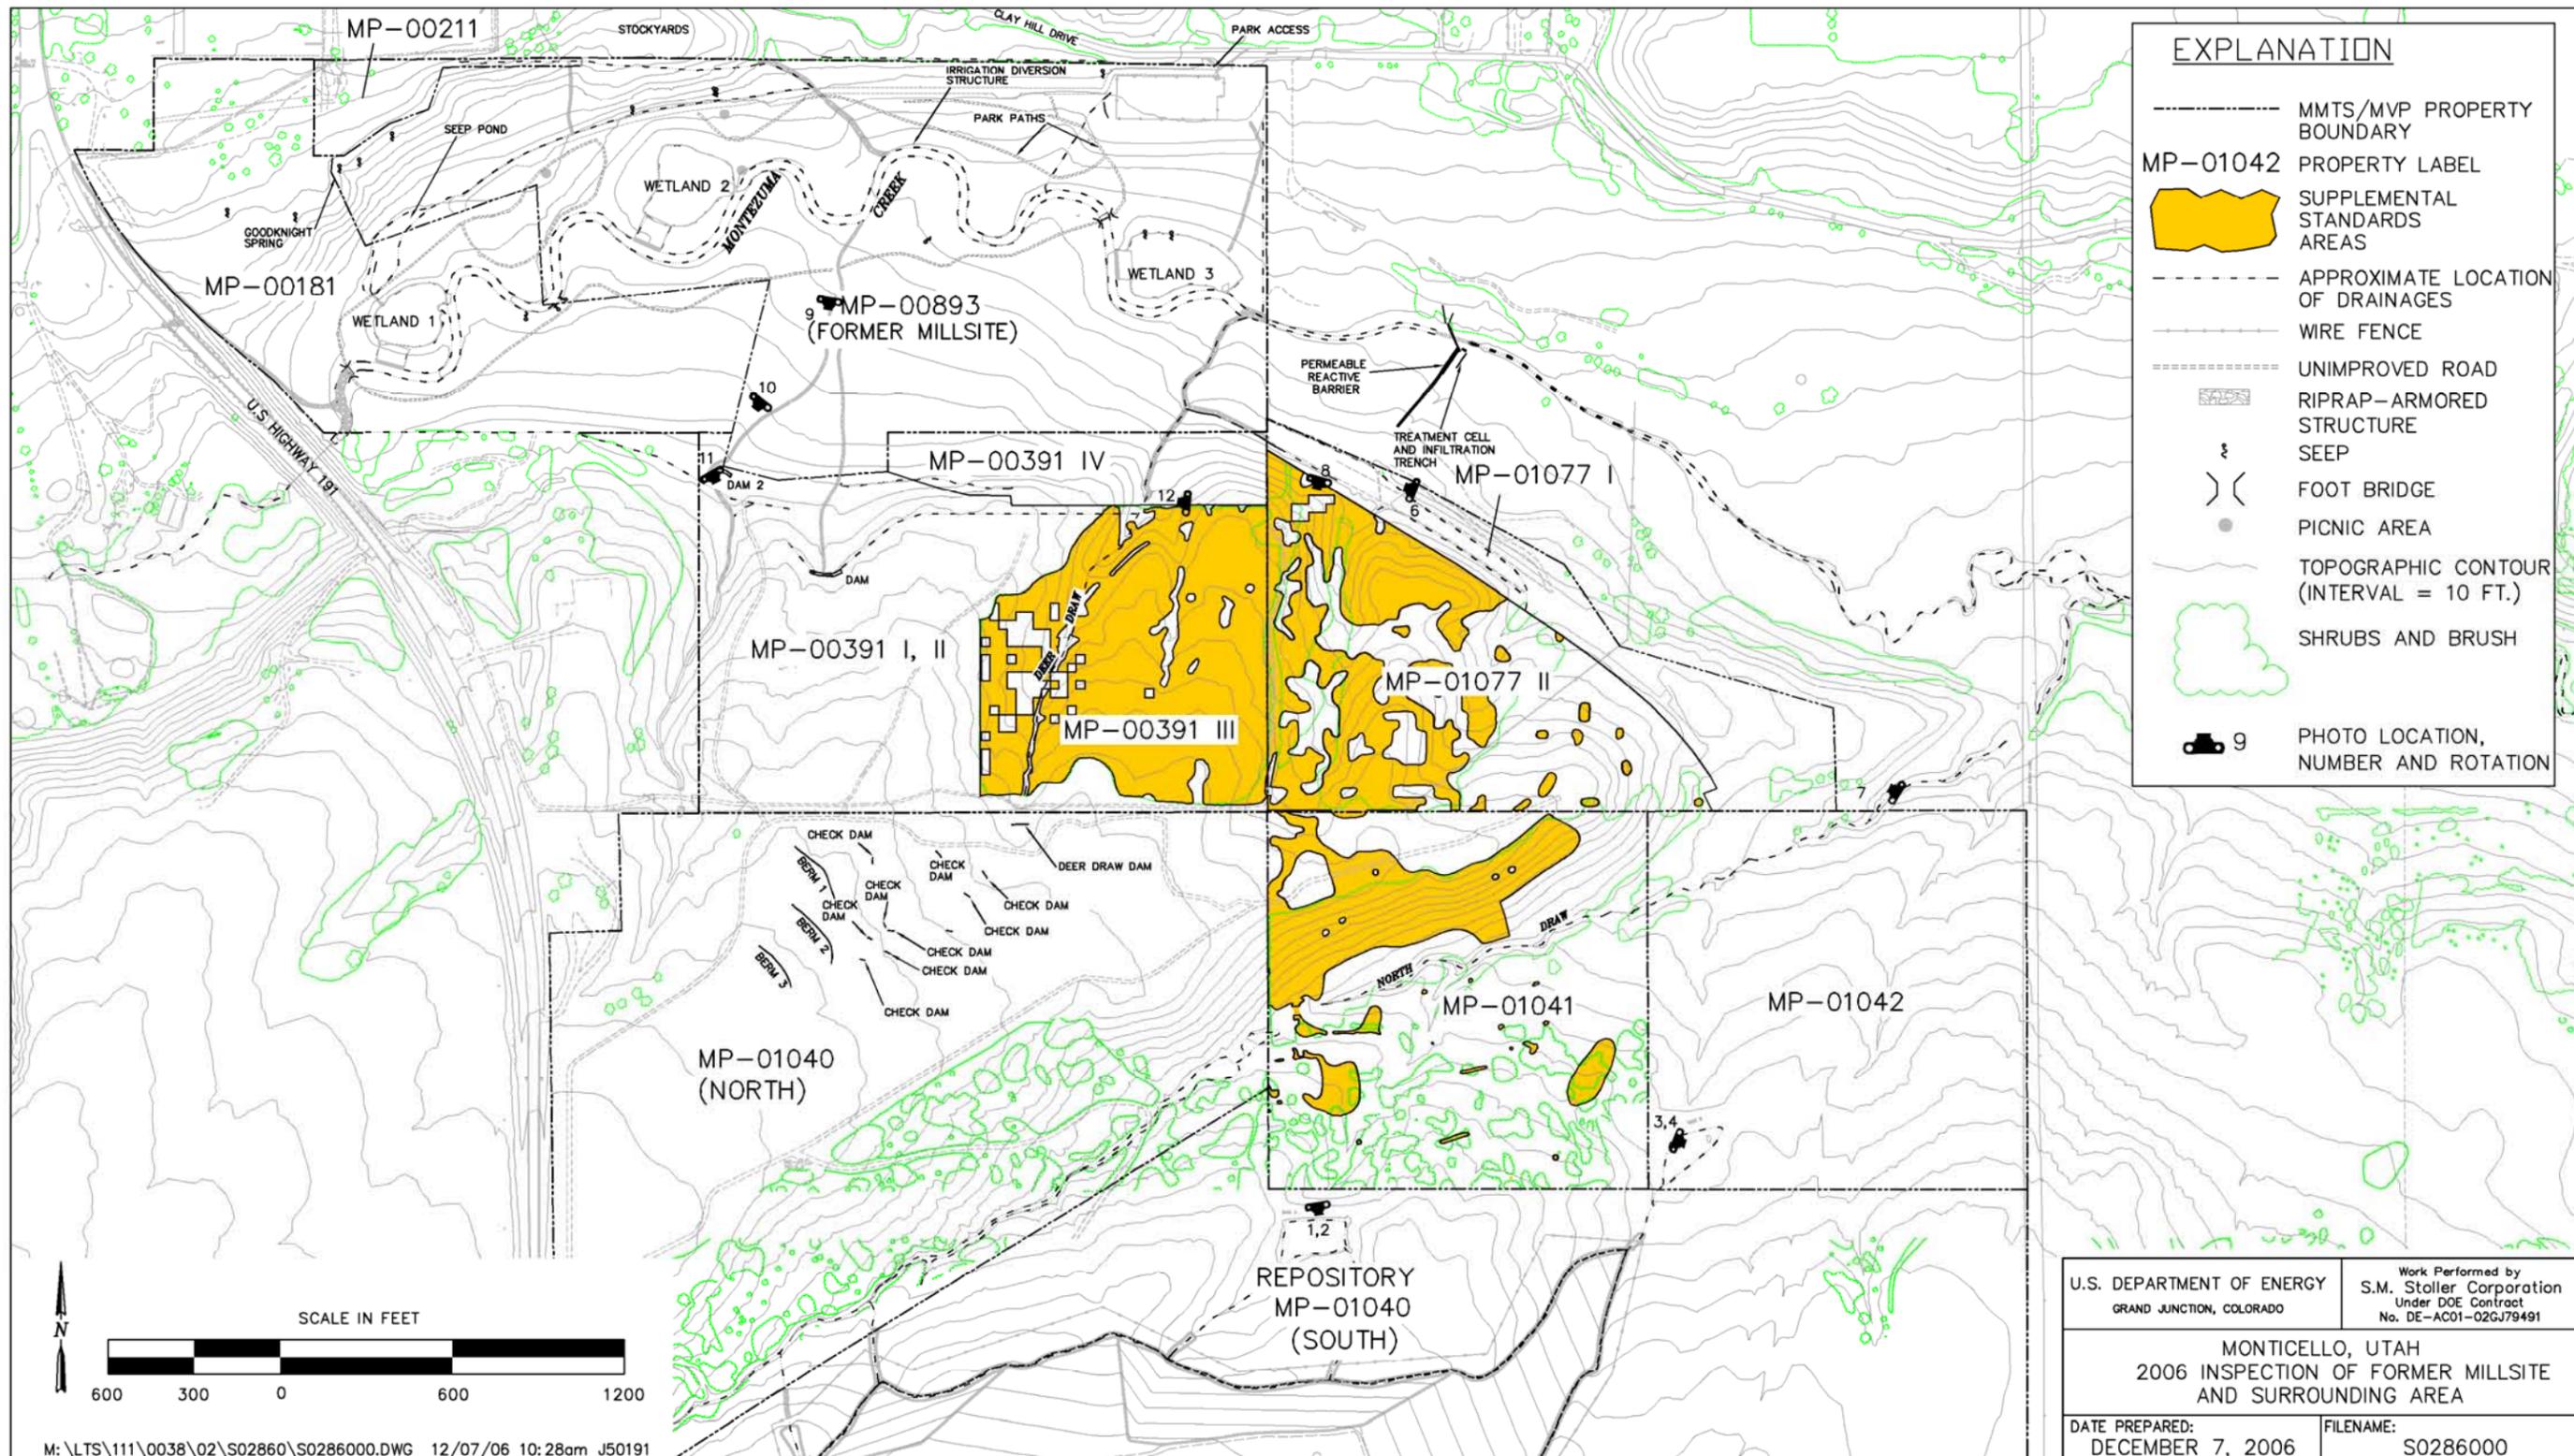
Figure 8. Inspection Findings: City-owned Properties

Undercutting of several fence posts by precipitation runoff was observed near the mouth of Deer Draw. All remaining fencing that encloses the supplemental standards areas of these properties was intact and functional during the 2006 inspection.

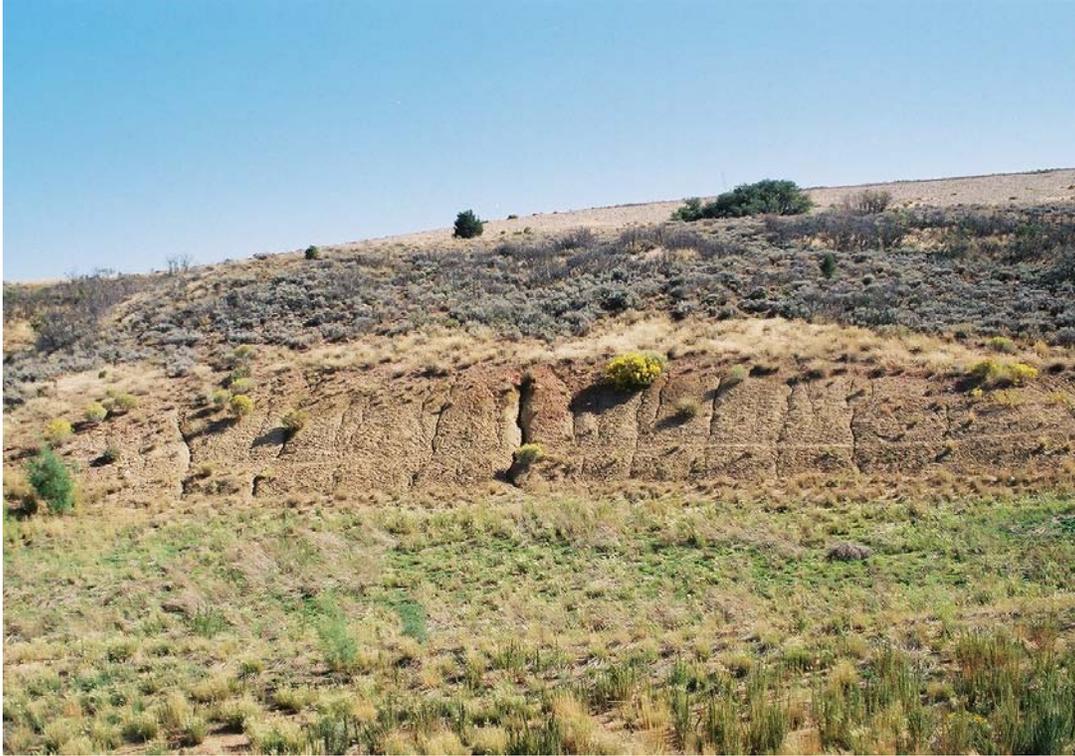
Gullies were noted on the south side of Sediment Pond A and the southeast side of Sediment Pond B. Baseline photographs of the gullies were taken in 2004. A comparison of a baseline photograph (PL-1) to a 2006 photograph (PL-2) demonstrates that the gullies at Sediment Pond A are stable. A comparison of a baseline photograph (PL-3) to a 2006 photograph (PL-4) demonstrates that the gullies at Sediment Pond B are stable. Subsequent annual inspections will note the condition of these gullies. Berm repair is not needed at this time.

MNT 9/2006. PL-1. Sediment Pond A, south side of pond, 2004 baseline.

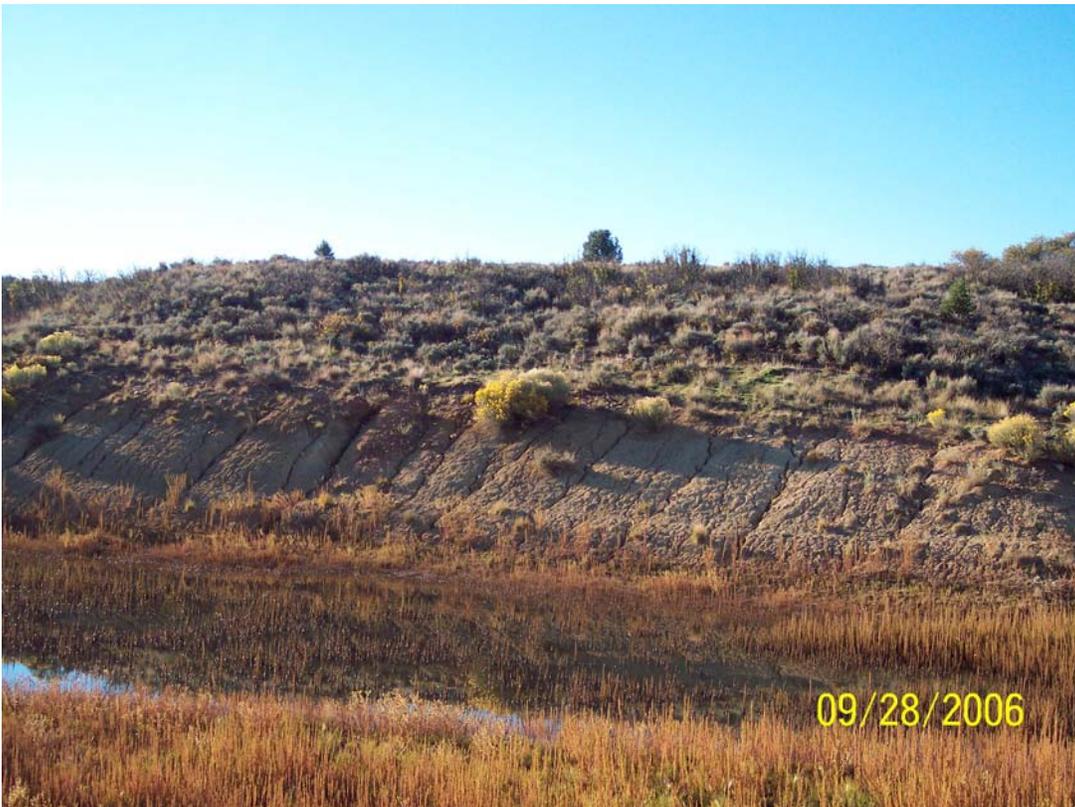
MNT 9/2006. PL-2. Sediment Pond A, south side of pond, September 2006.

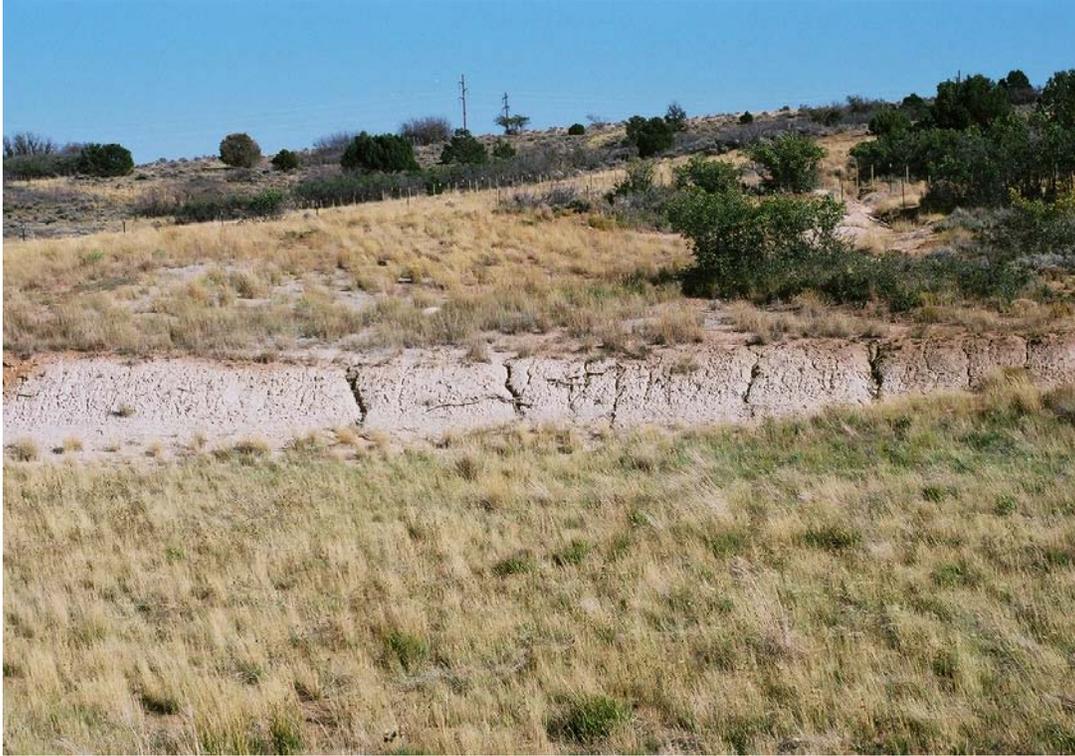
MNT 9/2006. PL-3. Sediment Pond B, south side of pond, 2004 baseline.

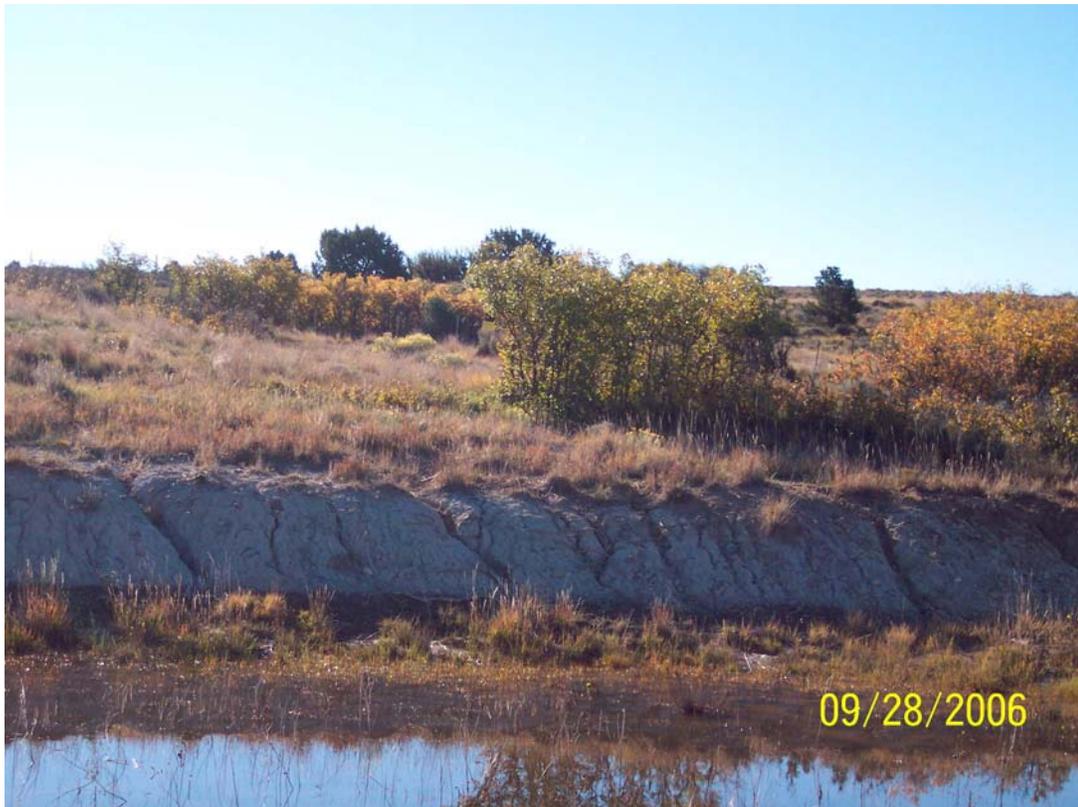
MNT 9/2006. PL-4. Sediment Pond B, south side of pond, September 2006.

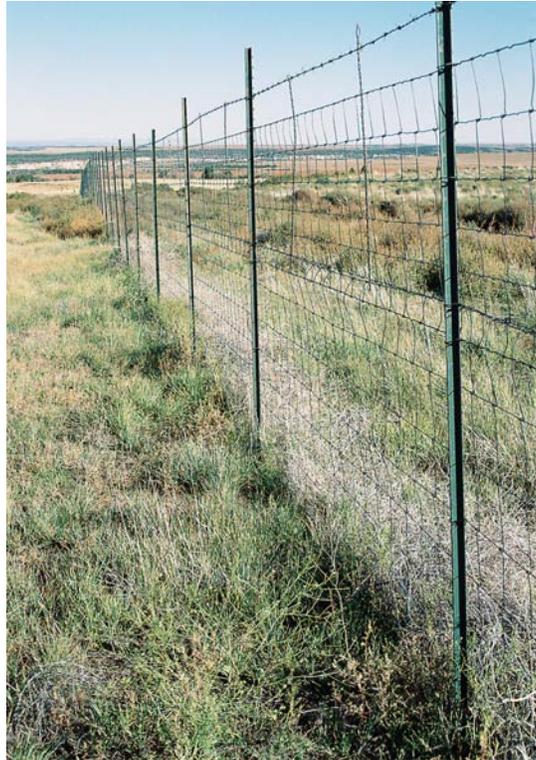
The chain link fence surrounding the disposal cell is 8-feet high with double gates on the west and east boundaries for vehicle access. Five smaller chain link gates are installed in the corners of the wildlife fence and in the center of the north section of fence to allow entry and exit of wildlife (mule deer). All fences and gates are in working condition, with no evidence of vandalism or damage. Vehicle gates are locked except when the repository is occupied. The wildlife gates were open to allow entry of deer and carnivorous predators. Significant tumbleweed accumulation was noted along the south section of the inner fence (PL-5).

MNT 9/2006. PL-5. Tumbleweed accumulation along outside of inner fence at repository, south section of fence.

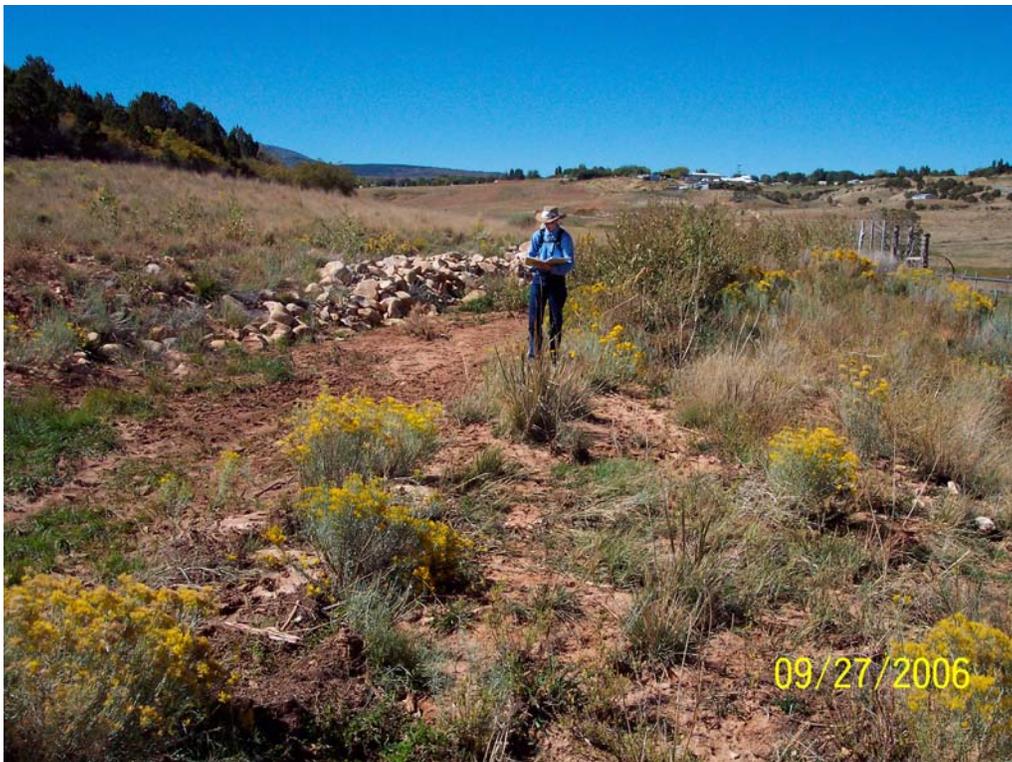
A drainage ditch runs along the northwest edge of MP-01077 Phase I (former haul road) to intercept and divert runoff to a shallow catch basin. The ditch and basin are intended to prevent erosion and sedimentation of adjacent property MP-01079-VL to the north (K. Somerville property). In 2006, a runoff event (or events) over-filled and breached the basin (PL-6), depositing 6 to 12 inches of sediment in the basin. The sediment should be removed from this basin and the breach repaired. Maintenance of this property is the responsibility of the City.

MNT 9/2006. PL-6. Shallow catch basin on former haul road; note sediment accumulation and apparent overflow, September 2006.

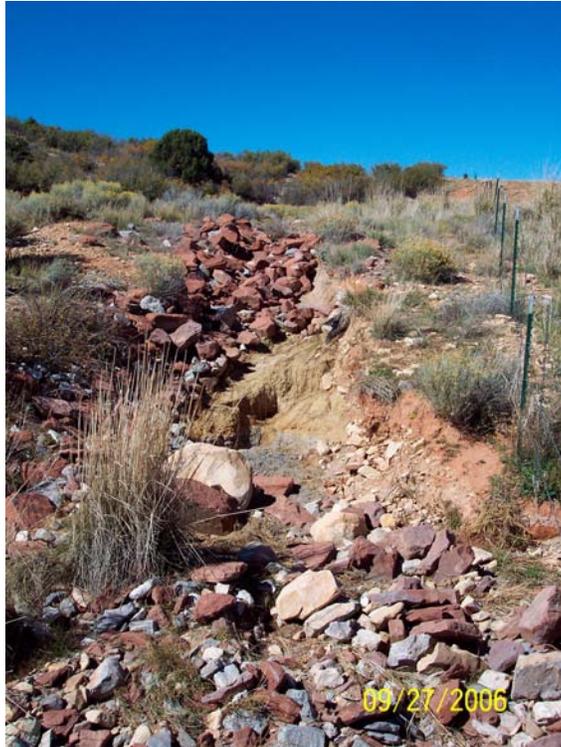
- A portion of the rock-armored channel of North Draw at the former haul road crossing has been washed out.
- Several fence posts on property MP-00391 (supplemental standards property) are undermined by surface runoff.

MNT 9/2006. PL-7. Washout of rock armoring in erosion control channel near downstream end of North Draw, September 2006.

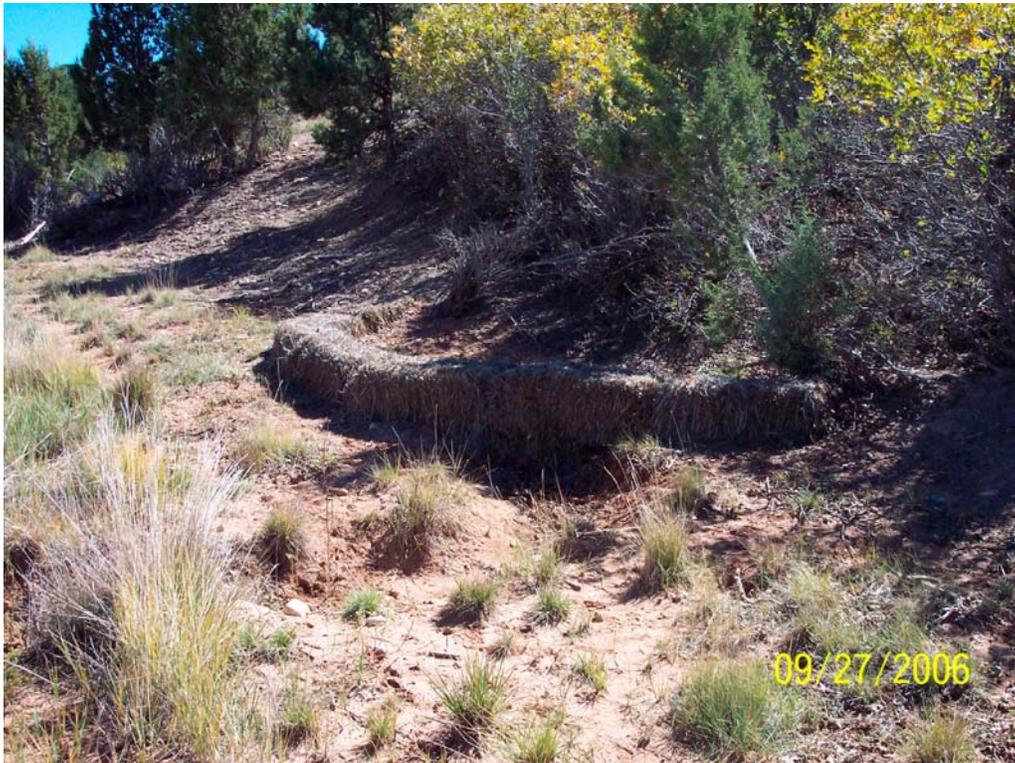
In 2005, straw bales were placed to control sediment movement in gullied areas along the former haul road. These controls were functioning as designed and were in excellent condition during the 2006 inspection (PL-8).

MNT 9/2006. PL-8. Straw bale erosion control in small drainage east of Deer Draw, bales placed in September 2005; September 2006 photo.

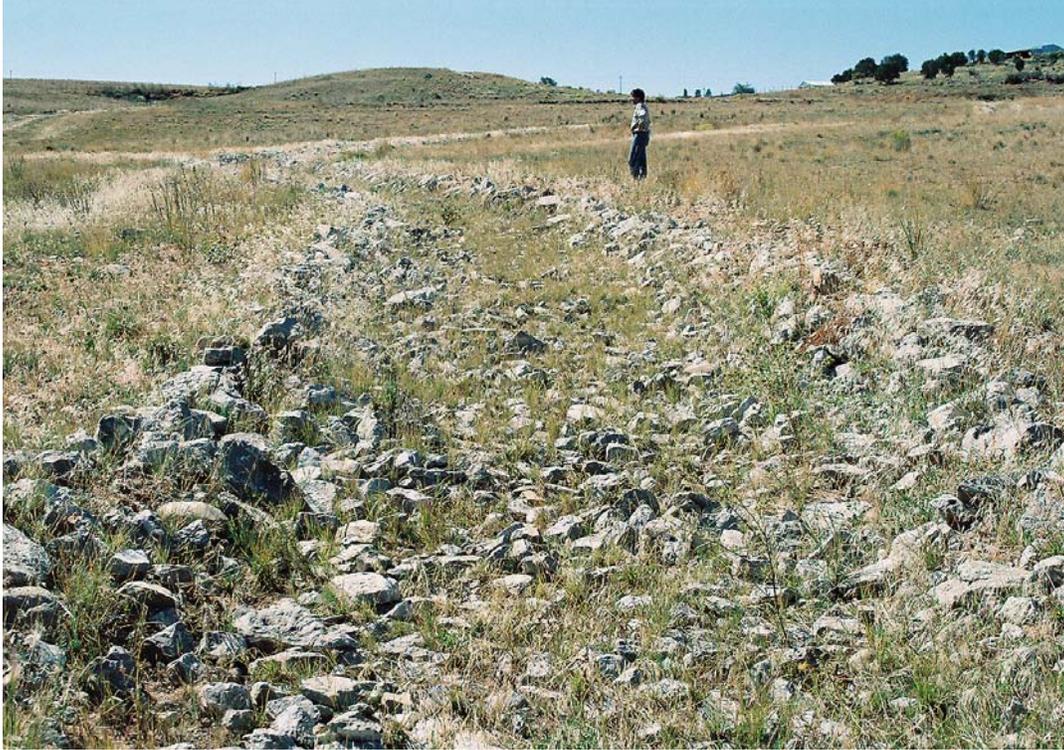
Inspectors noted that most of the erosion control structures constructed by DOE as of 2005 were intact and functioning as designed. Straw bales placed on the steep side slopes above Goodknight Spring were in excellent condition and had successfully rerouted runoff water to stable areas. Revegetation of the reconstructed rock-armored drainage ditches throughout the millsite property has been successful, as abundant grasses have established along the channels (PL-9 and PL-10).

MNT 9/2006. PL-9. Armored erosion control channel below Dam 2, former millsite area, September 2006.

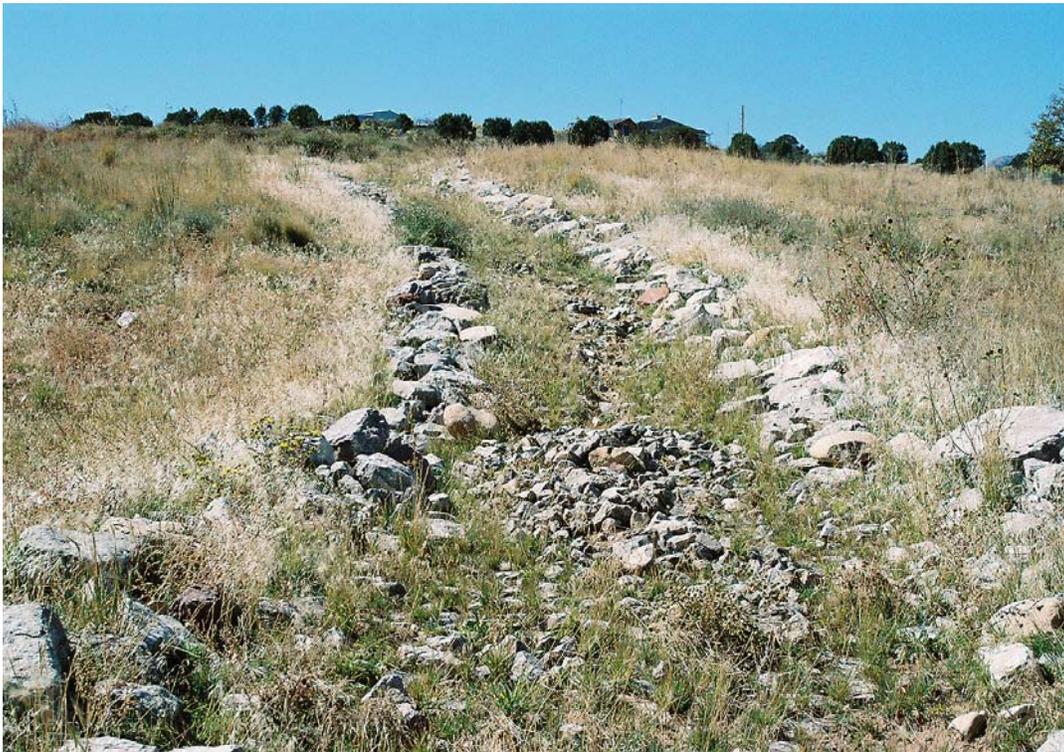
MNT 9/2006. PL-10. Armored erosion control channel below Dam 2, former millsite area, September 2006.

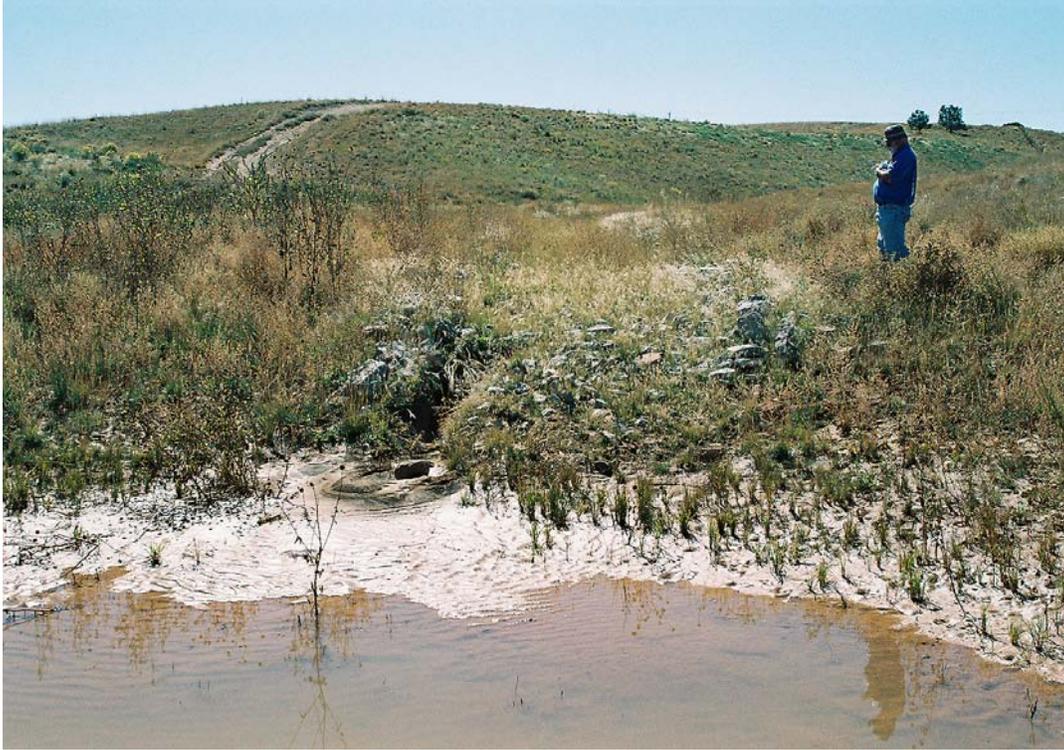
MNT 9/2006. PL-11. Small erosion cut at inlet to Dam 2 catch basin, September 2006.

- An erosional cut where the “Christensen drainage” empties into Dam 2. The riprap in the drainage channel may stabilize future down cutting.
- A deer trail cuts into the diversion ditch that routes runoff into Deer Draw near the southeast corner of the millsite. This cut may eventually deepen and allow runoff water to overflow the ditch and erode the lower slope.
- Sediment from an adjacent feedlot (Blue Mountain Meats) continues to fill the diversion ditch along the north boundary of the millsite.
- Other ditches/drains on the millsite require periodic maintenance.
- Piled riprap within the rocked drainage between Dam 2 and Montezuma Creek should be re-distributed.

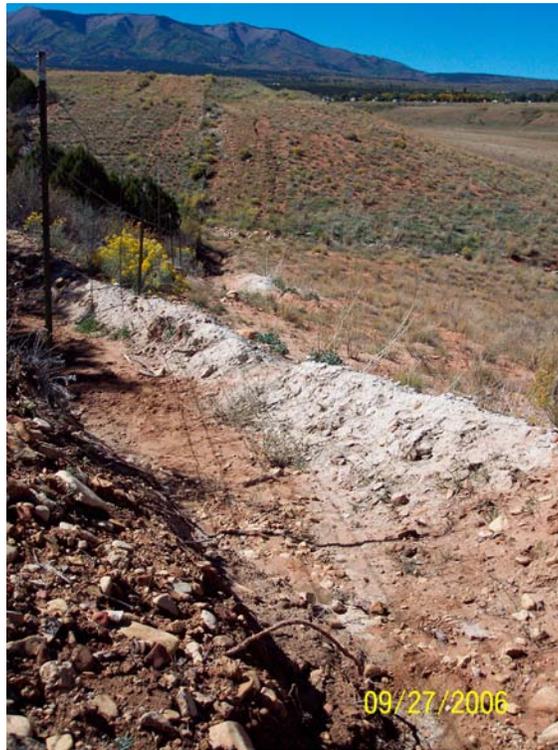
MNT 9/2006. PL-12. Low spot (deer trail) on bank of diversion ditch along south side of former millsite, September 2006.
