Appendix A

Site Inspection Photographs

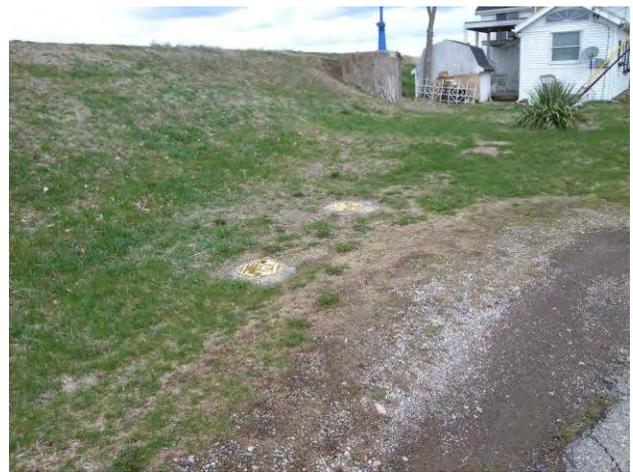
Wells 0333 and 0334, Off Site (removed from active monitoring program in 2009)

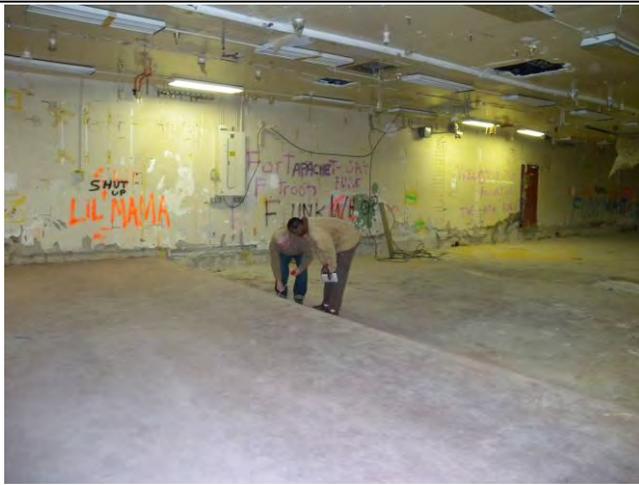
Art Kleinrath (LM) and Anthony Campbell (OEPA) examining red concrete cap in T Building during the physical inspection on April 12, 2011.

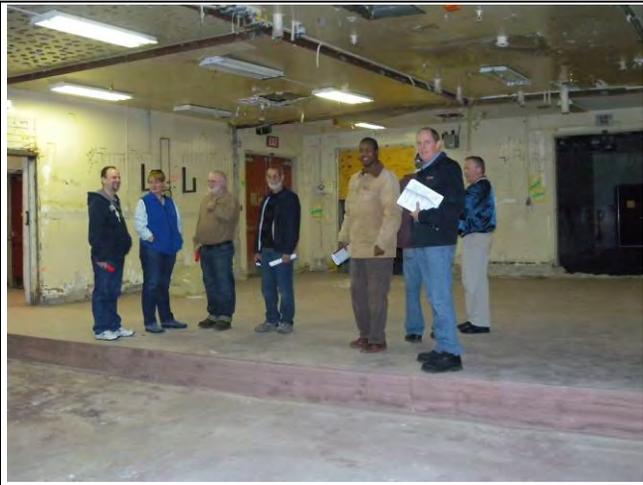
Tim Fisher,(EPA), Jane Powell and Jane Powell (LM), Ken Karp (Stoller), Anthony Campbell (OEPA), Jeff Smith (OEPA), and Frank Bullock (MDC) standing on red concrete cap in T Building during the physical inspection on April 12, 2011.
