Appendix C

Site Inspection Photographs

1.0 Parcels 6, 7, and 8 Remedy Wells and Seeps

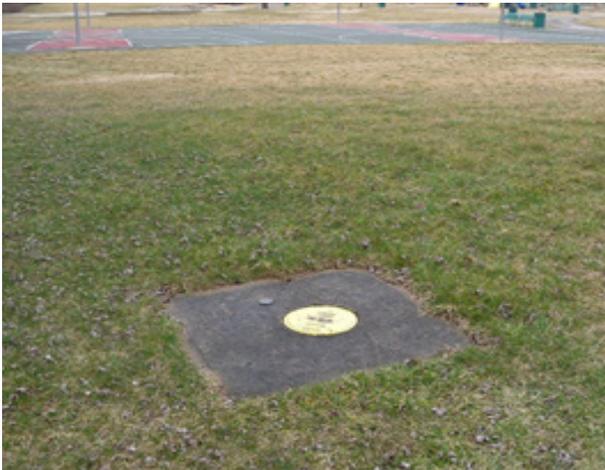
Well 0118, Offsite

Table C-1 and Figure C-1 list and identify the locations of the Parcels 6, 7, and 8 monitoring wells. Table C-2 contains photos of all wells and seeps. All of the Parcels 6, 7, and 8 wells were locked and in good condition and the seeps were accessible.

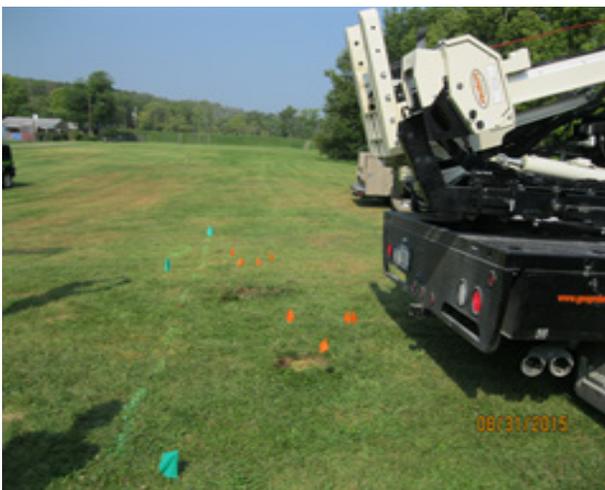
*Wells 0301 and 0311, Offsite
(abandoned in 2015)*

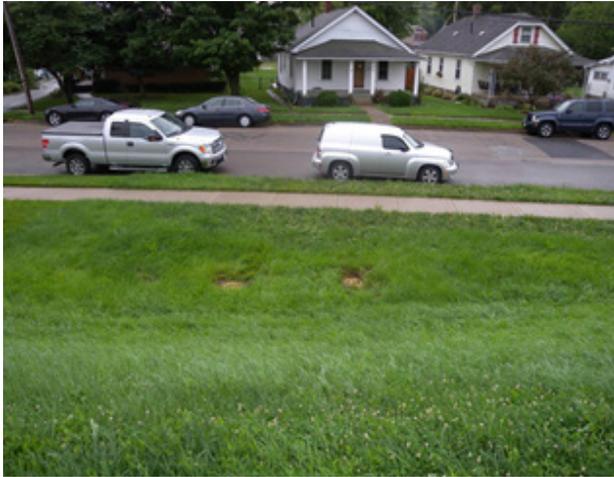
*Wells 0333 and 0334, Offsite
(abandoned in 2015)*

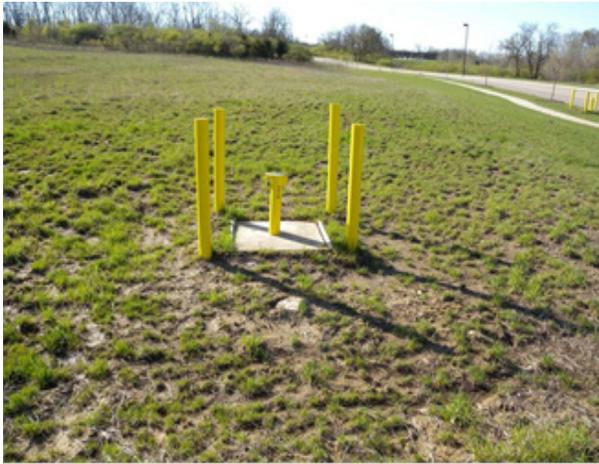
Well P015

Table C-3 and Figure C-2 list and identify the locations of the OU-1 monitoring wells, including those monitoring wells added as part of the OU-1 Field Demonstration project that was initiated in 2014. Table C-4 contains photos of all wells. All wells were locked and in good condition.

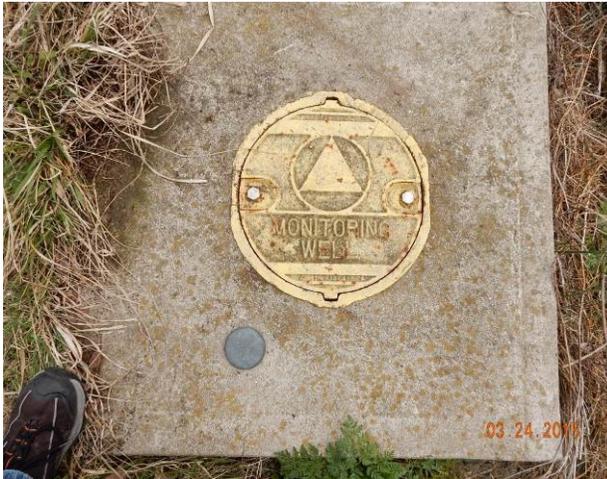
Well P033

Table C-5 and Figure C-3 list and identify the Phase I groundwater monitoring wells and one seep. Table C-6 contains photos of all wells and the seep. All wells were locked and in good condition.
