Technical Memorandum Regarding Instrumentation and Monitoring at the Rocky Flats OLF

Technical Memorandum

To:	Mr. Rick DiSalvo	From:	Heather Trantham, Ph.D. PE, Thomas A. Chapel, PE
Company:	S. M. Stoller Corporation	Date:	April 15, 2010
Re:	Instrumentation and Monitoring, Rocky Flats OLF	Tt Project #:	114-181750

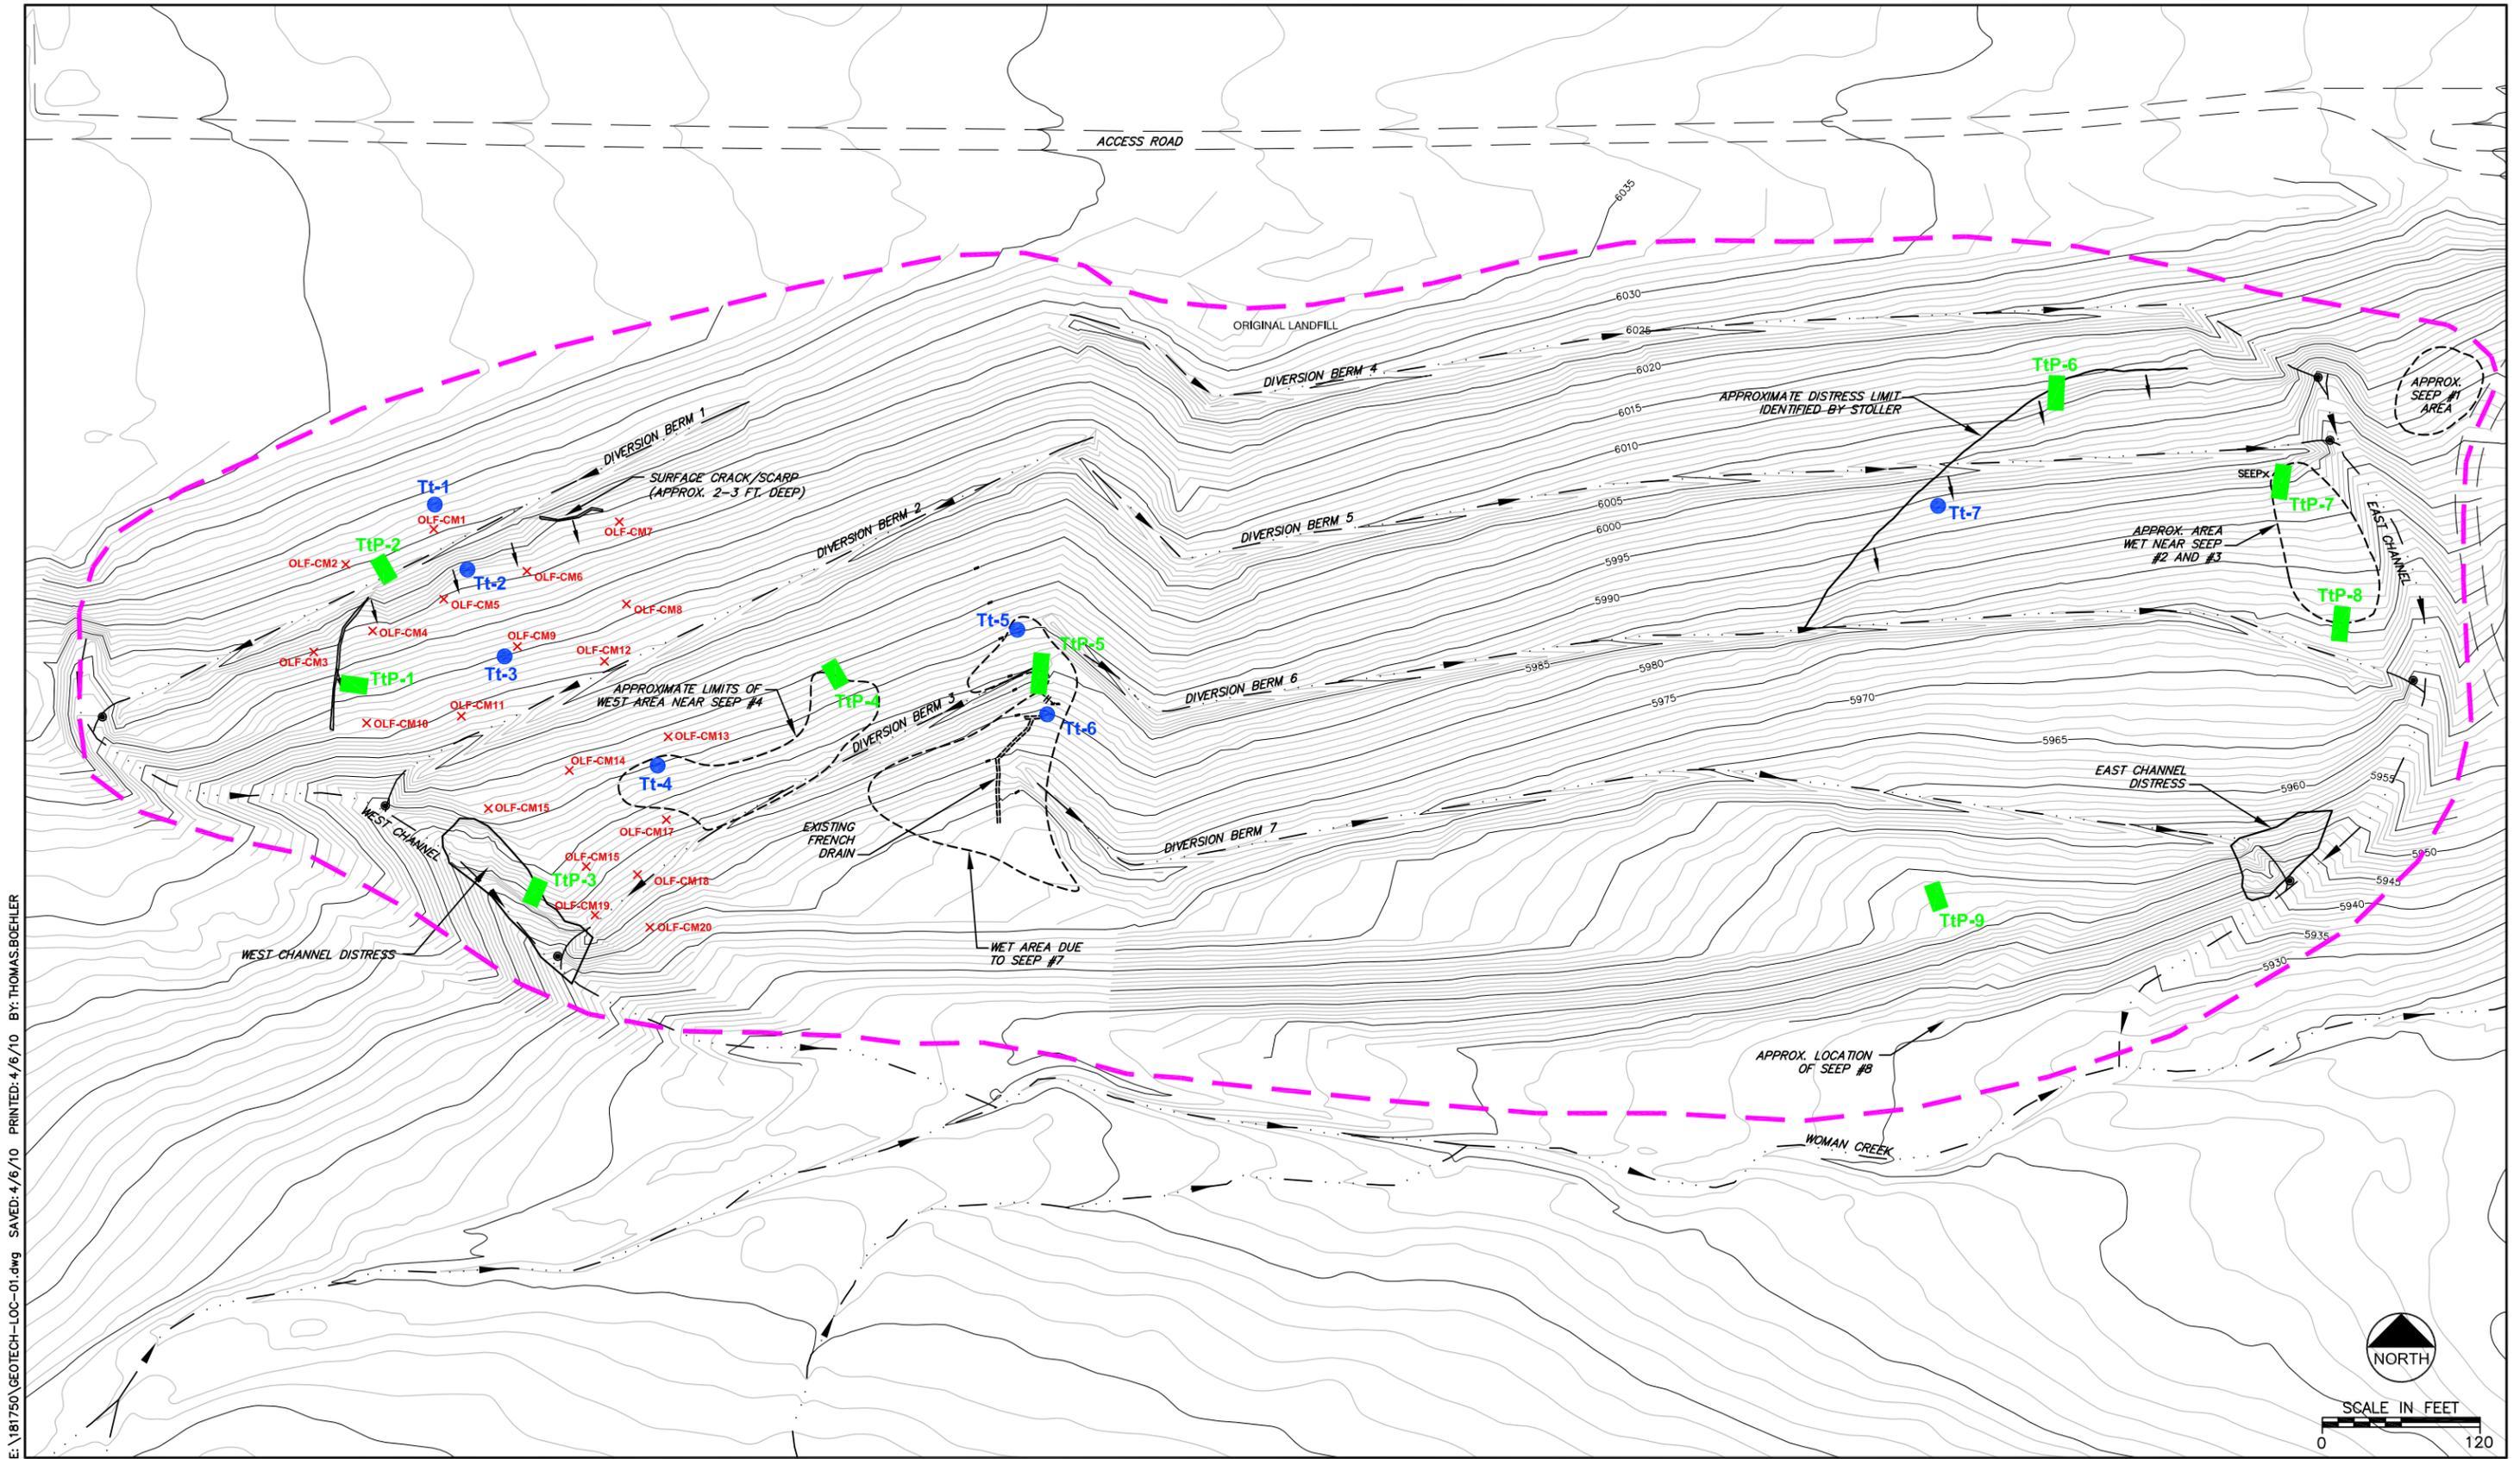
Figure 1
Plan View of OLF Site

The geotechnical investigation by Tetra Tech included a geophysical investigation, seven exploratory borings, nine test pits, laboratory testing, inclinometer and piezometer installation, and slope stability analyses. Figure 1, Plan View of OLF site, shows the locations of the localized cracking, slumping and settling, seeps, test pits and the inclinometers.

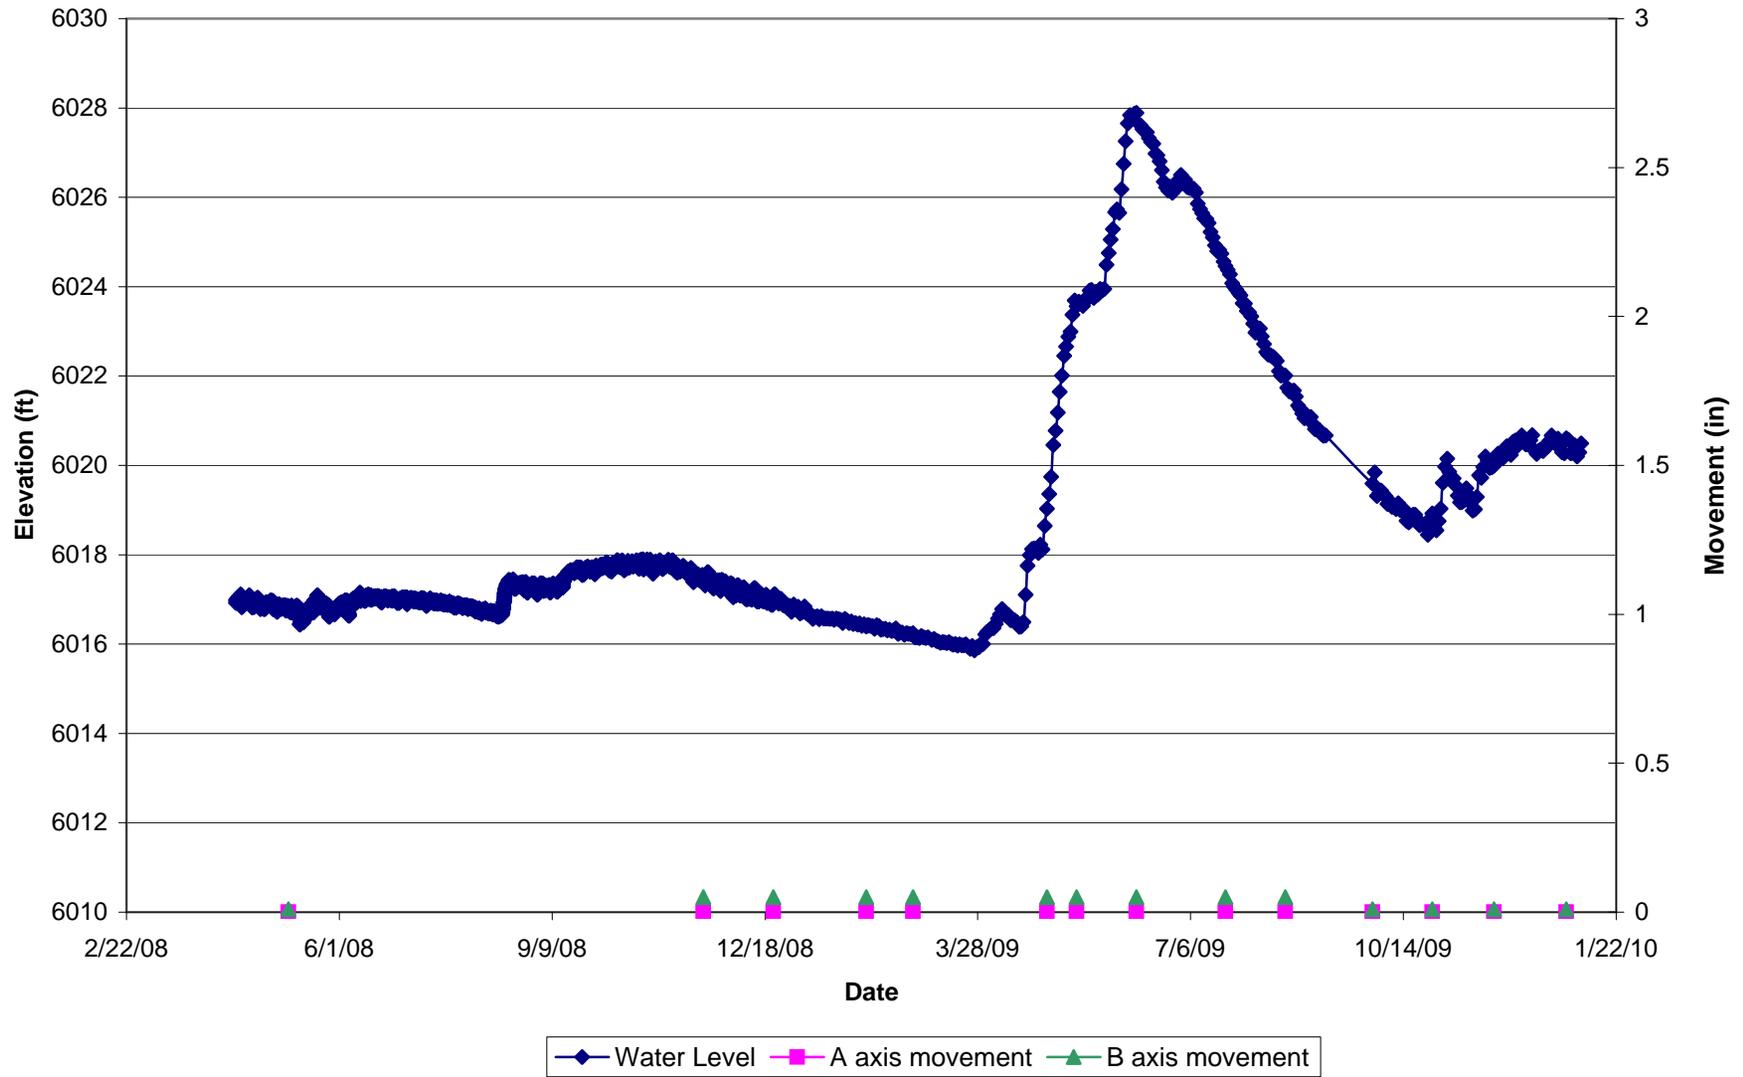
Inclinometer and Piezometer Data: Tt-1

Tt-1. There does not appear to be a relationship between piezometer readings and inclinometer readings for Tt-1. Tt-1 was intentionally placed outside of the current slide area. There is a very small increase in movement in the direction of the B-axis of the inclinometer.

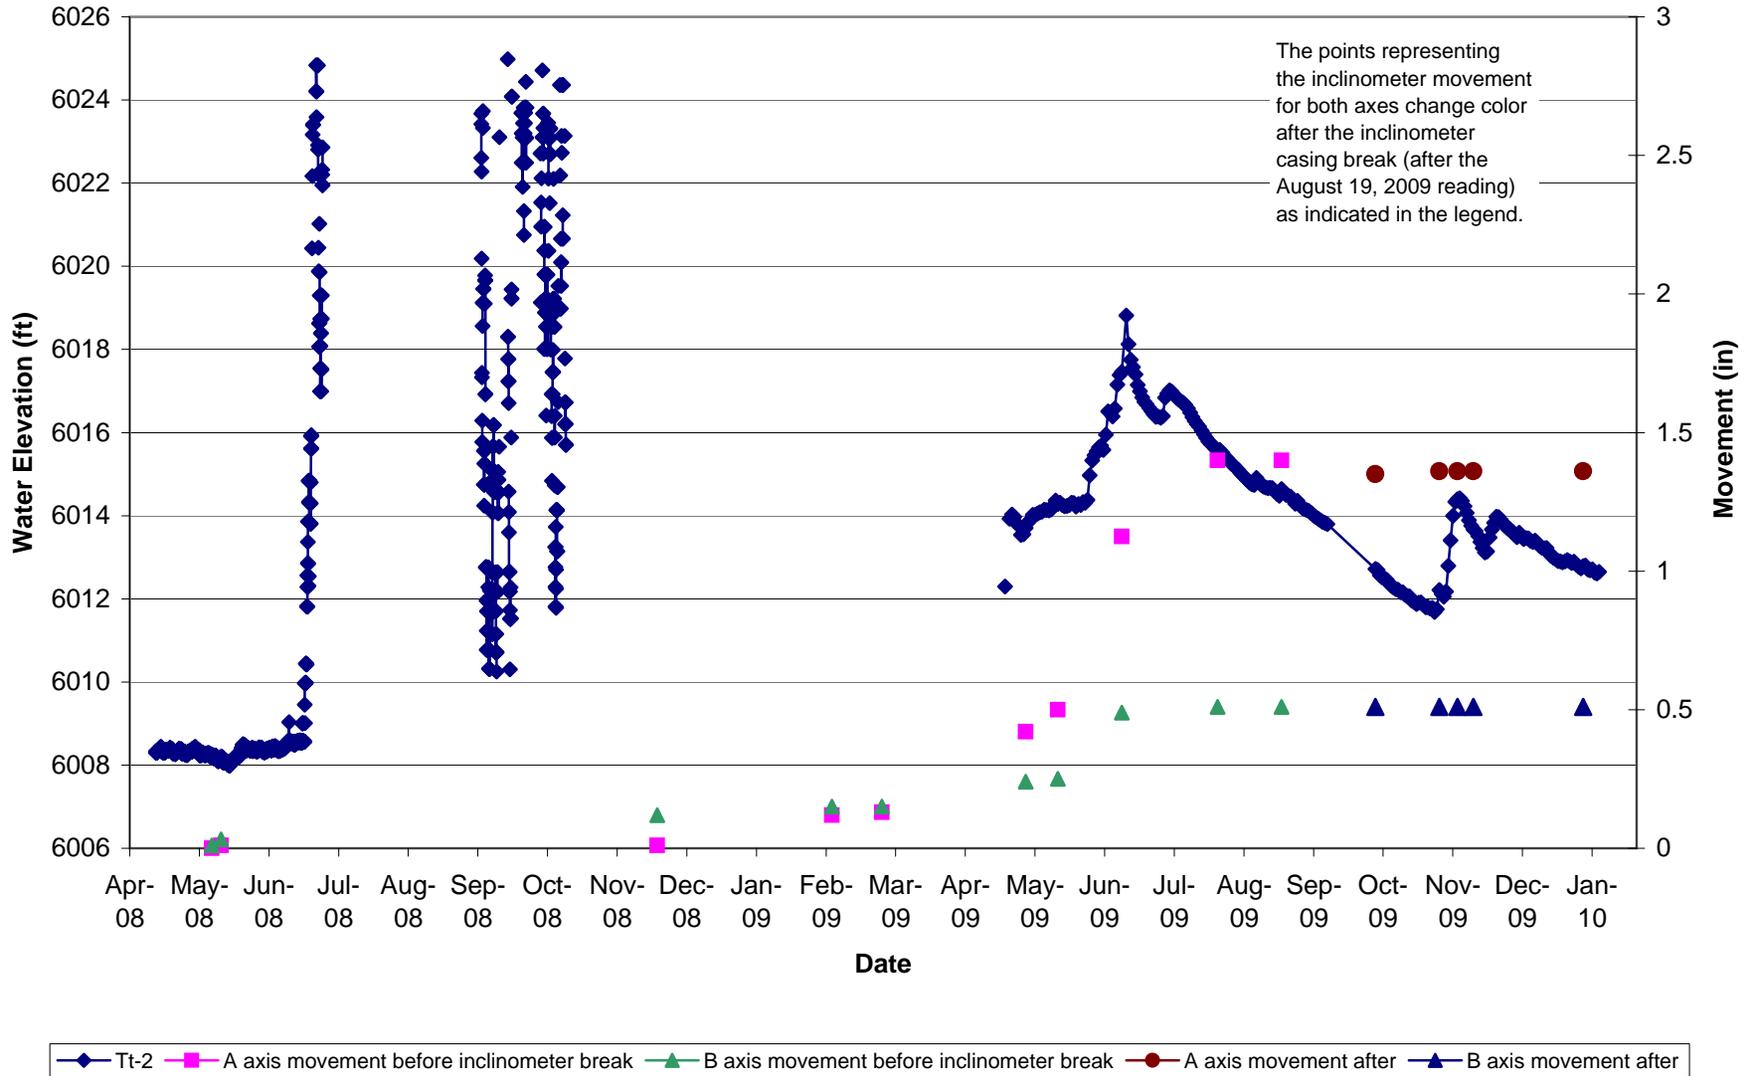
Inclinometer and Pizometer Data: Tt-2

Inclinometer Tt-2 was installed to a depth of 34 feet. Sometime after the August 19, 2009 reading, slope movement resulted in inclinometer tube deformation or breakage and the inclinometer could not be read below a depth of 25 feet on subsequent readings. Subsequent readings have been taken to a depth of 25 feet.

Tt-2. The inclinometer readings for Tt-2 show movements starting in May 2008 and continuing until a peak of 1.4 inches on the A-axis was recorded on July 22, 2009. This followed a spike in the high water level on 6/12/09. There is a lag time between the increase in water level and the measured movement of approximately 4 to 6 weeks. This lag time is seen when analyzing the

correlations for the other boreholes as well. During the same period, there was movement in the B-axis direction.

Movement in the B-axis direction that was recorded on July 22, 2009 may be related to an increase in the water level, but the data are not conclusive. It is not clear from the piezometer data if the large increase in water level shown is accurate or if it is “noise” recorded as part of the erratic behavior. After the movement occurred, a small decreasing trend can be seen in the A-axis, and no additional movement is apparent in the B-axis direction.

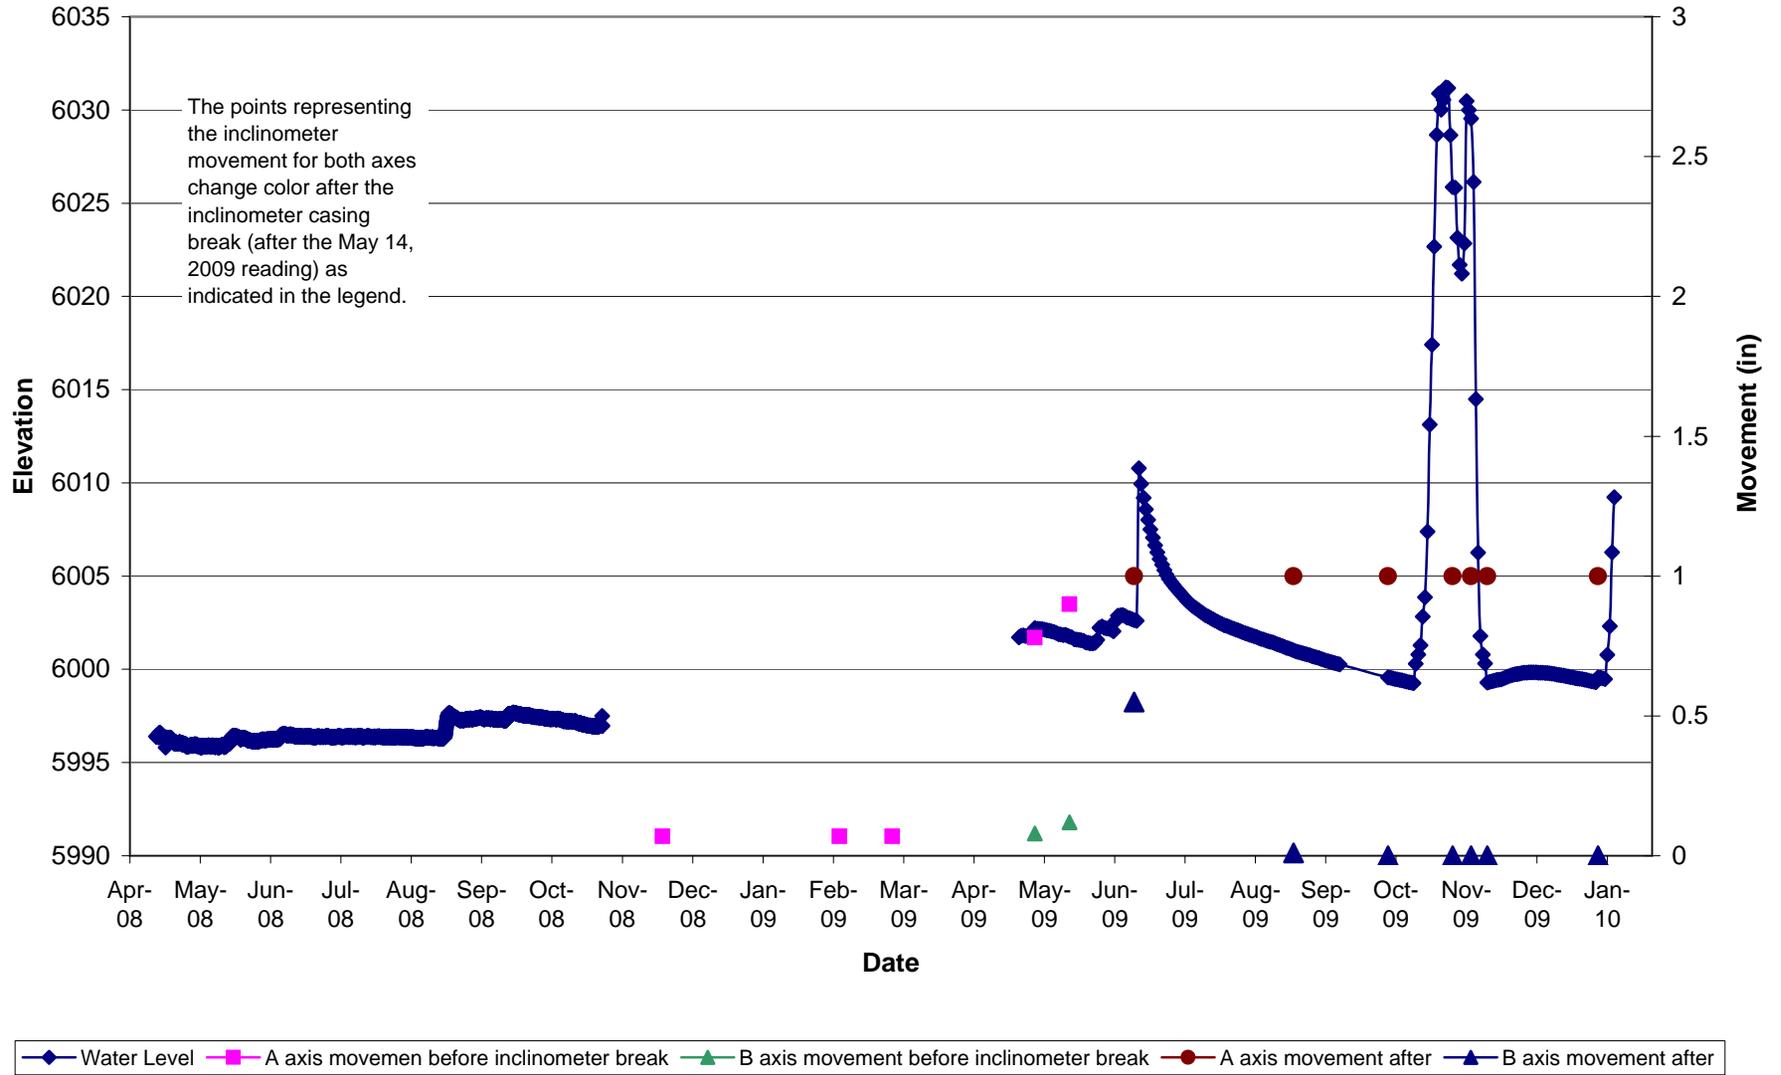
Inclinometer and Piezometer Data: Tt-3

Inclinometer Tt-3 was installed to a depth of 38 feet. Slope movement at this location also resulted in inclinometer tube deformation or breakage, and the inclinometer could not be read below a depth of 33 feet on subsequent readings. Subsequent readings have been taken to a depth of 33 feet.

Tt-3. Movement in the direction of the A-axis started in November 2008, and movement in the B-axis direction started in April 2009. The maximum movement in both the A- and B- axes seems to coincide with a spike in water level that occurred on June 13, 2009. It is likely that the precipitation that caused the maximum movement occurred prior to the water level spike seen at this time. We are unable to verify this due to the erratic piezometer behavior prior to the end of April 2009. After the peak movement occurred, the movement seems to decrease in the A-axis direction even though there is a large fluctuation in the water level as measured by the piezometer in October and November, 2009. Movement in the B-axis direction did not correlate with the large fluctuation in the water table seen in October and November, 2009.

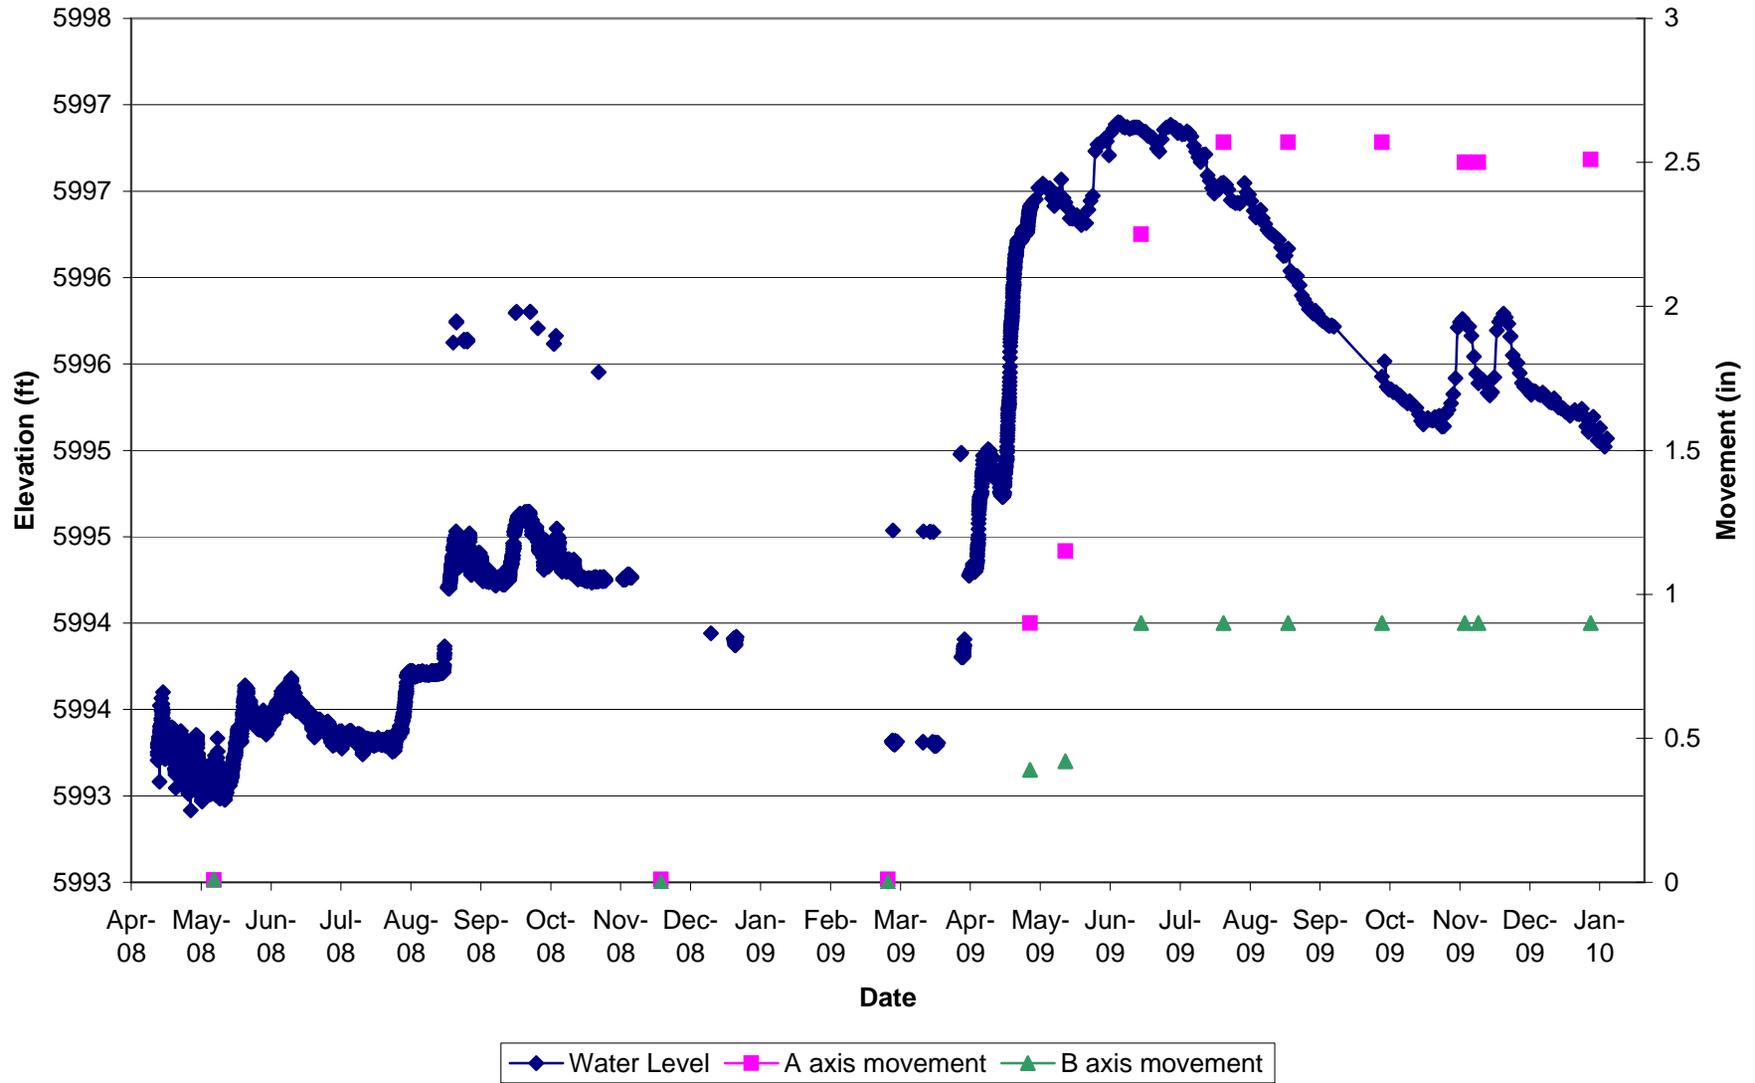
Inclinometer and Piezometer Data: Tt-4

Tt-4. The inclinometer readings in Tt-4 show movement in both axes starting in May 2009 and peaking in July 2009. The movement in both directions lagged behind a large increase in water level that occurred in the late spring and early summer of 2009.

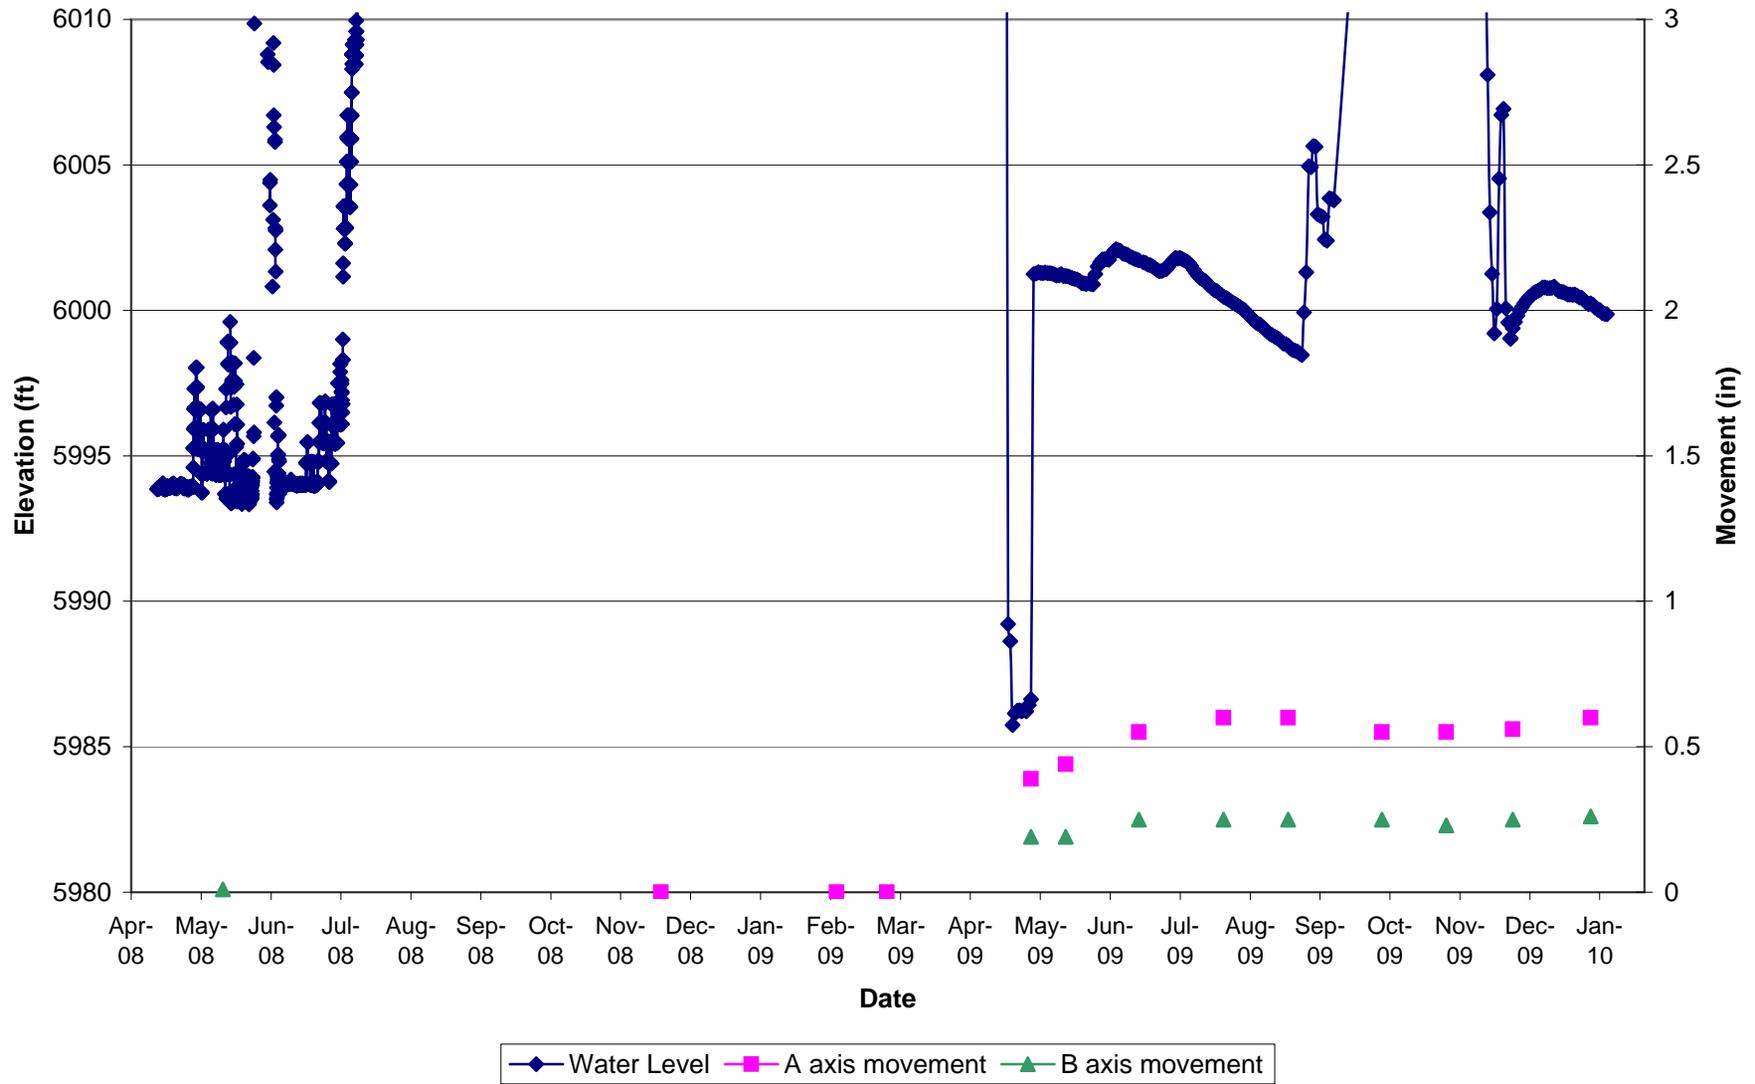
Inclinometer and Piezometer Data: Tt-5

Tt-5. The movement of the inclinometer casing in both axes correlated with an increase in water level as measured by the piezometer in Tt-5 at the beginning of June, 2009. The inclinometer movement leveled off during a period when the water level decreased according to the piezometer data in the middle of August, 2009. The piezometer in Tt-5 displayed erratic behavior from September to November of 2009, and it is not possible to draw conclusions between the water level measurements and the movement measured by the inclinometer during that time.

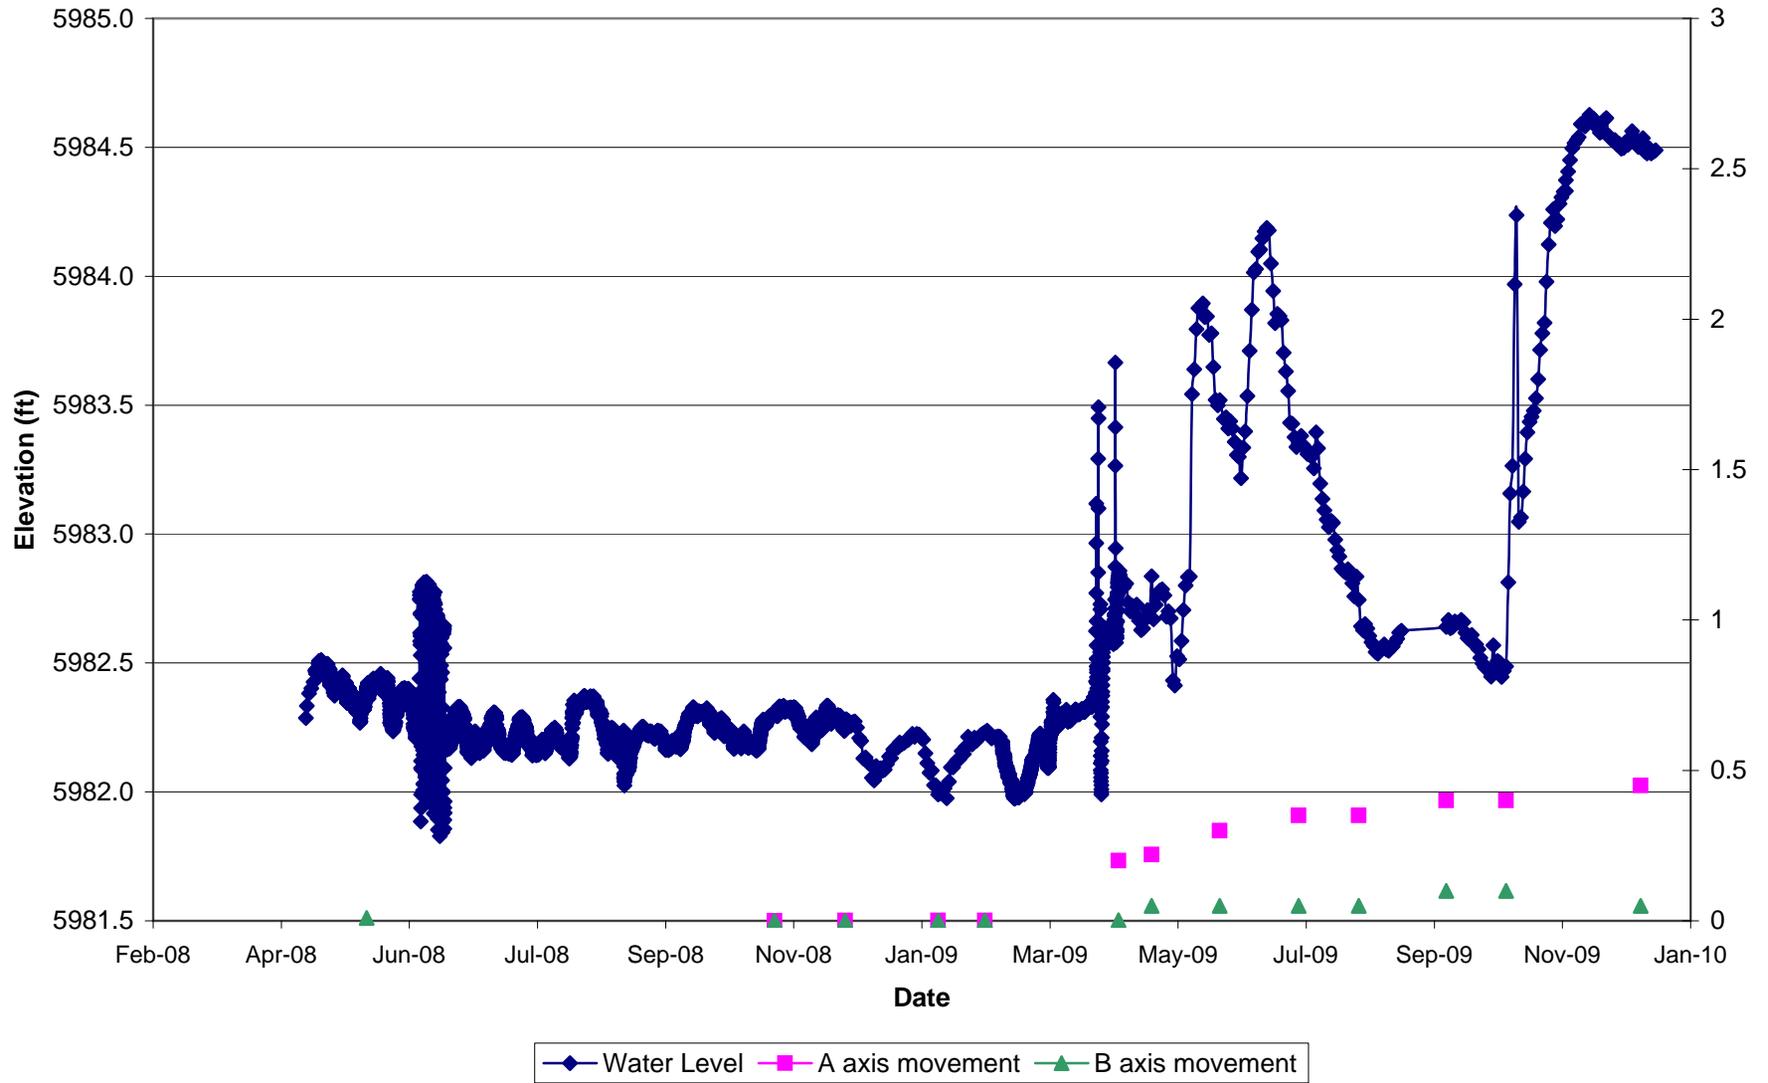
Inclinometer and Piezometer Data: Tt-6

Tt-6. The general trend of the inclinometer data in the A-axis is an increase in movement starting in April 2009 that reached a maximum of 0.45 inches. A small increase in the water level was indicated in 2008 and early 2009 as measured by the fluctuation of the piezometer. No significant movement of the inclinometers was apparent during that time. A general increase in water level started in April 2009 and continued throughout the rest of the year. There was a corresponding increase in movement measured by the inclinometer during that time. Small movements occurred along the B-axis.

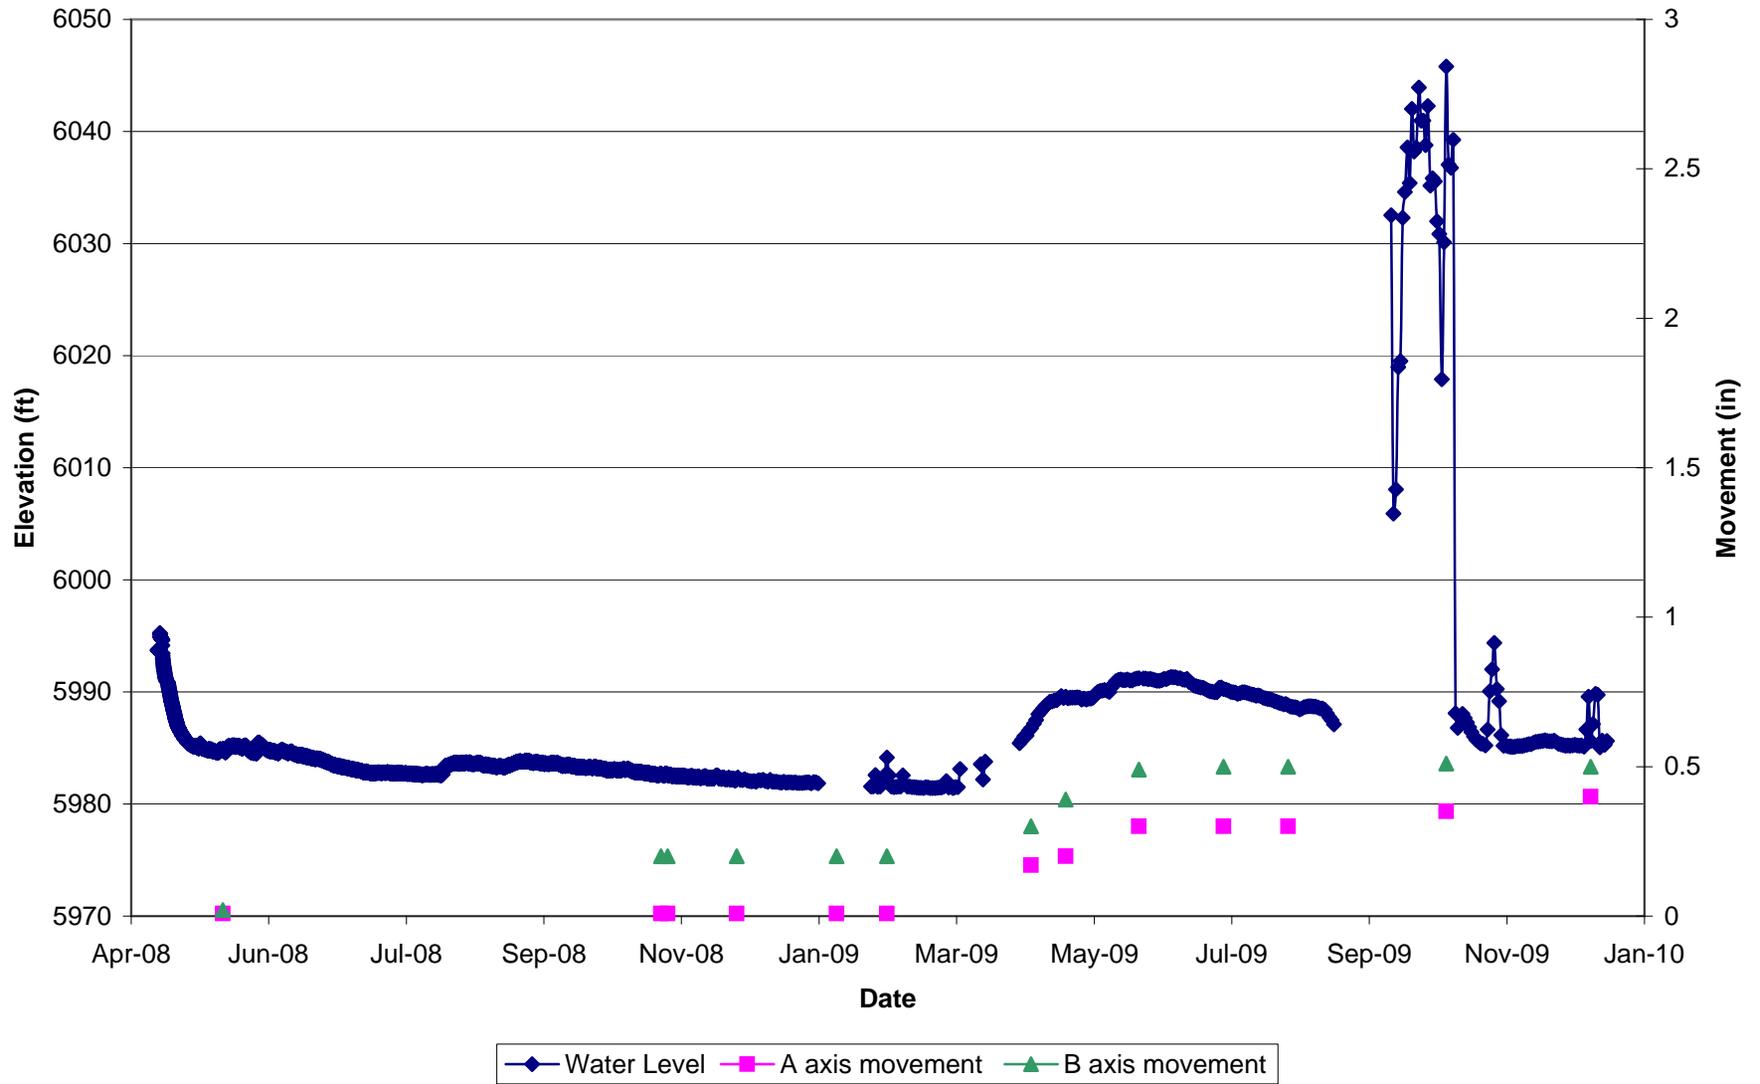
Inclinometer and Piezometer Data: Tt-7

Tt-7. There has been a general trend for an increase in movement along the A- and B- axes. A large movement that occurred along both axes in April, 2009 followed a gap in piezometer data which were eliminated from the graph to improve the clarity of the figure. There was precipitation during this time and it is likely that there was a rise in the water table as a result of the precipitation. The local precipitation data contained in Appendix B also indicates a large increase in precipitation during April 2009. The movement in the A-axis direction increased but then did not continue after June 2009. The movement in the B-axis direction reached a plateau in the summer of 2009, and then increased slightly.
