Appendix A

Annual Inspection Checklist, Maps, and Photographs

Annual Site Inspection 2011 Photos

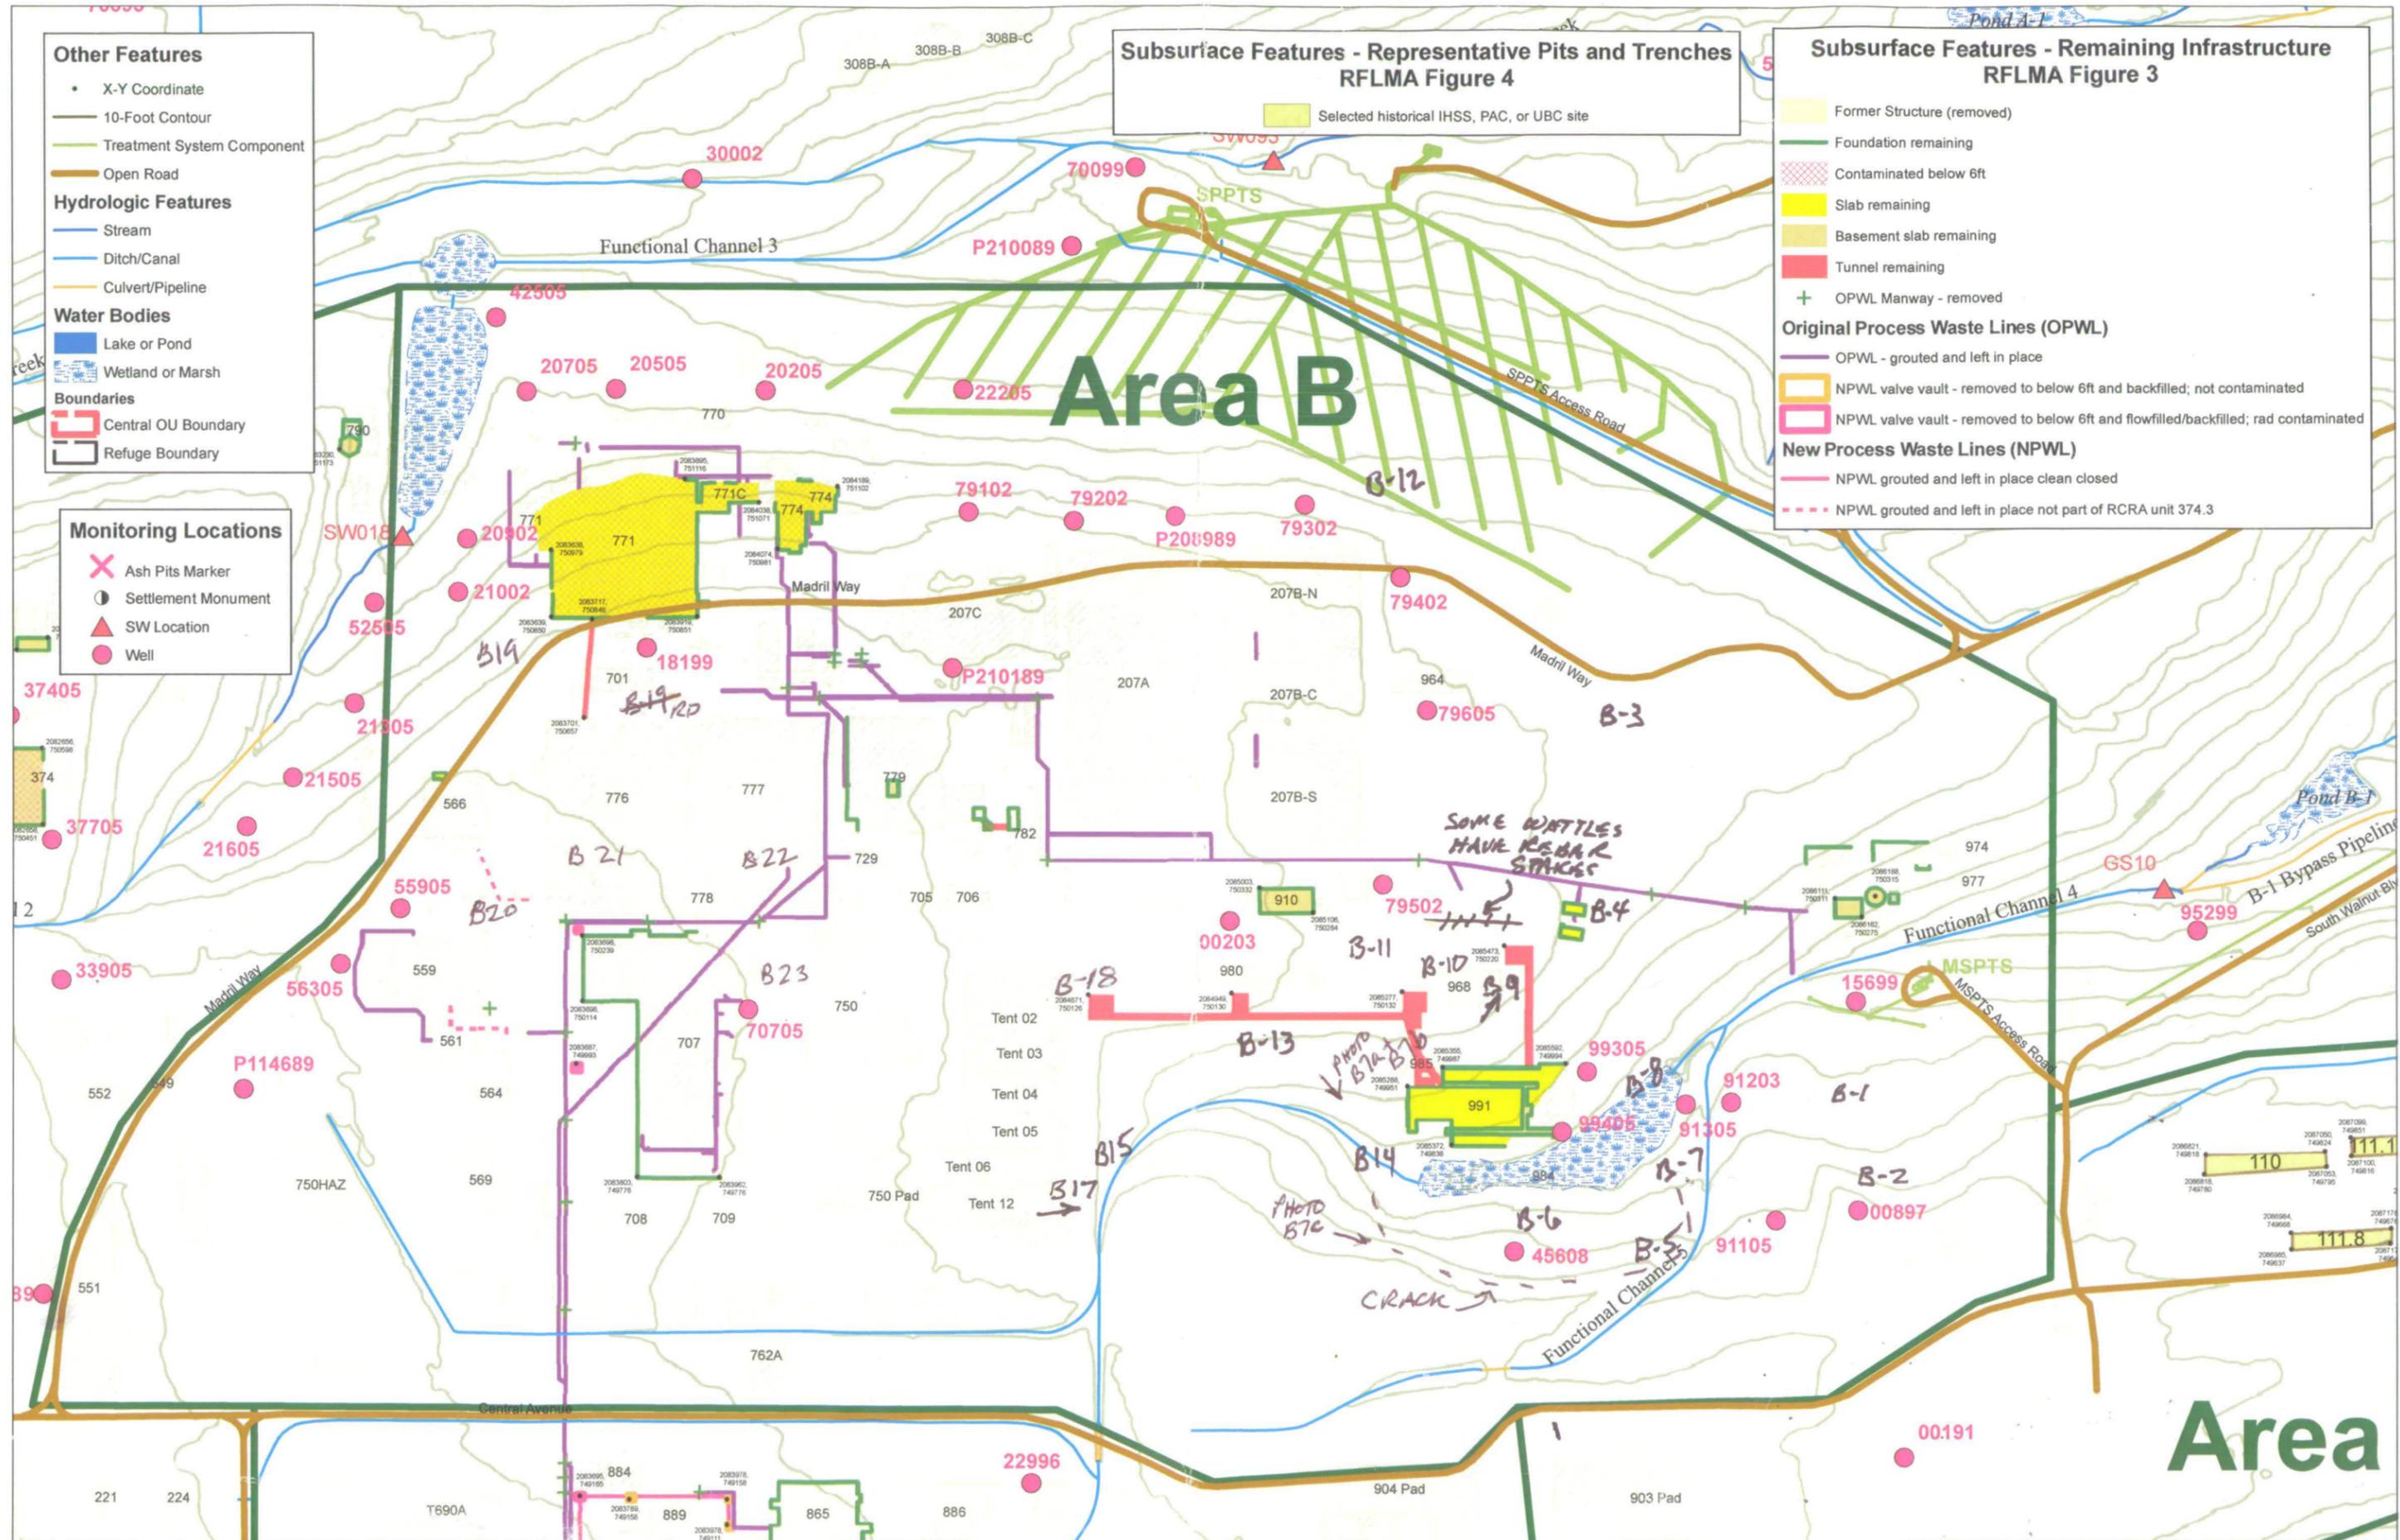
Area B

- B-1 - REBAR/ANCHOR ~ 2' LONG 9800.3 N 6250 E
- B-2 - REBAR/FENCE POST/WIRE - SMALL PILE 9743 N 6180 E
- B-3 ~ 2' DEEP DEPRESSION - ~ 5" DIA. FILLED W/ VEGETATION 0819 N 5467 E
- B-4 - 2 DEPRESSIONS - 1.5' DEEP x 6' DIA.; SMALLER ONE ~ 20" SOUTH 0306 N 5245 E
- 2 FLAGS -
- B-5 - 1.5" PVC ~ 3' LONG PVC 9617 N. 5690 E - INFLECTION POINT OF SLUMP/CRACK
RUNS NORTH TO FLAG B-7
- B-6 - 1/2 REBAR ~ 12" LONG 9694 N. 5575 E
- B-7 NORTH-VENTS OF CRACK GULLY 9718 N 5701 E.

* 3 PHOTOS OF CRACK FROM NORTH B7a, B7b, B7c

SOME WATTLES HAVE REBAR SPACES

PHOTO B7C

CRACK

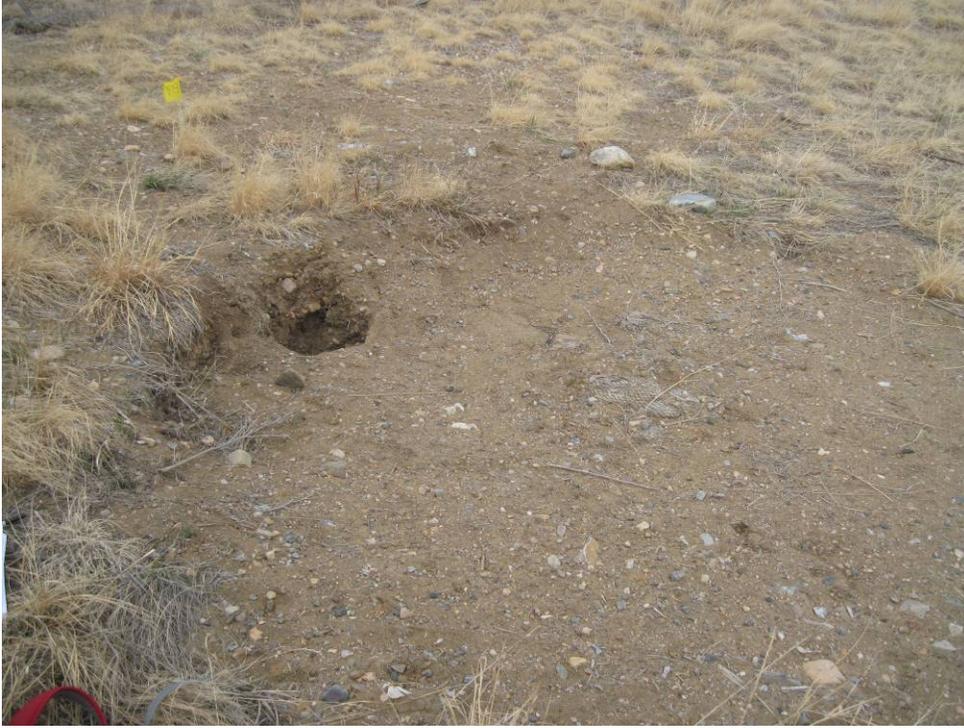
B-8- PVC + WIRE ~ 2' LONG 9893N. 5633E.
 B-9- DEPRESSION - FILLED - NEW HOLE ~ 1' DIA. 2-3" DEEP - BURROW? 75044N. 5509E - PHOTO
 B-10- WIRE ~ 3' LONG. 750776N. 5322E.
 B-11 ~ 3' REBAR - NYLON PLASTIC JUST SOUTH 10198N. 5240E
 B-12 CABLE ANCHOR ~ 1' HIGH 1123N. 5044E.
 B-13 ANCHOR ~ 12" HIGH 0078N. 5005E
 WEST END 9655N 5273E OF CRACK MID SOUTH OF CRACK 019536N 5465E
 ~ 2 FOOT DISPLACEMENT

B-9 – Depression that was filled in 2010; small hole on north side

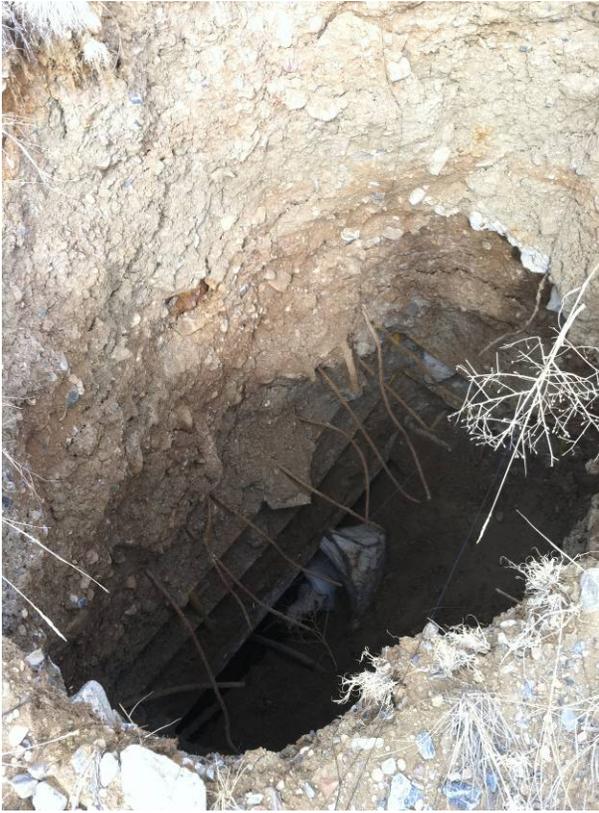
C-1 - wire - 9674 N 3412 E
 C-2: rebar pile 8193 N 3719 E
 C-3: metal + concrete 8068 N 3798 E
 C-4: slump 7896 N 3919 E
 C-5: slump 7954 N 4100 E
 C6: flagpole 8002 N 4114 E
 C7: rubber + metal 8223 N 3944 E
 * C8: BIG HOLE 8271 N 3795 E 6W x 10L x 2SD⁺

C-8 – Hole on southwest side of former B-881
