Appendix B

Landfill Inspection Forms and Survey Data

ORIGINAL LANDFILL – MONITORING AND MAINTENANCE PLAN INSPECTION FORM

Original Landfill January 2011 Monthly Inspection – Attachment 1

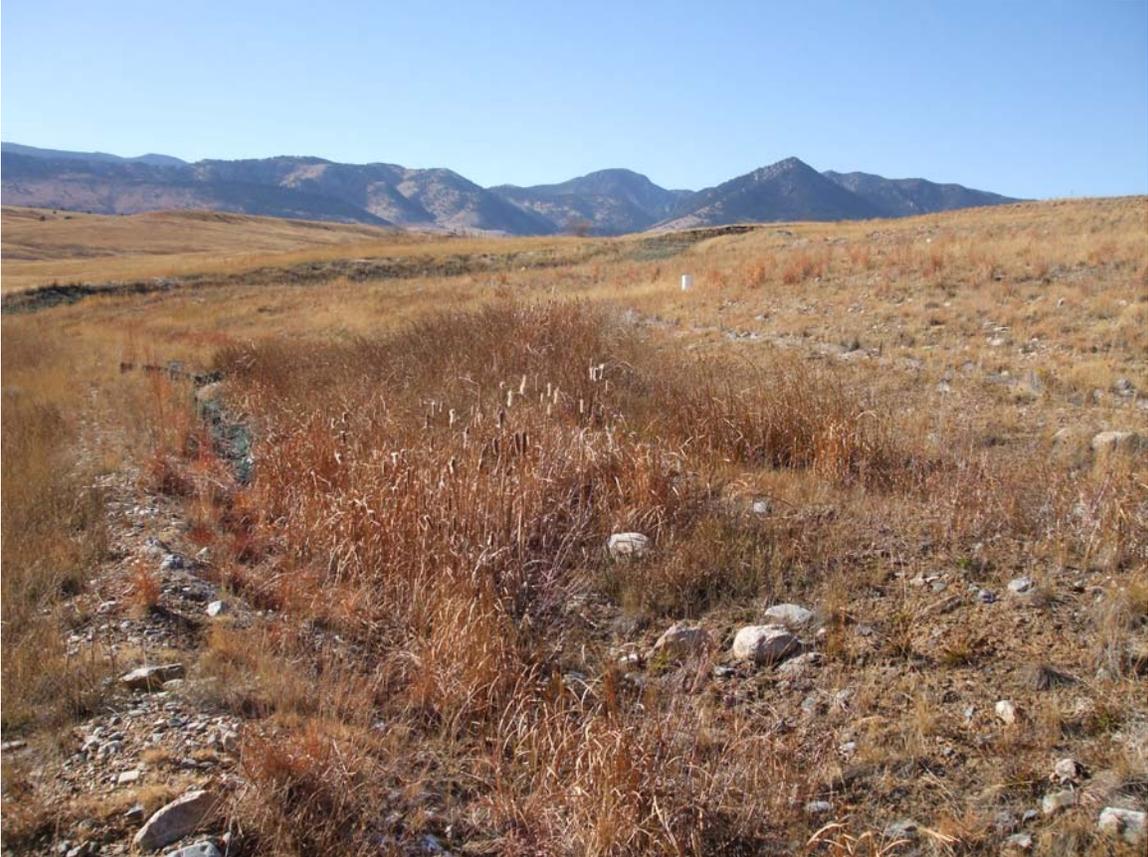
Seep 4 and 5 Area

The Seep 1 area was dry as usual. The Seep 2 and 3 areas were also dry. The Seep 4 and 5 areas had some surface expression. The Seep 6 area has three locations located above berm #7 that were all dry. The Seep 7 area is still dry. There is still wetland vegetation present in the upper and lower Seep 7 locations. Surface flow at Seep 8 has slowed significantly to approximately 1-2 gpm. Pictures of the main seep locations are included below.

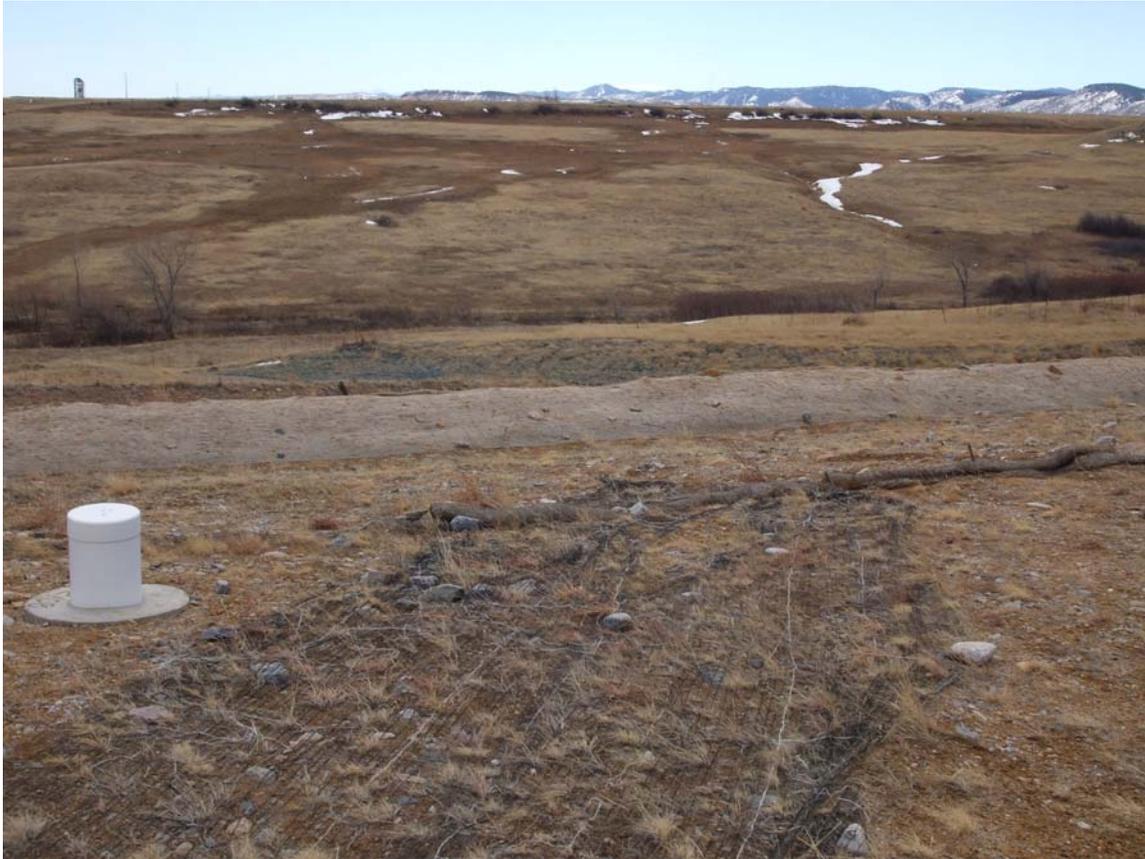
Berm 1 and 7 continue to look good with no new slumping or cracking present.

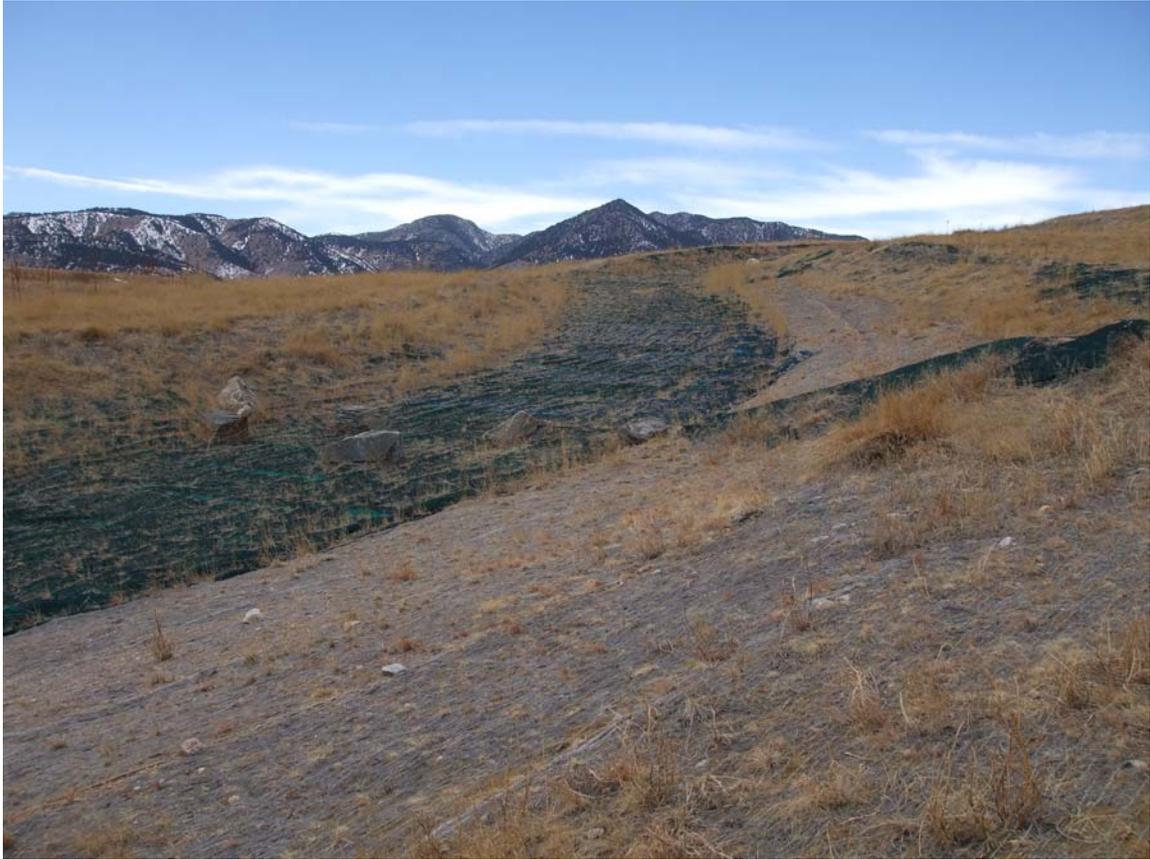
West Perimeter Channel

The Western Perimeter Channel is still in good shape. The vegetation is still dormant, but will be coming back in the next few months.

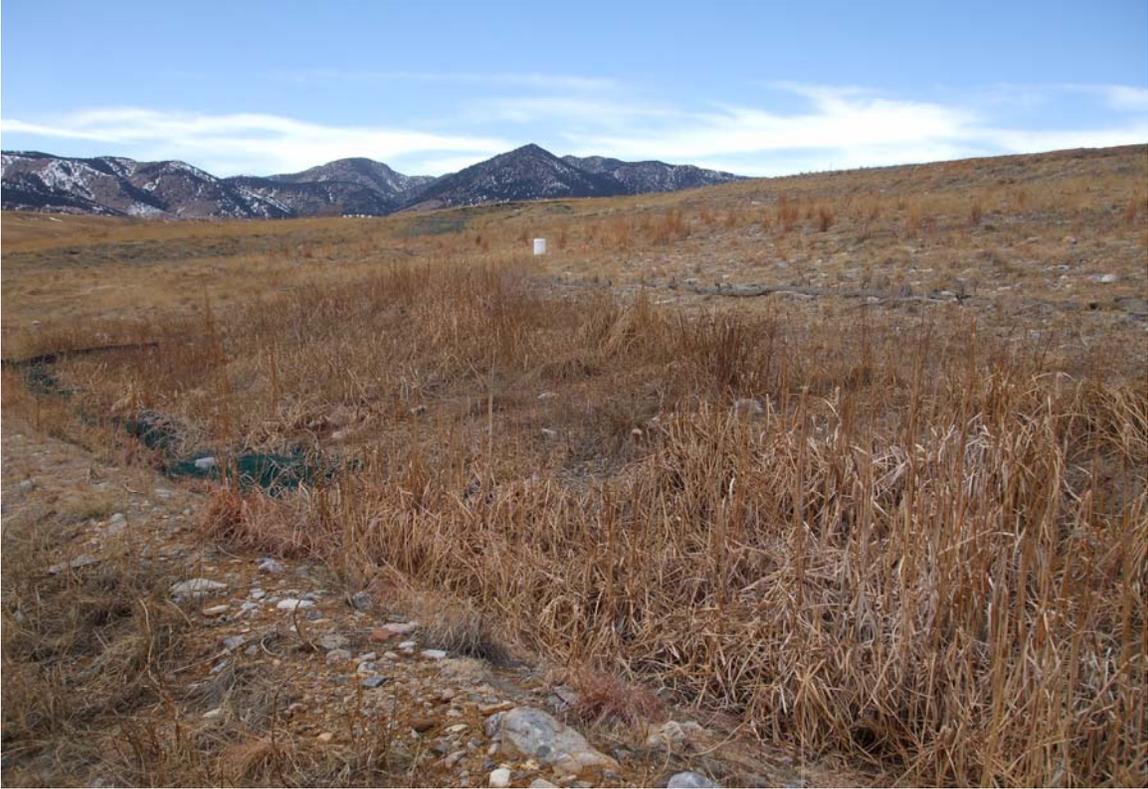
Seep 4 and 5 Area

The Seep 1 area was dry as usual. The Seep 2 and 3 areas were also dry. The Seep 4 and 5 areas had very little surface expression and are as dry as have been observed over the last several years. The Seep 6 area has three locations located above berm #7 that were all dry. The Seep7 area is still dry. Surface flow at Seep 8 continues to flow at a significantly reduced rate of approximately 1-2 gpm. Pictures of the main seep locations are included below.

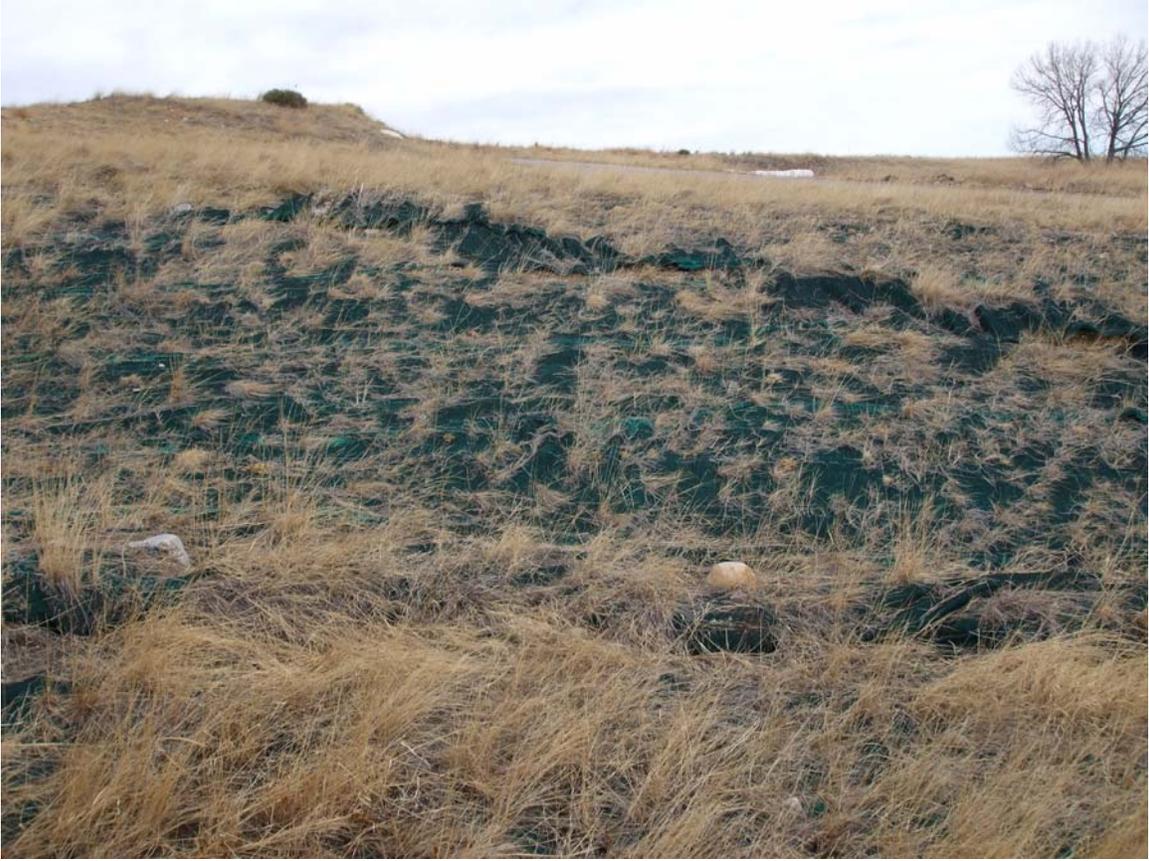
EPC Slump Area

The slump that was observed on the eastern slope of the EPC towards the top of the channel continues to slowly develop. The location of the slump has been recorded with a GPS unit and data is being updated on a quarterly basis. There is no vertical displacement being observed at this time. We will continue to monitor the slumping area for any changes during routine and non-routine inspections of the OLF.

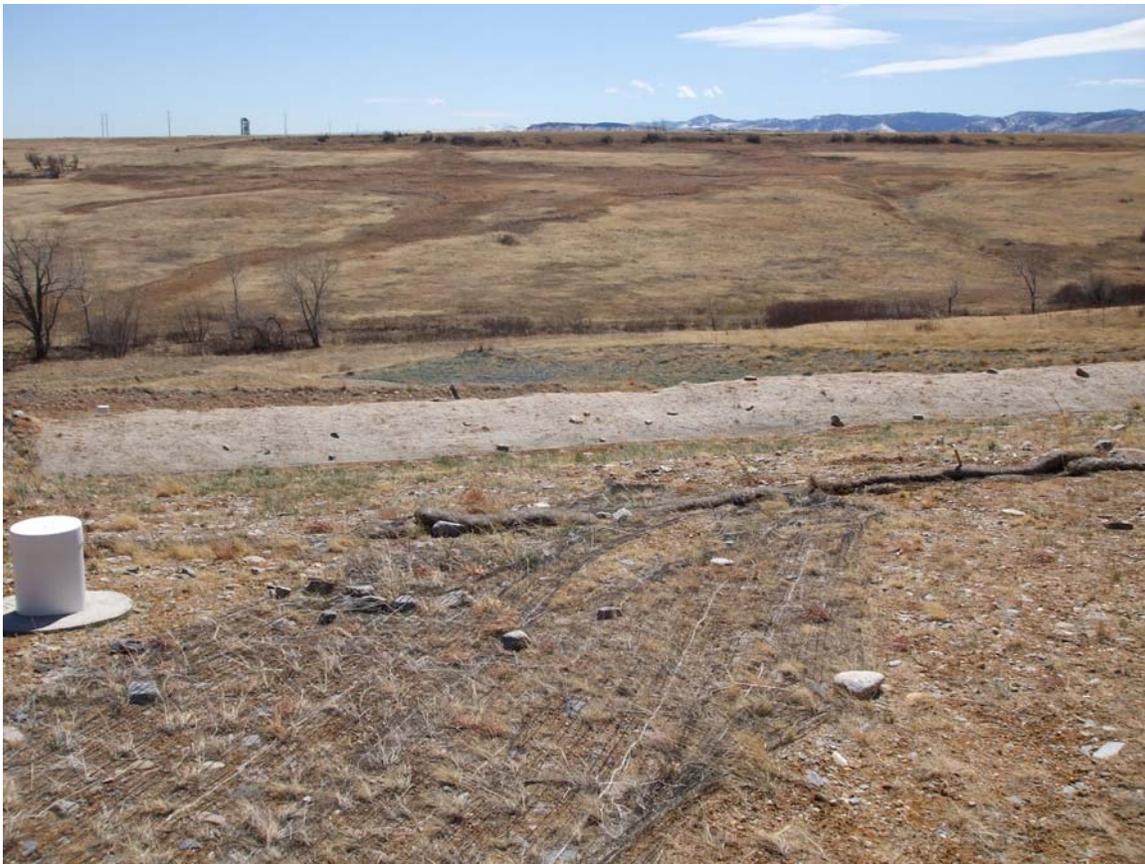
Berm 1 and 7 continue to look good with no new slumping or cracking present.

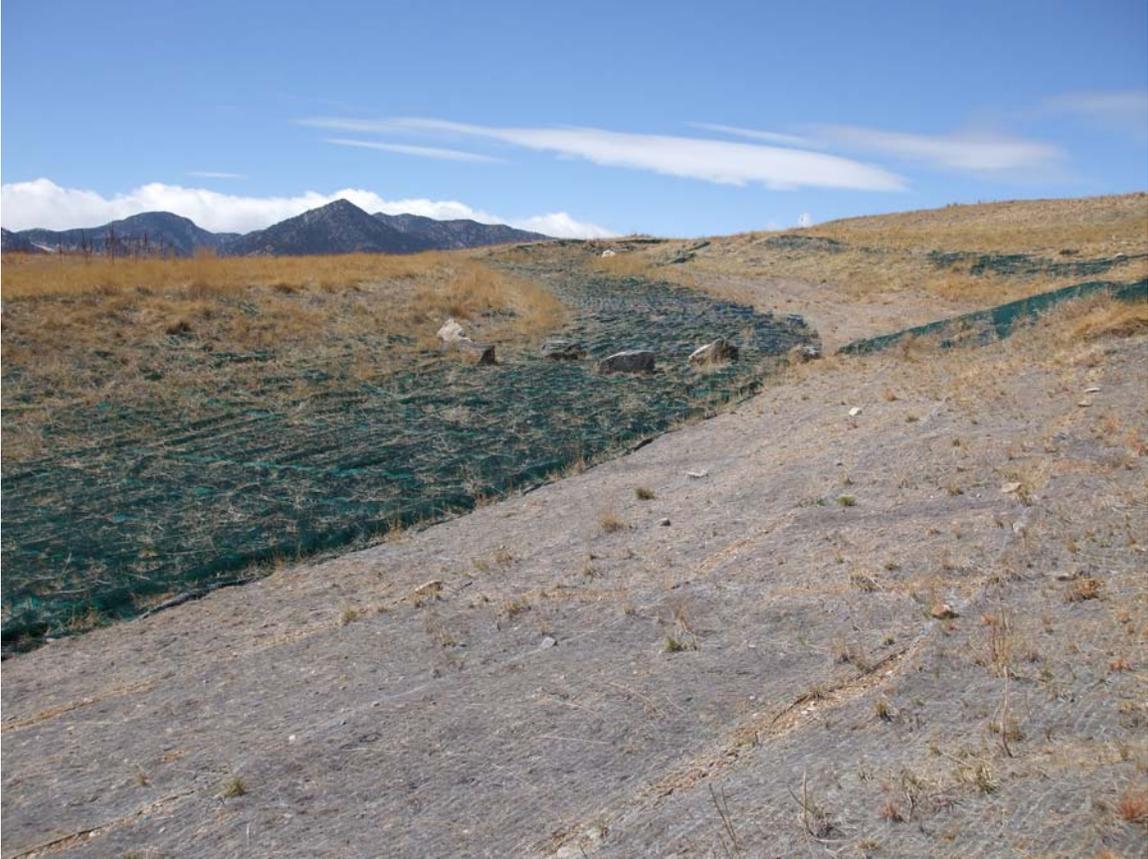
West Perimeter Channel

The Western Perimeter Channel is still in good shape. The vegetation is just starting to grow again.

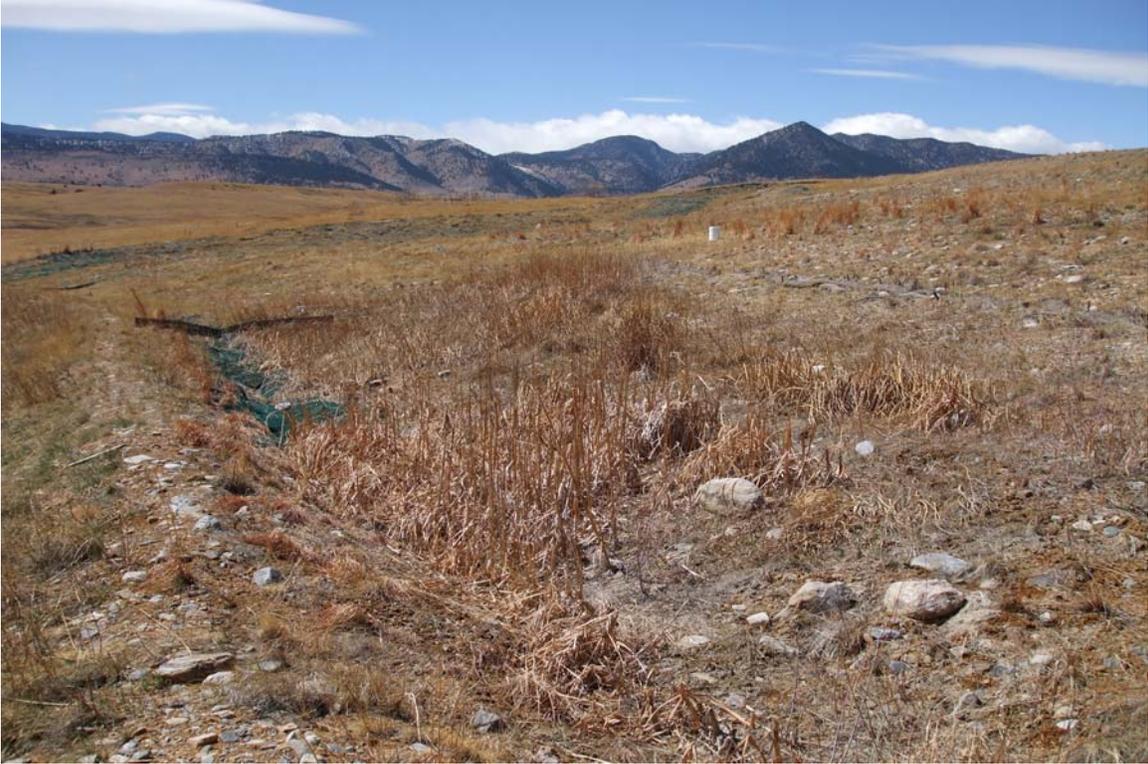
Seep 4 and 5 Area

The Seep 1 area was dry as usual. The Seep 2 and 3 areas were also dry. The Seep 4 and 5 areas had very little surface expression. The Seep 6 area has three locations located above berm #7 that were all dry. The Seep7 area is still dry. Surface flow at Seep 8 continues to flow at a reduced rate of approximately 1-2 gpm. Pictures of the main seep locations are included below.

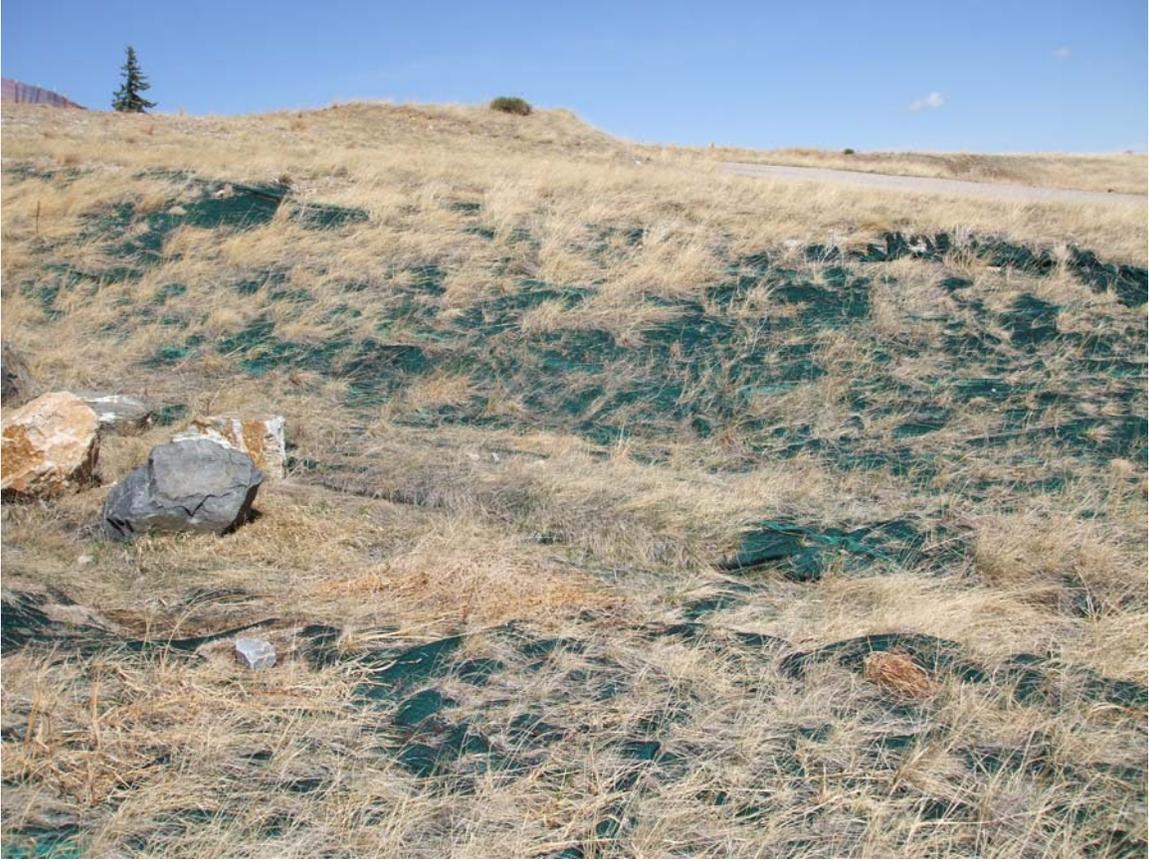
EPC Slump Area

The slump that was observed on the eastern slope of the EPC towards the top of the channel appears to be unchanged. The location of the slump has been recorded with a GPS unit and data is being updated on a quarterly basis. We will also be installing stakes delineating the perimeter of the slumping area to help evaluate any future movement. There is no vertical displacement being observed at this time. We will continue to monitor the slumping area for any changes during routine and non-routine inspections of the OLF.
