***Report of Steps Taken Regarding Monitoring Results at Surface Water  
Point of Evaluation (POE) SW027 and Contact Record 2010-06***

# **Report of Steps Taken Regarding Monitoring Results at Surface Water Point of Evaluation (POE) SW027**

## **August 31, 2010**

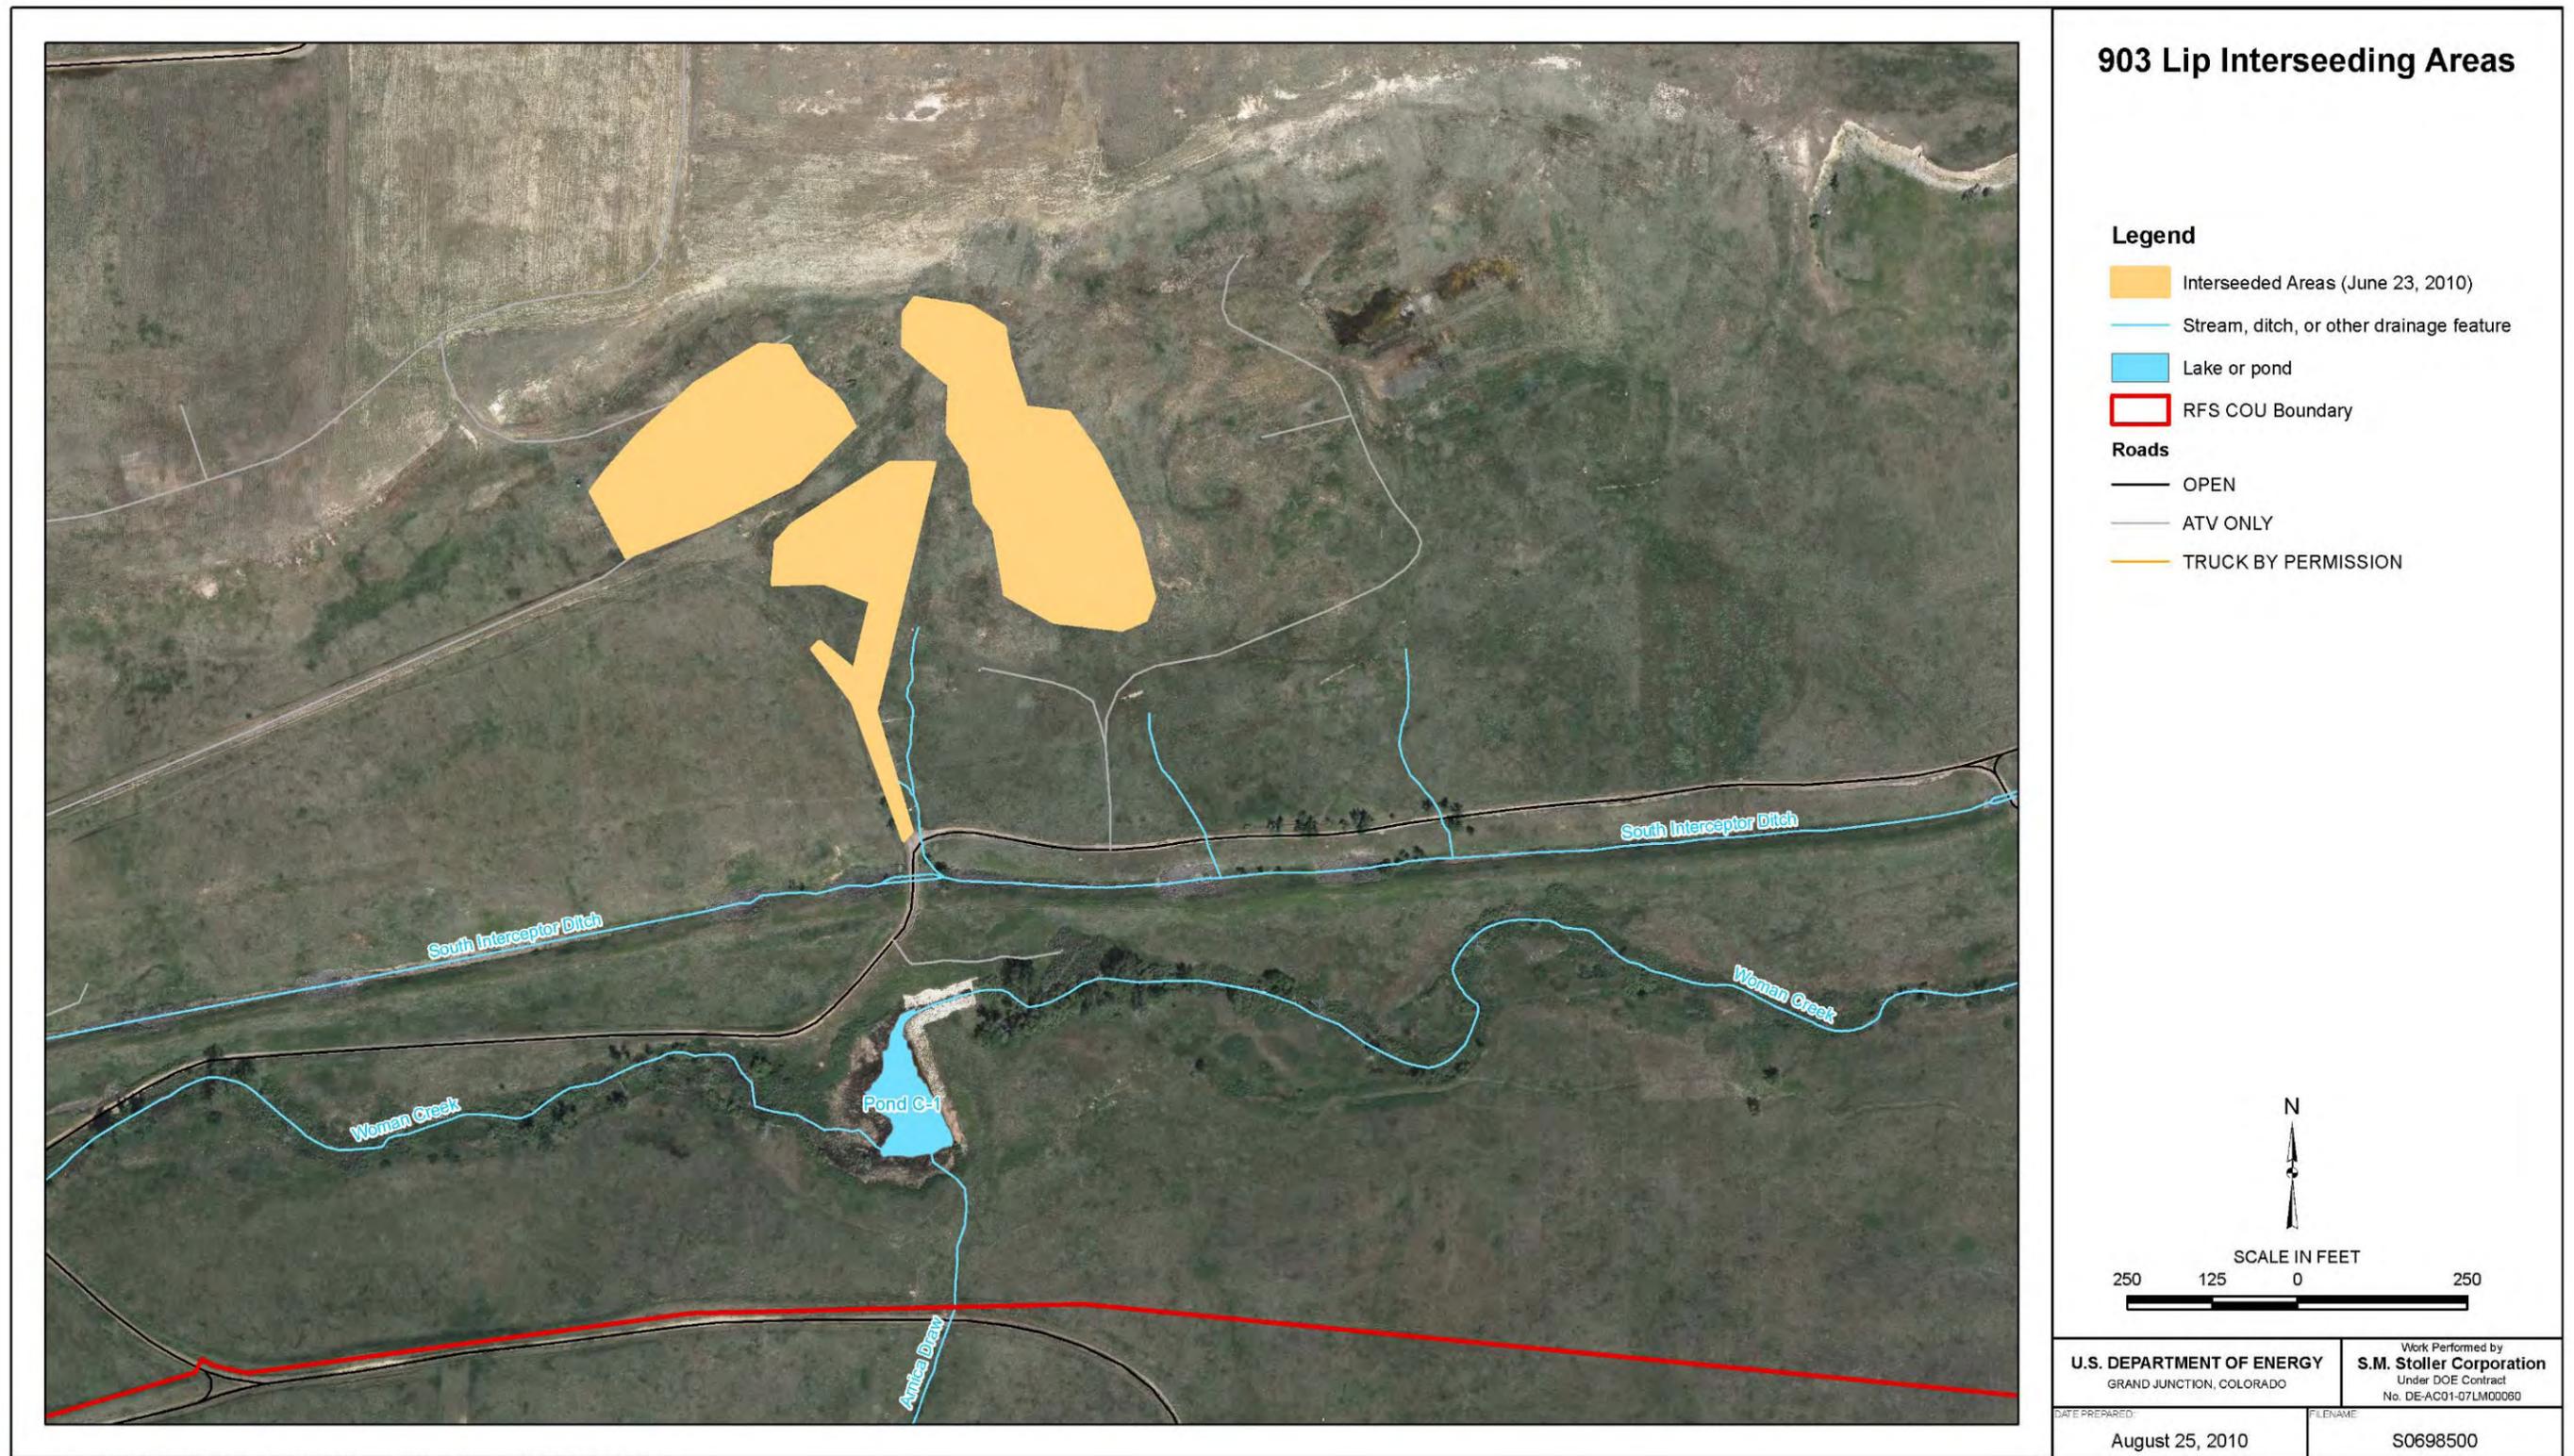
Figure 3. Interseeding Areas

Steps to improve vegetation cover will take time to be effective. Implementation of these steps began on June 23, 2010, when several areas were interseeded, as shown on Figure 3. Figure 4 shows potential locations for additional wattles.

- Install wattles as shown on Figure 3.

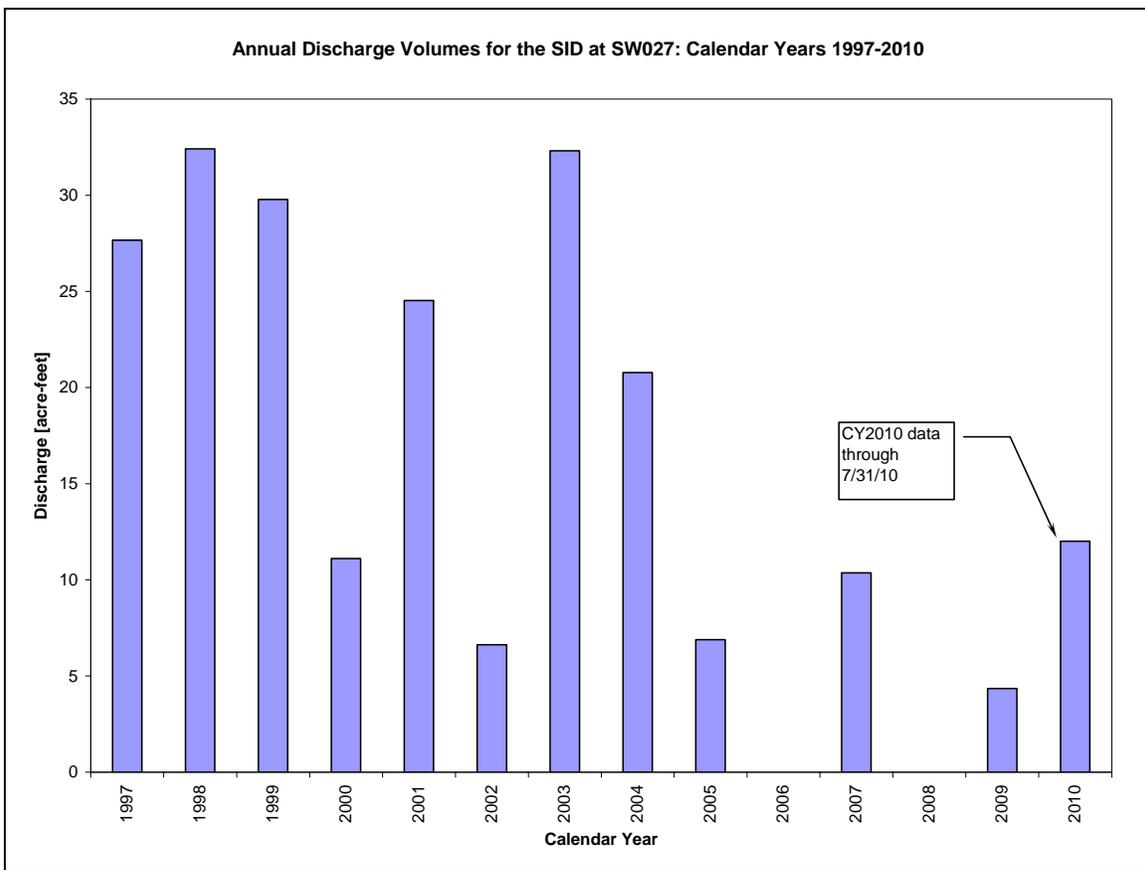
Figure 7. Flows at SW027

Figure 7 shows discharge volumes at SW027, and Figure 8 shows 12-month rolling average results at SW027. While the recent SW027 results indicate that the RFLMA standard for Pu will be exceeded when the April 2010, 12-month rolling average can be calculated, these results are within historical variability and do not indicate a previously unknown source or transport mechanism.

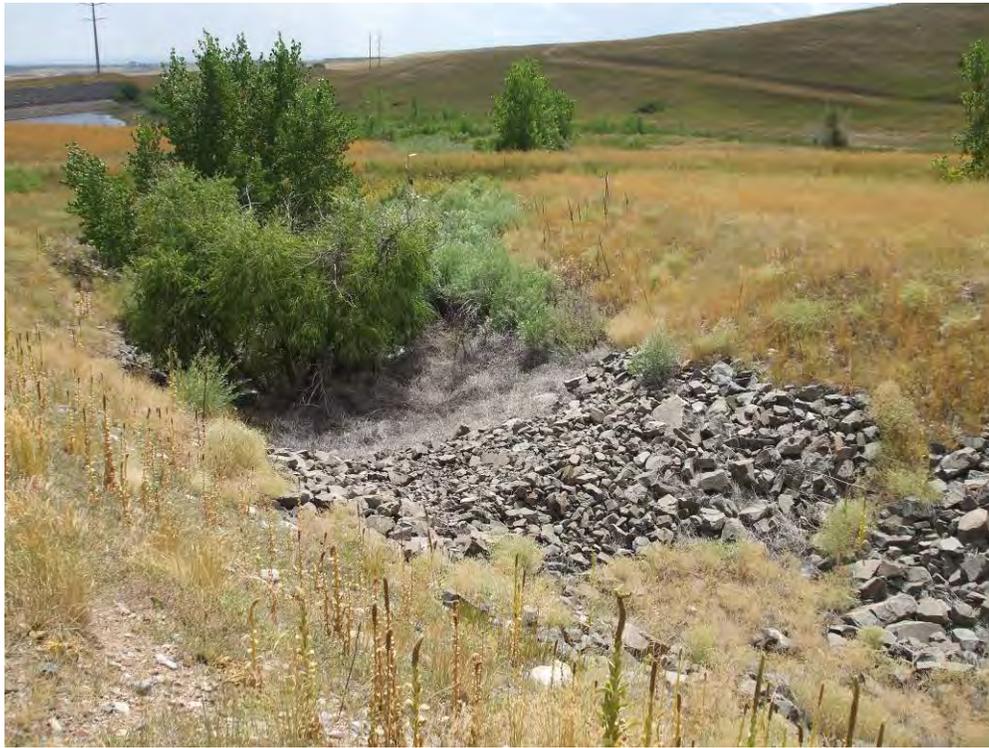
Much of the litter and the riprap, which has litter in the spaces between the rocks, appear to form natural erosion matting. Site personnel are evaluating where additional erosion controls, such as reseeded or installation of permanent erosion matting, might be used for localized areas in the SID and are evaluating the approach to installing these items, where recommended.

*Figure 9. SID Photopoint Location 1—Riprap and Vegetation Litter*

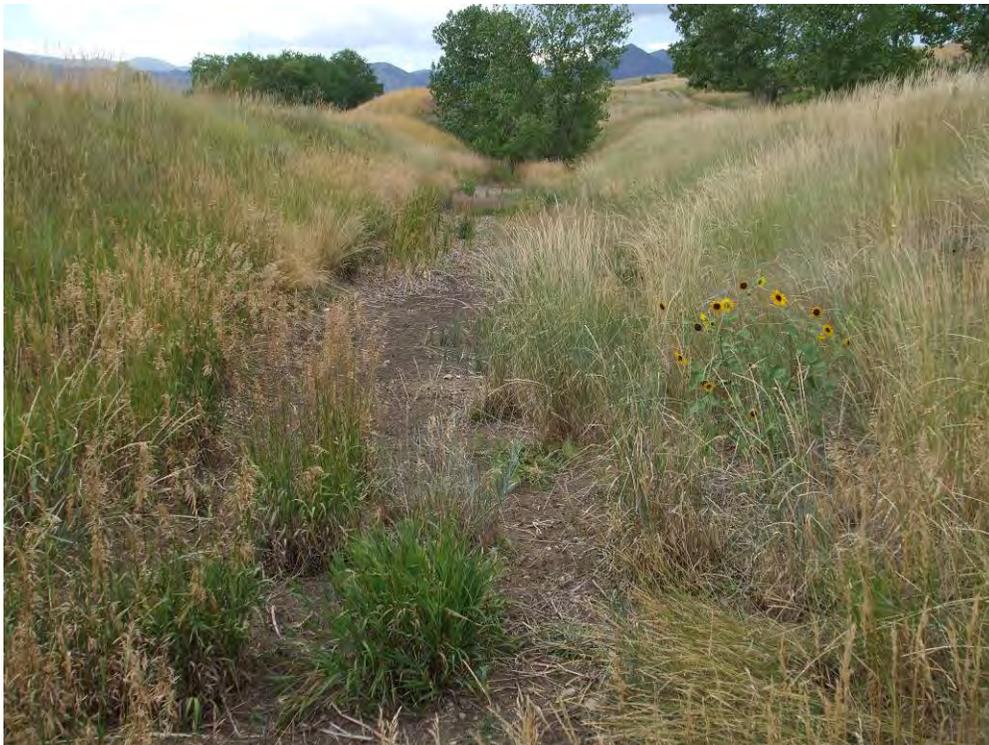
*Figure 10. SID Photopoint Location 6—Minimal Cover in Channel*

- Install erosion matting and interseeding in localized areas where vegetation cover is sparse.
- Reseed in localized areas in the SID where wetland vegetation no longer thrives.
- Evaluate placement of erosion matting in localized areas of the SID and install any recommended matting when conditions are appropriate (likely in late winter or early spring 2011).

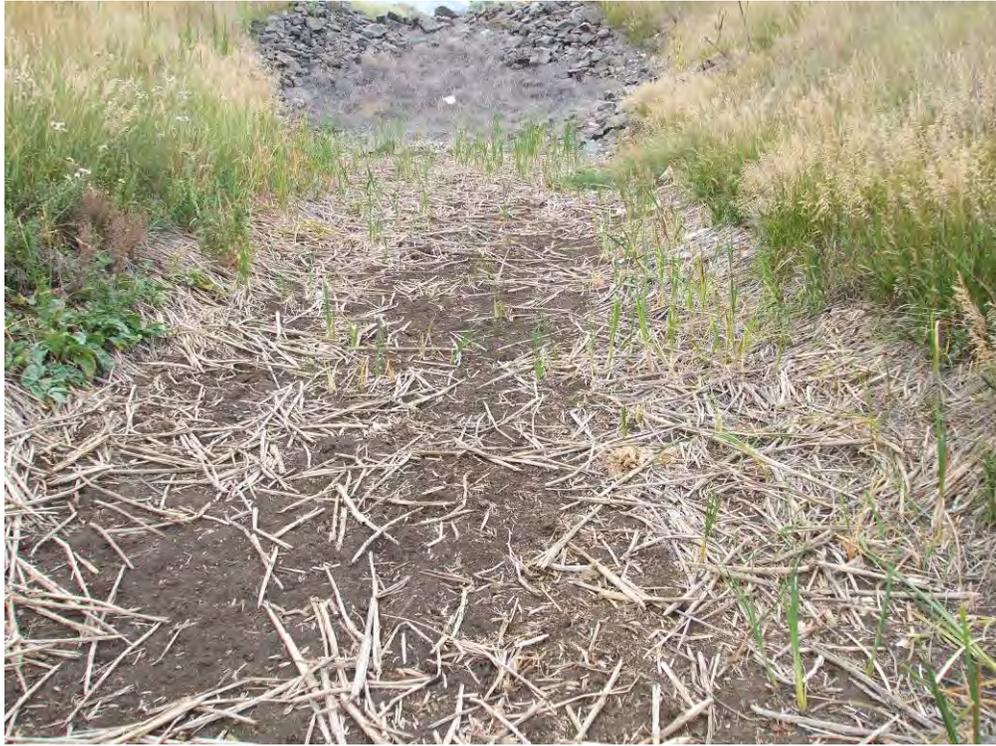
The generally reduced flow of water in the SID relative to pre-closure conditions was apparent in areas that previously supported wetland-type vegetation. The wetland plants are no longer thriving, and dead stands and litter now occupy these locations. These areas will be reseeded at the appropriate times with vegetation more suitable to the drier conditions.

*Figure 11. SID Photopoint Location 15—Dead Wetland Vegetation Litter*

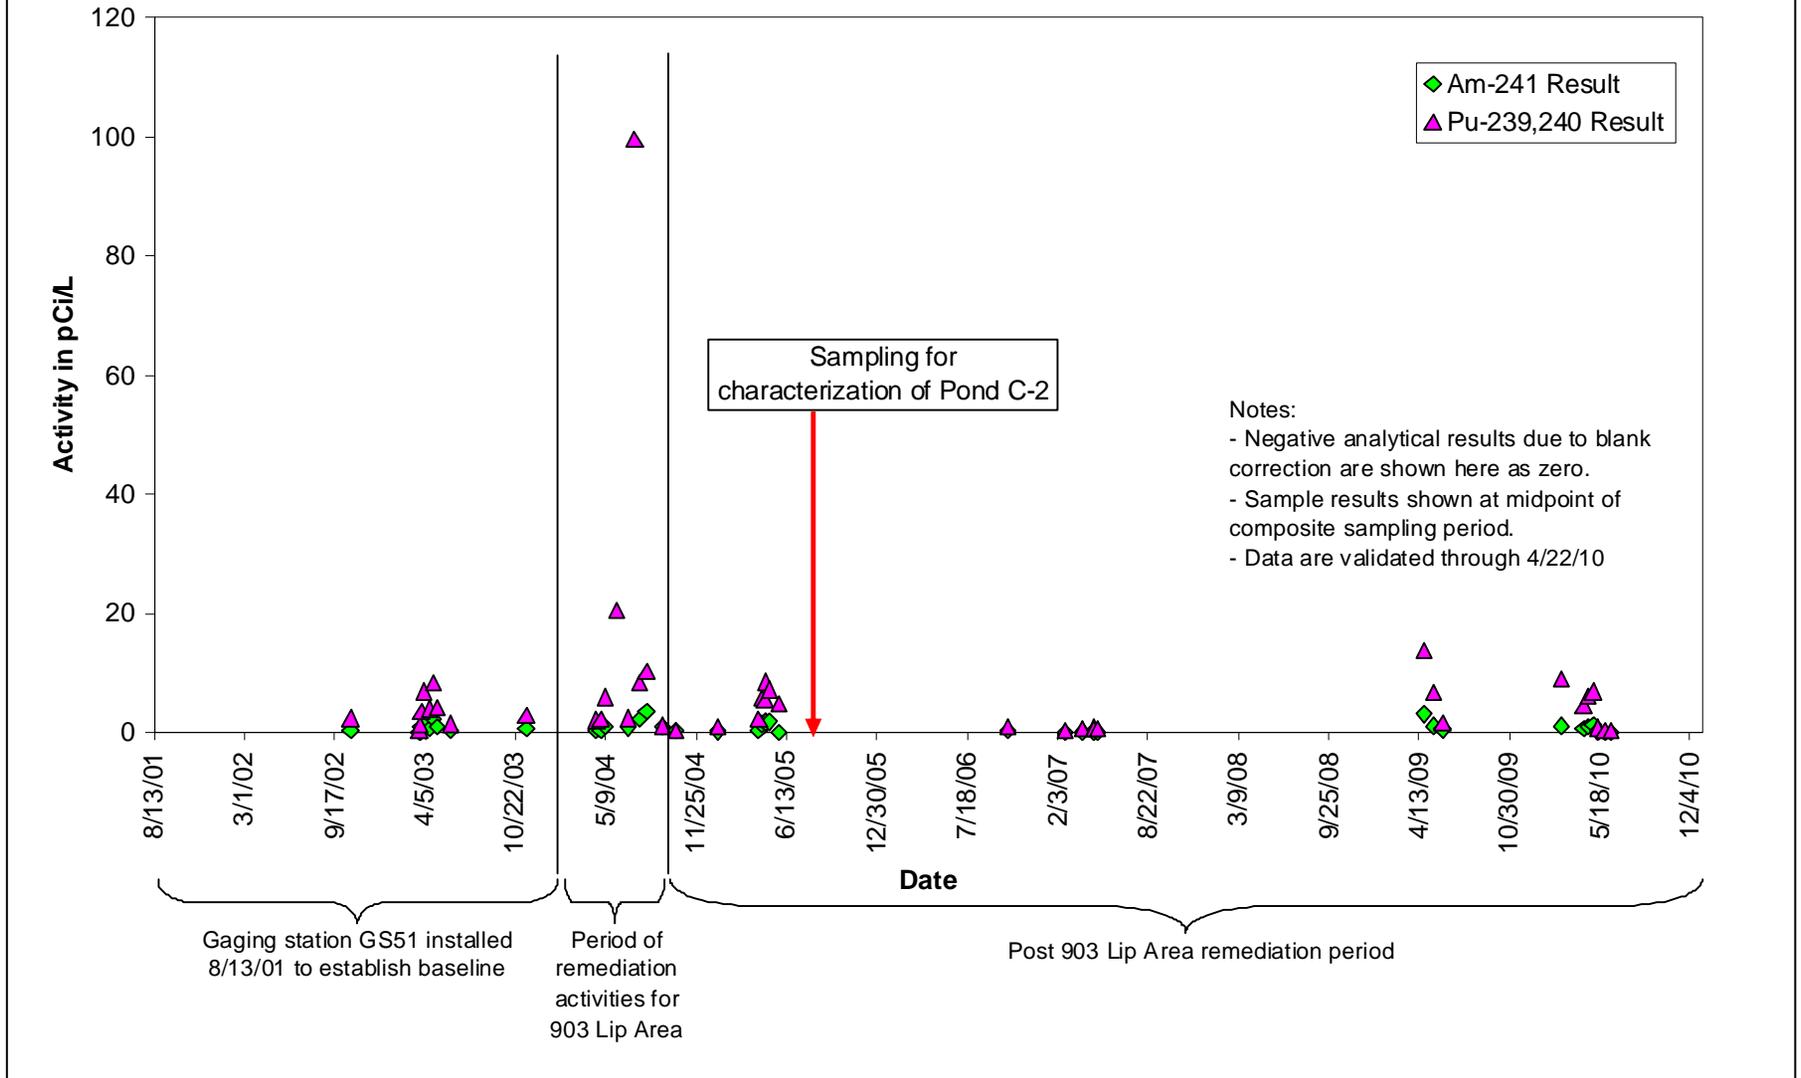
Figure 12. GS51 Data

The review does not indicate any unexpected source of Pu at GS51, and no upward trends are evident. Figures 9 and 10 provide the graphs of data reviewed.
