Appendix A

Landfill Inspection Forms and Survey Data

Original Landfill April 2011 Monthly Inspection – Attachment 1

Original Landfill May 2011 Monthly Inspection – Attachment 1

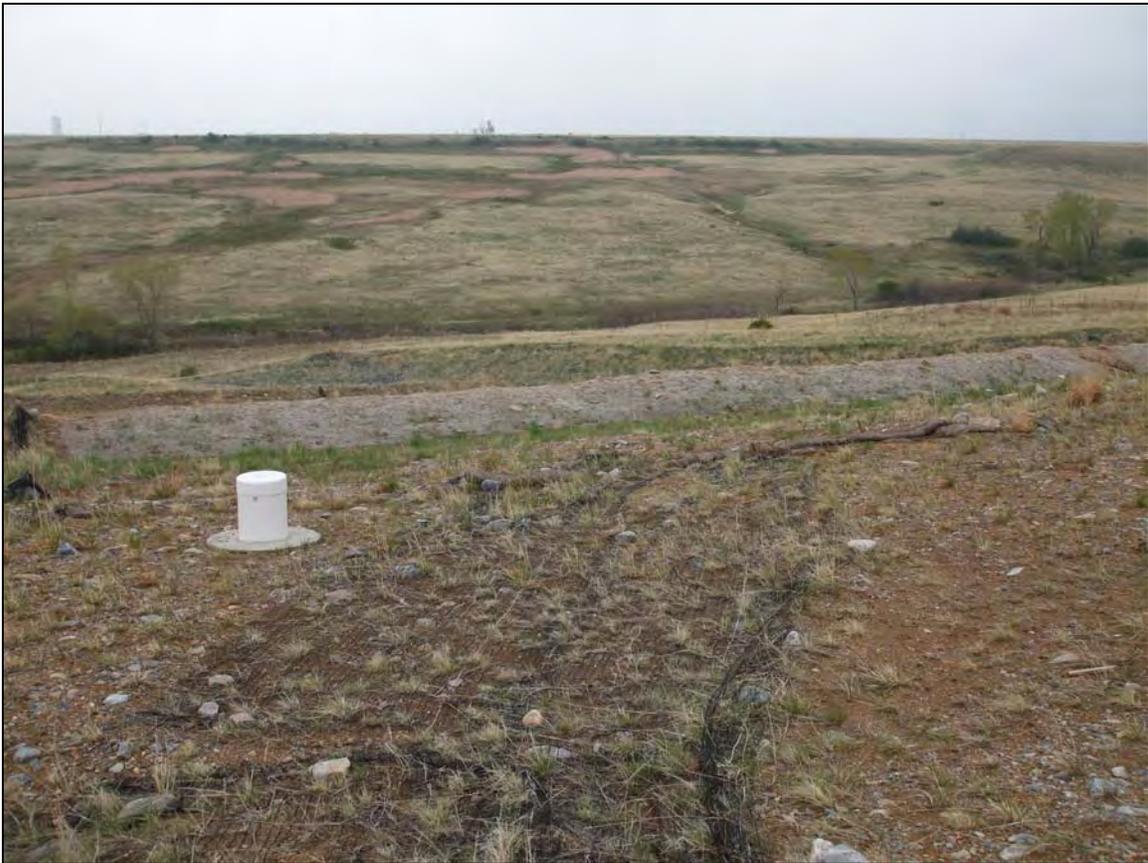
Berm 1 and 7 continue to look good with no new slumping or cracking present.

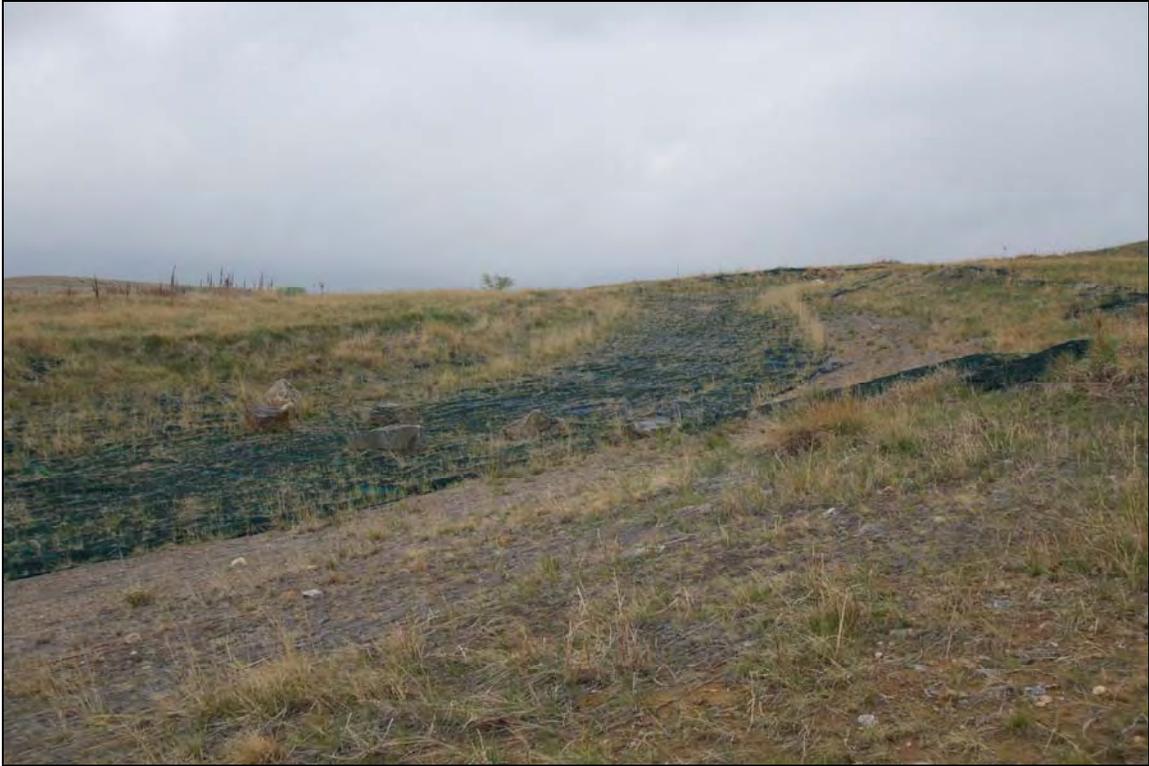
West Perimeter Channel

The Western Perimeter Channel is still in good shape. The vegetation is re-establishing

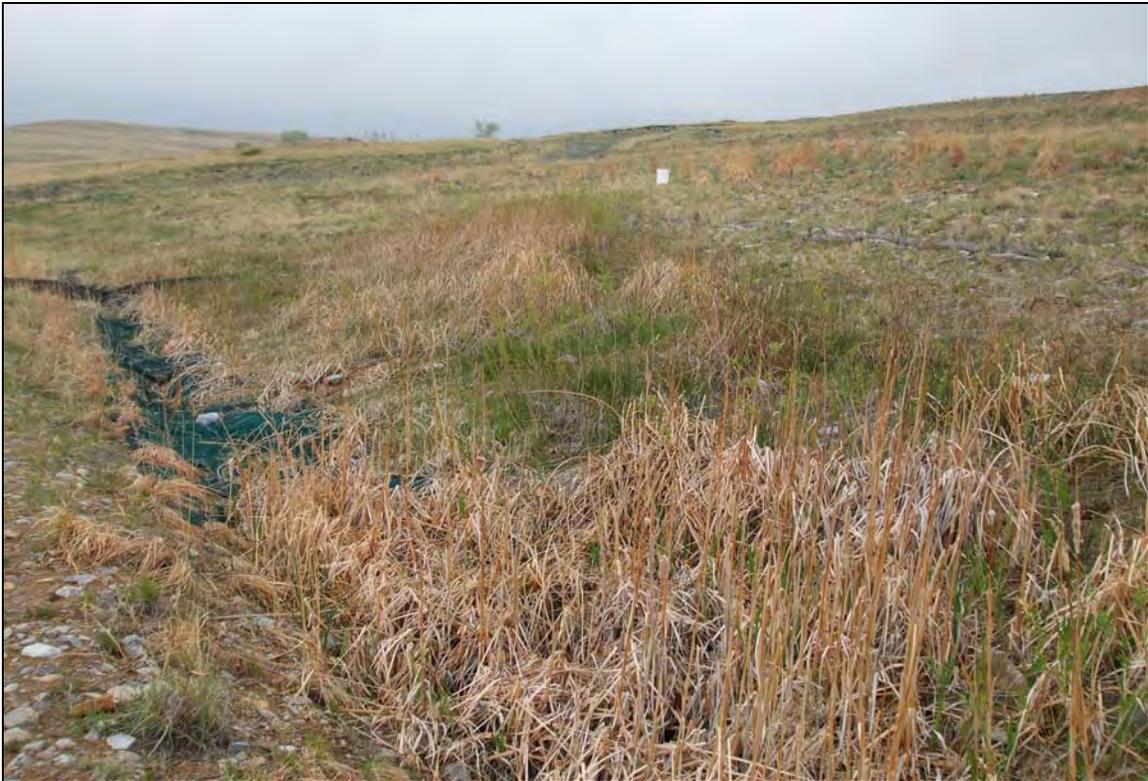
Seep 4 and 5 Area

The Seep 1 area was dry as usual. The Seep 2 and 3 areas were wet, but had no surface expression. The Seep 4 and 5 areas had some surface expression, but it was draining through the Berm 3 drain as designed. The Seep 6 area has three locations located above berm #7 that showed some wetness, but had no surface expression. The soil in the Seep7 area is moist, but there was no surface expression. Surface flow at Seep 8 continues to flow at a rate of approximately 2-3 gpm. Pictures of the main seep locations are included below.

As seen in the pictures, wetland vegetation is slowly re-establishing itself in most of the seep locations.

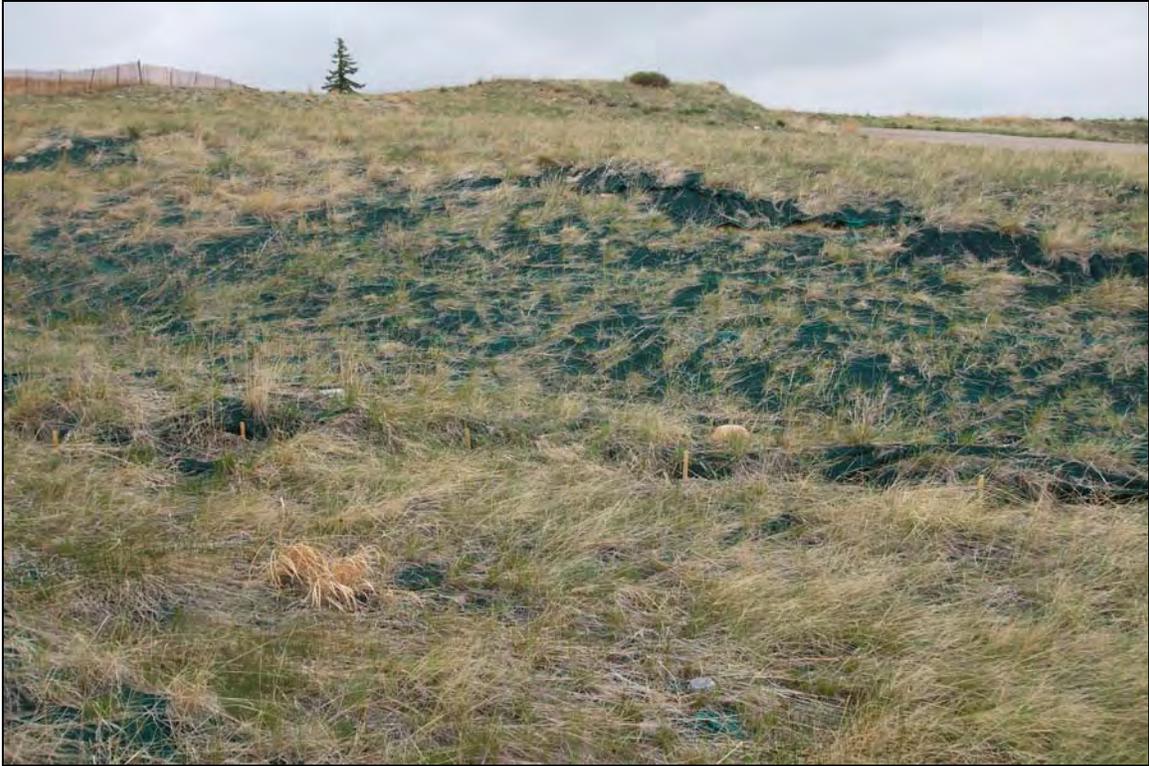
EPC Slump Area

The slump that was observed on the eastern slope of the EPC towards the top of the channel appears to be unchanged. The location of the slump has been recorded with a GPS unit and data is being updated on a quarterly basis. Wooden stakes were installed around the perimeter of the slumping area to help evaluate any future movement. There is no vertical displacement being observed at this time. We will continue to monitor the slumping area for any changes during routine and non-routine inspections of the OLF.

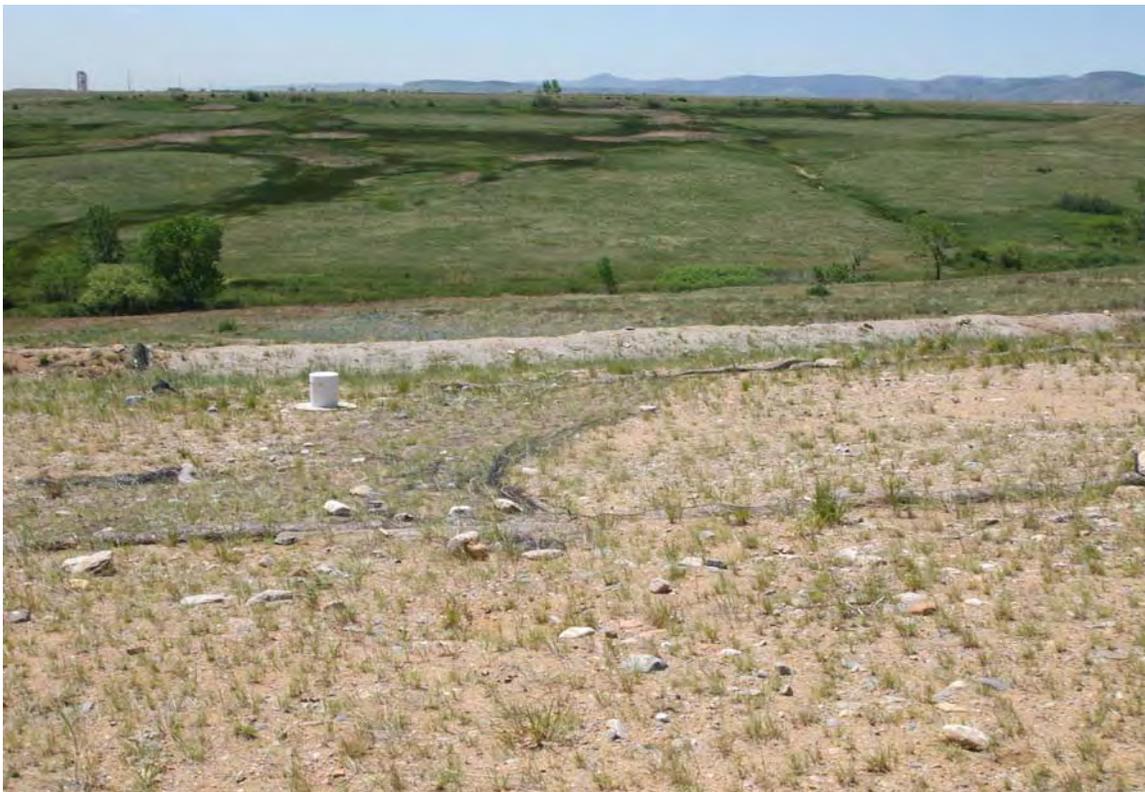
Berm 1 and 7 continue to look good with no new slumping or cracking present.

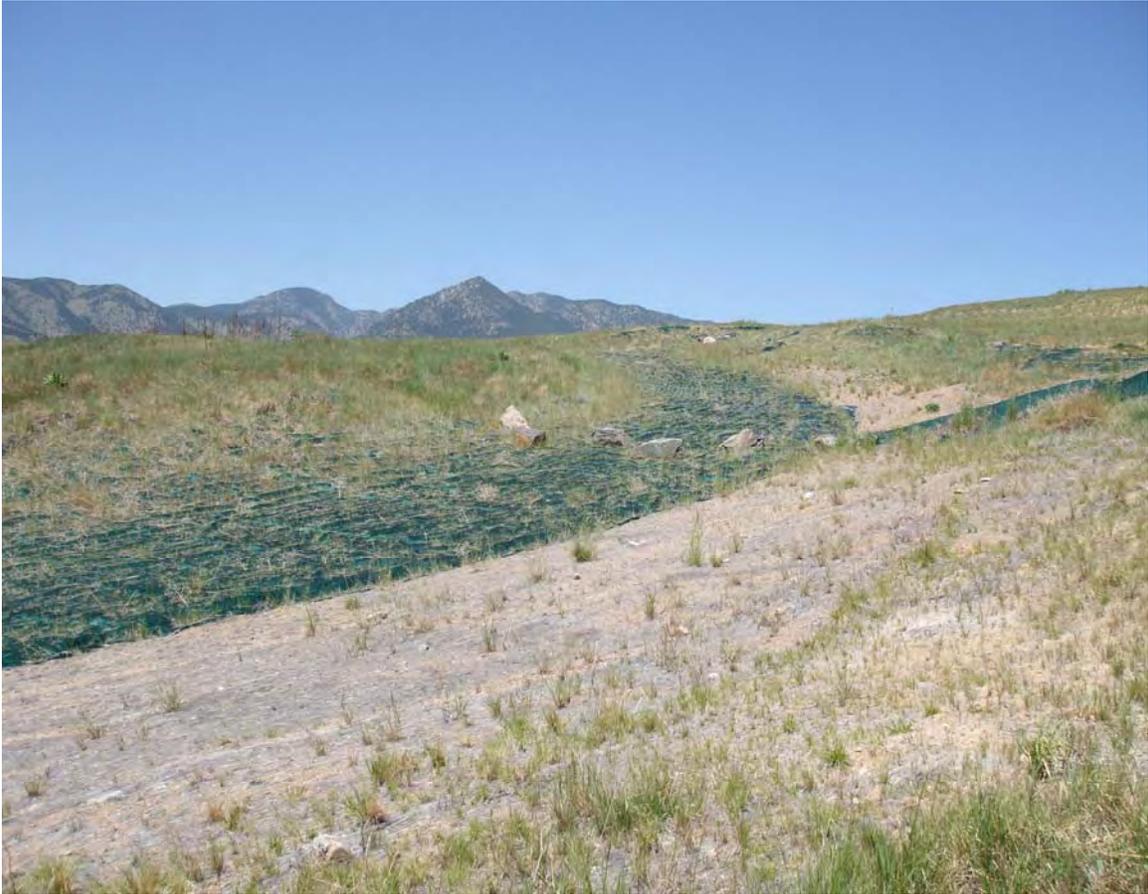
West Perimeter Channel

The Western Perimeter Channel is still in good shape. The vegetation is re-establishing itself nicely following the recent precipitation events.

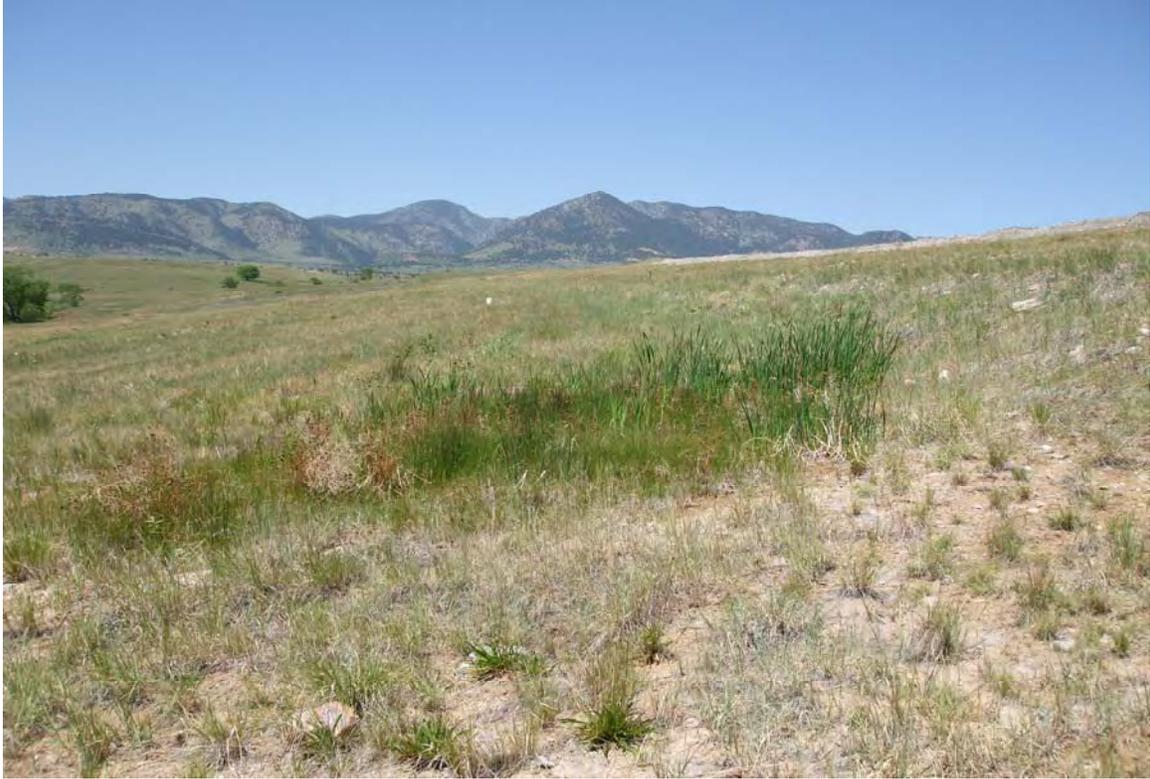
Seep 2 and 3 Area

The Seep 1 area was dry as usual. The Seep 2 and 3 areas were wet and showed some surface expression. The Seep 4 and 5 areas had some surface expression, but it was draining through the berm 3 drain as designed. The Seep 6 area has three locations located above berm #7 that were saturated. The Seep7 area was saturated and had a surface flow of ~ 1 gpm that was draining down berms #3 and #7. Surface flow at Seep 8 continues to flow at a rate of approximately 2-3 gpm. Pictures of the main seep locations are included below. As can be seen in the pictures, wetland vegetation is prominent in all of the active seep locations.

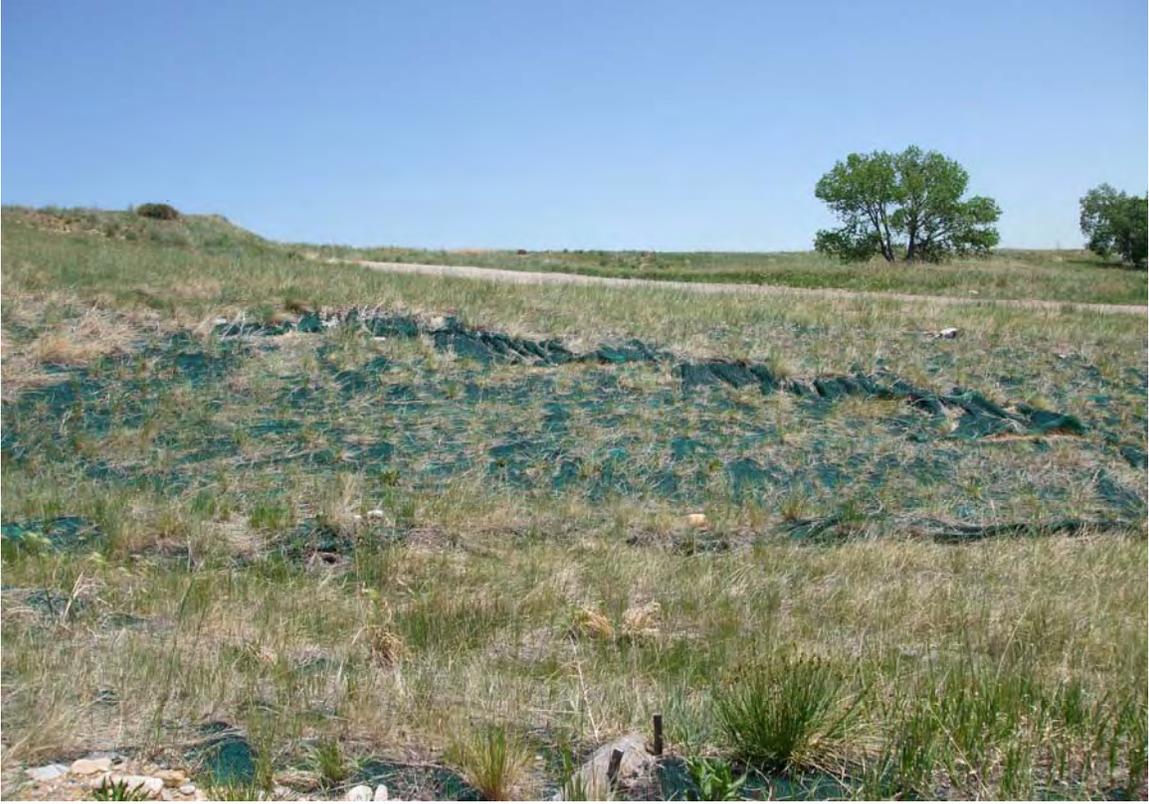
EPC Slump Area

The slump that was observed on the eastern slope of the EPC towards the top of the channel remains unchanged. The wooden stakes that were installed around the perimeter of the slumping area haven't moved. There is no vertical displacement being observed at this time. We will continue to monitor the slumping area for any changes during routine and non-routine inspections of the OLF.

*There is a small slumping area on the east side of the EPC.
See Attachment 1 for details.*

No maintenance is required.

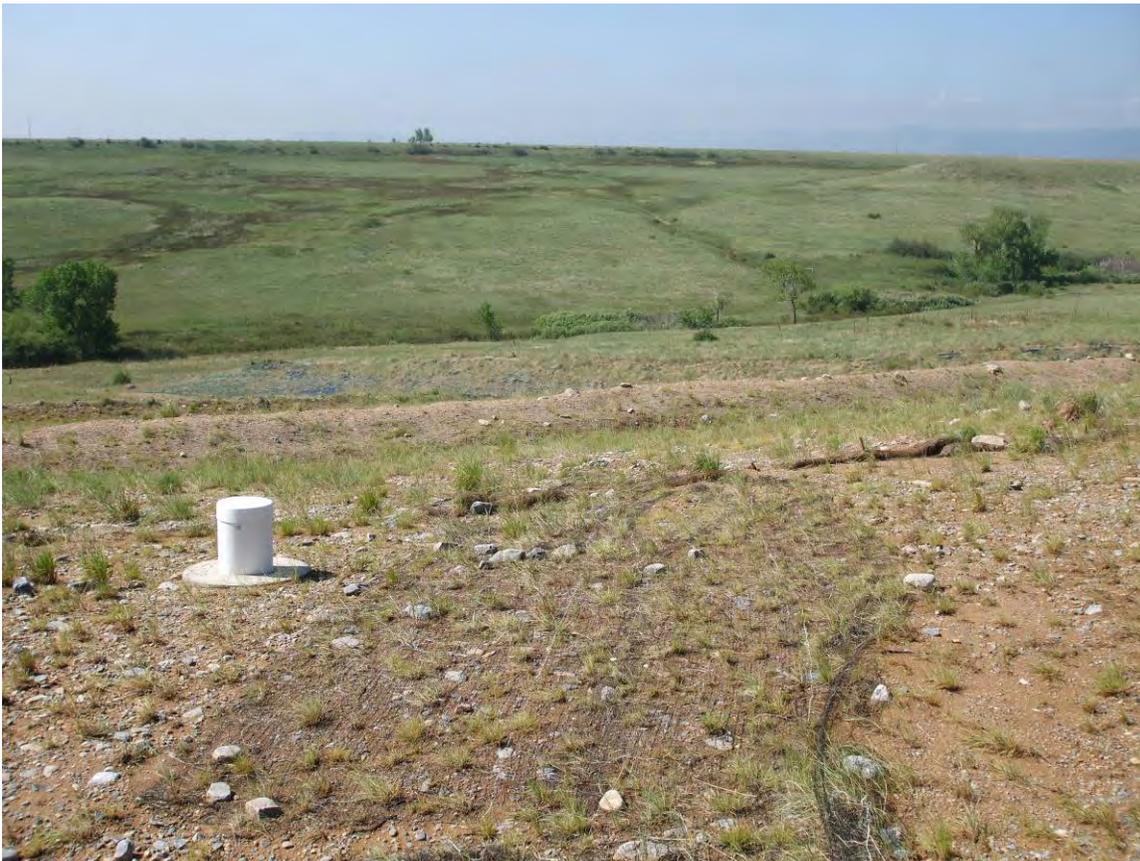
Berm 1

Berms 1 and 7 appear stable and satisfactory, with no new slumping or cracking present.

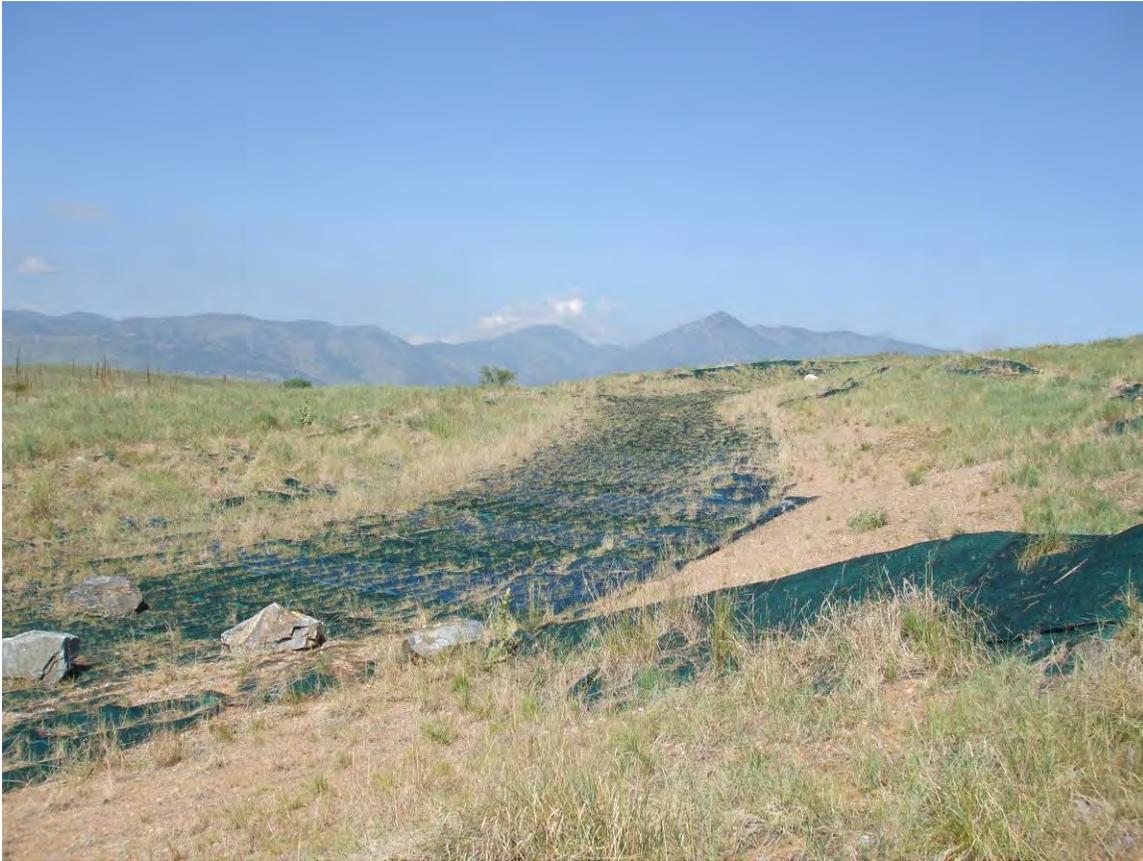
West Perimeter Channel

The Western Perimeter Channel is still in good shape. The vegetation continues to reestablish well.

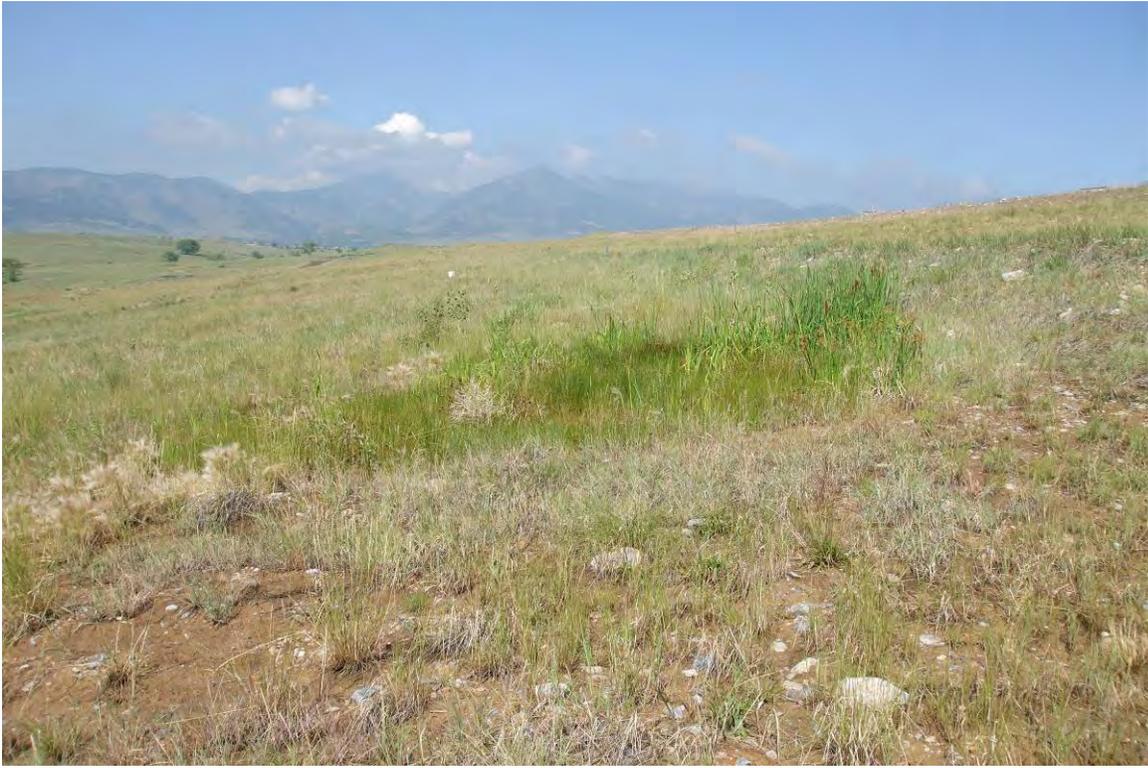
Seeps 2 and 3 Area

The Seep 1 area was dry, as usual. The area around Seeps 2 and 3 was saturated and showed some surface expression. The area around Seeps 4 and 5 had some surface expression that was draining through the berm 3 drain as designed. The Seep 6 area has three locations above berm 7 that were saturated. The Seep 7 area was saturated and had a surface flow of about 1–2 gallons per minute (gpm); the flow was draining down berms 3 and 7. Surface flow at Seep 8 continues at a rate of approximately 2–3 gpm. Pictures of the main seep locations are included below. As can be seen in the pictures, wetland vegetation continues to be prominent in all of the active seep locations.

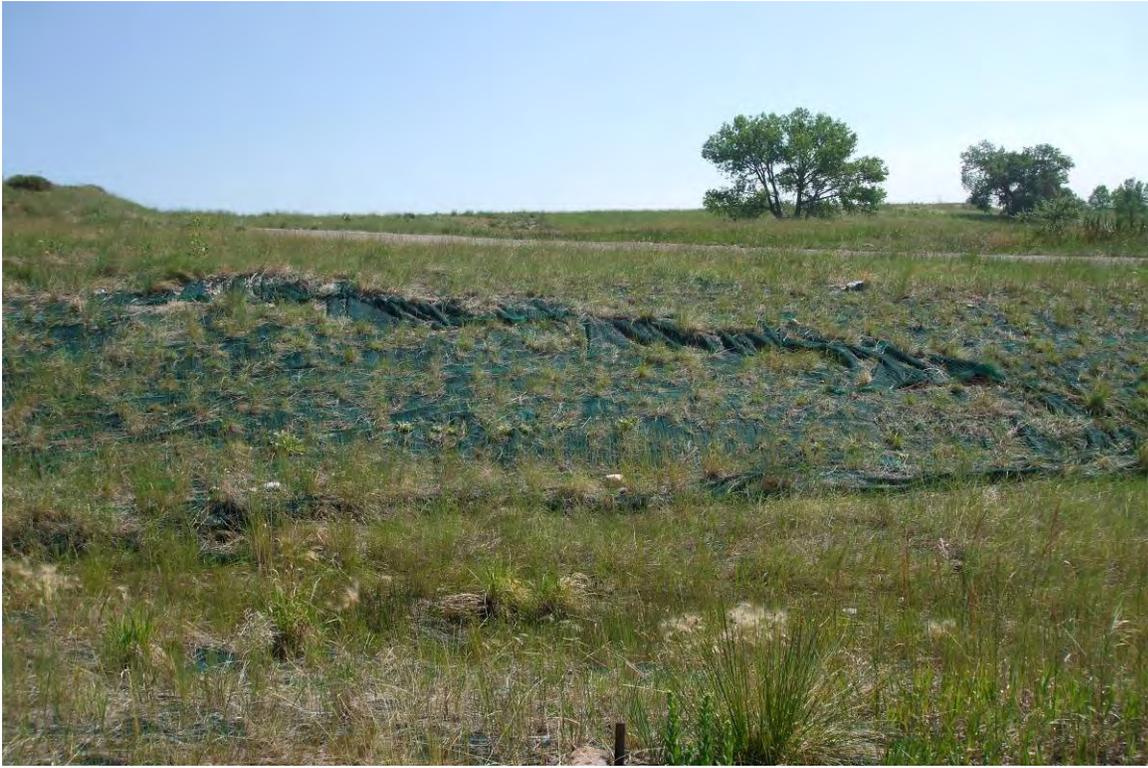
EPC Slump Area

The slump that was observed on the eastern slope of the EPC toward the top of the channel remains unchanged. The wooden stakes that were installed around the perimeter of the slumping area have not moved. No vertical displacement or cracking is apparent. We will continue to monitor the slumping area for any changes during routine and nonroutine inspections of the OLF.
