Appendix A

Landfill Inspection Forms and Survey Data

ORIGINAL LANDFILL – MONITORING AND MAINTENANCE PLAN INSPECTION FORM

Original Landfill July 2011 Monthly Inspection—Attachment 1

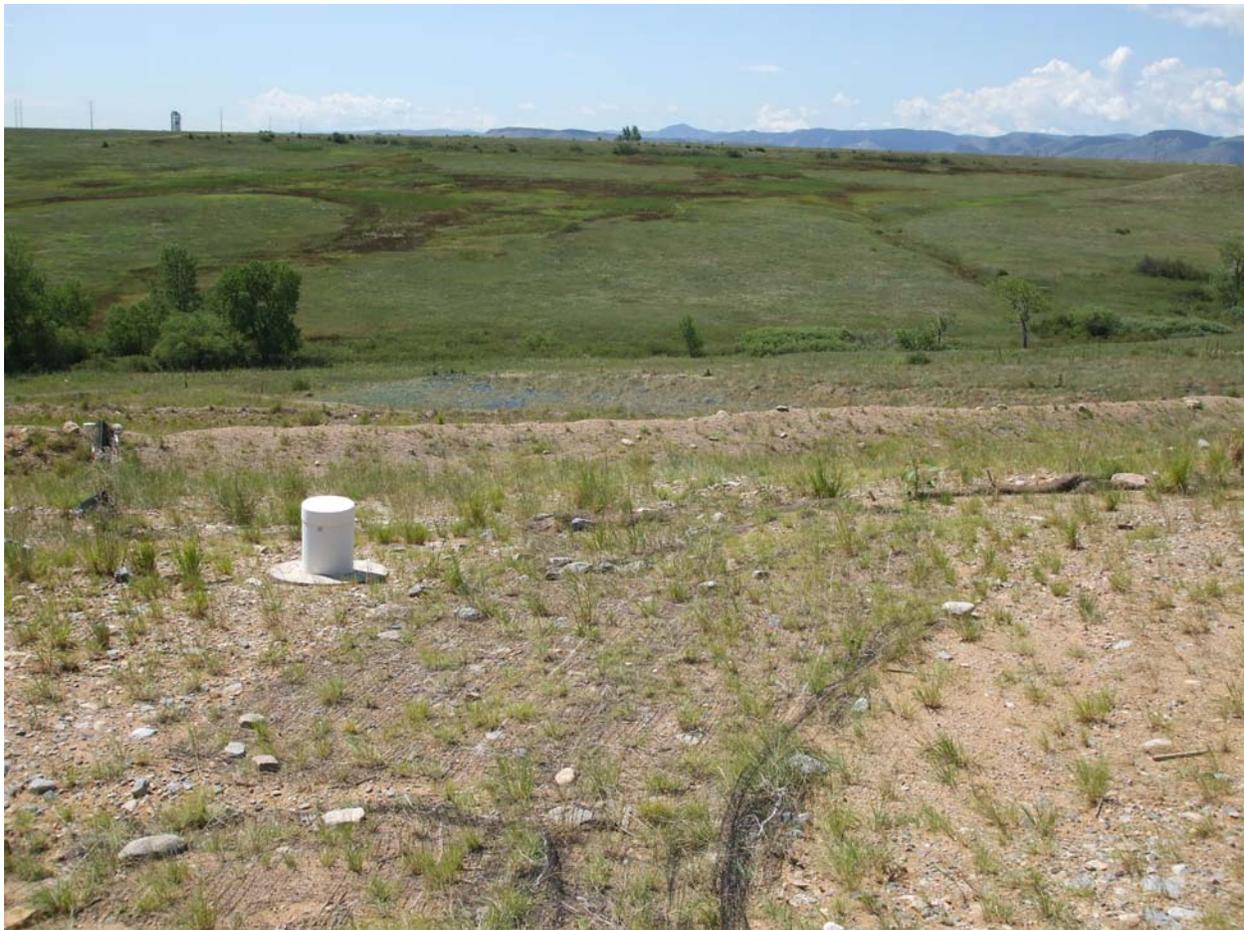
Berm 1

Berms 1 and 7 appear stable and satisfactory, with no new slumping or cracking present.

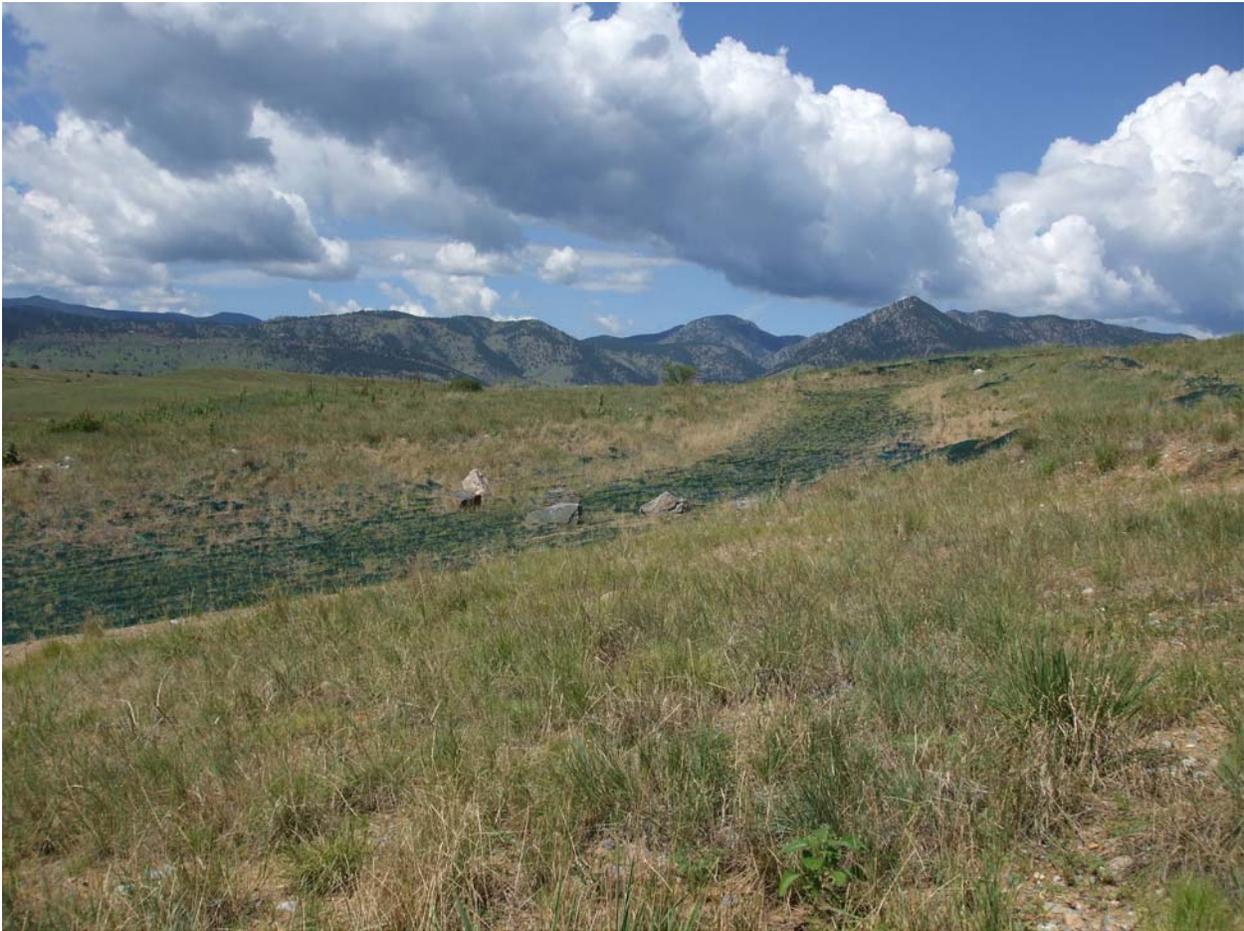
West Perimeter Channel

The Western Perimeter Channel is still in good shape. The vegetation continues to reestablish well.

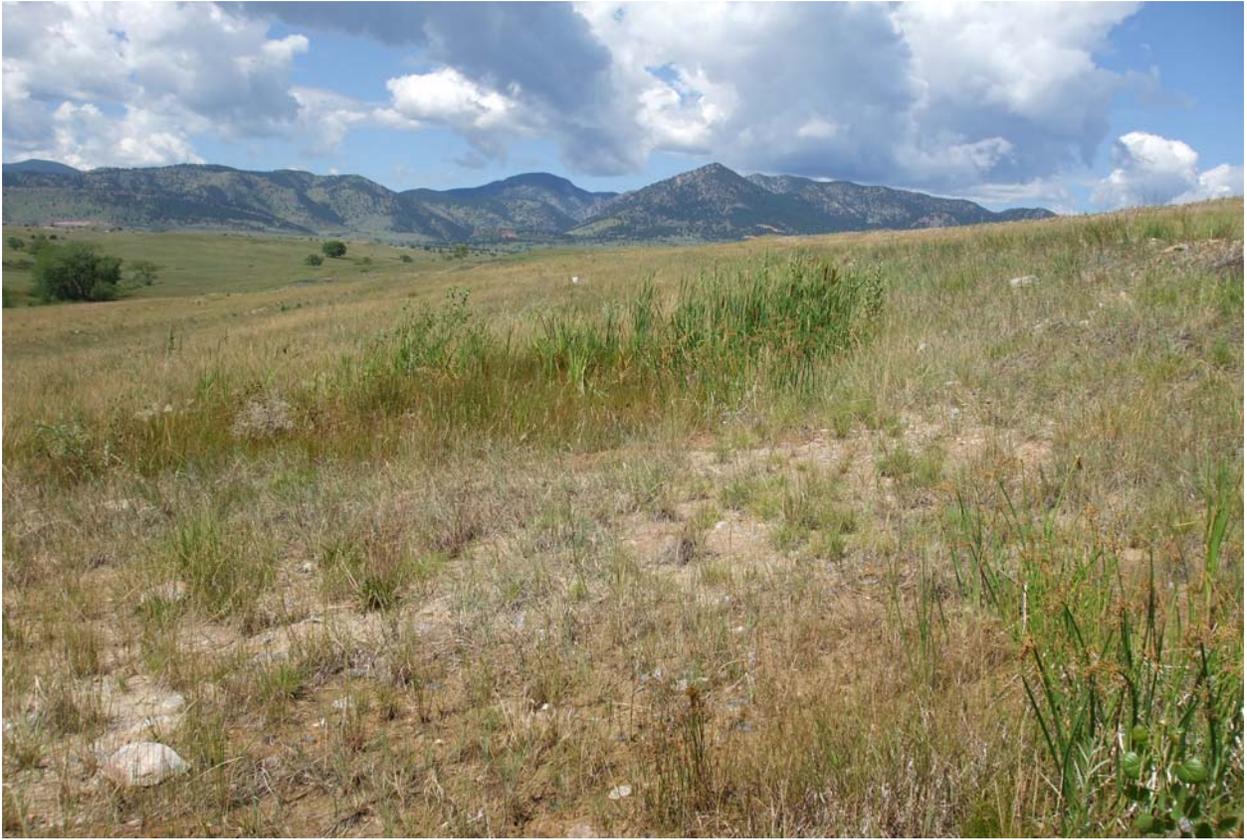
Seeps 2 and 3 Area

The Seep 1 area was dry, as usual. The area around Seeps 2 and 3 was saturated and showed some surface expression. The area around Seeps 4 and 5 had some surface expression that was draining through the berm 3 drain as designed. The Seep 6 area has three locations above berm 7 that were saturated. The Seep 7 area was saturated and had a surface flow of about 1–2 gallons per minute (gpm) in the upper and lower sections; the flow was draining down berms 3 and 7. Surface flow at Seep 8 continues at a rate of approximately 2–3 gpm. Pictures of the main seep locations are included below. As can be seen in the pictures, wetland vegetation continues to be prominent in all of the active seep locations.

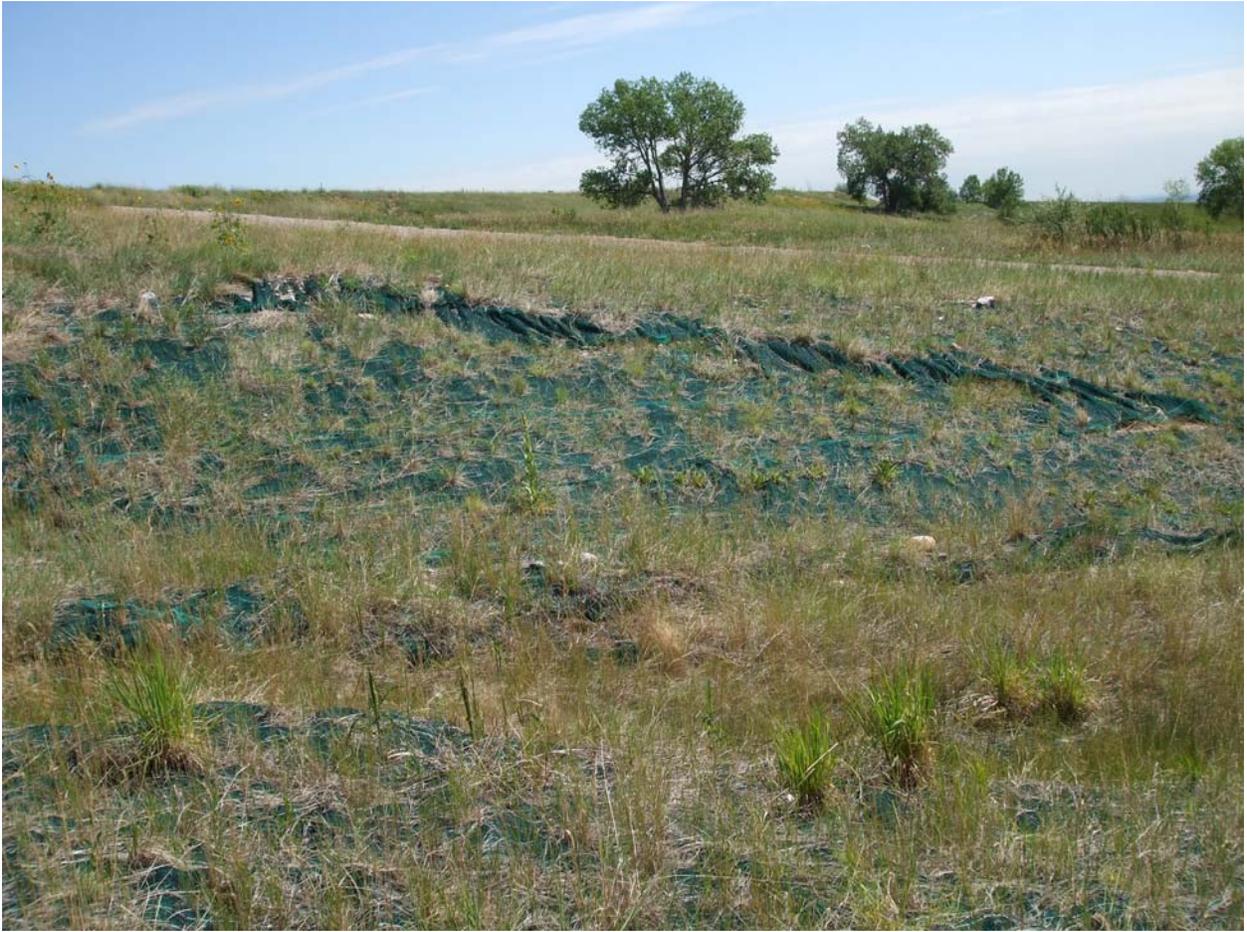
EPC Slump Area

The slump that was observed on the eastern slope of the EPC toward the top of the channel remains unchanged. The wooden stakes that were installed around the perimeter of the slumping area have not moved. No vertical displacement is apparent. A small crack approximately 2' long was observed on the upper part of the slumping area. The crack was filled and compacted at the time of the inspection. We will continue to monitor the slumping area for any changes during routine and nonroutine inspections of the OLF.

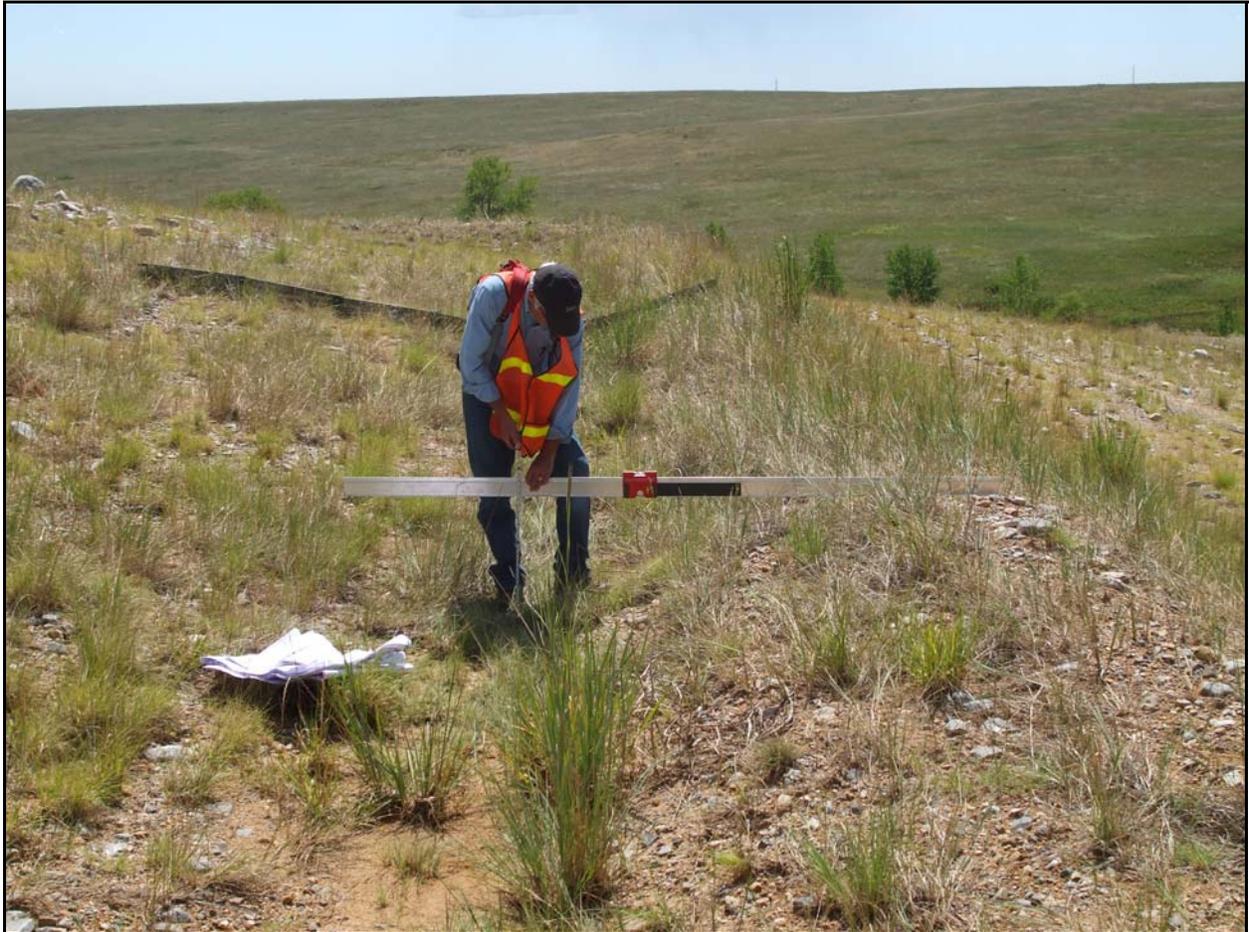
Measuring Berm Heights

The OLF Maintenance 2011 Project was completed on August 16 and 17. The scope of the project included adjusting berm heights to the requirements established in the OLF Monitoring and Maintenance Plan and installing new erosion matting in the West Perimeter Channel. The berm areas that were disturbed during this project were re-seeded and had erosion matting applied to help hold the additional soil in place. Approximately 700 feet of berms had additional soil added during this project. Two locations in the West Perimeter Channel that previously had coconut matting applied were covered with new Turf Reinforcement Matting (TRM).

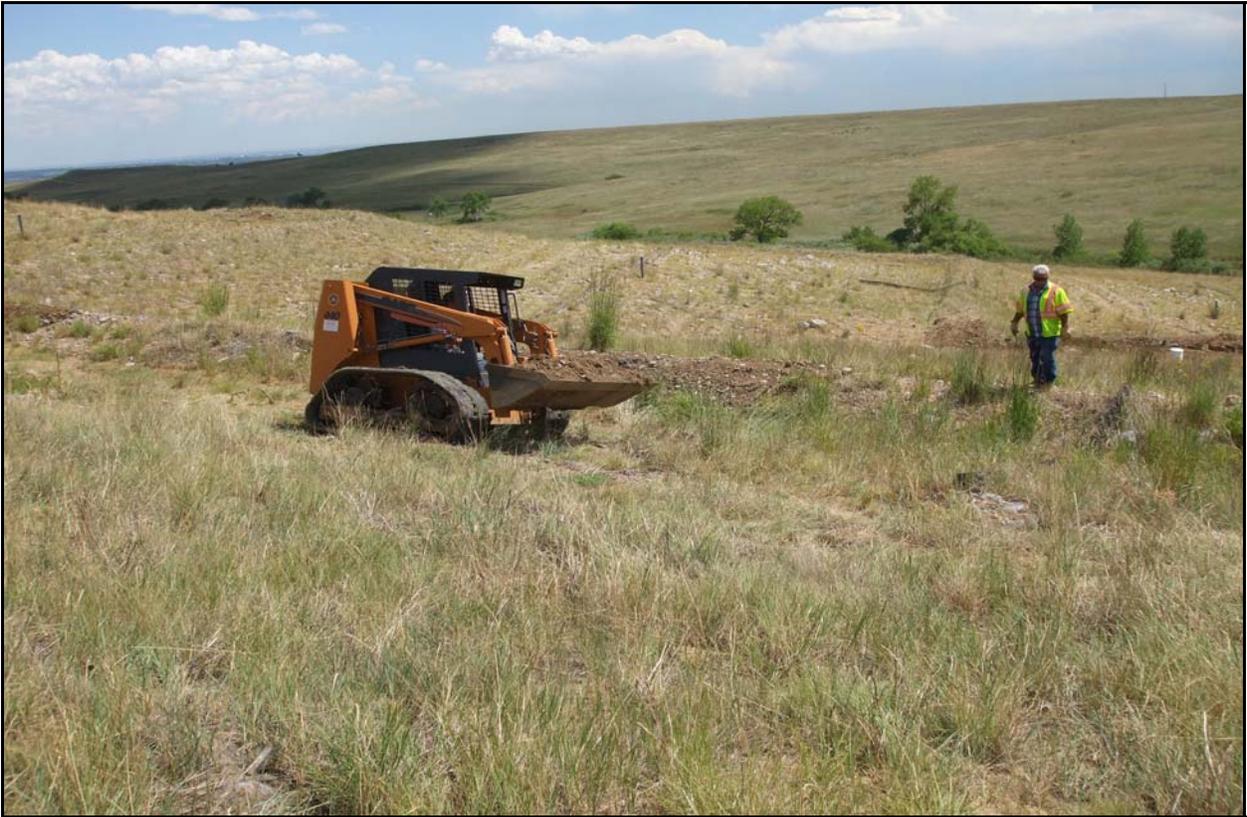
Adding Soil to Berms

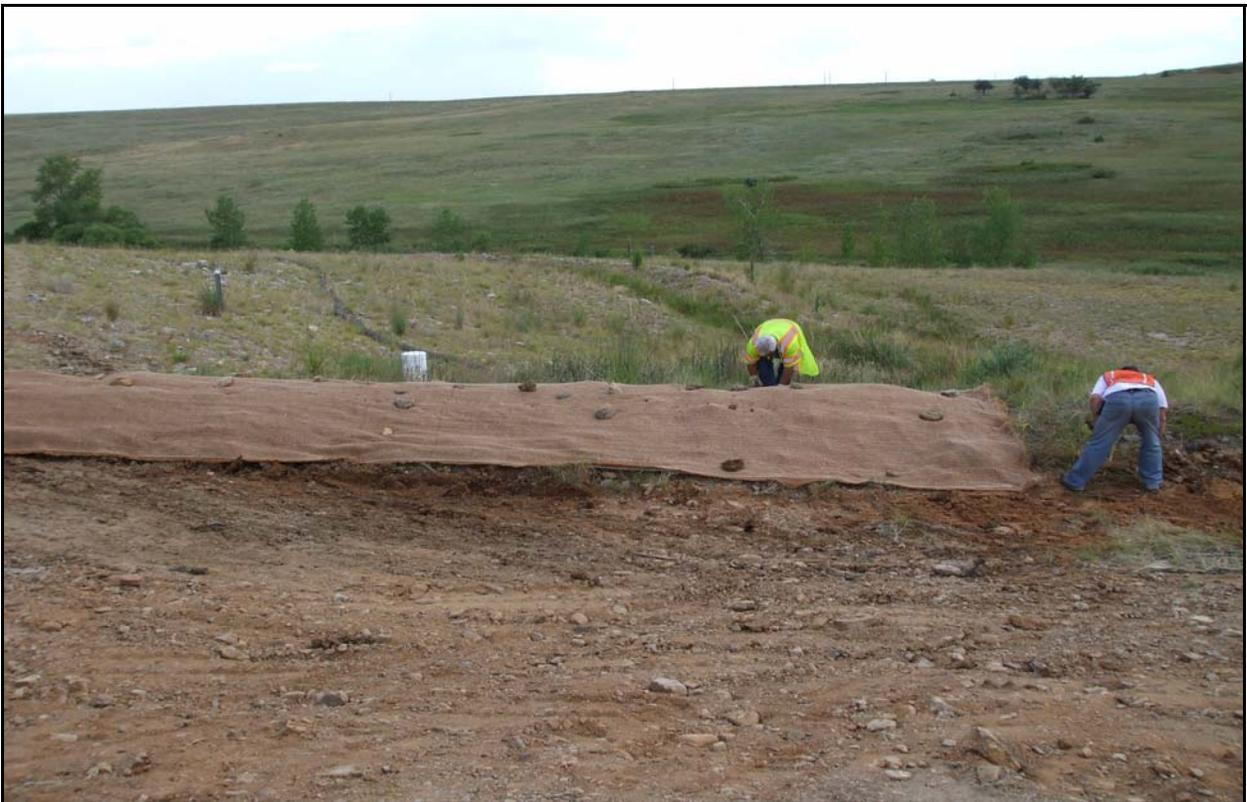
Applying Erosion Matting to Berms

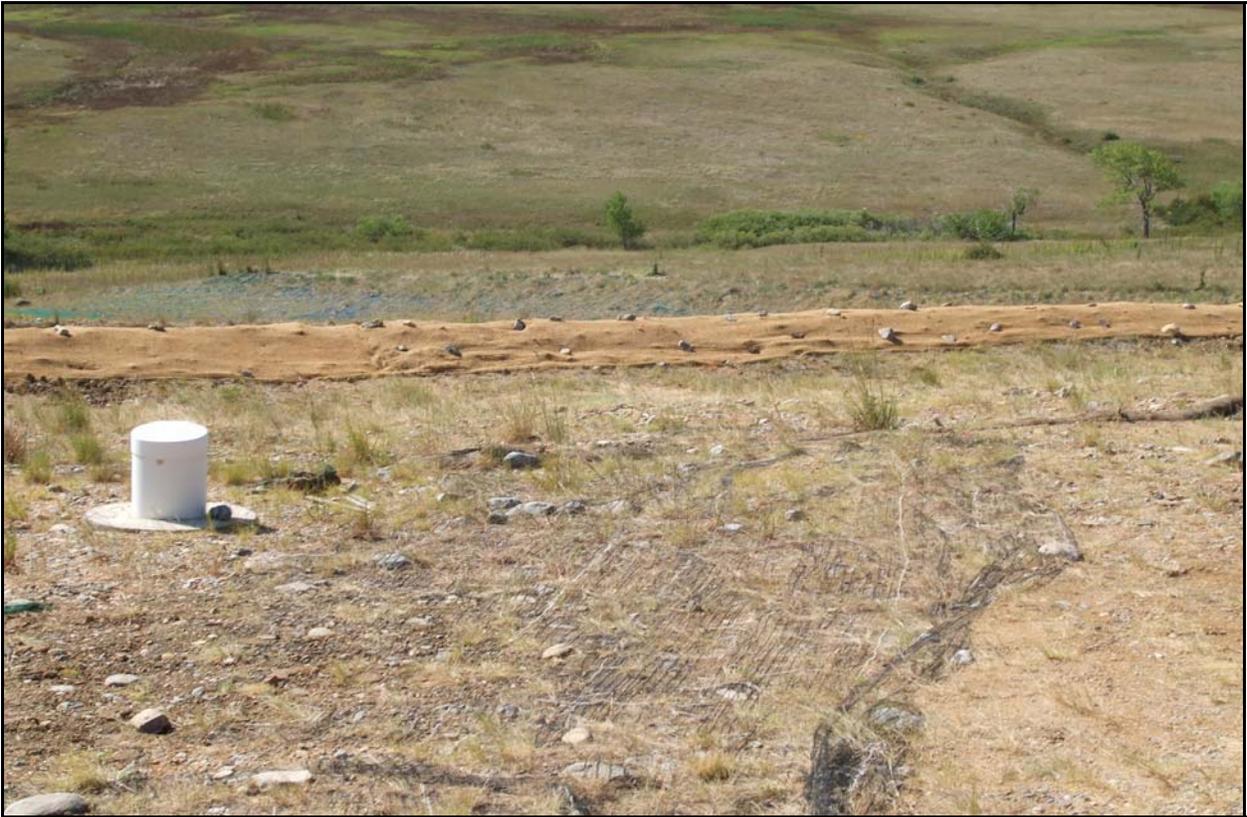
Completed Berm 1 Location

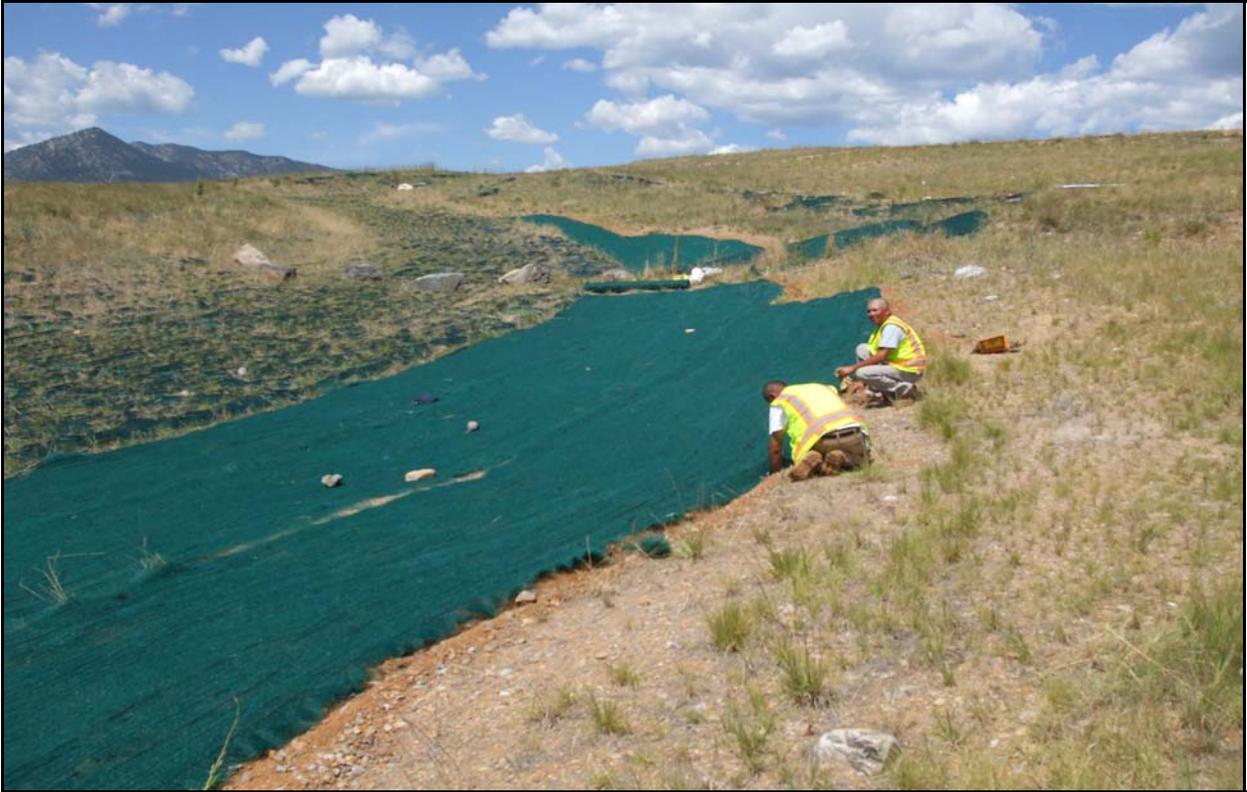
Installing Erosion Matting in West Perimeter Channel

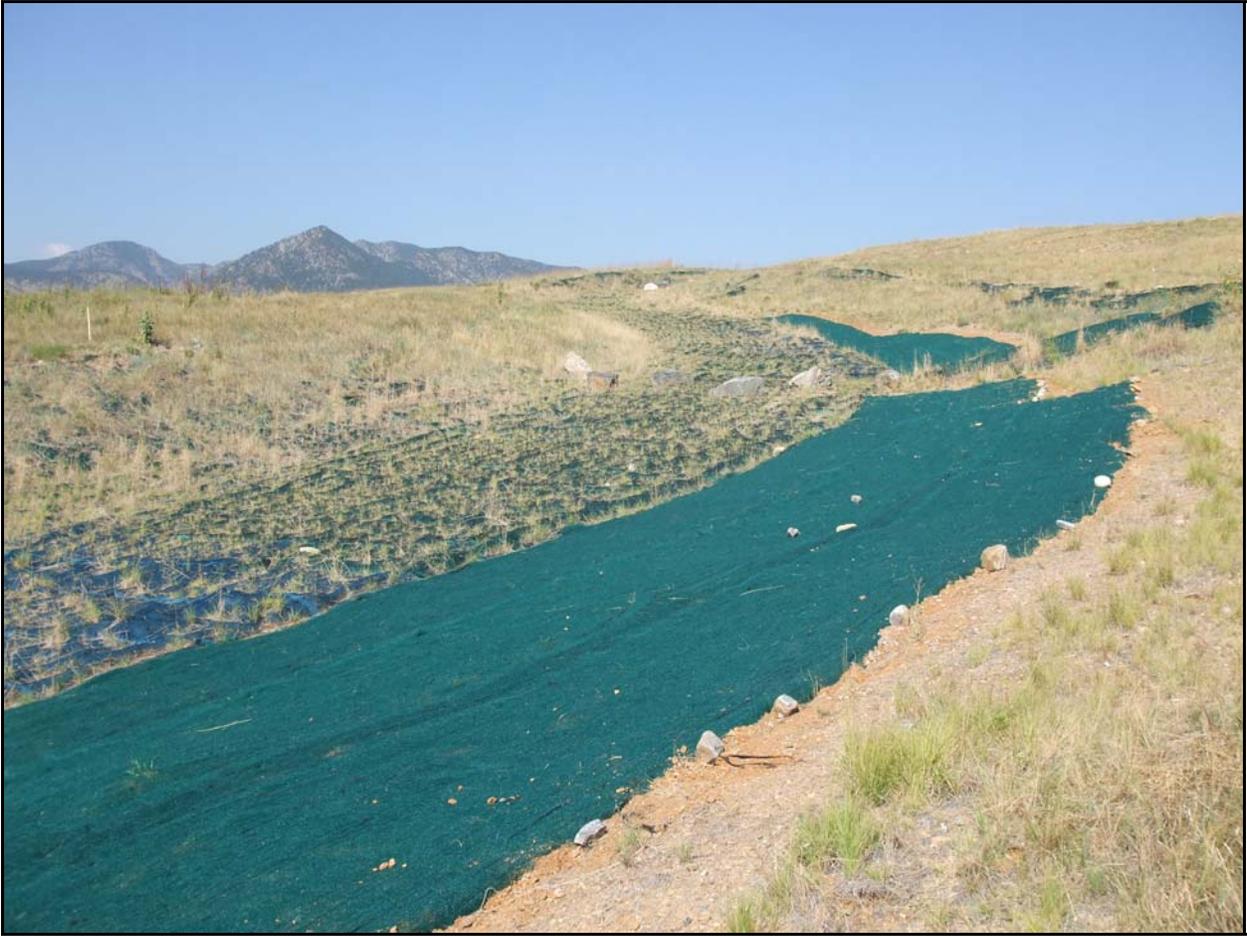
Completed West Perimeter Channel

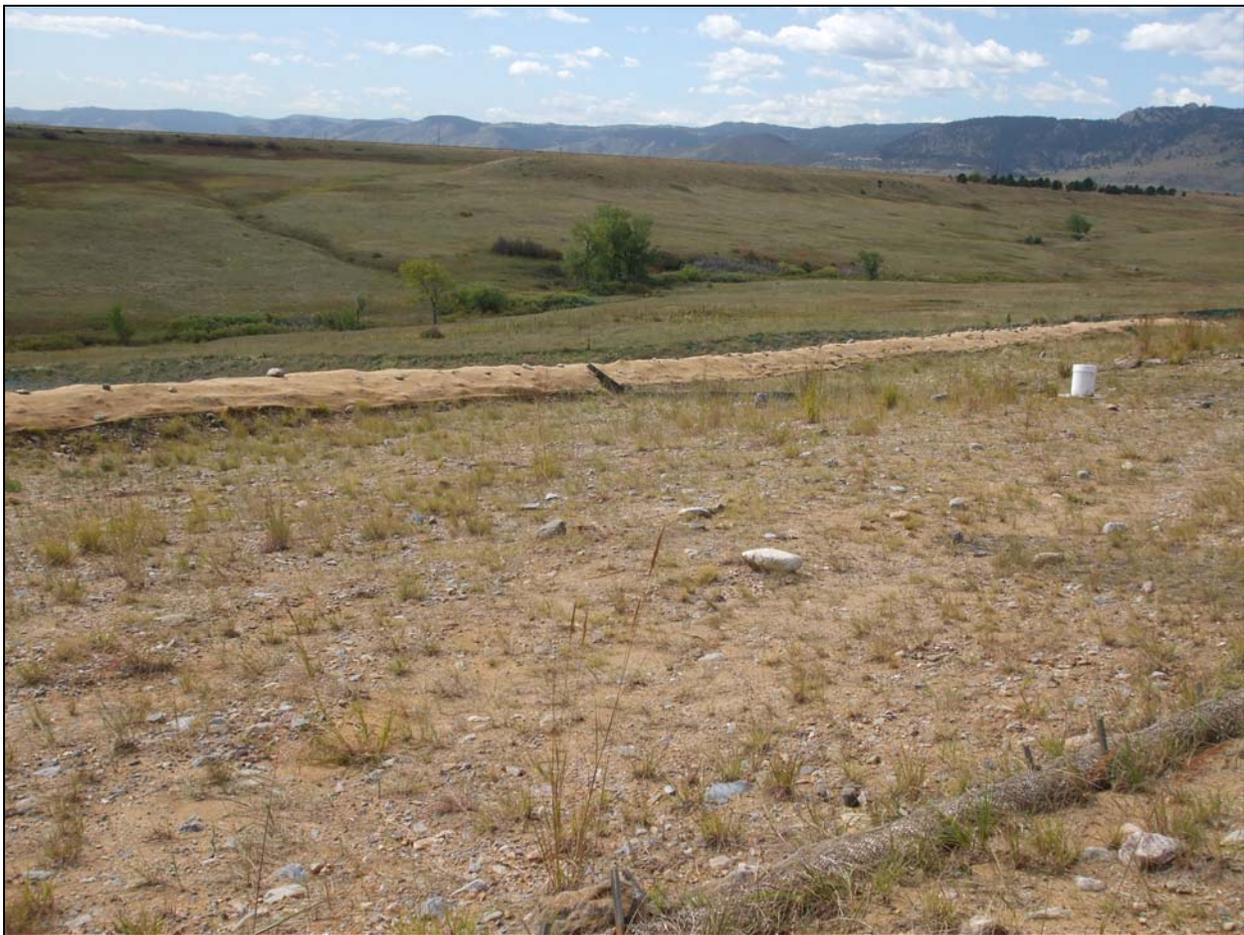
Berm 1

Special inspections of the OLF cover were completed on September 8 and 15 due to the site receiving precipitation events of 1.1 and 1.24 inches. Berm locations that were re-graded during the OLF Maintenance 2011 Project remained in good condition. A small section of the newly installed erosion matting in the West Perimeter Channel needed to be re-staked following the precipitation event on September 14. No other repairs were needed.

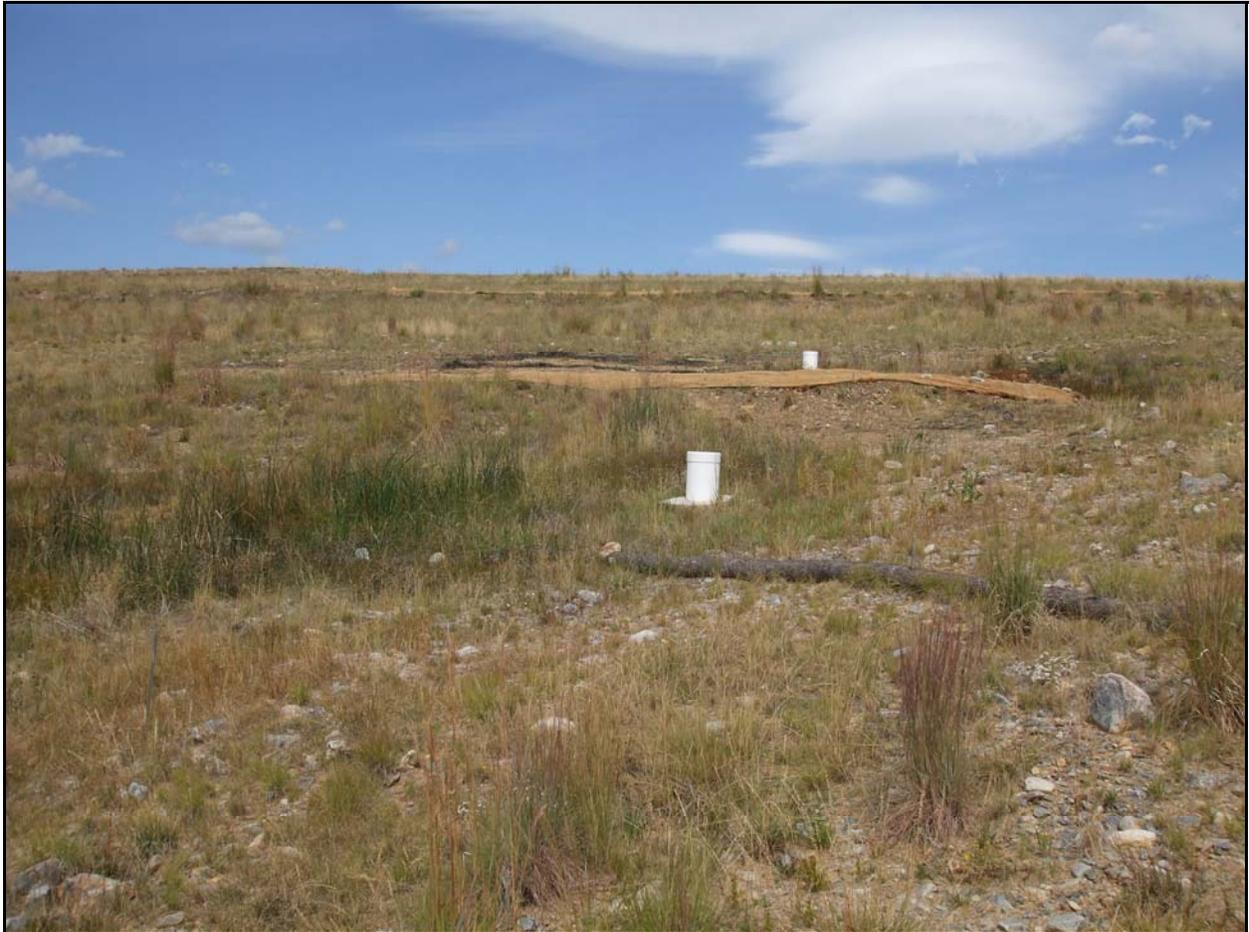
Seep 7

The Seep 1 area was dry, as usual. The area around Seeps 2 and 3 were dry and showed no surface expression. The area around Seeps 4 and 5 had some surface expression that was draining through the berm 3 drain as designed. The Seep 6 area has three locations above berm 7 that were dry. The Seep7 area was saturated, but had no surface flow. Surface flow at Seep 8 continues at a rate of approximately 1-2 gpm. The seep locations continue to support wetland vegetation even though drier conditions are present.
