Appendix A

Annual Inspection Checklist, Maps, and Photographs

Annual Site Inspection Check List (See RFLMA Attachment 2, section 5.3.4; 5.3.6 and 5.4.3)

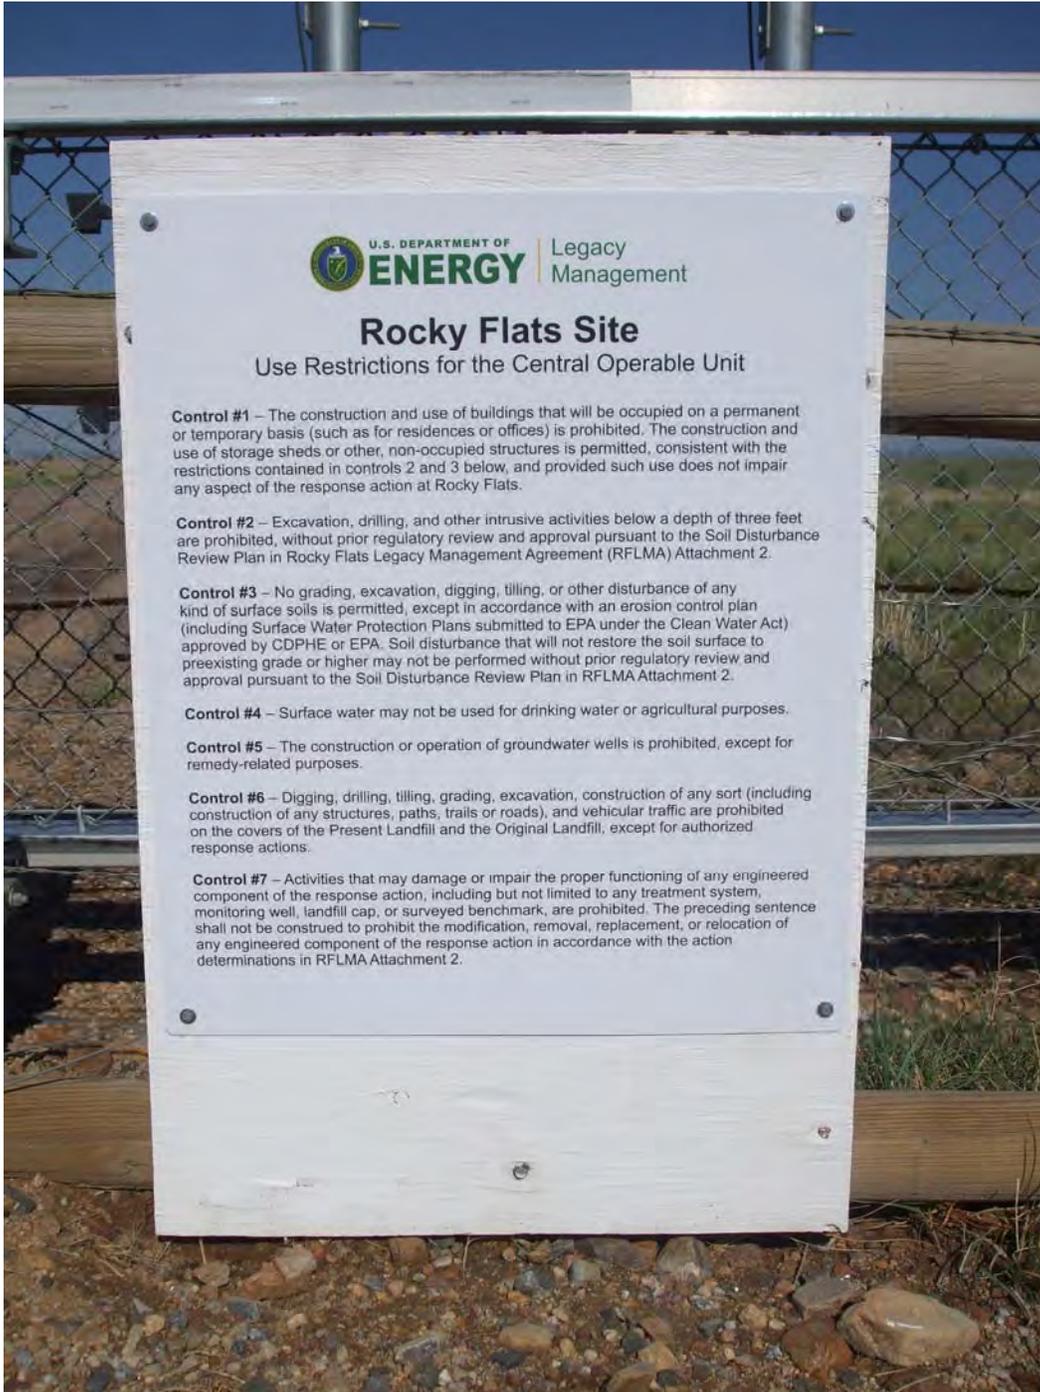
Photograph A1. Sign listing the institutional controls; posted at the west entrance road to the Central OU. Signs are posted at each of the Central OU entry/exit gates at the Central OU boundary.

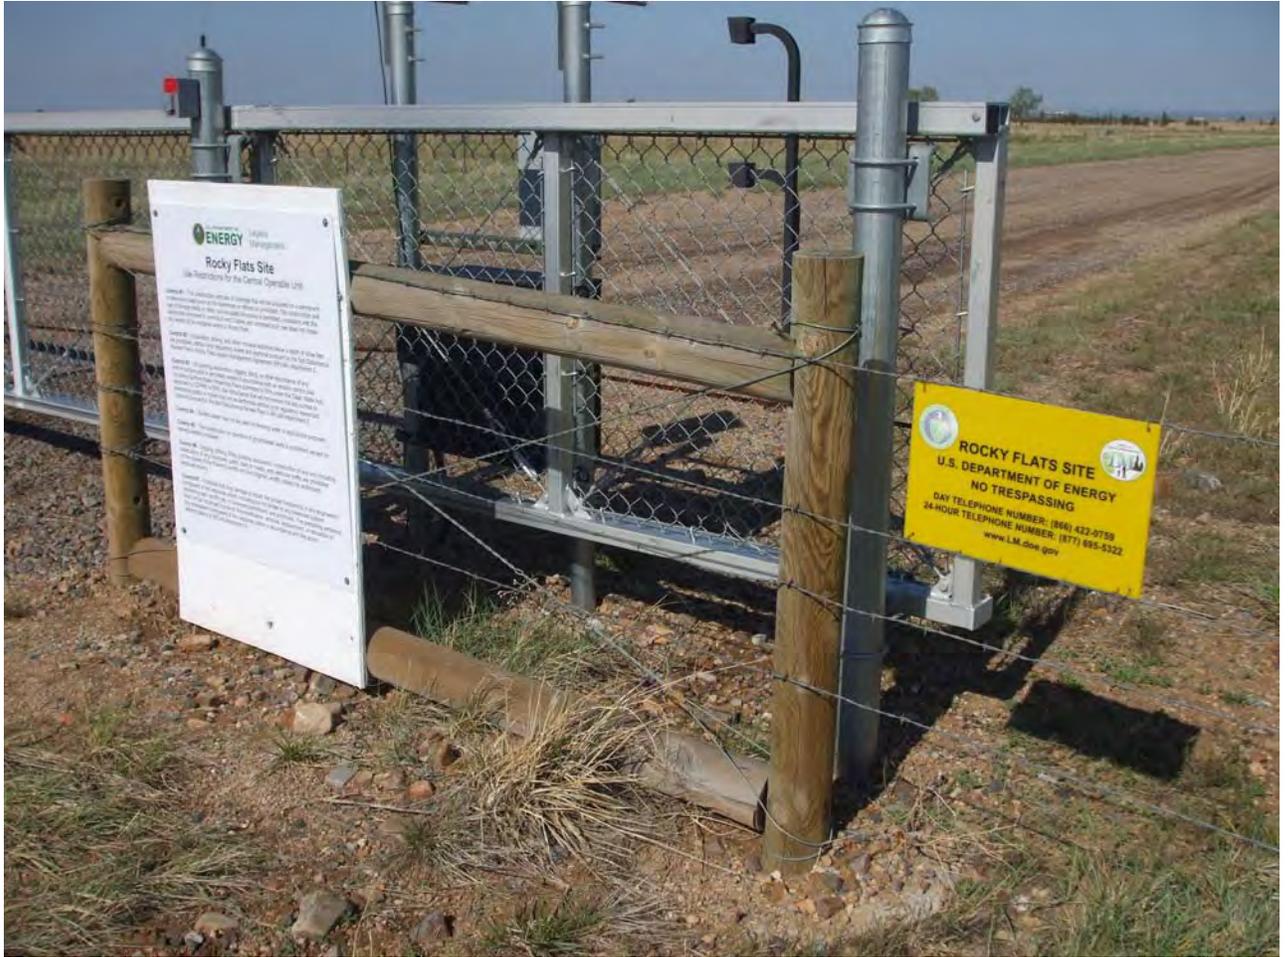
Photograph A2. No trespassing sign. Signs are posted at Central OU boundary at intervals specified by RFLMA Attachment 2.

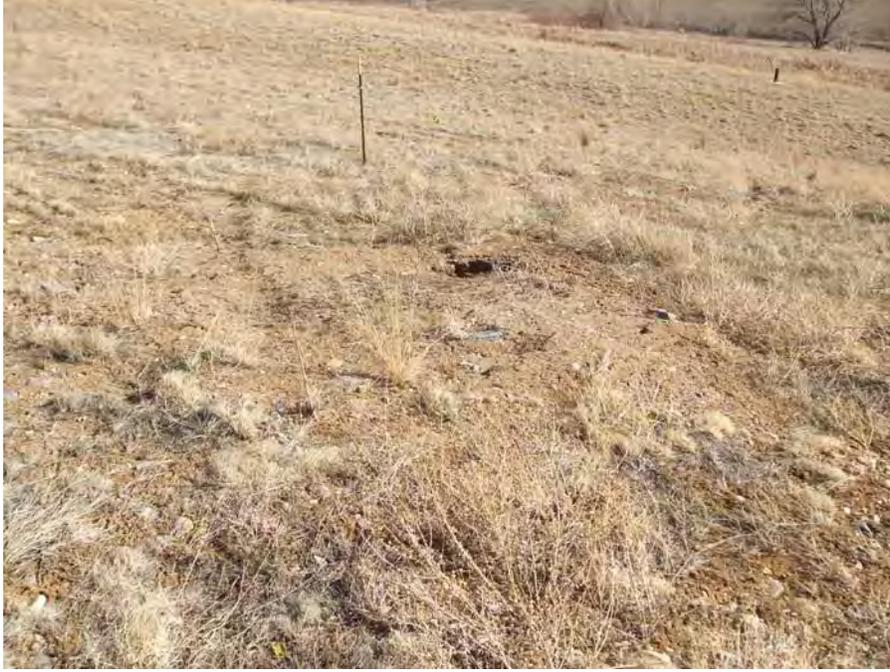
Photograph A3. Hole in the location of the former B881 stairwell

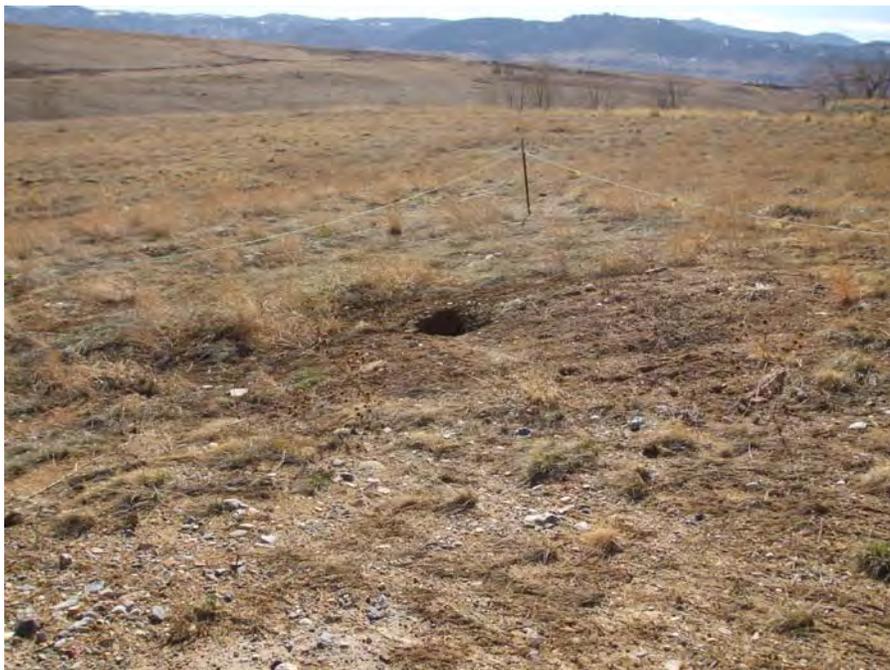
Photograph A4. Hole in the location of the former B881 stairwell

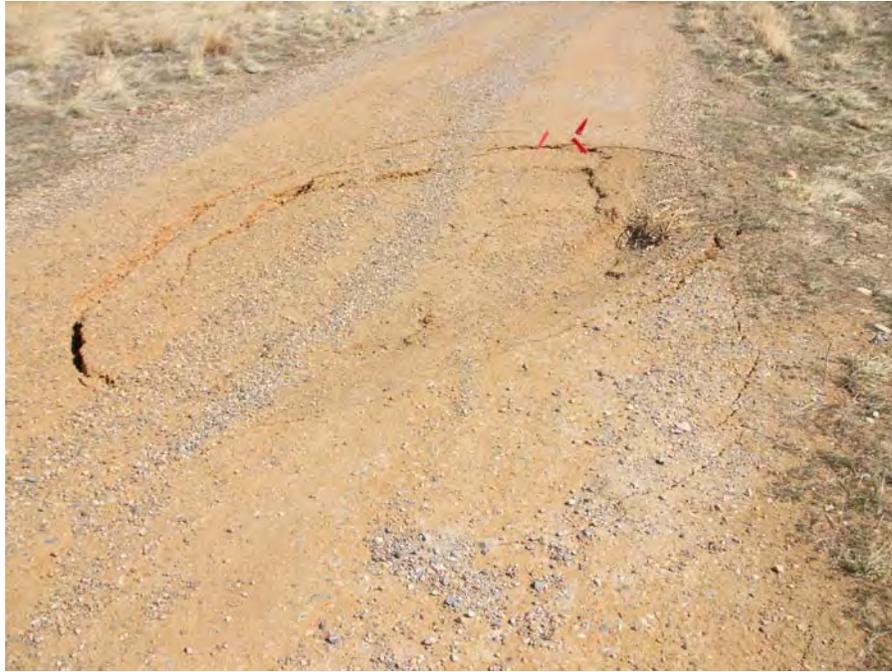
Photograph A5. Depression in the roadway in the vicinity of former B771

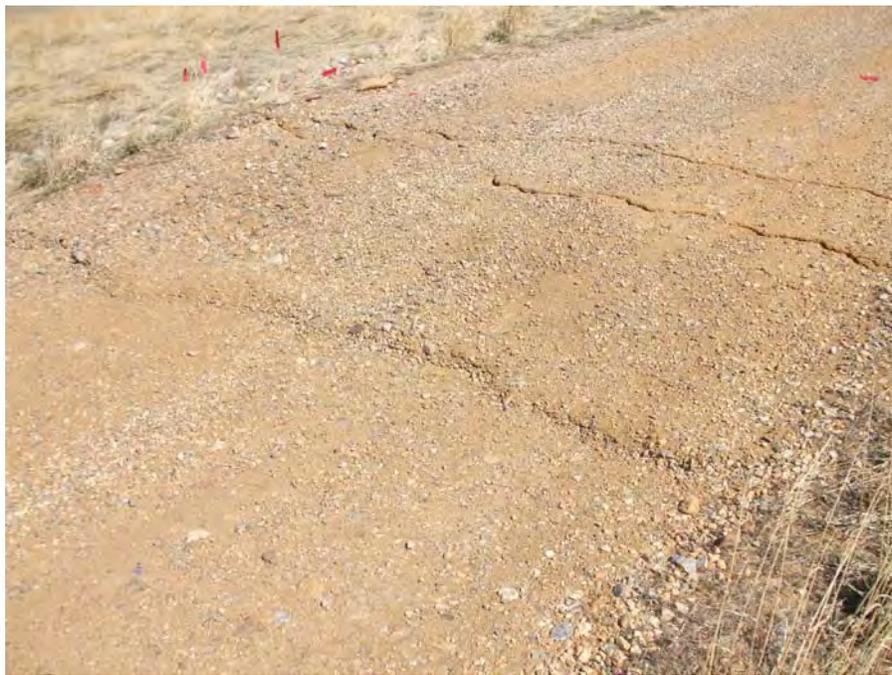
Photograph A6. Cracks in the roadway in the vicinity of former B771
