Appendix B

Landfill Inspection Forms and Survey Data

Original Landfill January 2012 Monthly Inspection—Attachment 1

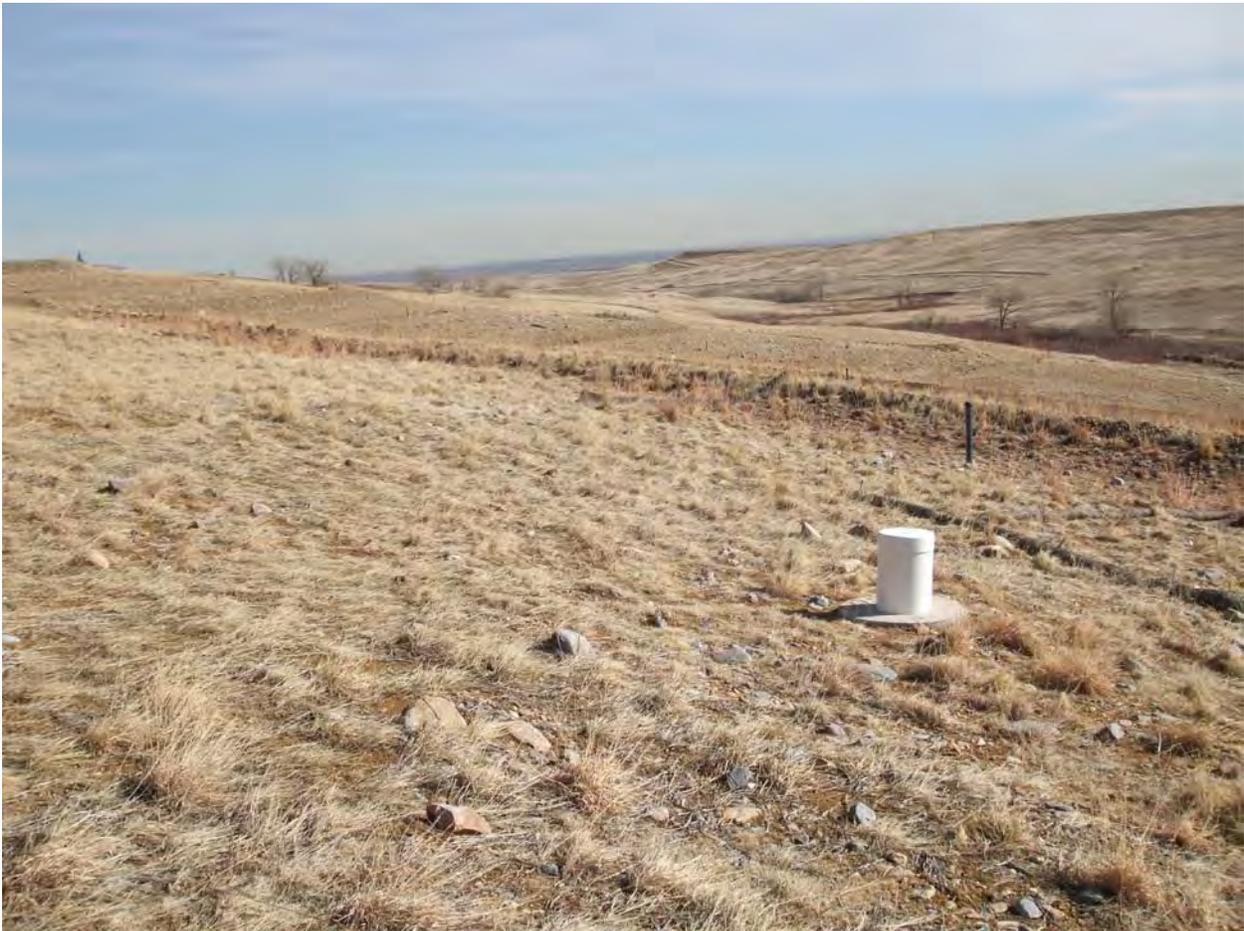
Lower OLF Cover Facing East

Berm locations that were re-graded during the OLF Maintenance 2011 Project remained in good condition. Vegetation on the landfill cover including the seep areas remains dormant.

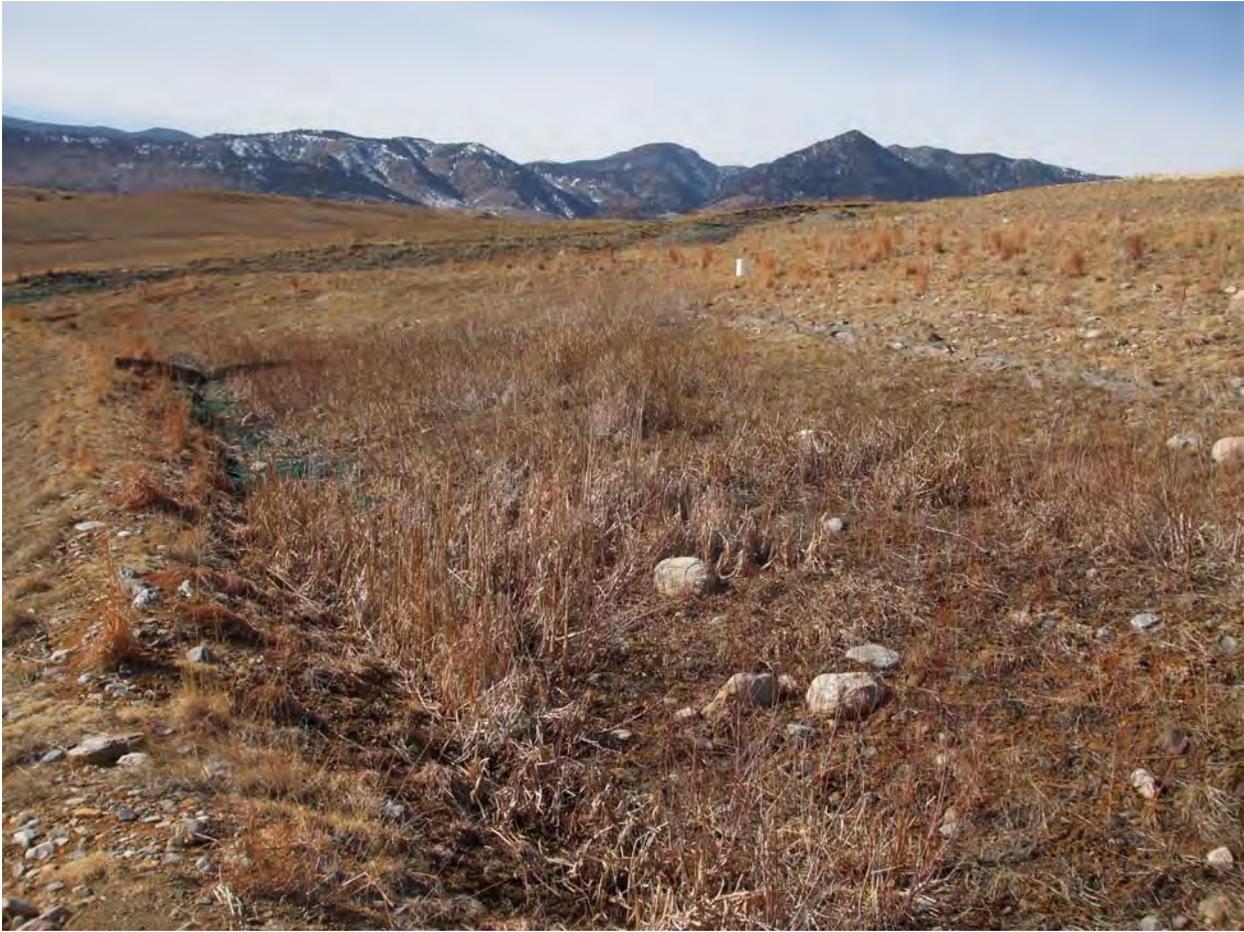
Seep 4 and 5 Area

The seep locations were saturated at the time of this inspection. Seep 7 was flowing at a rate of approximately .5 gallons per minute (gpm). Seep 8 was flowing at approximately 2 gpm. No other seeps produced any surface flow.

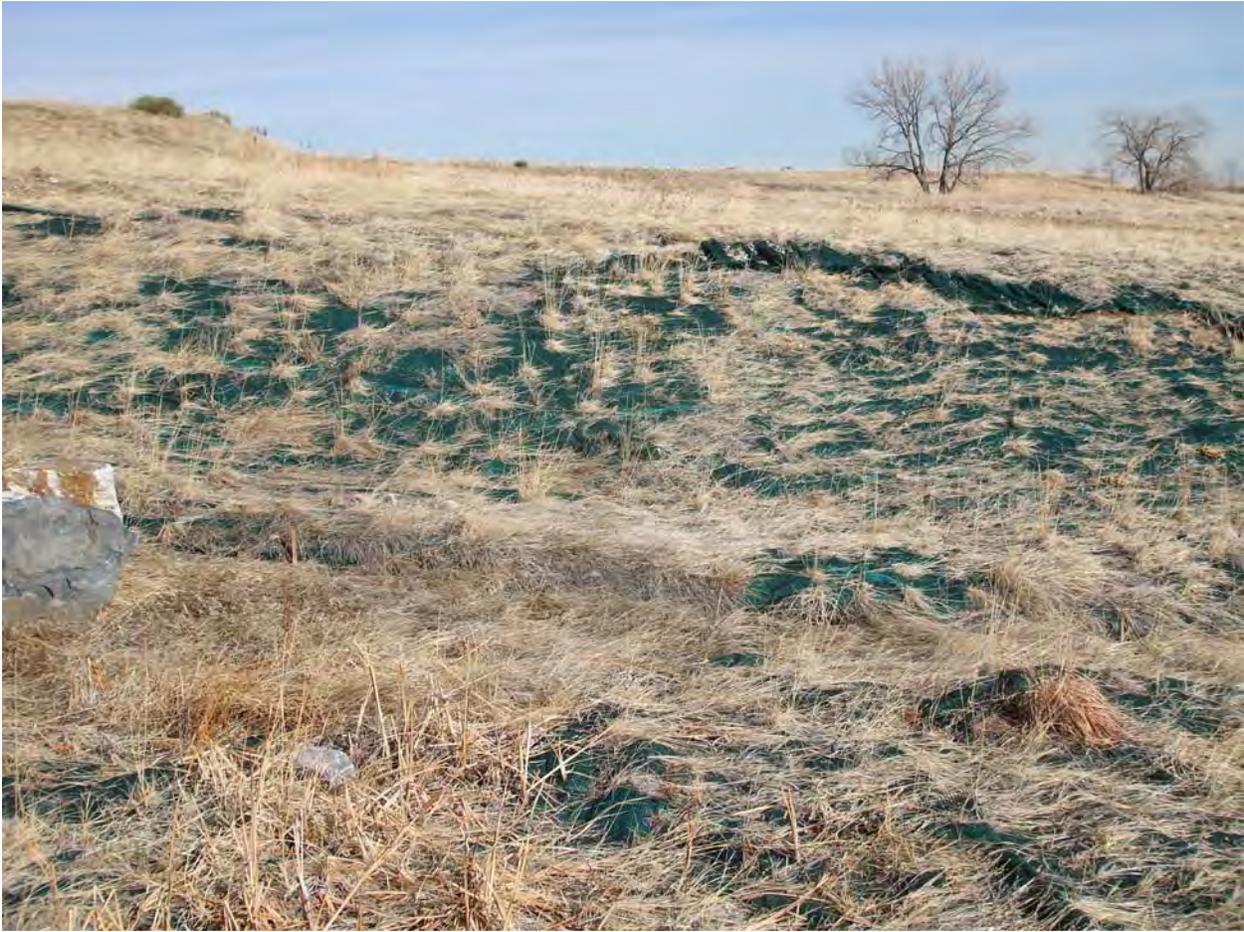
EPC Slump

The slump that was observed on the eastern slope of the EPC toward the top of the channel remains unchanged. The wooden stakes that were installed around the perimeter of the slumping area have not moved. No vertical displacement is apparent. We will continue to monitor the slumping area for any changes during routine and nonroutine inspections of the OLF.

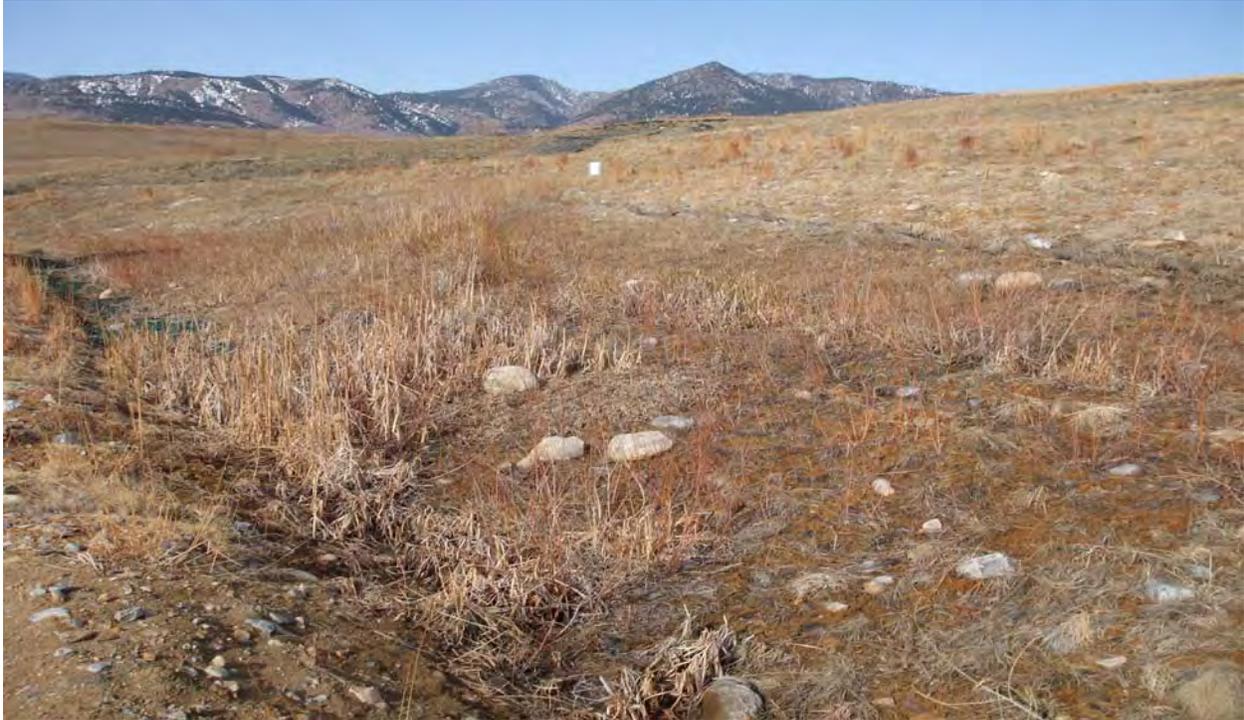
Seep 4 and 5 Area

The seep locations were dry at the time of this inspection except for Seeps 4, 5, 7, and 8. Seeps 4 and 5 were flowing at a rate of approximately .5 gallons per minute (gpm). Seep 7 produced a flow rate of approximately 2 gpm and Seep 8 was flowing at approximately 5 gpm. No other seeps produced any surface flow. Vegetation in the seep locations remains dormant.

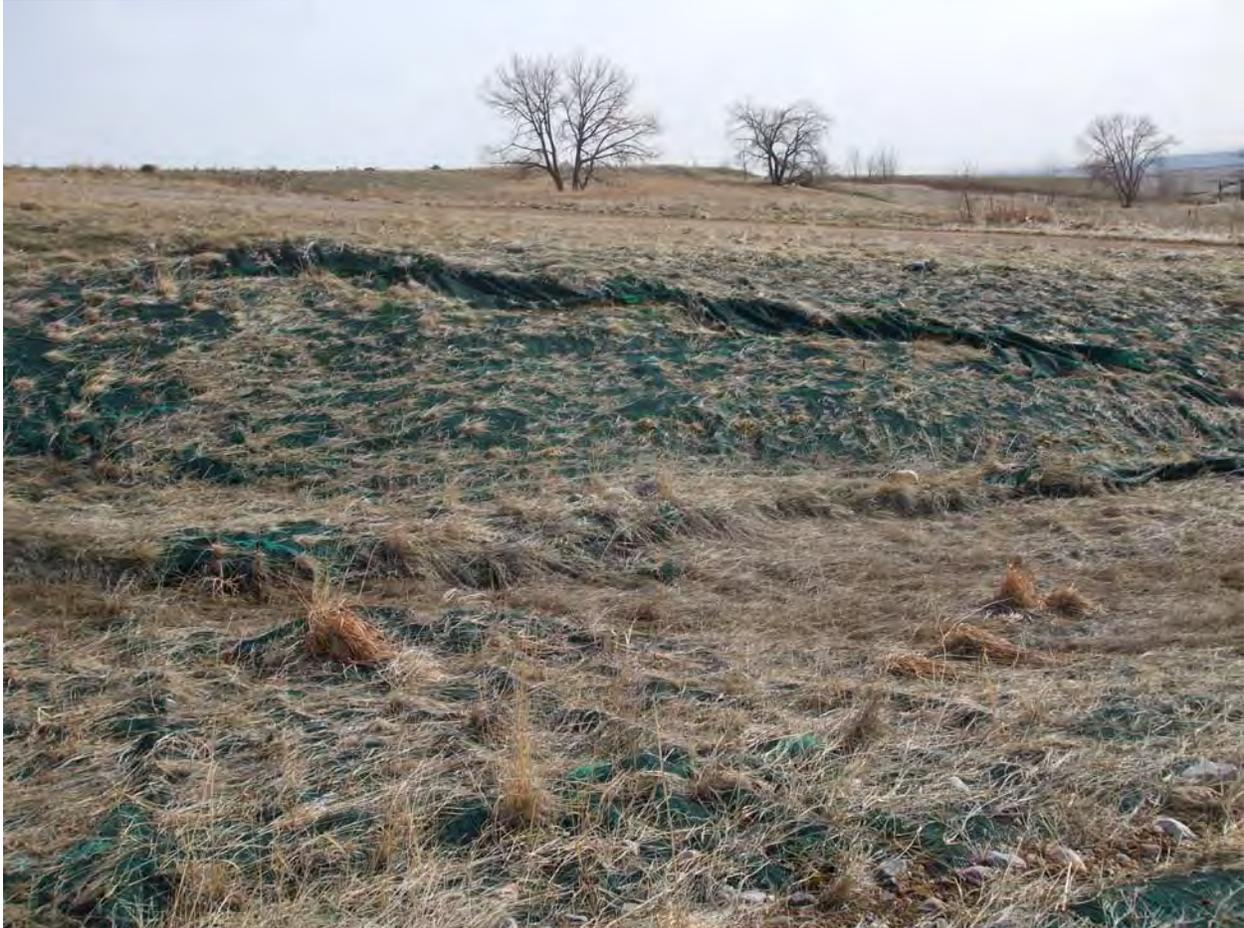
EPC Slump

The slump that was observed on the eastern slope of the EPC toward the top of the channel remains unchanged. The wooden stakes that were installed around the perimeter of the slumping area have not moved. No cracks are apparent. We will continue to monitor the slumping area for any changes during routine and nonroutine inspections of the OLF.

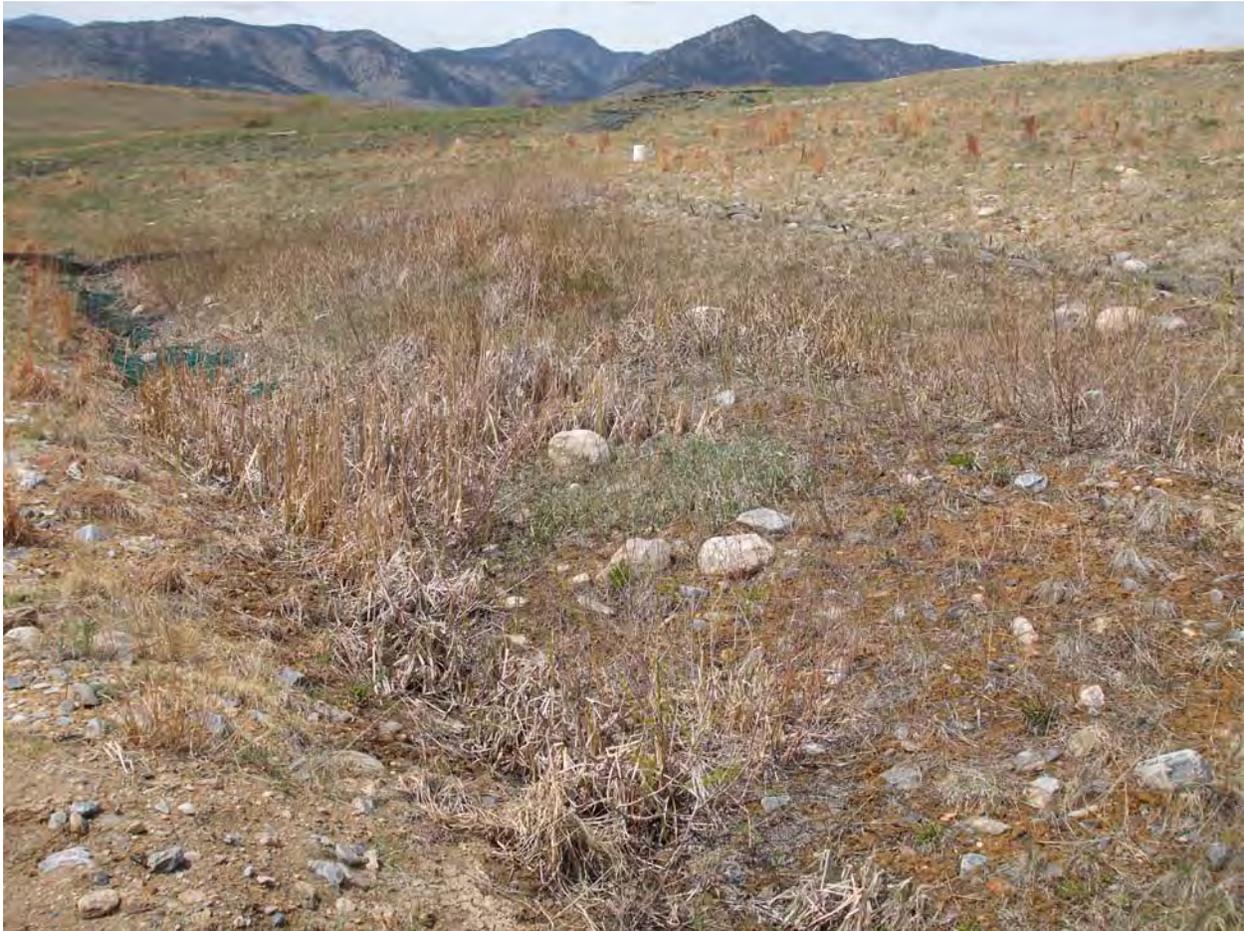
Seep 4 and 5 Area

The seep locations were dry at the time of this inspection except for Seeps 4, 5, 7, and 8. Seeps 4 and 5 were flowing at a rate of approximately .5 gallons per minute (gpm). Seep 7 produced a flow rate of approximately .5 gpm and Seep 8 was flowing at approximately 1-2 gpm. No other seeps produced any surface flow. Vegetation in the seep locations is beginning to enter the growth stage.

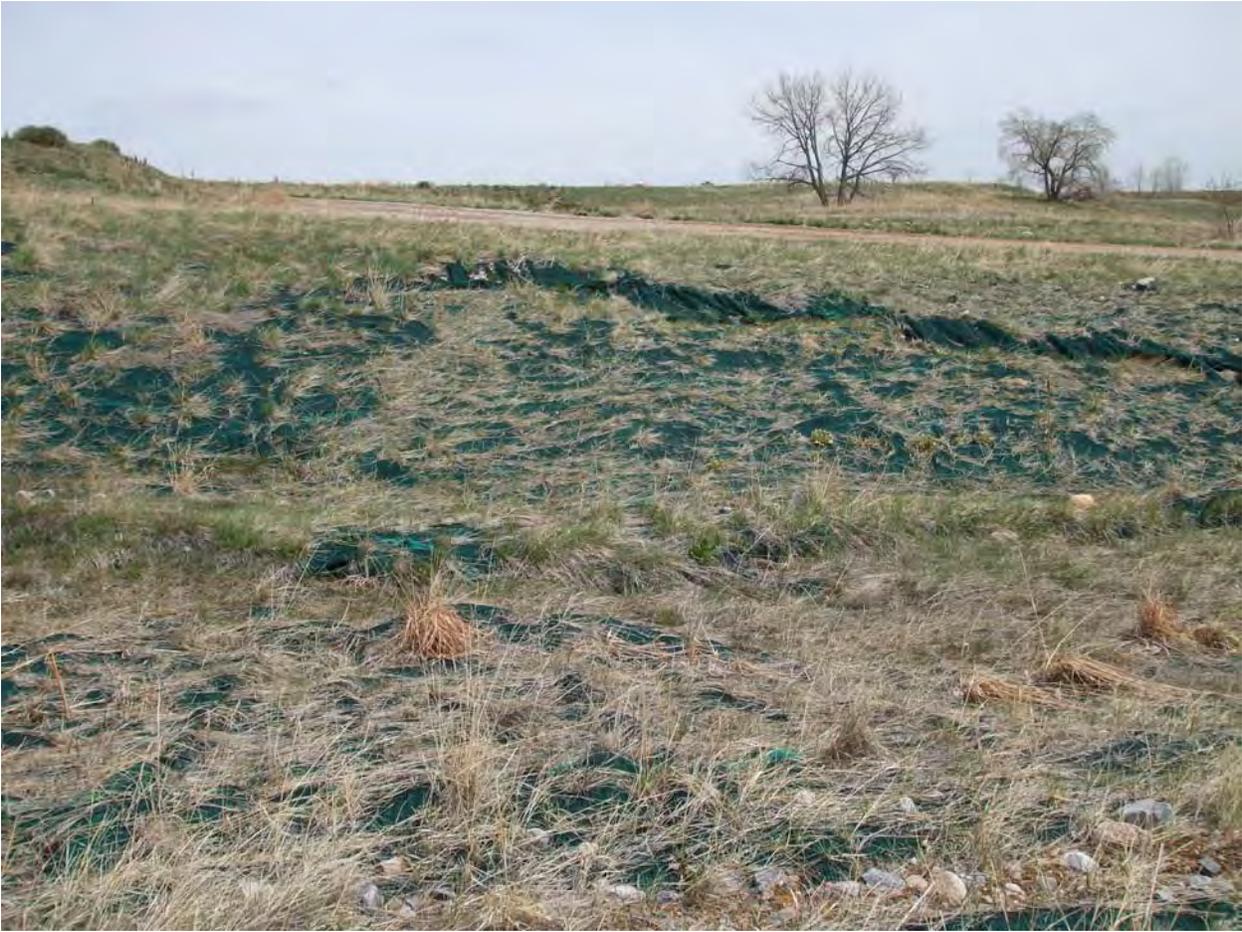
EPC Slump

The slump that was observed on the eastern slope of the EPC toward the top of the channel remains unchanged. The wooden stakes that were installed around the perimeter of the slumping area have not moved. No cracks are apparent. We will continue to monitor the slumping area for any changes during routine and nonroutine inspections of the OLF.
