Amchitka Mud Pit Caps 2016 Post-Closure Monitoring and Inspection Report Amchitka Island, Alaska

November 2016

U.S. DEPARTMENT OF
ENERGY

Legacy
Management

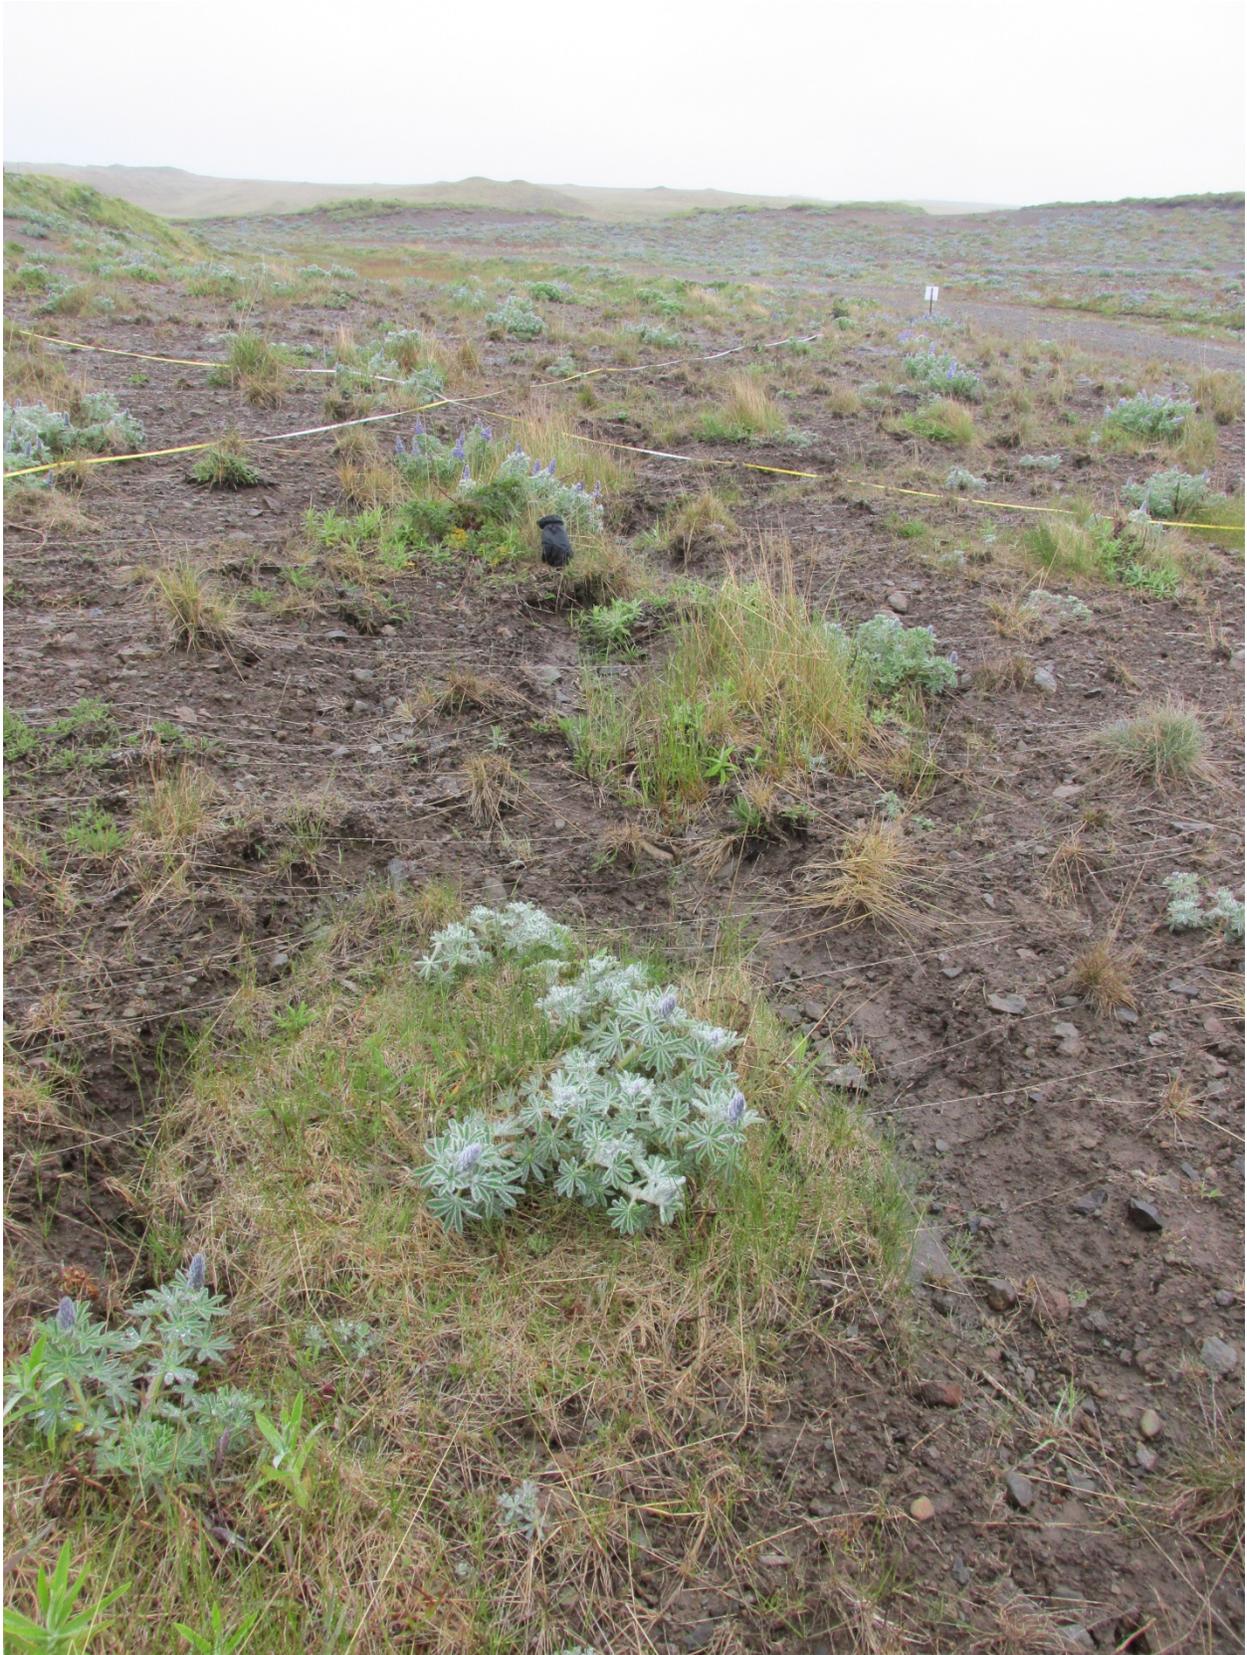
b. Signs damaged or removed?		X	New sign installed at USFWS Monument. Other signs are in good condition.
3. Cap			
a. Evidence of subsidence?		X	
b. Evidence of cracking?	X		Two cracks from the 2014 earthquake are in N part of mud pit cap

IMG_0818 – View W showing straight slump scarp (~9 in.) near intersection of Transects RR-1 and RR-3, Rifle Range

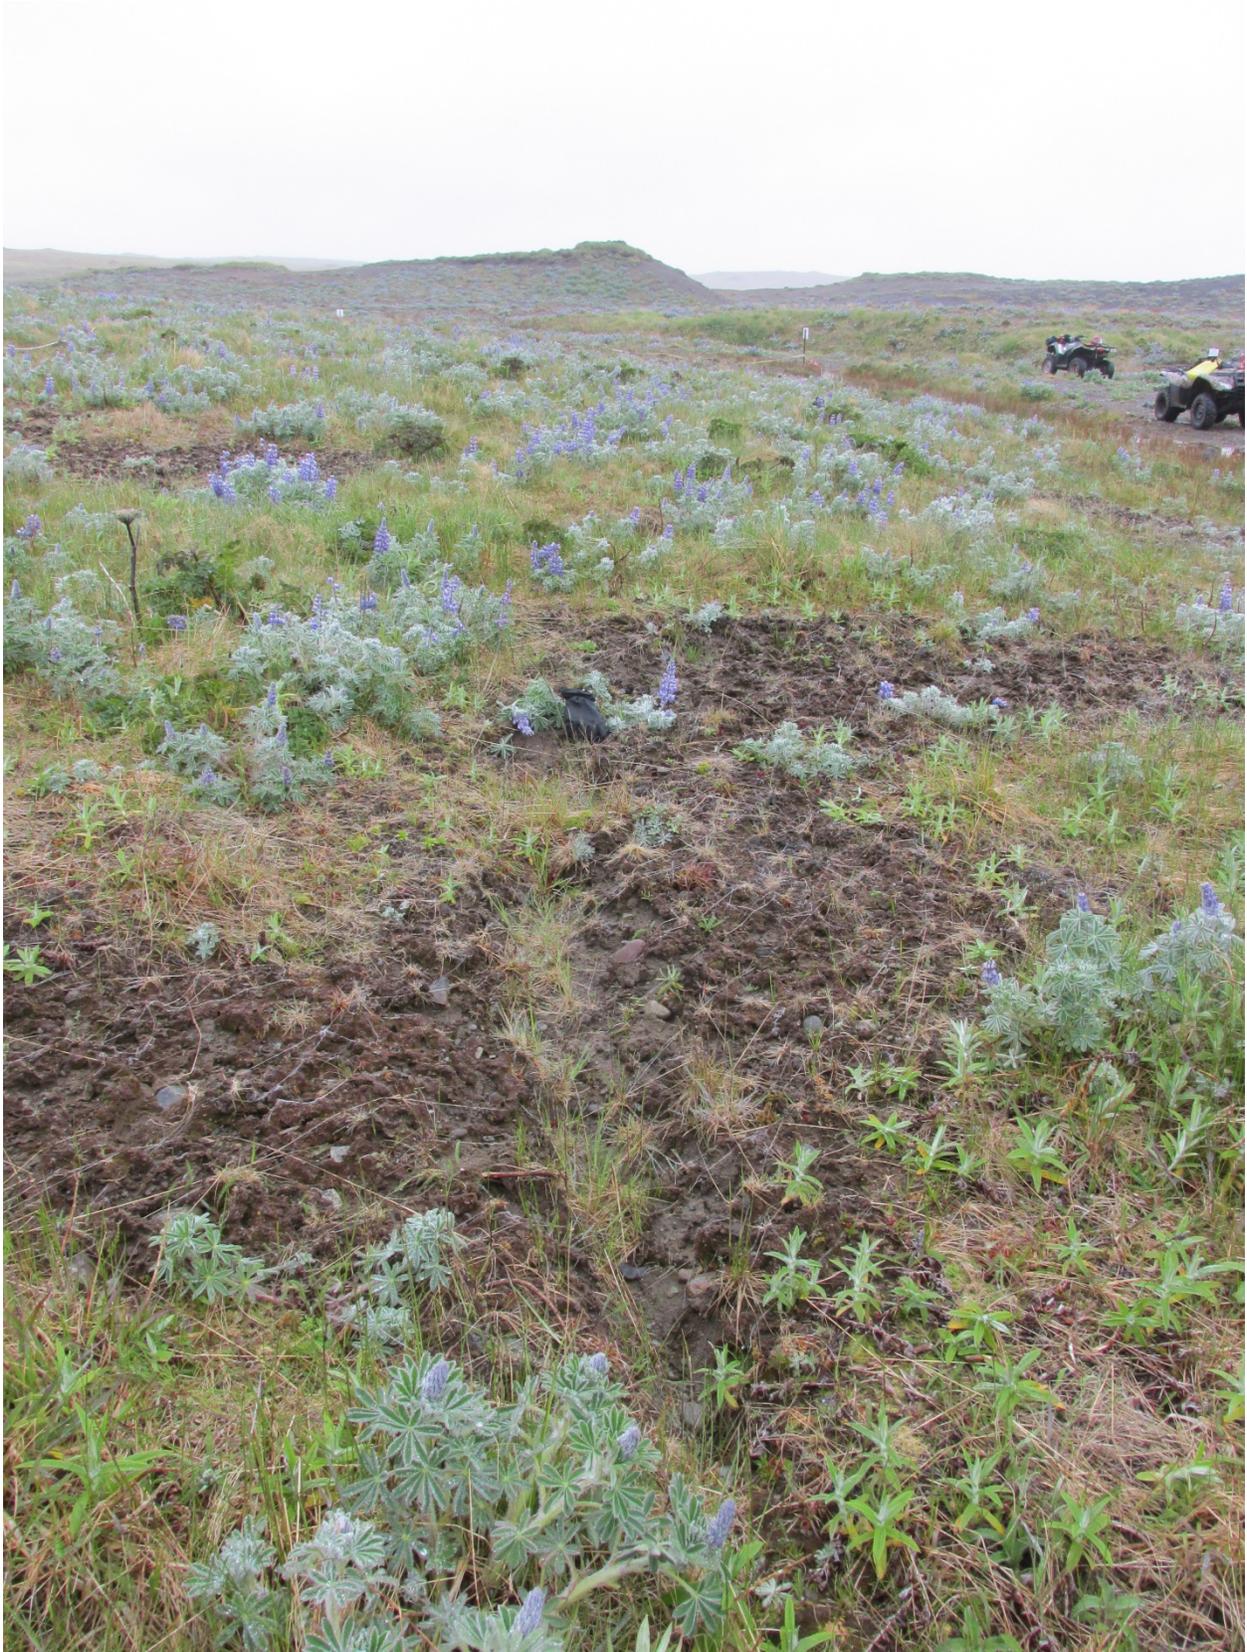
IMG_0819 – View WNW showing arcuate slump scarp (~6 in.) in the NE part of the mud pit cap, Rifle Range

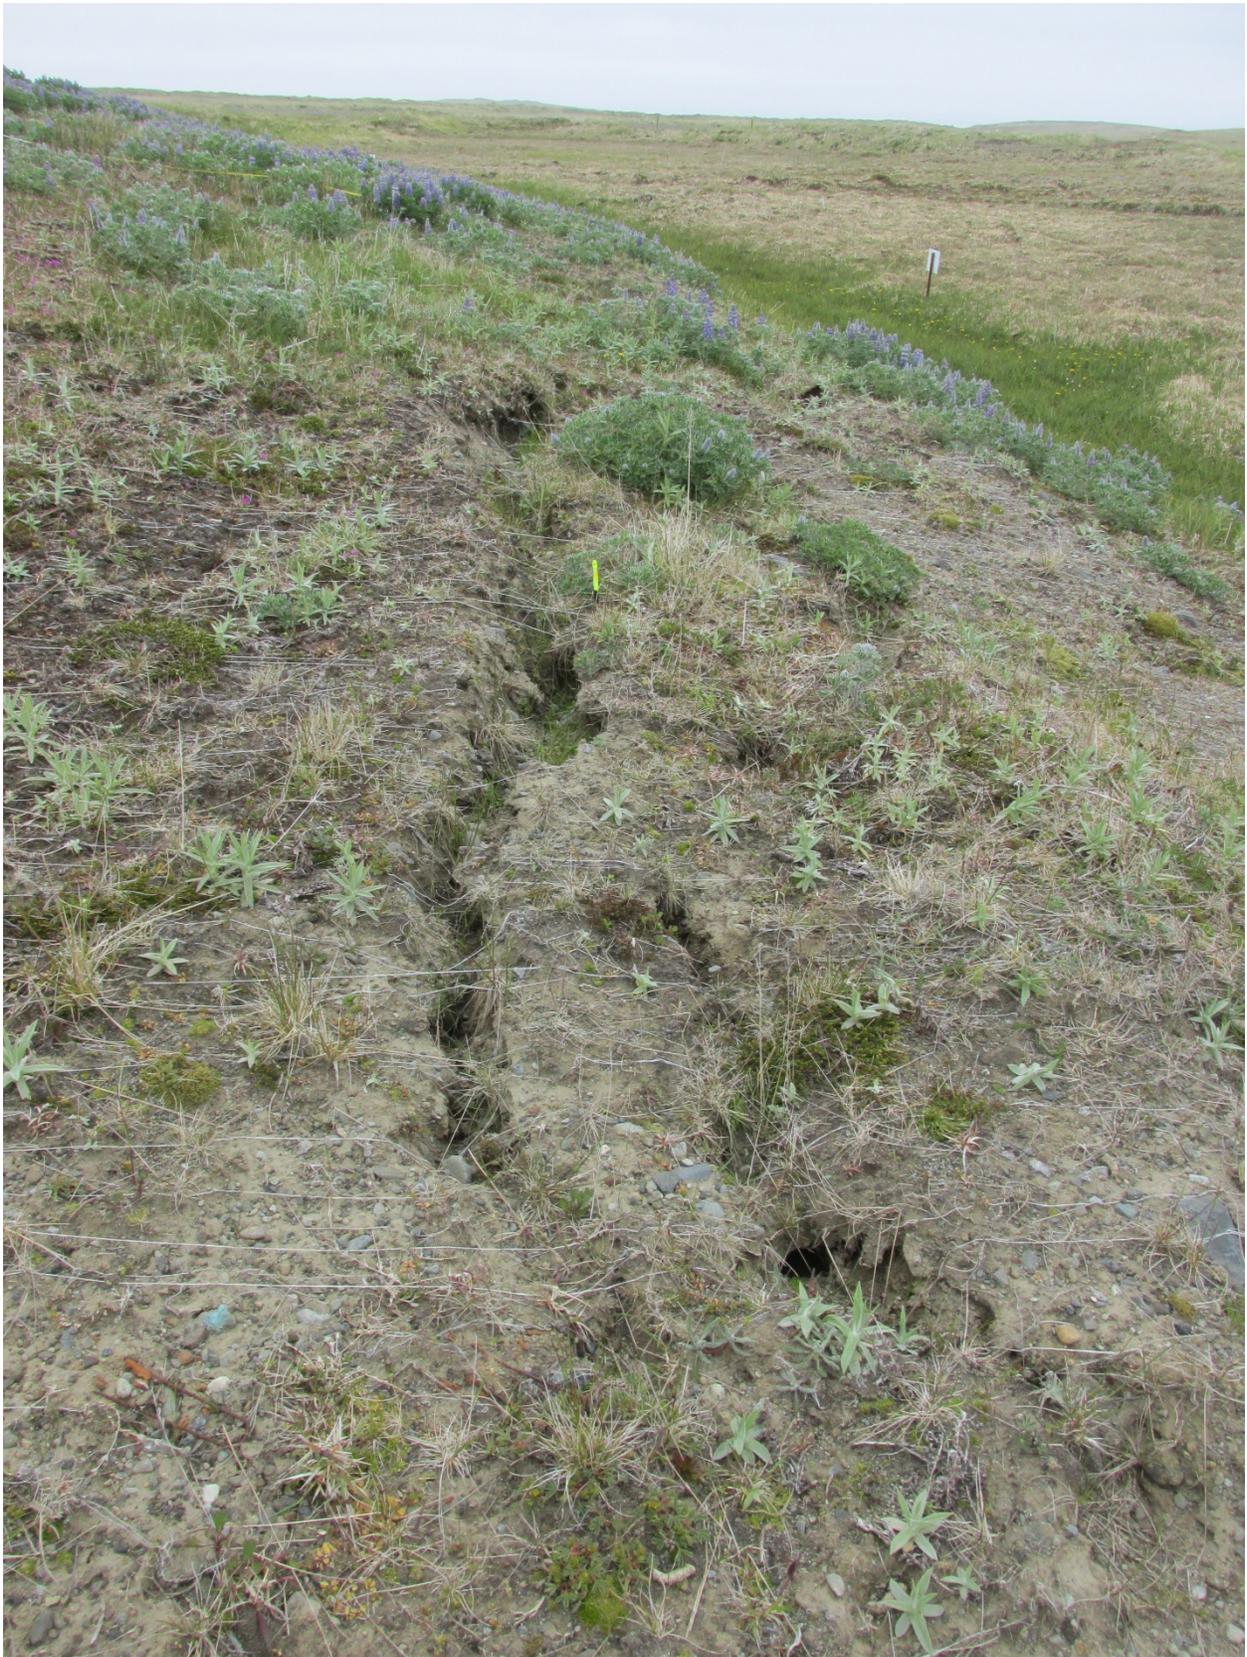
IMG_0793 – View NNE of slump scarp near SE base of mud pit cap, Long Shot

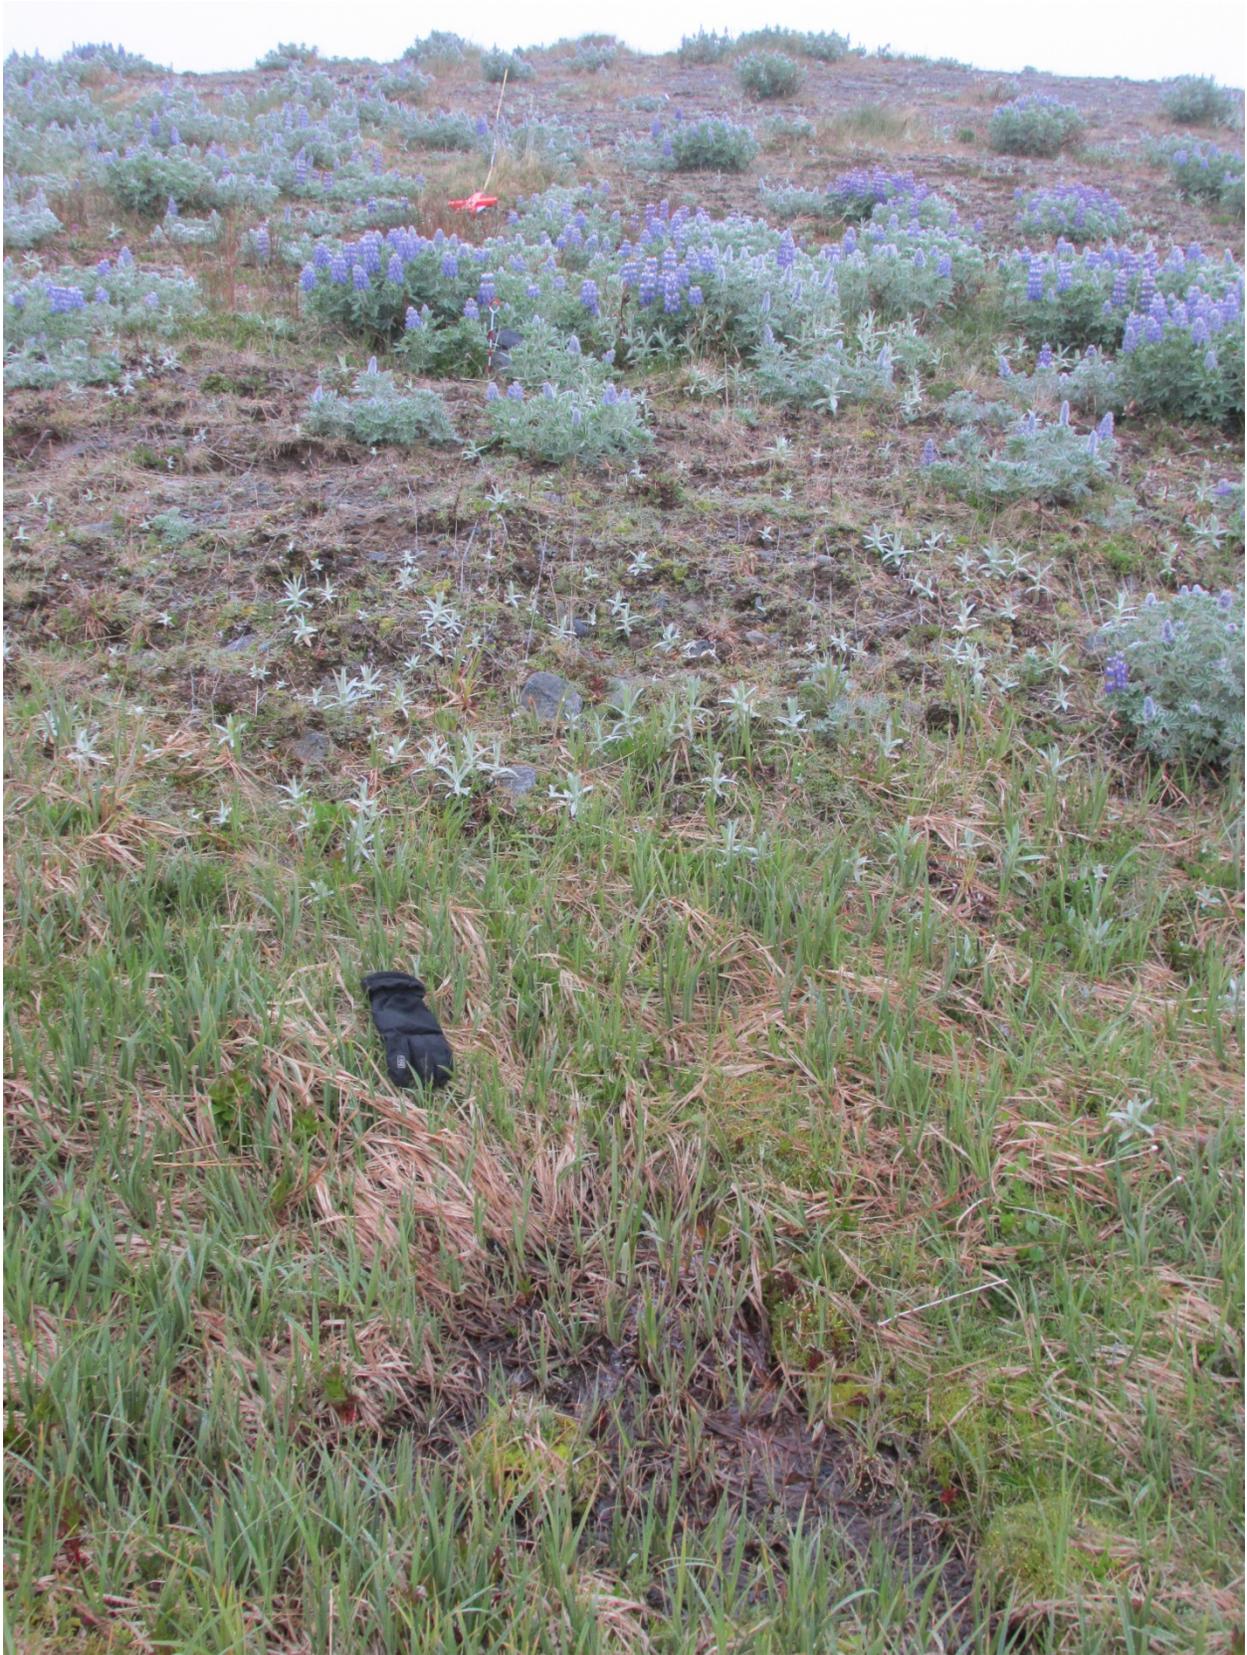
IMG_0795 – View W of small reddish-brown seep just E of mud pit cap, Long Shot

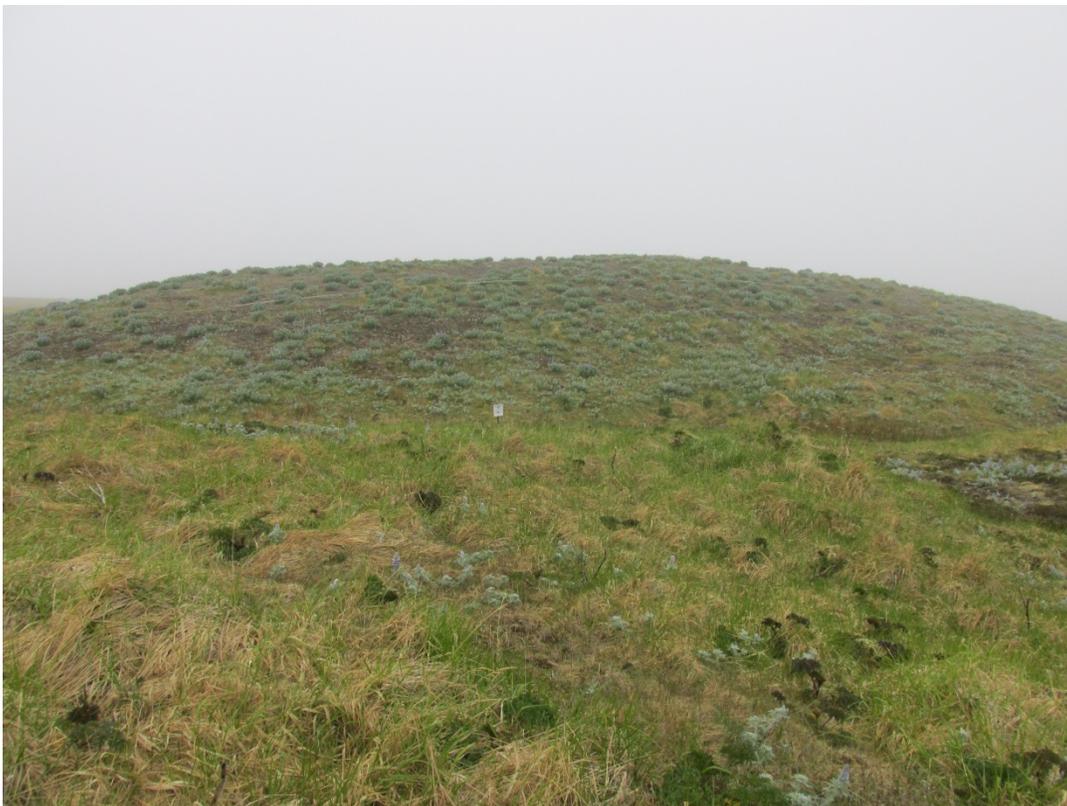
IMG_0804 – View SSW of N side slope of mud pit cap, Long Shot

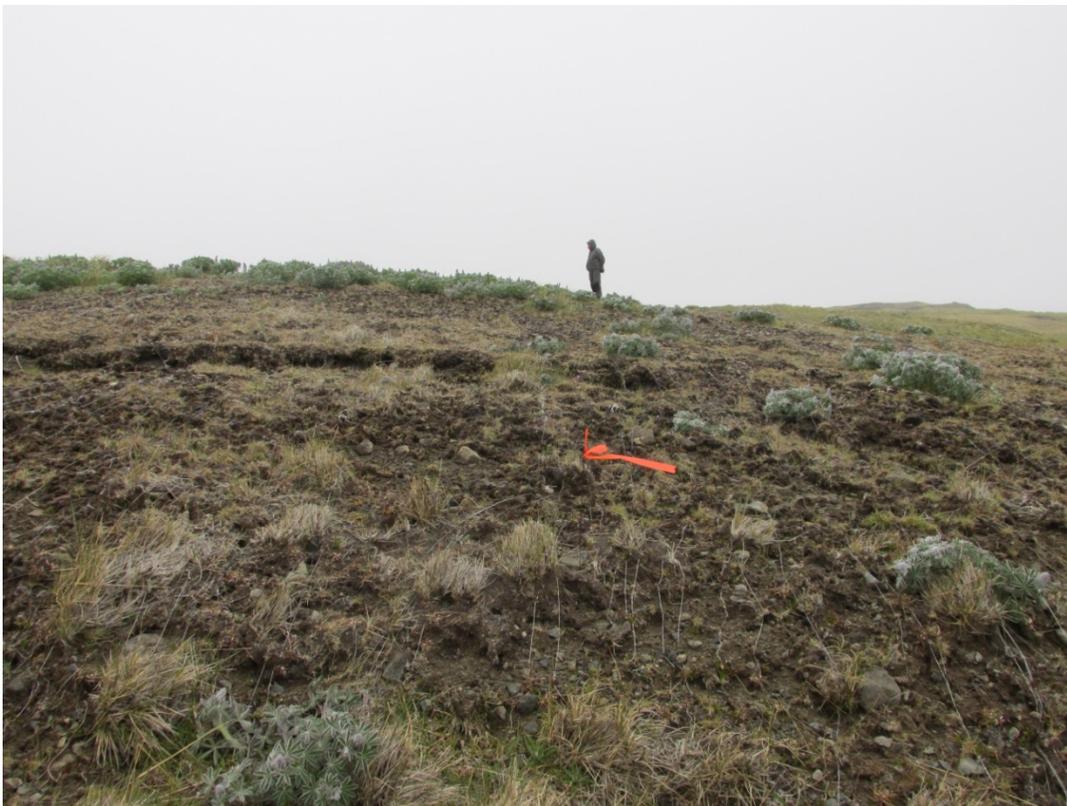
IMG_0717 – View N at Transect D-11SW, small scarp, P. Darr, Site D

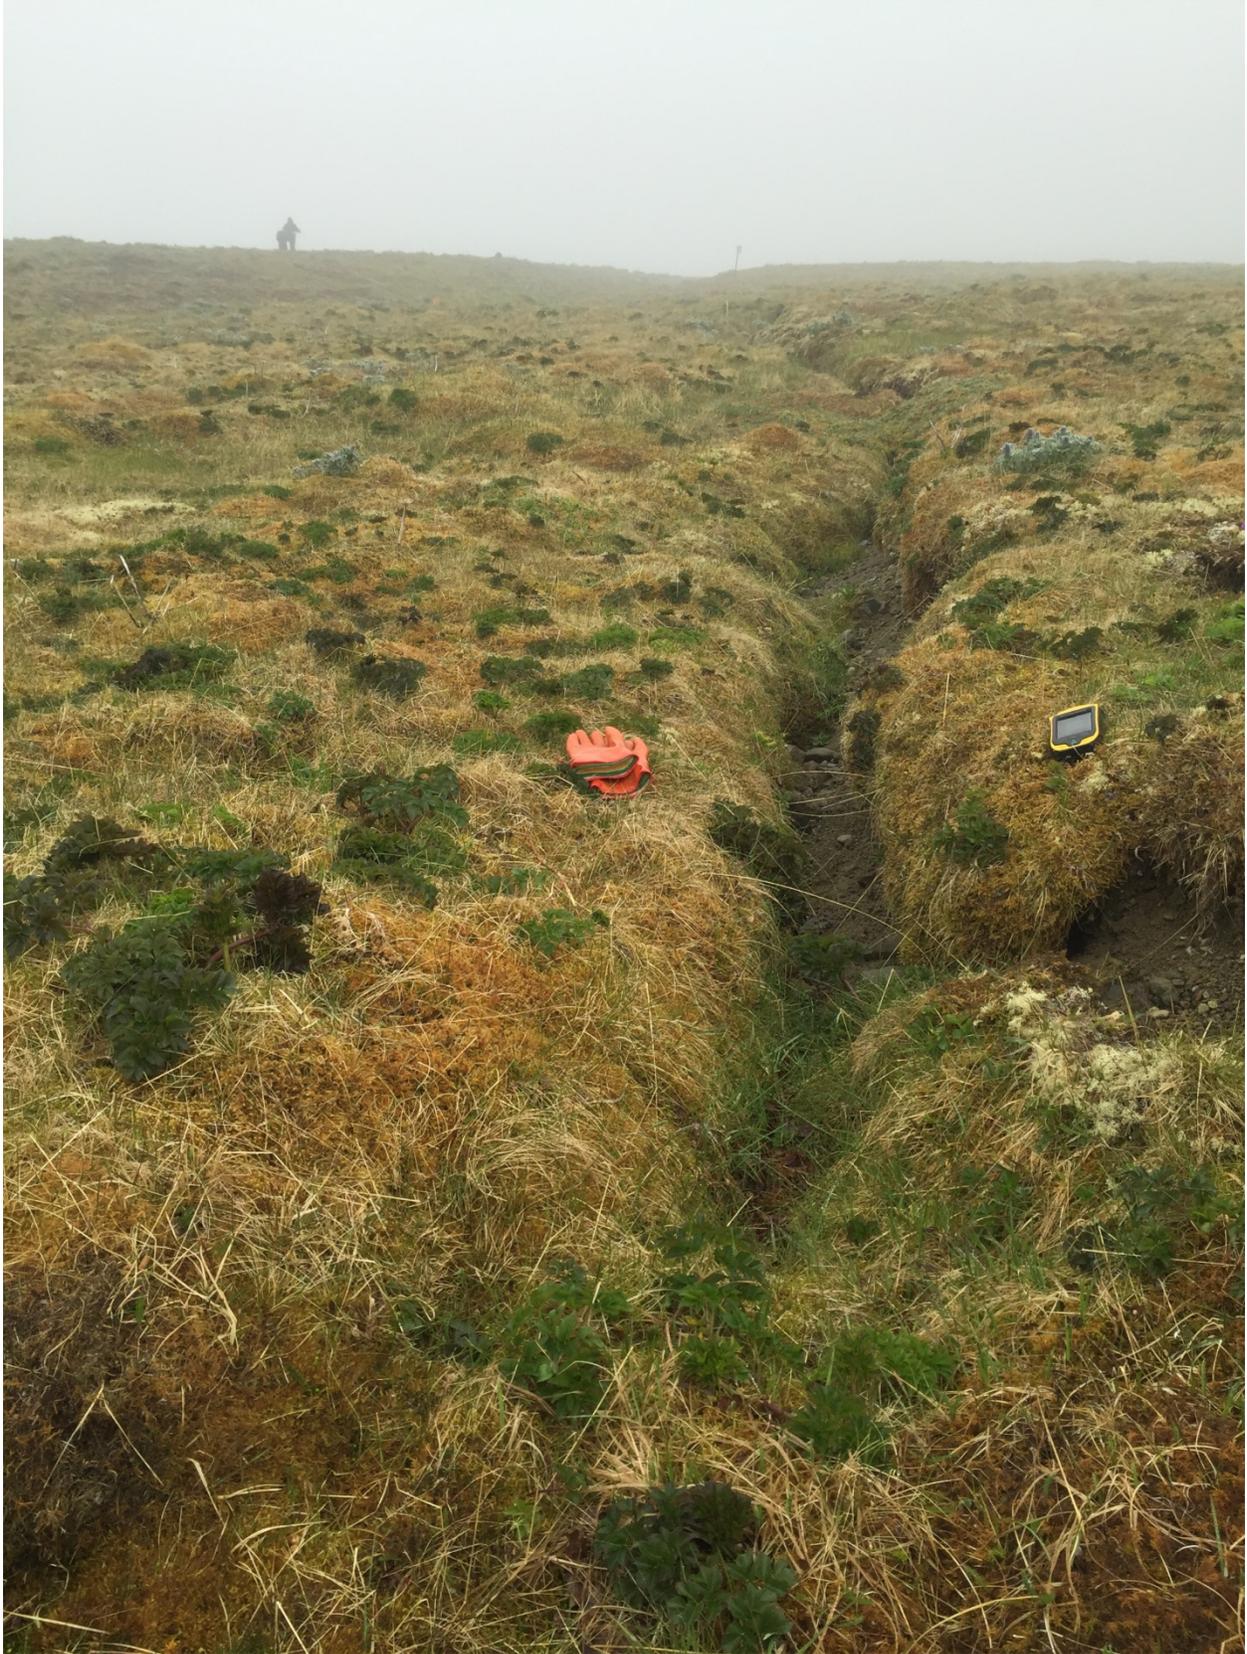
IMG_1103 – View WSW of Crack NE of Mud Pit Cap

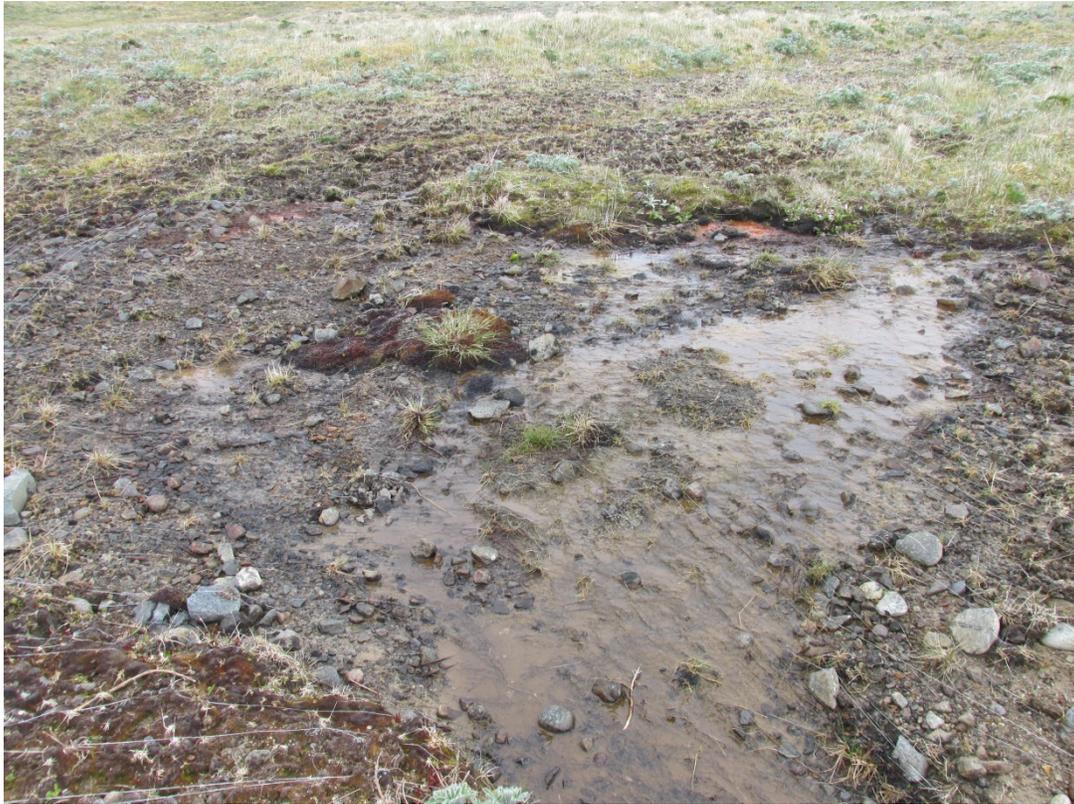
IMG_0683 – View N of small area of reddish-brown seep about 100 ft N of mud pit cap, Site E

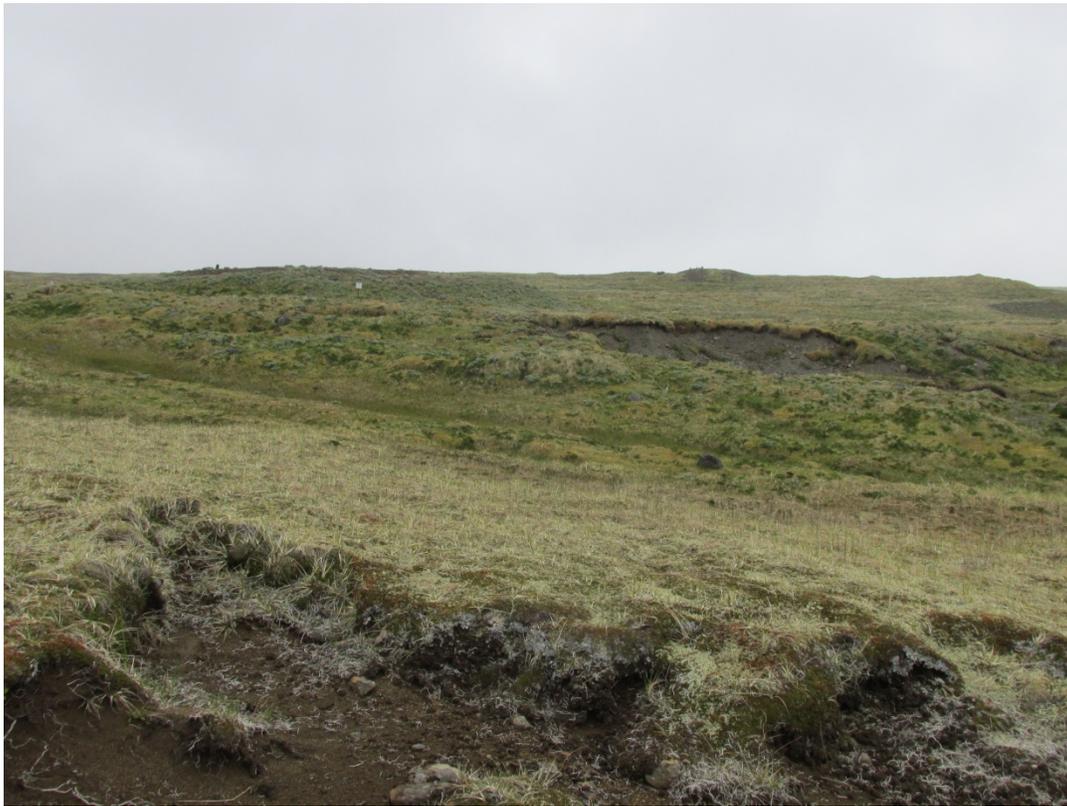
IMG_0685 – View NNE of mud pit cap and slump scarp from 2014 earthquake, Site E

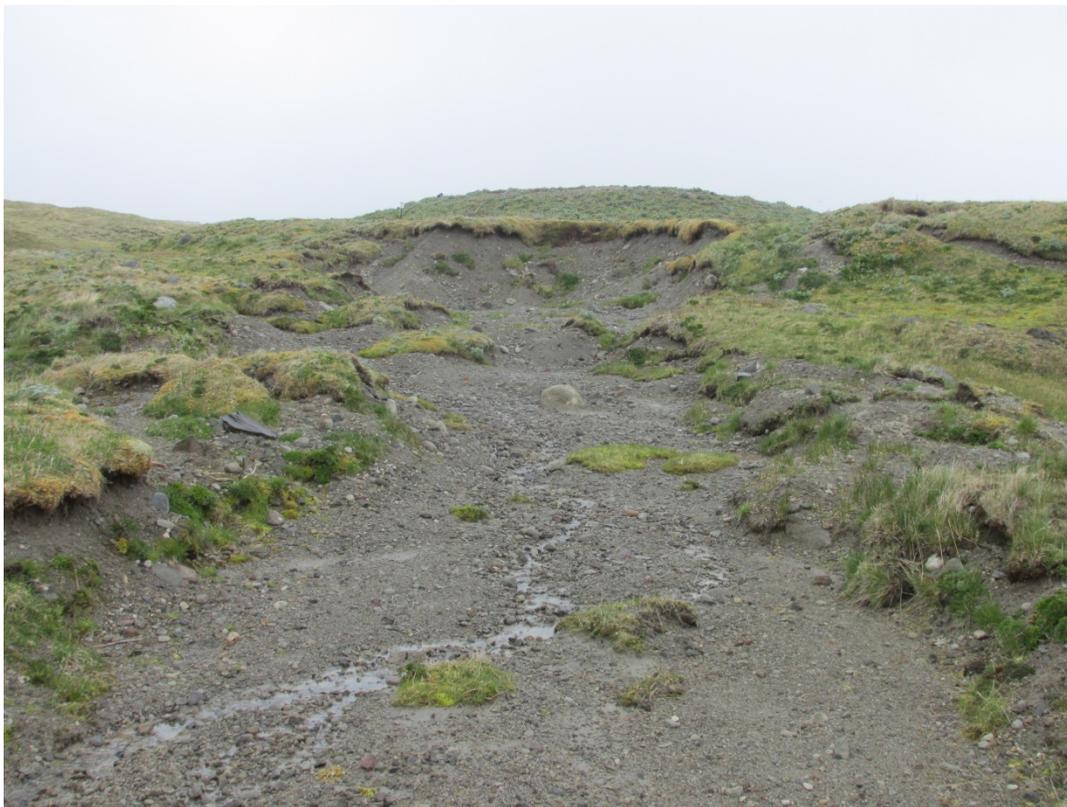
IMG_0686 – View NNW of mud pit cap and slump scarp from 2014 earthquake, Site E

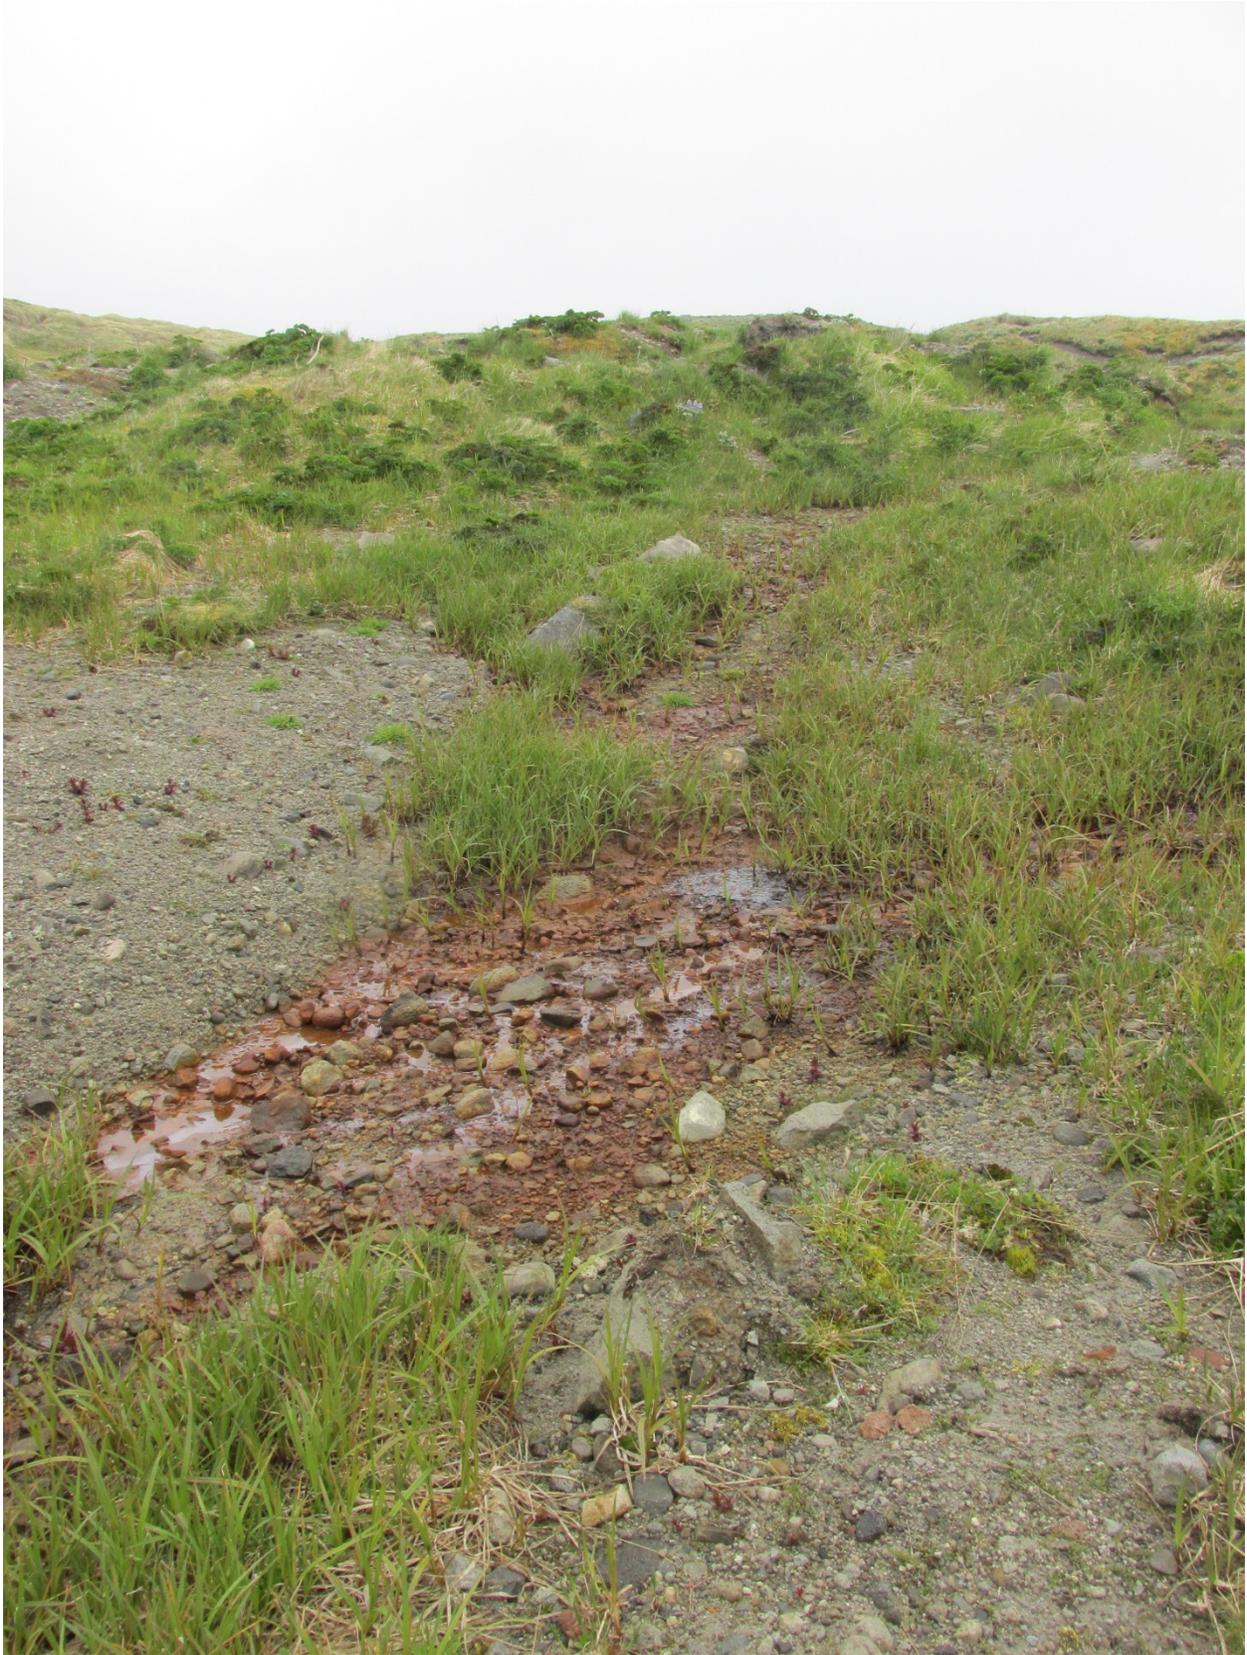
IMG_0687 – View NNW of large area of reddish-brown seeps about 200 ft SSE of mud pit cap, Site E
